## **SEMI-ANNUAL PROGRESS REPORT #7**

1071 HOWELL MILL ROAD  
ATLANTA, FULTON COUNTY, GEORIGIA  
HSI SITE NO. 10637 (WELCOME YEARS, INC.)

**RE: Semi-Annual Progress Report #7**  
**1071 Howell Mill Road**  
**Atlanta, Georgia**  
**HSI Sub-Listed Site No. 10637 (Welcome Years, Inc.)**  
**Tax Parcel ID#17-0150-009-14**

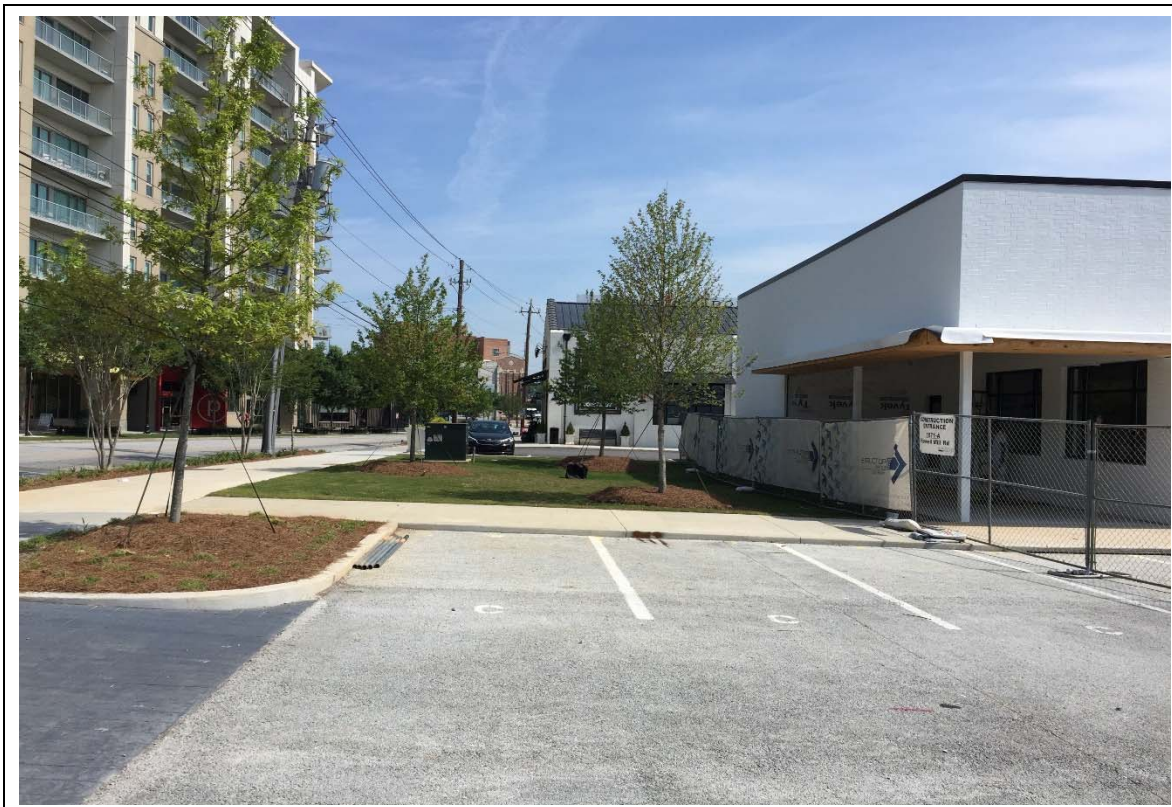
Stormwater control measures have included the installation of a trench drain in the parking area and the installation of an underground detention vault in the western portion of the property (Photo 2). A small area in the northwest corner of the property has been landscaped using borrow soil certified by testing in the Fifth Progress Report dated April 15, 2015 (Photo 1).

Photo 1. View north from southwest property corner.

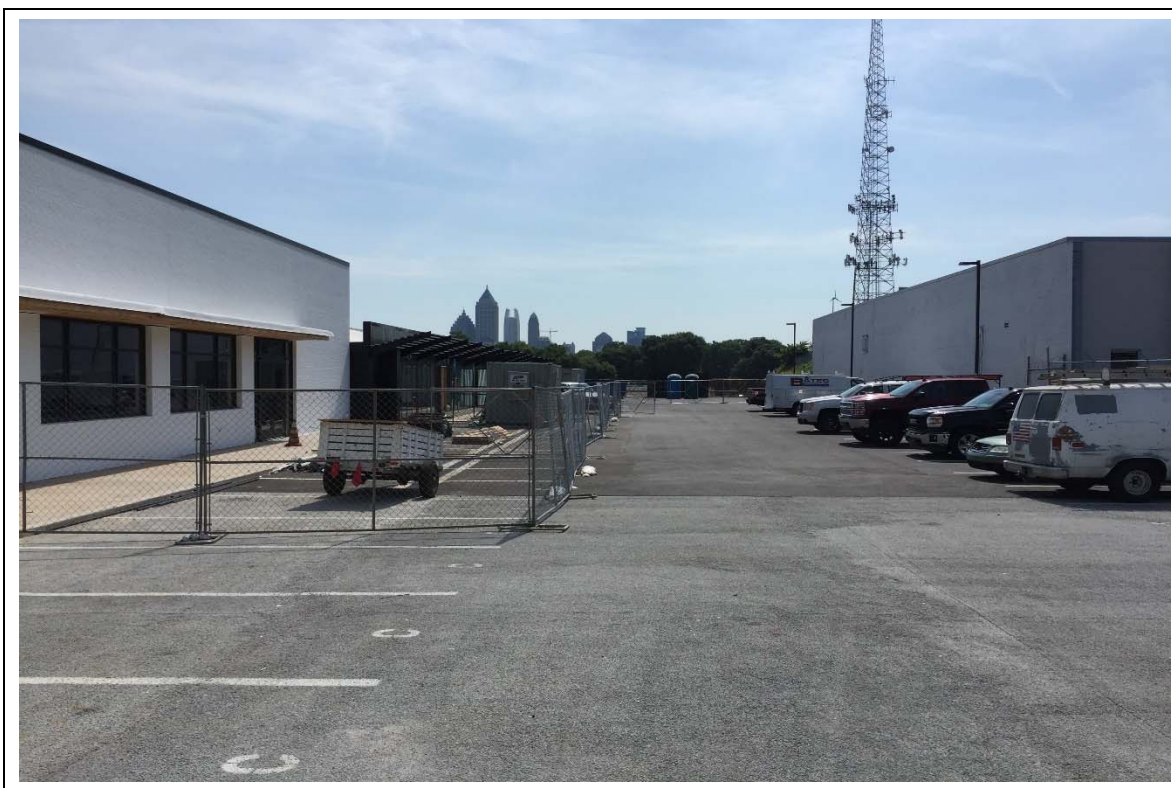
Photo 2. View east across parking lot from Howell Mill Road.

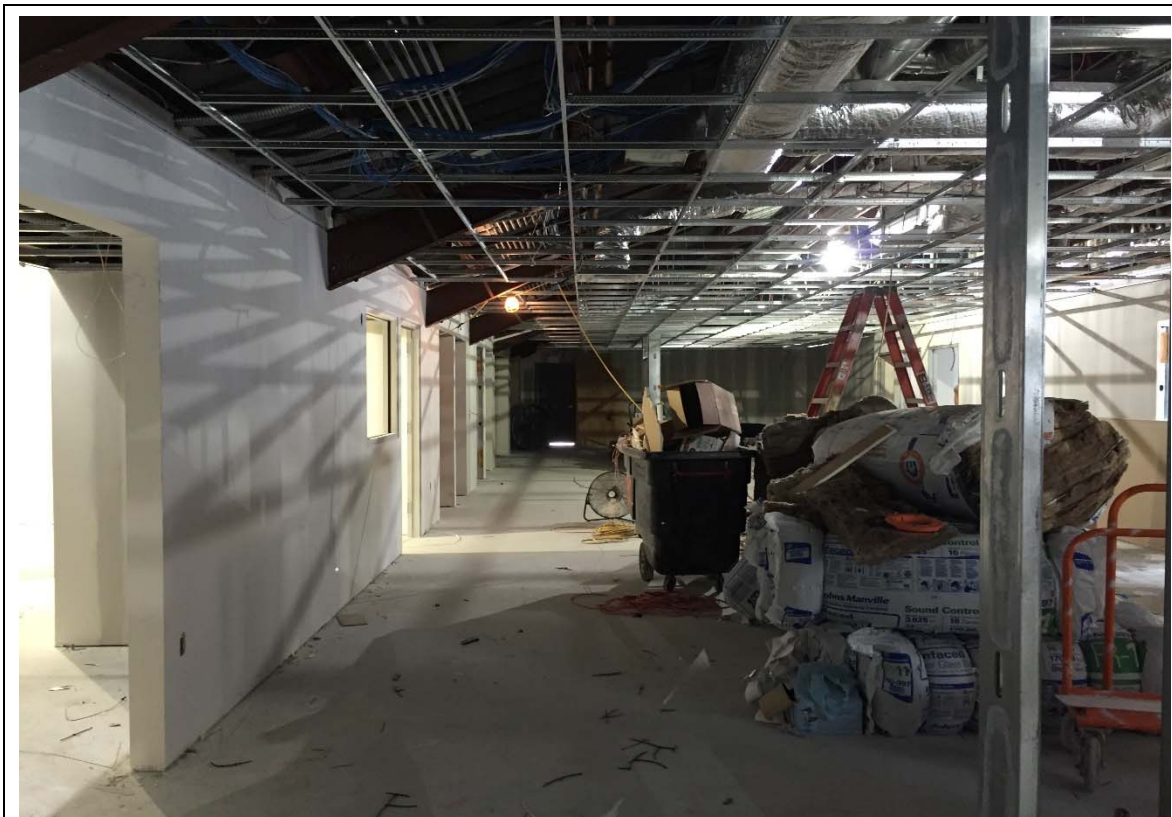
1071 WB, LLC has engaged a contractor, Structor Group, to renovate the existing building. As shown on the attached Figure 1, the building on the southern half of the Site has been demolished and the area converted to a parking lot by overlaying asphalt on the remaining building floor slab as the pavement hardcover. The remaining building on the northern half of the Site has been gutted for renovation, re-using the existing building super-structure and floor slab. A restaurant is under construction at the western end of the existing building. The remainder of the building is currently being built out to house a veterinary clinic. Floor slab penetrations reported in the Sixth Progress Report observed have been filled. An additional concrete floor slab has been poured in the restaurant space as well as throughout the remainder of the building (Photos 3 and 4).

Photo 3. Interior of building looking east.

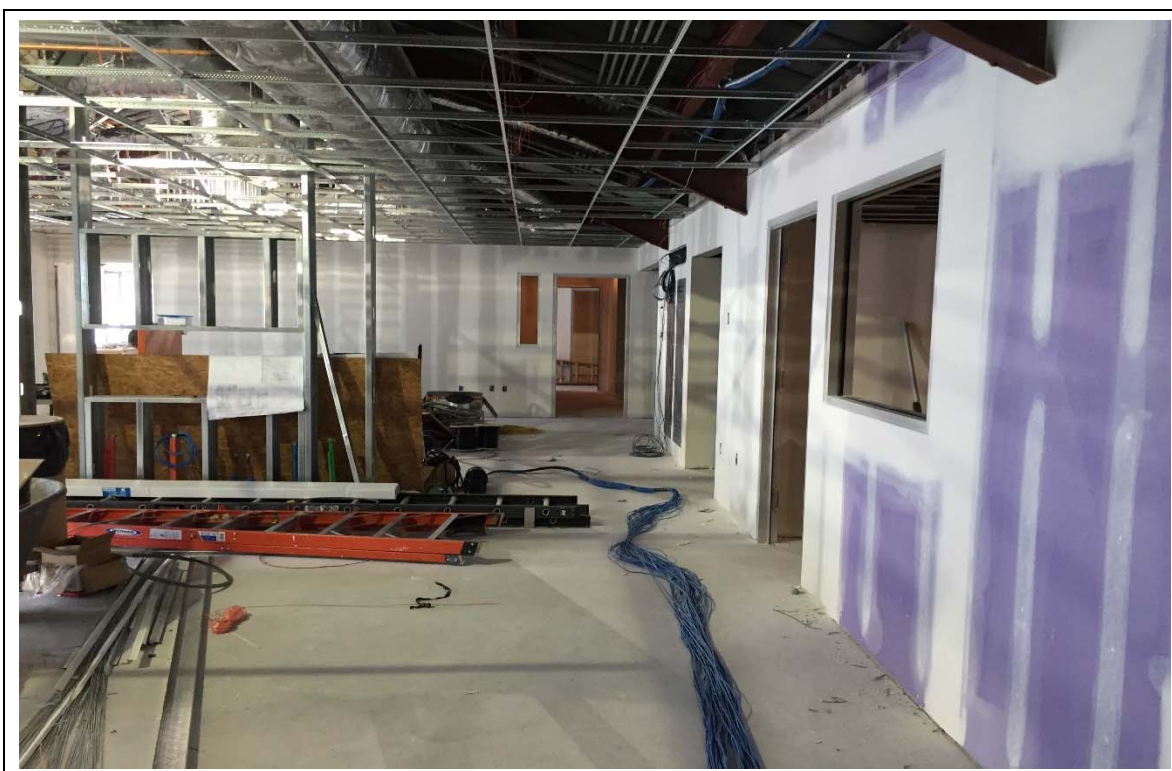
Photo 4. Interior of building (office).

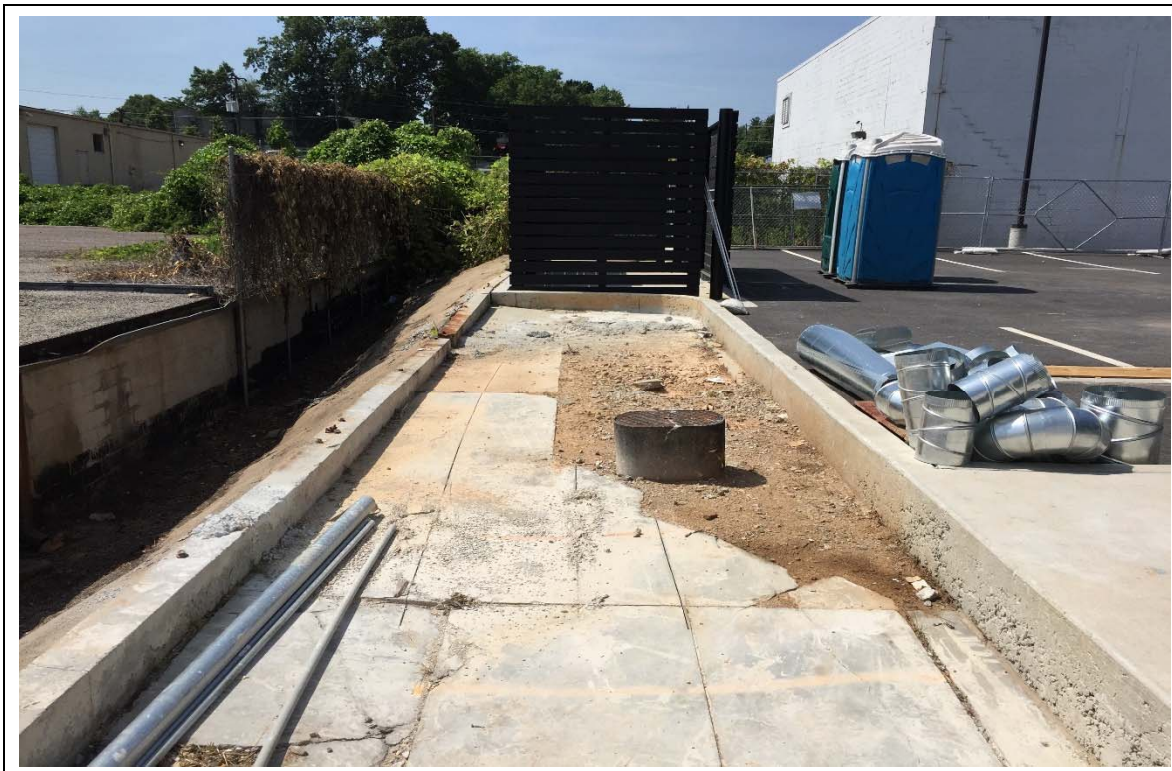
Portions of the concrete pavement at the east end of the Site have been saw-cut in preparation for installation of footings to support a canopy over a planned dog walk at the east exterior of the building. Temporary fencing in the area has also been removed and will be replaced after construction of the dog walk.

Heavy vegetation has been removed from the slope at the east end of the Site. Spray-applied grout (gunite) has been placed as cover and for stabilization on the slope up to the property boundary.

Photo 5. View of saw-cut concrete, exposed soil, fencing gap and cleaned slope at east end of the property.

The slope at the east end of the property has been cleared and gunited to the property line. The cut concrete and exposed soil at the east end of the property will be covered with an additional concrete slab, installed during construction of a dog walk. Permanent fencing along the east side of the property will also be installed after construction of the dog walk.

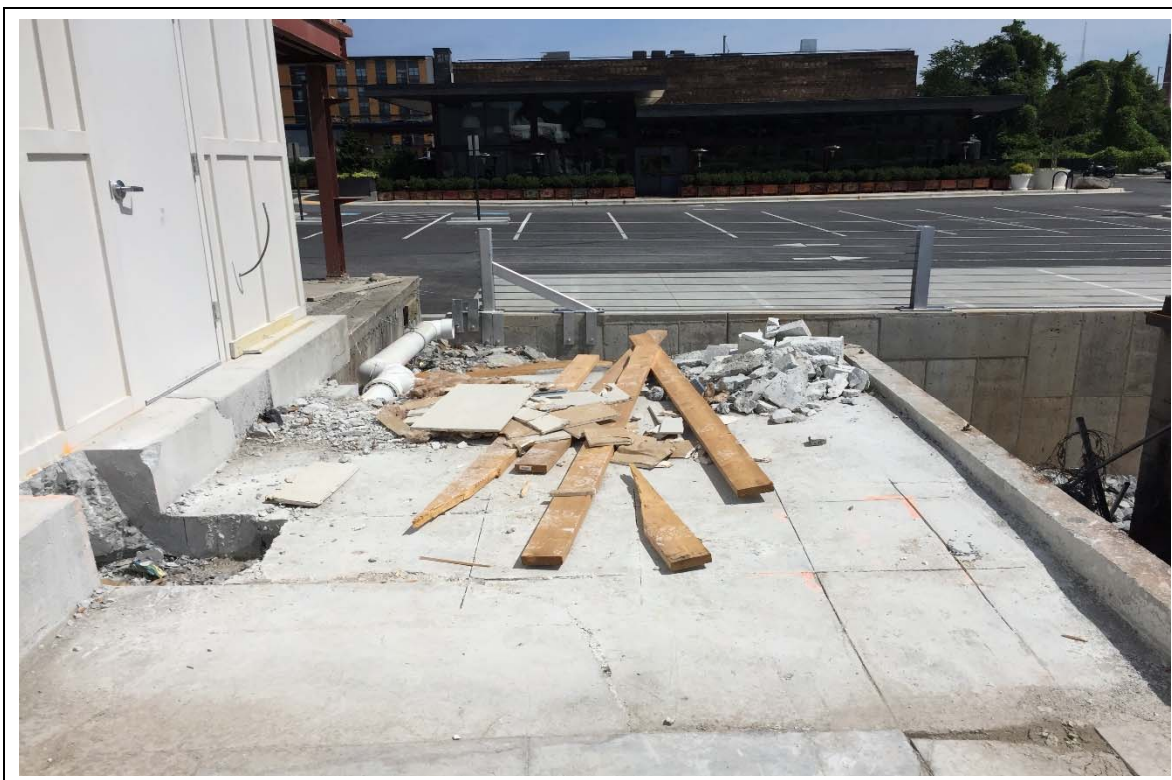
Photo 6. View of saw-cut concrete and fencing gap behind building at east end of site.
