SUPPORTING THE GEORGIA WORLD CONGRESS CENTER

February 14, 2014

**Subject: Quarters-38/39 Landfill Maintenance and Inspection Report
 Northside Drive Landfill Site, Atlanta, Georgia**

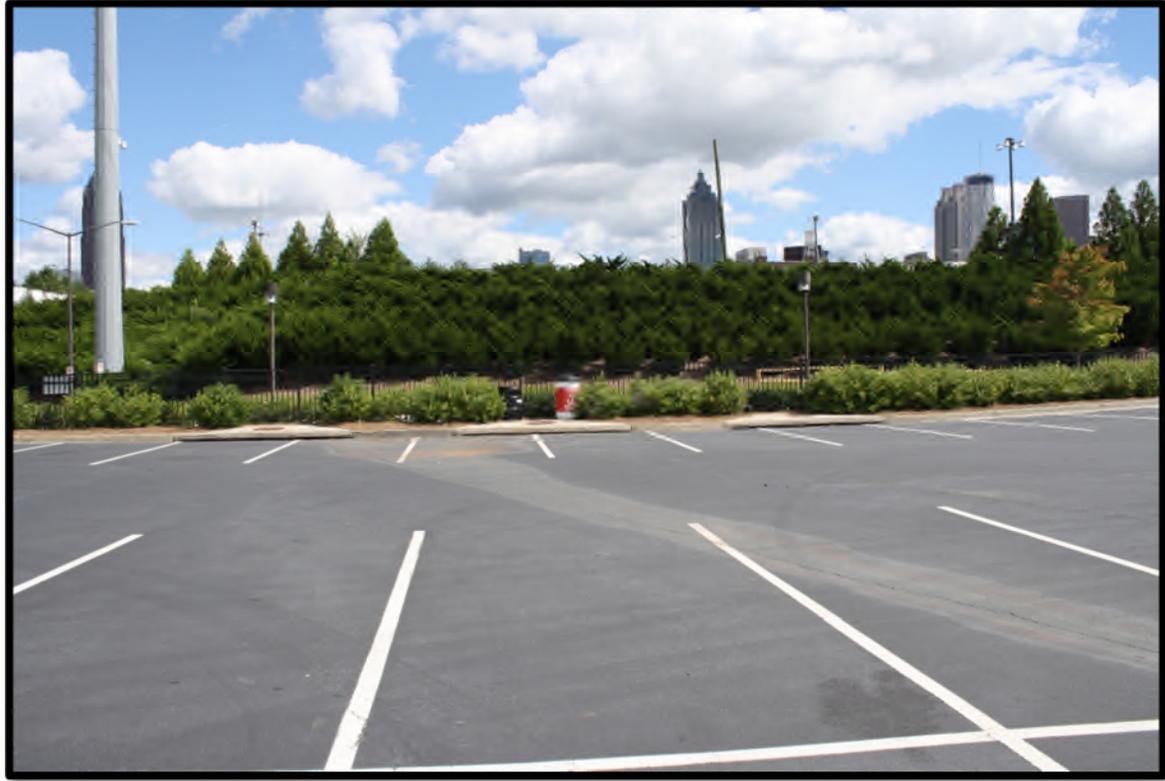
OFFICIAL PHOTOGRAPH NO. 23
TETRA TECH

Subject: Stormwater drains located at the eastern parking lot perimeter.
The existing crack was still present, but had not increased in size.

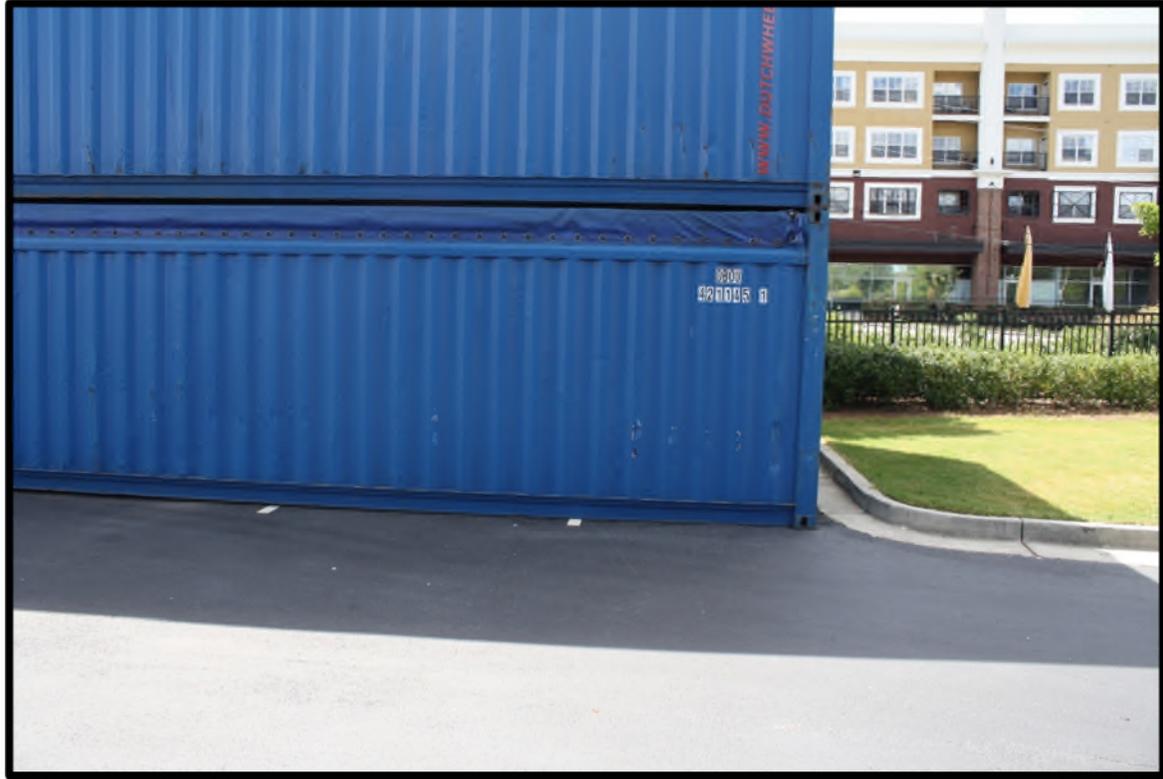
**OFFICIAL PHOTOGRAPH NO. 26
TETRA TECH**

During both the September and December 2013 inspections, Tetra Tech observed a number of sea-land shipping containers placed at the western end of the parking lot, adjacent to Northside Drive. The containers, shown in photograph 41 of the respective photographic logs, are located at the edge of the parking area, outside the limits of the slurry wall and no damage to the parking lot or landscaping structures was observed during our inspections. As shown in photograph 26A in each photographic log, the containers have been placed so that the storm drain present at that location is not blocked.

Subject: Location of stormwater drain on the west side of the parking lot perimeter. A cargo container is being stored in front of the drain.

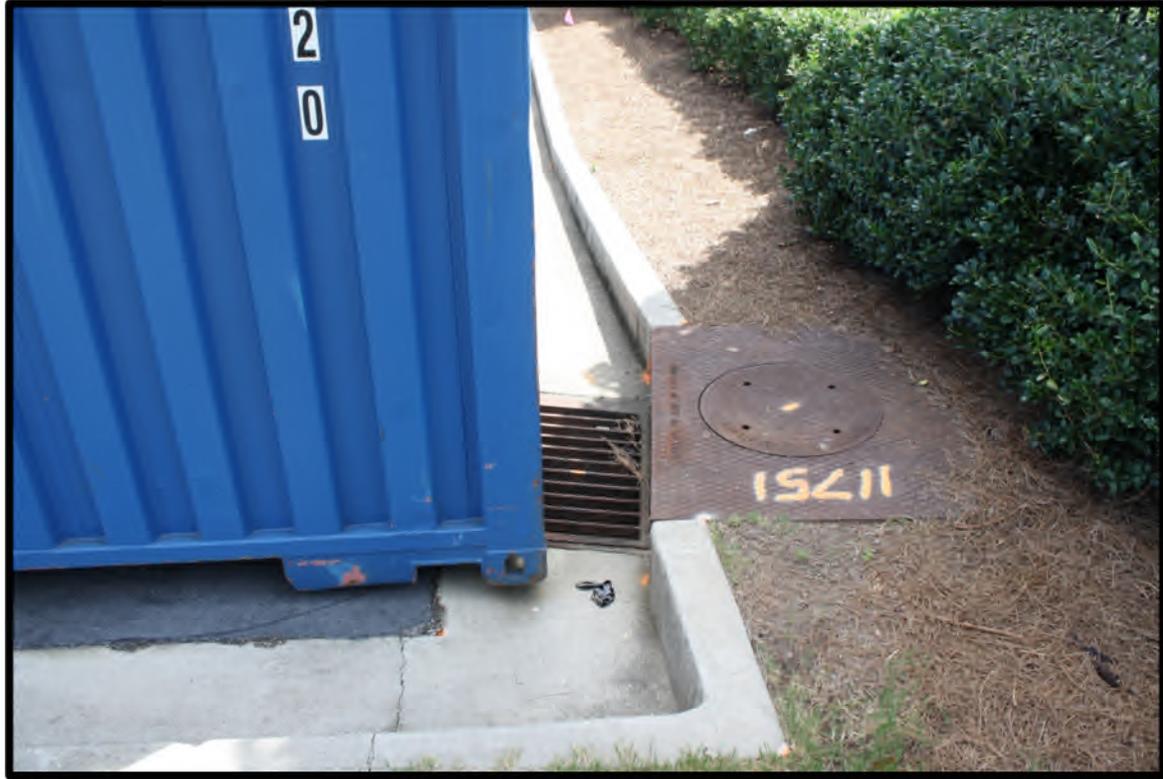
OFFICIAL PHOTOGRAPH NO. 26A
TETRA TECH

Subject: Close-up view of the stormwater drain located behind the cargo container stored along the west side of the parking lot perimeter.

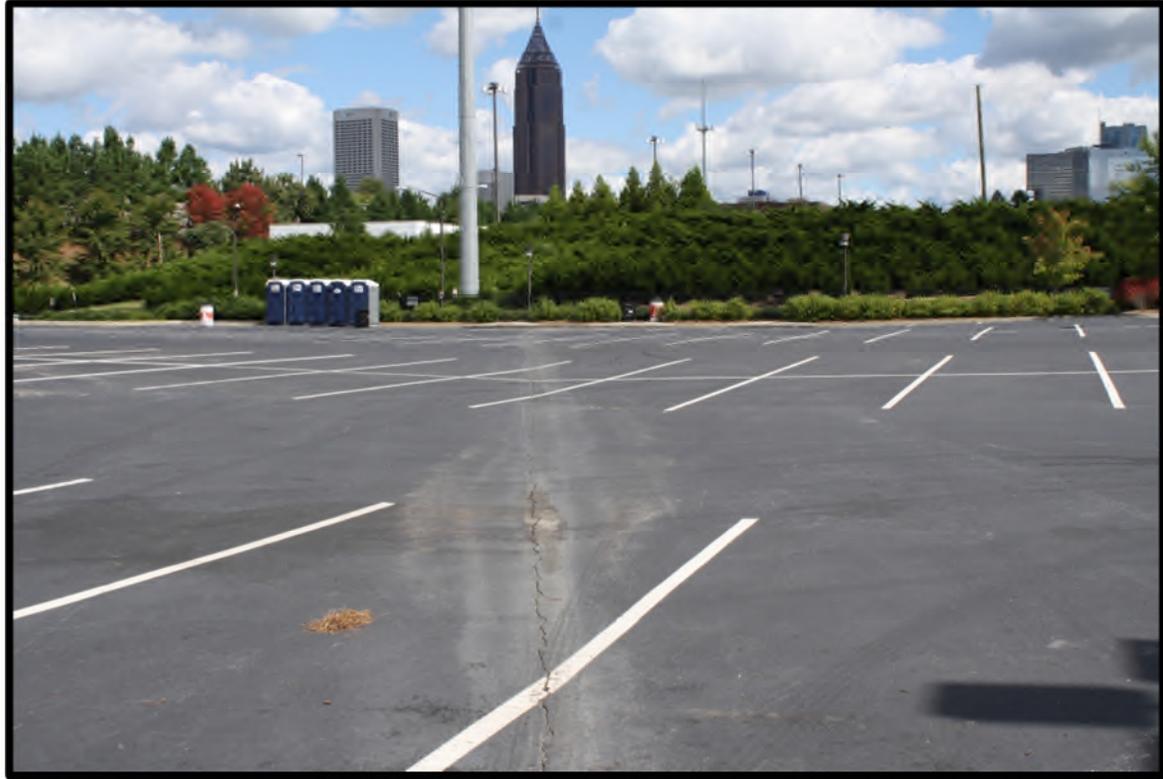
OFFICIAL PHOTOGRAPH NO. 27
TETRA TECH

Subject: A small crack in the asphalt leading to the stormwater drains on the eastern side of the parking lot. Stormwater flows in this low point of the parking lot, which has caused minor staining. The crack is estimated to be approximately 200 feet long, ¼ inch wide and ¼ inch deep. The existing crack was still present, but had not increased in size.

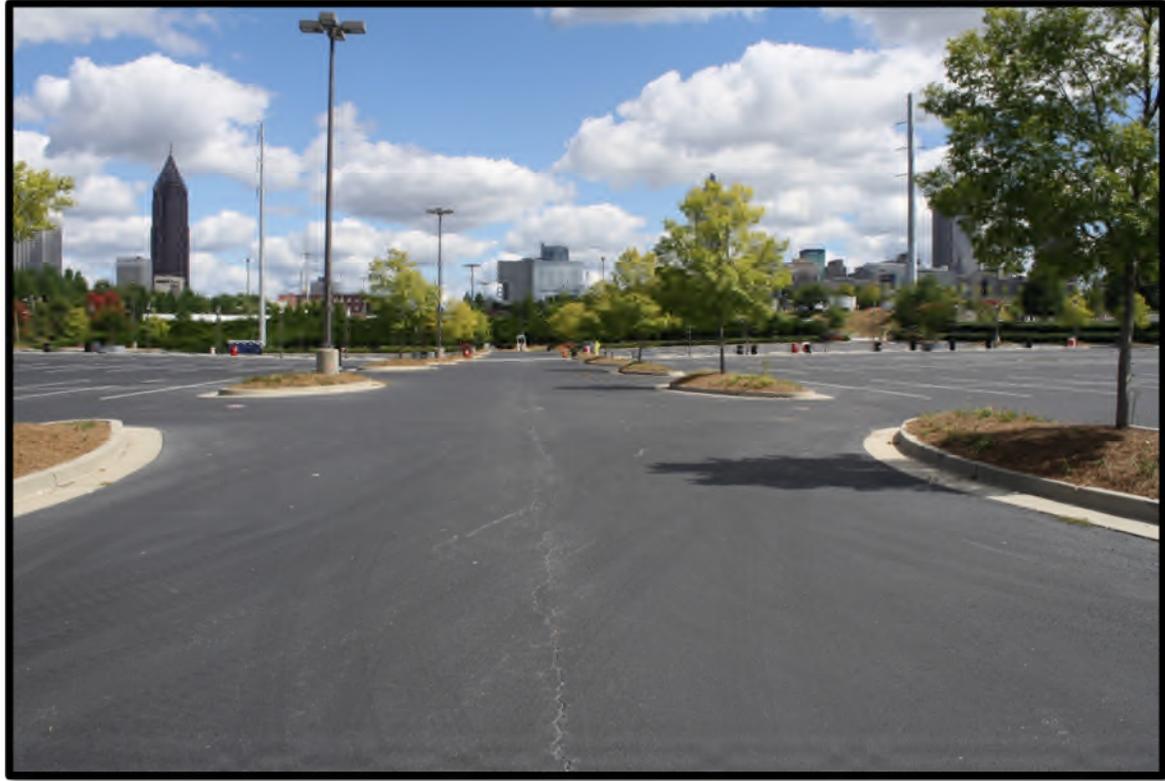
OFFICIAL PHOTOGRAPH NO. 28
TETRA TECH

Subject: Example of another crack which runs east to west on the main entrance/exit roadway. Like the previously observed crack, it is no larger than ¼ inch wide and ¼ inch deep. This crack traverses almost the entire length of the entrance/exit roadway. The existing crack was still present, but had not increased in size.

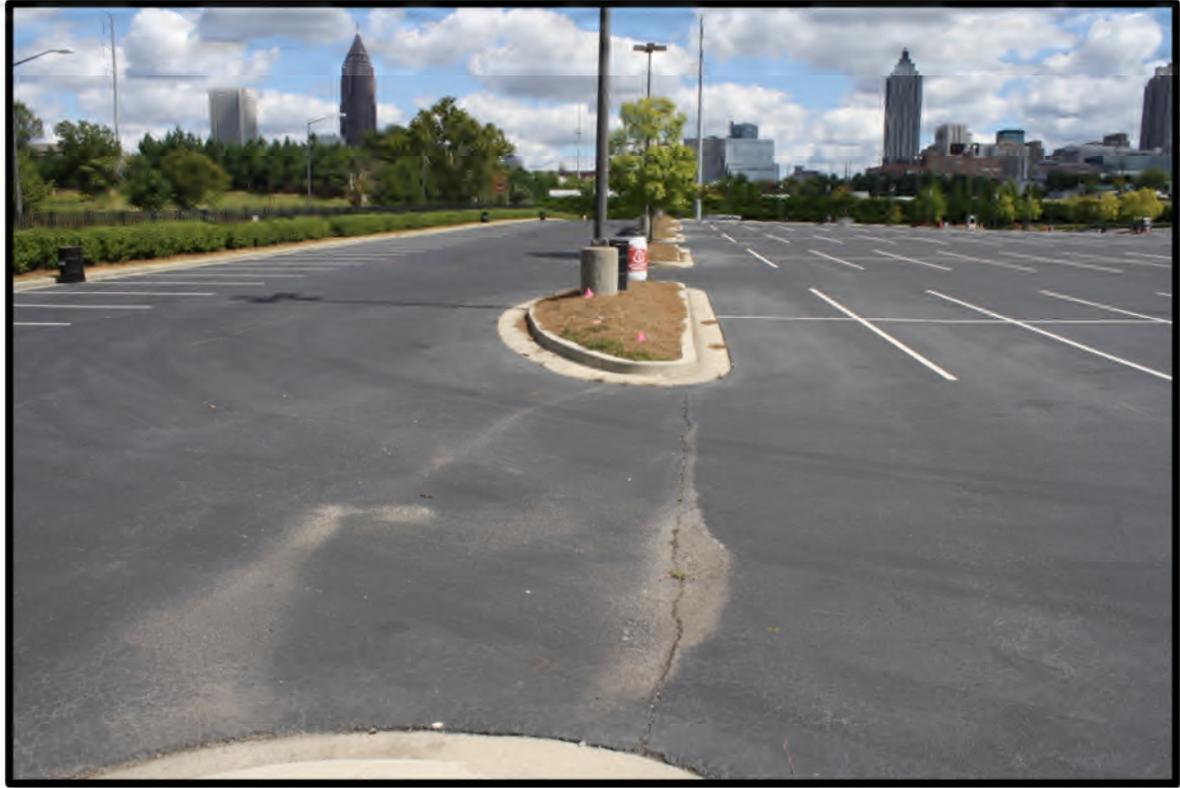
**OFFICIAL PHOTOGRAPH NO. 29
TETRA TECH**

Subject: Example of another crack which runs east to west on the entrance way of the parking lot row. Over half of the rows have cracks similar to this one. They occur where the asphalt seams are joined. Like the previously observed crack, it is no larger than $\frac{1}{4}$ inch wide and $\frac{1}{4}$ inch deep. The existing crack was still present, but had not increased in size.

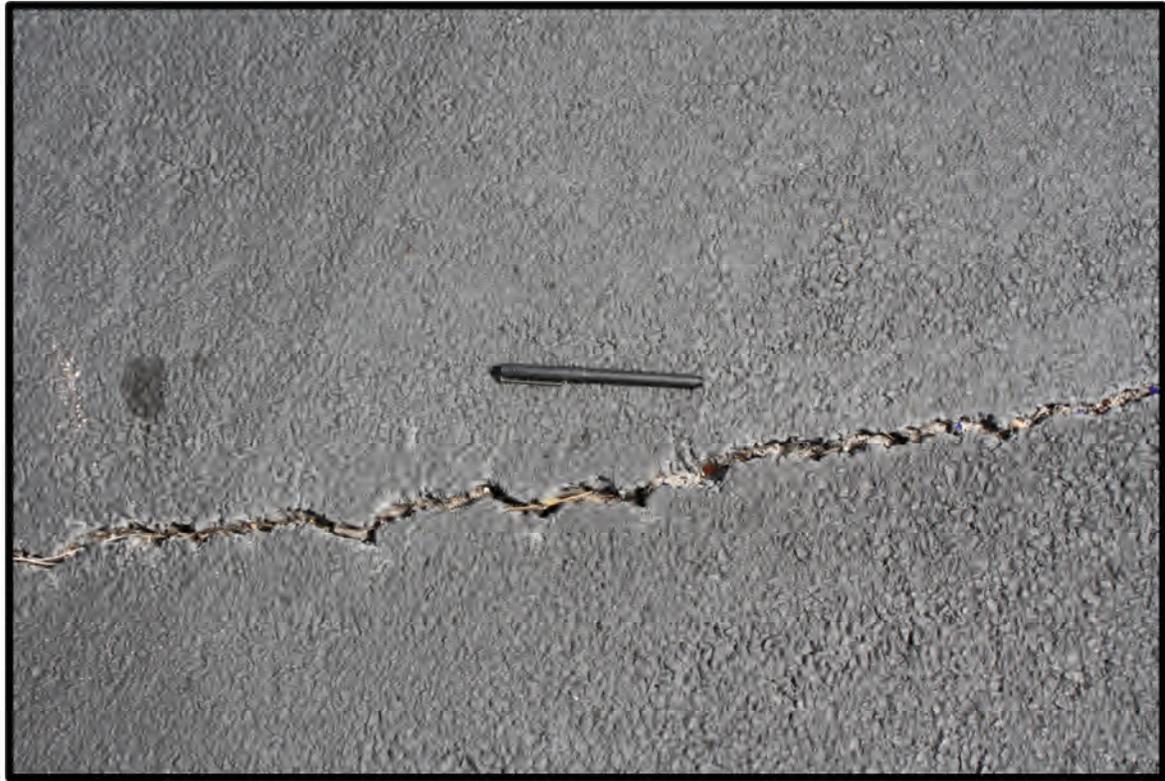
OFFICIAL PHOTOGRAPH NO. 30
TETRA TECH

Subject: Example of another crack, which runs north to south on the western most row of the north parking lot. A standard pen is used to show the approximate width of the crack. The width of this crack is typical of all cracks observed in the asphalt of the north parking lot. The existing crack was still present, but had not increased in size.

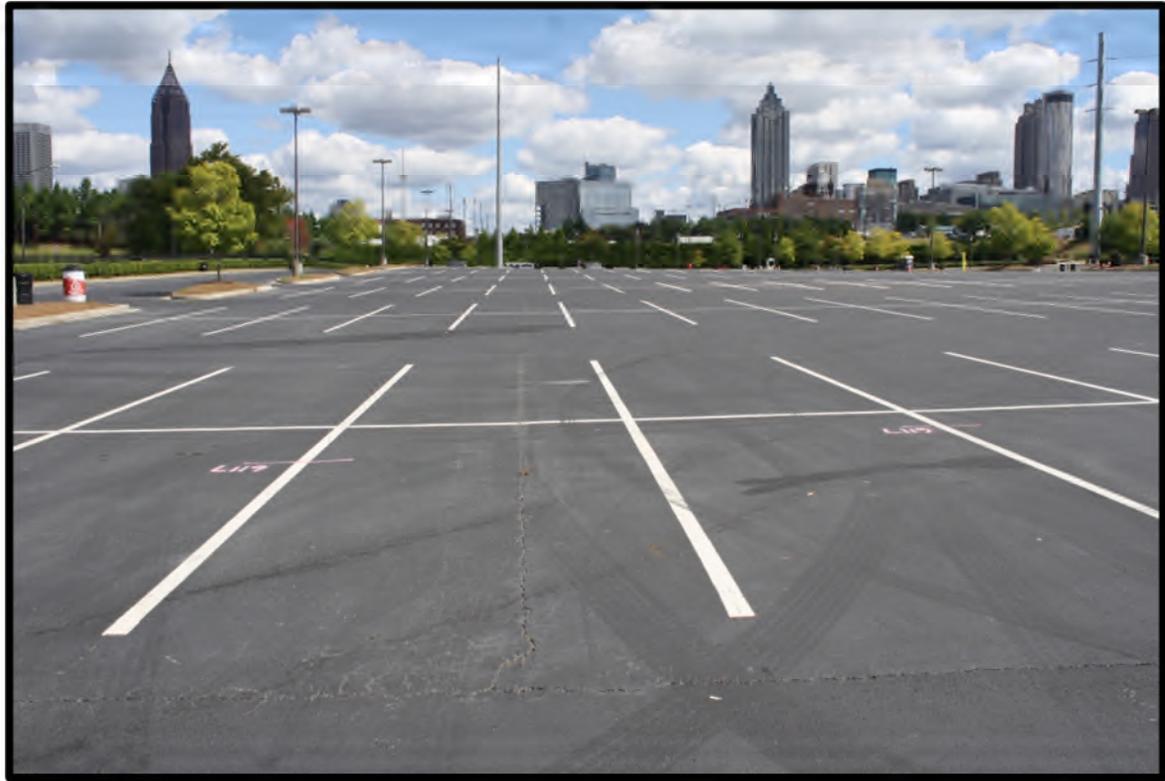
**OFFICIAL PHOTOGRAPH NO. 31
TETRA TECH**

Subject: Example of another crack which runs east to west. This crack is located on the northern portion of the parking lot and traverses the entire parking lot west of the north/south walkway. Once again, this crack occurs where the asphalt seams are joined. Like the previously observed cracks, it is no larger than $\frac{1}{4}$ inch wide and $\frac{1}{4}$ inch deep. The existing crack was still present, but had not increased in size.

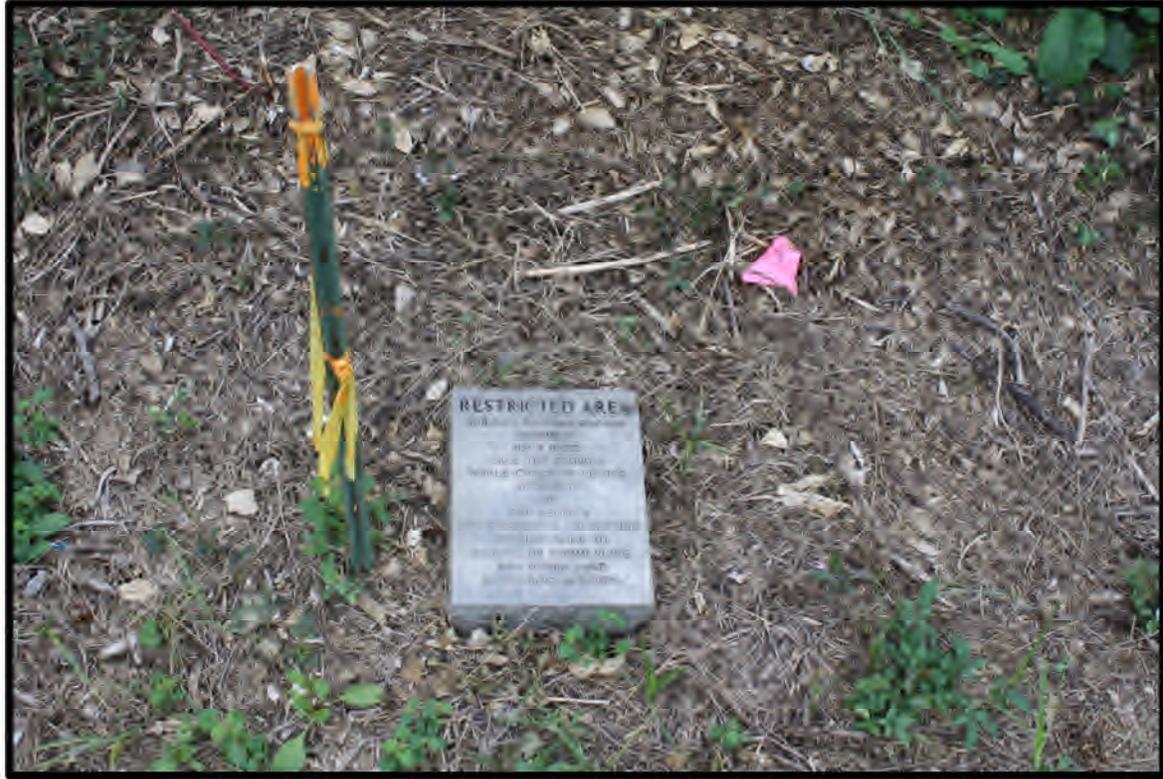
**OFFICIAL PHOTOGRAPH NO. 34
TETRA TECH**

Subject: Granite plaque on the northern perimeter of the property. This plaque was noted to be missing in previous inspections due to overgrown brush.

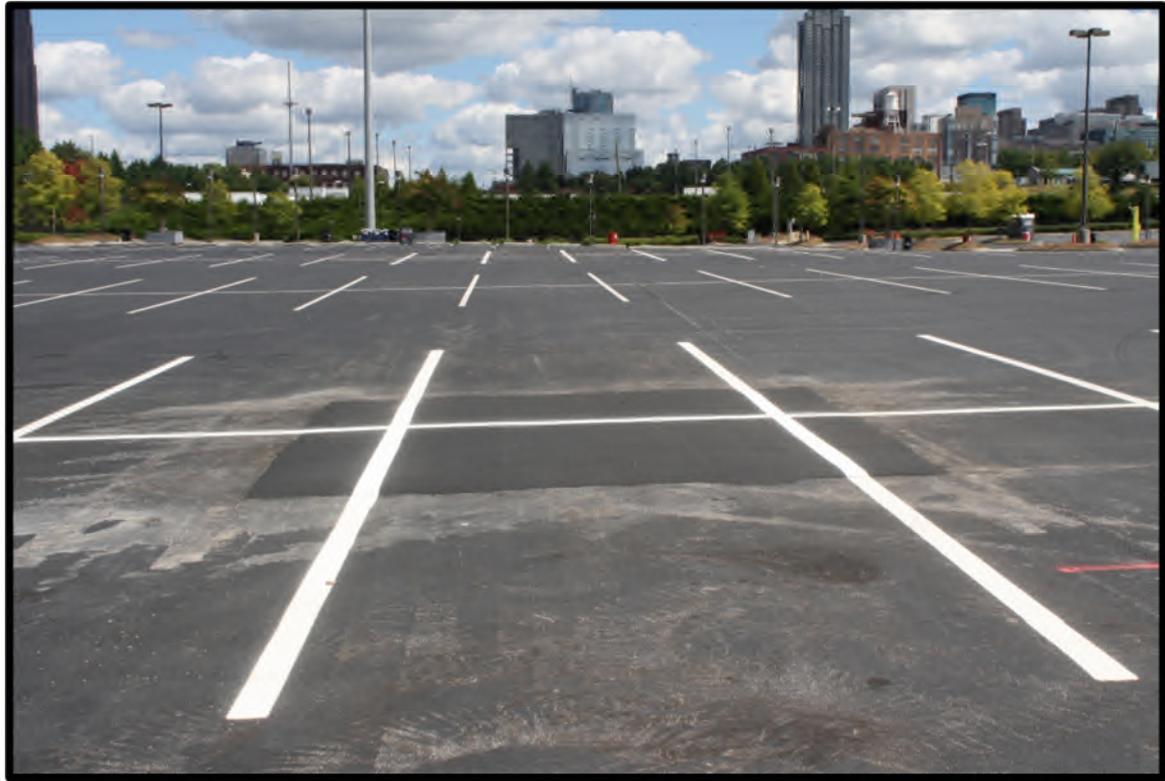
OFFICIAL PHOTOGRAPH NO. 35
TETRA TECH

Subject: Restored asphalt patch for direct push location DP-30, located in the northwest part of the parking lot.

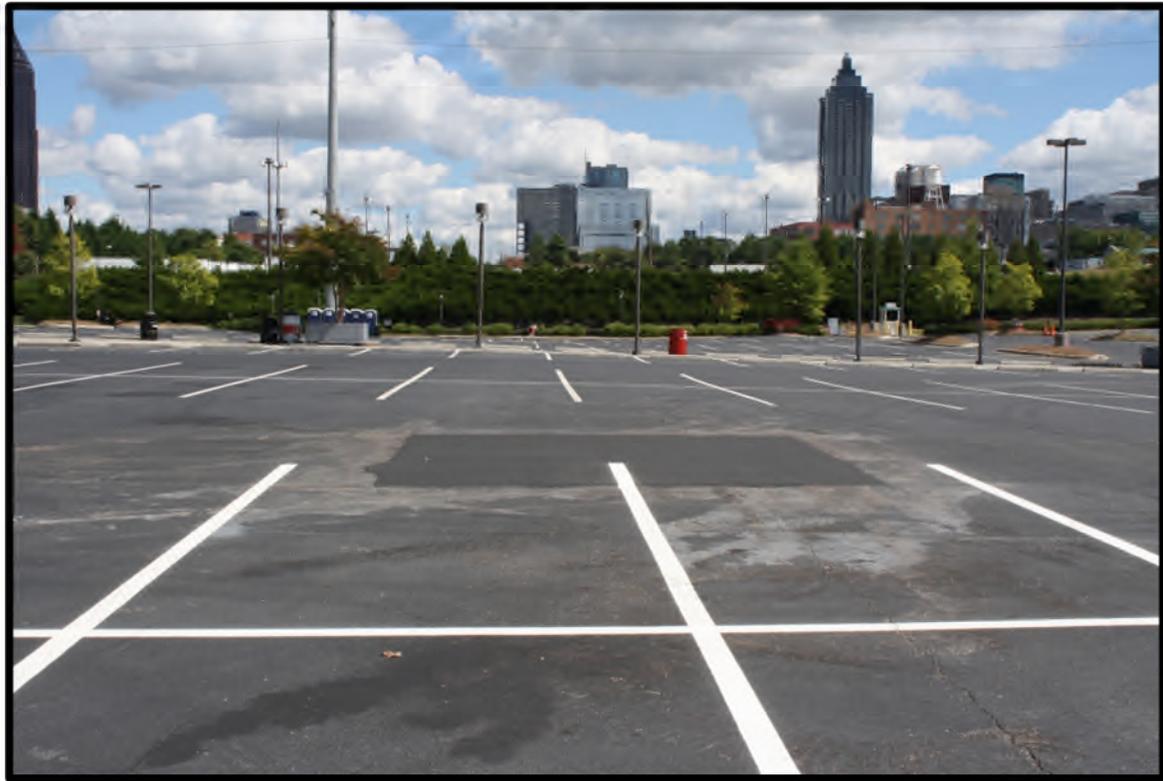
**OFFICIAL PHOTOGRAPH NO. 36
TETRA TECH**

Subject: Restored asphalt patch for direct push location DP-31, located in the north part of the parking lot.

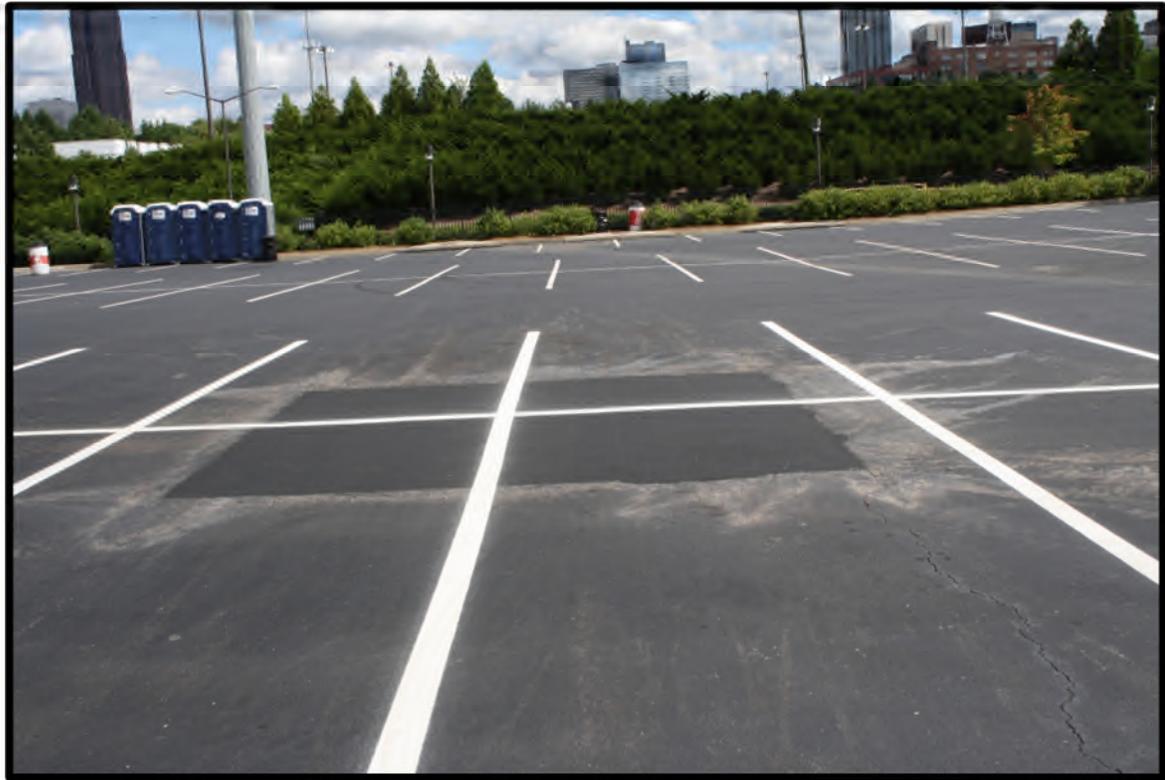
OFFICIAL PHOTOGRAPH NO. 37
TETRA TECH

Subject: Restored asphalt patch for direct push location DP-32, located in the northeast part of the parking lot.

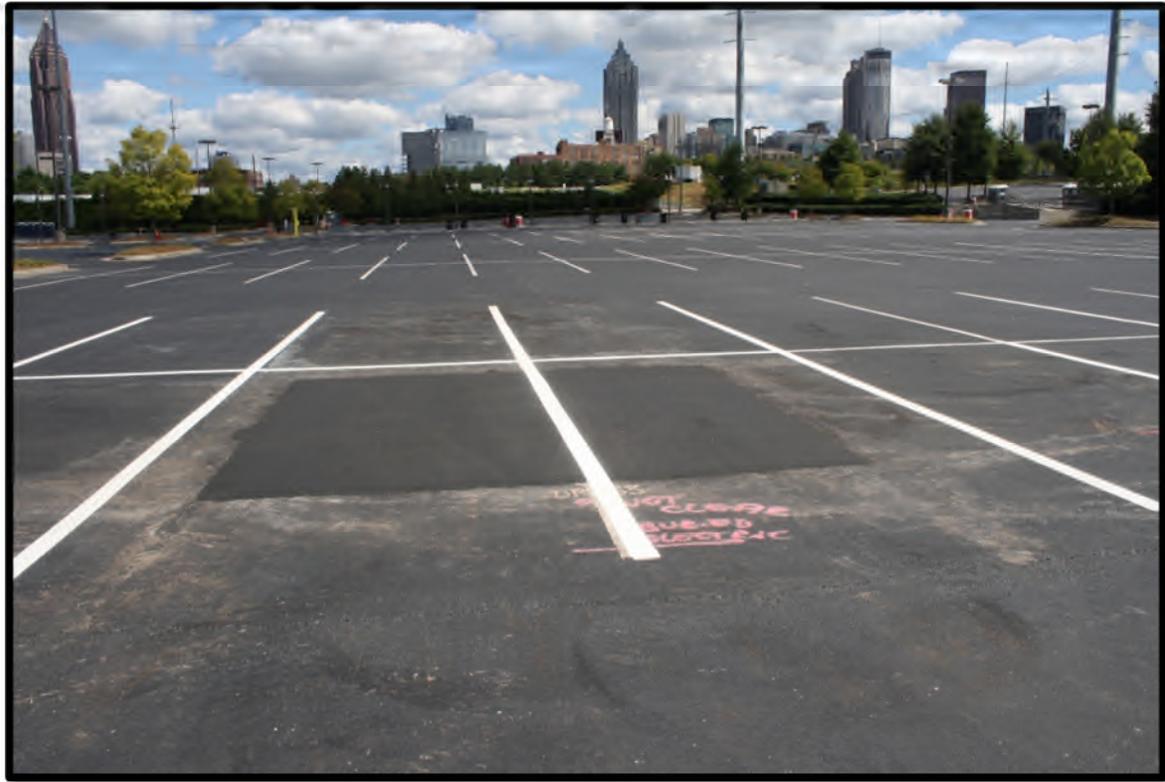
**OFFICIAL PHOTOGRAPH NO. 38
TETRA TECH**

Subject: Restored asphalt patch for direct push location DP-33, located in the southwest part of the parking lot.

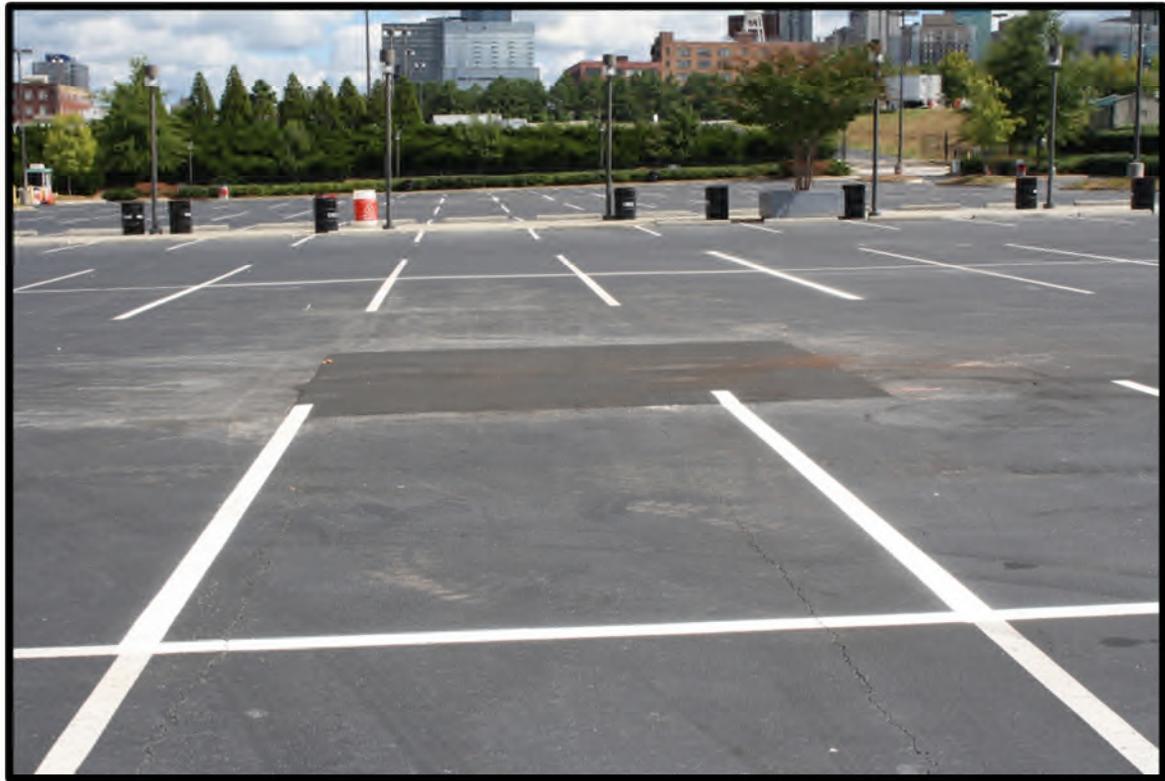
OFFICIAL PHOTOGRAPH NO. 39
TETRA TECH

Subject: Restored asphalt patch for direct push location DP-34, located in the south part of the parking lot.

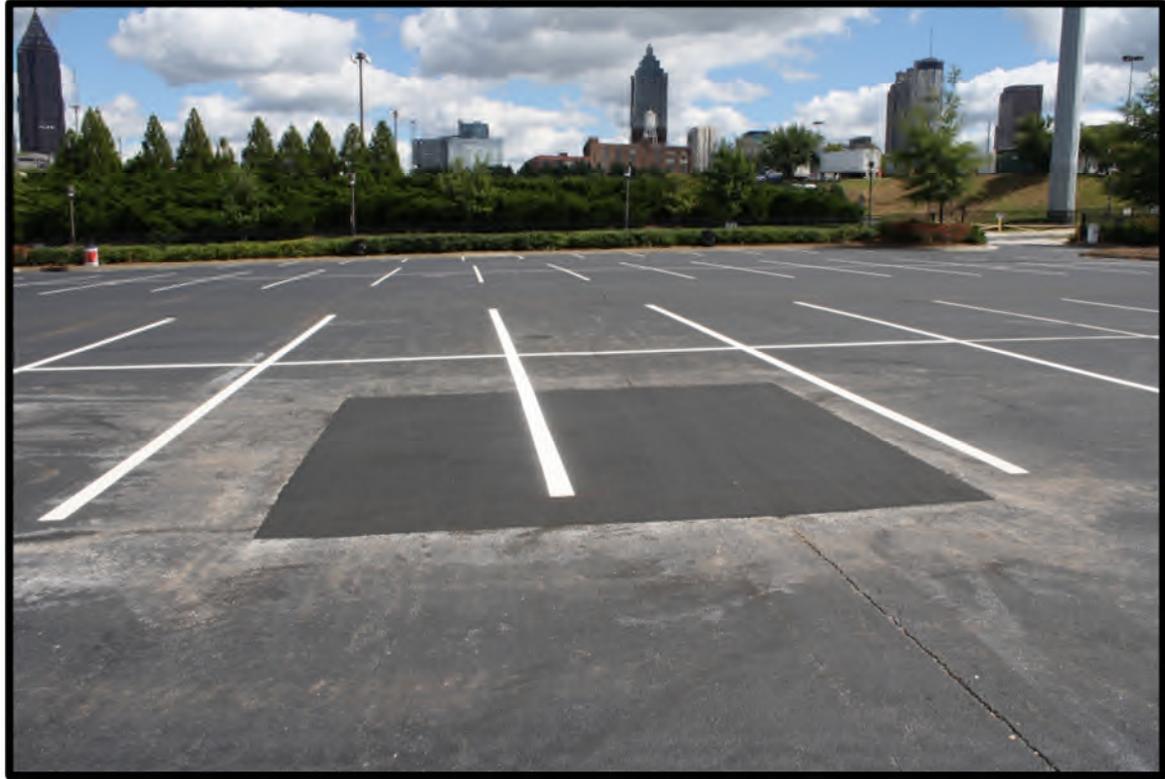
**OFFICIAL PHOTOGRAPH NO. 40
TETRA TECH**

Subject: Restored asphalt patch for direct push location DP-35, located in the southeast part of the parking lot.

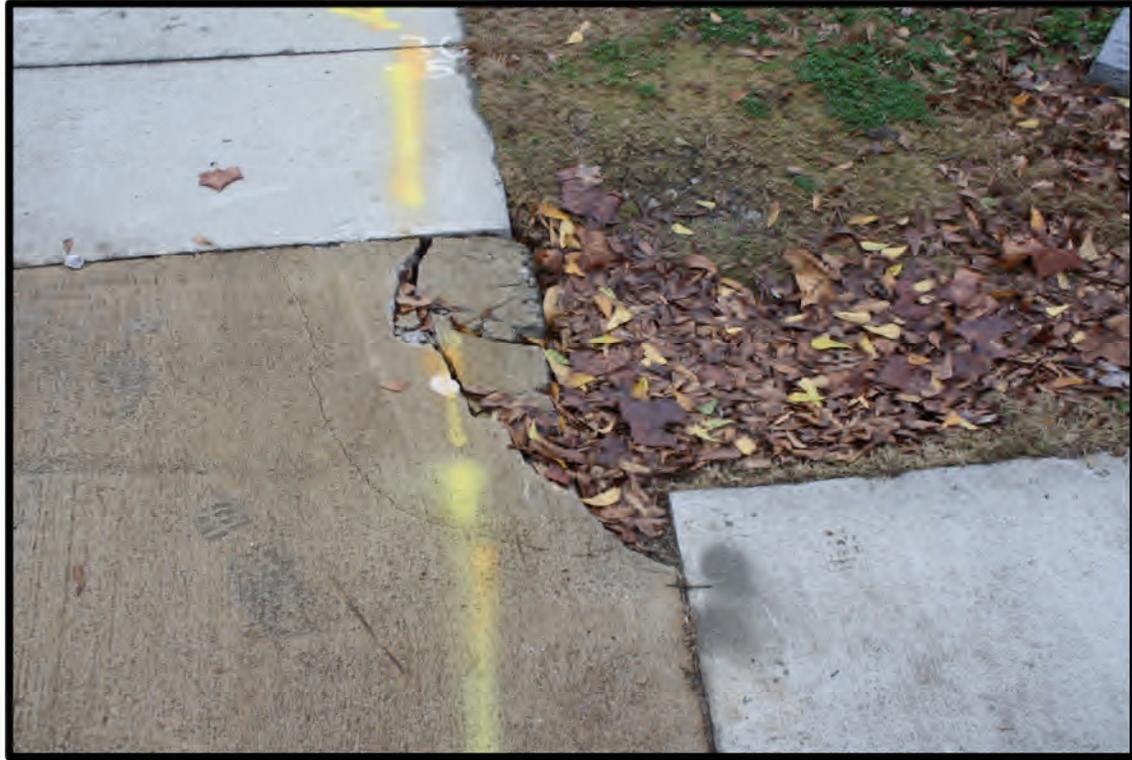
**OFFICIAL PHOTOGRAPH NO. 42
TETRA TECH**

Finally, during the December 2013 inspection, a cracked area of the sidewalk was observed outside the limits of the parking lot on the northern corner of the site by John Street and Gray Street. The sidewalk was also marked with yellow paint to indicate the presence of an underground natural gas line, although no evidence of excavation was noted during our inspection. Photograph 42 in the photographic log for the December 2013 shows the marked sidewalk area.
