Subject: 2018 Annual CAMP Inspection Report
Atlanta Gas Light Company
Former Manufactured Gas Plant Site
Rome, Georgia

Attached please find the Annual Continuing Action Monitoring Plan (CAMP) Inspection for the Atlanta Gas Light Company (AGLC) former Manufactured Gas Plant (MGP) site located 200 West 1st Street, Rome, Georgia (Site). This survey was completed in accordance with the Continuing Action Monitoring Plan dated August 2014 prepared by Burns & McDonnell. Pertinent Site features and the Type 4 and 5 areas included in the CAMP Inspection are shown on Figure 1 (attached). Site conditions as observed in the August 2018 survey for the Type 5 and Type 4 parcels are summarized in Tables 1 and 2, respectively. Photographic documentation of Site conditions is included as an attachment.

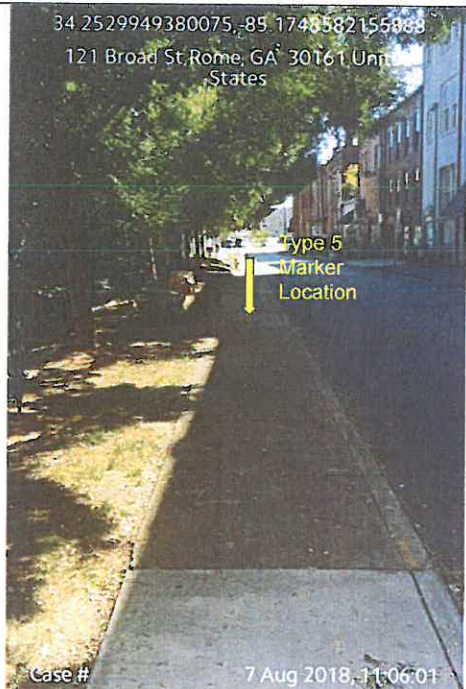
Photo No.
1

West 1st Street and
Right-of-Way.

Good ground cover, no
erosion

No disturbed asphalt

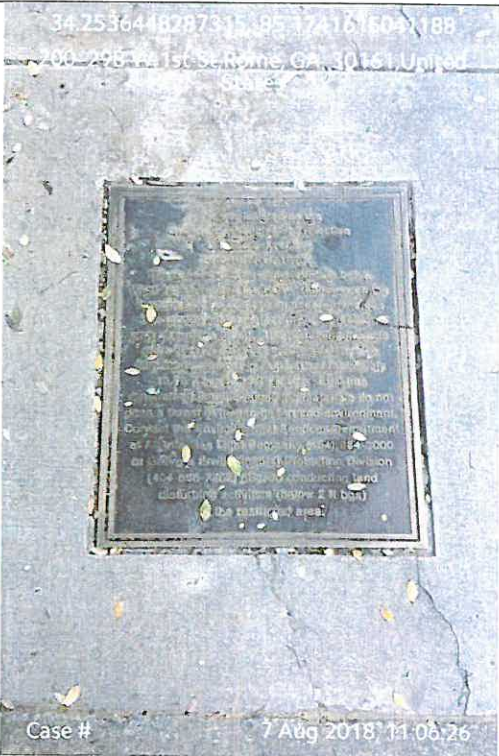
Photo No.
2

Bronze Type 5 Marker
installed July 2015

Marker in good
condition

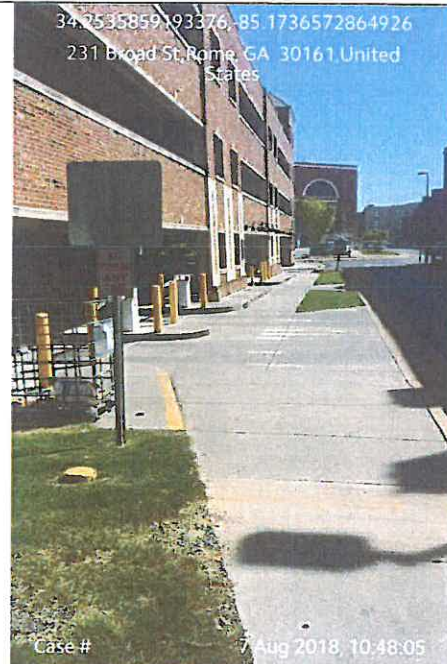
Photo No.
3 Date:
8/7/2018

Parcel 1 along West 1st
Street

Parcel used as a
parking deck

No groundwater use

No erosion concerns

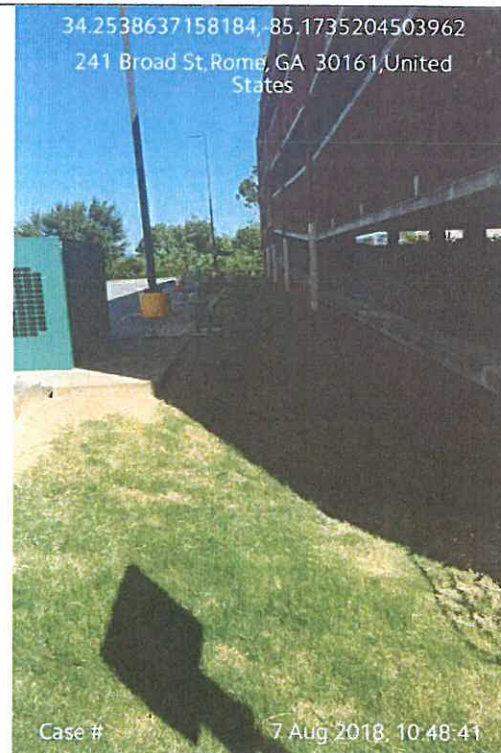
Photo No.
4 Date:
8/7/2018

Parcel 1 adjacent to
Parcel 7

Parcel used as a
parking deck

No groundwater use

Good grass cover - no
erosion concerns

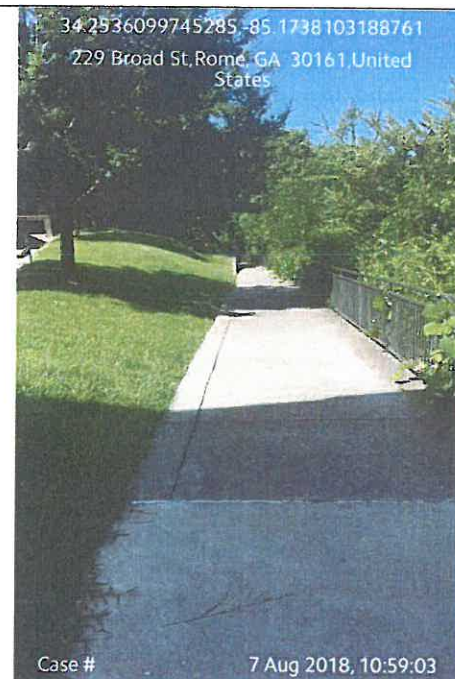
Photo No.
5

Parcel 2 between
riverbank and walking
trail

No groundwater use

Good vegetation cover -
no erosion concerns

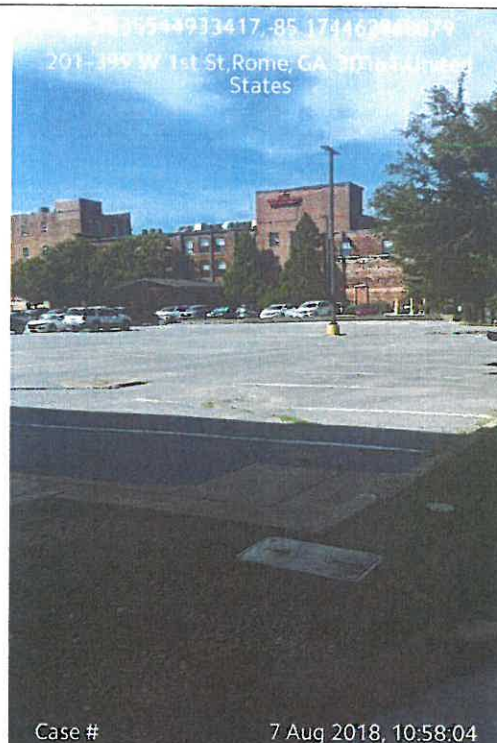
Photo No.
6

Parcel 2 – Parking Lot

No groundwater use

Good grass/mulch
cover on edge of
parking lot - no erosion
concerns

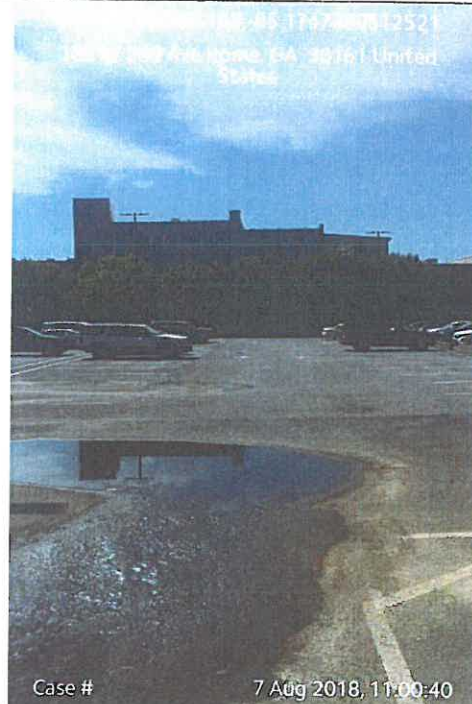
Photo No.
7

Parcel 3 – Parking Lot

No groundwater use

Asphalt cover – no
erosion concerns

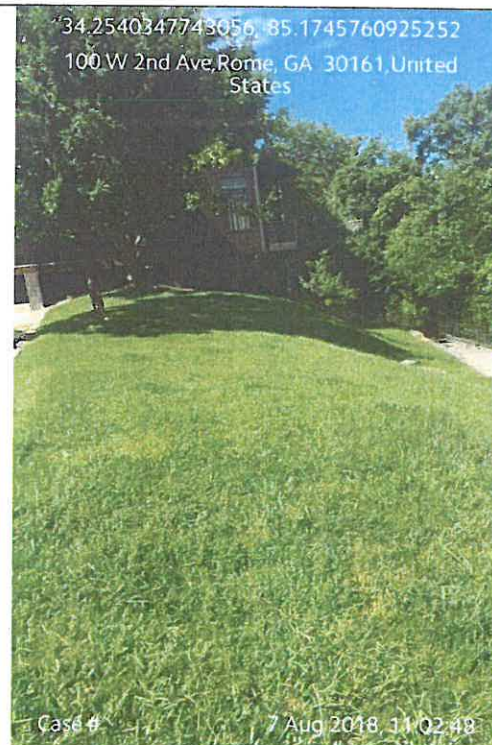
Photo No.
8

Parcel 3A – Grass
embankment north of
parking lot

No groundwater use

Good grass cover - no
erosion concerns

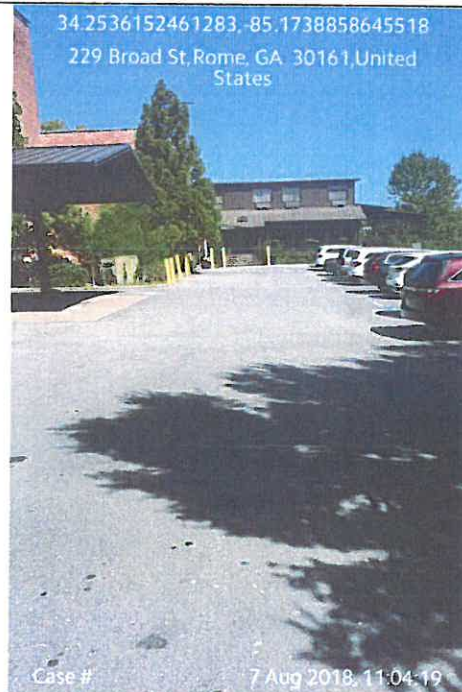
Photo No.
9 Date:
8/7/2018

Parcel 4 – Hawthorne
Suites Parking Lot

No groundwater use

Asphalt cover – no
erosion concerns

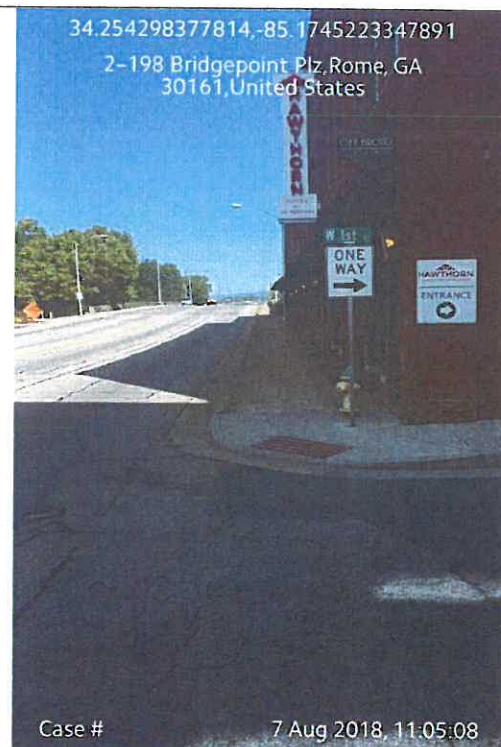
Photo No.
10 Date:
8/7/2018

Parcel 5 – Hawthorne
Suites Hotel

Retail space on ground
floor

No groundwater use

No erosion concerns

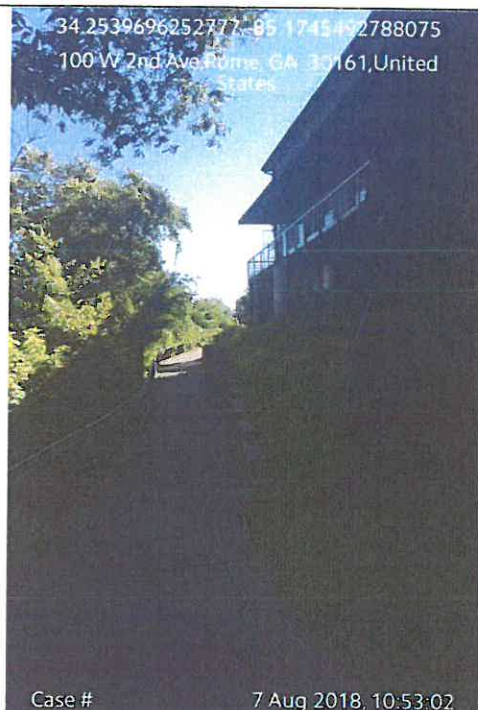
Photo No.
11

Parcel 6 – NW of
Hawthorne Suites

No groundwater use

Good grass cover - no
erosion concerns

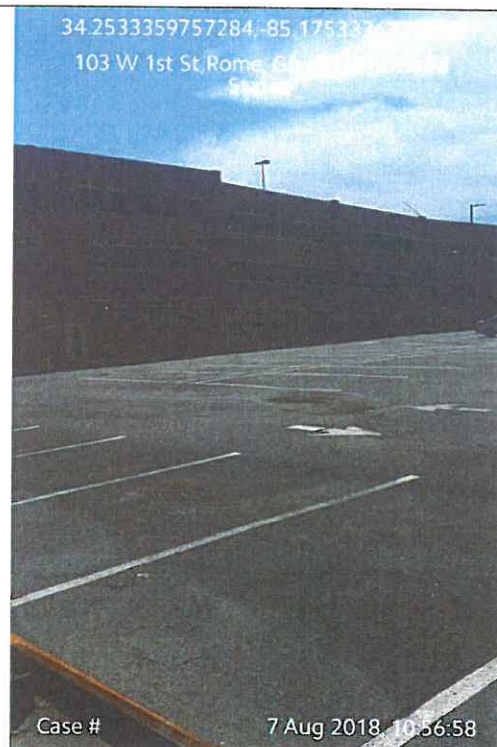
Photo No.
12

Parcel 7 – Parking Lot

No groundwater use

Asphalt cover – no
erosion concerns

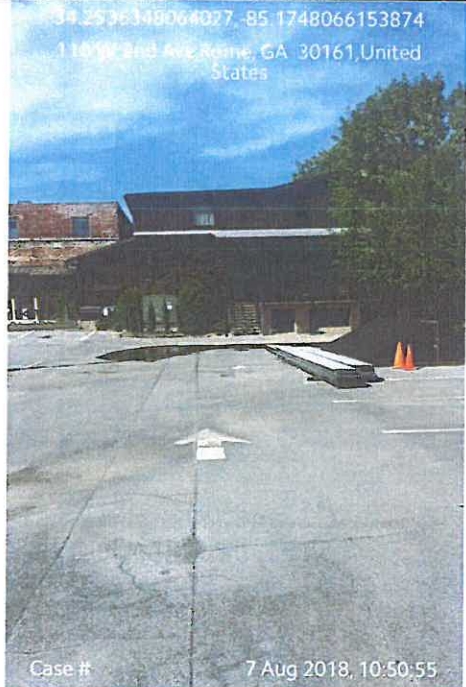
Photo No.
13

Parcel 8 –wooden
building used as
restaurant

Not in residential use

No groundwater use

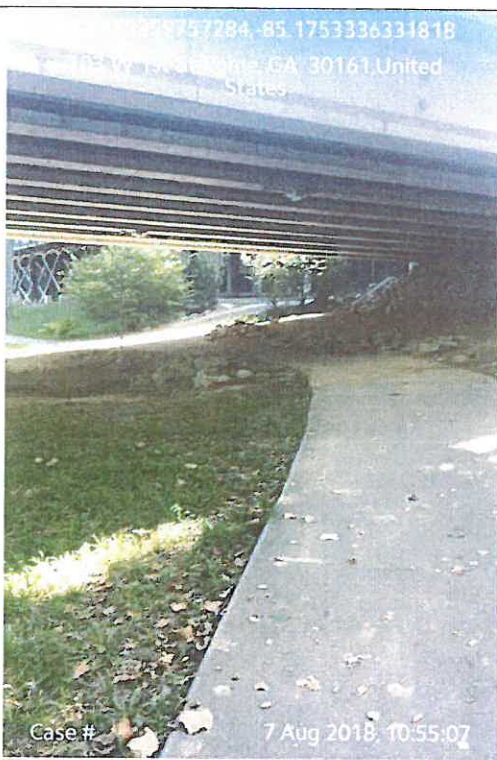
Photo No.
14

All information included within this CAMP Inspection Report is based on a visual inspection of the Site conducted on August 7, 2018. No action is required at this time based on the survey. The right-of-way (ROW) beneath the 2nd Avenue Bridge deck had some bare soil but no signs of erosion were present. Cobbles placed in the area appear to be providing sufficient cover. AGLC will continue monitoring for signs of erosion.

ROW under 2nd Ave
Bridge

No visible signs of
erosion – some bare
soil under bridge deck,
but rock cover appears
to be preventing any
erosion

Continue to monitor for
signs of erosion
