SUPPORTING THE **GEORGIA WORLD CONGRESS CENTER**

February 12, 2016

**Subject:       Quarters-46/47 Landfill Maintenance and Inspection Report  
                  Northside Drive Landfill Site, Atlanta, Georgia**

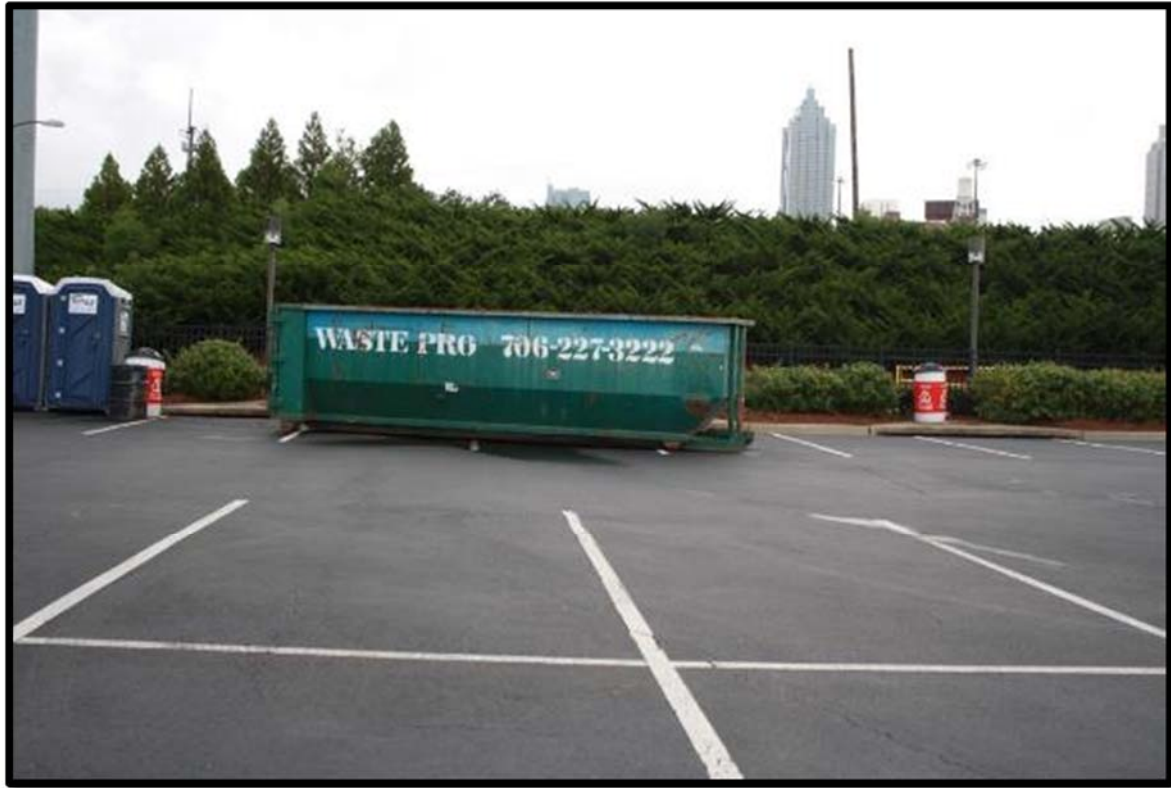
**OFFICIAL PHOTOGRAPH NO. 23**  
**TETRA TECH**

**Subject:** Stormwater drains located at the eastern parking lot perimeter.  
The existing crack was still present, but had not increased in size.

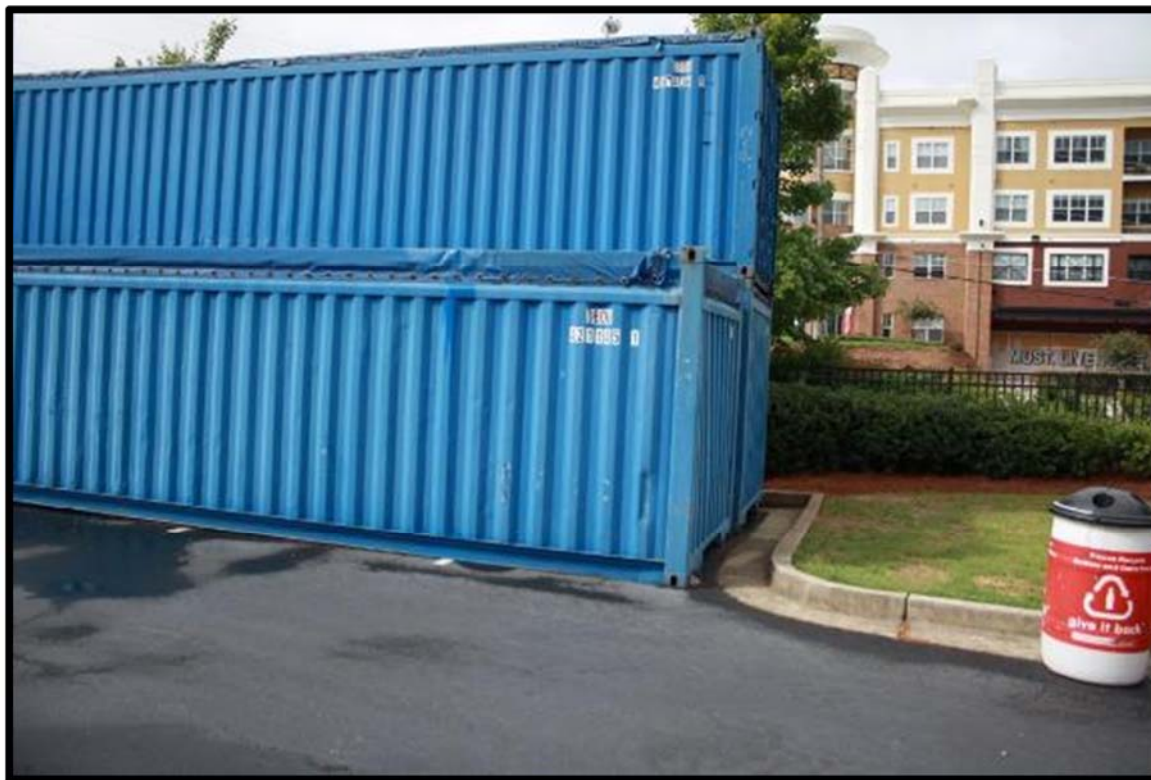
**OFFICIAL PHOTOGRAPH NO. 26**  
**TETRA TECH**

During the September 2015 inspection, Tetra Tech observed a number of sea-land shipping containers placed at the western end of the parking lot, adjacent to Northside Drive. The containers, shown in photograph 26 of the September 2015 photographic log, are located at the edge of the parking area, outside the limits of the slurry wall and no damage to the parking lot or landscaping structures was observed during our inspections. As shown in photograph 26A in the September photographic log, the containers have been placed so that the storm drain present at that location is not blocked. The shipping containers were removed sometime between the September and December inspections.

**Subject:** Location of stormwater drain on the west side of the parking lot perimeter. A cargo container is being stored in front of the drain.

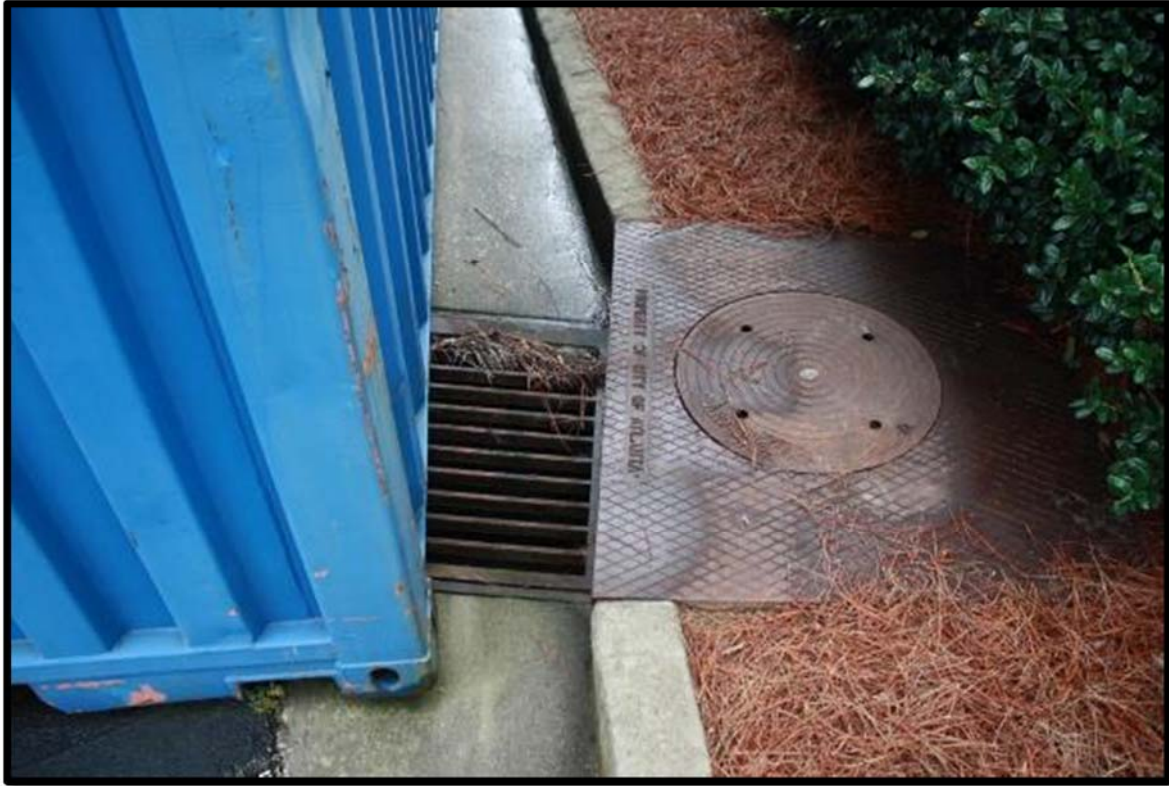
**OFFICIAL PHOTOGRAPH NO. 26A**  
**TETRA TECH**

**Subject:** Closeup of the stormwater drain located behind the cargo container stored along the west side of the parking lot perimeter.

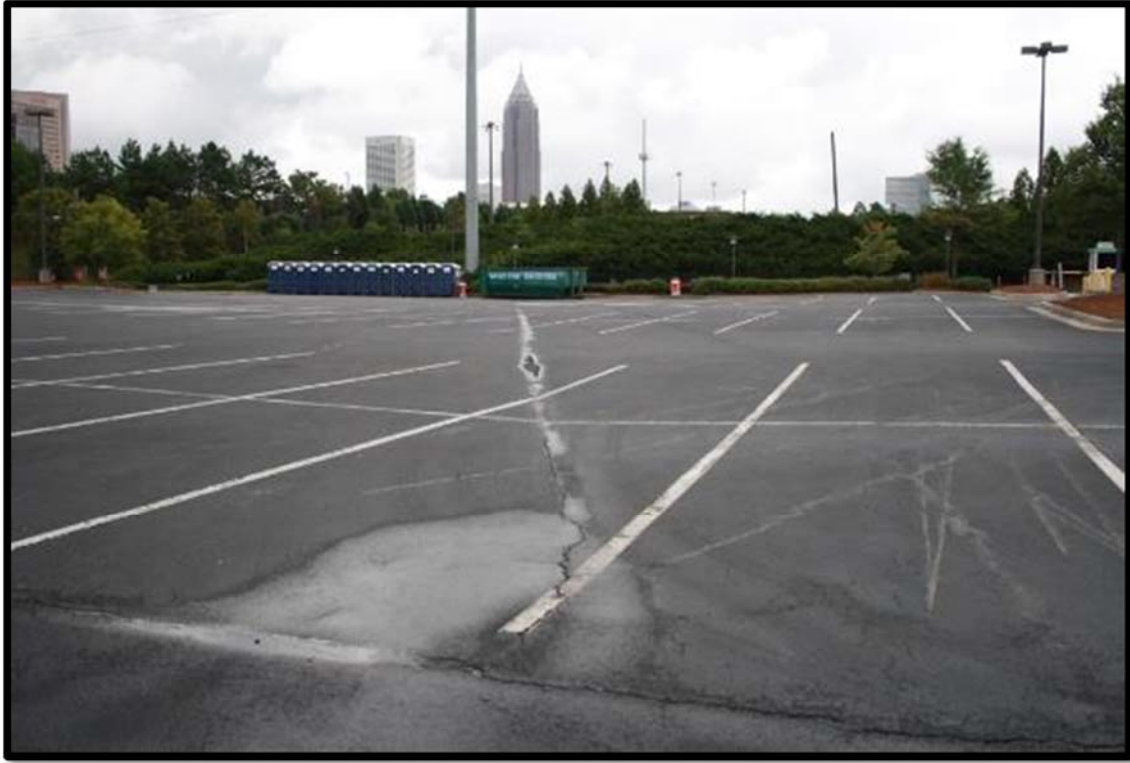
**OFFICIAL PHOTOGRAPH NO. 27**  
**TETRA TECH**

During the September and December 2015 inspections, minor cracking in the asphalt surface was observed at various locations throughout the parking lot, but this does not represent major damage

requiring immediate repair. Many of these cracks are located at the connection where strips were initially laid down during the paving process. No cracks appeared to be wider than 1/4-inch and none appeared to have penetrated the asphalt surface into the underlying fill; however, the cracking indicates that weathering is beginning to impact the asphalt. Asphalt parking lots typically require resealing and restriping every five years. During repairs to the landfill liner and cap in 2013, the asphalt cap was observed to consist of 8-inches of asphalt that included a 6-inch bottom binder layer and a 2-inch finish coat. Cracks appear to be located only in the surface of the finished coat. Tetra Tech and GWCC will monitor the condition of the cracked areas in the asphalt to determine when the cracks in the lot should be filled in, when the repaired surface areas should be resealed, and when the affected striping should be restriped before weathering processes penetrate the underlying fill.

**Subject:** A small crack in the asphalt leading to the stormwater drains on the eastern side of the parking lot. Stormwater flows in this low point of the parking lot, which has caused minor staining. The crack is estimated to be approximately 200 feet long, ¼ inch wide and ¼ inch deep. The existing crack was still present, but had not increased in size.

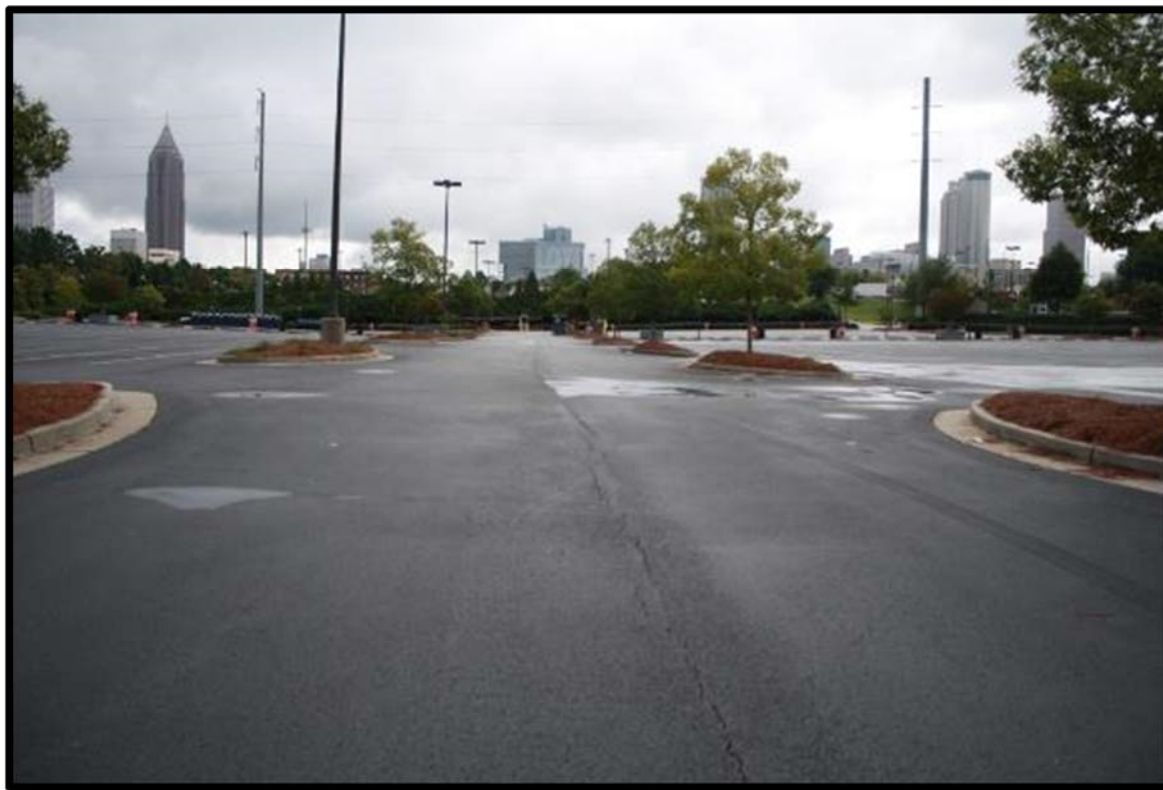
**OFFICIAL PHOTOGRAPH NO. 28**  
**TETRA TECH**

**Subject:** Example of another crack which runs east to west on the main entrance/exit roadway. Like the previously observed crack, it is no larger than ¼ inch wide and ¼ inch deep. This crack traverses almost the entire length of the entrance/exit roadway. The existing crack was still present, but had not increased in size.

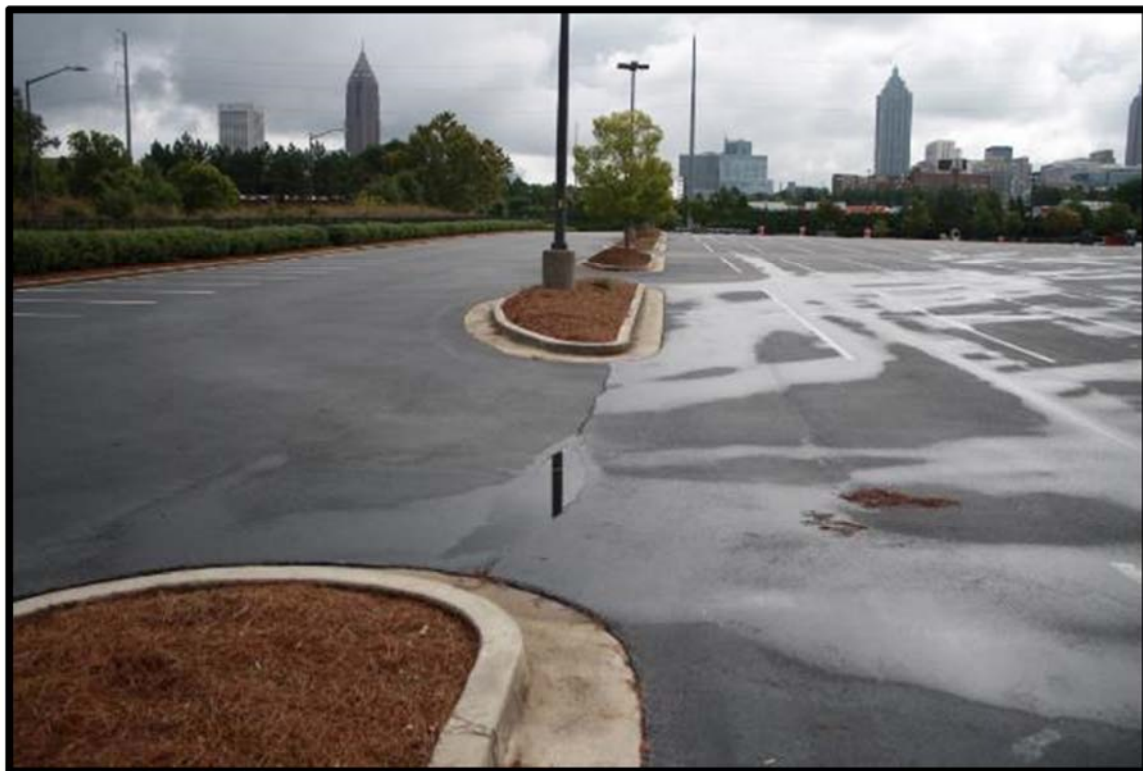
**OFFICIAL PHOTOGRAPH NO. 29**  
**TETRA TECH**

**Subject:** Example of another crack which runs east to west on the entrance way of the parking lot row. Over half of the rows have cracks similar to this one. They occur where the asphalt seams are joined. Like the previously observed crack, it is no larger than  $\frac{1}{4}$  inch wide and  $\frac{1}{4}$  inch deep. The existing crack was still present, but had not increased in size.

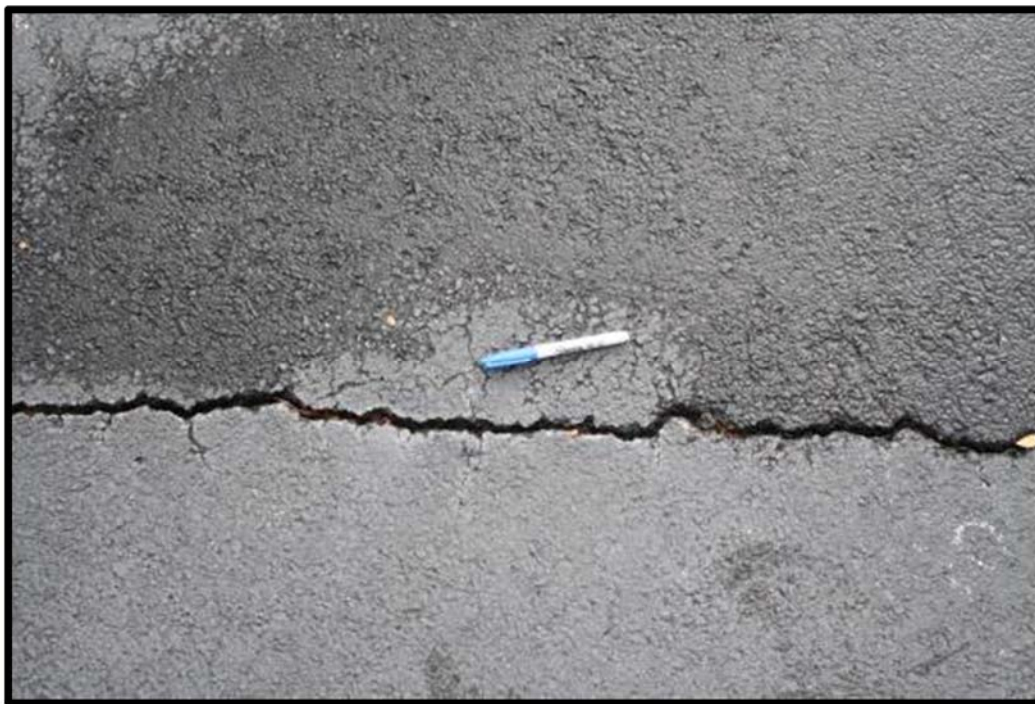
**OFFICIAL PHOTOGRAPH NO. 30**  
**TETRA TECH**

**Subject:** Example of another crack, which runs north to south on the western most row of the north parking lot. A standard pen is used to show the approximate width of the crack. The width of this crack is typical of all cracks observed in the asphalt of the north parking lot. The existing crack was still present, but had not increased in size.

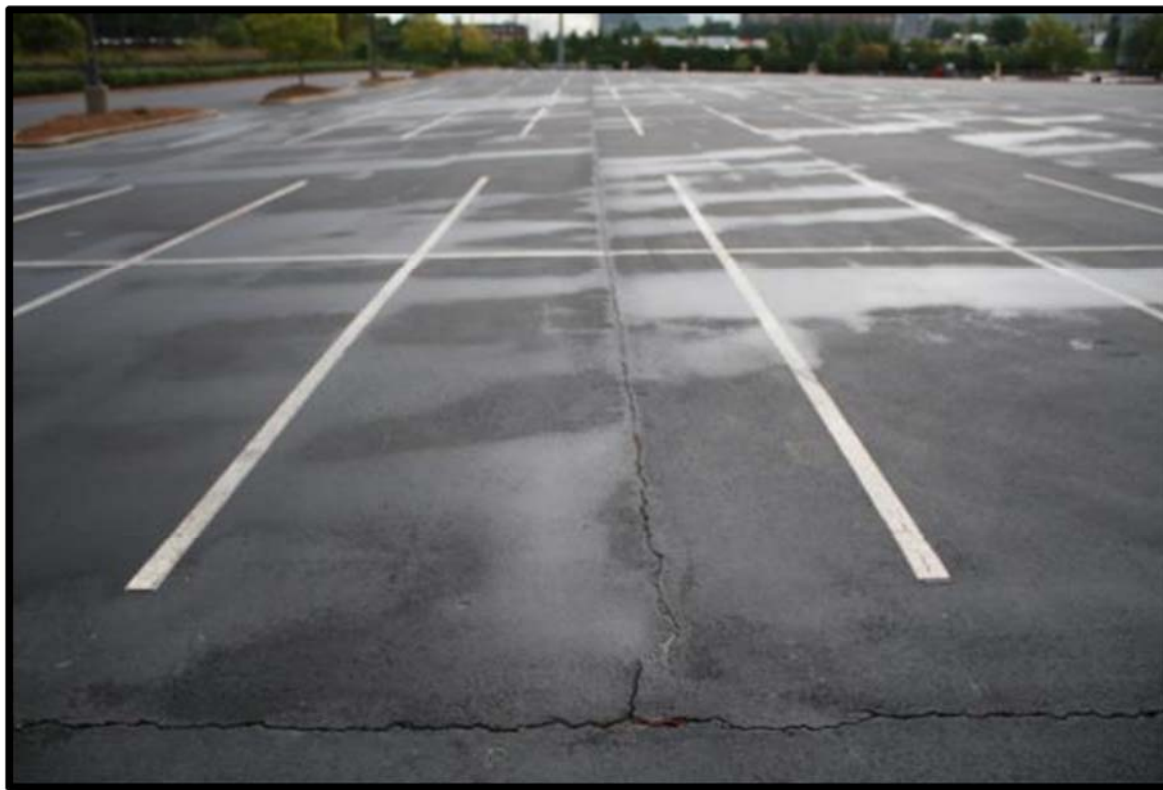
**OFFICIAL PHOTOGRAPH NO. 31**  
**TETRA TECH**

**Subject:** Example of another crack which runs east to west. This crack is located on the northern portion of the parking lot and traverses the entire parking lot west of the north/south walkway. Once again, this crack occurs where the asphalt seams are joined. Like the previously observed cracks, it is no larger than  $\frac{1}{4}$  inch wide and  $\frac{1}{4}$  inch deep. The existing crack was still present, but had not increased in size.

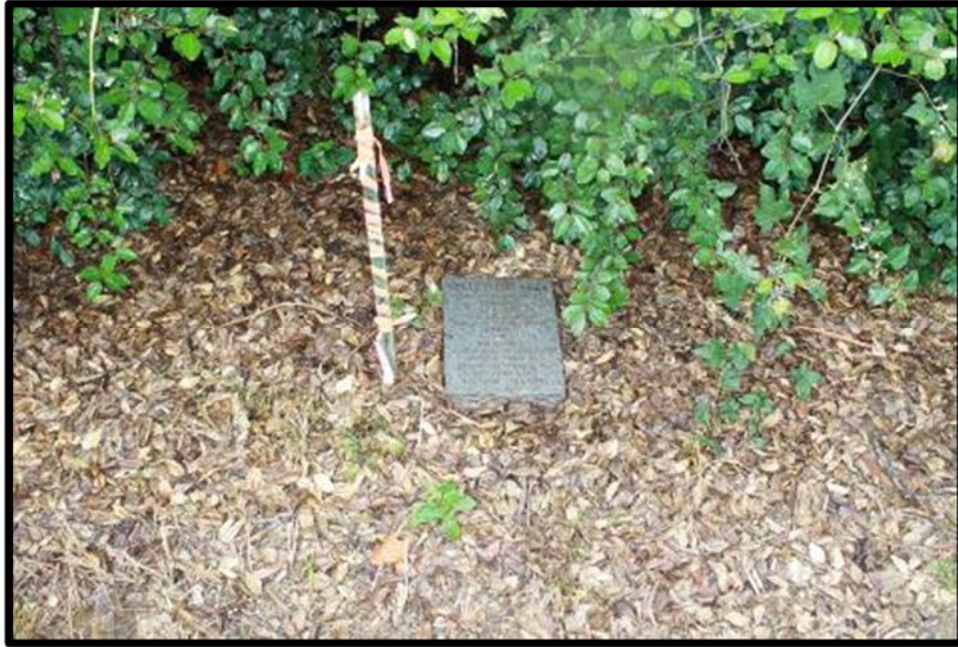
**OFFICIAL PHOTOGRAPH NO. 34**  
**TETRA TECH**

**Subject:** Granite plaque on the northern perimeter of the property. This plaque was noted to be missing in previous inspections due to overgrown brush.

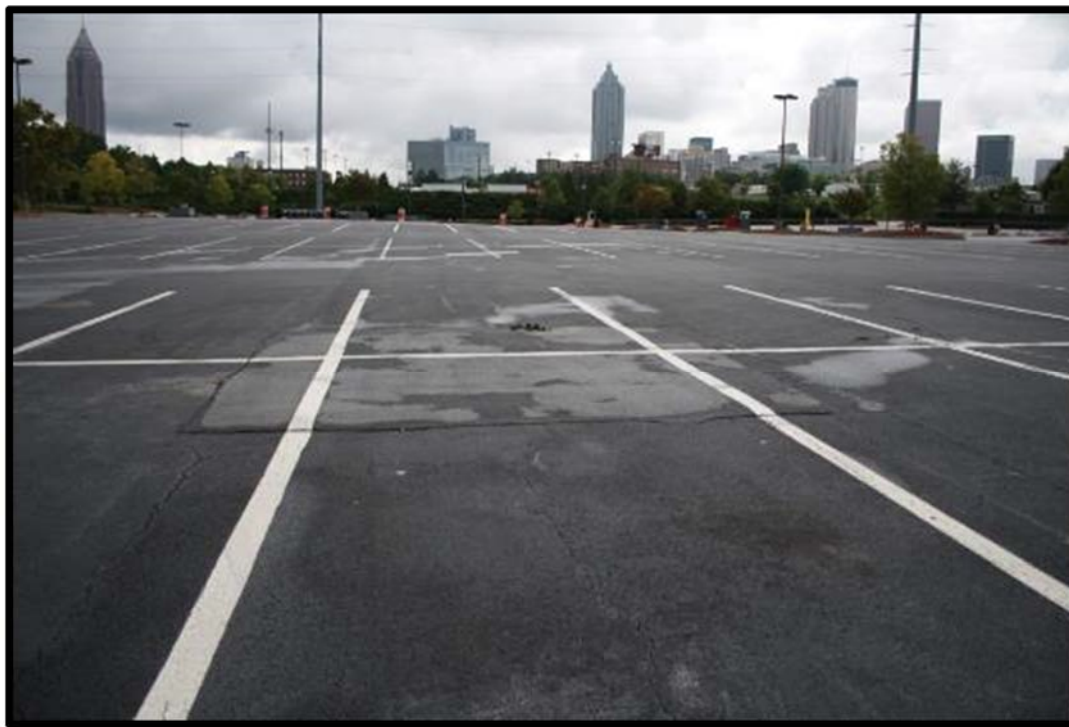
**OFFICIAL PHOTOGRAPH NO. 35**  
**TETRA TECH**

**Subject:** Restored asphalt patch for direct push location DP-30, located in the northwest part of the parking lot.

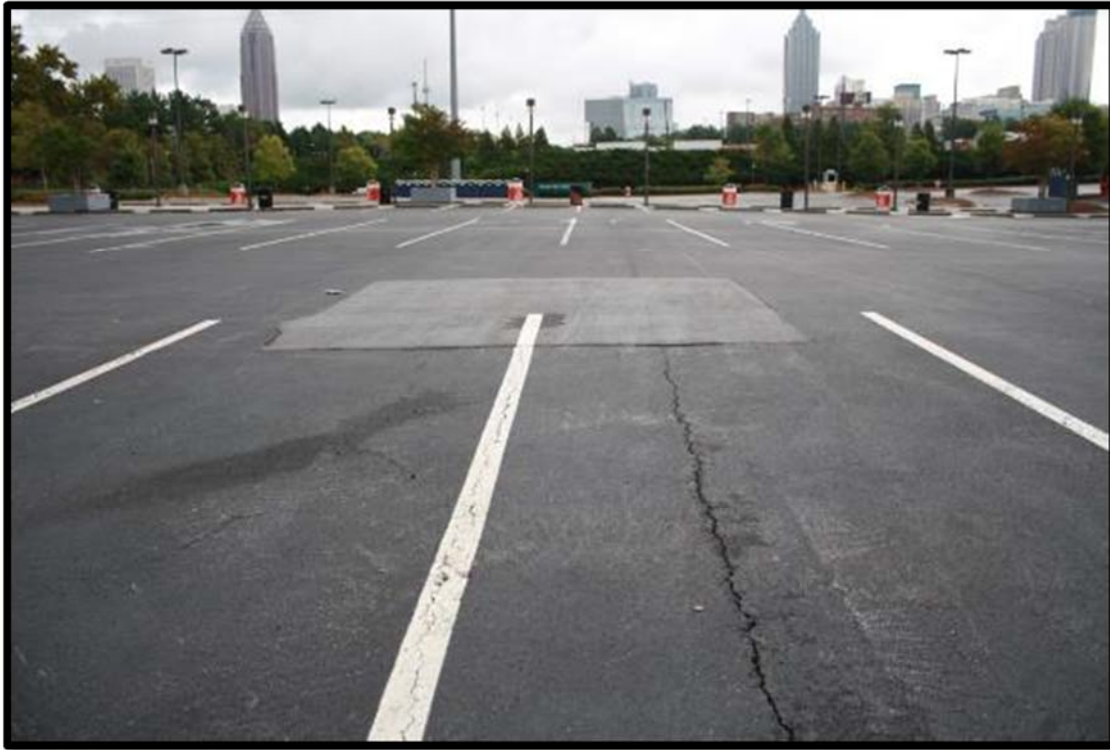
**OFFICIAL PHOTOGRAPH NO. 36**  
**TETRA TECH**

**Subject:** Restored asphalt patch for direct push location DP-31, located in the north part of the parking lot.

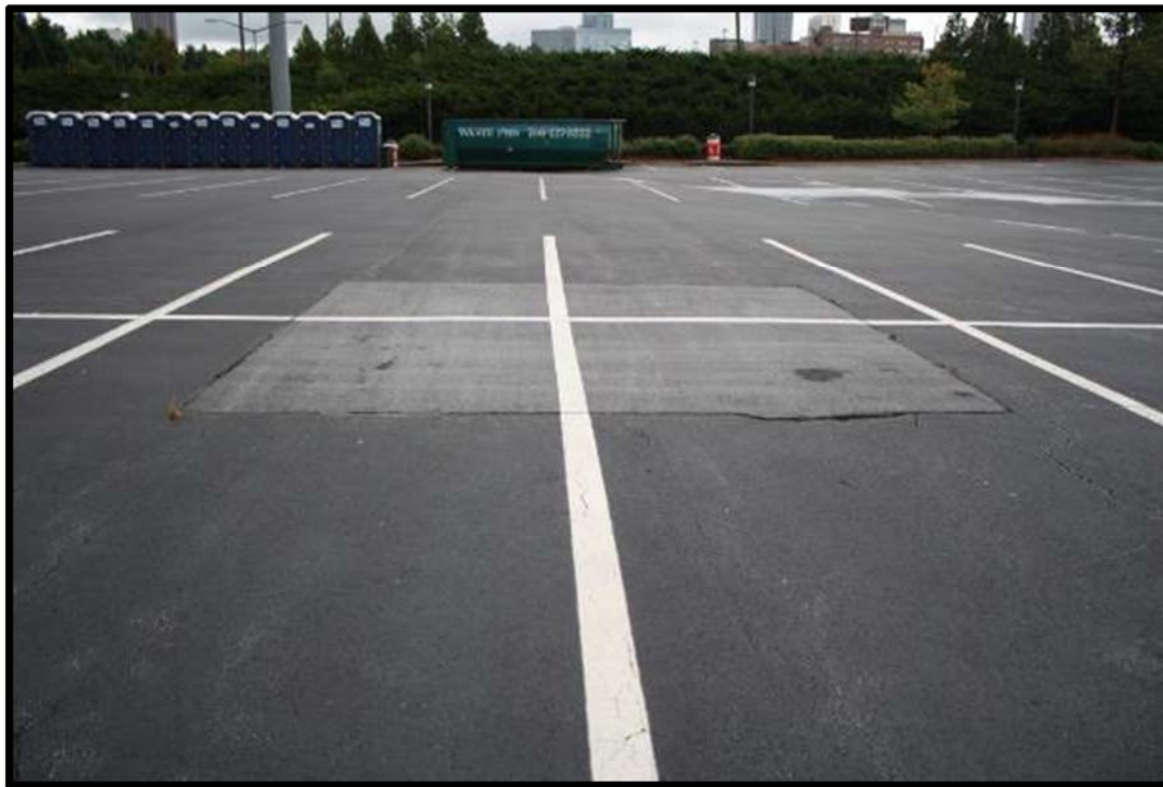
**OFFICIAL PHOTOGRAPH NO. 37**  
**TETRA TECH**

**Subject:** Restored asphalt patch for direct push location DP-32, located in the northeast part of the parking lot.

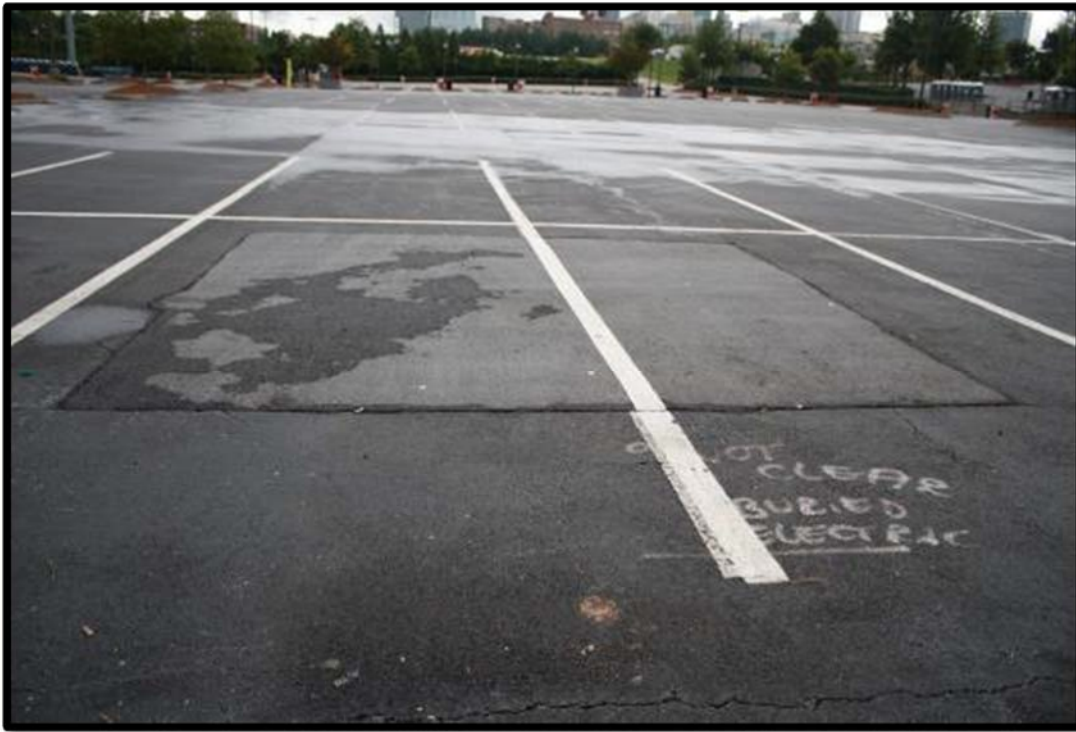
**OFFICIAL PHOTOGRAPH NO. 38**  
**TETRA TECH**

**Subject:** Restored asphalt patch for direct push location DP-33, located in the southwest part of the parking lot.

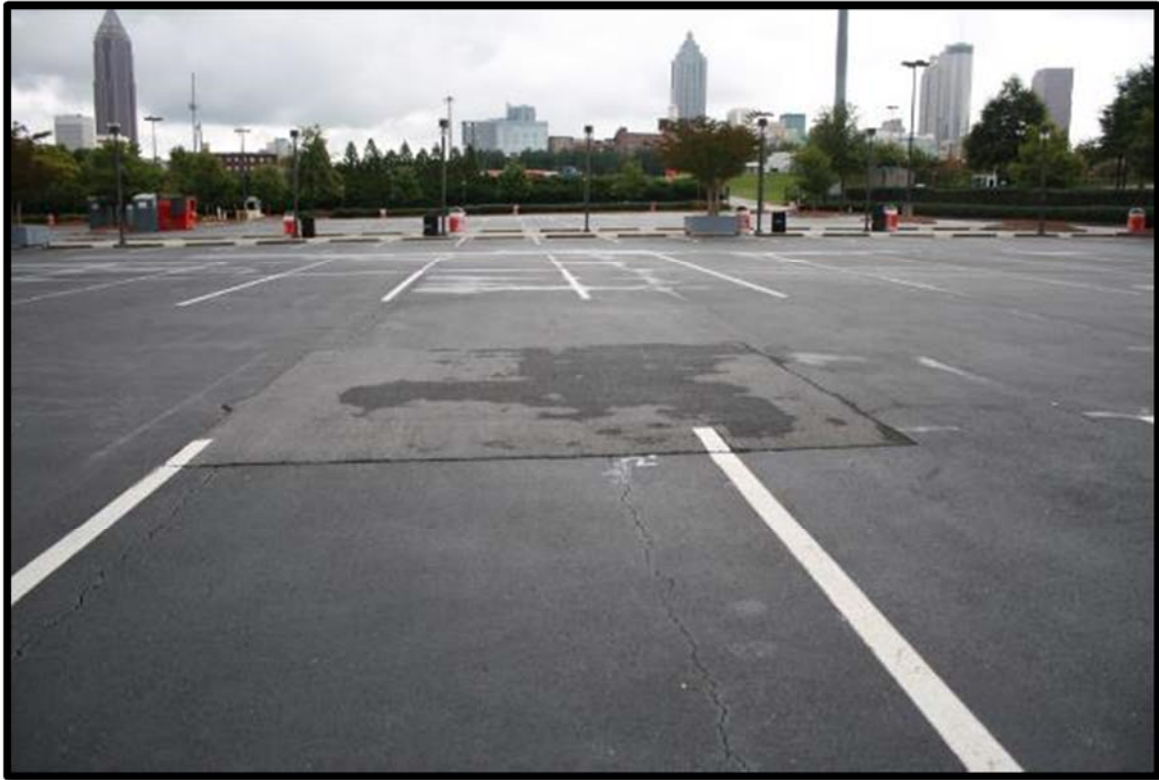
**OFFICIAL PHOTOGRAPH NO. 39**  
**TETRA TECH**

**Subject:** Restored asphalt patch for direct push location DP-34, located in the south part of the parking lot.

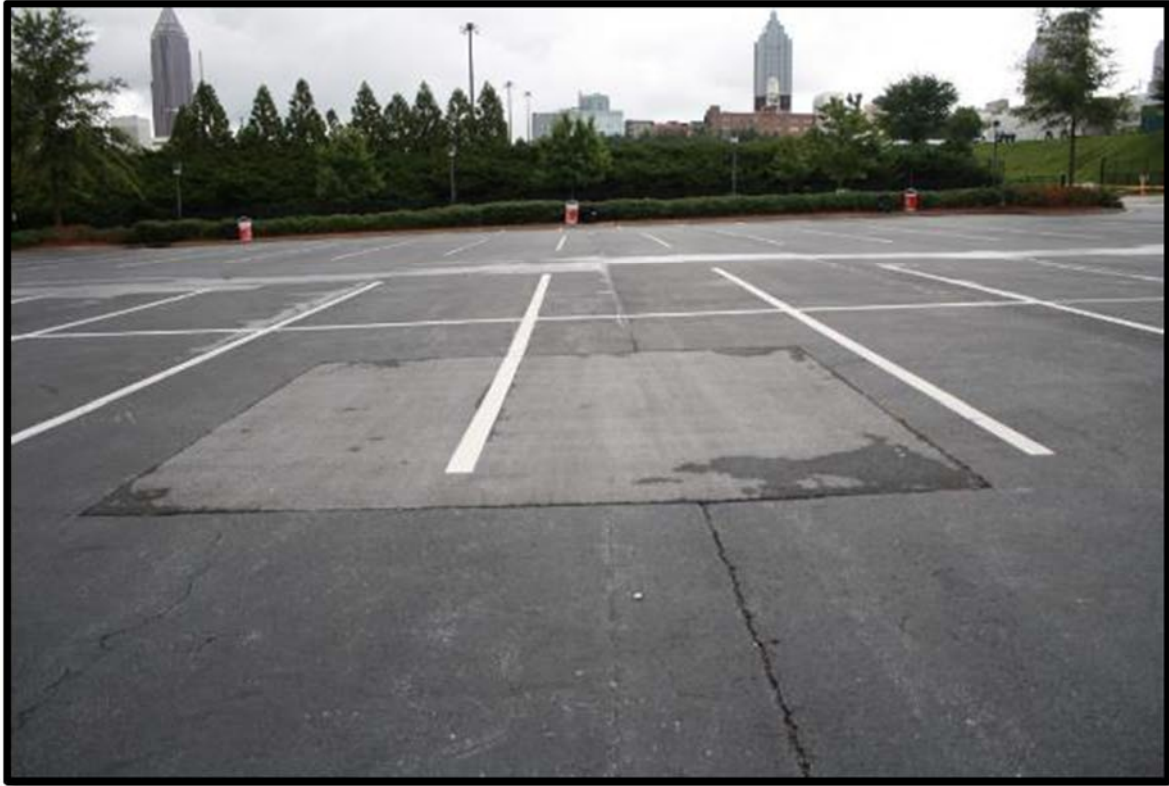
**OFFICIAL PHOTOGRAPH NO. 40**  
**TETRA TECH**

**Subject:** Restored asphalt patch for direct push location DP-35, located in the southeast part of the parking lot.

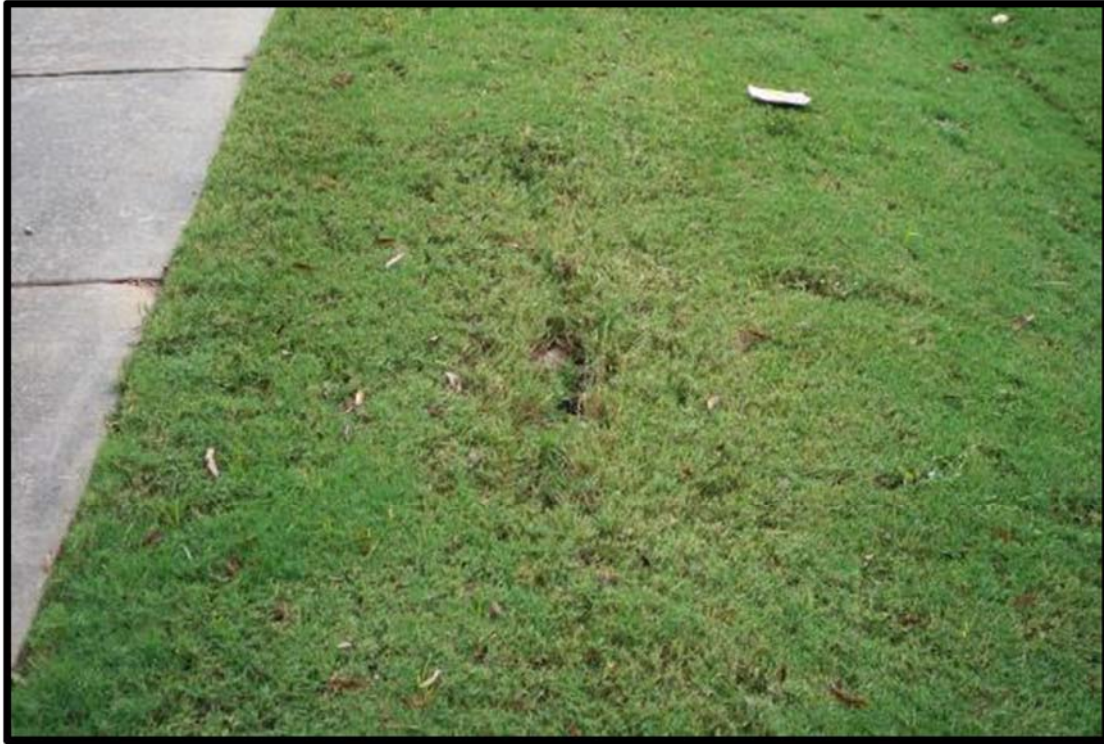
**OFFICIAL PHOTOGRAPH NO. 41**  
**TETRA TECH**

**Subject:** Eroded soil along sidewalk south of John Street.

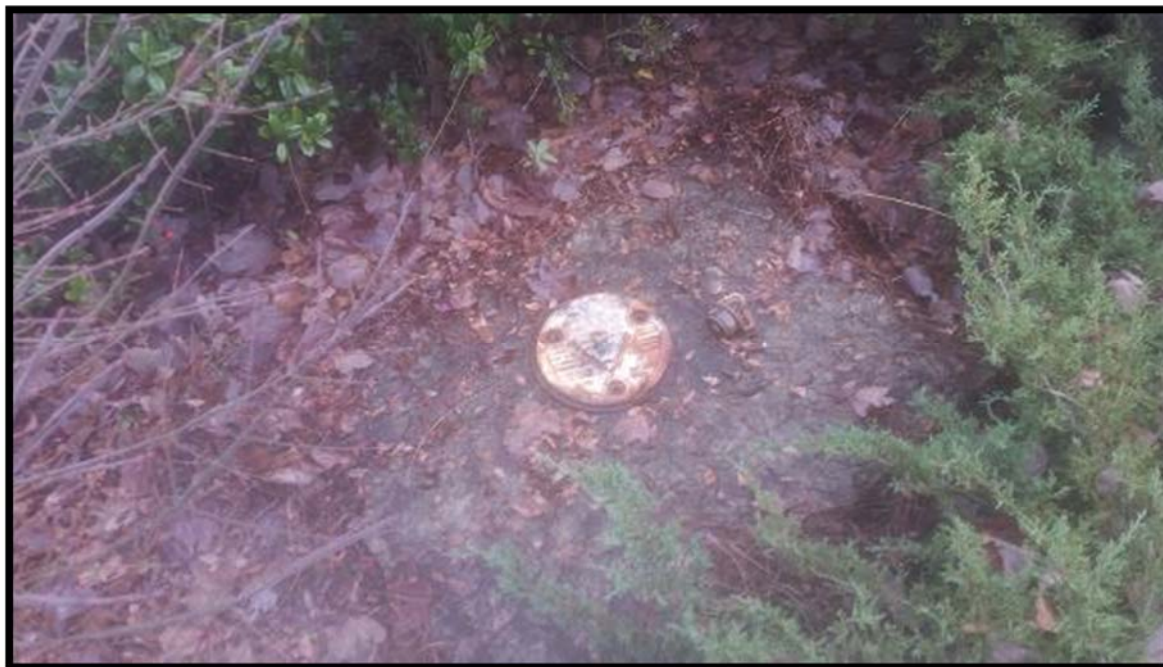
**OFFICIAL PHOTOGRAPH NO. 7**  
**TETRA TECH**

**Subject:** Monitoring well, MM-01.  
Site gauging activities were being performed. Well cap was temporarily removed.
