August 15, 2017

**Subject: Quarters-52/53 Landfill Maintenance and Inspection Report
 Northside Drive Landfill Site, Atlanta, Georgia**

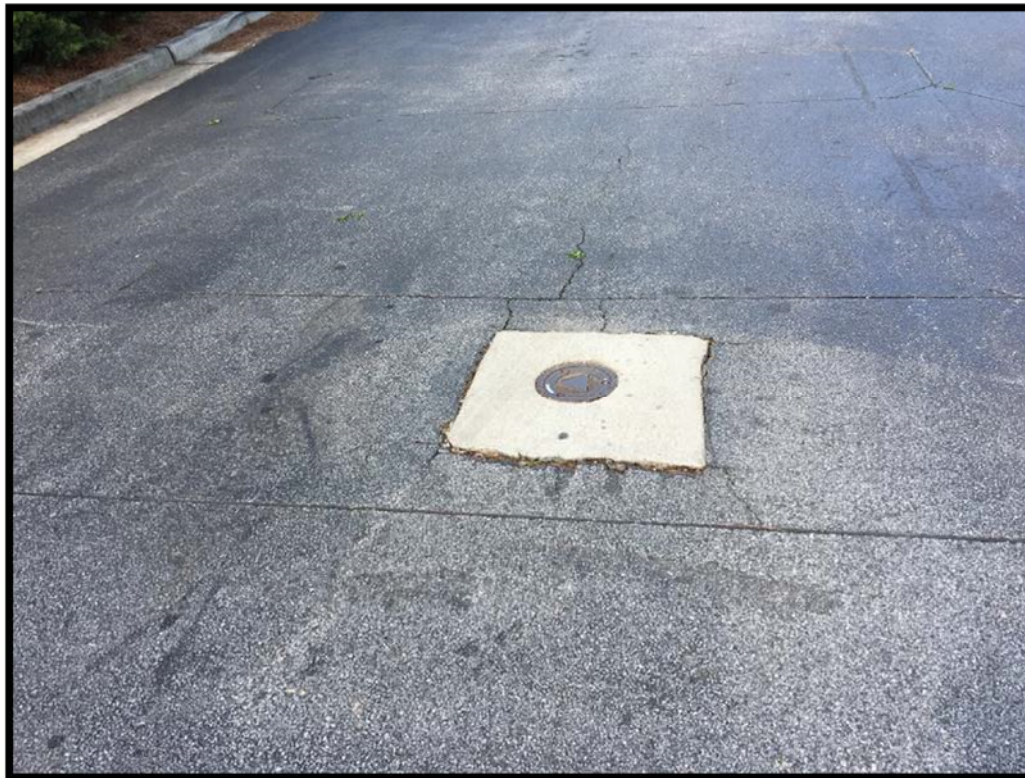
**OFFICIAL PHOTOGRAPH NO. 2
TETRA TECH**

Subject: Background monitoring well, MM-04.

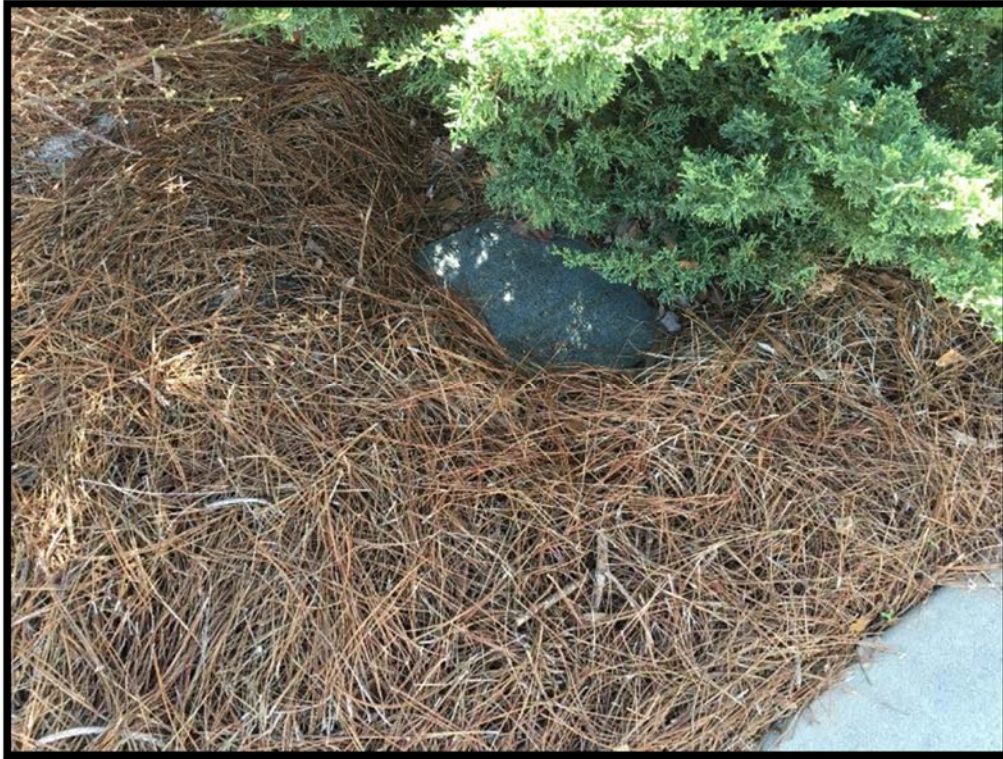
**OFFICIAL PHOTOGRAPH NO. 8
TETRA TECH**

Subject: Granite plaque on the western perimeter of the property.
Vegetation is overgrown.

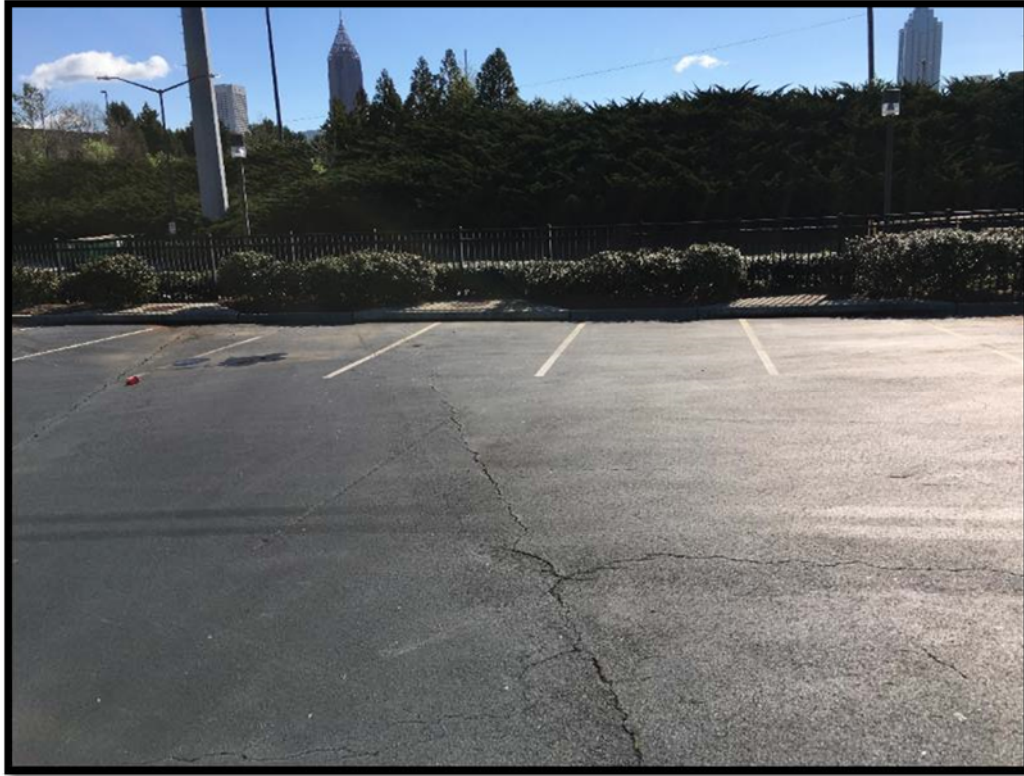
**OFFICIAL PHOTOGRAPH NO. 23
TETRA TECH**

Subject: Storm water drains located at the eastern parking lot perimeter.
The existing crack was still present, but had not increased in size.

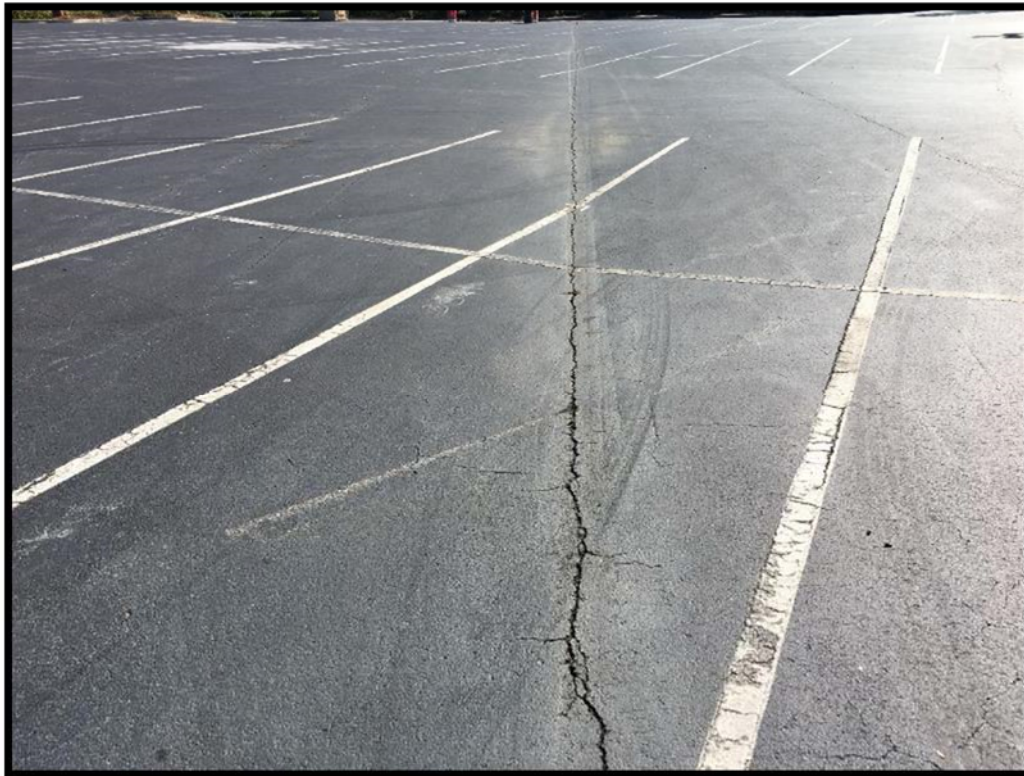
OFFICIAL PHOTOGRAPH NO. 27
TETRA TECH

Subject: A small crack in the asphalt leading to the storm water drains on the eastern side of the parking lot. Storm water flows in this low point of the parking lot, which has caused minor staining. The crack is estimated to be approximately 200 feet long, 1/4 inch wide and 1/4 inch deep. The existing crack was still present, but had not increased in size.

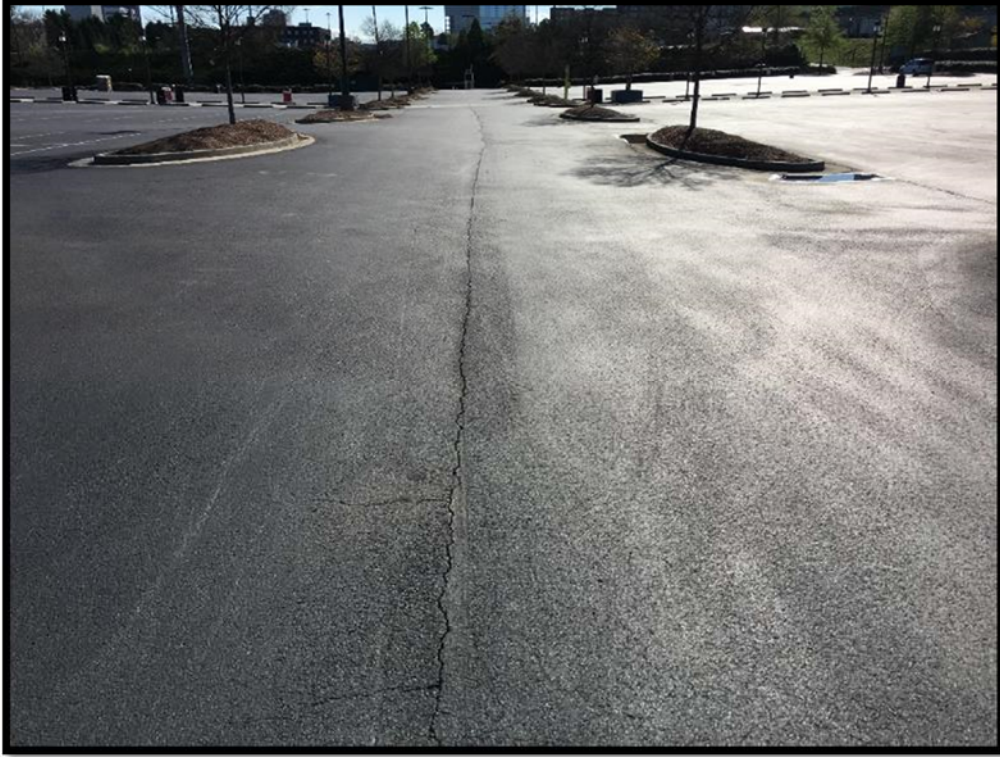
**OFFICIAL PHOTOGRAPH NO. 28
TETRA TECH**

Subject: Example of another crack which runs east to west on the main entrance/exit roadway. Like the previously observed crack, it is no larger than $\frac{1}{4}$ inch wide and $\frac{1}{4}$ inch deep. This crack traverses almost the entire length of the entrance/exit roadway. The existing crack was still present, but had not increased in size.

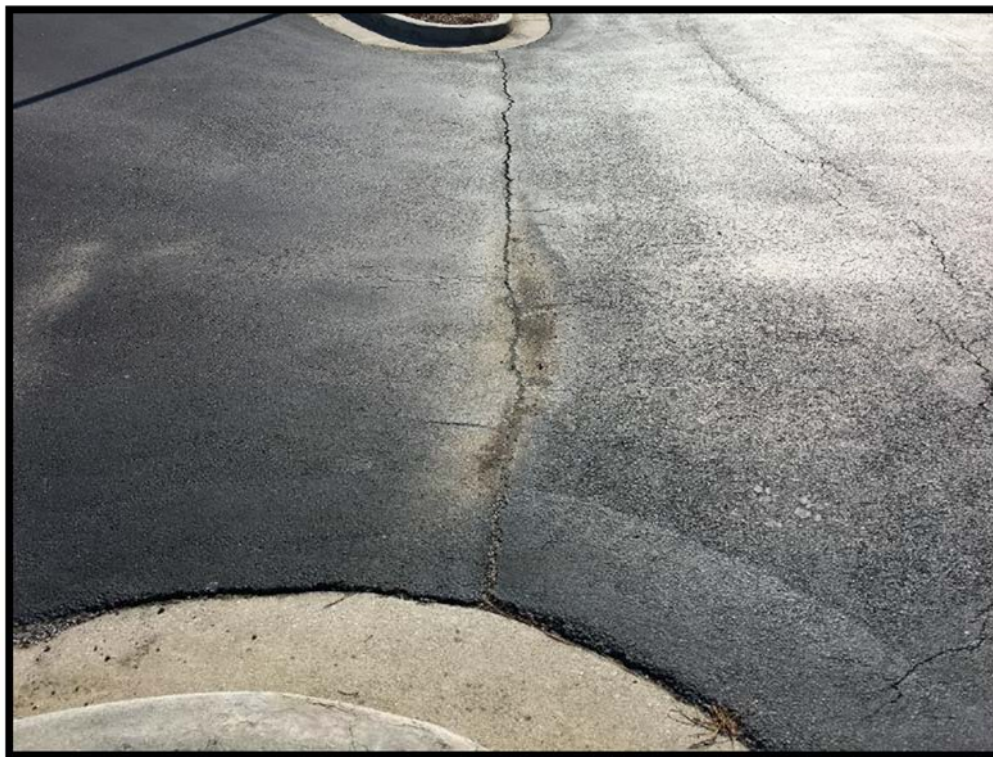
OFFICIAL PHOTOGRAPH NO. 29
TETRA TECH

Subject: Example of another crack which runs east to west on the entrance way of the parking lot row. Over half of the rows have cracks similar to this one. They occur where the asphalt seams are joined. Like the previously observed crack, it is no larger than ¼ inch wide and ¼ inch deep. The existing crack was still present, but had not increased in size.

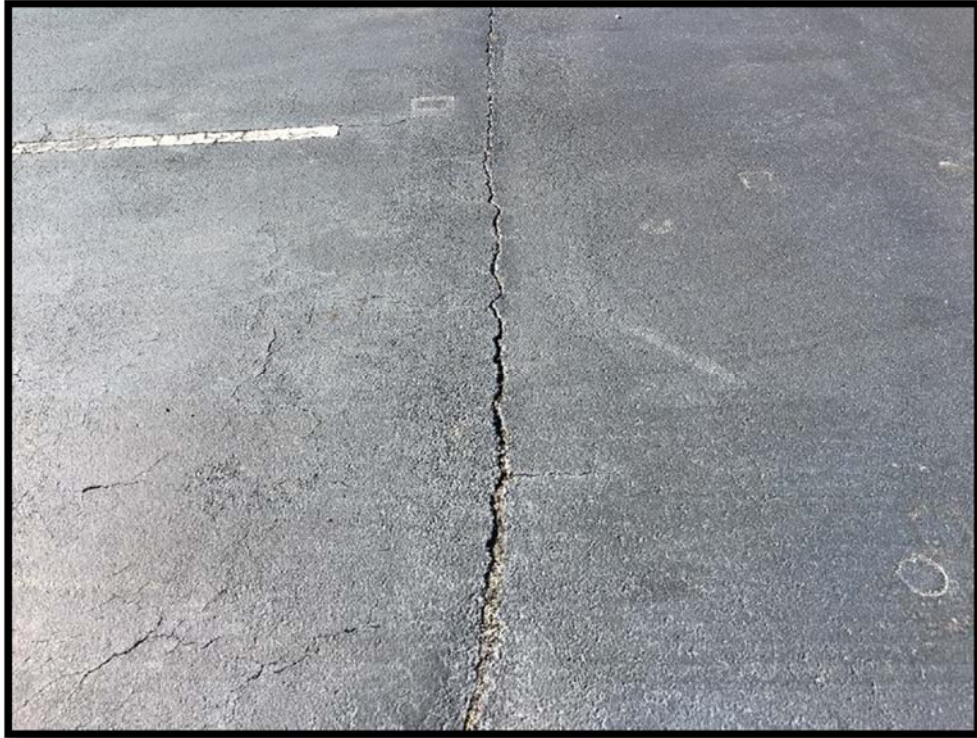
**OFFICIAL PHOTOGRAPH NO. 30
TETRA TECH**

Subject: Example of another crack, which runs north to south on the western most row of the north parking lot. A standard pen is used to show the approximate width of the crack. The width of this crack is typical of all cracks observed in the asphalt of the north parking lot. The existing crack was still present, but had not increased in size.

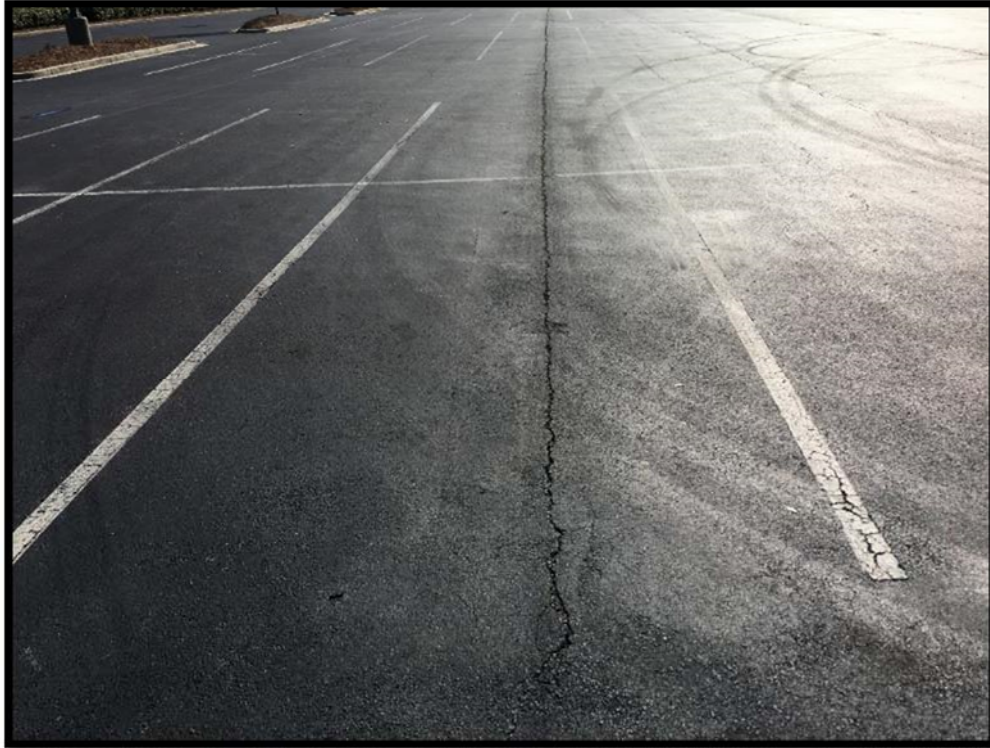
OFFICIAL PHOTOGRAPH NO. 31
TETRA TECH

Subject: Example of another crack which runs east to west. This crack is located on the northern portion of the parking lot and traverses the entire parking lot west of the north/south walkway. Once again, this crack occurs where the asphalt seams are joined. Like the previously observed cracks, it is no larger than 1/4 inch wide and 1/4 inch deep. The existing crack was still present, but had not increased in size. Note significant trailer storage was observed in this area of the parking lot.

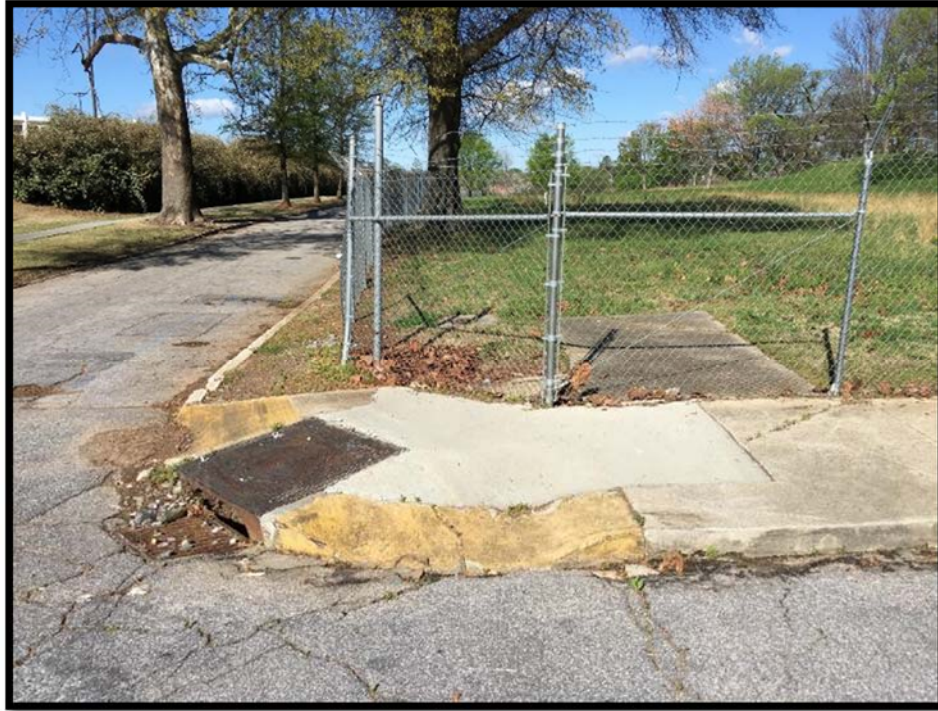
**OFFICIAL PHOTOGRAPH NO. 32
TETRA TECH**

Subject: Storm water drainage inlet at the northwest corner of the John Street and Gray Street intersection. The inlet is obstructed with sediment, gravel, trash and debris. The pavement around the inlet is in poor condition. Monitoring wells, MW-1A, MW-1B and MW-1C can be seen in the background.

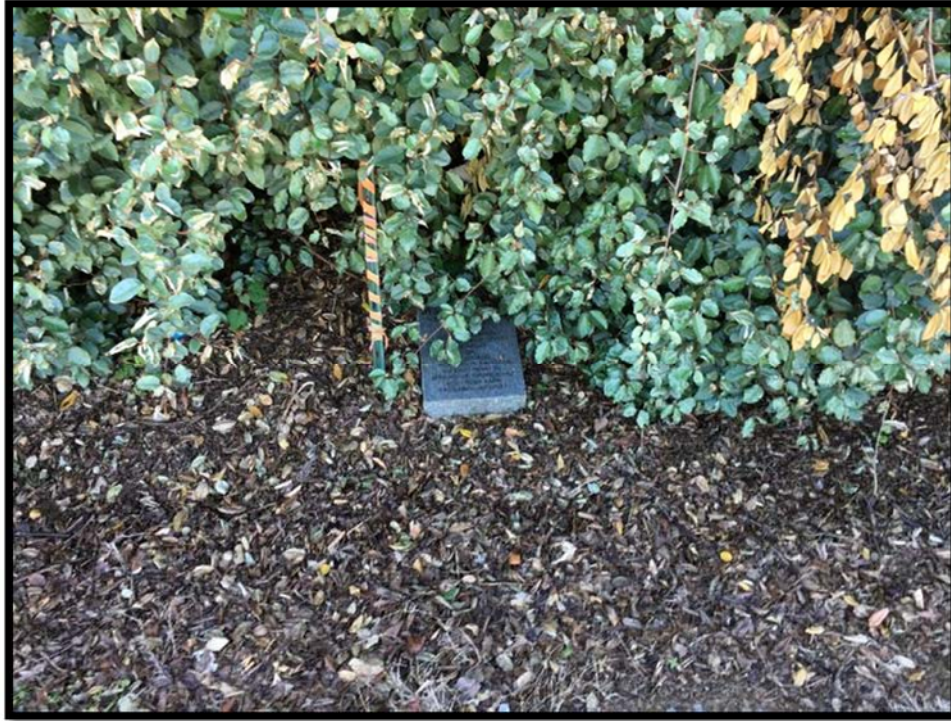
OFFICIAL PHOTOGRAPH NO. 33
TETRA TECH

Subject: Granite plaque on the northern perimeter of the property. This plaque was noted to be missing in previous inspections due to overgrown brush.

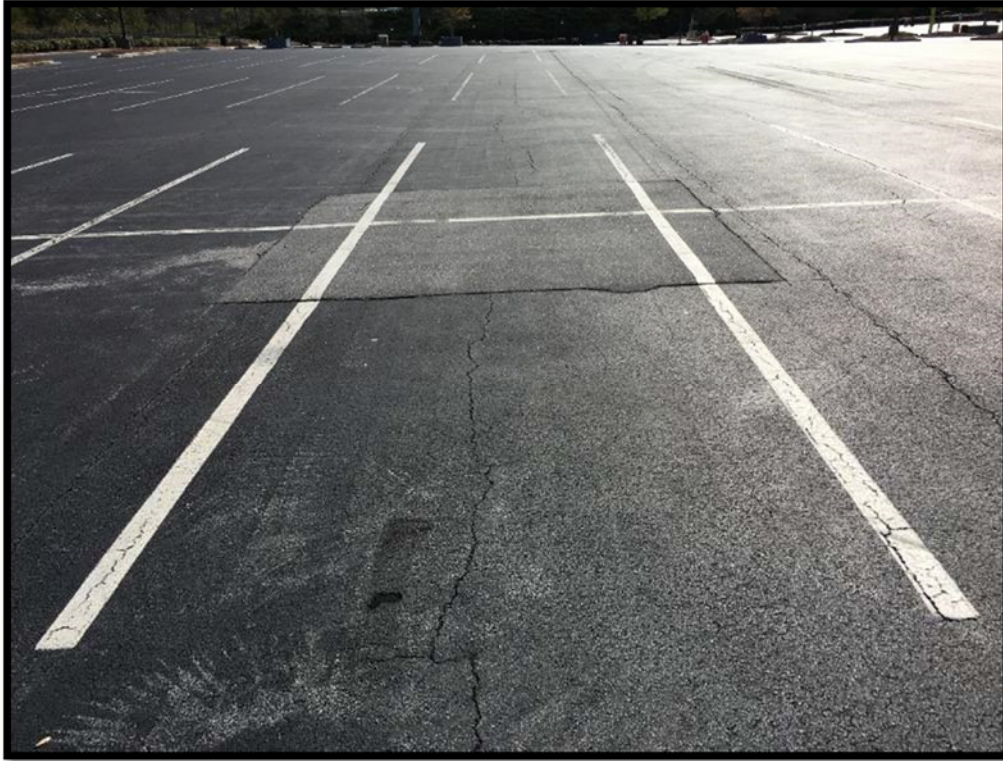
**OFFICIAL PHOTOGRAPH NO. 34
TETRA TECH**

Subject: Restored asphalt patch for direct push location DP-30, located in the northwest part of the parking lot. Area is partially covered with trailer storage in the area.

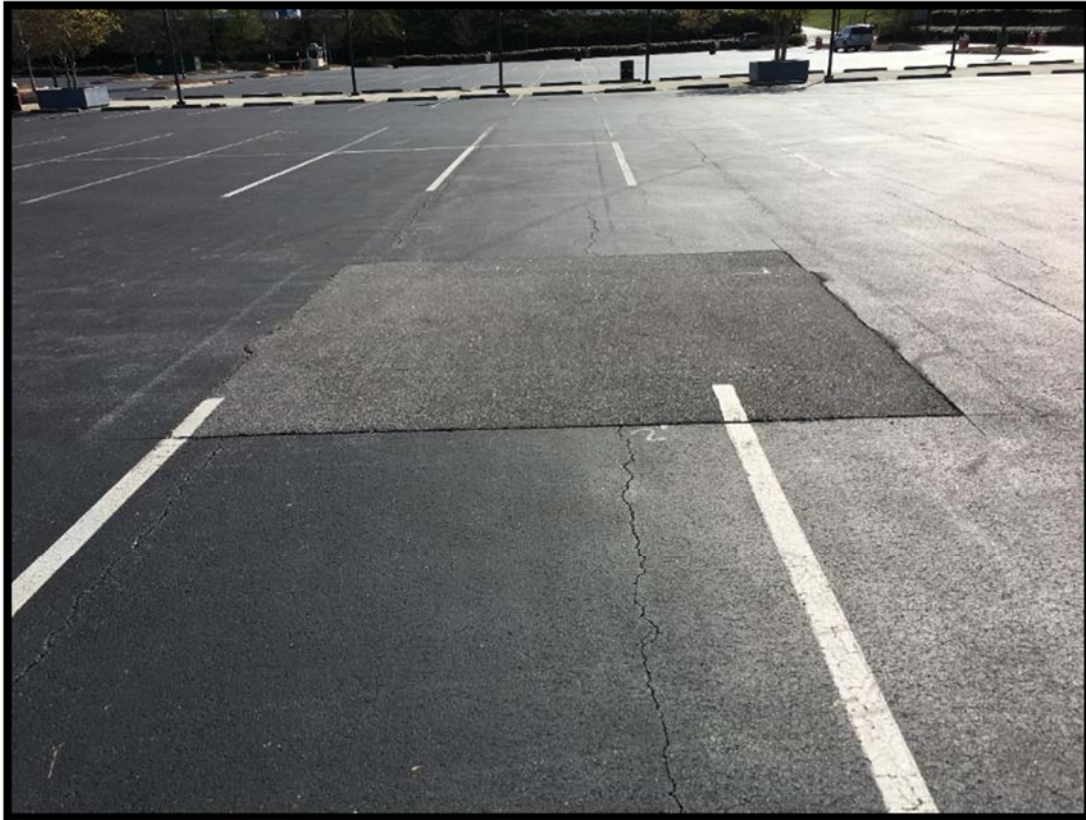
**OFFICIAL PHOTOGRAPH NO. 38
TETRA TECH**

Subject: Restored asphalt patch for direct push location DP-34, located in the south part of the parking lot.

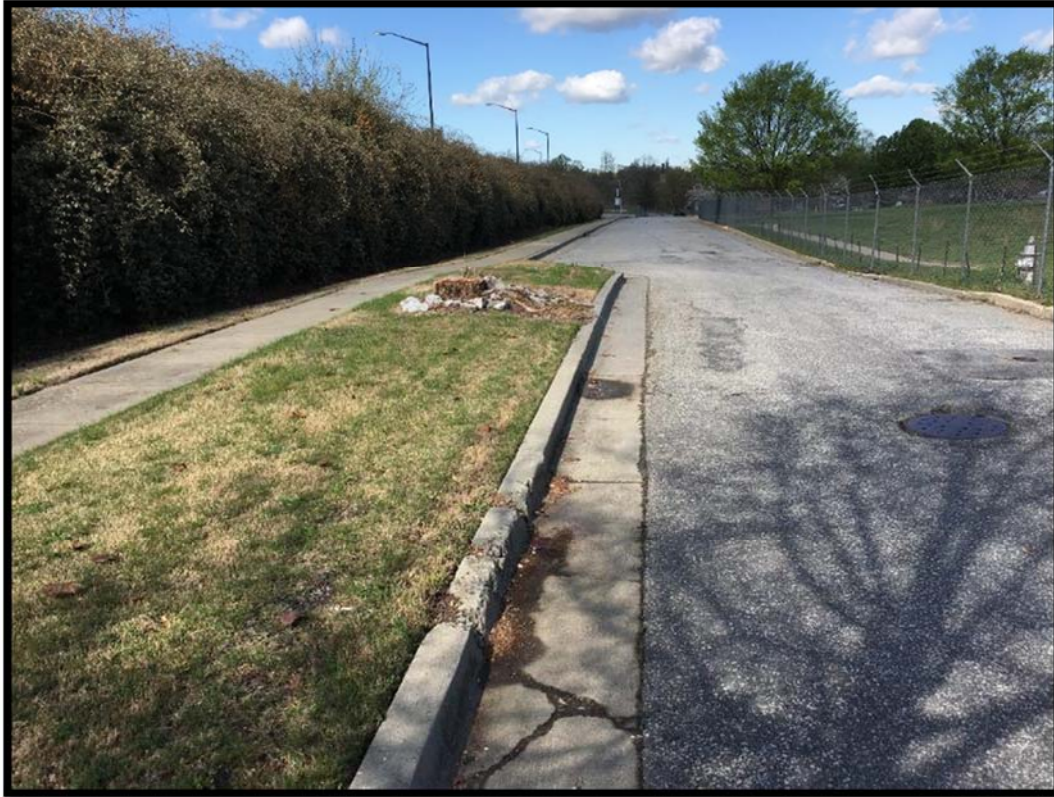
**OFFICIAL PHOTOGRAPH NO. 41
TETRA TECH**

Subject: Repaired rutted vegetation area (approx. 60' x 18" by 6") along John Street. The rut appeared to have been caused by automobile and was noted in the December 2015 and March 2016 inspections. Repair was made between March 23, 2016, and June 29, 2016. The repair appears thorough and vegetation is restored.

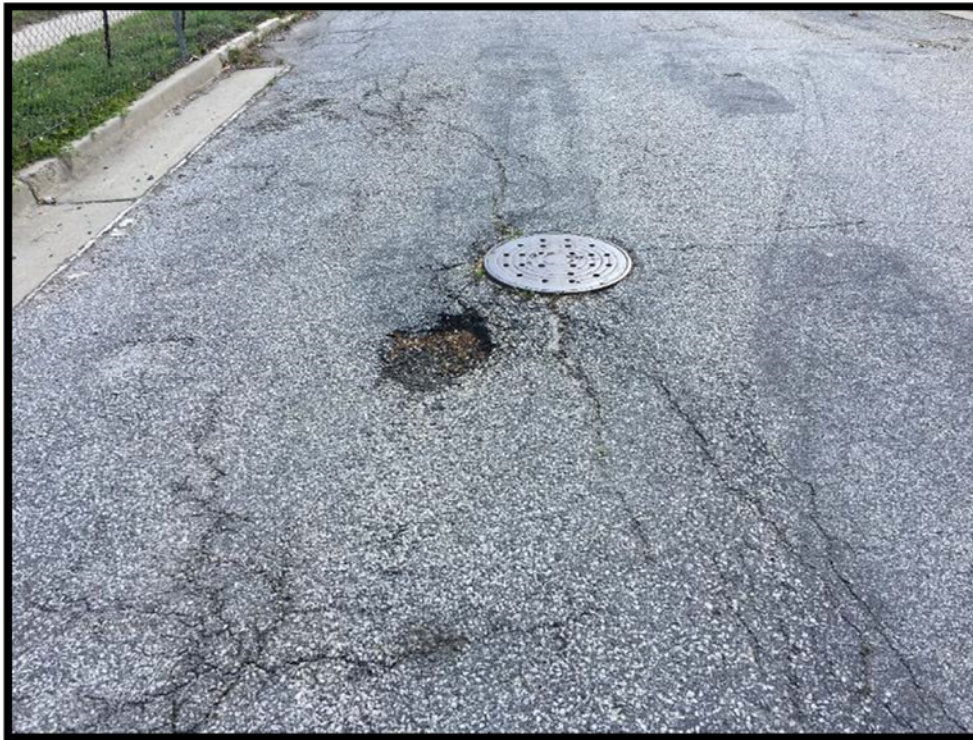
**OFFICIAL PHOTOGRAPH NO. 42
TETRA TECH**

Subject: Pothole found near manhole in John Street – approx. 10” diameter and 4” deep.

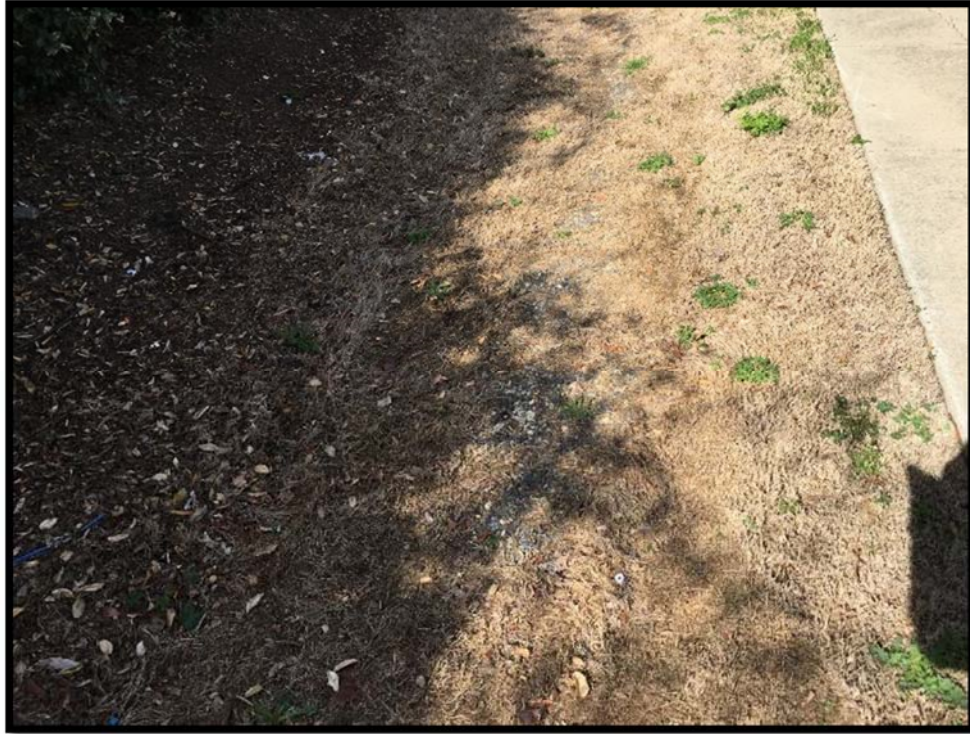
**OFFICIAL PHOTOGRAPH NO. 44
TETRA TECH**

Subject: Repaired eroded soil in the storm water drainage path along John Street. As noted in the December 2015 and March 2016 inspections, the storm water appeared to have caused a clear separation and was undercutting the sod. The hole was approximately 16” deep and extended approximately 8 feet. The repaired occurred between March 23, 2016, and June 29, 2016.

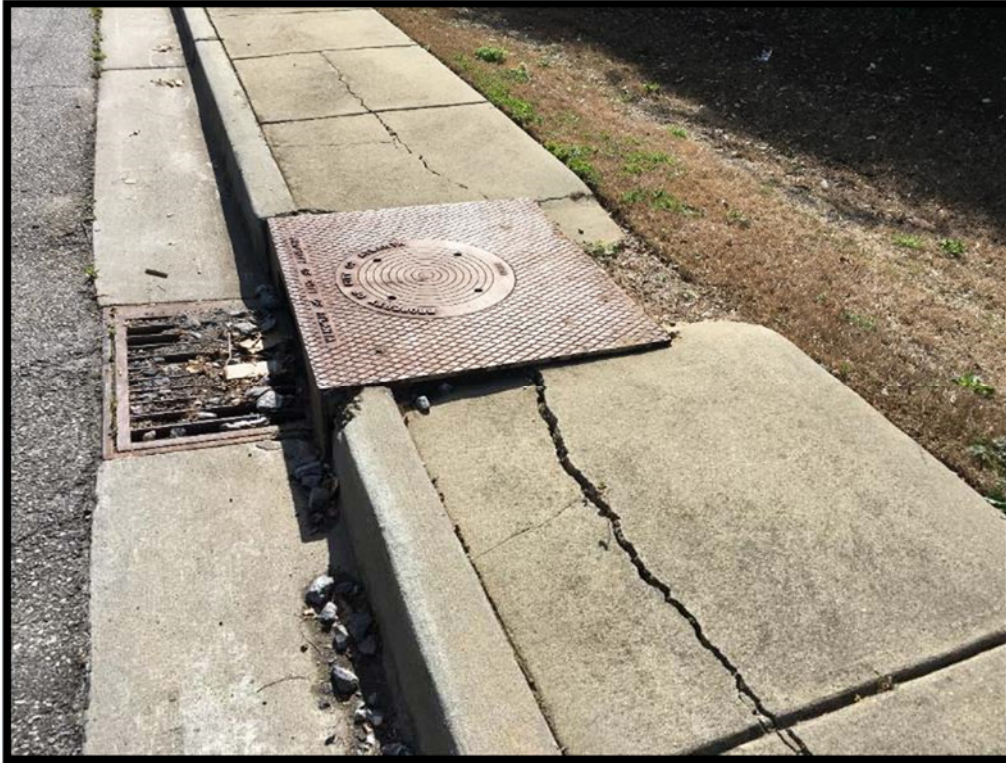
**OFFICIAL PHOTOGRAPH NO. 45
TETRA TECH**

Subject: Storm water drain along John Street partially obstructed by gravel, sediment, and vegetation. This drain is located adjacent to the repaired area presented in Photograph 44. Note the depressed concrete on the south and west sides of the metal vault.
