**Re: 2016 Annual CAMP Report
Atlanta Gas Light Company
Former Manufactured Gas Plant Site
Rome, Georgia**

PHOTOGRAPHIC LOG

Project No. 0337279

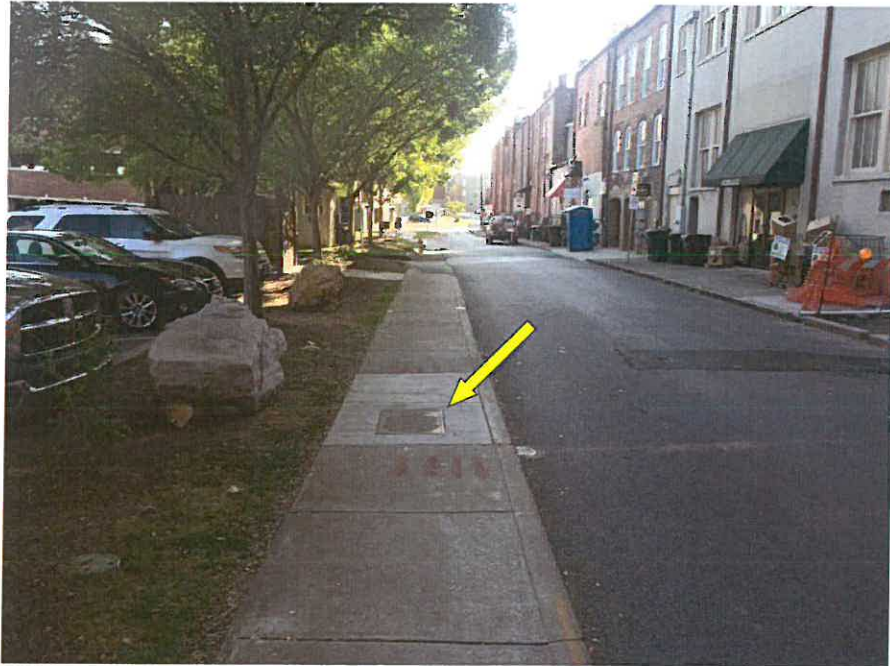
Photo No.
1

West 1st Street and Right-of-Way.

New pavement where Type 5 Marker was installed. MW-507 abandoned in place

Good ground cover, no erosion

No disturbed asphalt

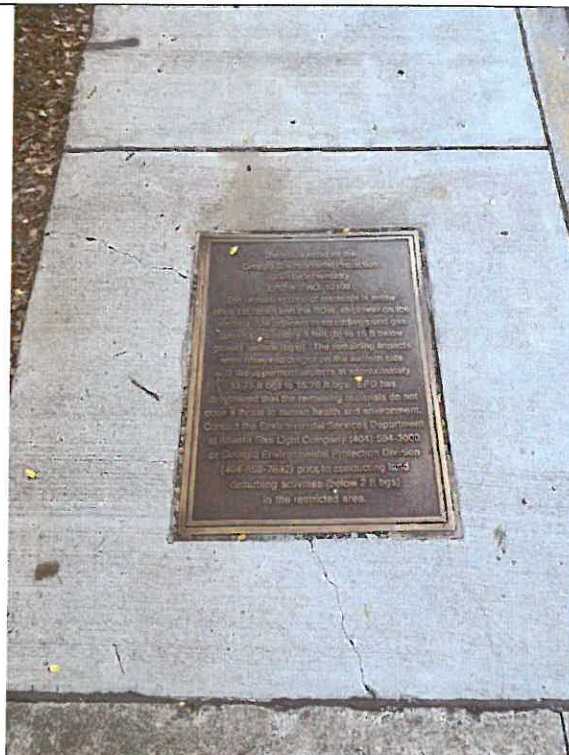
Photo No.
2

Bronze Type 5 Marker installed July 2015

Marker in good condition

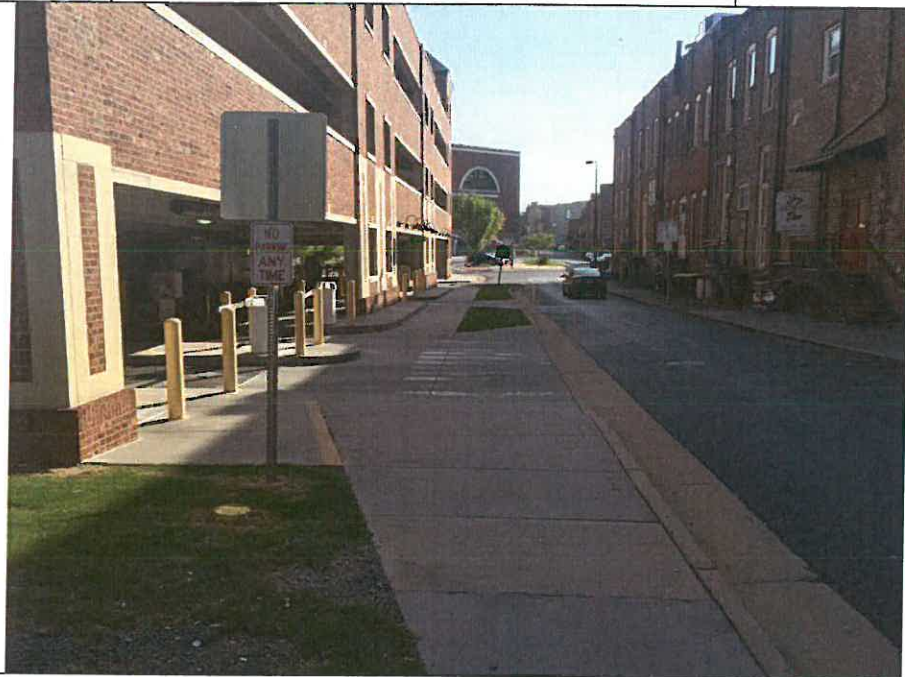
Photo No.
3

Parcel 1 along West 1st Street

Parcel used as a parking lot

No groundwater use

No erosion concerns

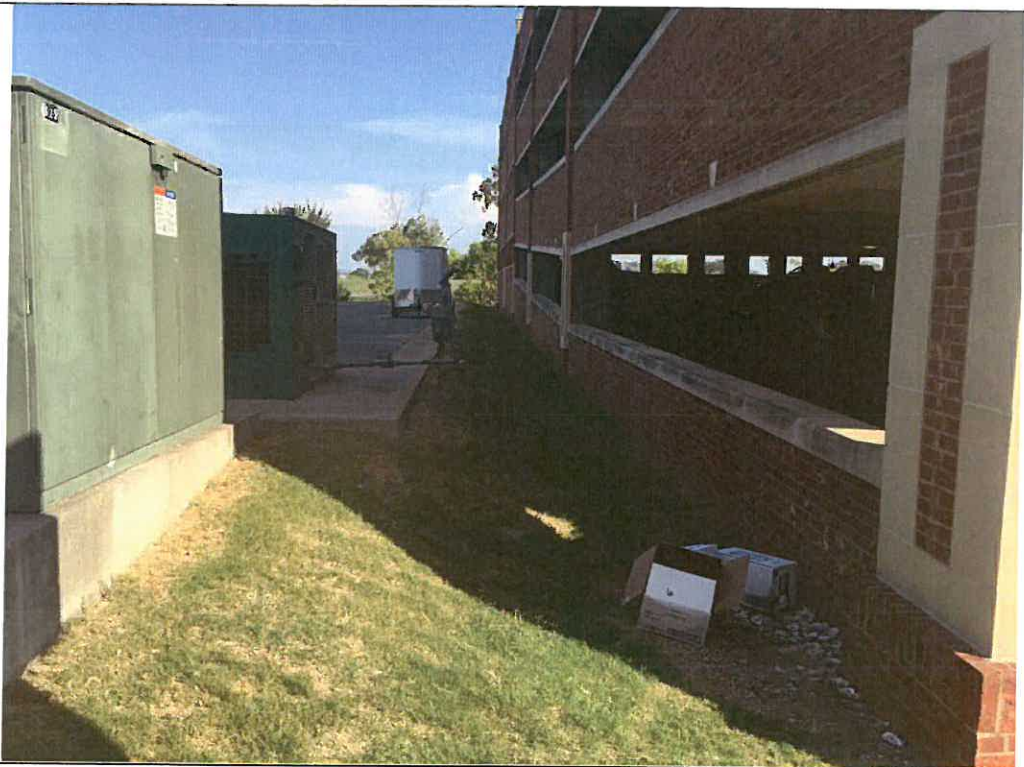
Photo No.
4

Parcel 1 adjacent to Parcel 7

Parcel used as a parking lot

No groundwater use

Good grass cover - no erosion concerns

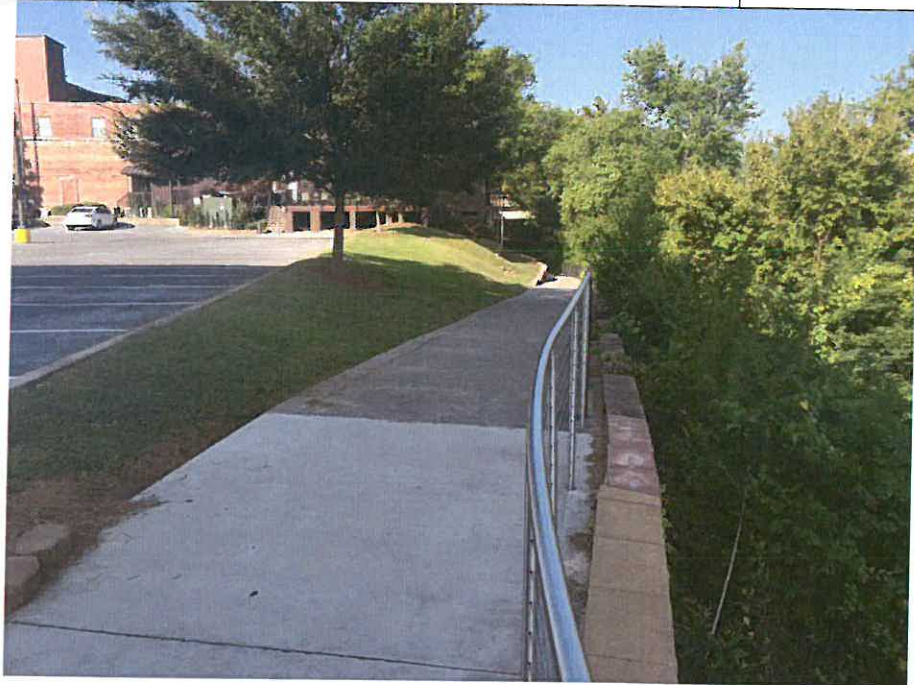
Photo No.
5

Parcel 2 between riverbank and walking trail

No groundwater use

Good vegetation cover - no erosion concerns

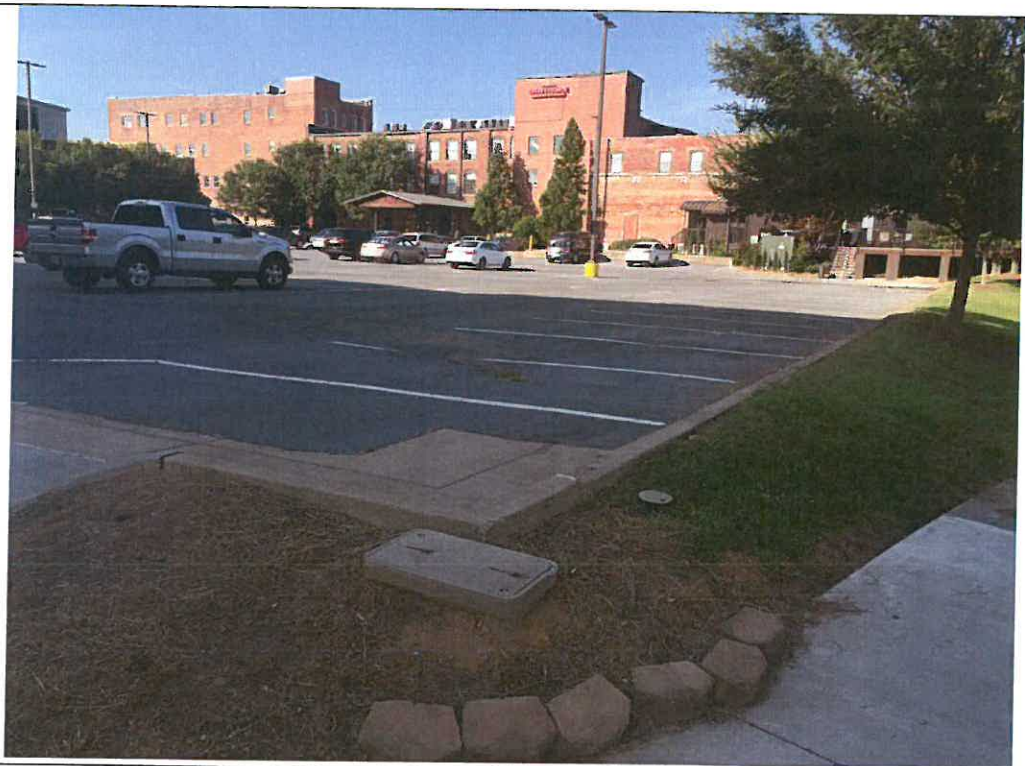
Photo No.
6

Parcel 2 – Parking Lot

No groundwater use

Good grass/mulch cover on edge of parking lot - no erosion concerns

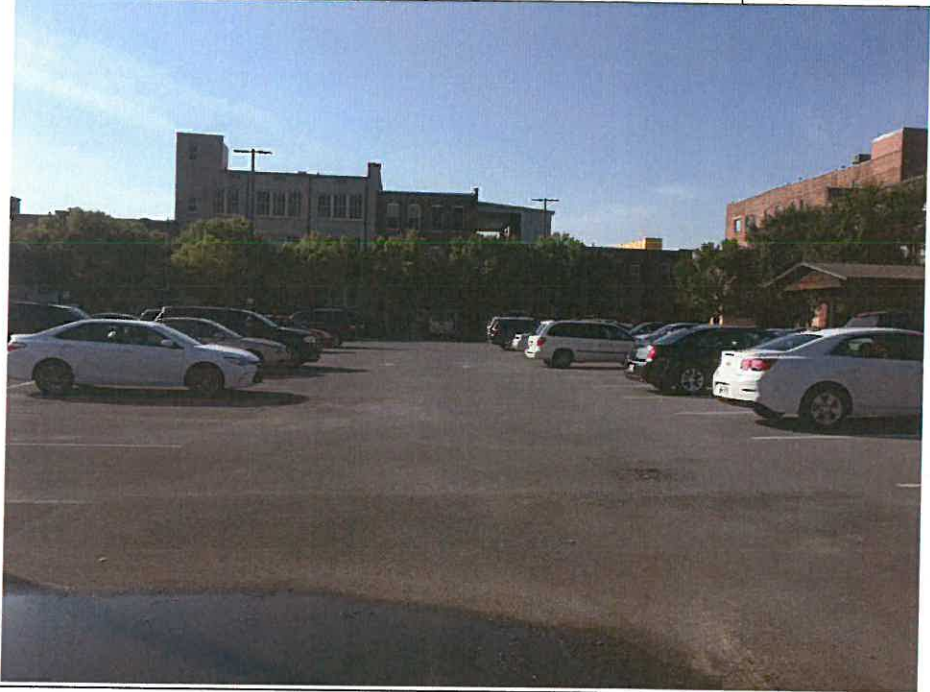
Photo No.
7

Parcel 3 – Parking Lot

No groundwater use

Asphalt cover – no erosion concerns

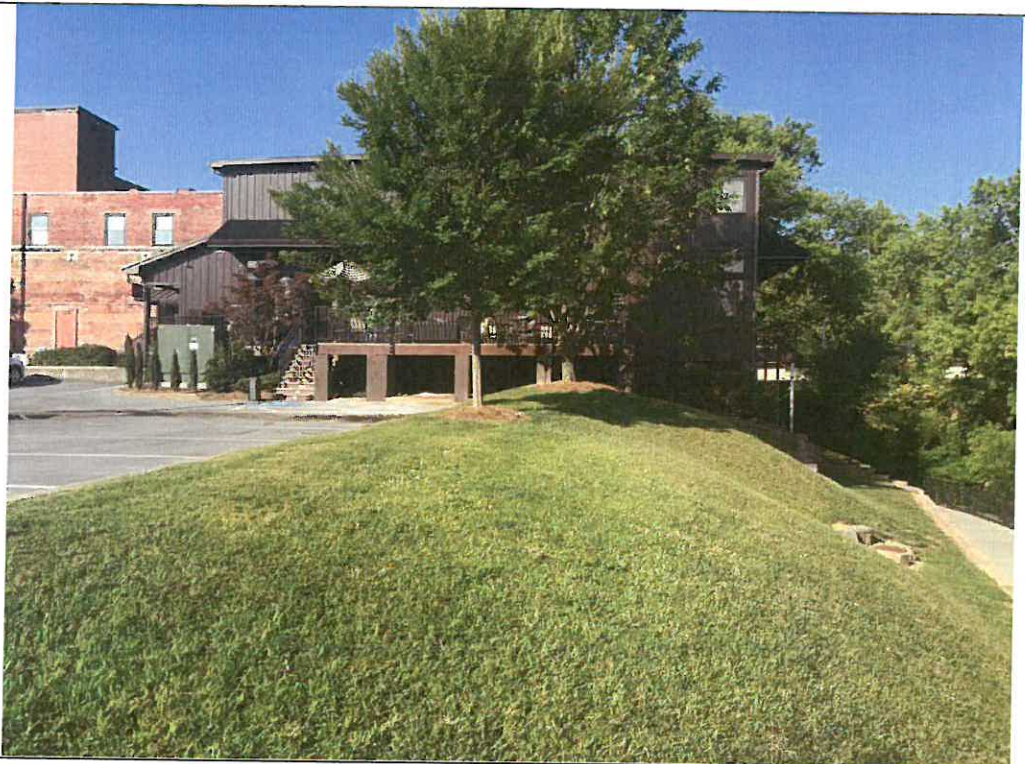
Photo No.
8

Parcel 3A – Grass embankment north of parking lot

No groundwater use

Good grass cover - no erosion concerns

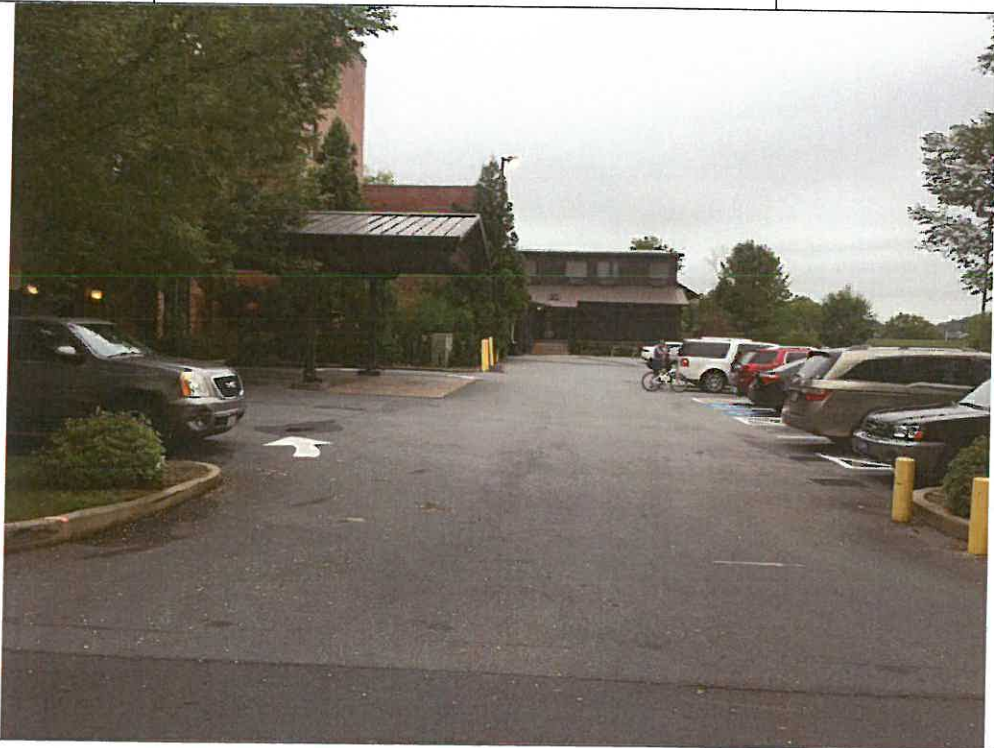
Photo No.
9

Parcel 4 – Hawthorne Suites Parking Lot

No groundwater use

Asphalt cover – no erosion concerns

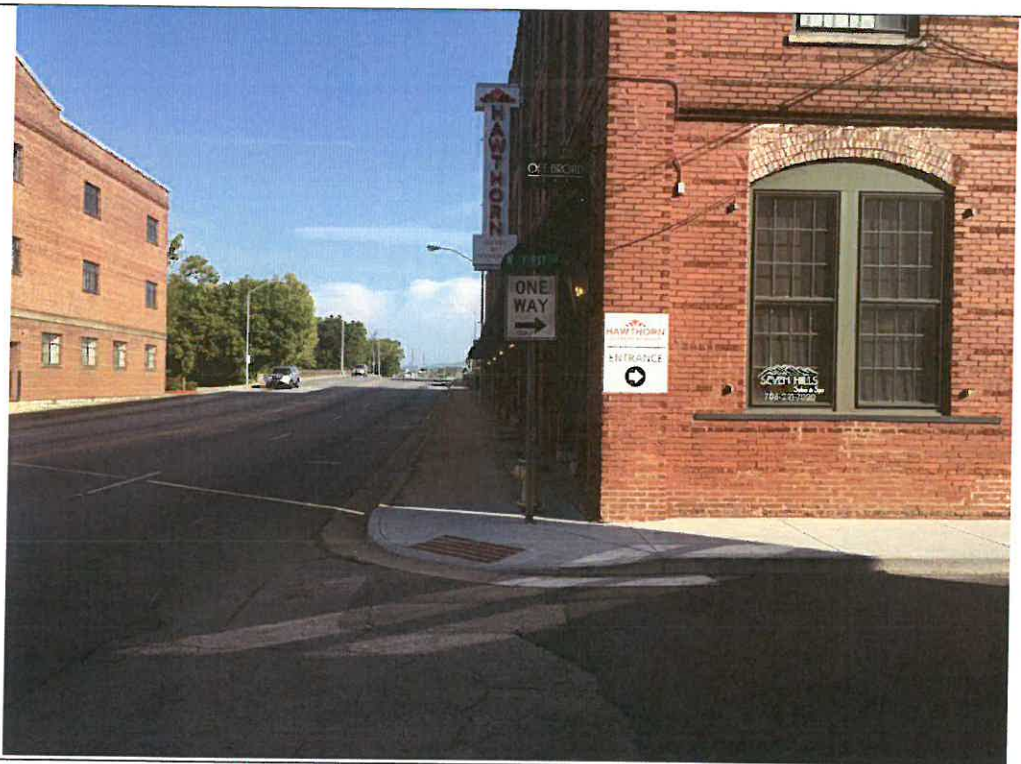
Photo No.
10

Parcel 5 – Hawthorne Suites Hotel

Retail space on ground floor

No groundwater use

No erosion concerns

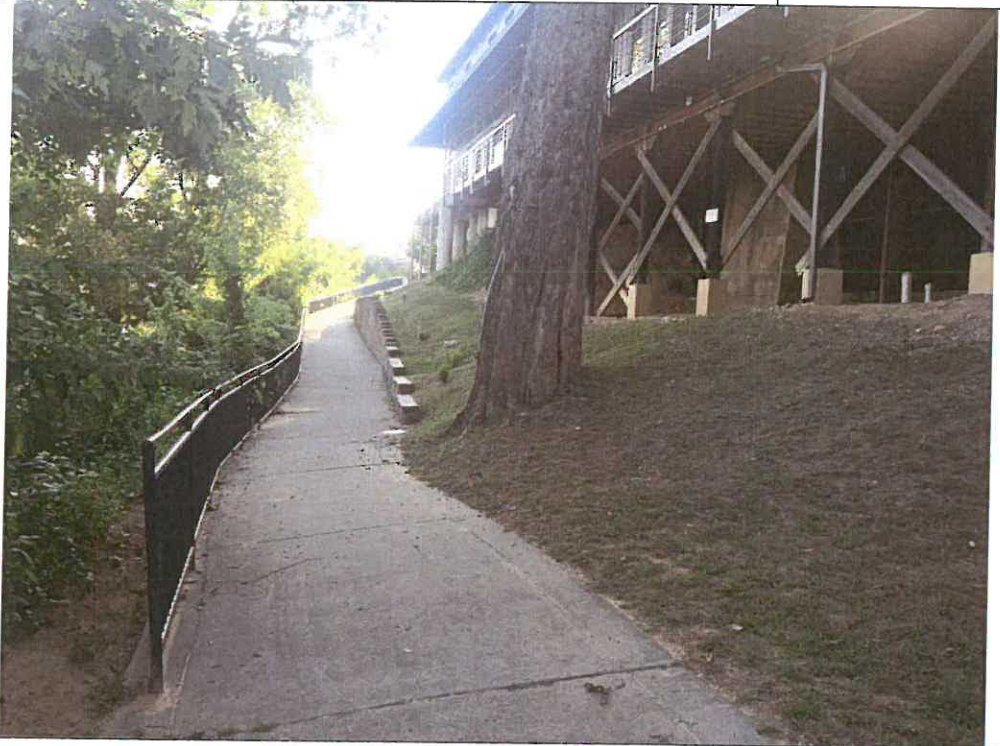
Photo No.
11

Parcel 6 – NW of Hawthorne Suites

No groundwater use

Good grass cover - no erosion concerns

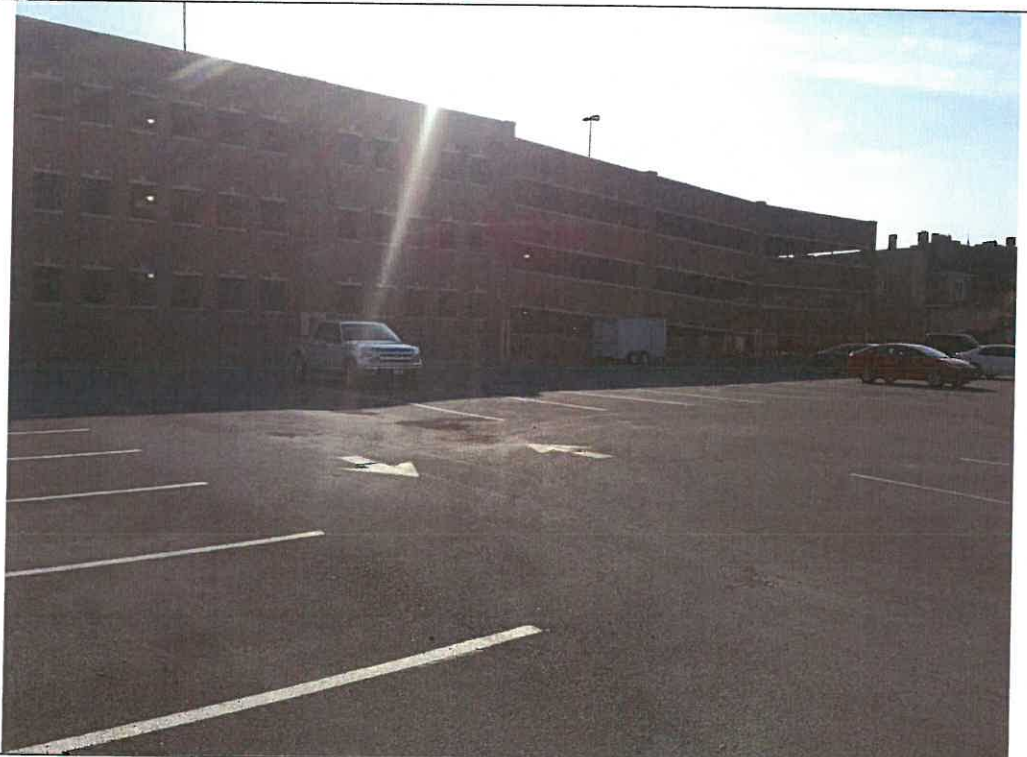
Photo No.
12

Parcel 7 – Parking Lot

No groundwater use

Asphalt cover – no erosion concerns

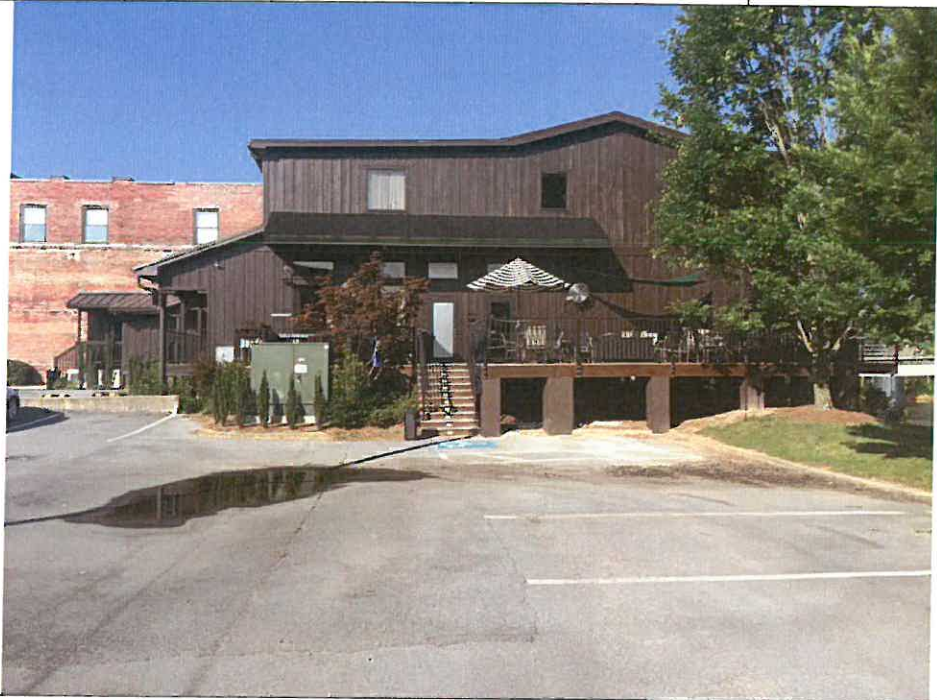
Photo No.
13

Parcel 8 –wooden building

Not in residential use

No groundwater use

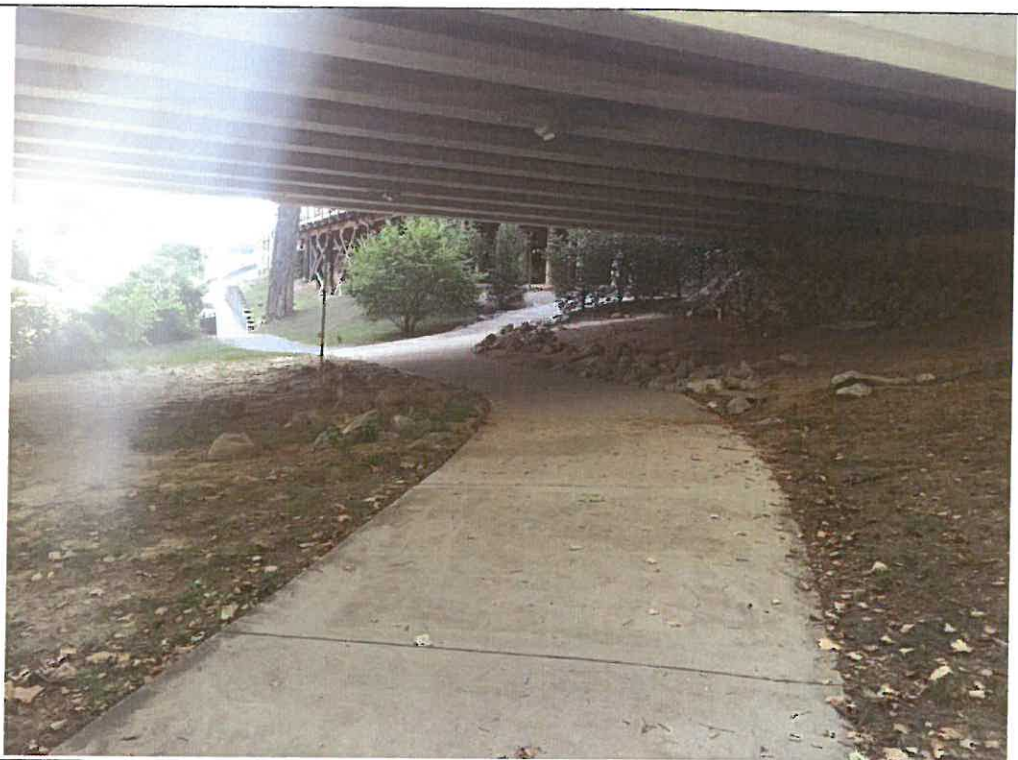
Photo No.
14

ROW under 2nd Ave Bridge

No visible signs of erosion – some bare soil but rock cover appears to be preventing any erosion

MONITORING ITEM	CONDITION ¹			COMMENTS
	NA	MN	IA	
VRP STANDARDS INSTITUTIONAL CONTROLS				
Groundwater Restriction	NA			No extraction of groundwater occurring
Residential Use Requirements/Barriers	NA			
Erosion	NA			No visible erosion, some bare soil, continue to monitor
Other				
Monitoring Performed By: Will Virgo				
Date: August 2, 2016				
Condition¹: NA, no action needed; MN, maintenance needed; IA, immediate action needed

Continue to monitor for signs of erosion
