Subject: **Response to Georgia Environmental Protection Division May 16, 2019 Comments on the VRP CSR Addendum and 2018 Annual Monitoring and Inspection Report Thermo King Corporation - Louisville, Jefferson County, Georgia HSI Site No. 10702 Tax Parcel 0090-024 Wood Project 6122-09-0322**

**REVISED OPERATION AND MAINTENANCE PLAN AND INSPECTION SCHEDULES FOR
ENGINEERING CONTROLS
7/18/2019**

**RESPONSE TO GEORGIA ENVIRONMENTAL PROTECTION DIVISION COMMENTS
DATED MAY 16, 2019 FOR THE THERMO KING CORPORATION SITE –
LOUISVILLE, JEFFERSON COUNTY, GEORGIA**

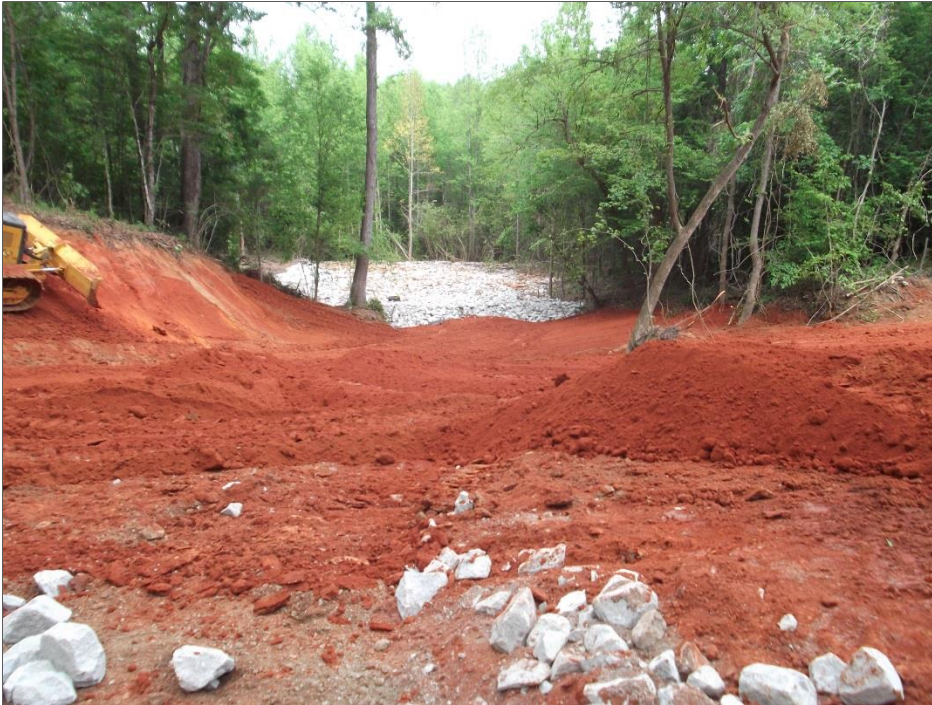
Client: Ingersoll Rand
Location: ThermoKing, Louisville, Georgia
Project: Riprap Blanket Install
Date: 5/12/12
Photo #: 155
Photographer: P. Gazzo
Description: Riprap around seep MB#2 looking down from top of slope

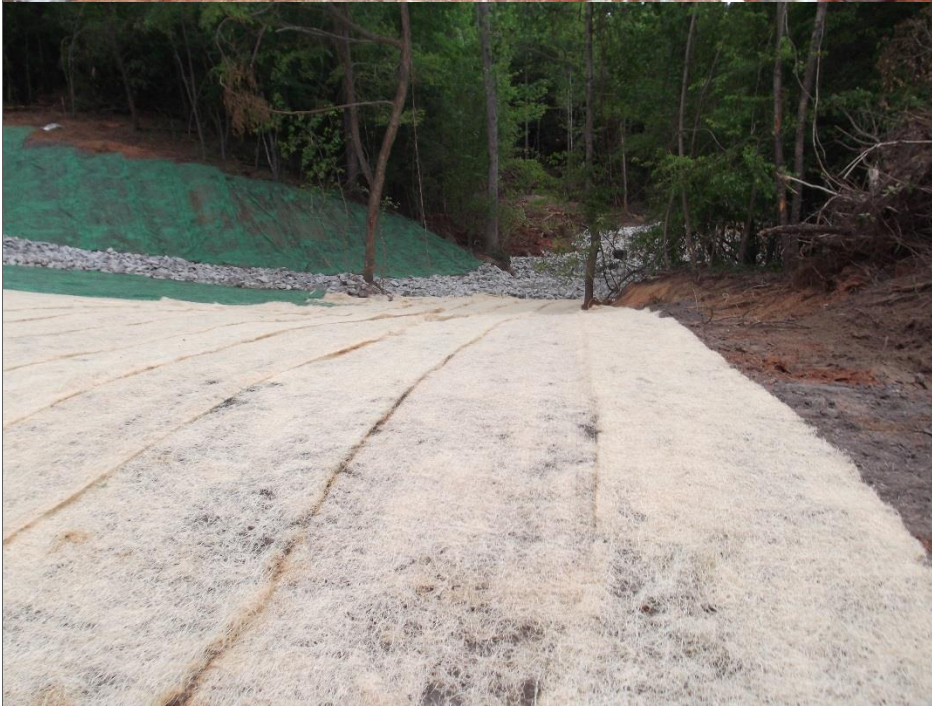
Client: Ingersoll Rand
Location: ThermoKing, Louisville, Georgia
Project: Riprap Blanket Install
Date: 5/17/12
Photo #: 183
Photographer: P. Gazzo
Description: Flume leading down to riprap blanket at MB#2 with erosion control matting laid

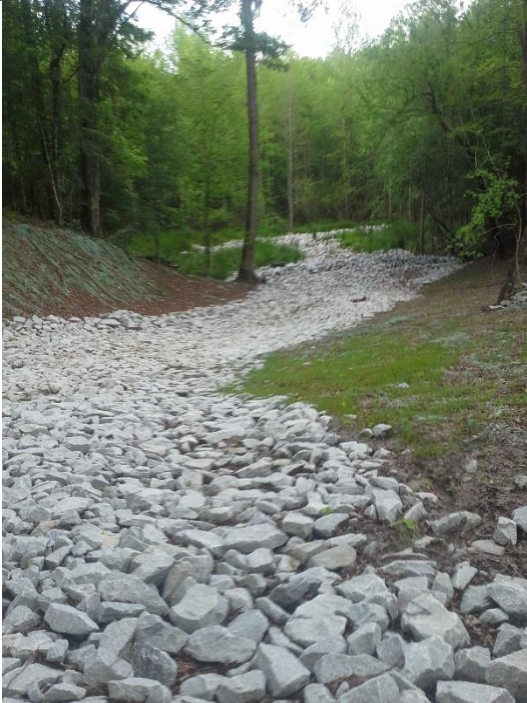
Description: Riprap blanket looking down at MB#2 from top of slope

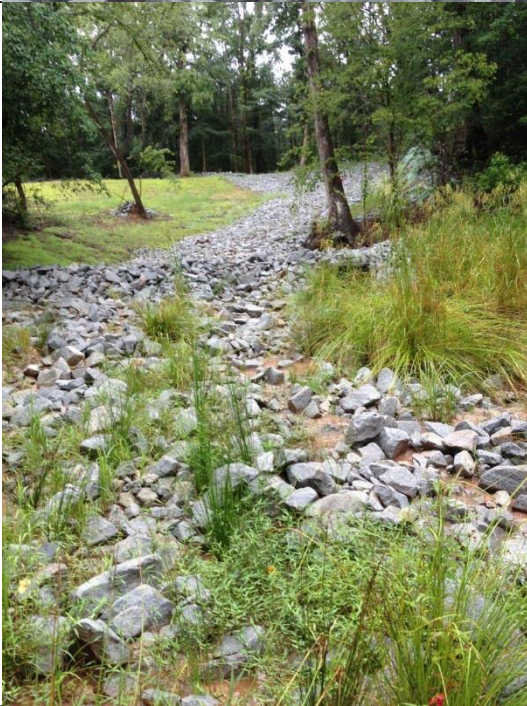
Description: Looking up at top of slope from check dam near MB#2

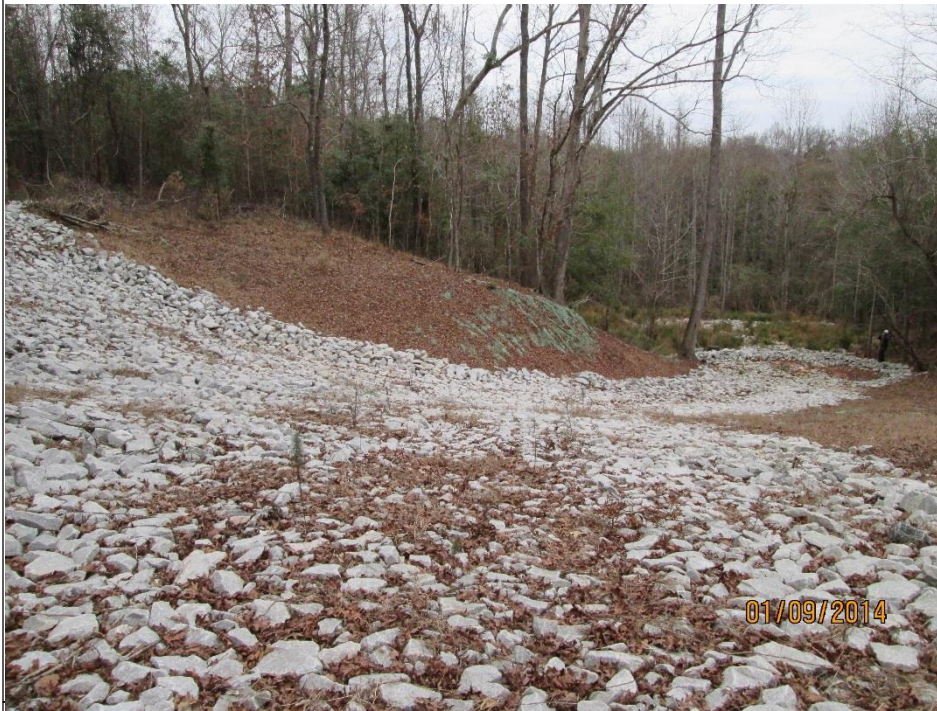
Client: Ingersoll Rand
Location: ThermoKing, Louisville, GA
Project: Riprap Blanket Inspection
Date: 1/9/14
Photo #: 077
Photographer:
Description: Riprap blanket looking down at MB#2 from top of slope

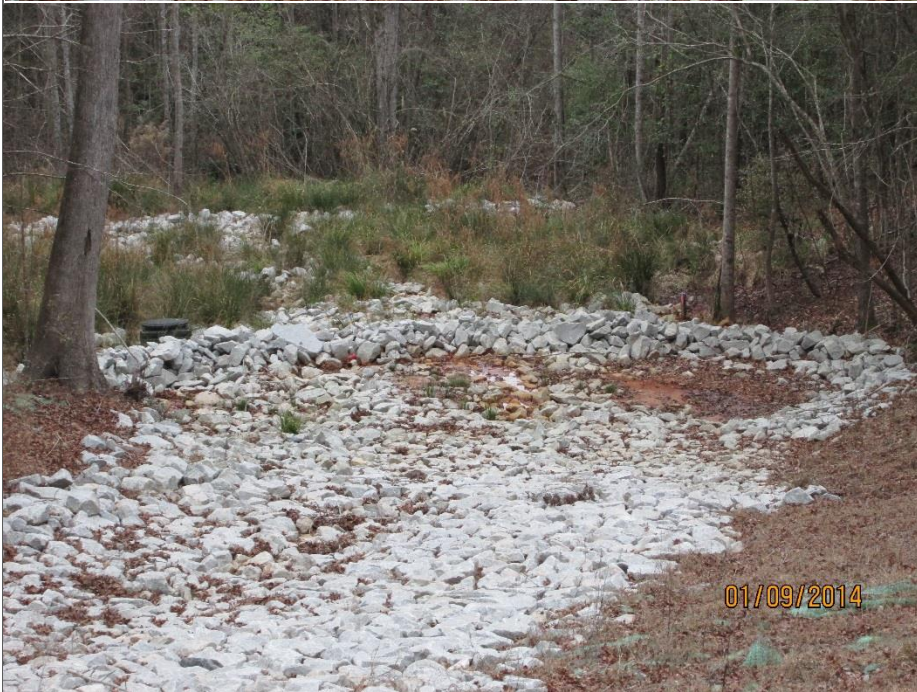
Client: Ingersoll Rand
Location: ThermoKing, Louisville, GA
Project: Riprap Blanket Inspection
Date: 1/9/14
Photo #: 078
Photographer:
Description: Riprap blanket and check dam at MB#2

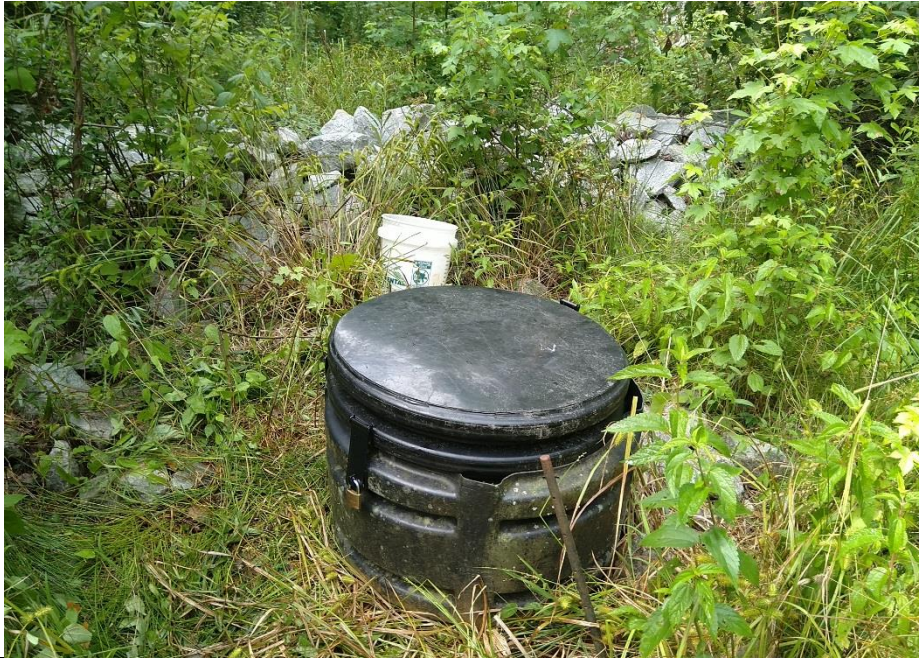
Manson Branch # 2 Seep

Secured seep access looking S towards check dam

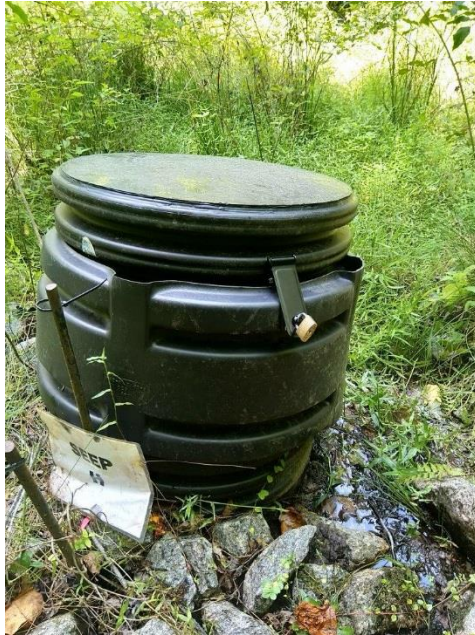
Seep H

Secured seep access looking NE and downgradient

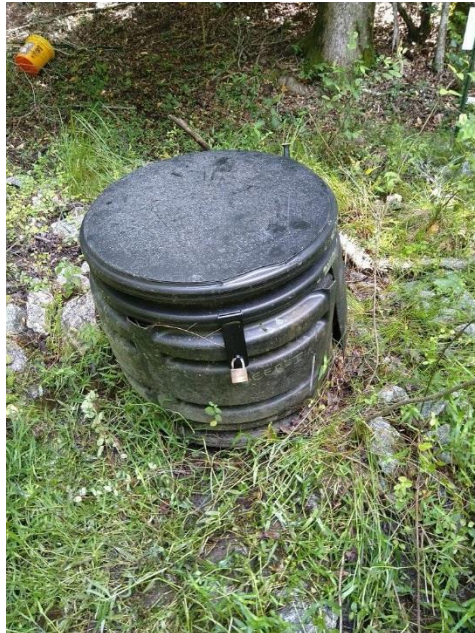
Seep H

Seep access secured with padlocks looking SW

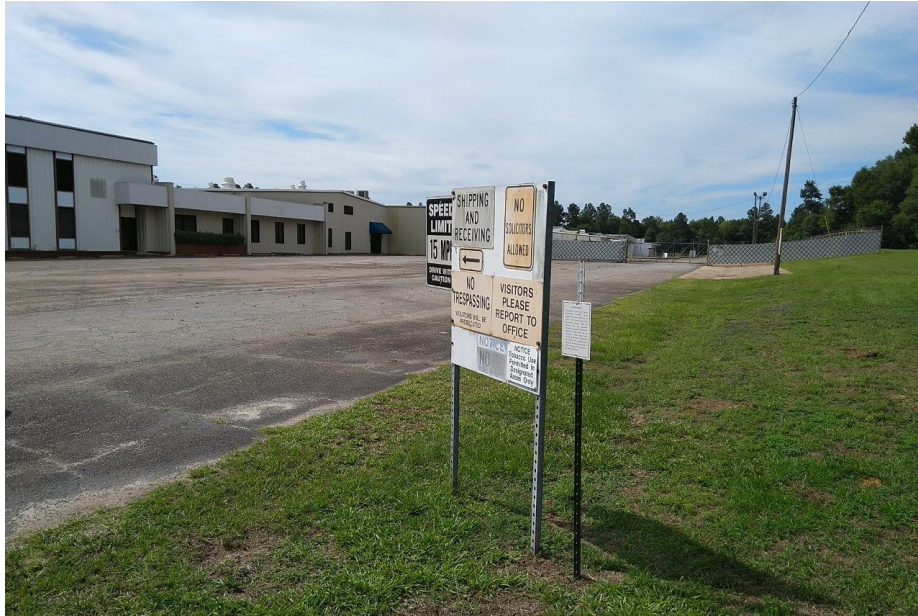
Marker 1

Site NW entrance drive looking SE

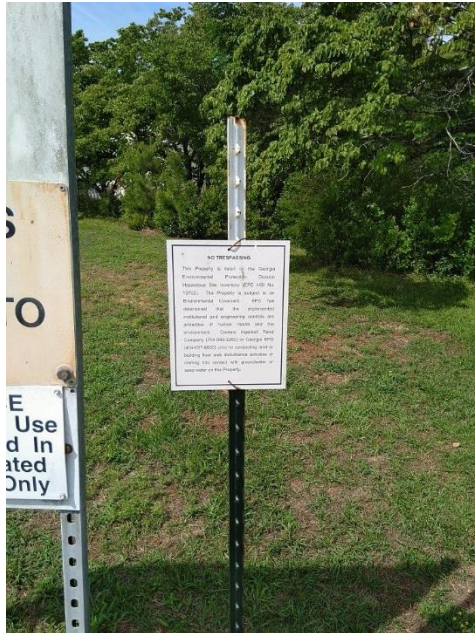
Marker 1

Closeup of marker sign looking towards SW

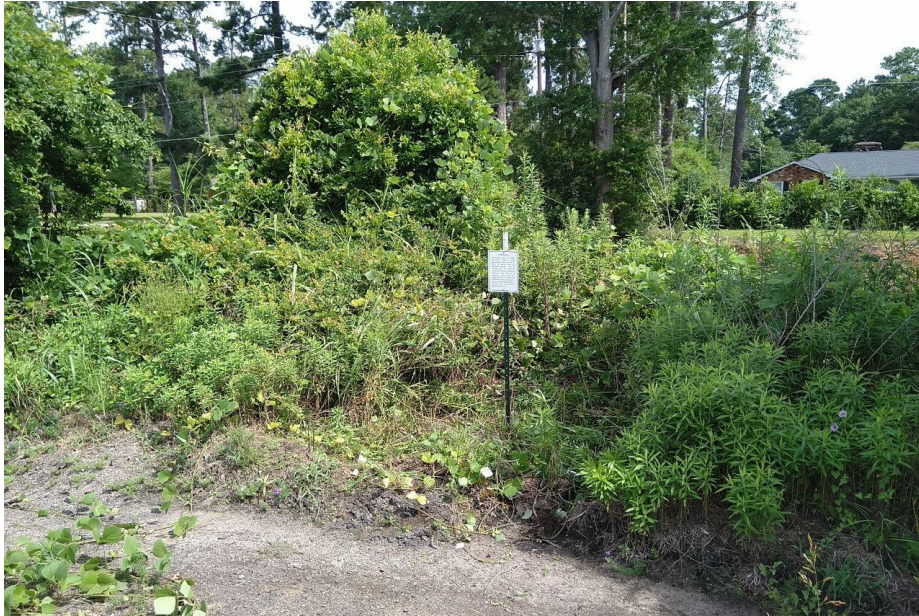
Marker 2

Northern boundary of NE asphalt lot looking NW

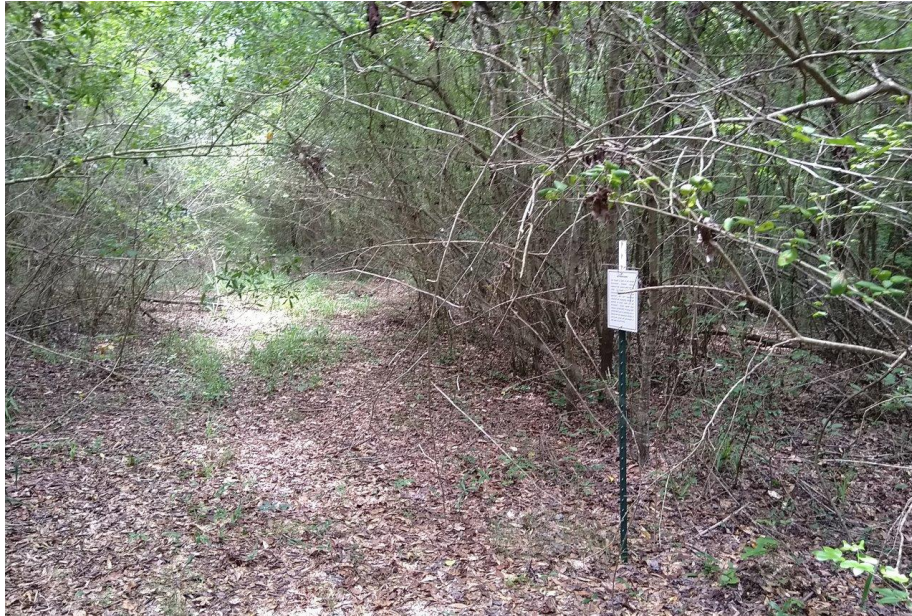
Marker 3

Eastern property boundary looking SW

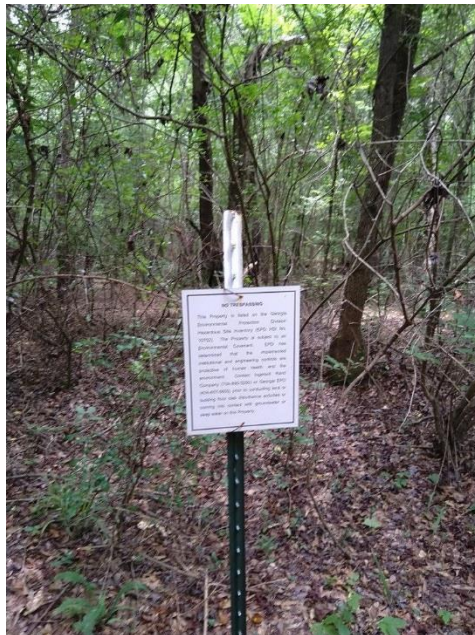
Marker 3

Closeup of marker sign looking towards W

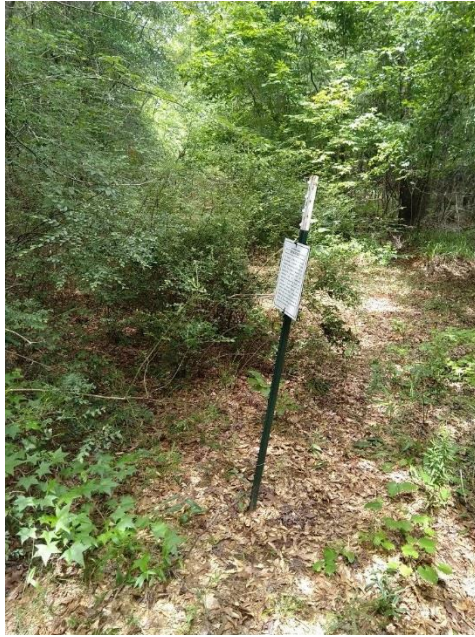
Marker 4

SE property boundary looking W.

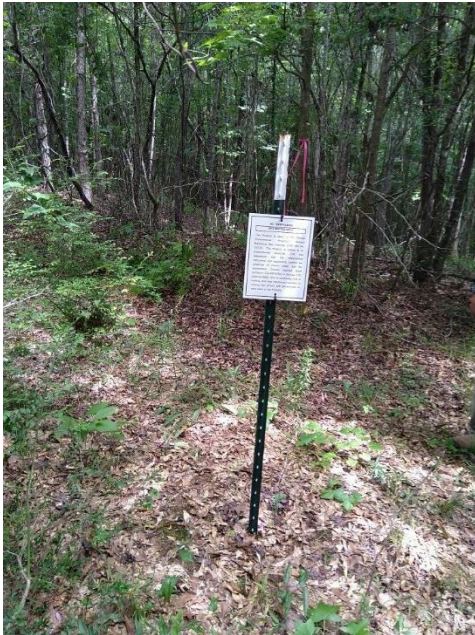
Marker 4

Closeup of marker sign looking towards N

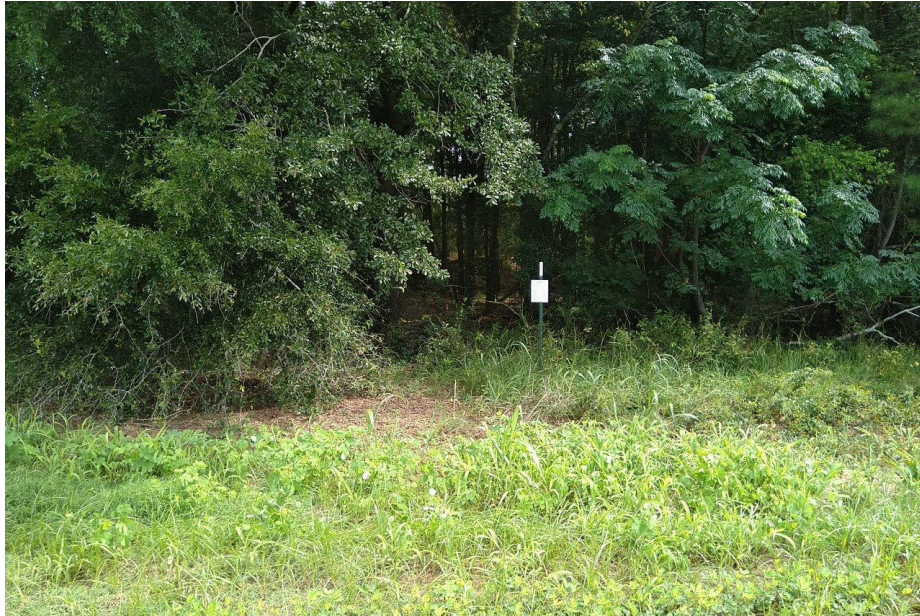
Marker 5

SW property boundary looking NE from field

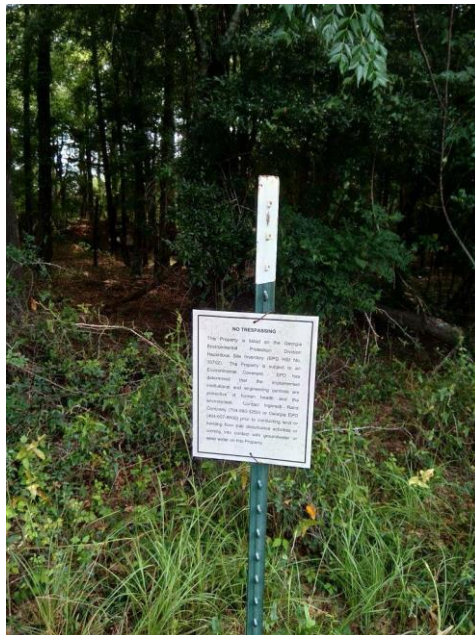
Marker 5

Closeup of marker sign looking towards N

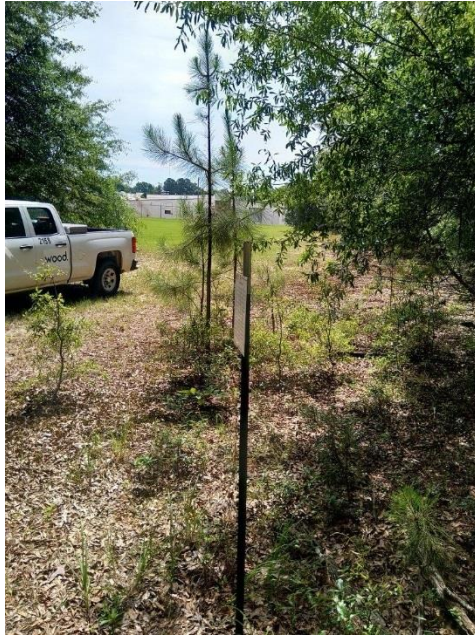
Marker 6

Western property boundary looking E to facility

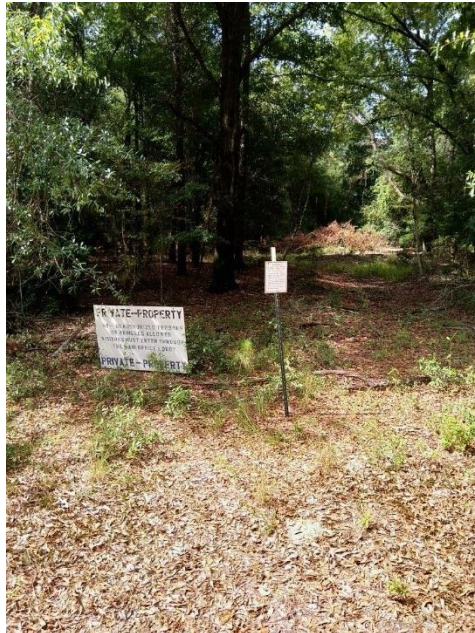
Marker 6

Marker beside private property sign looking SW

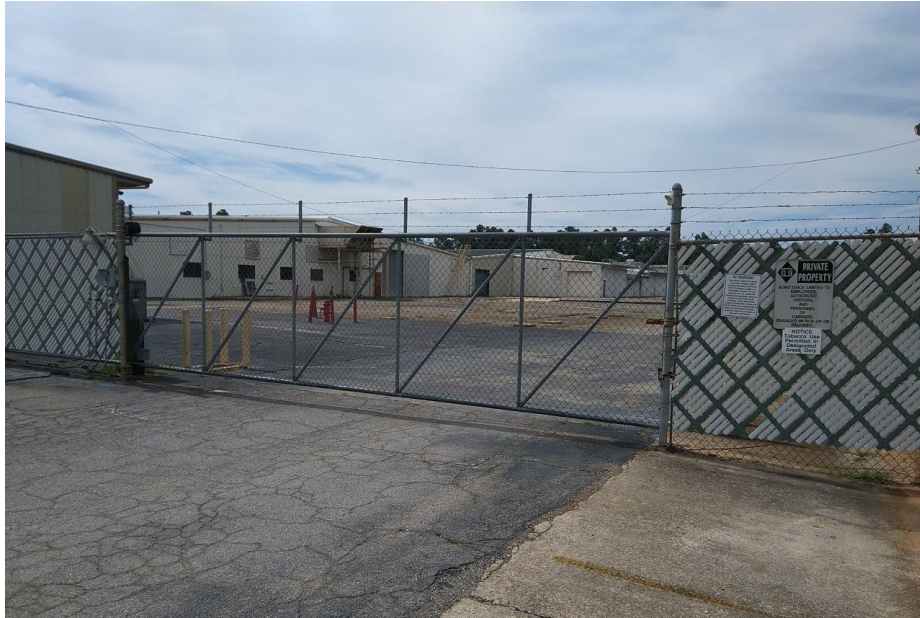
Marker 7

Facility fence with truck entrance gate looking SE

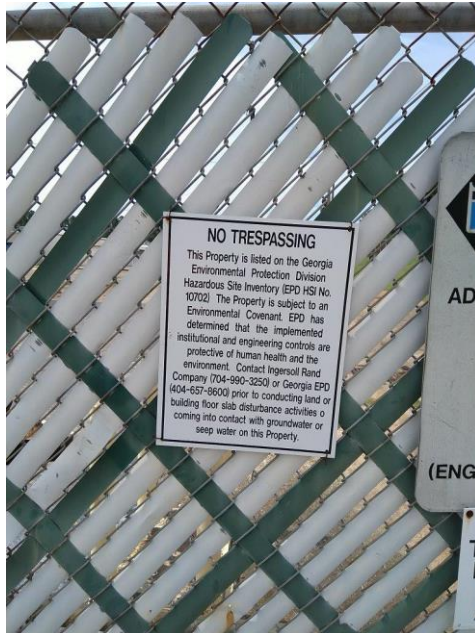
Marker 7

Closeup of marker sign looking towards S

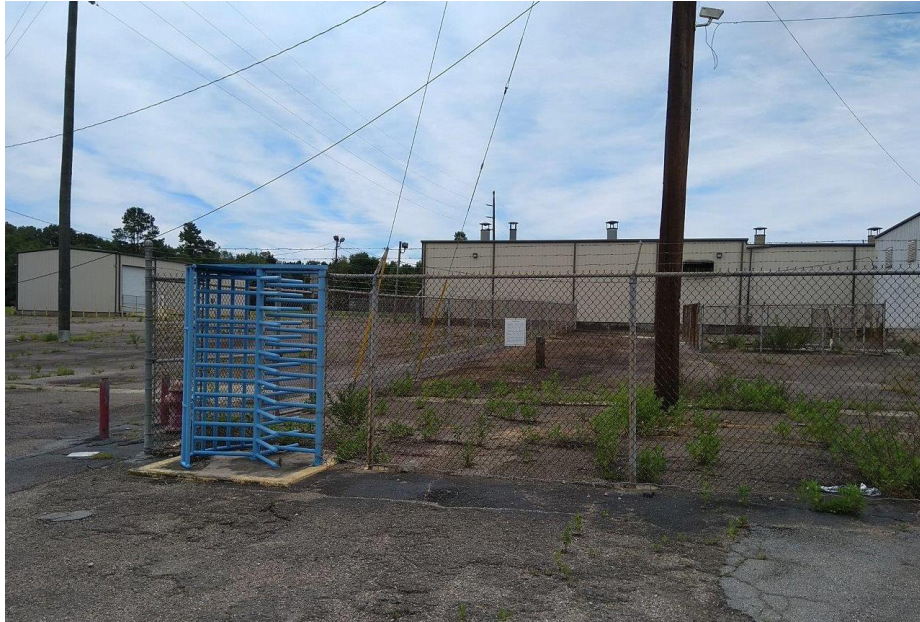
Marker 8

Facility fence line near NE corner looking SE

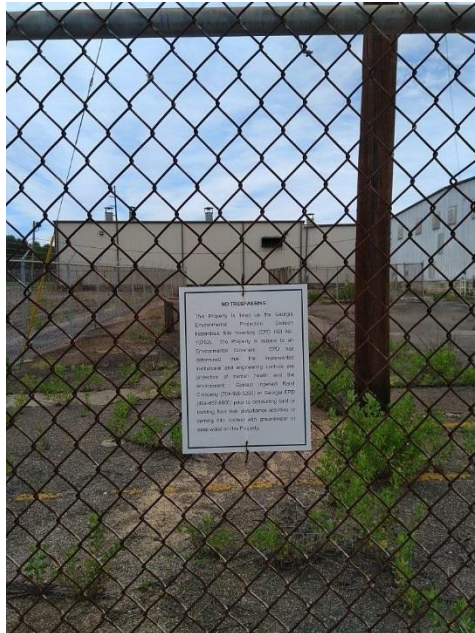
Marker 8

Closeup of marker sign looking towards S

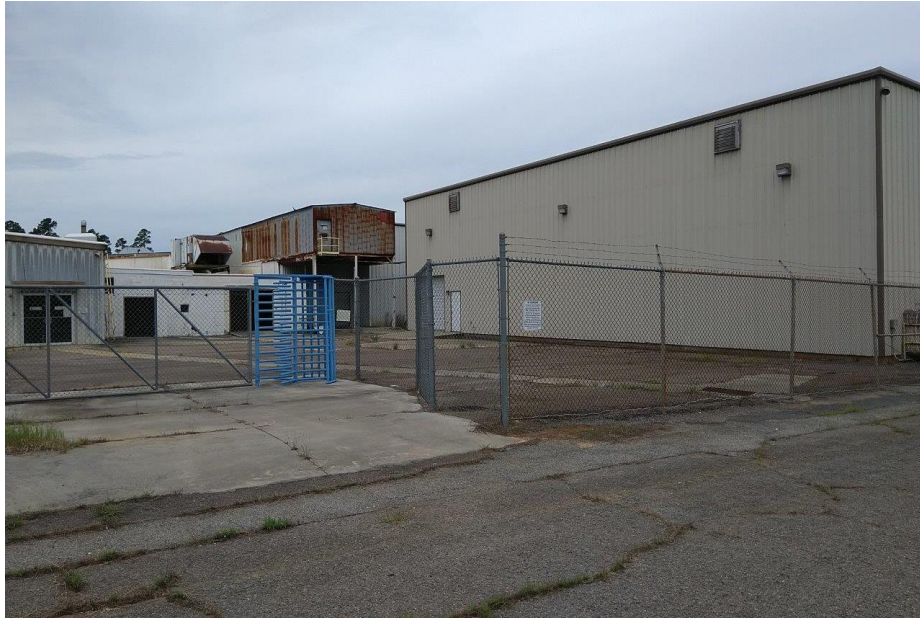
Marker 9

Facility eastern fence line near turnstile looking NW

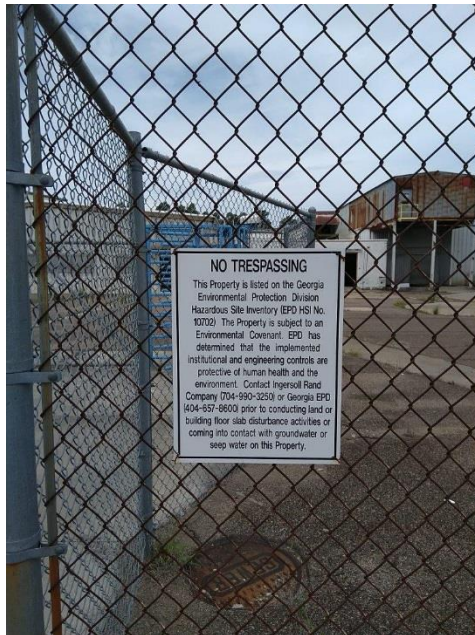
Marker 9

Closeup of marker sign looking towards W

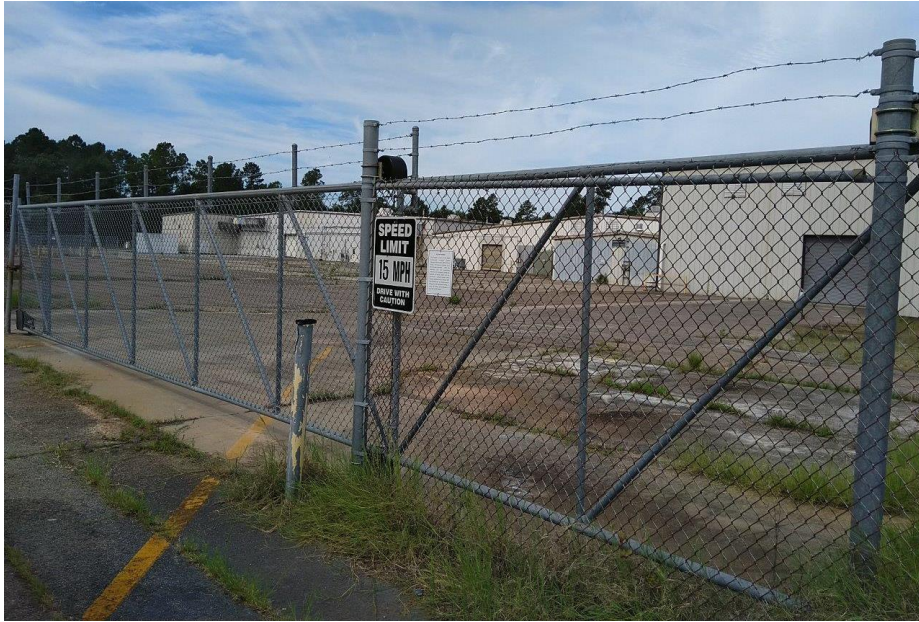
Marker 10

Facility fence line near eastern gate looking SW

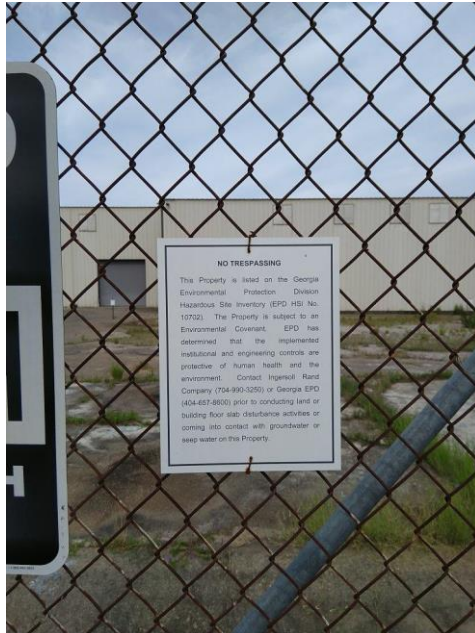
Marker 10

Closeup of marker sign looking towards W

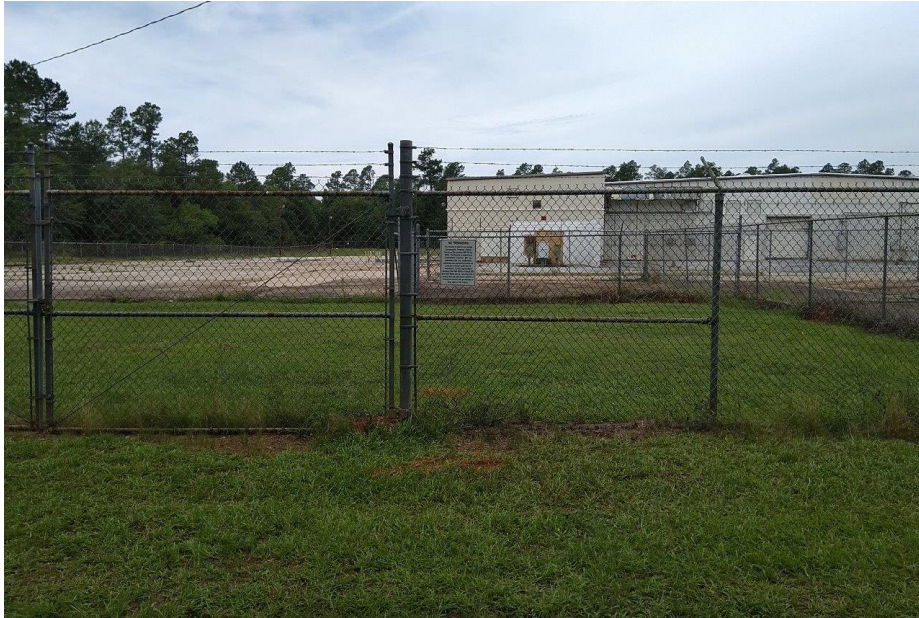
Marker 11

Facility fence line near SE corner looking W

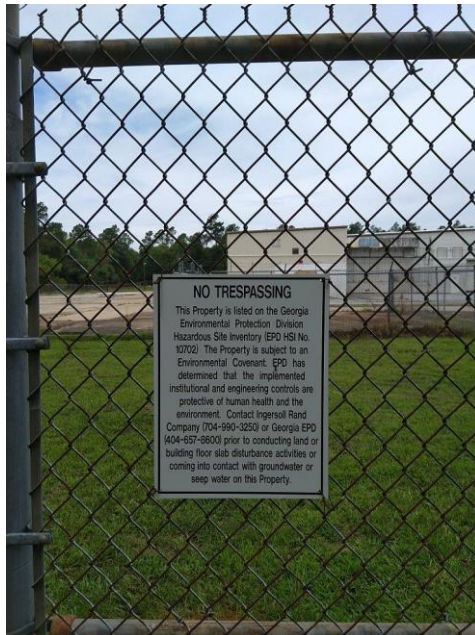
Marker 11

Closeup of marker sign looking towards W

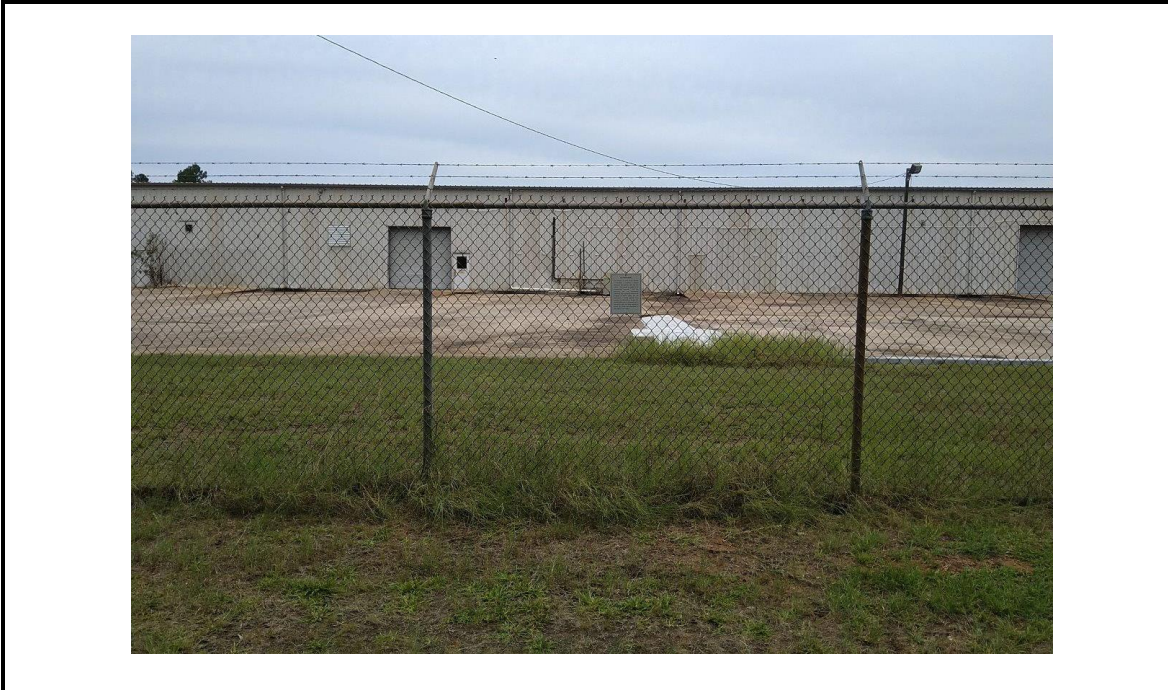
Marker 12

Facility southern fence line looking N

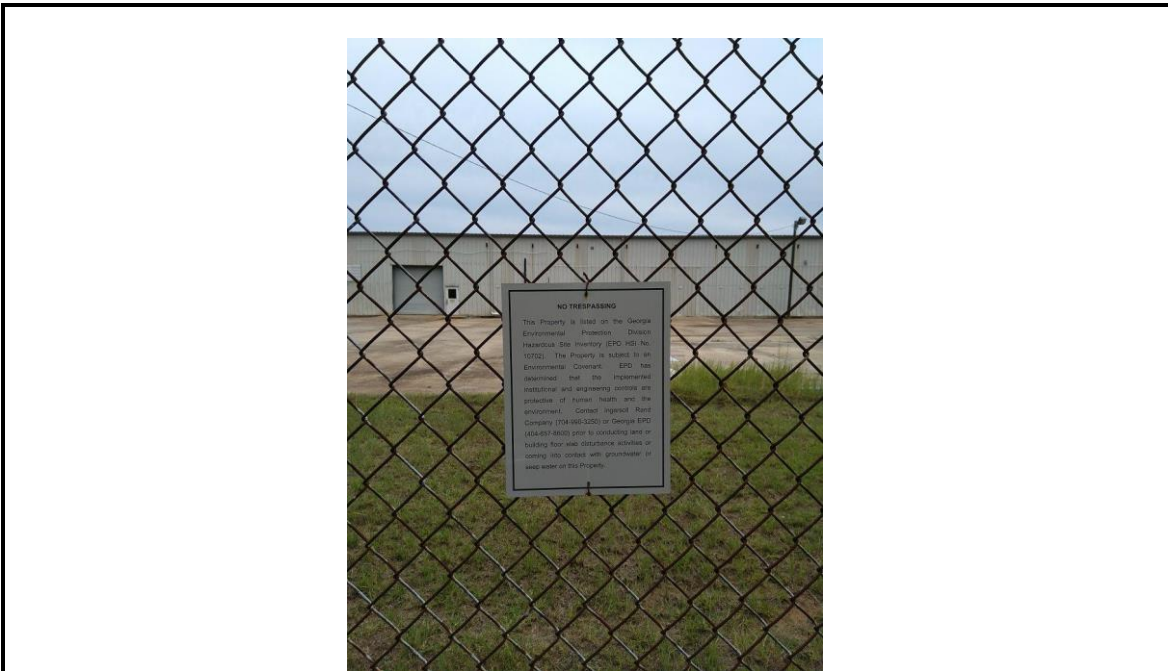
Marker 12

Closeup of marker sign looking towards N

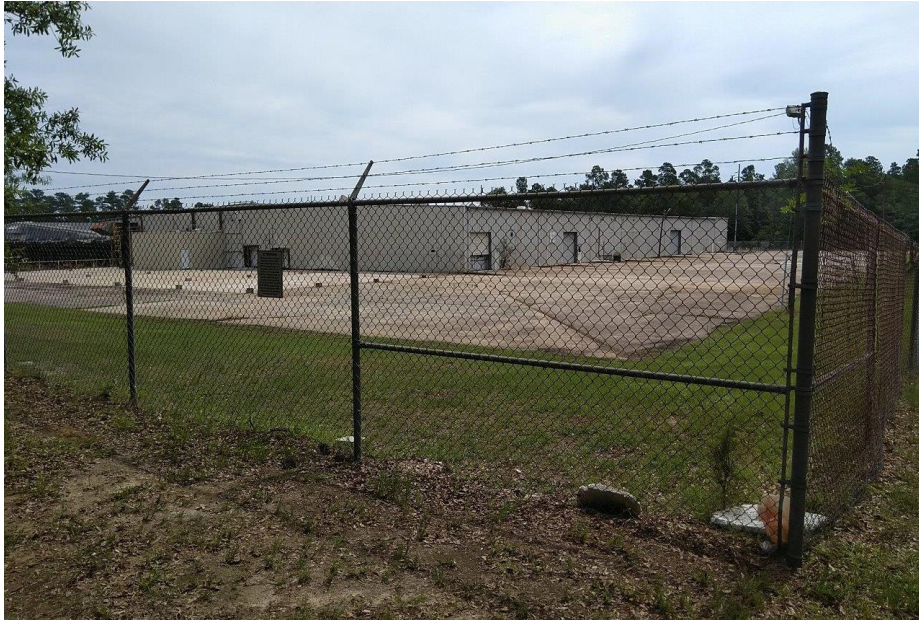
Marker 13

Facility fence line at SW corner looking NE

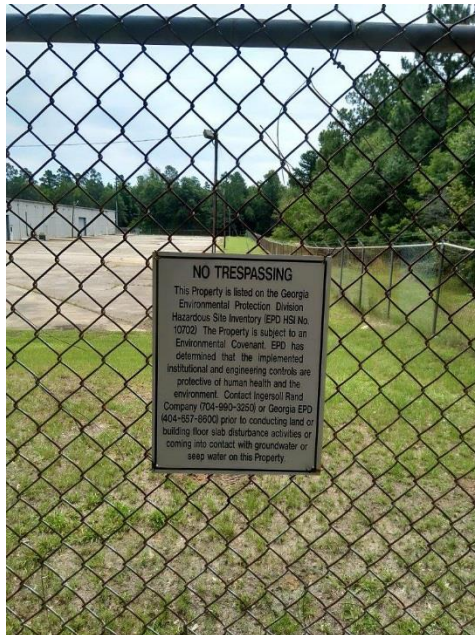
Marker 13

Closeup of marker sign looking towards E

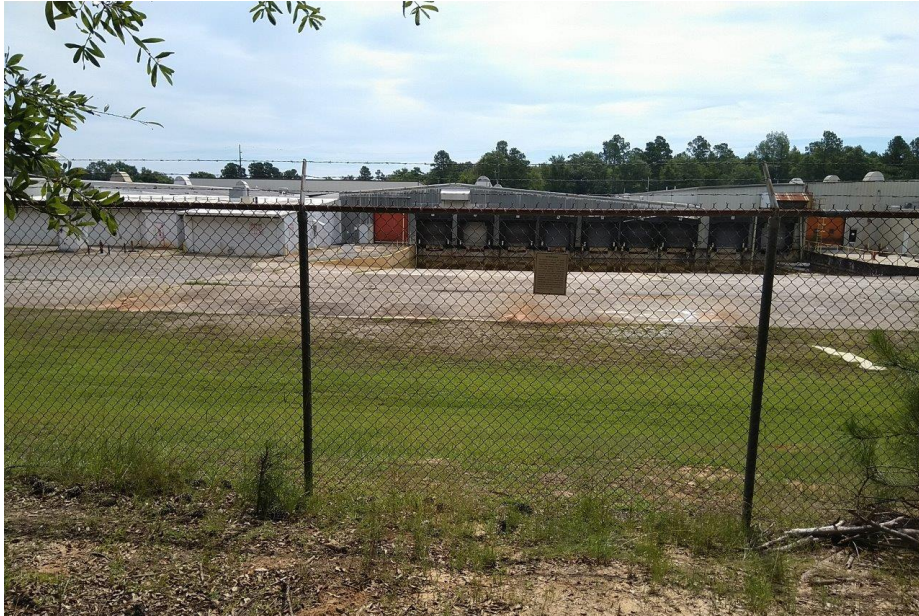
Marker 14

Facility western fence line looking E

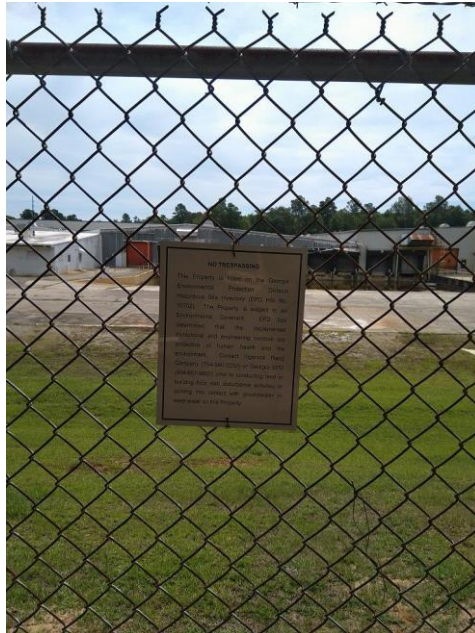
Marker 14

Closeup of marker sign looking towards E

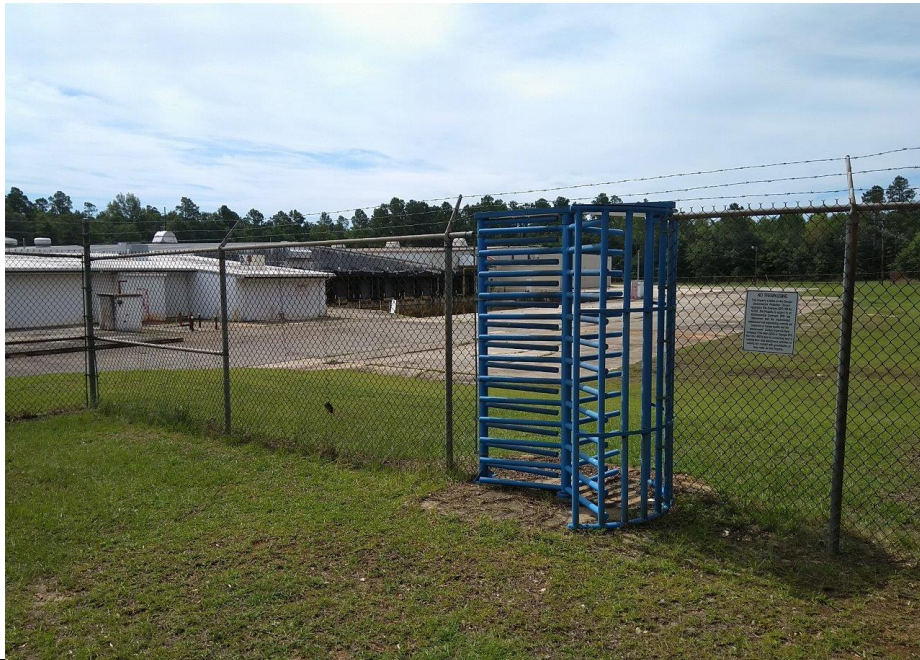
Marker 15

Facility western fence line turnstile looking SE

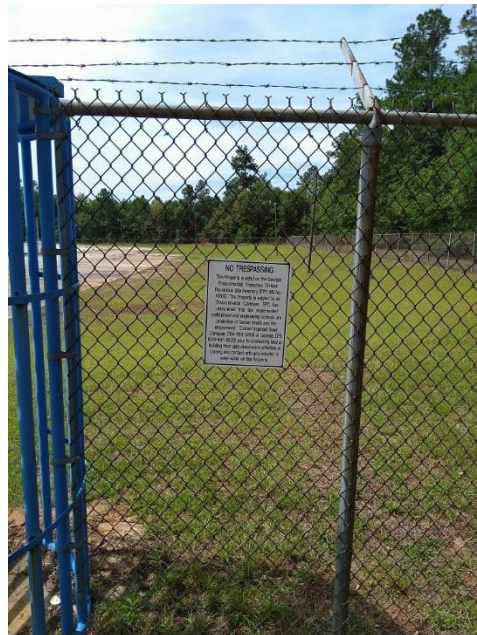
Marker 15

Closeup of marker sign looking towards S

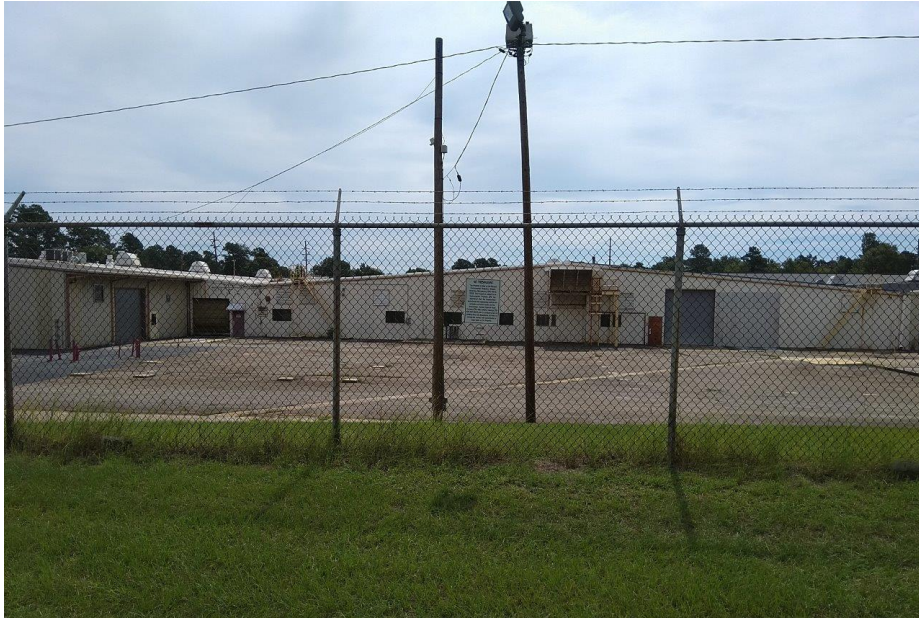
Marker 16

Facility western fence line near NW corner looking E

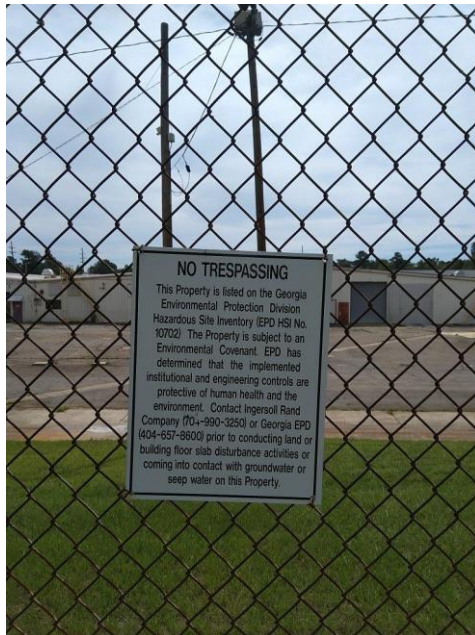
Marker 16

Closeup of marker sign looking towards E

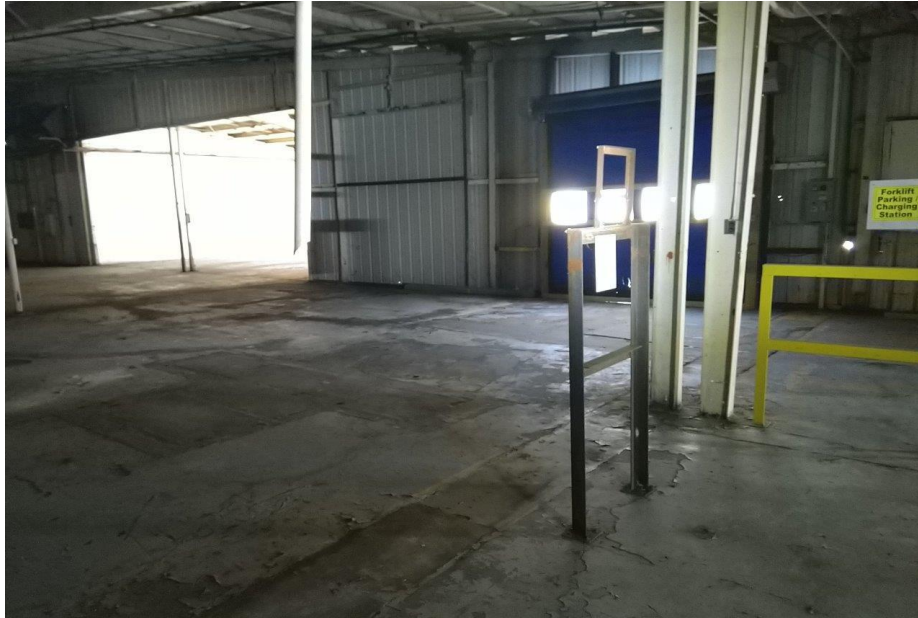
Marker 17

NW corner delineation boundary looking SW

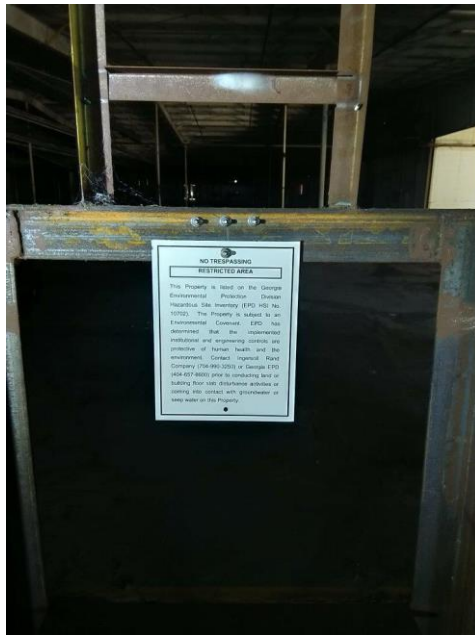
Marker 17

Closeup of area marker looking towards S

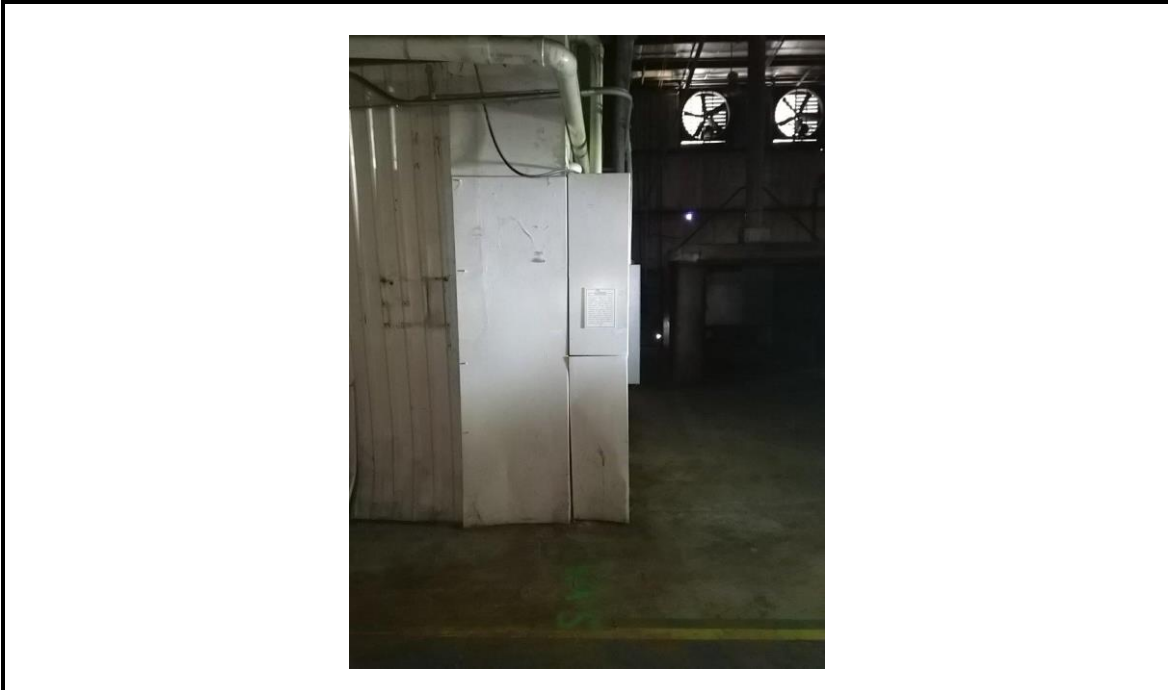
Marker 18	NE corner delineation boundary looking E	
<i>Building Type 5 RRS Area Delineation Marker Locations</i>	wood.	<i>1430 Highway 24 East Louisville, Jefferson County, Georgia</i>

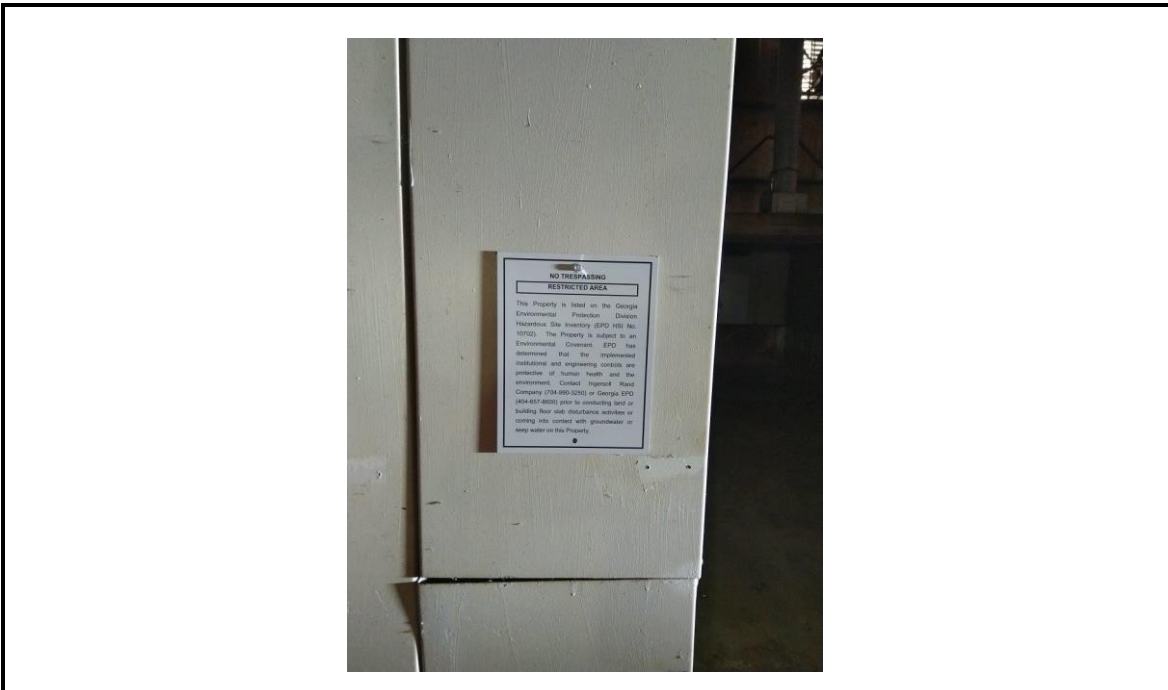
Marker 18	Closeup of area marker looking towards E	
<i>Building Type 5 RRS Area Delineation Marker Locations</i>	wood.	<i>1430 Highway 24 East Louisville, Jefferson County, Georgia</i>

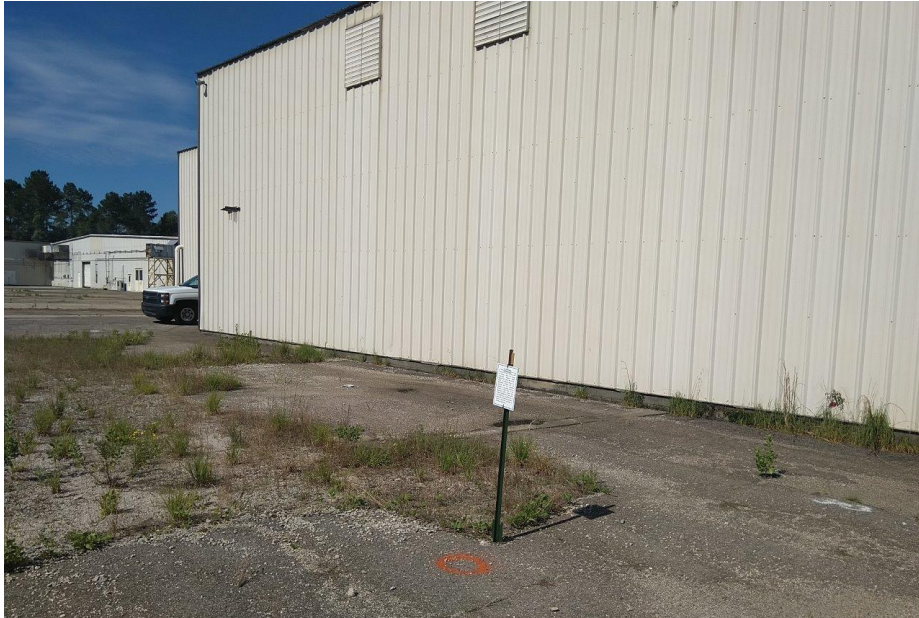
Marker 19

Eastern delineation boundary marker looking NW
