Subject: **Response to Georgia Environmental Protection Division May 16, 2019 Comments on the VRP CSR Addendum and 2018 Annual Monitoring and Inspection Report Thermo King Corporation - Louisville, Jefferson County, Georgia HSI Site No. 10702 Tax Parcel 0090-024 Wood Project 6122-09-0322**

**REVISED OPERATION AND MAINTENANCE PLAN AND INSPECTION SCHEDULES FOR
ENGINEERING CONTROLS
7/18/2019**

**RESPONSE TO GEORGIA ENVIRONMENTAL PROTECTION DIVISION COMMENTS
DATED MAY 16, 2019 FOR THE THERMO KING CORPORATION SITE –
LOUISVILLE, JEFFERSON COUNTY, GEORGIA**

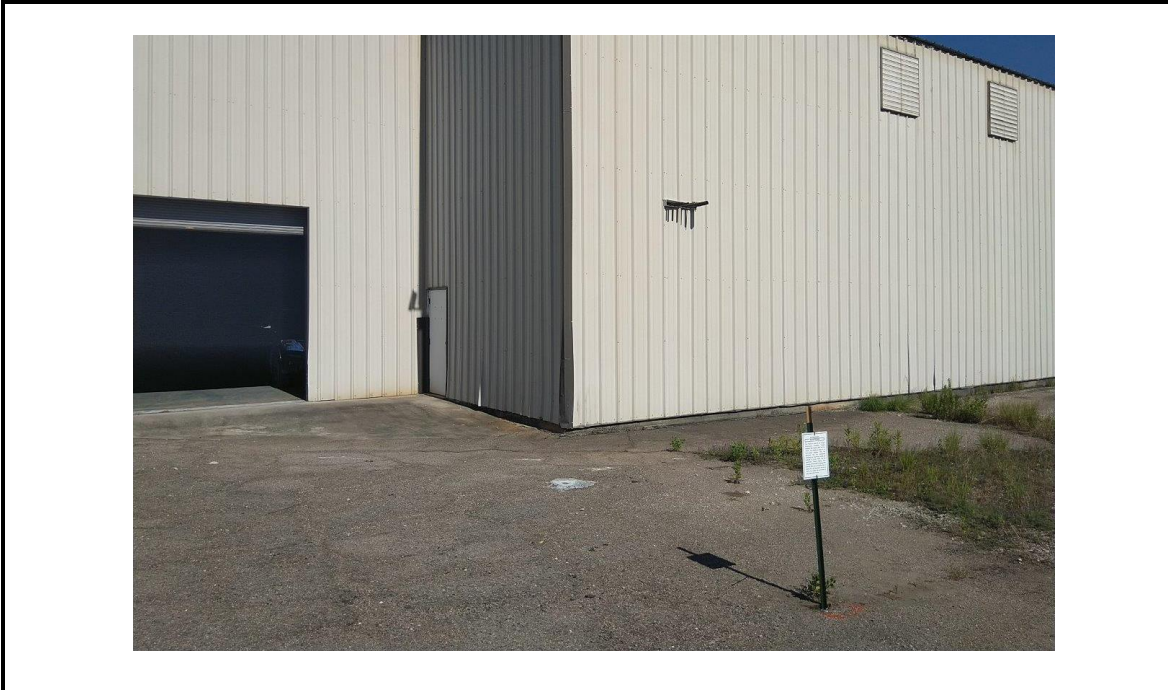
Marker 20	Eastern delineation boundary marker looking NE	
<i>Building Type 5 RRS Area Delineation Marker Locations</i>	wood.	<i>1430 Highway 24 East Louisville, Jefferson County, Georgia</i>

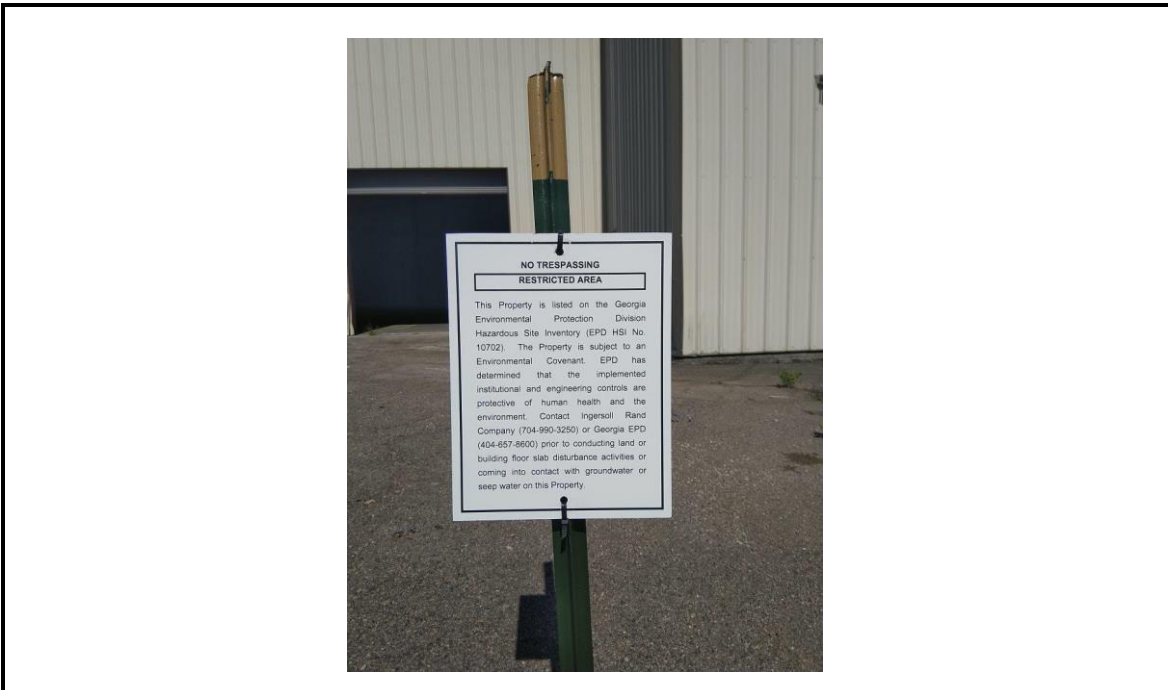
Marker 20	Closeup of area marker looking towards W	
<i>Building Type 5 RRS Area Delineation Marker Locations</i>	wood.	<i>1430 Highway 24 East Louisville, Jefferson County, Georgia</i>

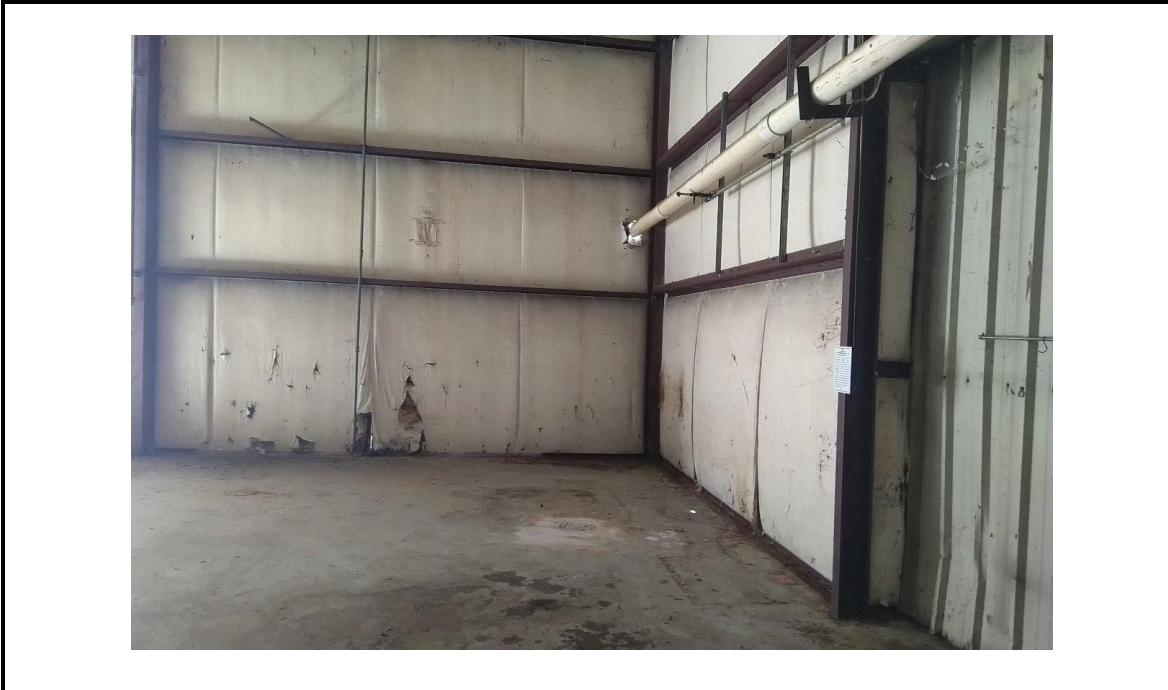
Marker 21

SE corner delineation boundary looking SE

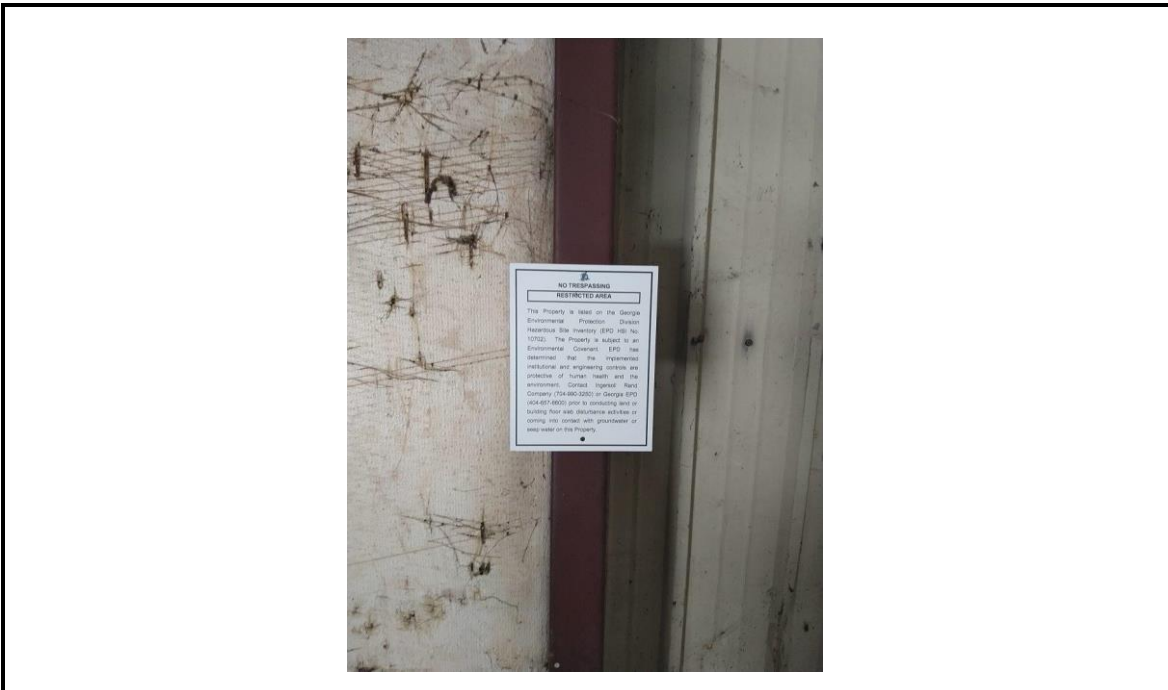
Marker 21

Closeup of area marker sign looking towards S

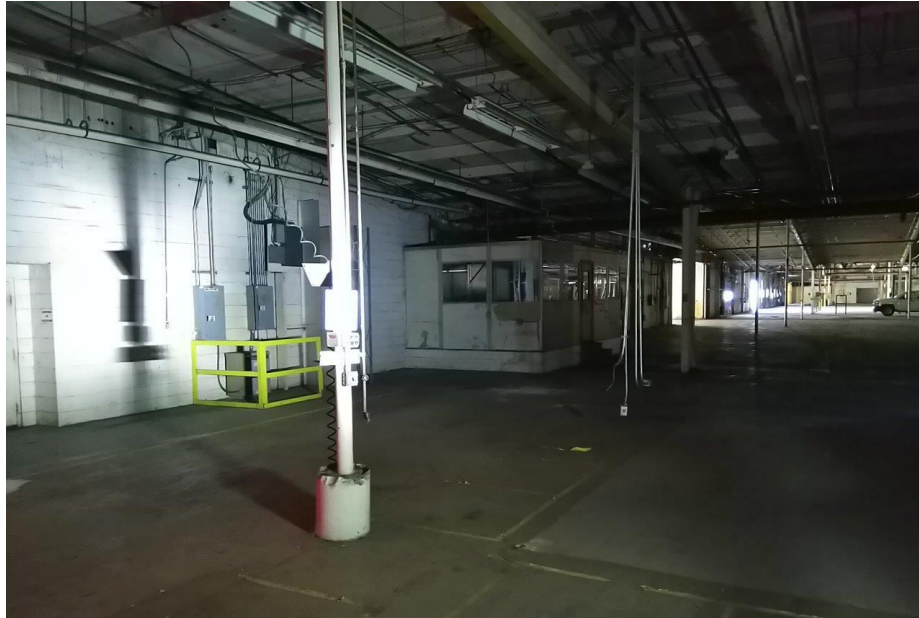
Marker 22

SW corner delineation boundary looking NW

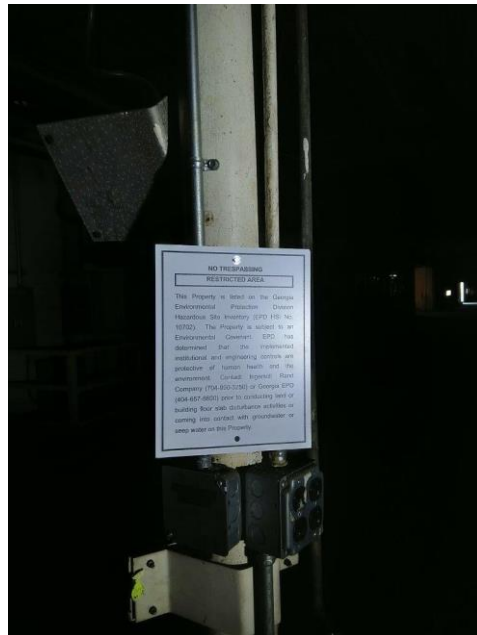
Marker 22

Closeup of area marker sign looking towards NW

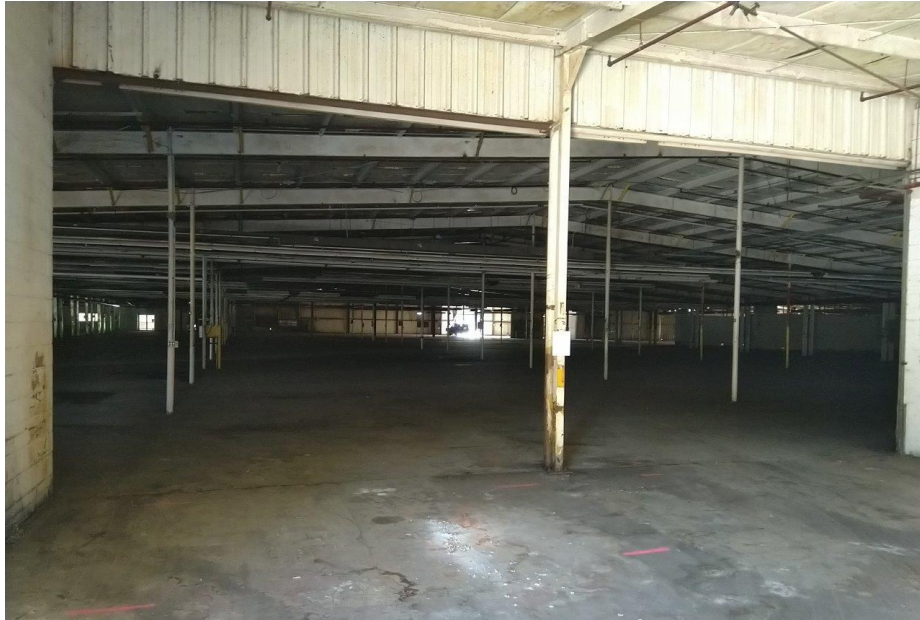
Marker 23

Western delineation boundary marker looking E

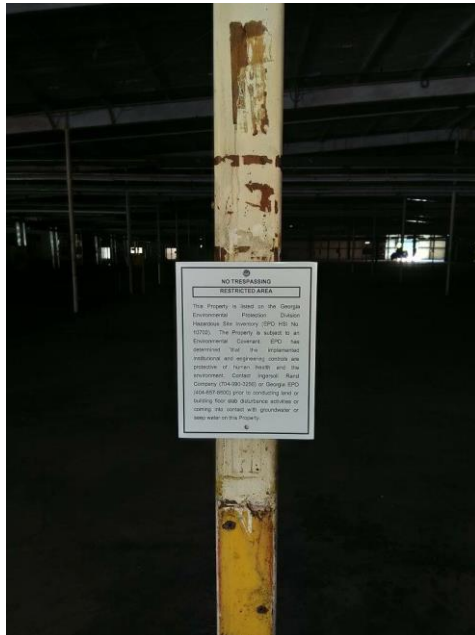
Marker 23

Closeup of area marker looking towards E

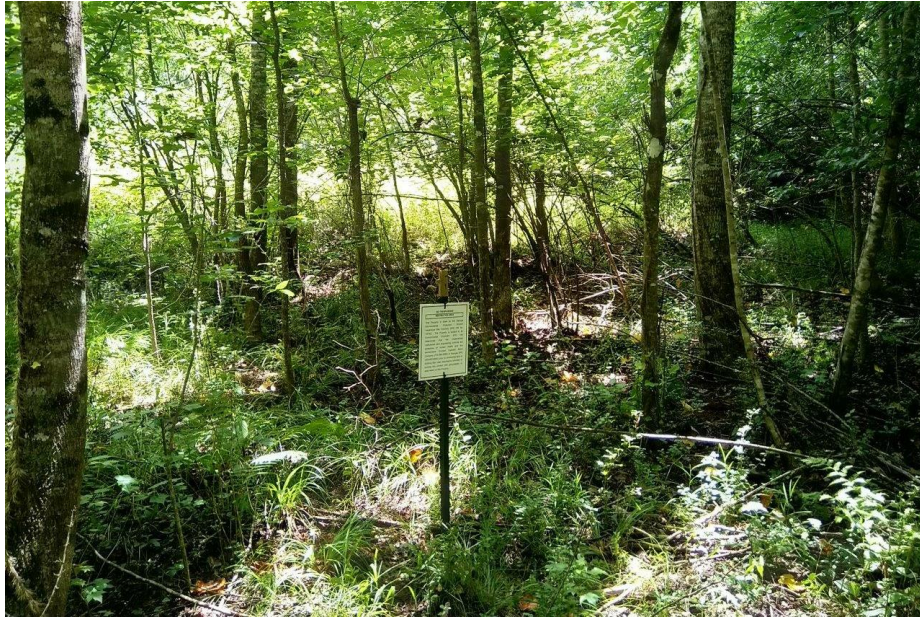
Marker 24

NW boundary looking SW towards clearing

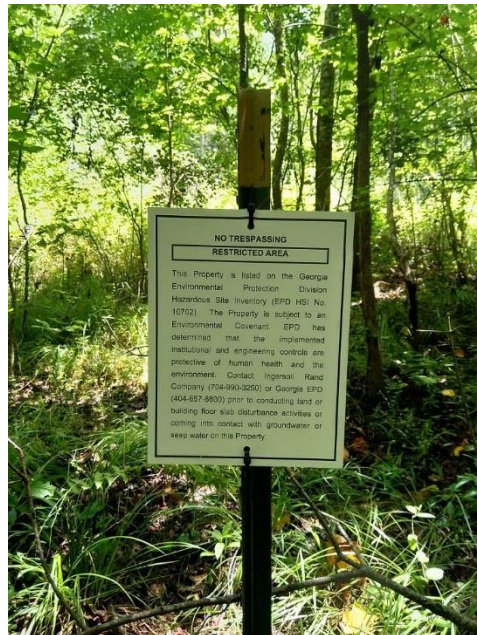
Marker 24

Closeup of marker looking towards S

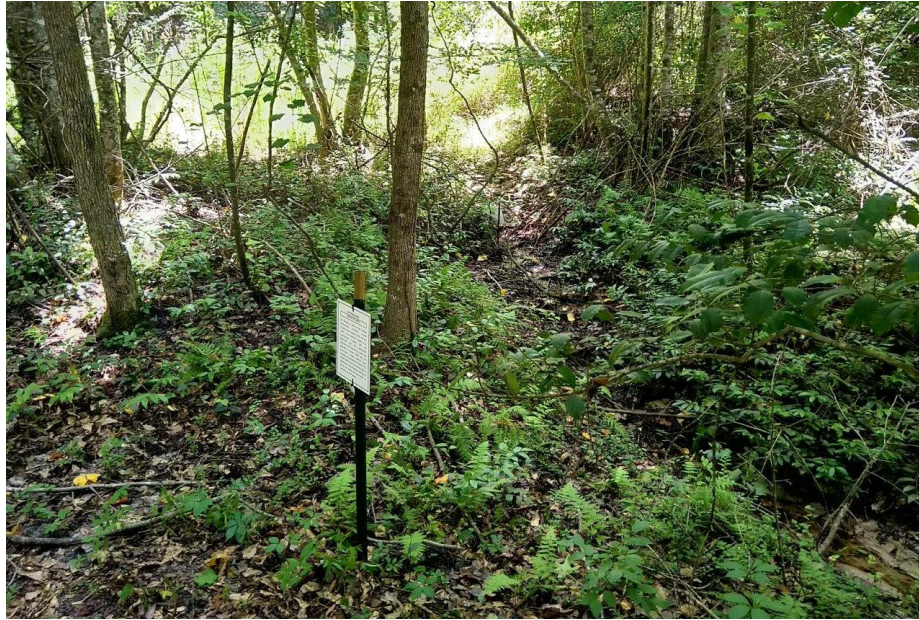
Marker 25

NE boundary looking SW along tributary channel

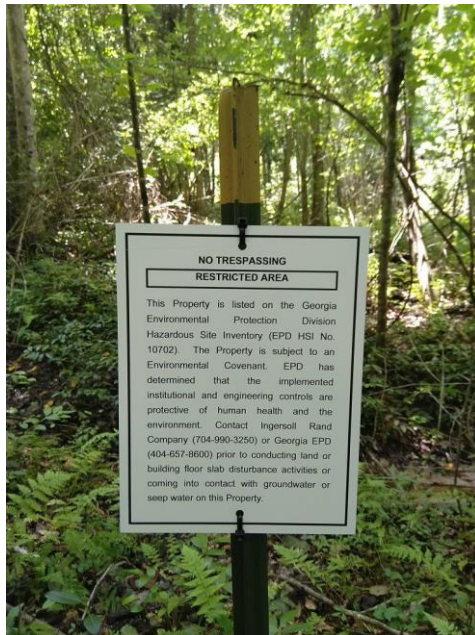
Marker 25

Closeup of marker looking towards W

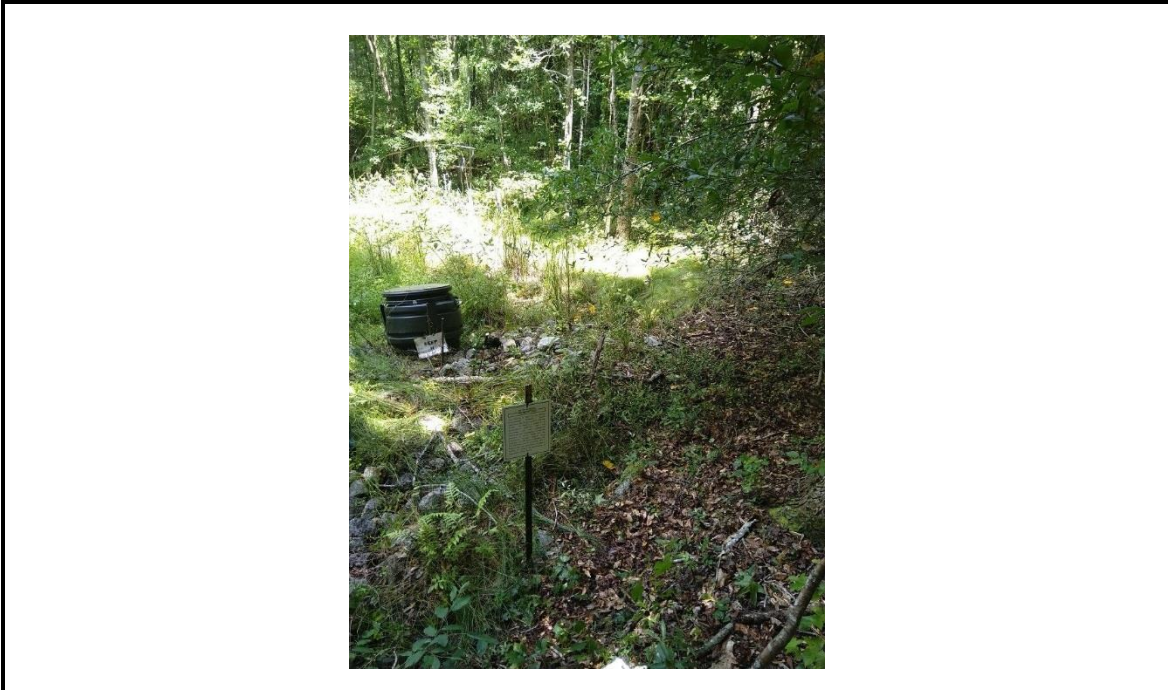
Marker 26

SE boundary looking NE toward Seep H

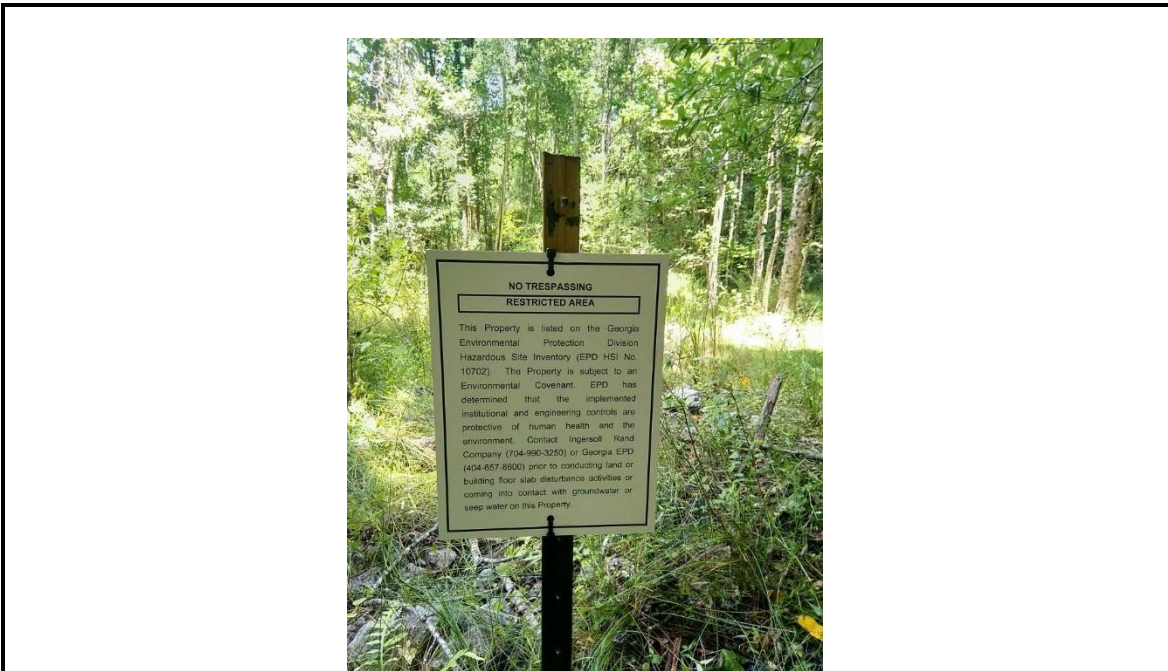
Marker 26

Closeup of marker looking towards N

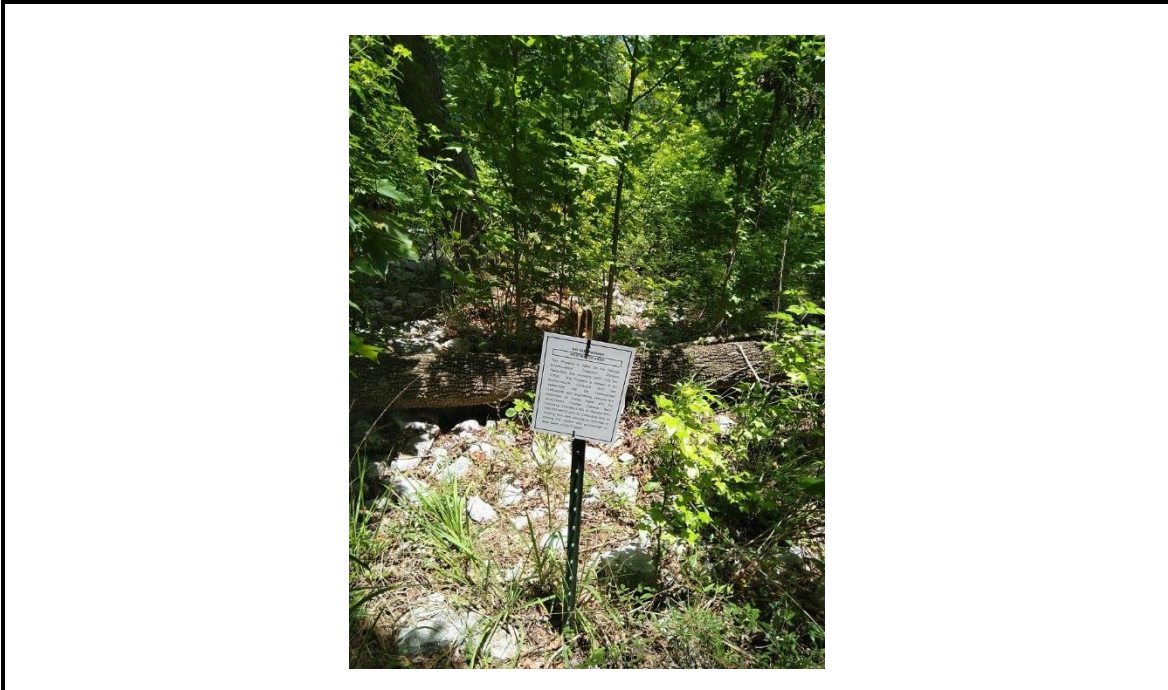
Marker 27

SW upgradient boundary marker looking NE

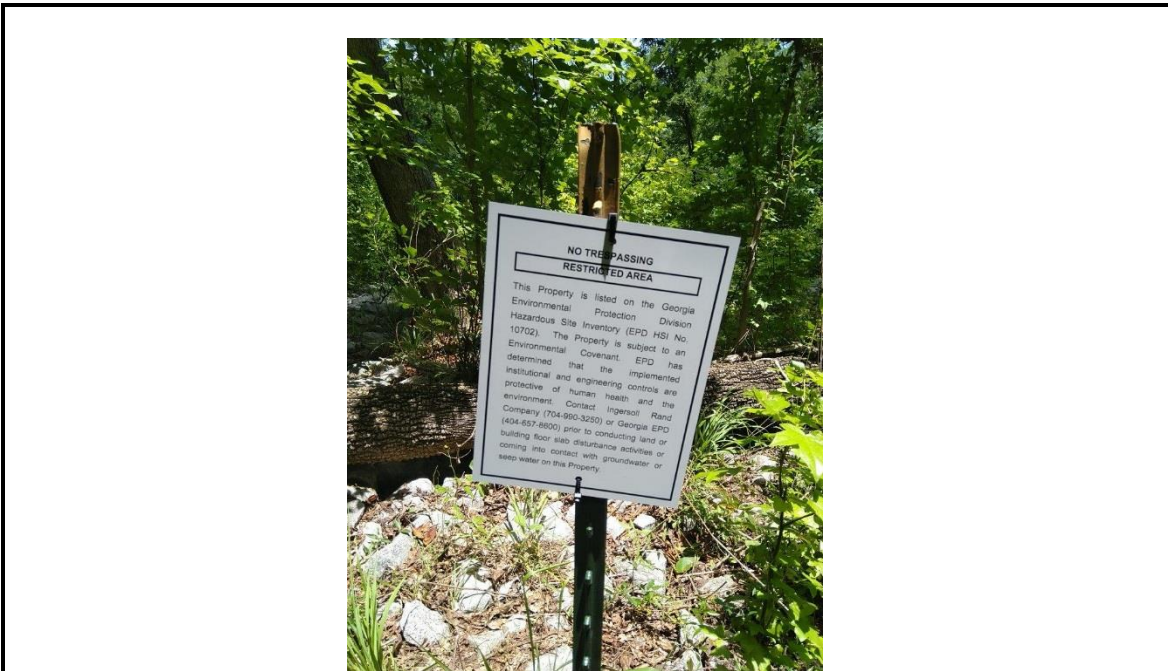
Marker 27

Closeup of marker looking towards NE
