### Construction Completion Report - Vapor Intrusion

# CONSTRUCTION COMPLETION REPORT

## STILLHOUSE CONTROL ROOM AND CHEMICAL PLANT CONTROL ROOM AND LABORATORY SUB-SLAB DEPRESSURIZATION SYSTEMS

### **Hercules/Pinova Facility Brunswick, Georgia**

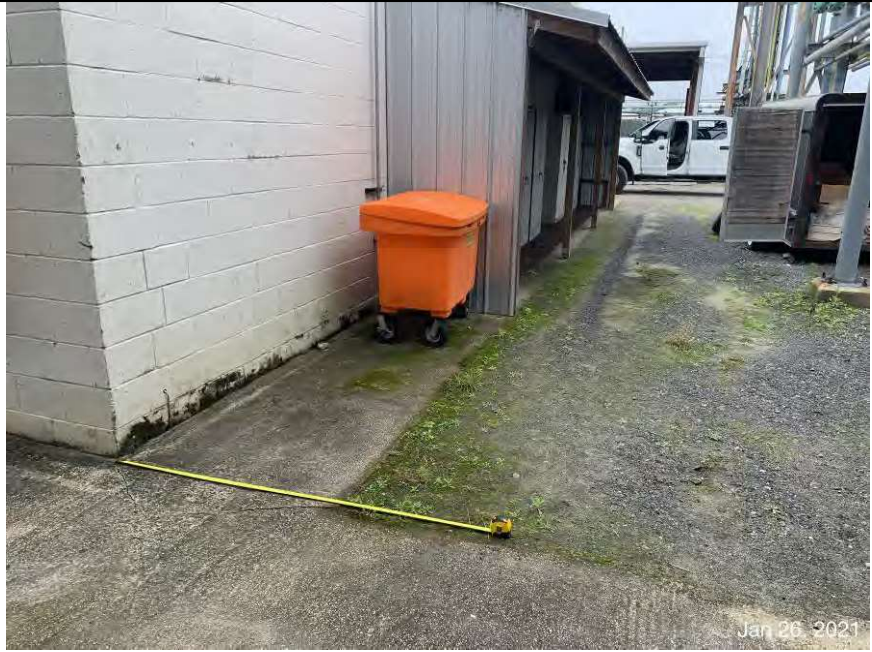
Photograph 2

Comments:  
Identified location for  
SSD system at Stillhouse  
Control Room

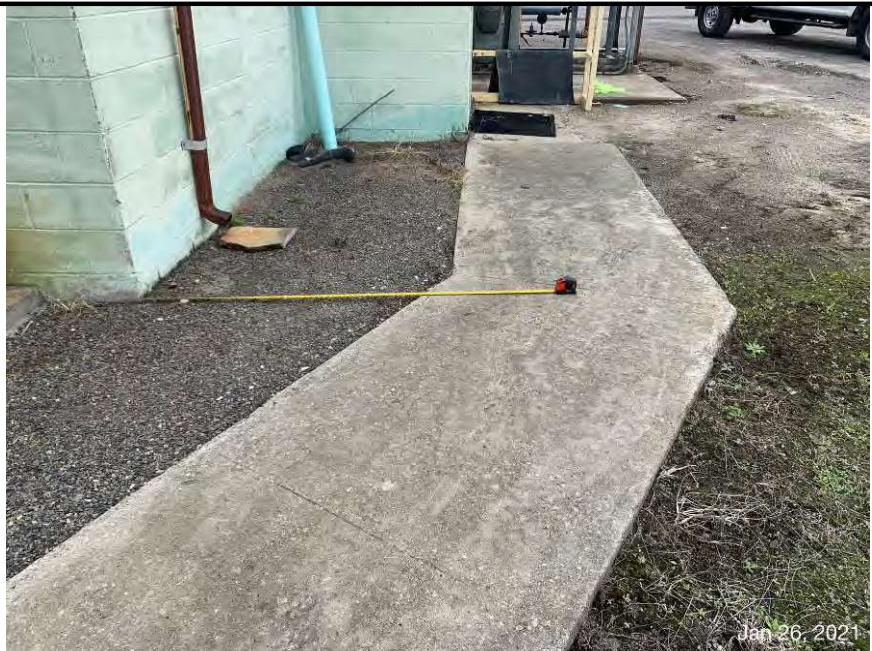
Comments:  
SSD enclosure on new  
concrete pad at Chemical  
Plant Control Room and  
Laboratory

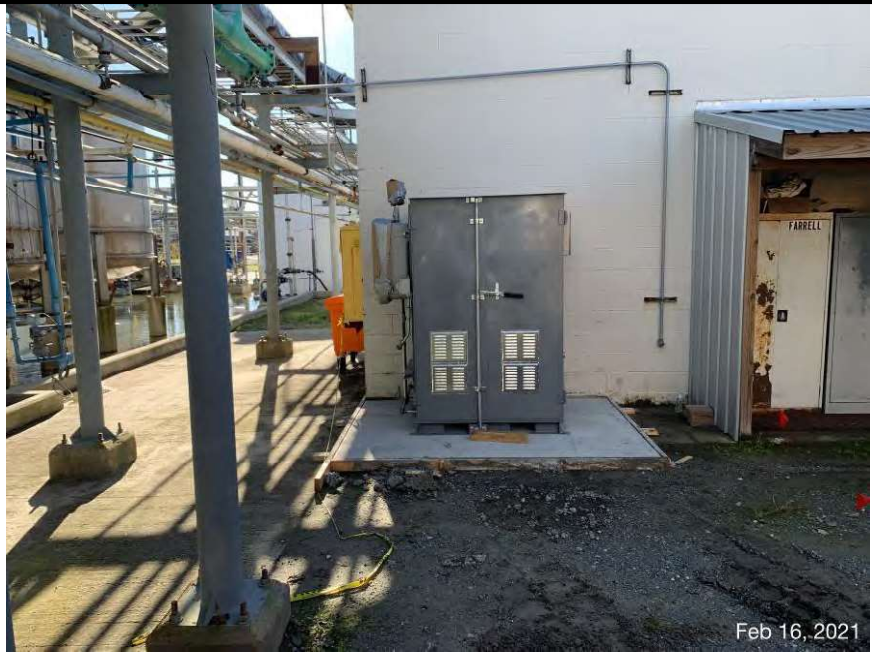
Photograph 4

Comments:  
SSD enclosure on new  
concrete pad at Stillhouse  
Control Room.

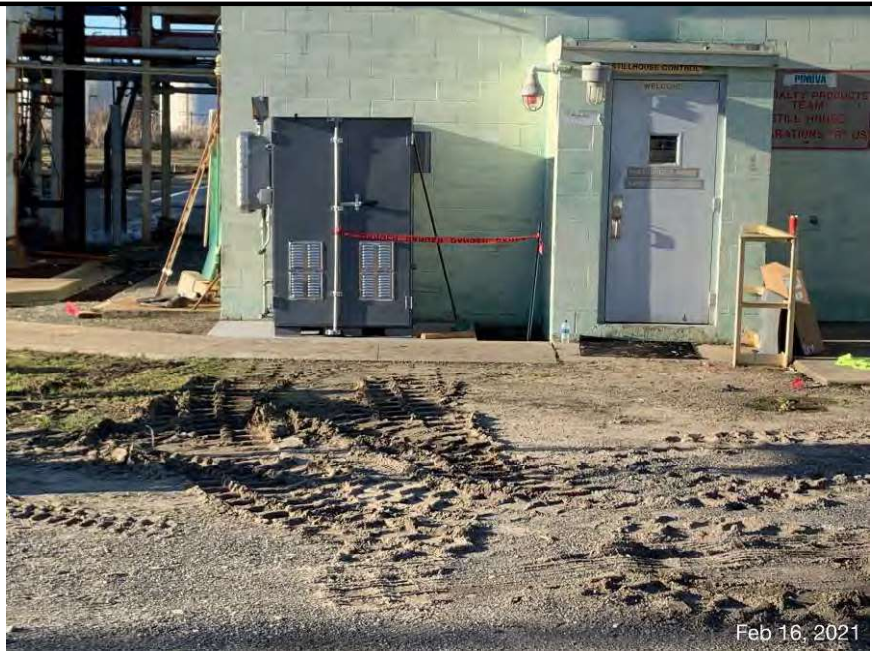
Comments:  
Suction point SP-1 and  
piping installed at  
Stillhouse Control Room

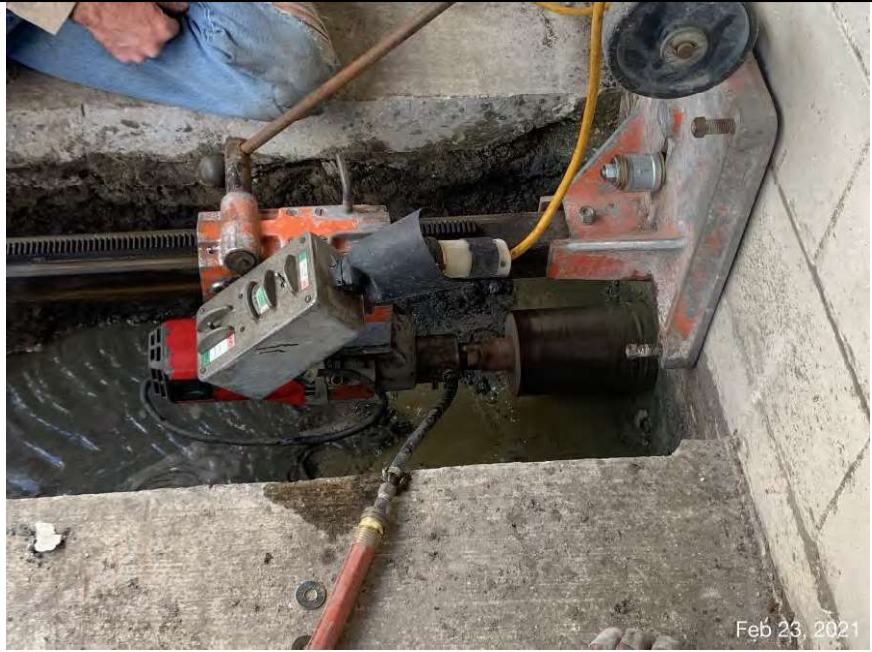
Photograph 8

Comments:  
Piping laid in trench and installed through footer for suction point SP-1 at Chemical Plant Control Room and Laboratory.

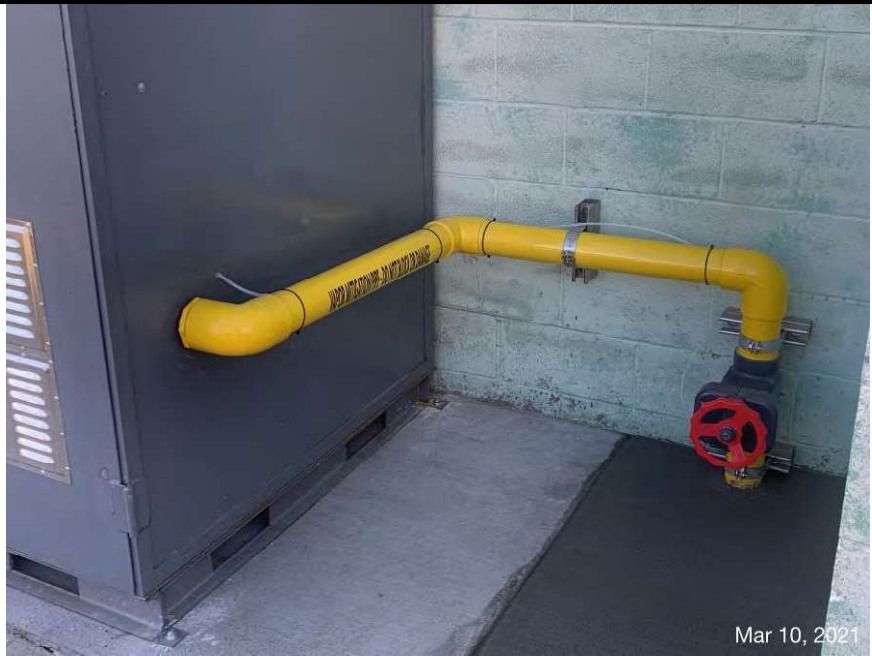
Photograph 10

Comments:  
Finished, painted and  
labelled vapor recovery  
piping at the Chemical  
Plant Control Room and  
Laboratory.
