Re: Semi-Annual Voluntary Remediation Program Progress Report (3), May 27, 2014  
Semi-Annual Voluntary Remediation Program Progress Report (4), February 4, 2015  
Professional Cleaners & Linen Service  
2040 Beaver Ruin Road  
Norcross, Gwinnett County, Georgia  
Tax Parcel ID 6212 036

The Georgia Environmental Protection Division (EPD) has reviewed the 3<sup>rd</sup> and 4<sup>th</sup> Semi-Annual Voluntary Remediation Program (VRP) Progress Reports submitted by Environmental Management Associates, LLC (EMA) pursuant to the Georgia Voluntary Remediation Program Act (the Act) O.C.G.A. 12-8-100. EPD has the following comments:

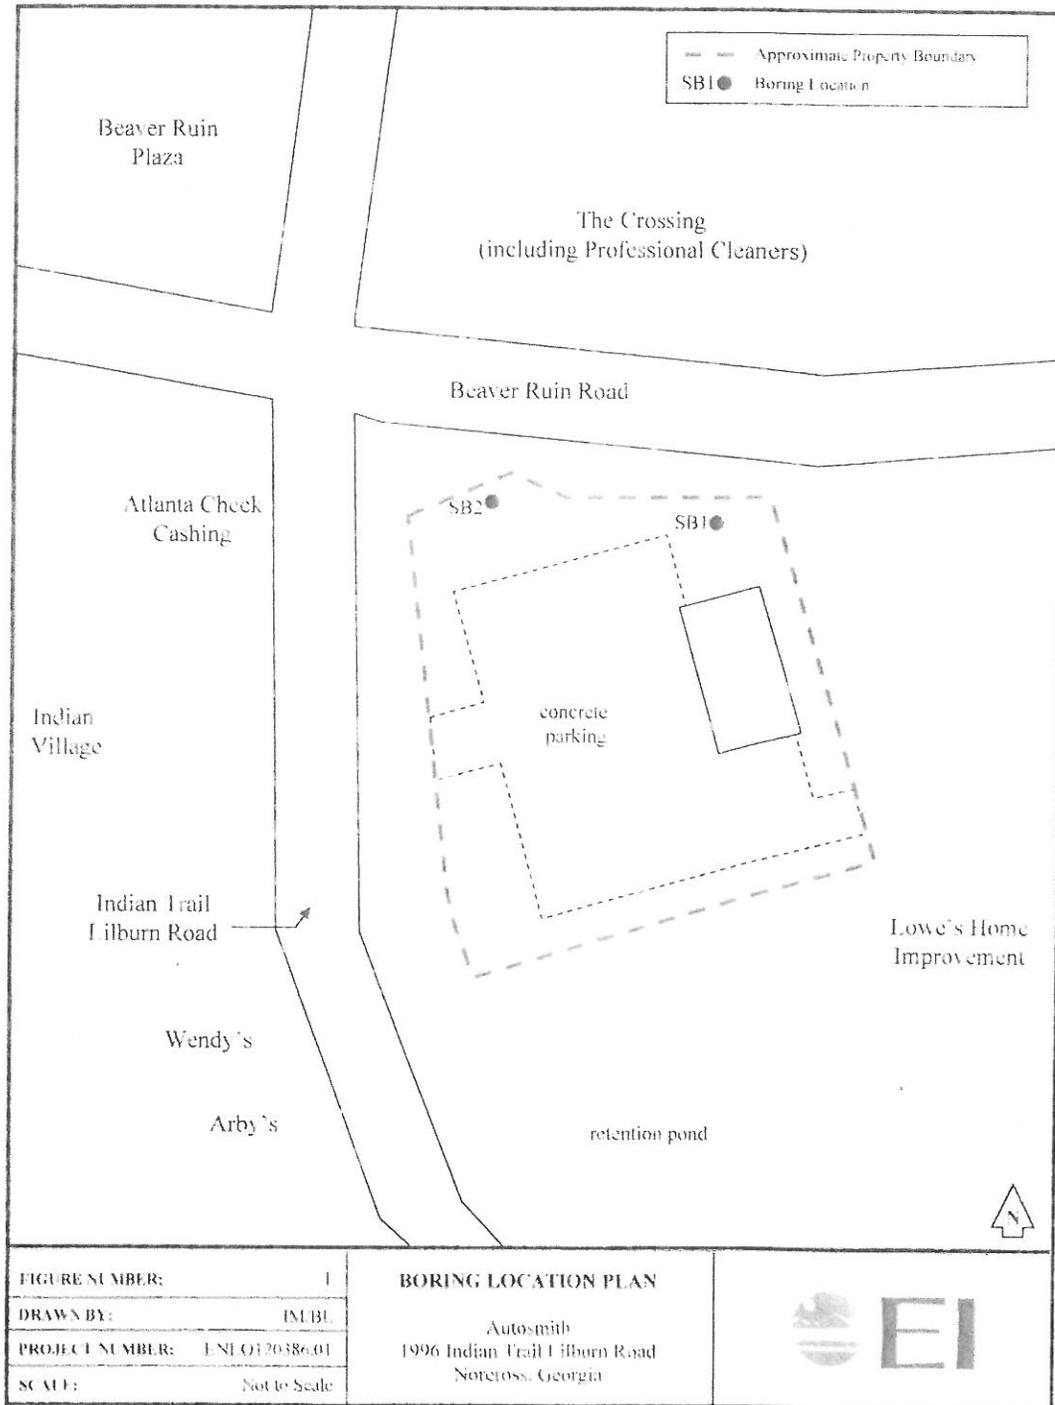
**Attachment:** 1996 Indian Trail Road Sample Locations

10. A release notification has been submitted to EPD for a site directly downgradient of the Professional Cleaners site. According to the notification, PCE was detected at a concentration of 60 µg/L at the former Autosmith Used Car facility (currently Flamingo Auto Sales, 1996 Indian Trail Road). Since there has been no known historic use of PCE at this location and Professional Cleaners is the suspected source of contamination, additional groundwater wells should be installed at 1996 Indian Trail Road to confirm the presence of PCE. The wells should be located in close proximity to where the samples were previously taken, as indicated on the attached sample map. Please coordinate this sampling event with the current owners and include the results in the next monitoring report.
