**Subject: Class 3 Permit Modification Request**  
Morito Scovill Americas, LLC, dba Scovill Fasteners, Clarkesville, Georgia  
Hazardous Waste Facility Permit No. HW-090(D)  
EPD ID No. GAD003480530

**Attachment A:**  
**Basin Clean Closure Report & Certification**  
**(DRE Technologies; April 1990)**

APR 1 1990  
CLARKESVILLE, GA  
CLOSURE REPORT AND CERTIFICATION

SCOVILL FASTENERS, INC.  
CLARKESVILLE, GEORGIA

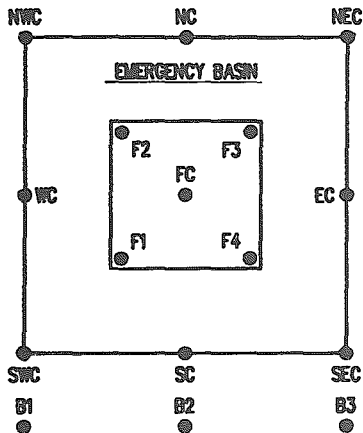
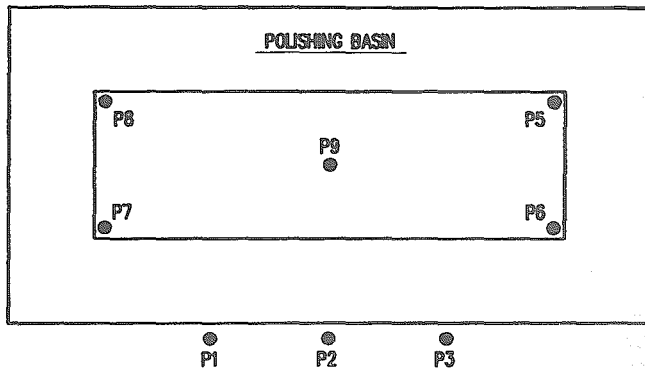
Emergency basin subfloor soil samples were collected at each basin corner and the center of the basin as shown in the attached Figure 1-2. A two foot continuous sample was collected by hand augering two 1 ft samples. This sample was mixed and a 1 kg sample collected for analysis. Following the removal of this sample, the hole was machine augered to depths of 4, 6, 8, and 10 ft. In each case, a 6" to 1 ft tailing cleanout sample
