**Chemtrade Solutions LLC**  
90 East Halsey Road  
Parsippany, New Jersey 07054

**SEMI-ANNUAL GROUNDWATER  
MONITORING REPORT NO. 15  
JULY THROUGH DECEMBER 2015  
CHEMTRADE SITE  
EAST POINT, GEORGIA  
HSI# 10498**

Project Number GR5060

January 2016

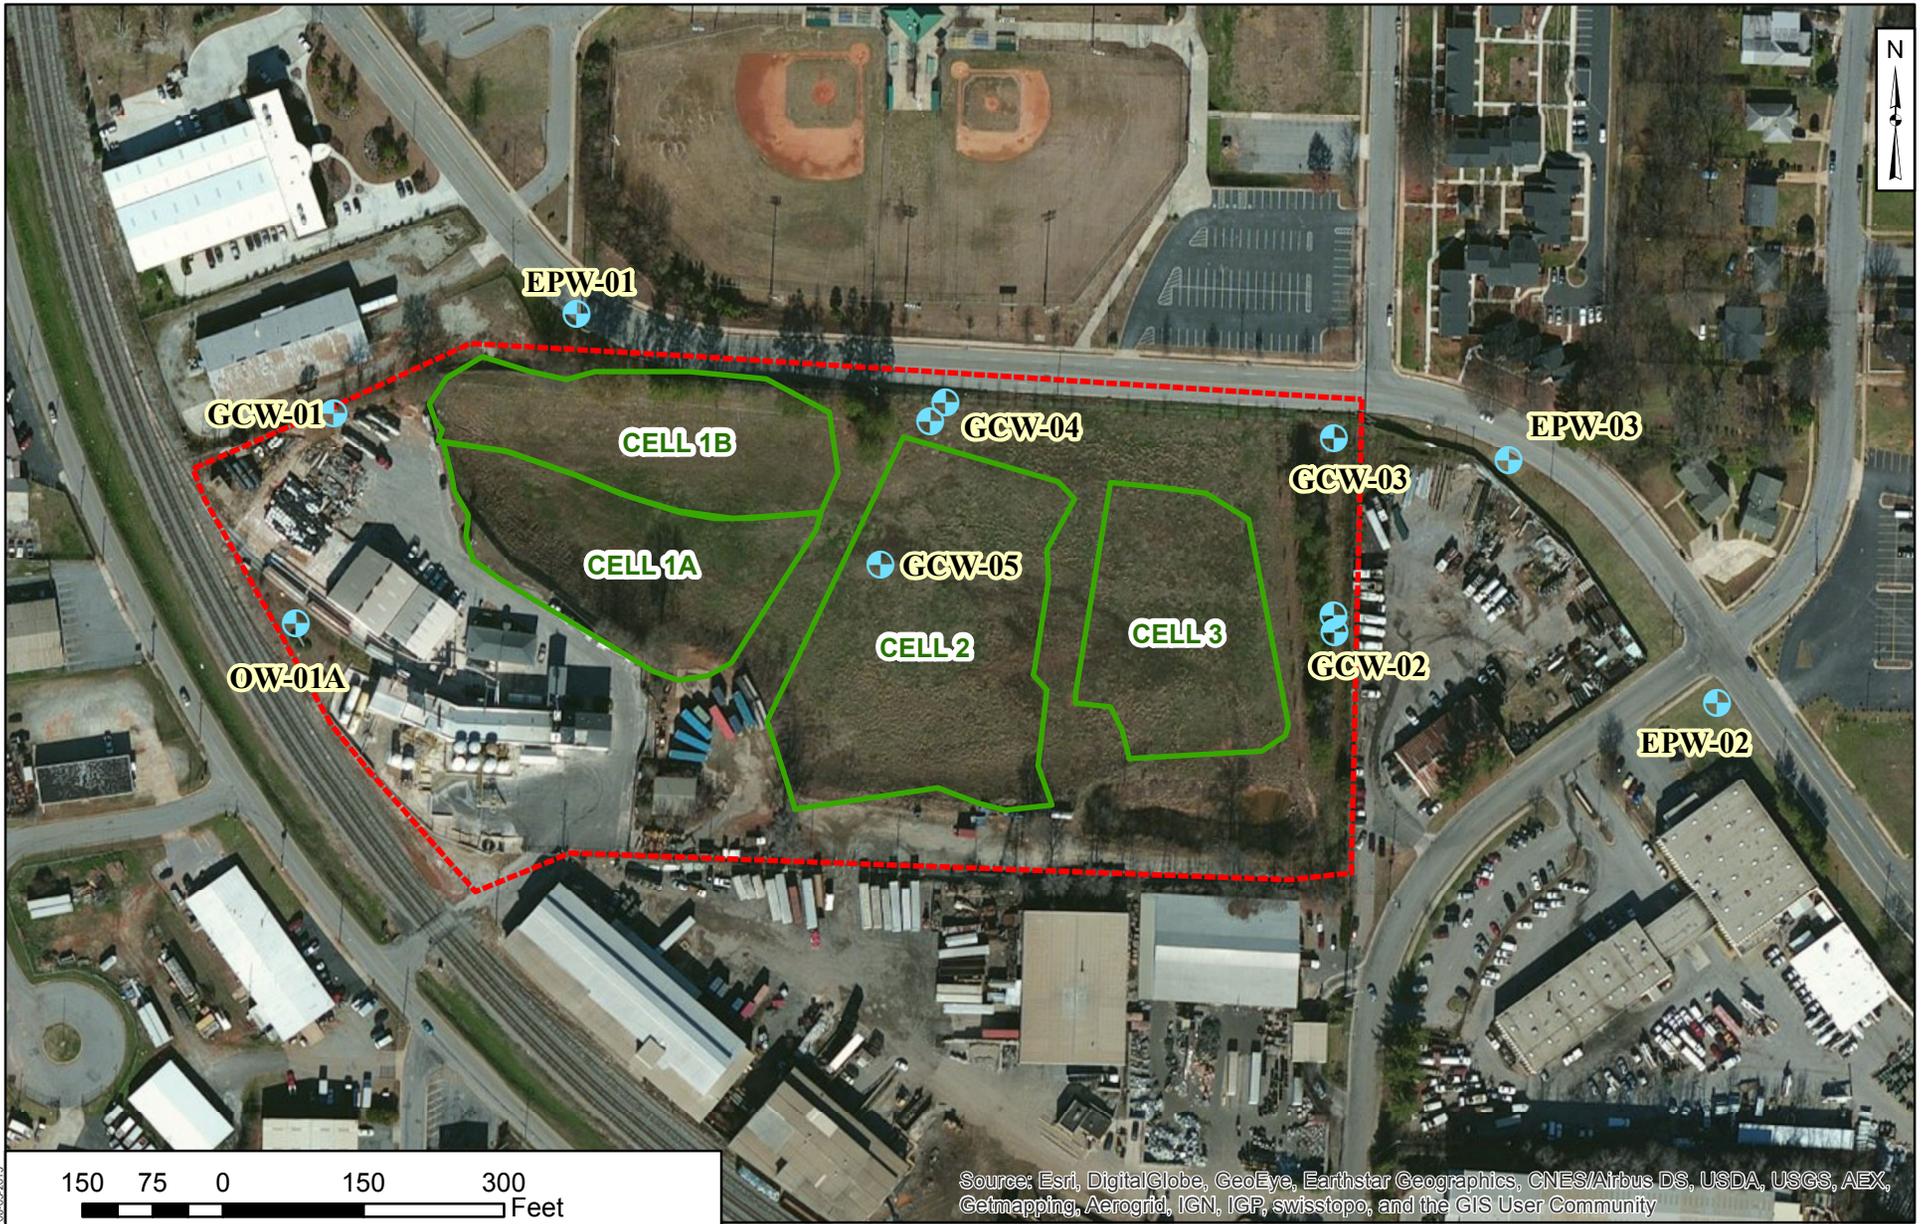
Figure  
 1-2

- Sampling of 6 on-site wells (**Figure 1-2**);
- Sampling of 3 off-site wells (**Figure 1-2**); and
- Sampling of surface water at one on-site and three off-site locations (**Figure 1-3**).
