PART II -- RELEASE INFORMATION

RE: Hazardous Sites Response Program Notification Form
Former Good Samaritan Property
239 Ivan Allen Jr. Boulevard, NW
Atlanta, Fulton County, Georgia

HSRA Notification
Ivan Allen Property
 239 Ivan Allen Jr. Blvd.
 Atlanta, Fulton County, Georgia

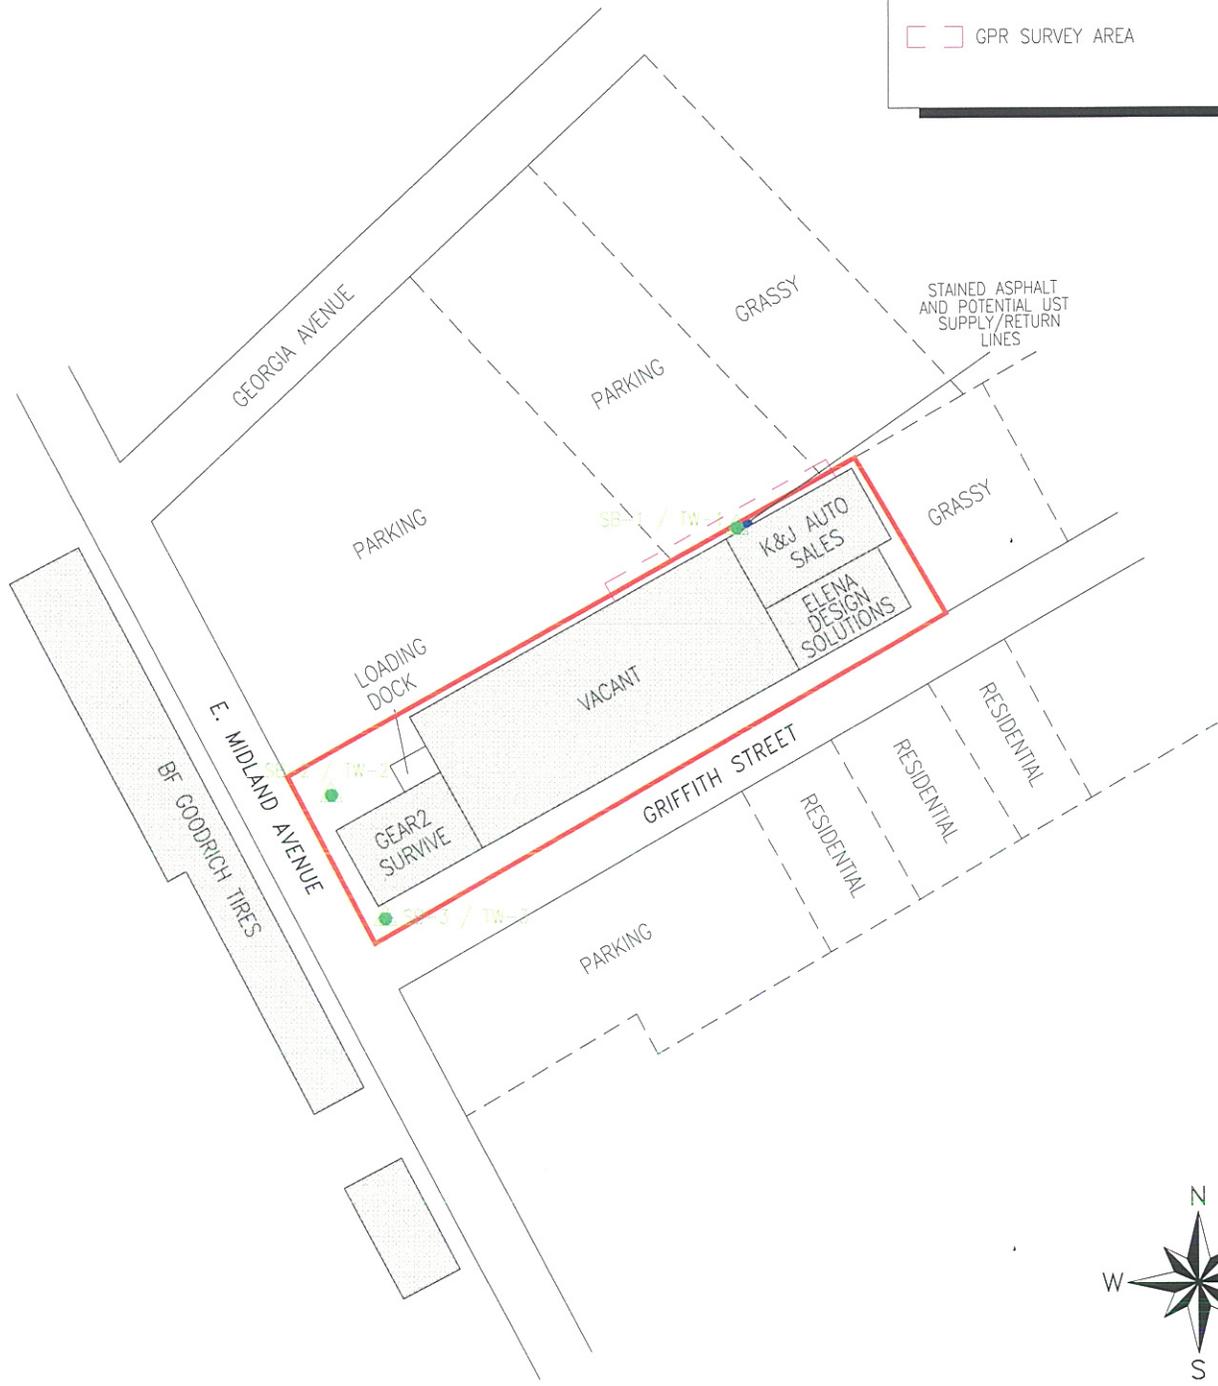
FIGURE 1. SITE PLAN

To investigate the on-Site visual staining and the possibility of impacts from upgradient off-site activities at the western boundary of the Site, in March 2012, AEROSTAR advanced soil borings SB-1 through SB-3 at the Site. The locations are shown on Figure 1. The borings were advanced to a depth of 20 feet below land surface (BLS) using a truck-mounted Geoprobe. Groundwater at each boring location was encountered at approximately 15 feet BLS. Soil samples were collected continuously from land surface to boring termination and were screened at 5 foot intervals using a calibrated organic vapor analyzer with photo ionization detector (OVA-PID). Soil samples were also inspected for signs of contamination (such as staining and unusual odors). Soil sample SB-1@10 feet was collected from SB-1 at 10 feet BLS for analyses of benzene, toluene, ethylbenzene and xylenes (BTEX) and polynuclear aromatic hydrocarbons (PAHs) by EPA Methods 8260 and 8270, respectively. No soil samples for laboratory analyses were collected from SB-2 and SB-3.

AEROSTAR installed temporary monitoring wells TW-1 through TW-3 at boring locations SB-1 through SB-3, respectively. The groundwater sample collected from TW-1 was analyzed for BTEX and PAHs by EPA Methods 8260 and 8270, respectively. The groundwater samples collected from TW-2 and TW-3 were analyzed for volatile organic compounds (VOCs) by EPA Methods 8260.

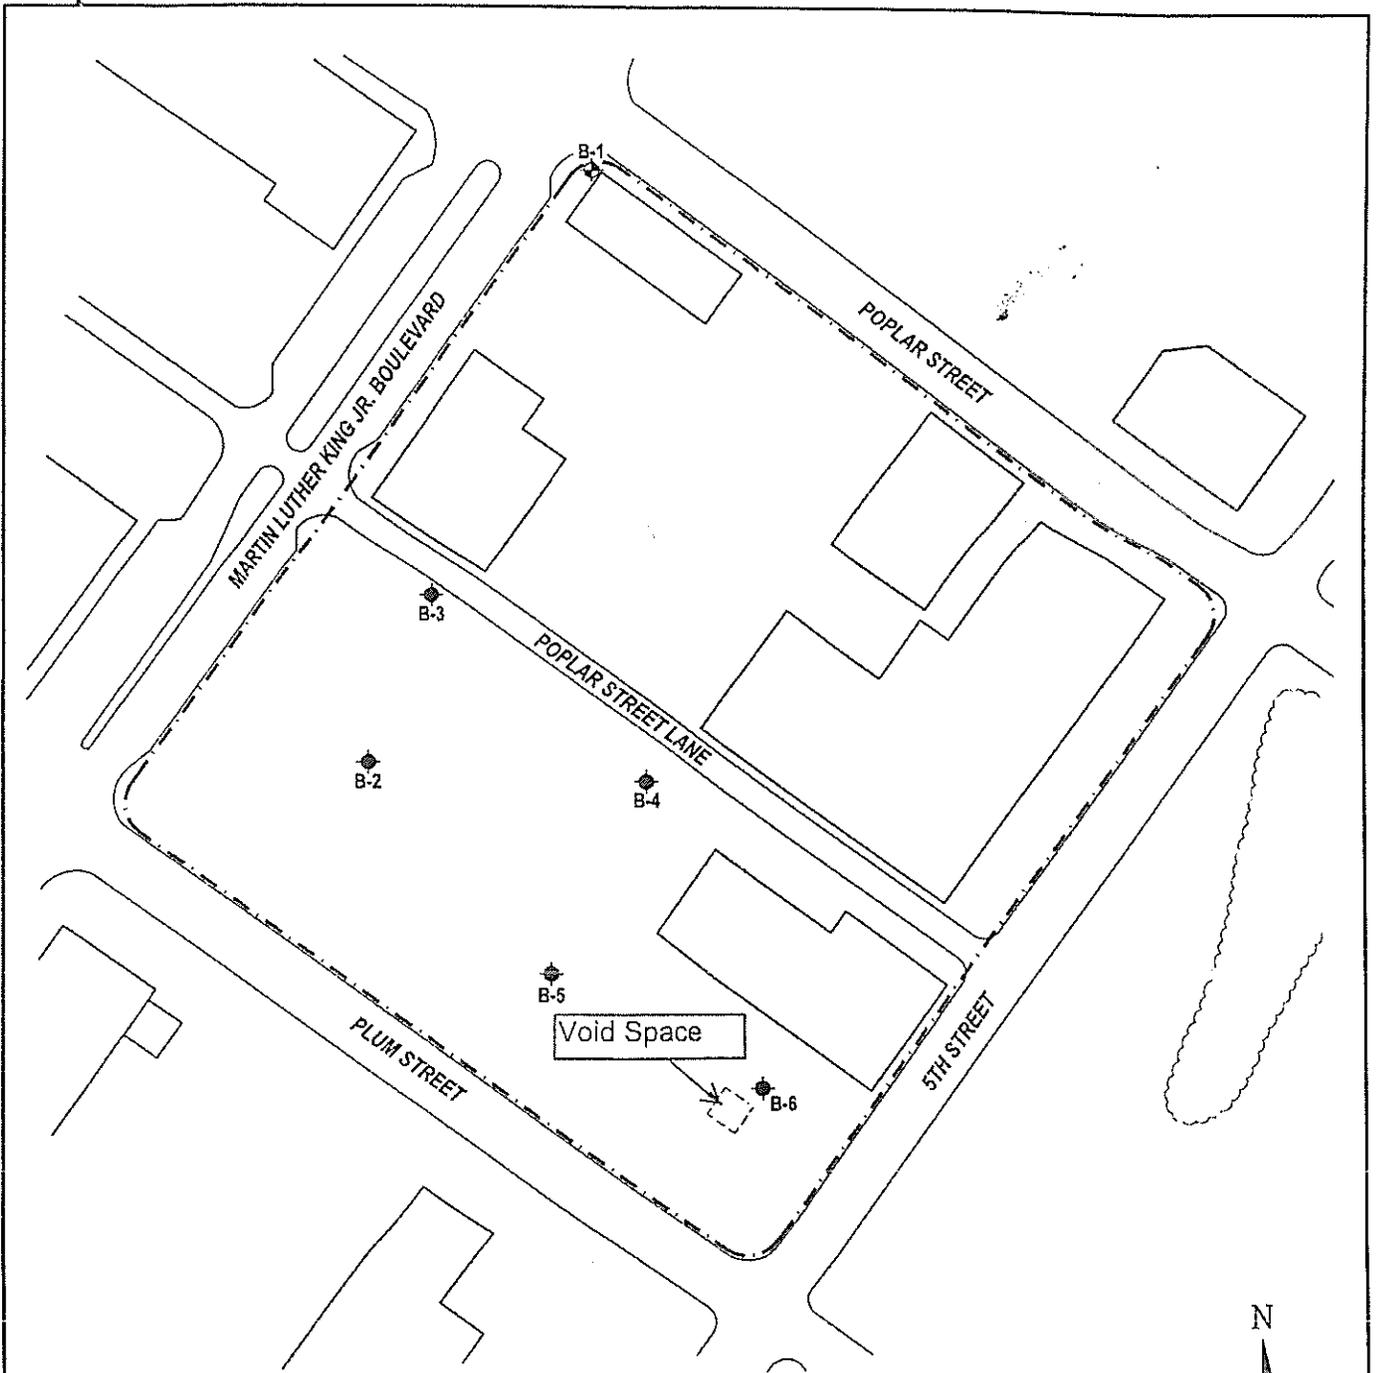
In July 2012, Terracon conducted a Limited Site Investigation (LSI) which included the advancement of six soil borings (denoted B-1 through B-6). Soil samples were collected at each boring location and were field-screened using a photoionization detector (PID) to detect the presence of volatile organic vapors (VOVs). No significant PID readings were recorded and no visual evidence of impact was observed in collected soil samples. Soil boring B-1 refused at 6.5 feet below grade surface (bgs) and groundwater was not encountered; and, due to refusal and the absence of groundwater, a soil sample was collected at the 6.5-foot bgs refusal depth. Due to the presence of remnant building materials (concrete pads, stairs, and other related appurtenances), soil samples were collected from the upper 5-feet (where applicable) at each of the remaining boring locations. Groundwater was encountered in borings B-2 through B-6 at depths ranging from 5.22-feet bgs to 10.6-feet bgs. Soil borings B-2 through B-6 were converted to temporary groundwater monitoring wells and a groundwater sample was collected from each temporary well location. Groundwater samples were collected from temporary well locations B-2 through B-6. Soil and groundwater samples collected during the investigation were submitted for laboratory analysis of the following constituents of concern (COCs): volatile organic compounds (VOCs) by EPA Method 8260B and semivolatile organic compounds (SVOCs) by EPA Method 8270C, total Resource Conservation and Recovery Act (RCRA) metals by EPA Method 6010B/7470A/7471B. Additionally, soil samples were analyzed for total petroleum hydrocarbons - gasoline range organics (TPH-GRO) and total petroleum hydrocarbons - diesel range organics (TPH-DRO). Following a review of the laboratory analytical results, select groundwater samples were also analyzed for select dissolved metals by EPA Method 6010B.

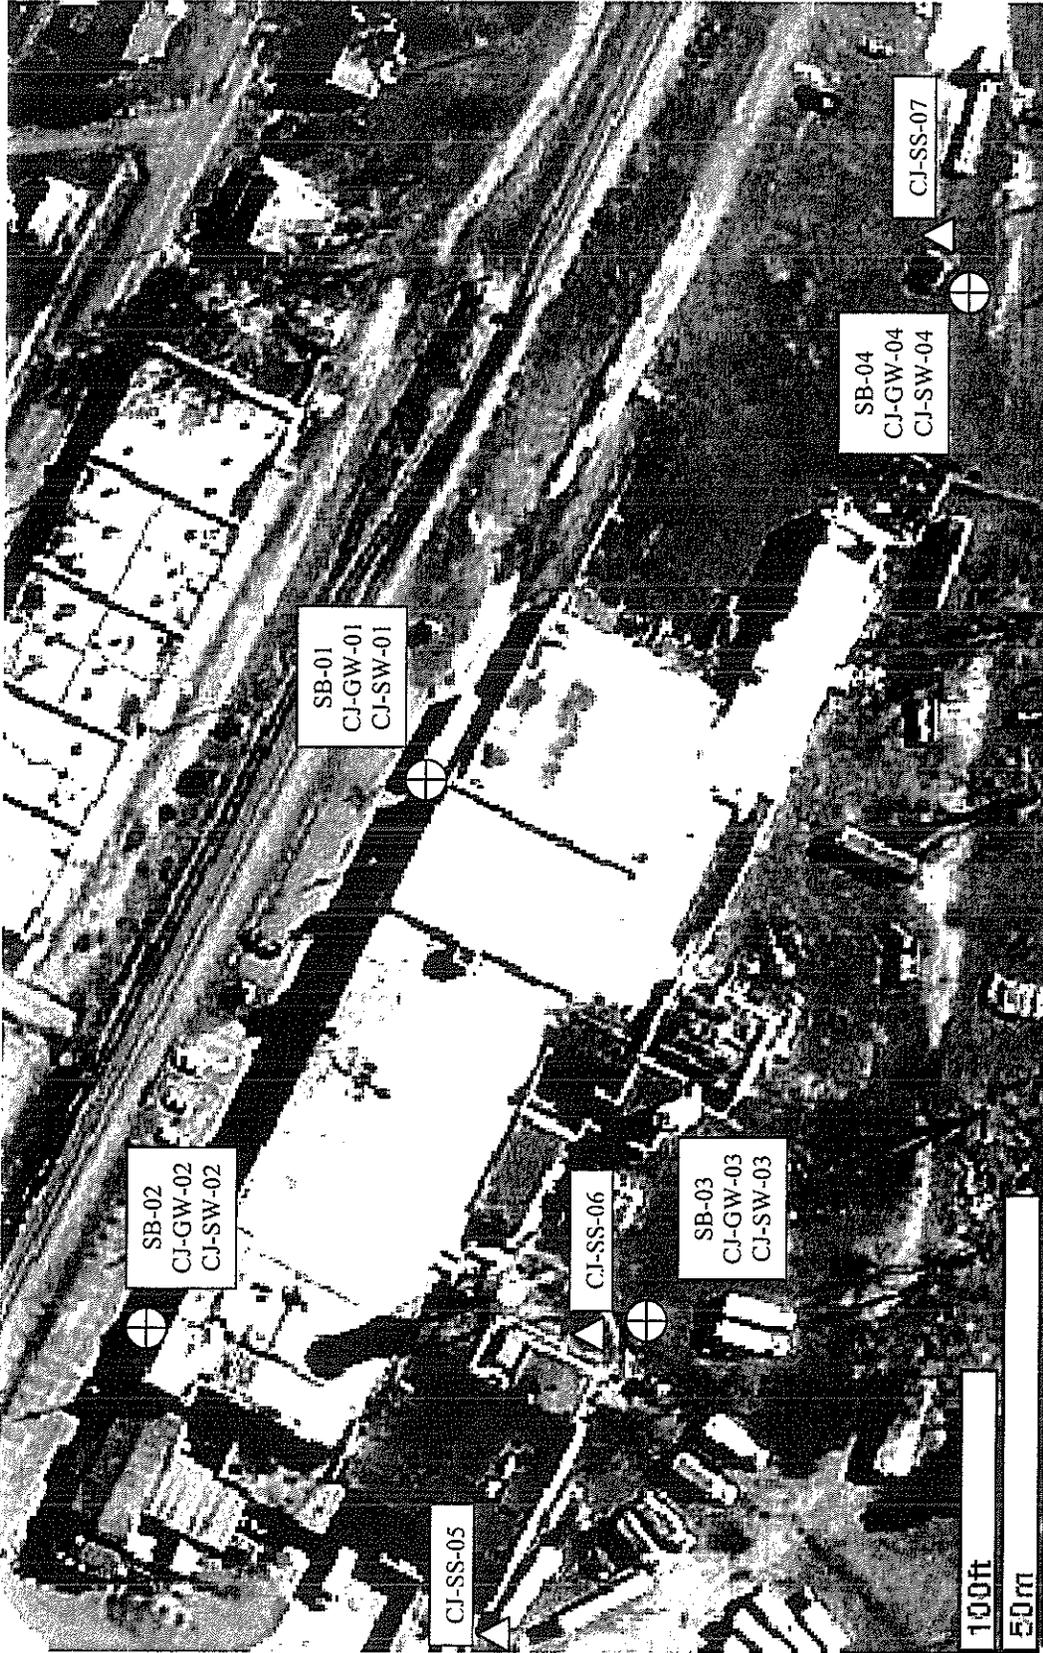
Surface Soil Sample Location \triangle

Approximate Boring Location \oplus

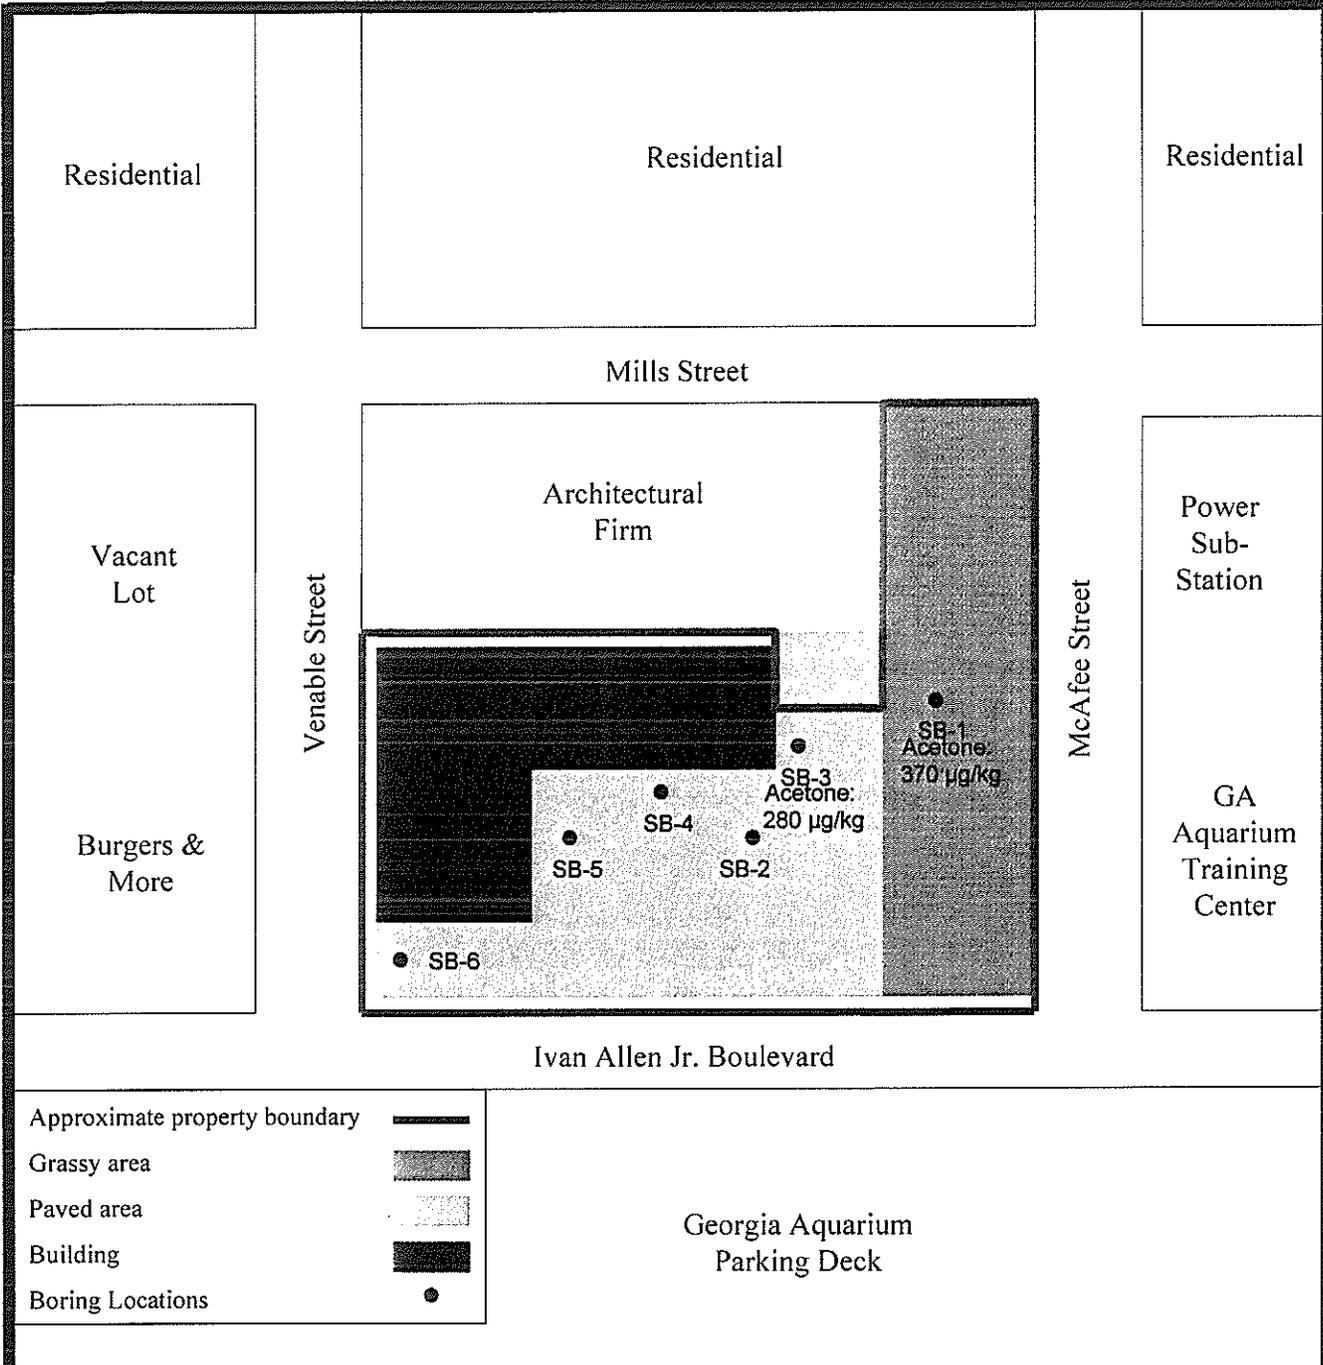
Scale: 1" ≈ 53' **SITE SKETCH WITH SOIL BORING LOCATIONS**

The three groundwater samples collected, SB-1-GW, SB-3-GW and SB-6-GW, contained chemical concentrations above minimum laboratory reporting limits. Trichloroethene (TCE) was detected in SB-1-GW and SB-2-GW at concentrations of 16.0 and 8.9 µg/L, respectively. Chloroform was detected in SB-6-GW at a concentration of 59.0 µg/L. These concentrations are above the laboratory minimum detection limit (MDL) of 5.0 µg/kg.

Two soil samples collected, SB-1-7' and SB-3-2', contained chemical concentrations above minimum laboratory reporting limits. Acetone was detected in SB-1-7' and SB-3-2' at concentrations of 370 and 280 µg/kg, respectively. This chemical is frequently understood to be laboratory interference or preservative interference but based on the site's history as a paint store, the reported low concentration of acetone in the soil by the laboratory cannot be excluded as a true positive. The reported soil concentrations are well below the HSRA notification concentration of 2,740 µg/kg.

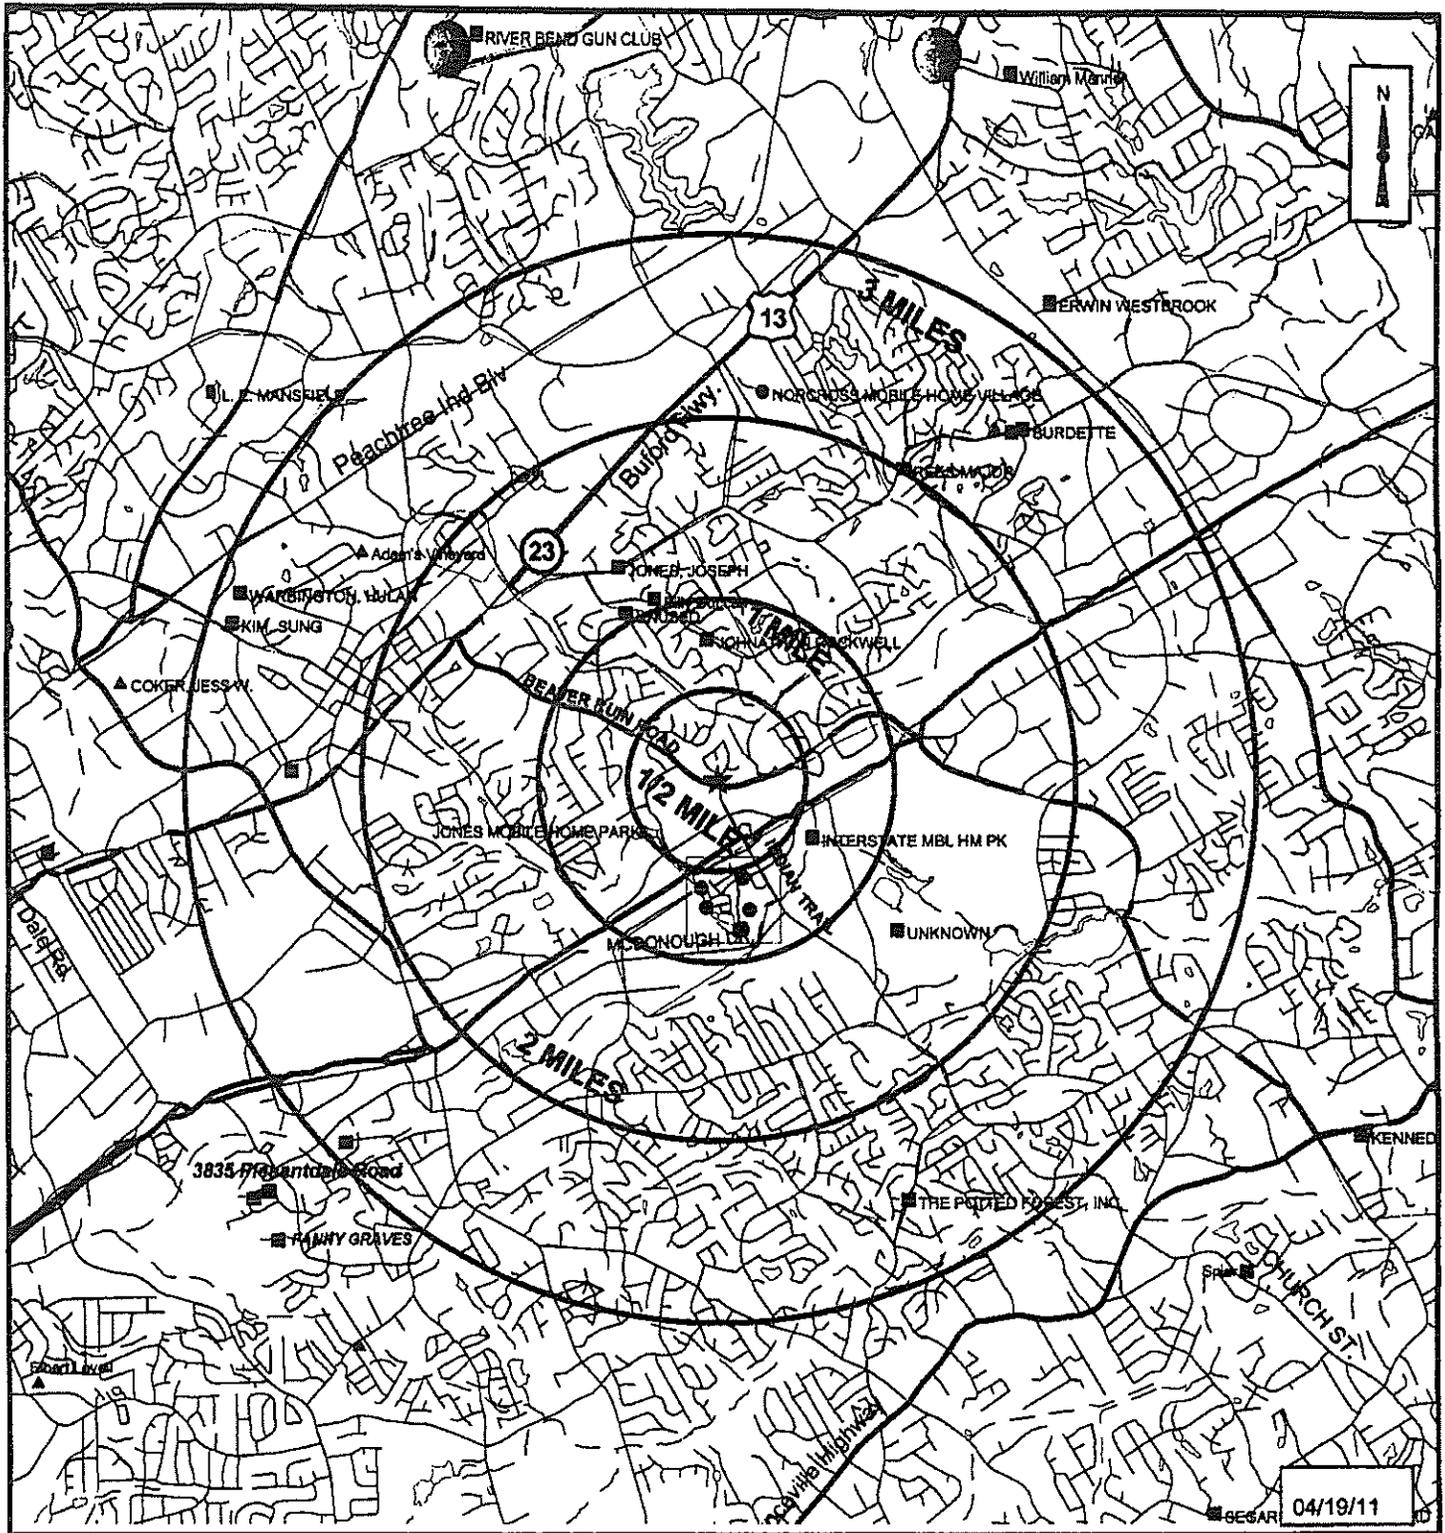
- Roads
- State and US Highways
- Interstate Highways
- Rivers/Streams
- Lake/Pond
- Swamp/Marsh
- Census Block Group Boundaries
- Census Block Groups > 0 Domestic Wells
- Household
- Unused
- Public Supply
- Irrigation
- Irrigation Unused

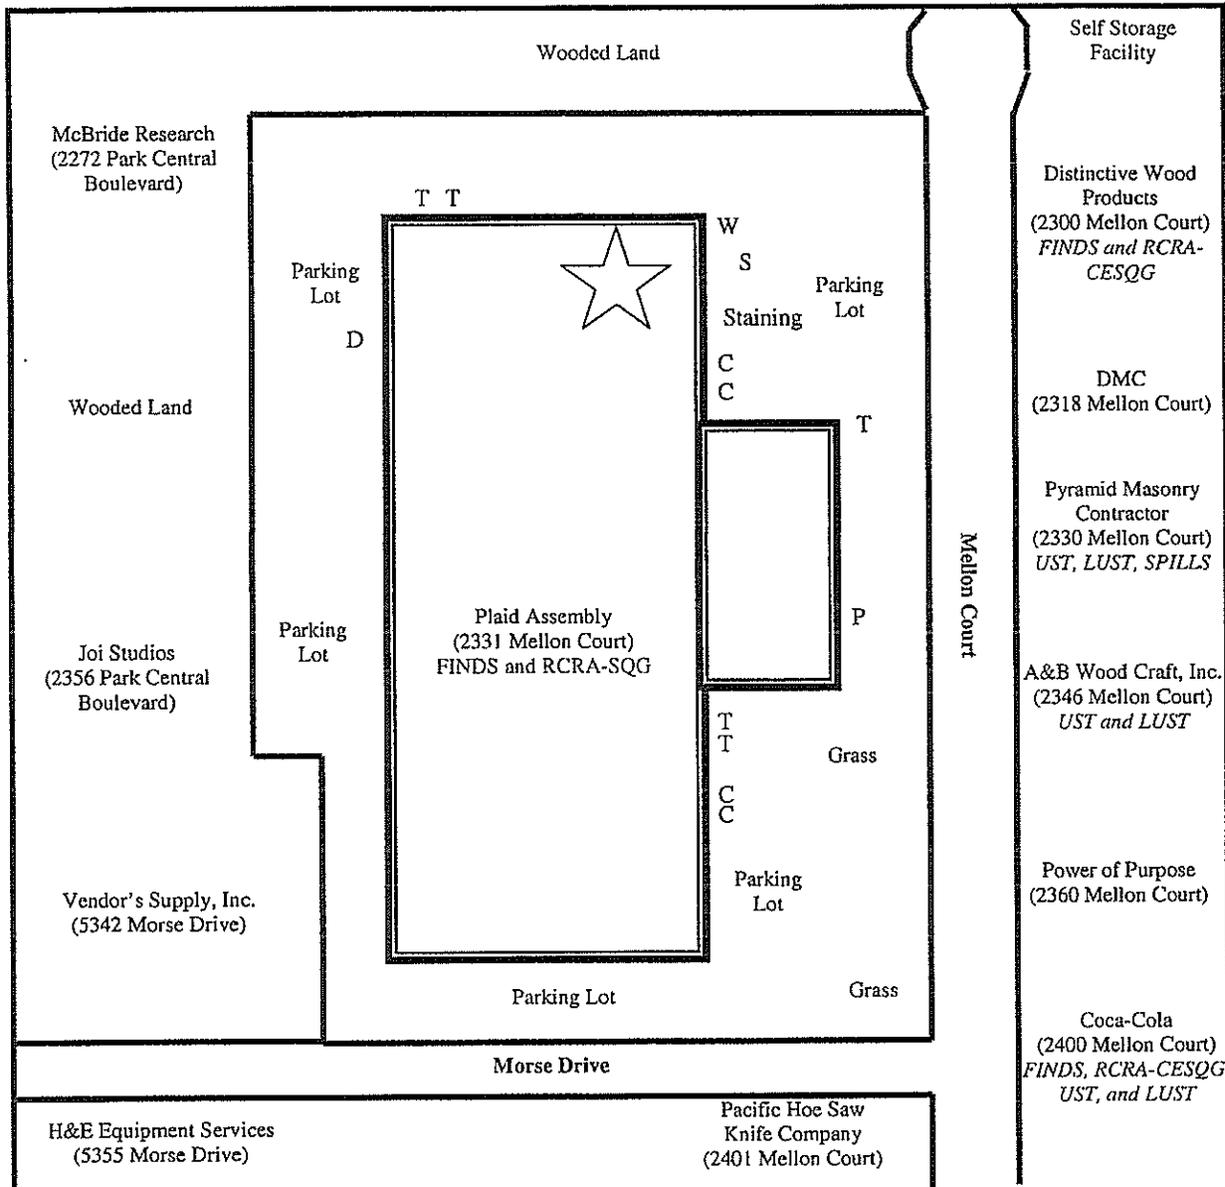
Field Sketch

Key:
 — Project Boundary
 T – Pad-Mounted Electrical Transformer
 ☆ Aboveground Storage Tanks Area
 S – Secondary Containment for Delivery
 W – Non-Potable Well
 C – Trash Compactor D – Dumpster
 P – Propane Storage

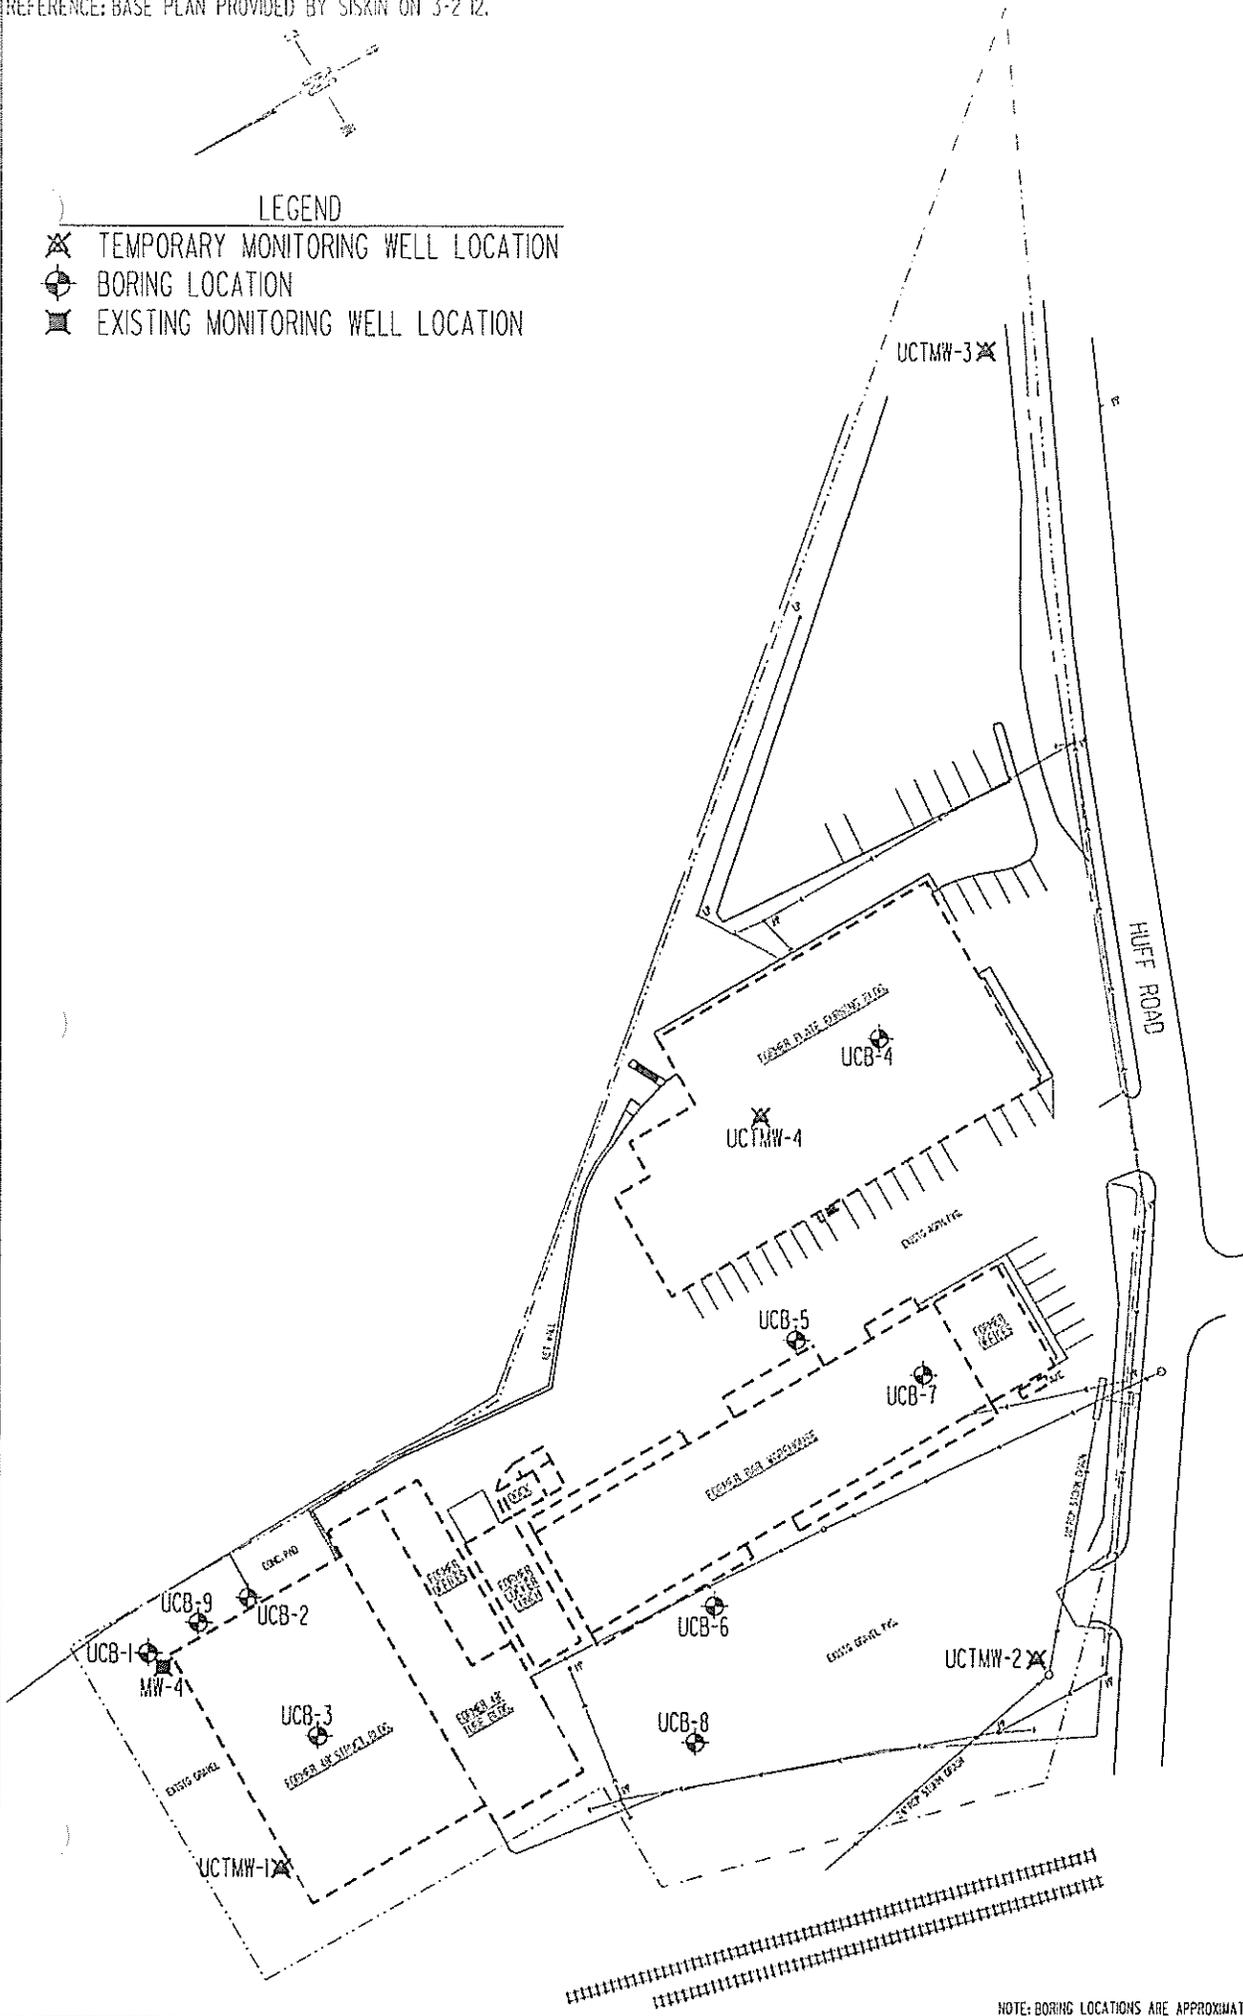
SCALE: 1" = 100'	DATE: 4-24-12	PROJECT NO: 2011.2522.02	TITLE: BORING LOCATION PLAN FORMER SISKIN STEEL FACILITY ATLANTA, FULTON COUNTY, GEORGIA
PREPARED: VPV	CHECKED: RC	REVISIONS:	625 Holcomb Bridge Road Norcross, Georgia 30071 770-209-0029 Fax 582-2900 www.unitedconsulting.com Copyright © United Consulting, Inc. 2012
CLIENT: SISKIN STEEL	UNITED CONSULTING <i>We're here for you</i>

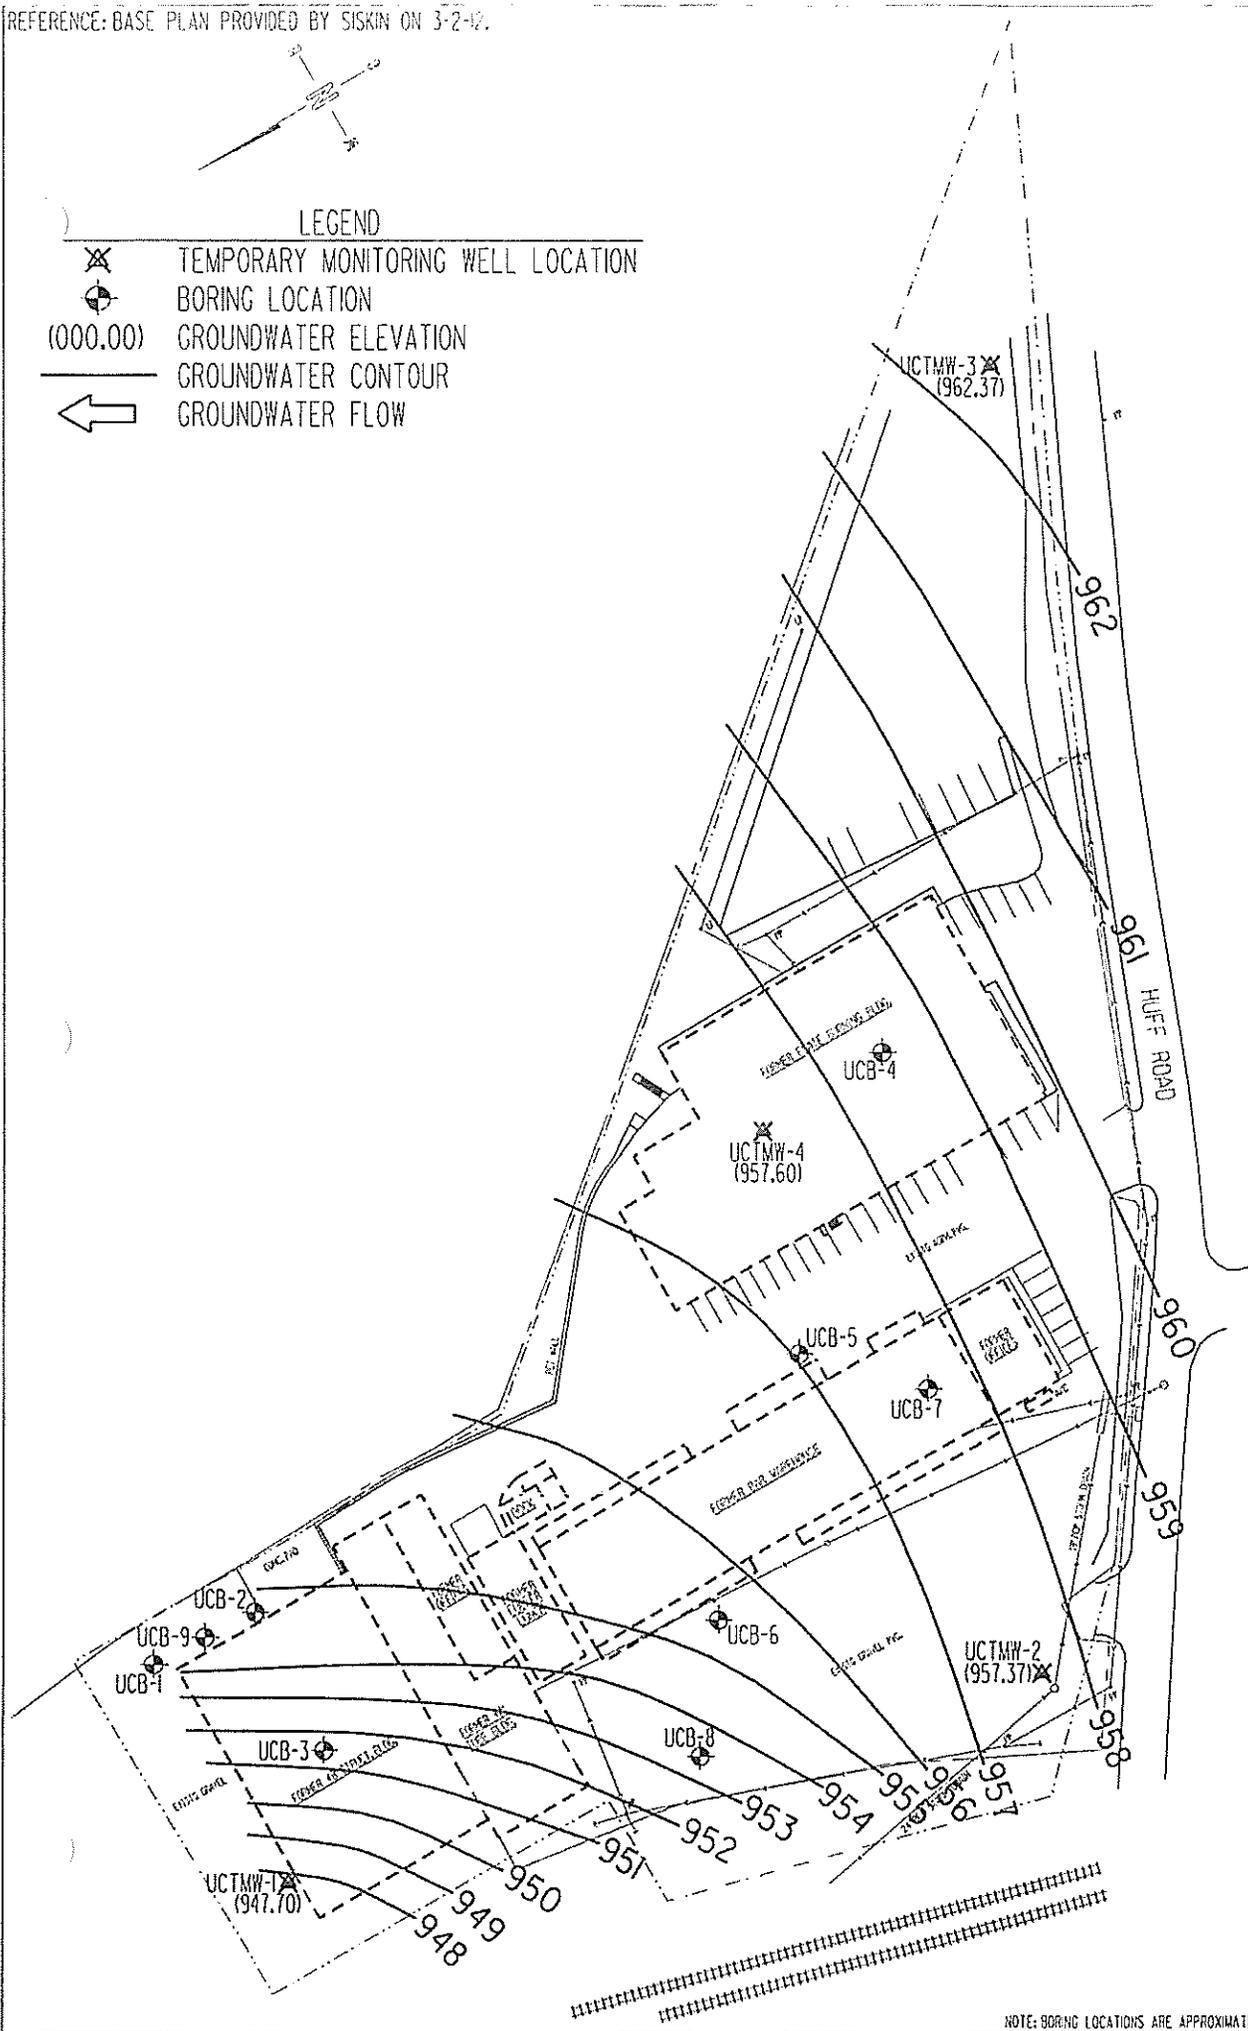
- TEMPORARY MONITORING WELL LOCATION
- BORING LOCATION
- (000.00) GROUNDWATER ELEVATION
- GROUNDWATER CONTOUR
- ← GROUNDWATER FLOW
