COPY**RELEASE NOTIFICATION/REPORTING FORM**

Project: Former Ace Automotive Center
3190 Mercer University Drive
Macon, Georgia

Monitor Well Location Plan
for:
3190 Mercer University Drive
Macon, Georgia
Former Ace Automotive

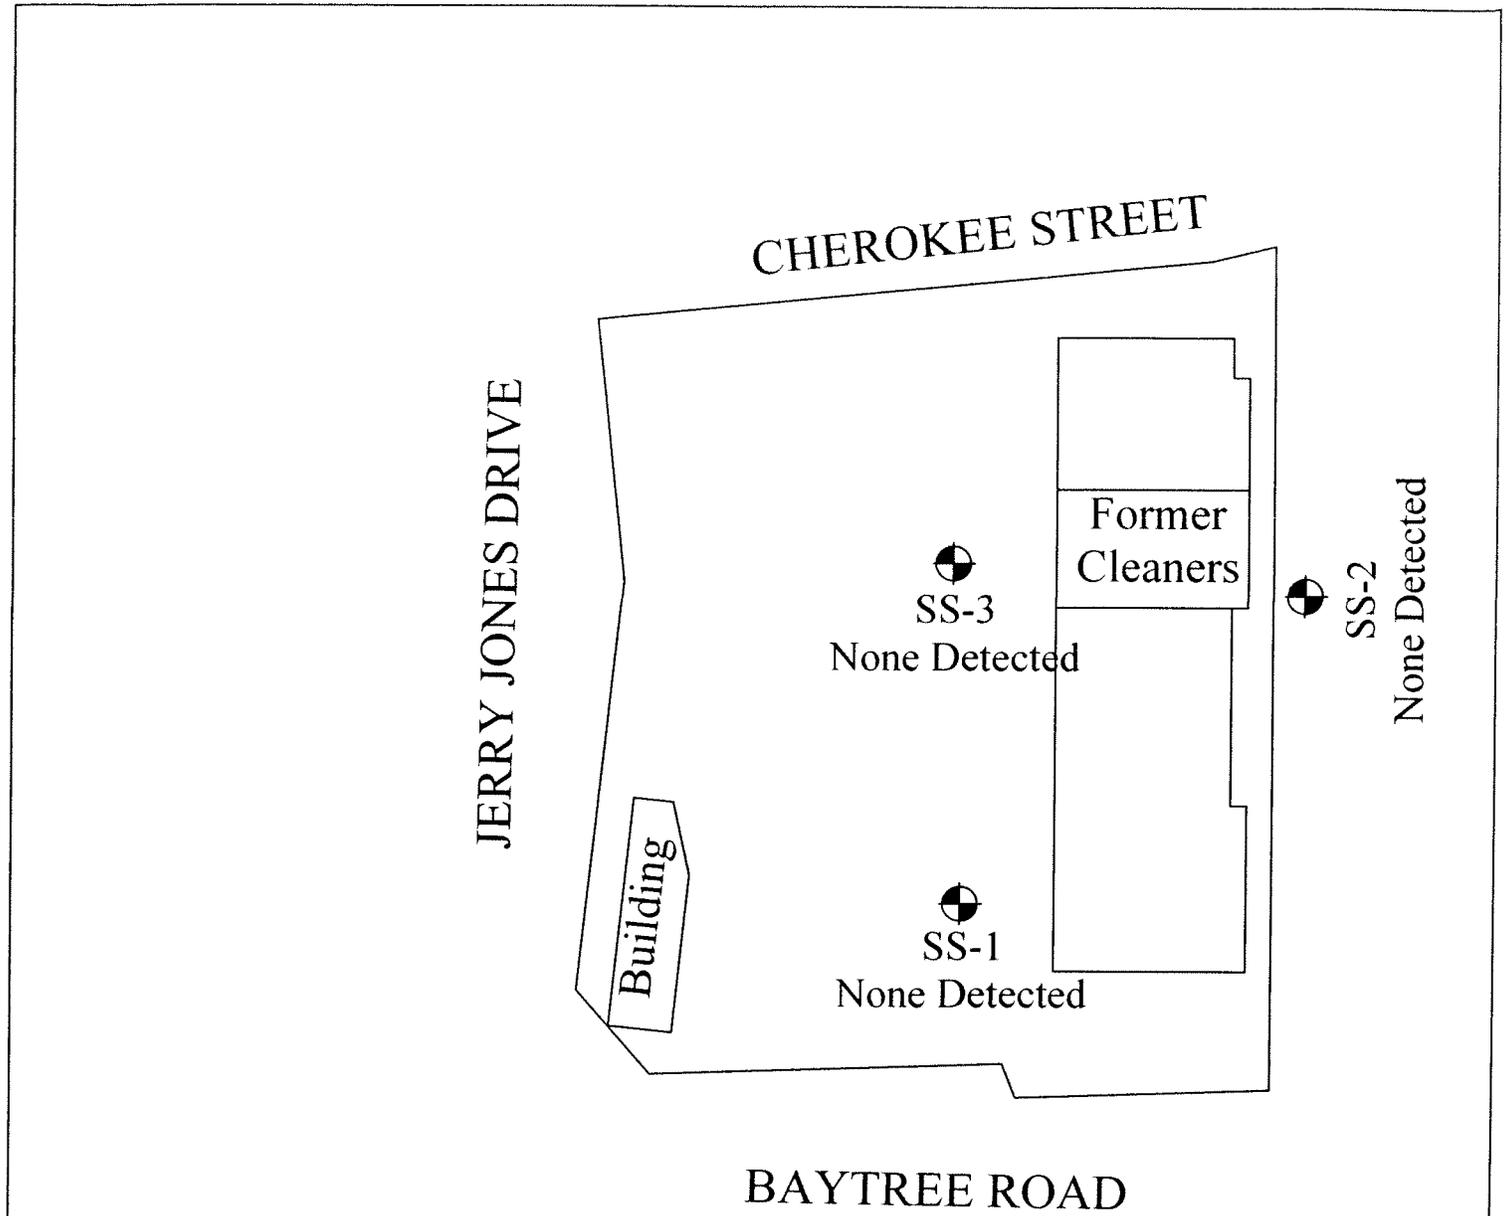
FIGURE 2
 SOIL QUALITY MAP
 BAYTREE PROPERTIES
 908 BAYTREE ROAD
 VALDOSTA, GEORGIA

N
 4
 NOTE: Soil samples collected at 5 feet.

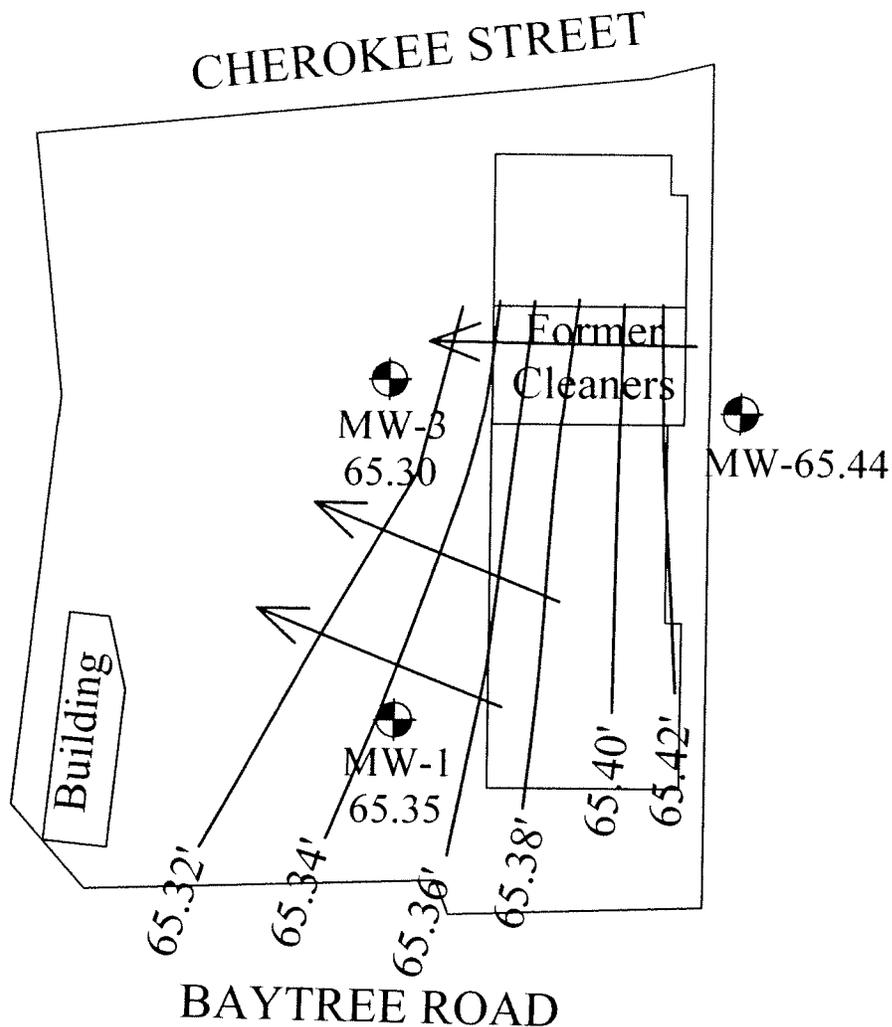
Well Number	Date Measured	Ground Elev. (ft)	TOC* Elev. (ft)	Water Depth (ft)	Corrected* GW Elev. (ft)
MW-1	2/20/2013	100.44	100.00	34.65	65.35
MW-2	2/20/2013	105.06	104.73	39.29	65.44
MW-3	2/20/2013	101.01	100.43	35.13	65.30

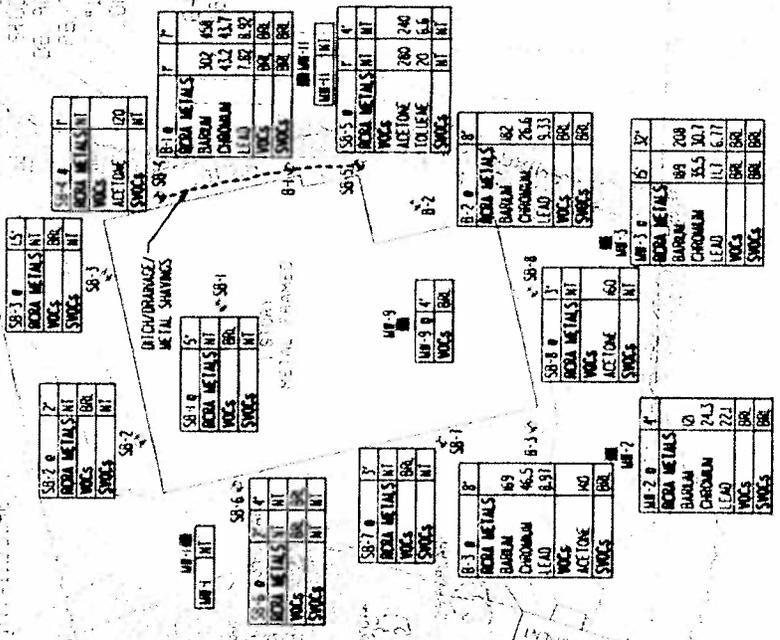
SCALE: 1" = 60'	DATE: 4-2-13	PROJECT NO: 2012.3366.08	TITLE: SOIL QUALITY MAP FORMER BEMD, INC. HOLLY SPRINGS, CHEROKEE COUNTY, GEORGIA
PREPARED: VPV	CHECKED:	REVISIONS:	
CLIENT: MEYERS BROTHERS PROPERTIES

NOTE: VOCS & SWOCS RESULTS ARE REPORTED IN MICROGRAMS PER KILOGRAM (ug/kg).
 HCRA METALS RESULTS ARE REPORTED IN MILLIGRAMS PER KILOGRAM (mg/kg).
