VOLUNTARY REMEDIATION PROGRAM
VOLUNTARY INVESTIGATION AND REMEDIATION PLAN SEMIANNUAL STATUS REPORT

Site Name: Fashion Care/Executive Care Site, HSI No. 10786

Site Address: 2211 Savoy Drive, Chamblee, Georgia

Voluntary Investigation and Remediation Plan Semiannual Status Report Voluntary Remediation Program

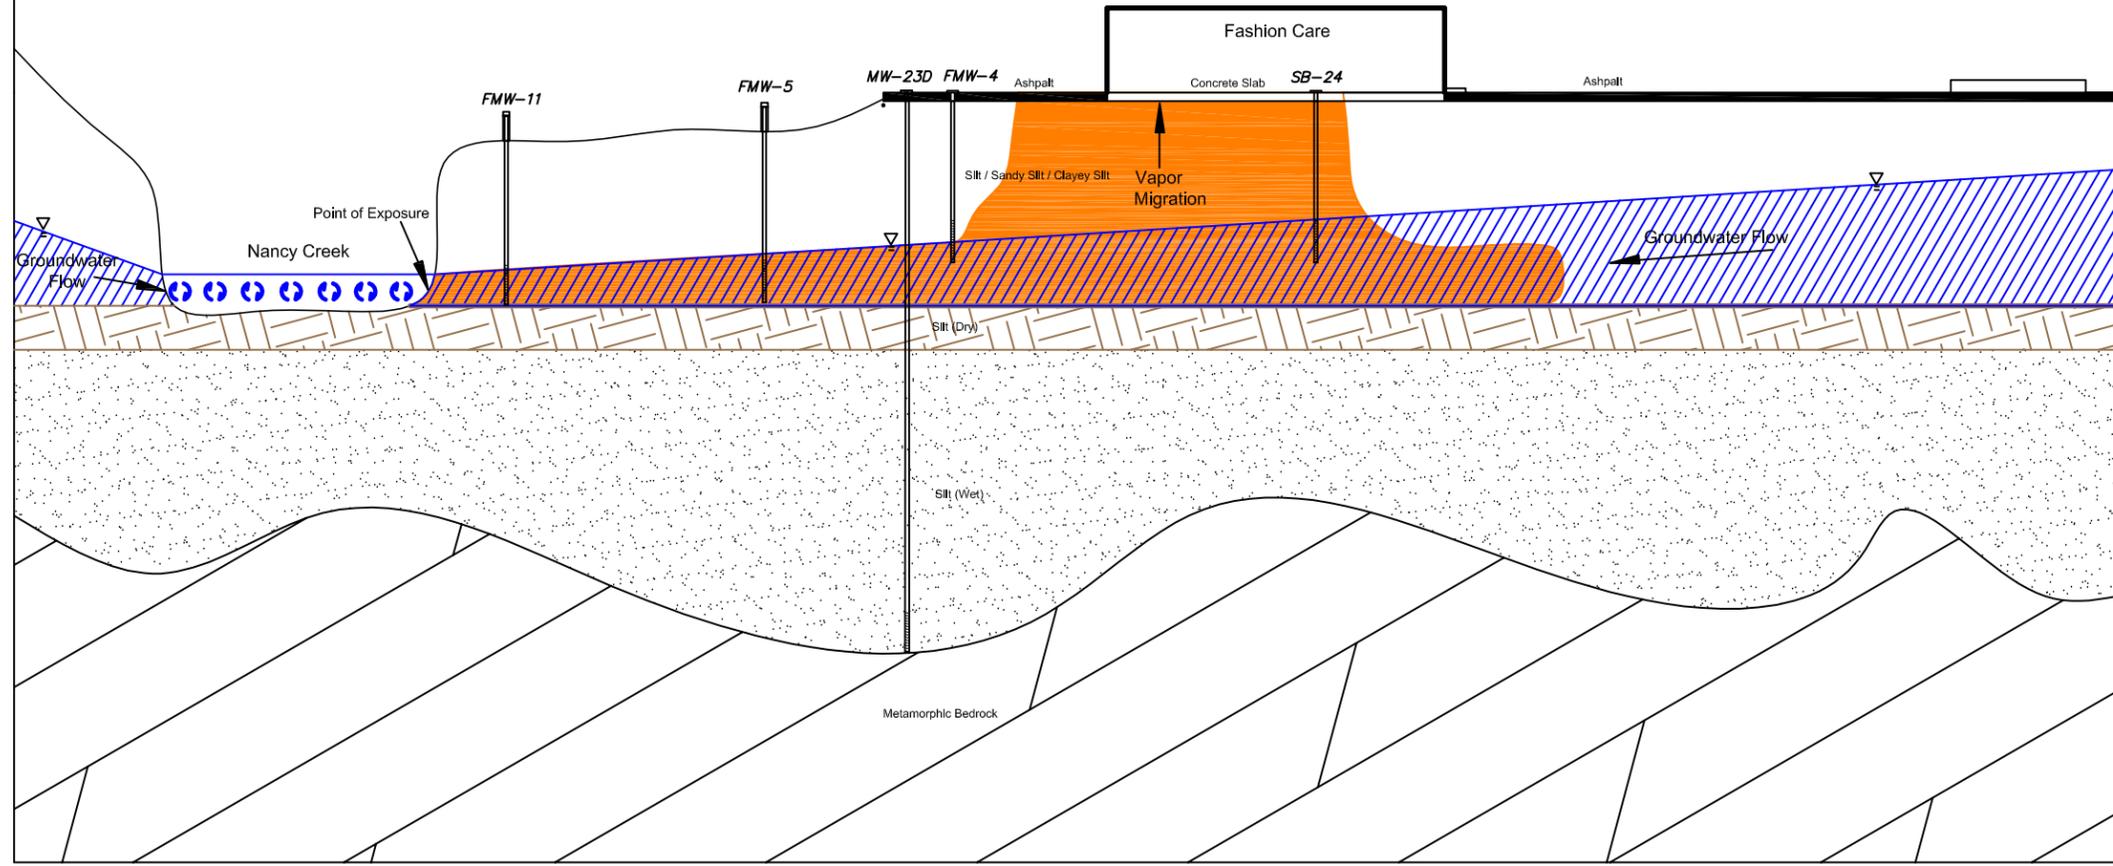
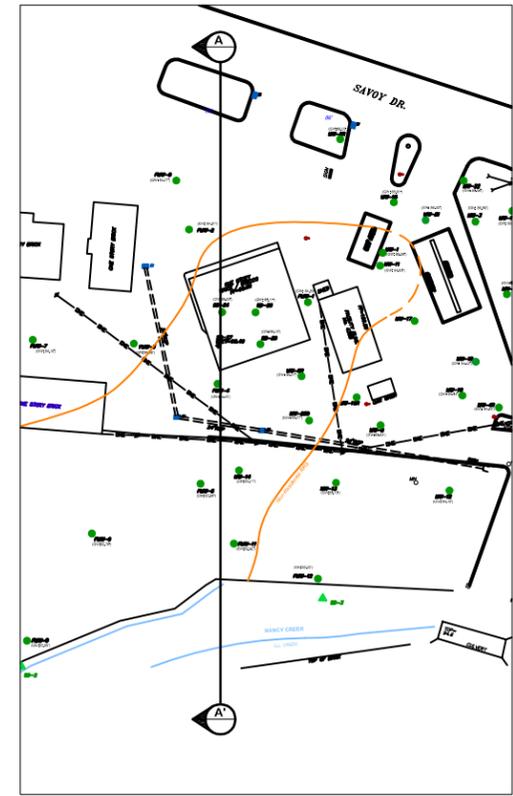
Figure 1
 Conceptual Site Model
 Fashion Care / Executive Care Site
 2211 Savoy Dr
 Chamblee, GA 30341

The primary activity that has been performed from June 3, 2013 through December 2, 2013 is the refining of the Conceptual Site Model (Figure 1) through the installation of soil borings across the impacted area to confirm presence/absence of a dry silt, shallow confining unit.

Prior to the most recent soil boring event conducted in November 2013, the lithology and suspected hydrogeology presented in the conceptual site model had been based upon the theory that the saturated soil zone is divided into an upper and lower water bearing zone, separated by a dense, dry silt. This was based upon evidence that the upper water bearing zone is thinner adjacent to Nancy Creek where saturated conditions are encountered in borings as shallow as 5 feet below grade and the dense dry silt is encountered at depths of 8 to 16 feet below grade, which generally corresponds to the streambed of Nancy Creek adjacent to the Site. The vertical walls and wide streambed also supported this hypothesis.

The thickness of the potential upper water bearing zone appears to be greater to the north near Savoy Drive and thins as Nancy Creek is approached. It was theorized that the dense dry silt had not been encountered in the borings near Savoy Drive because all the borings had penetrated the water table generally no more than 7 to 8 feet to set wells and the upper water bearing zone in this area is thicker. This suspected division in the water table aquifer on Site is significant for the evaluation of groundwater impacts and the groundwater modeling to be conducted to establish a VRP groundwater monitoring plan. It is suspected that the previous deep well, MW-23D, installed by the UST Program contractor for the adjacent EZ-Serve UST remediation site, may have penetrated this dry silt separating the shallow water bearing zones and provided a limited conduit for vertical migration of constituents. MW-23D has since been abandoned by the UST program.

- Completion of the Conceptual Site Model (Figure 1):
 - Installation and sampling of a Type III monitoring well screened below the dry silt, between the base of the dry silt and the top of bedrock. The well location agreed upon by the EPD and Woodard & Curran is shown on Figure 4.
 - Conduct an additional slug test in the shallow water bearing zone for input into a groundwater model. Two previous slug tests have been conducted in the shallow water bearing zone.

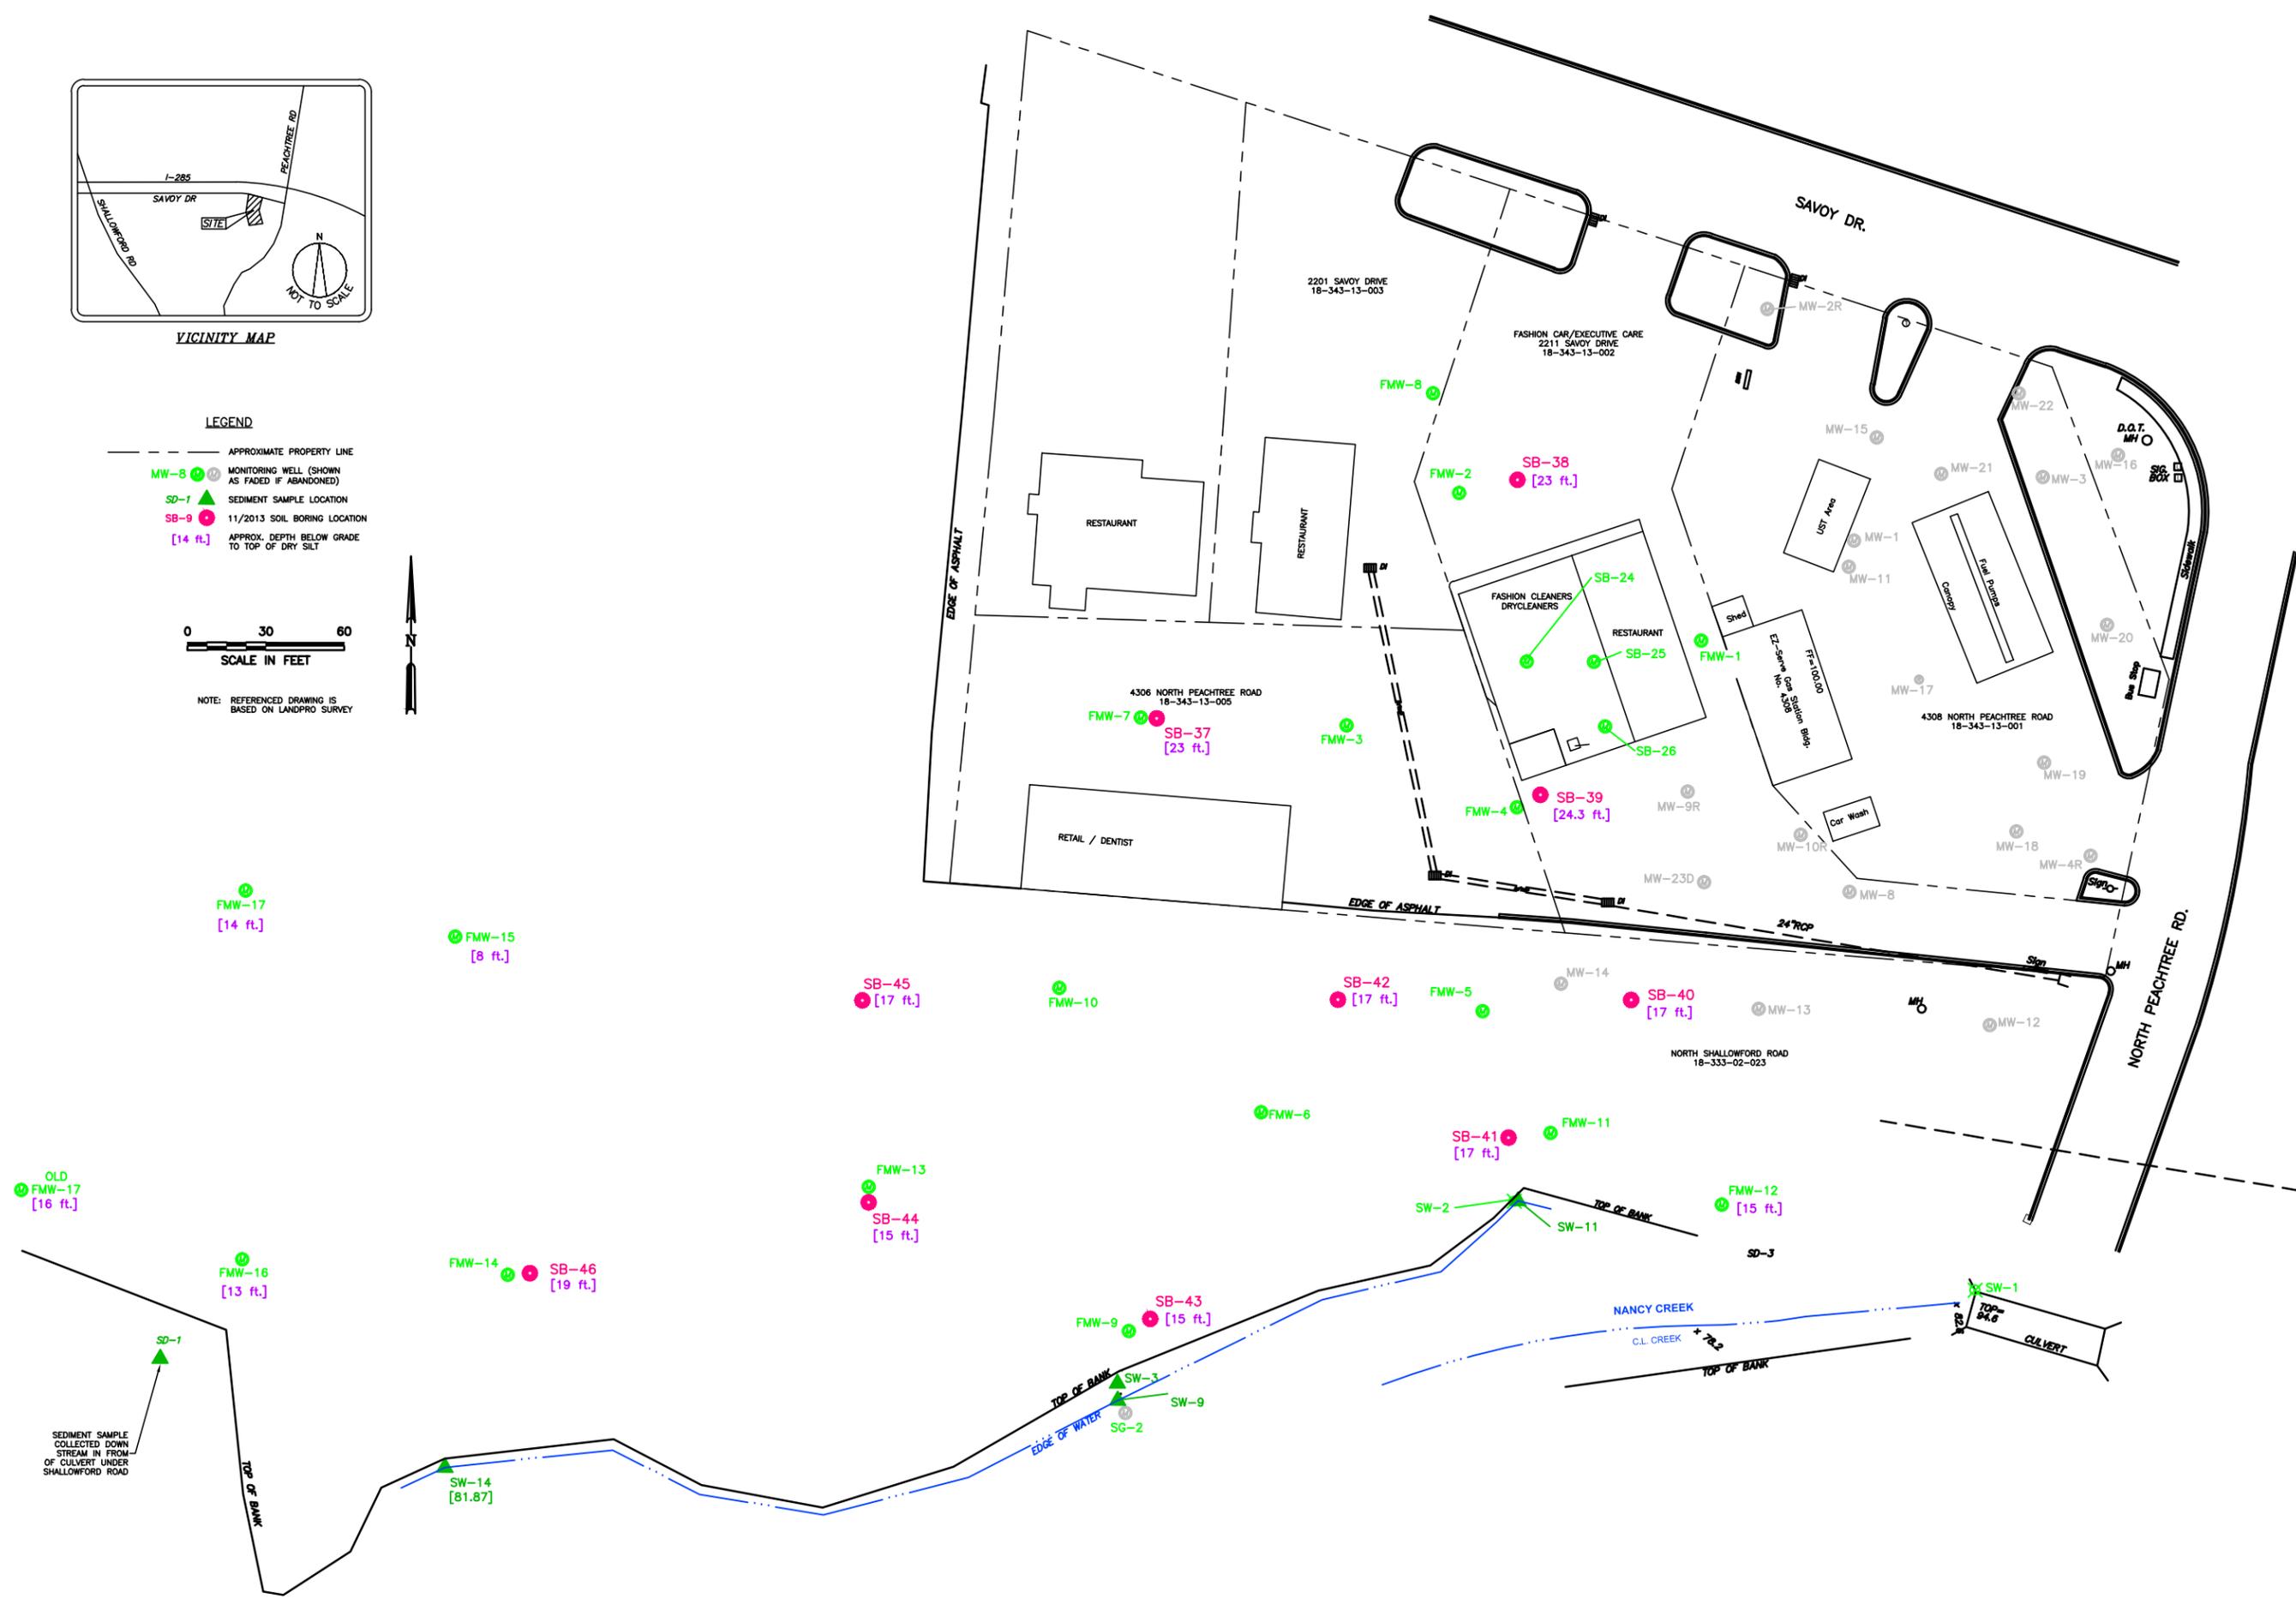
FIGURE 2
DEPTH TO TOP OF DRY SILT

- APPROXIMATE PROPERTY LINE
- MW-8 (circle with dot) MONITORING WELL (SHOWN AS FADED IF ABANDONED)
- SD-1 (triangle) SEDIMENT SAMPLE LOCATION
- SB-9 (circle with dot) 11/2013 SOIL BORING LOCATION [14 ft.]
- [14 ft.] APPROX. DEPTH BELOW GRADE TO TOP OF DRY SILT

To confirm the lithology presented in the conceptual site model, ten (10) additional soil borings were advanced across the Site in November 2013 using a direct-push drilling method (DPT). These borings, SB-37 through SB-46 shown on Figure 2, were advanced to confirm the consistent presence of the dry silt across the site and to determine the thickness of this layer. Five (5) previous borings on the property adjacent to Nancy Creek had encountered the dry silt, FMW-12, FMW-15, FMW-16, old FMW-17 (boring was advanced but well not installed) and FMW-17. The presence of the dry silt was confirmed across the Site. As anticipated, the dry silt was encountered at deeper depths at the higher elevation around the Fashion Care building, depths ranging from 23 feet below ground surface (bgs) to 23.3 feet bgs. Toward the creek, as elevations get lower, the dry silt is encountered at shallower depths below grade ranging from 8 feet bgs (FMW-15) to 19 feet bgs (SB-46).

The dry silt is reddish-brown in color and very dense. In a number of borings drilling was terminated with DPT refusal due to the dense, hard nature of the material. When slight pressure was applied to a solid core of the silt it would crumble into loose material, indicative of the lack of moisture in the silt.

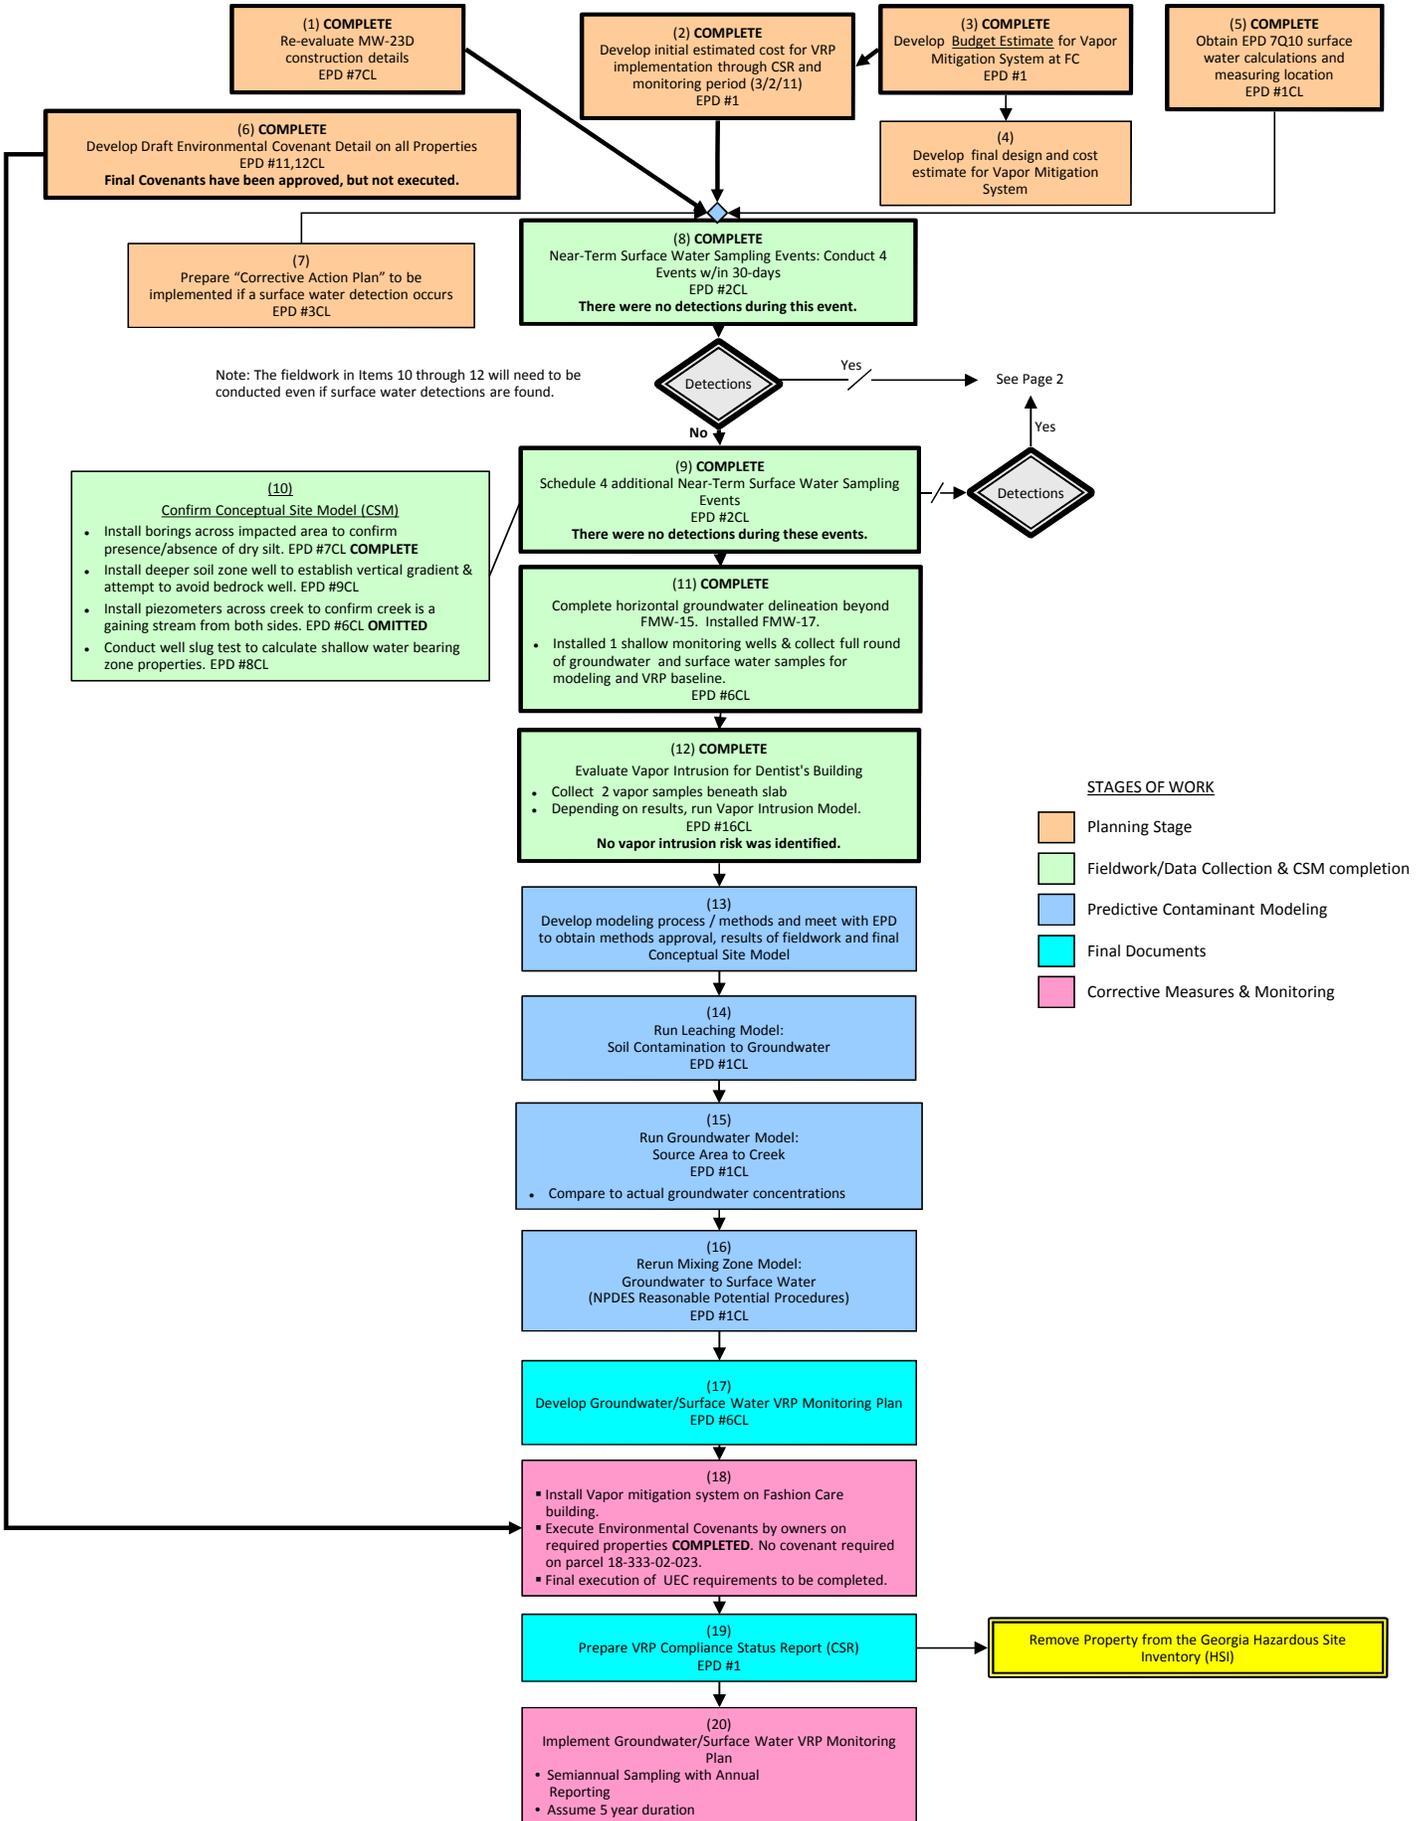
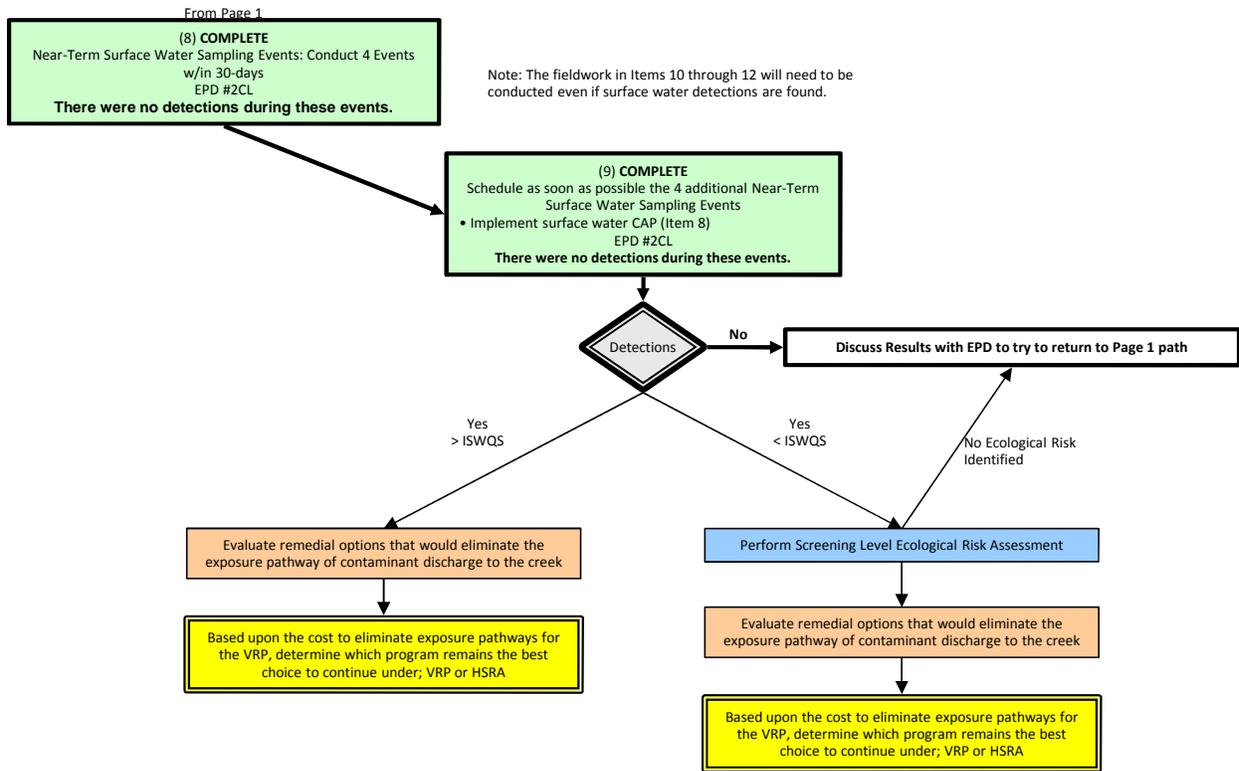
Figure 3
Flow Chart – Voluntary Investigation & Remediation Plan Tasks
 (Completed tasks are noted.)

- Planning Stage
- Fieldwork/Data Collection & CSM completion
- Predictive Contaminant Modeling
- Final Documents
- Corrective Measures & Monitoring

These tasks are presented on Figure 3. The primary tasks anticipated to be completed during the next six months for the period ending June 2, 2014 are presented in detail below.

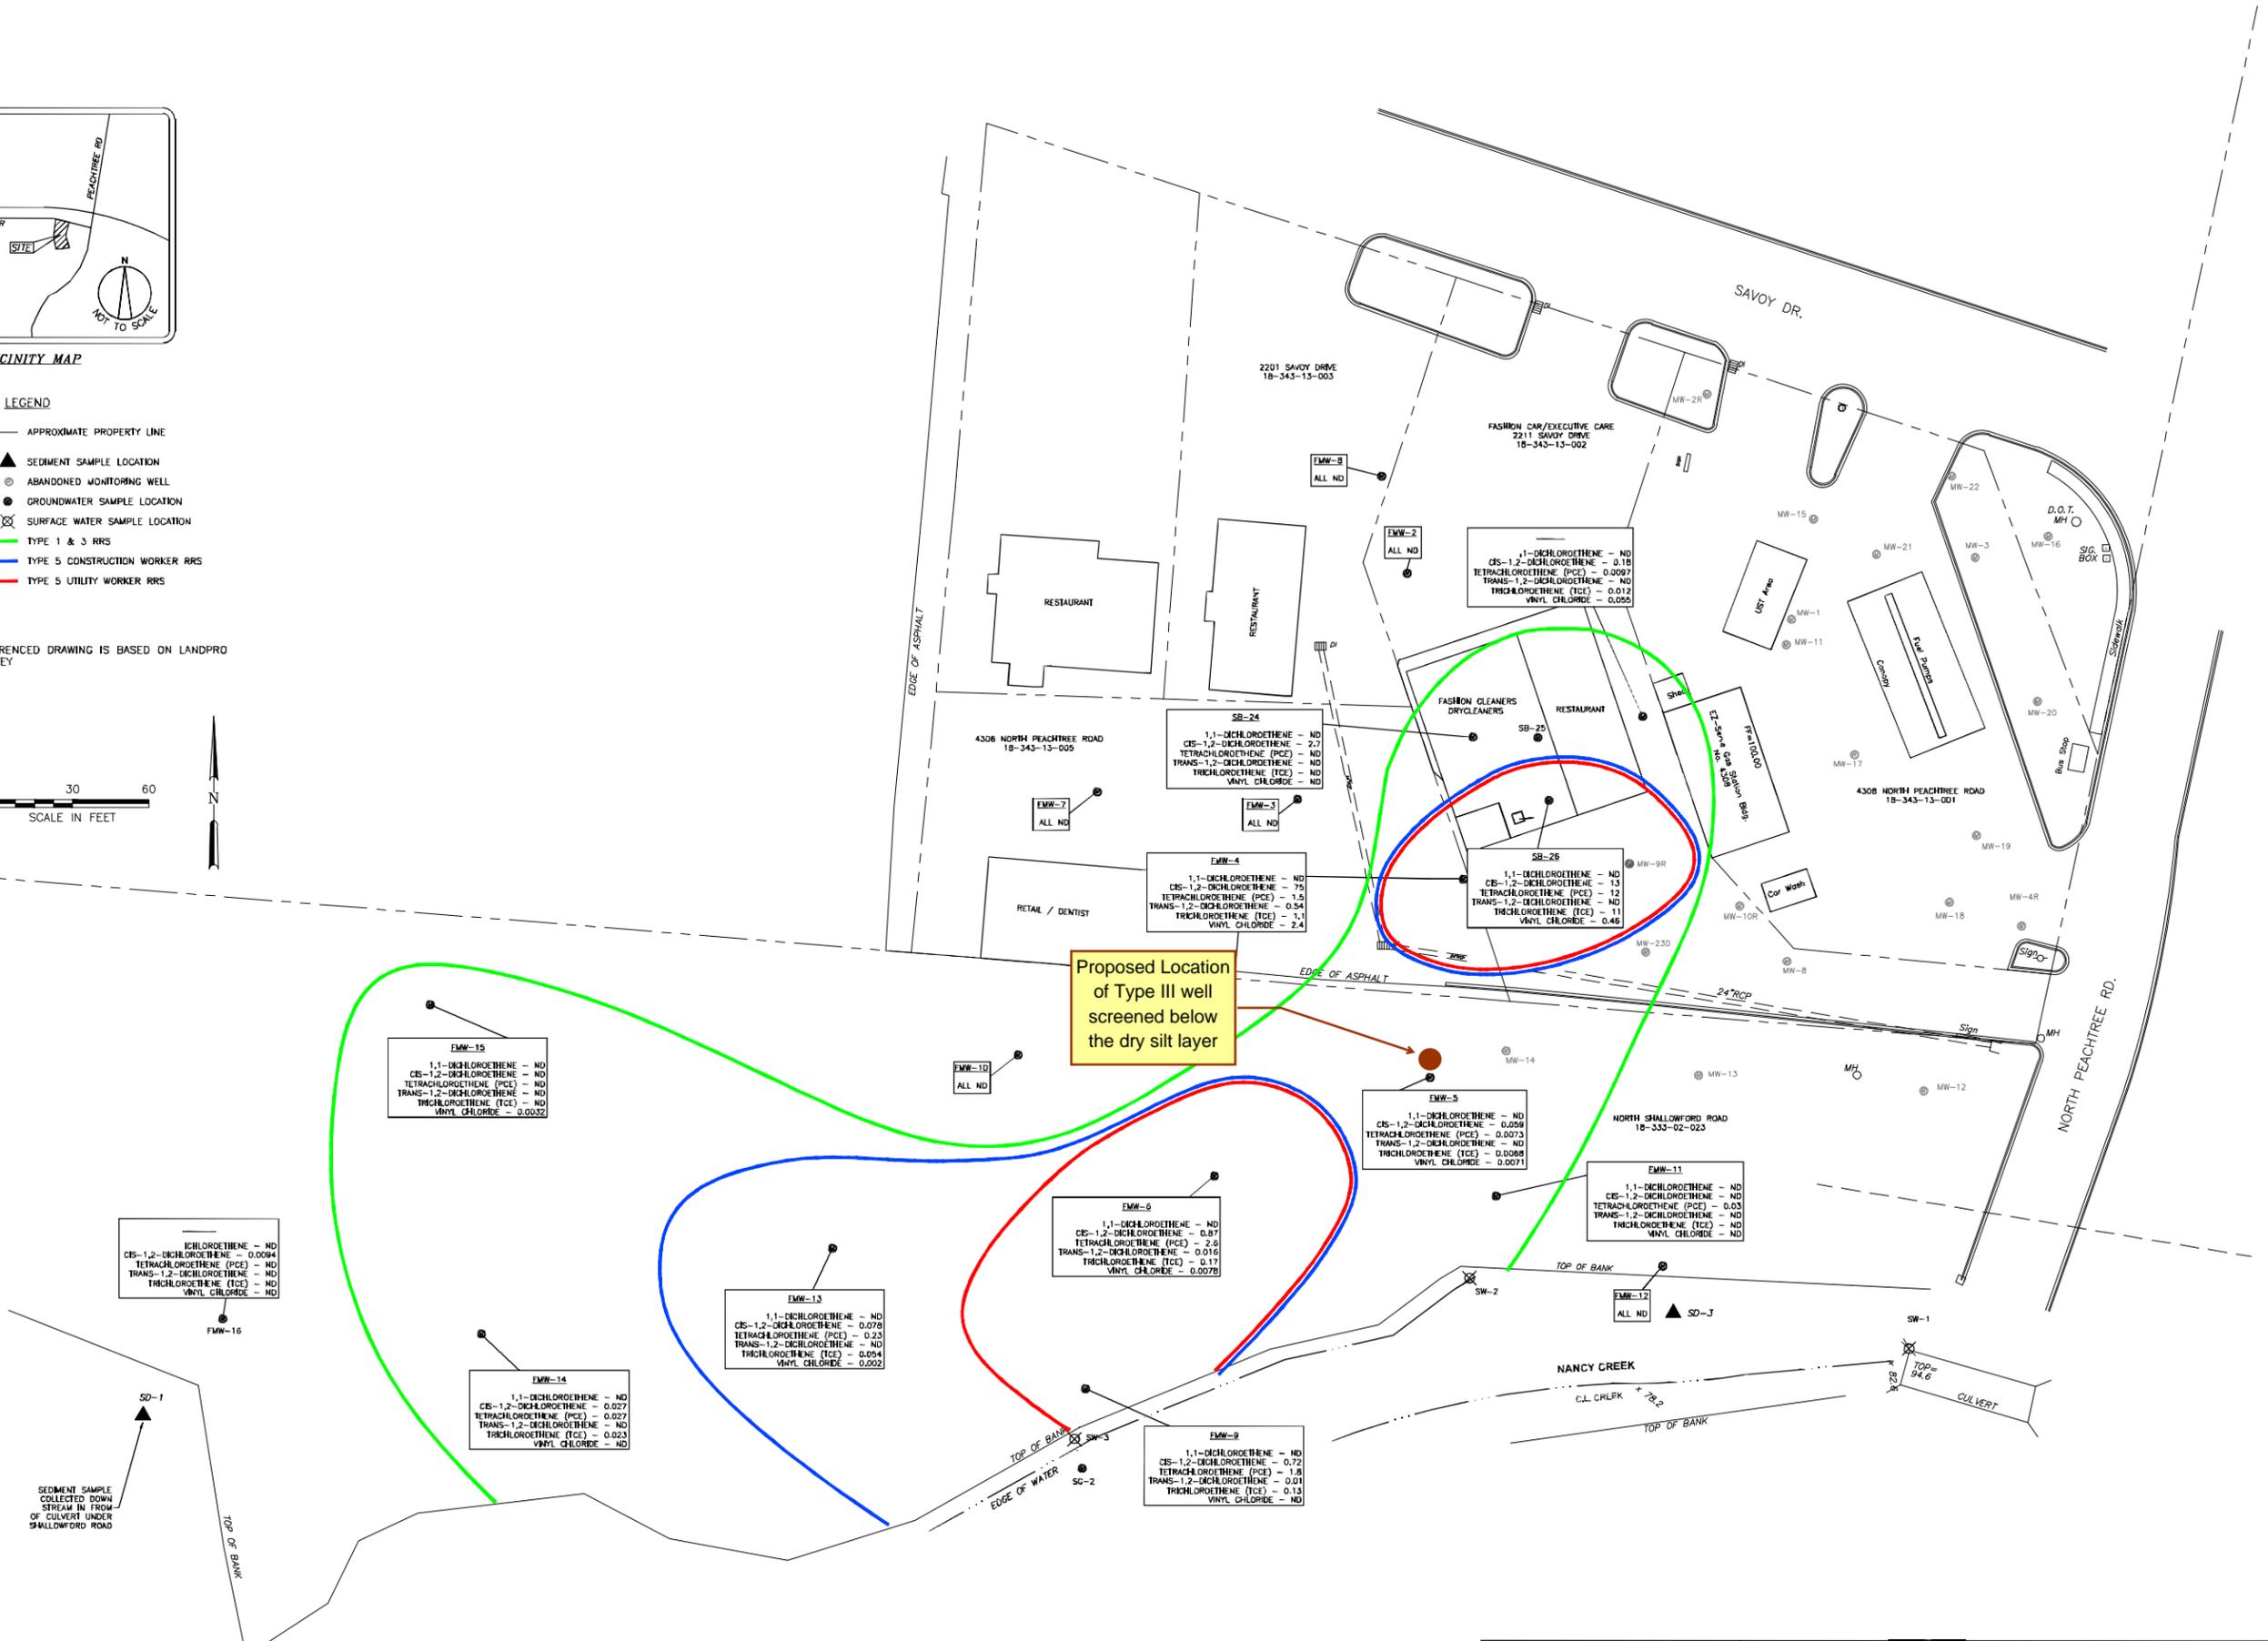
FIGURE 4
 PROPOSED DEEP WELL LOCATION
 (July 2012 Groundwater Data)
 Fashion Care Executive Care VRP Site
 2211 Savoy Drive, Chamblee, GA

Proposed Location of Type III well screened below the dry silt layer
