VOLUNTARY  
INVESTIGATION AND  
REMEDIATION PLAN

TARA SHOPPING CENTER  
8564 TARA BOULEVARD  
JONESBORO, GEORGIA  
HSI# 10798

EHS Support, Inc.

January 2012

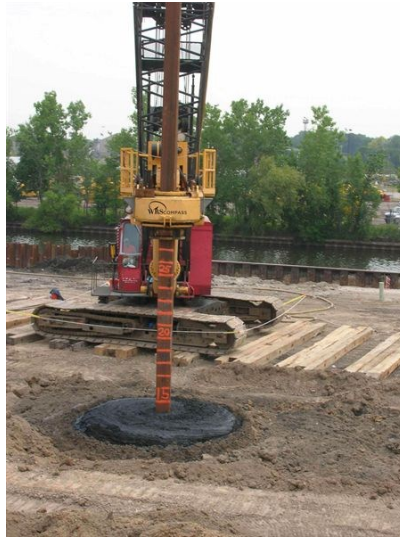
**Picture of LDA**

S/S using LDA will utilize 6-ft, 8-ft, or 10-ft diameter augers to mix soils in situ at the Site (See Picture below). This technology will solidify and stabilize unsaturated source soils to a depth of 25 ft bgs in Areas 1A and 1B and saturated source soils to a depth of approximately 35 ft bgs in Area 1 (**Figure D-17**). Unsaturated source soils within Areas 2 and 3 are likely to be a continual source of dissolution to groundwater and therefore, will also be solidified and stabilized.

Solidification and stabilization of the impacted soils would most likely be achieved using a 5% cement addition and a 1%-2% activated carbon addition. However, a treatability study would need to be performed on the soils to determine the actual type and quantity of reagents. A treatability study would involve collecting and reviewing key geotechnical and analytical data including, but not limited to, soil types, density, compressive strength, permeability, levels of contamination, odor issues, water table/perched water issues, potential subsurface obstructions, etc. After remediation is complete, the area will be restored to pre-remediation conditions.

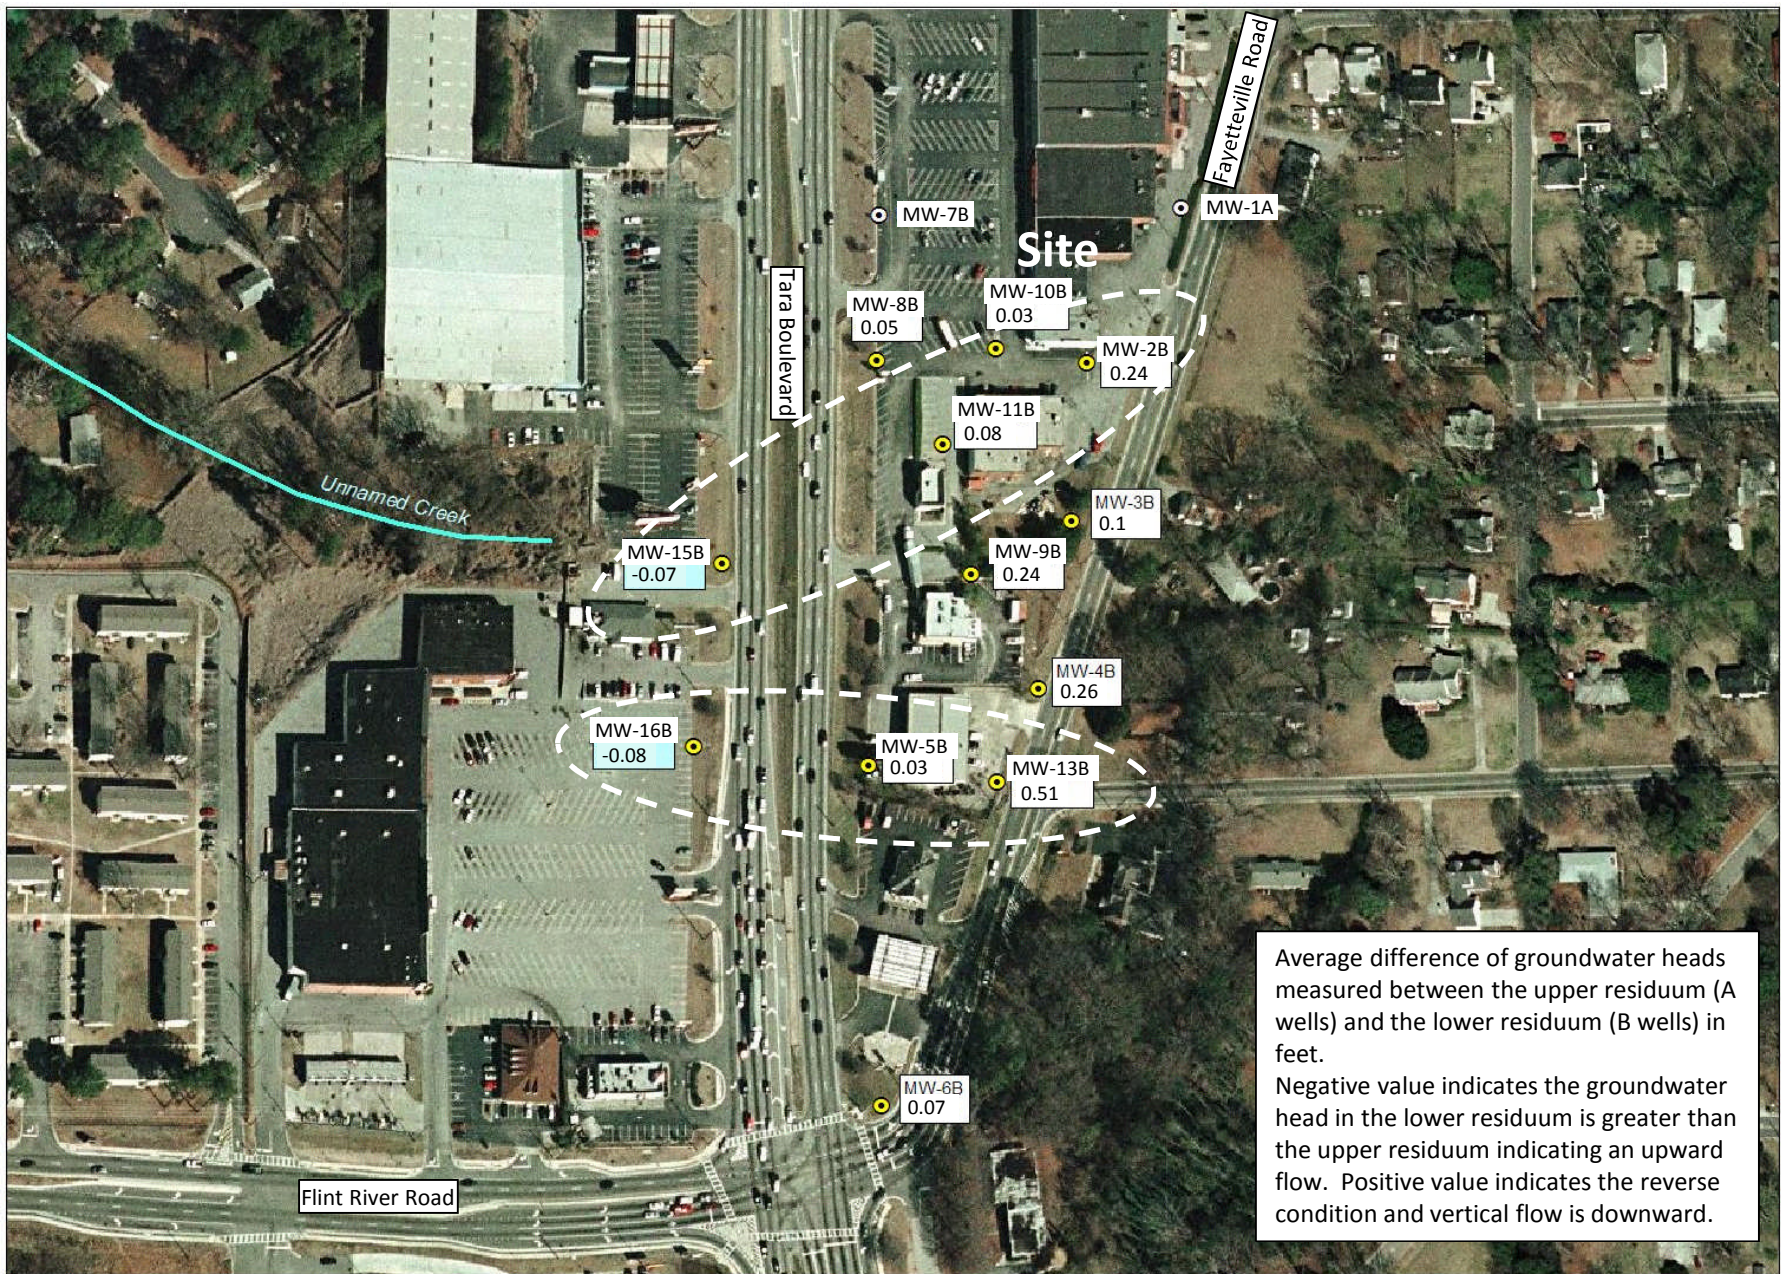
Average difference of groundwater heads measured between the upper residuum (A wells) and the lower residuum (B wells) in feet. Negative value indicates the groundwater head in the lower residuum is greater than the upper residuum indicating an upward flow. Positive value indicates the reverse condition and vertical flow is downward.

A negative value indicates the groundwater head in the lower residuum is greater than the upper residuum indicating an upward flow. A positive value indicates the reverse condition and vertical flow is downward.
