STATE OF GEORGIA
TIER 2 TMDL IMPLEMENTATION PLAN **REVISION 1**
 Little Tennessee River Watershed
 Tennessee River Basin
 April 28, 2006

Local Watershed Governments:
 Rabun County
 City of Mountain City
 City of Dillard
 City of Sky Valley

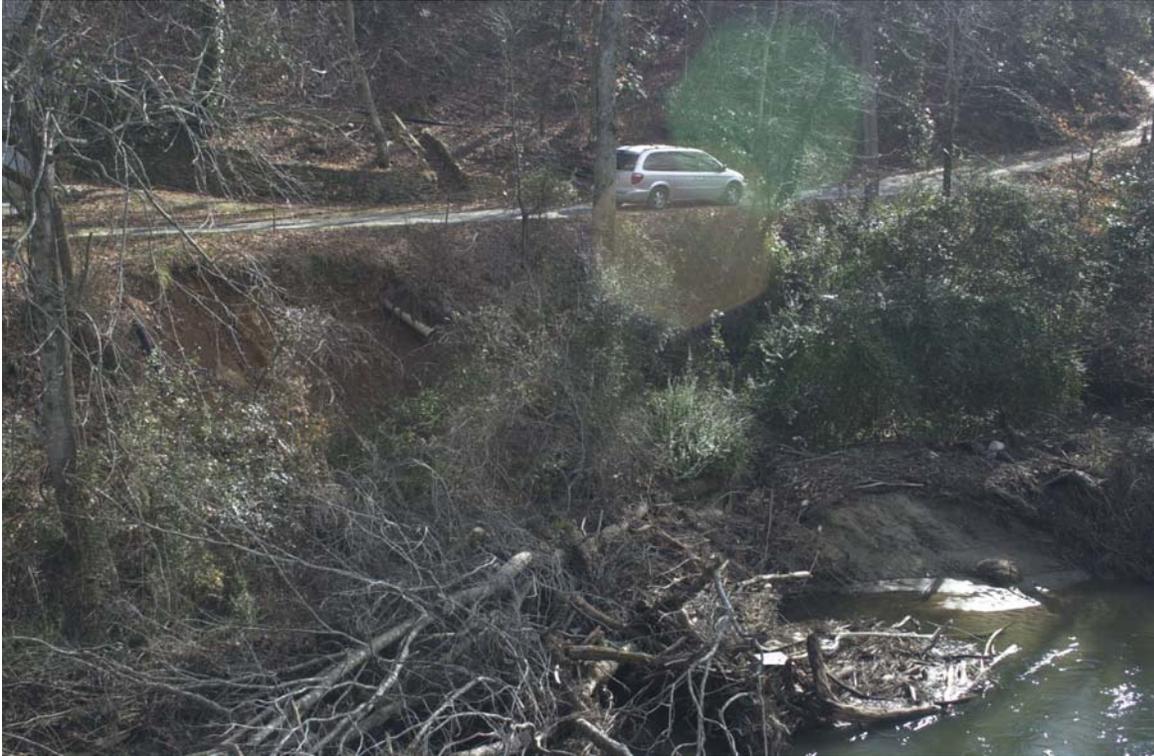
Photograph taken from bridge at SR 246 and the Little Tennessee River, facing south
Note the banks of the Little Tennessee River with channel instability, debris accumulation, and
unmaintained pipe-end in channel bank.

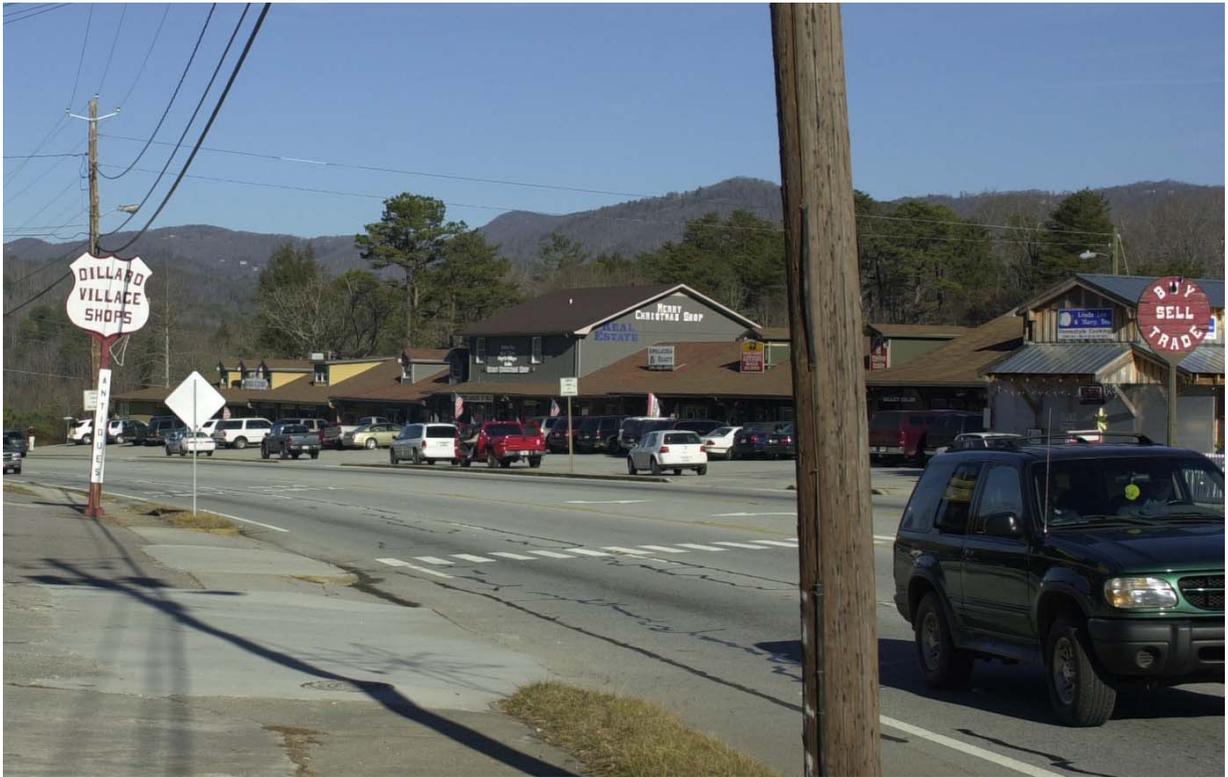
Photograph taken from downtown Dillard, facing north.
Note U.S 441 and moderate commercial development.

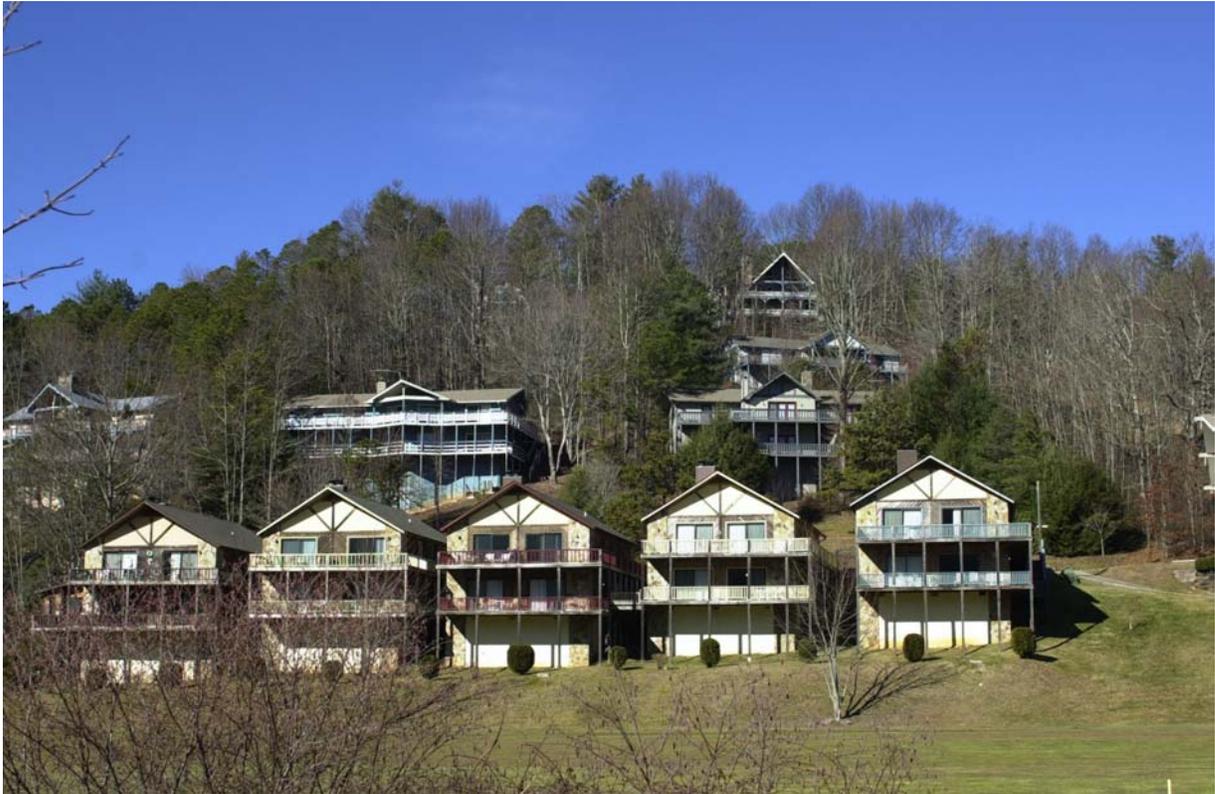
Mud Creek Watershed
Photograph taken from golf course in Sky Valley, facing west
Note moderate to high density residential development on moderate to steep slopes.

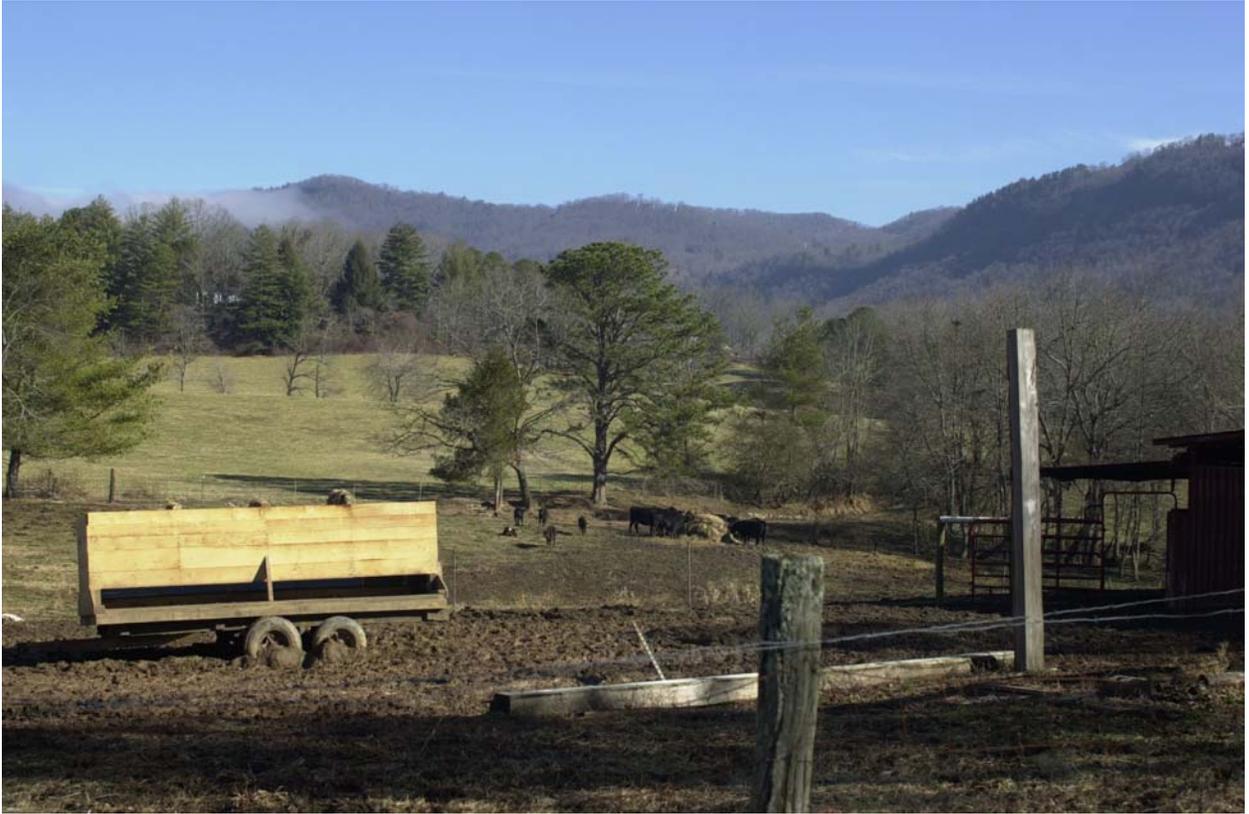
Kelly Creek Watershed
Photograph taken from Enloe Rd., facing east
Note cattle grazing activity and placement of hay bale away from waterbodies

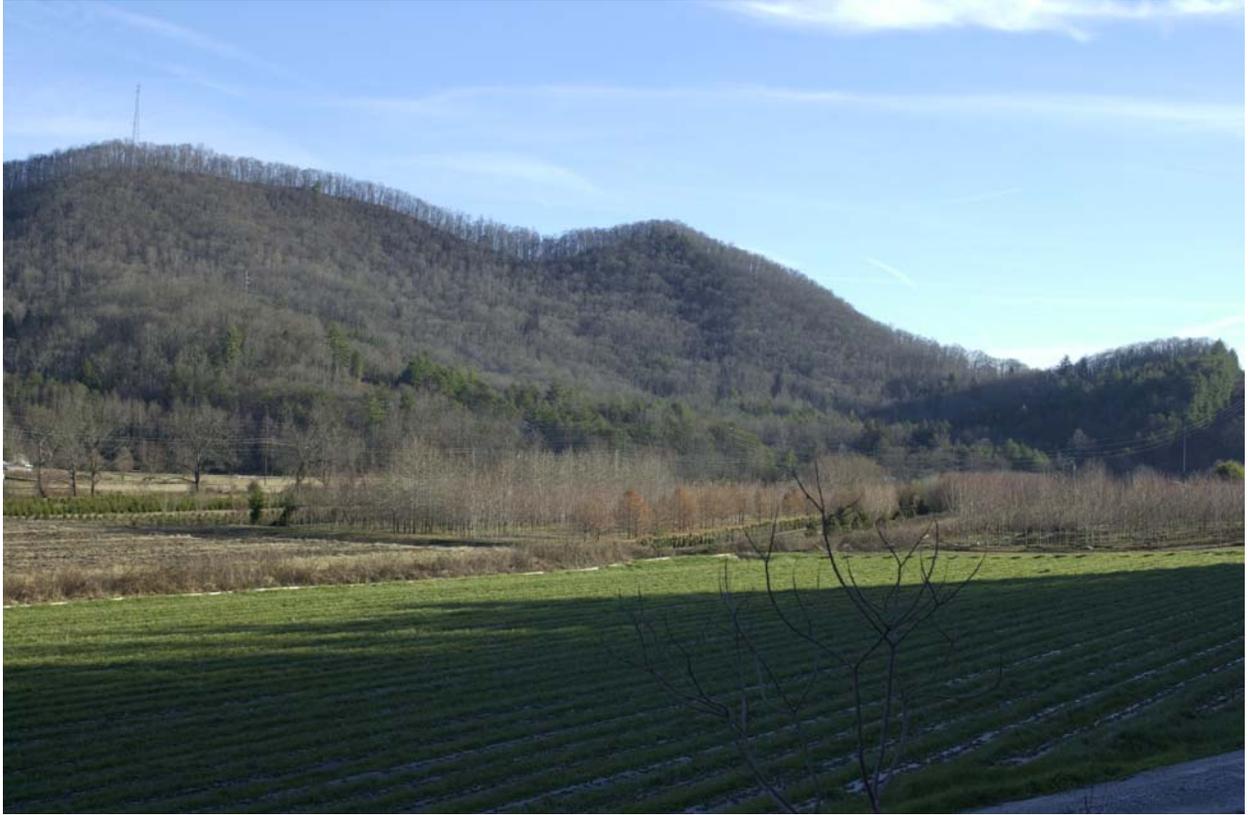
Blacks Creek Watershed
Photograph taken from U.S 441 at Darnell Farms, facing southeast
Note intensive agricultural row cropping

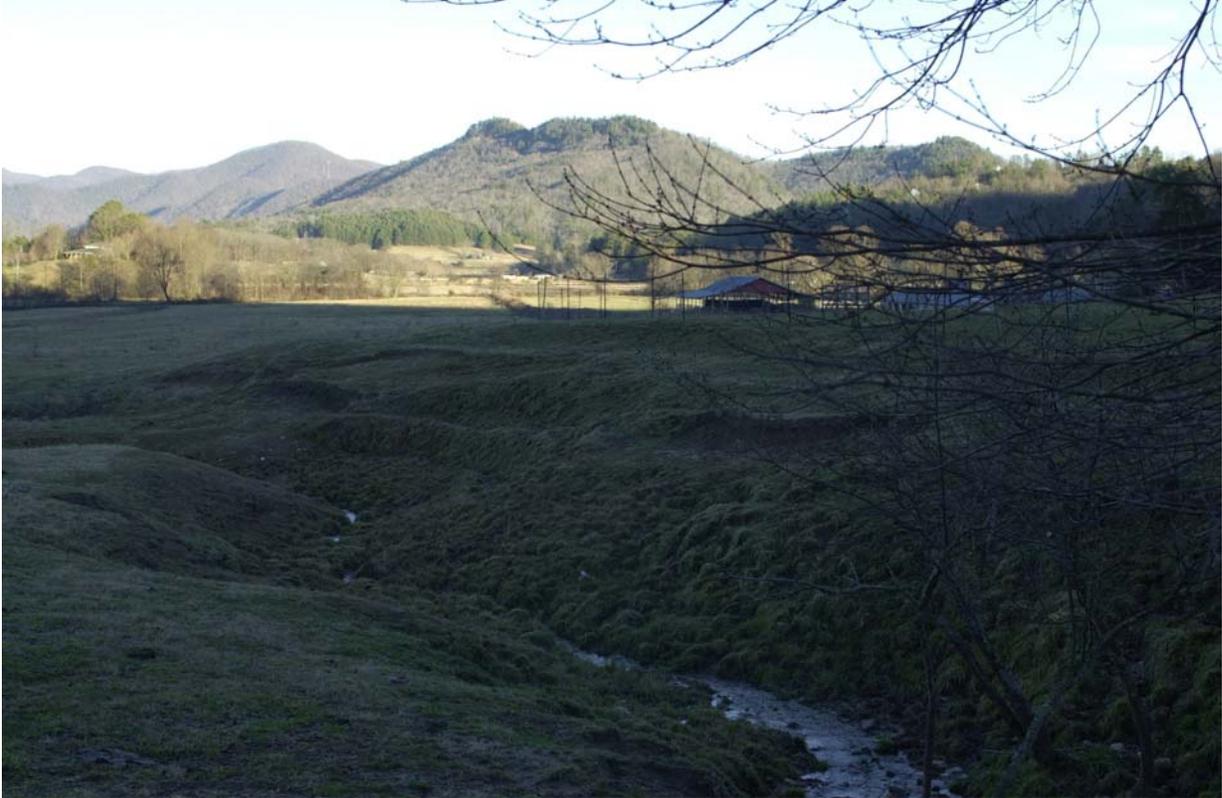
Photograph taken from Wolf Fork Road at Billy Creek, facing east
Note cattle paths adjacent to and crossing Keener Creek

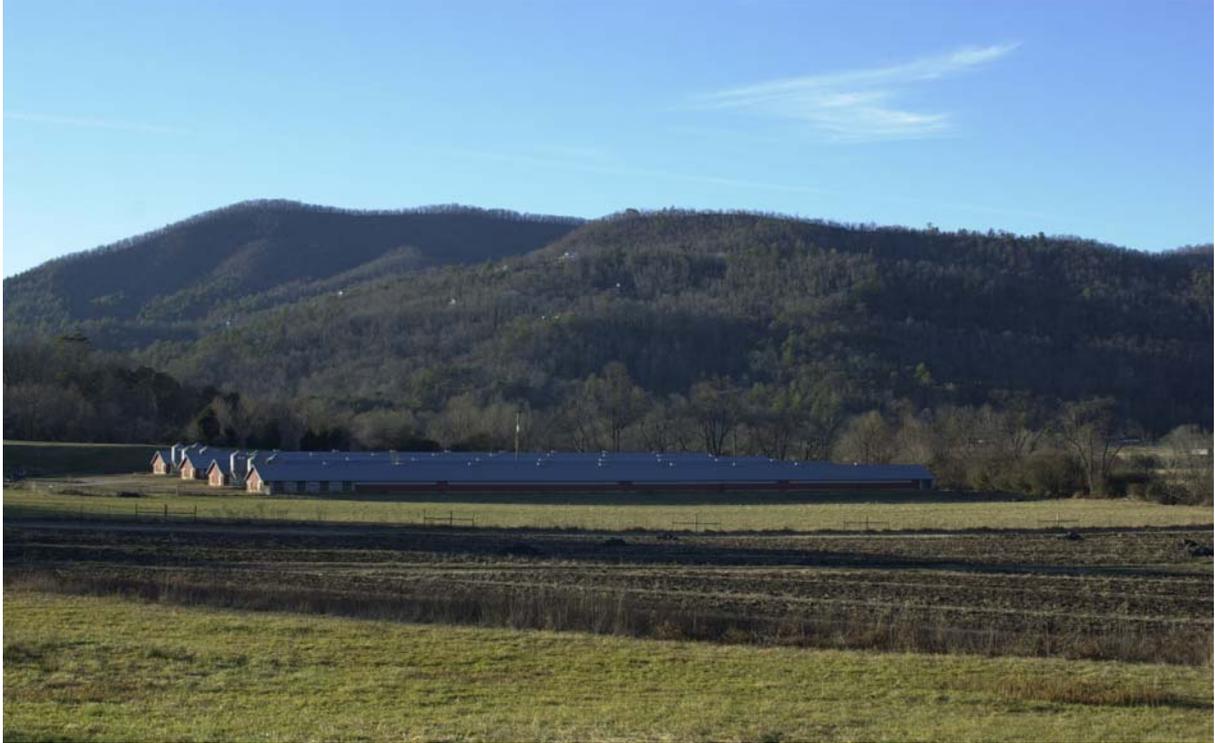
Photograph taken from West Fork Road, near Billy Creek, facing north
Note poultry houses and agricultural lands in close proximity. Indicates the possibility of chicken waste spreading on agricultural fields.

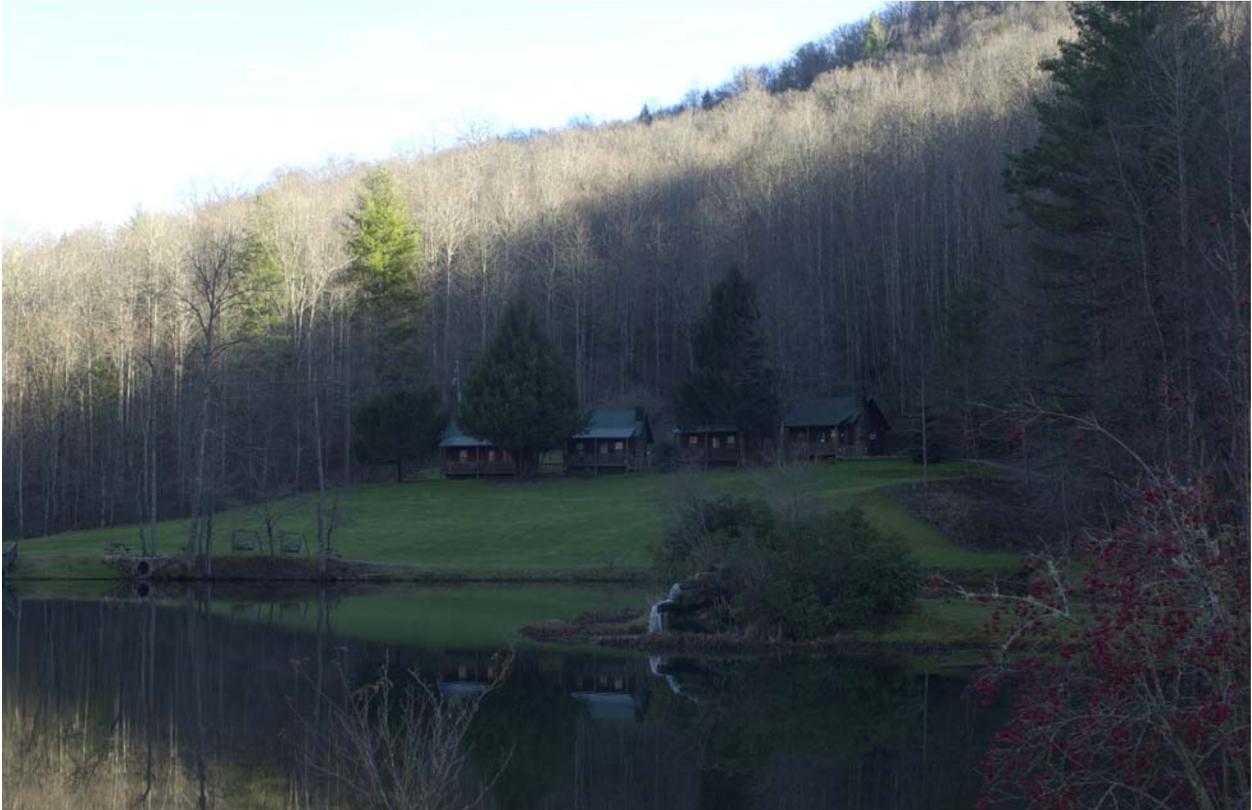
Betty Creek Watershed
Photograph taken of Patterson Gap Creek from Patterson Gap Road, facing east
Rental cabins

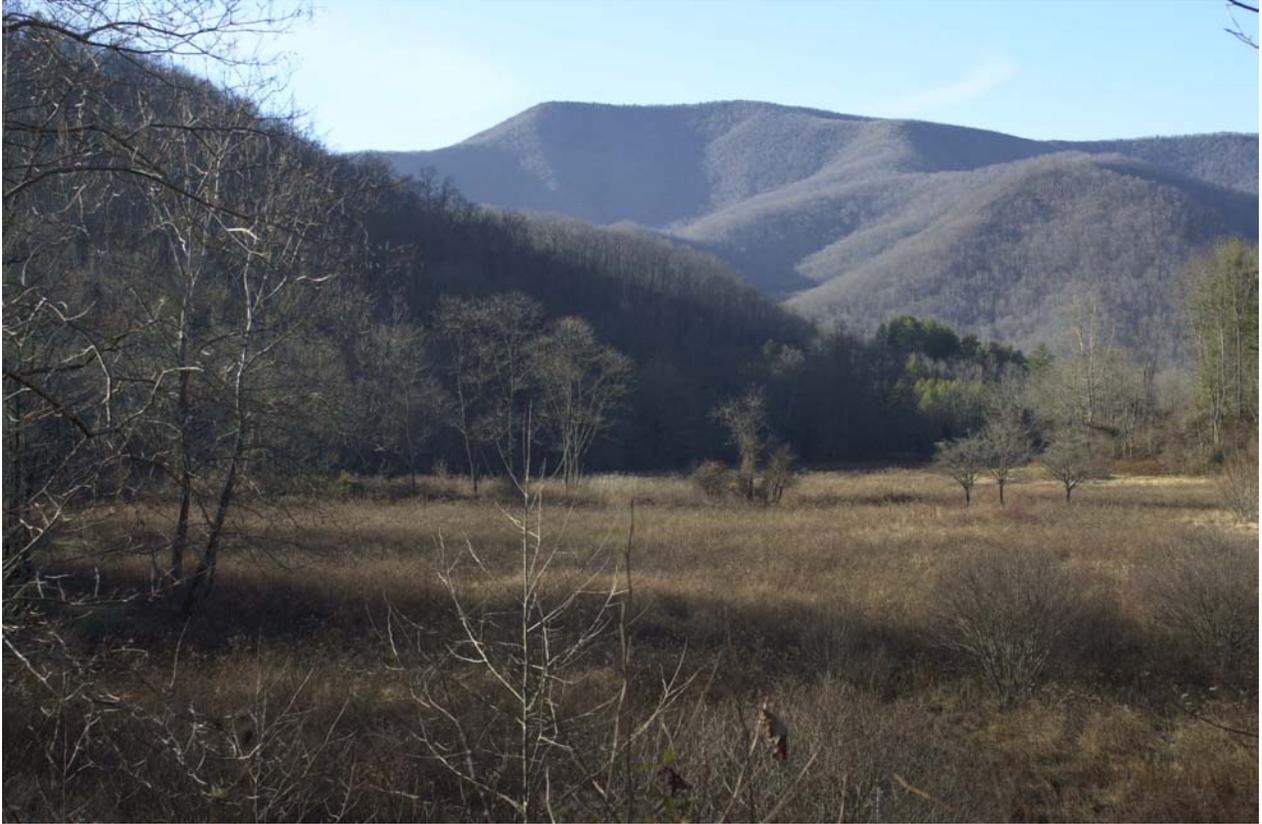
Betty Creek Watershed
Photograph taken from Betty Creek Rd. near Hambidge Center
Excellent habitat and riparian area (Betty Creek located near left edge of image).

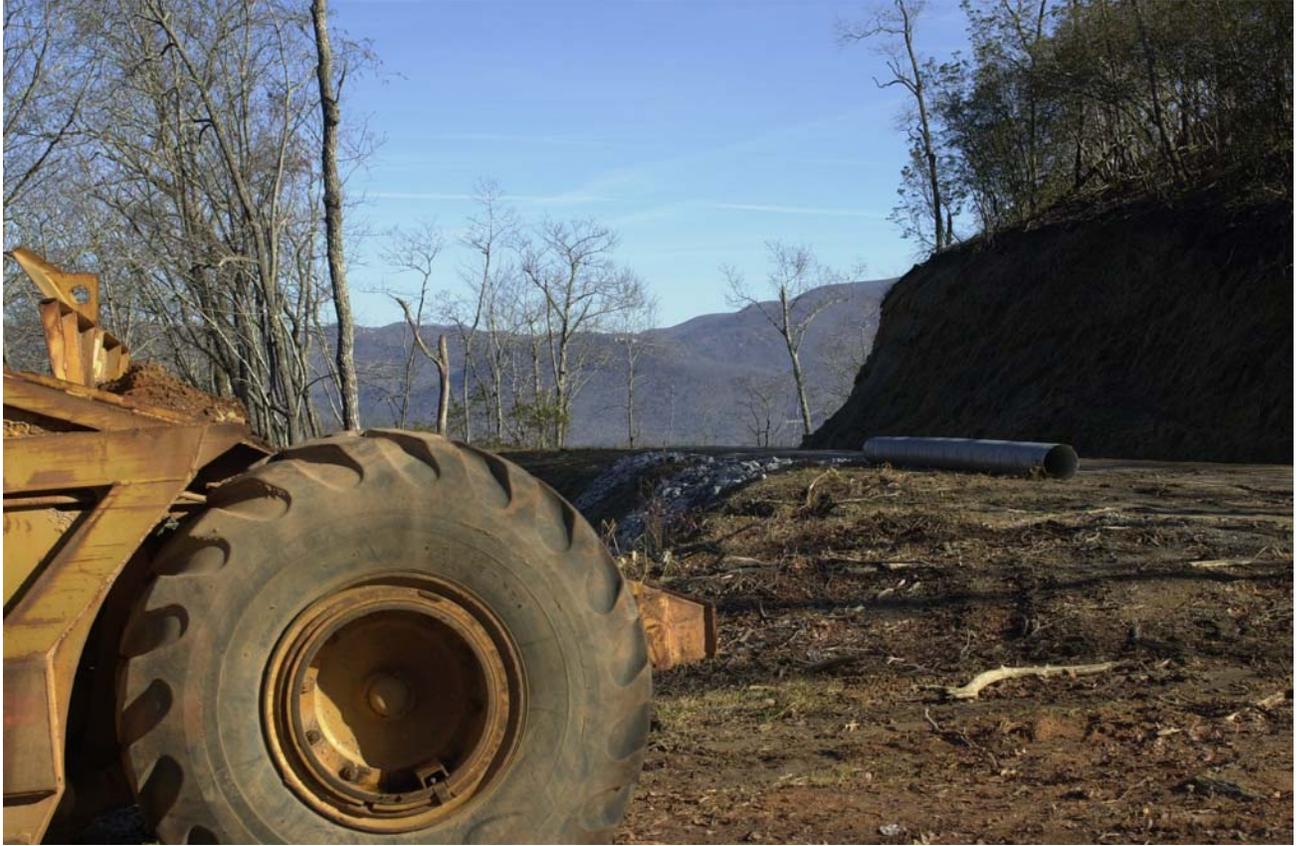
Lamb Creek Watershed
Photograph taken from unnamed road in Lamb Creek watershed.
Ongoing residential development
