STATE OF GEORGIA
TIER 2 TMDL IMPLEMENTATION PLAN **REVISION 01**
 Bearmeat Creek Watershed
 Tennessee River Basin
 April 28, 2006

Local Watershed Governments:
 Towns County
 City of Hiwassee

Bearmeat Creek TMDL Stream Segment

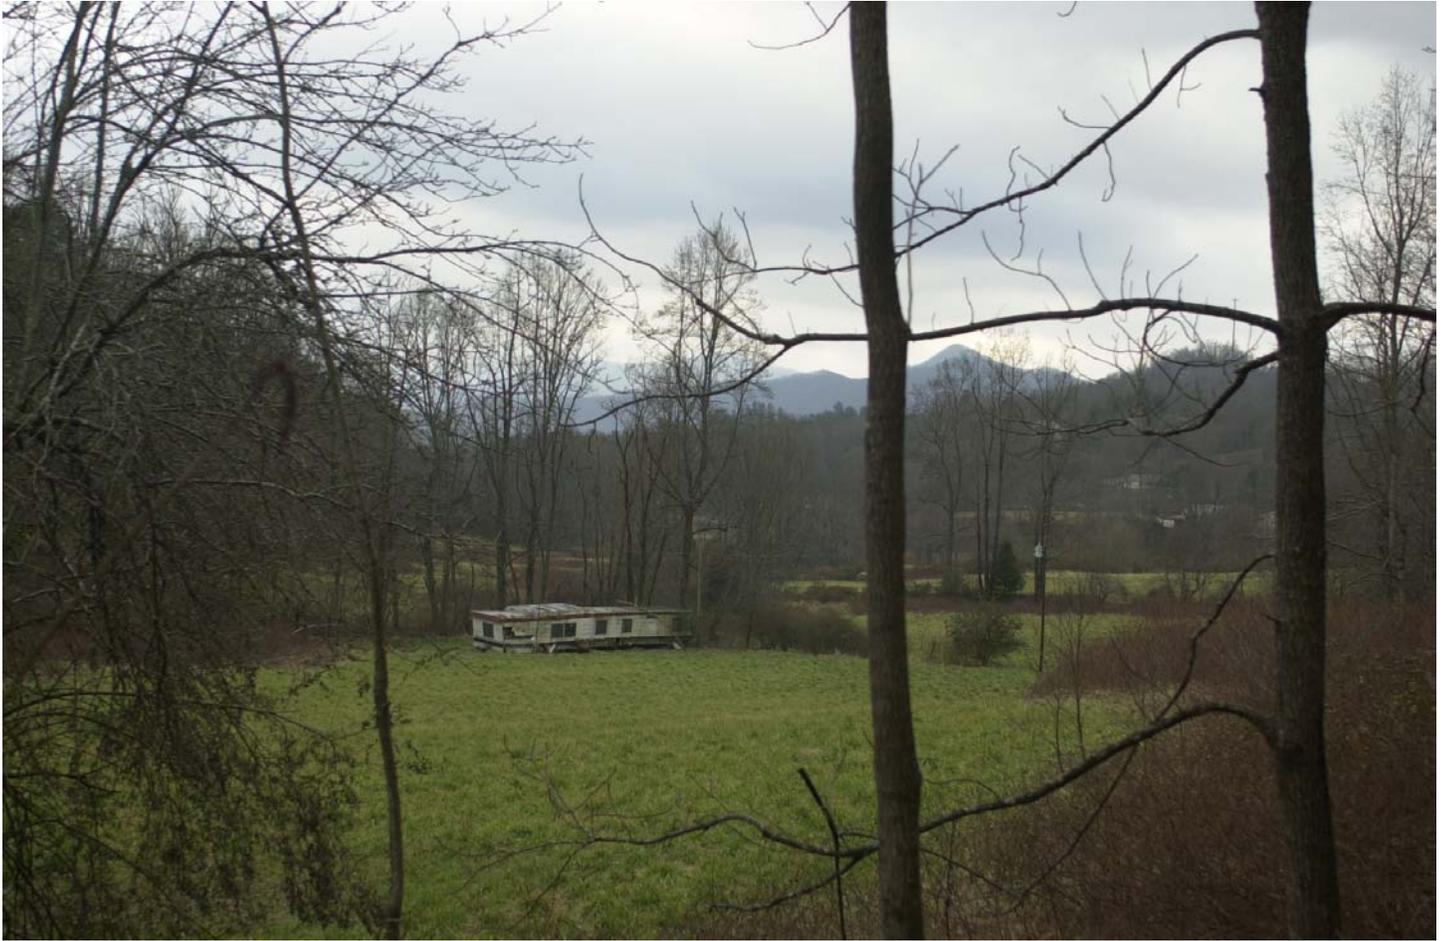
Photograph taken from end of Bearmeat Rd., facing east.
Bearmeat Creek runs from left to right along tree line slightly behind abandoned manufactured home.
Note passive agricultural lands, fenced access to stream, and small riparian buffer.

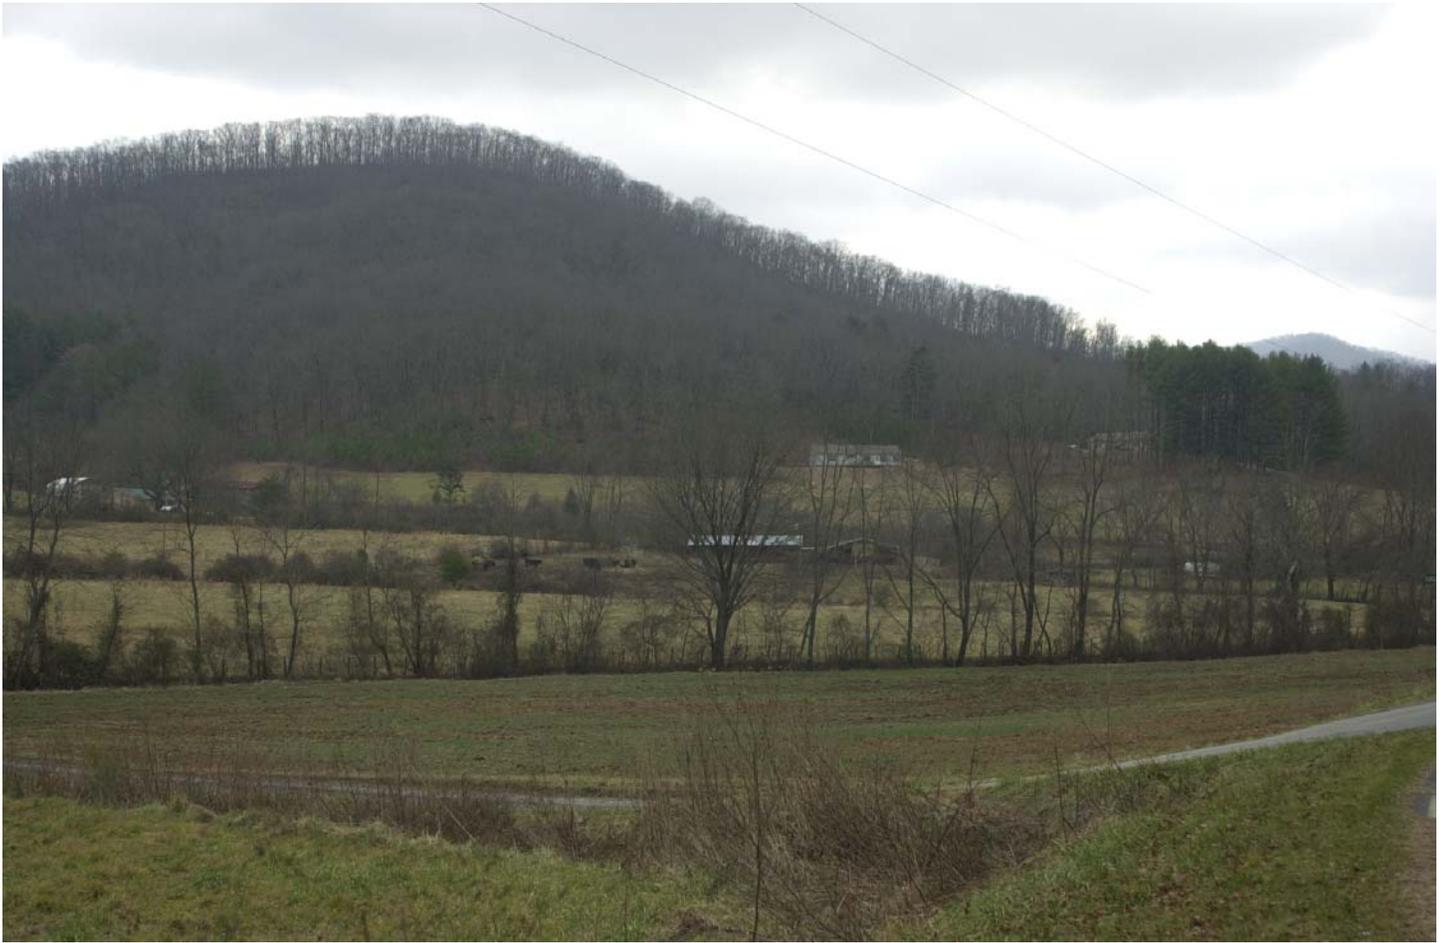
Photograph taken near intersection of Bearmeat Rd. and Bearmeat Spur, facing east.
Note row cropping in foreground, hay/pasture lands in near background and lands managed by the Forest Service in far background.

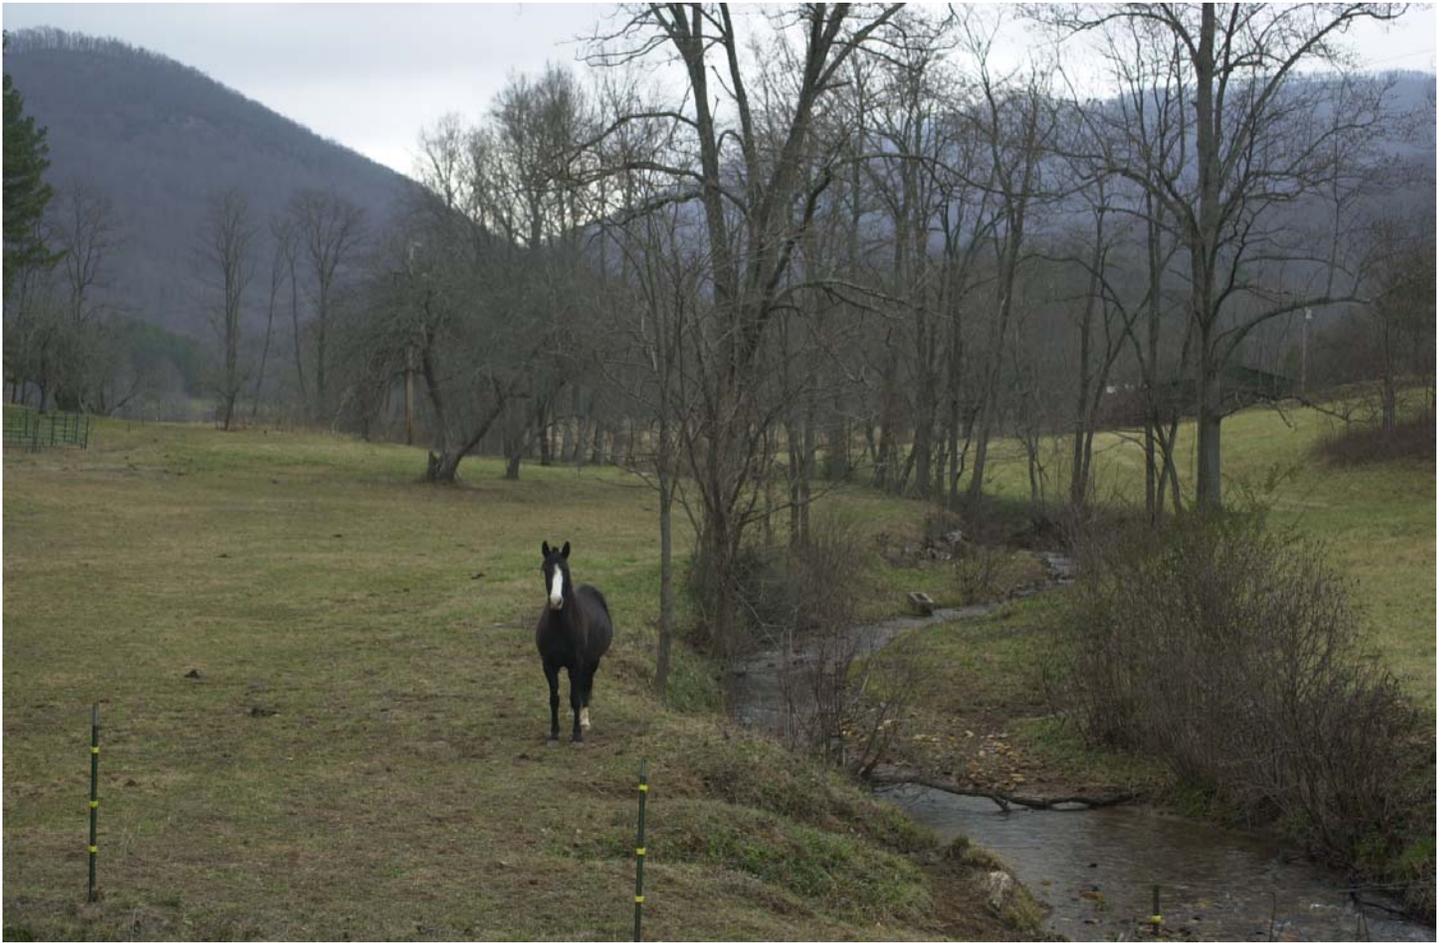
Photograph taken from crossing of Bearmeat Rd. and Bearmeat Creek, facing north.
Note light horse activity, unlimited access to Bearmeat Creek, and limited riparian area along stream.

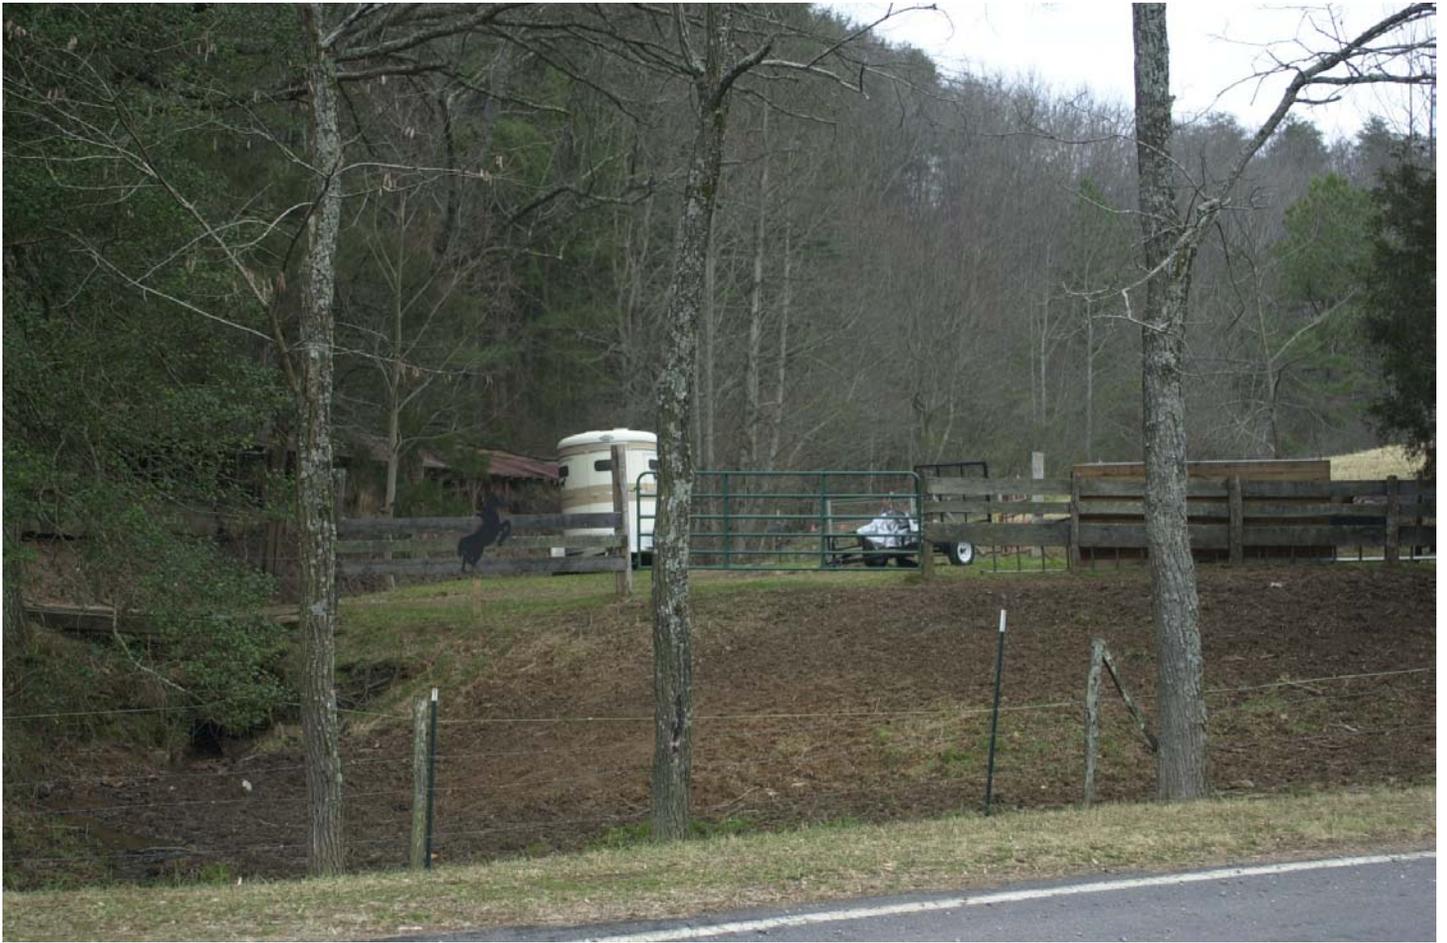
Photograph taken from Bearmeat Rd. near crossing with Bearmeat Creek, facing west.
Note land disturbance from horse stables and intermittent stream located in left frame of image.

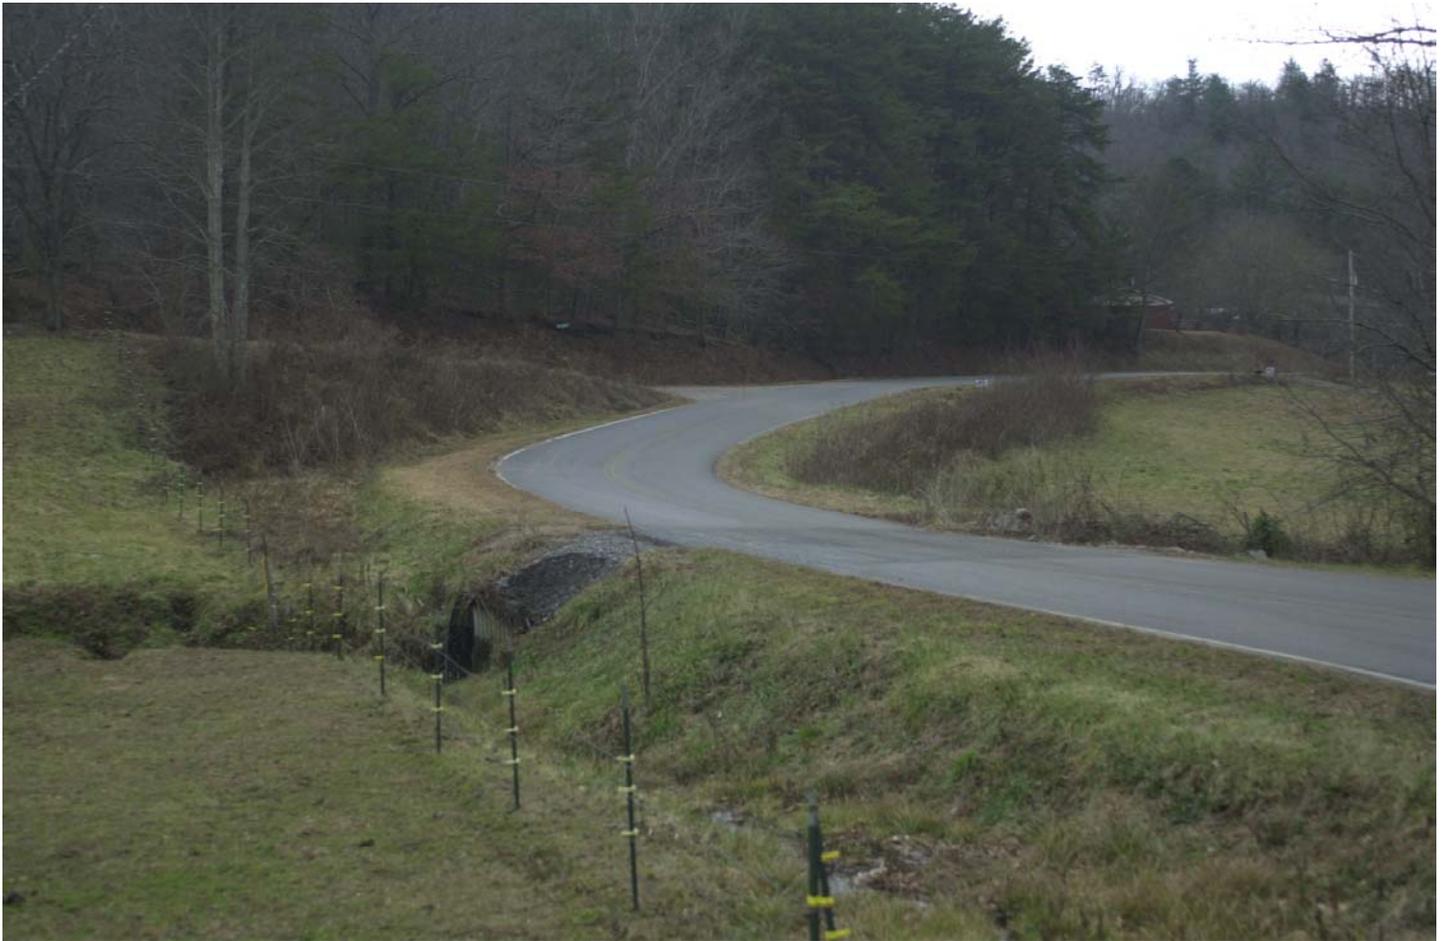
Photograph taken near crossing of Bearmeat Rd. and Bearmeat Creek.
Note recent maintenance work on culvert and paved road surface as well as additional erosion of gravel above culvert.

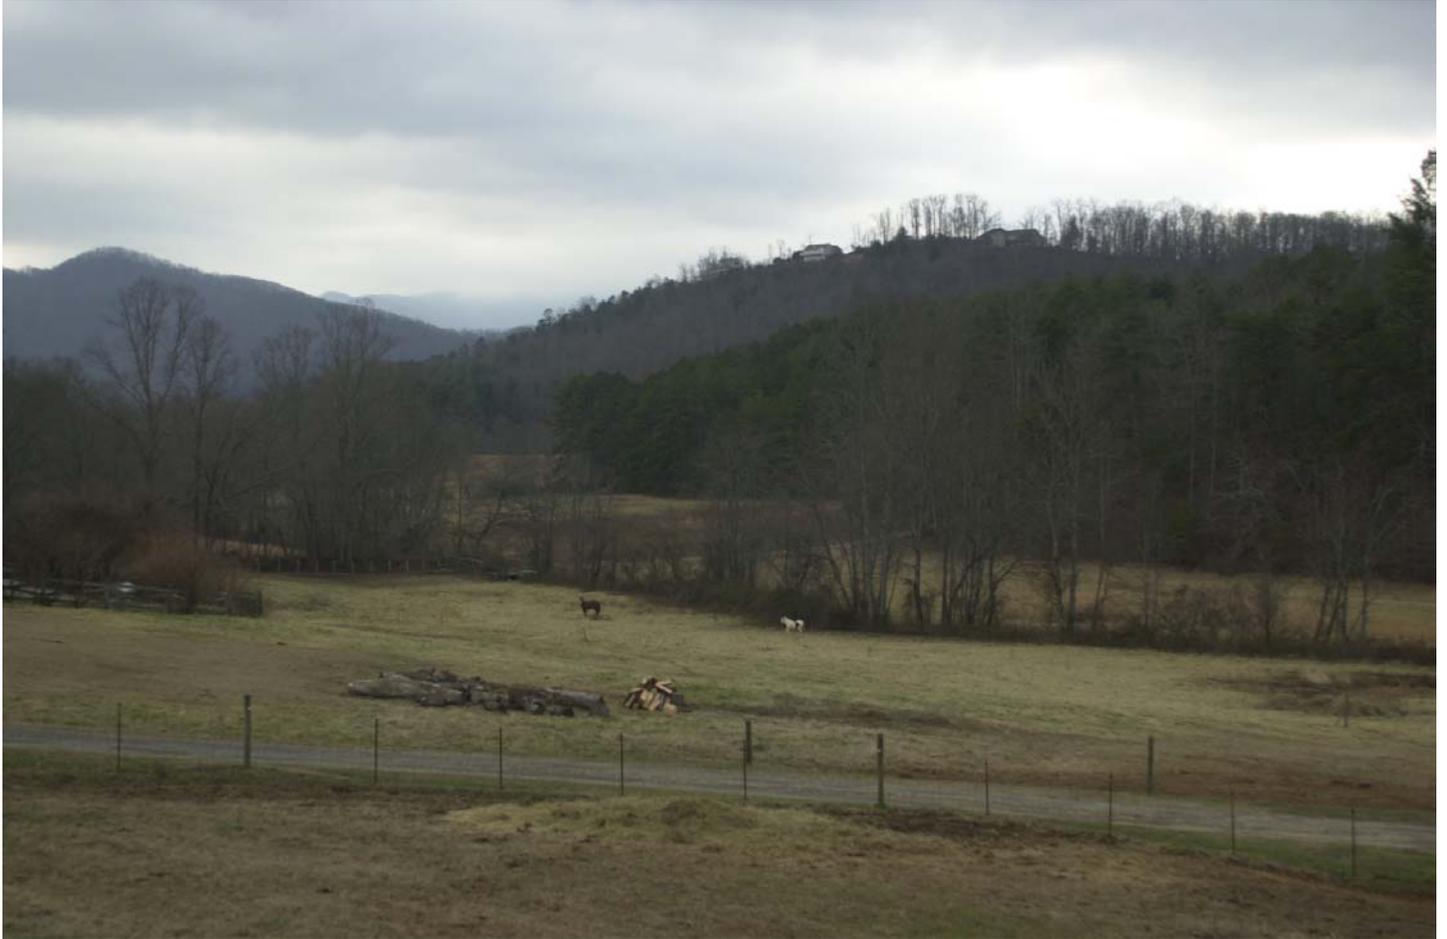
Photograph taken near Bearmeat Rd. and Ira Coleman Rd, facing south.
Note low intensity agricultural lands in Bearmeat Creek valley with residential development on ridgeline in background.

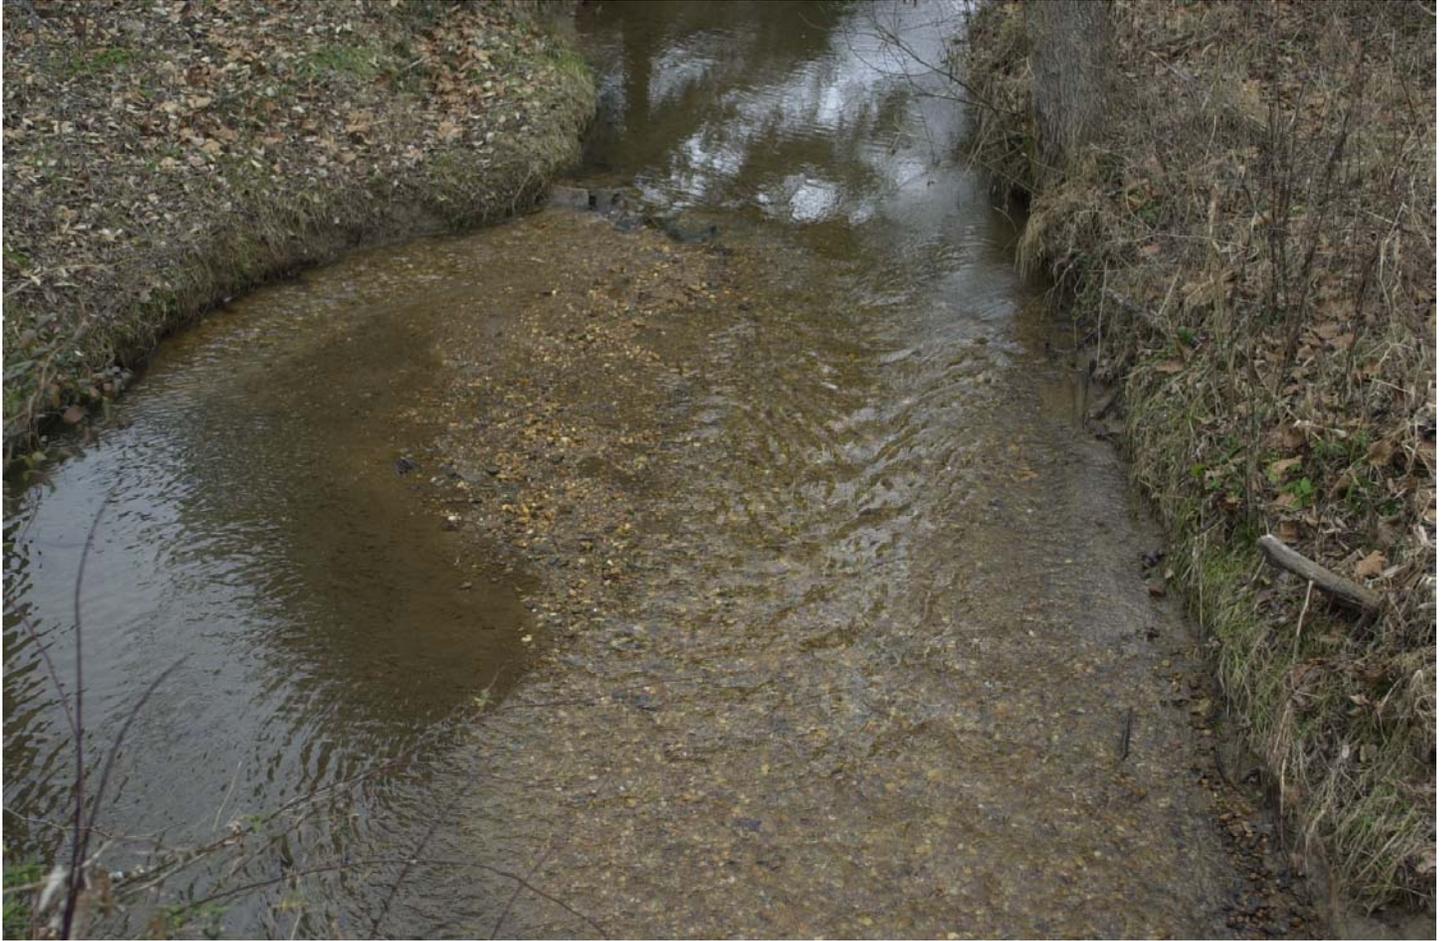
Photograph taken from Bearmeat Village Rd. at crossing of Bearmeat Creek,
facing down (stream flow from top to bottom).
Note moderate sediment deposition within stream channel

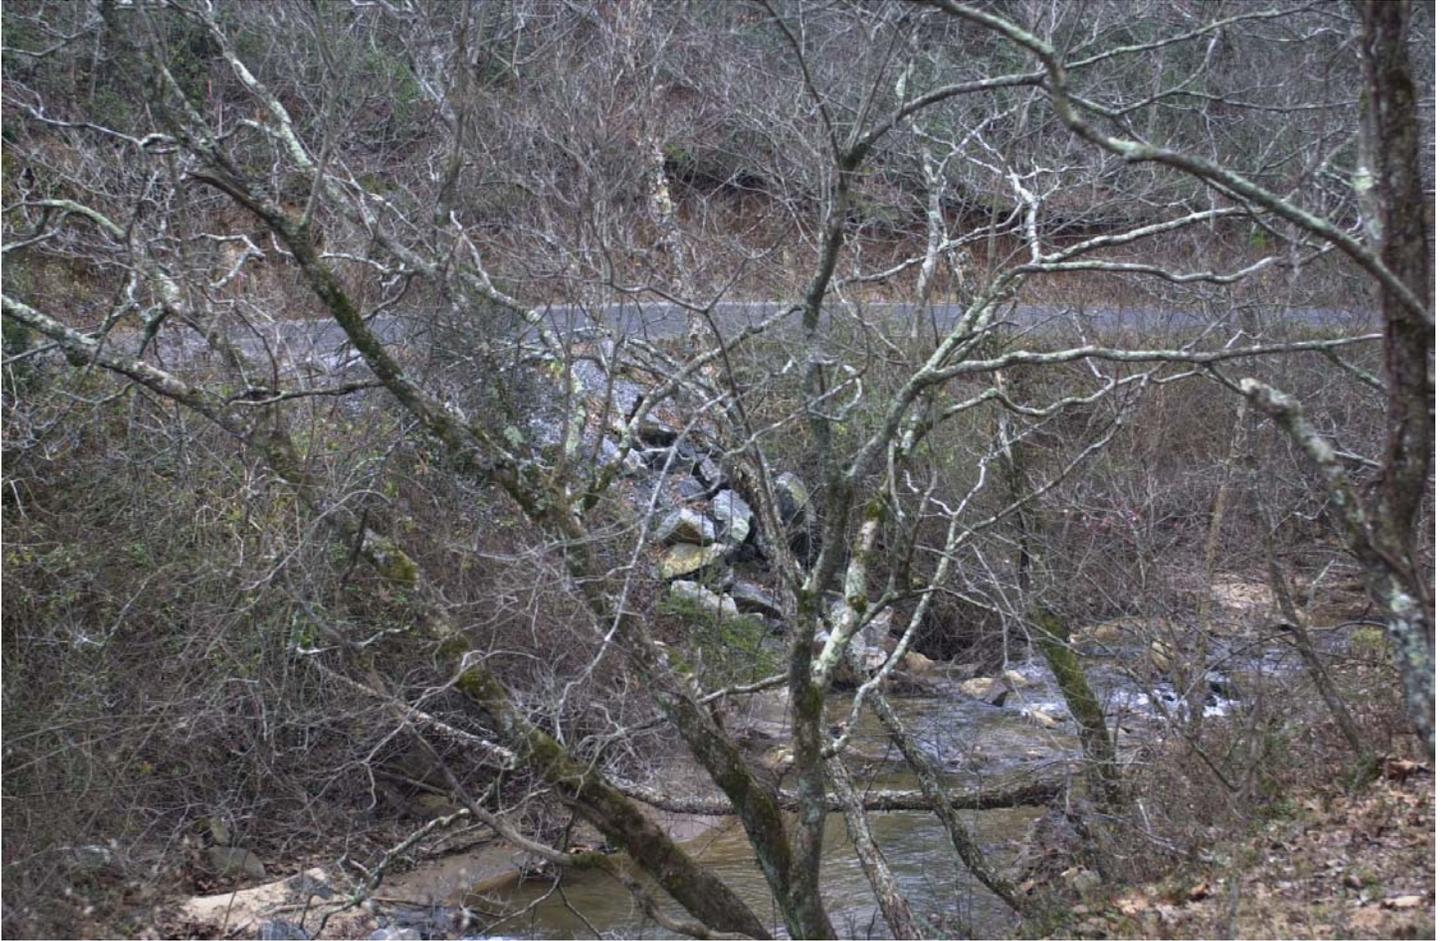
Photograph taken at crossing of Bearmeat Village Rd. and Bearmeat Creek, facing south.
Note extensive erosion and rip-rap along stream bank
