STATE OF GEORGIA
TIER 2 TMDL IMPLEMENTATION PLAN REVISION 01
Nottely River and Youngcane Creek Watershed
Tennessee River Basin
April 28, 2006

Local Watershed Governments:
Union County
City of Blairsville

I. INTRODUCTION

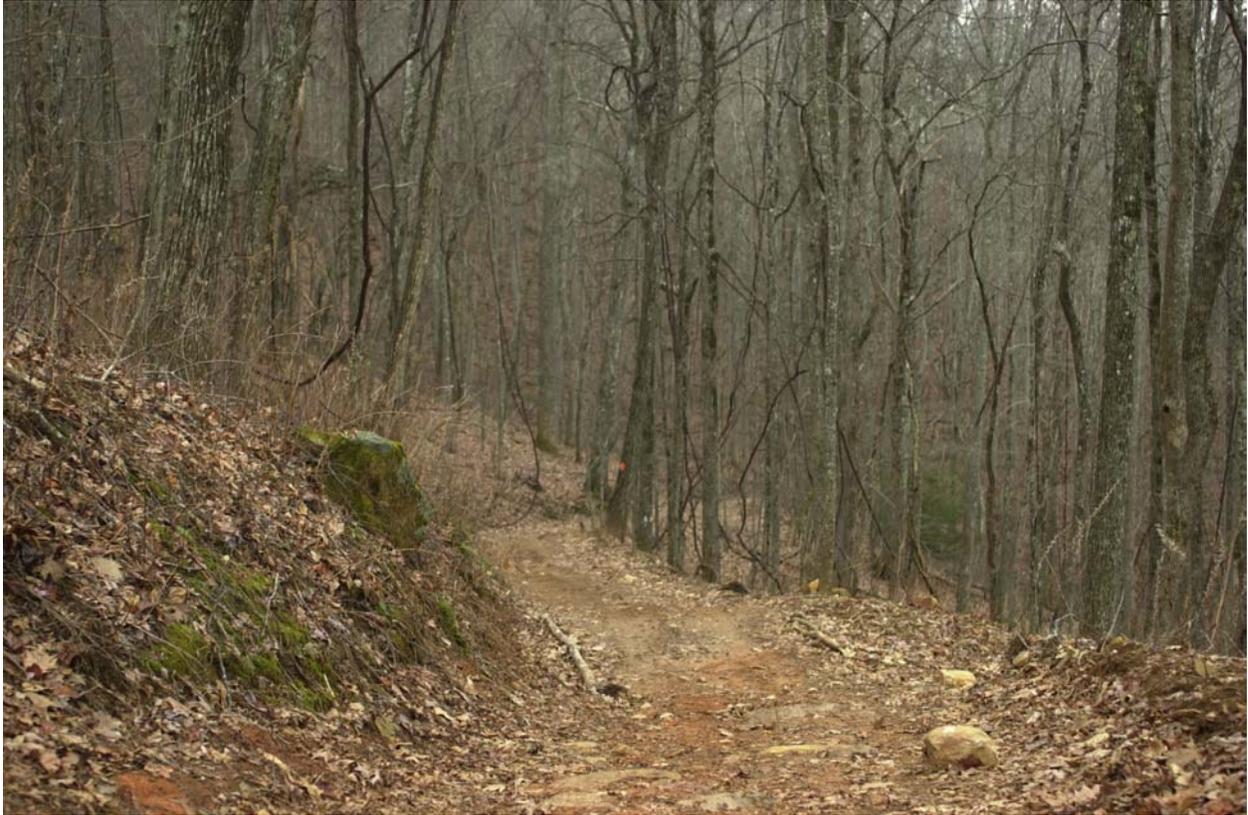
Picture taken at Beasley Knob OHV Area, facing south
Note well maintained trail with erosion breaks.

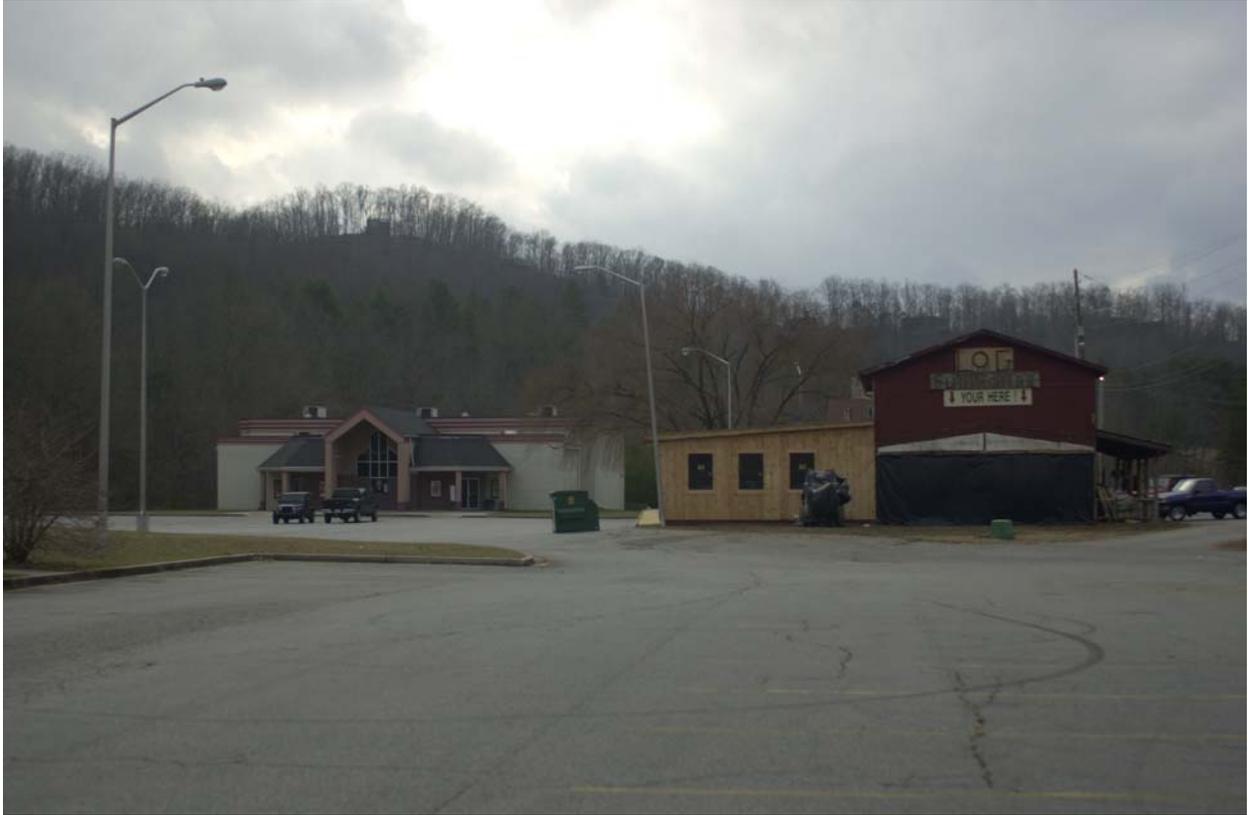
Photograph taken from shopping center on SR 515, facing south
Note expansive impervious cover.

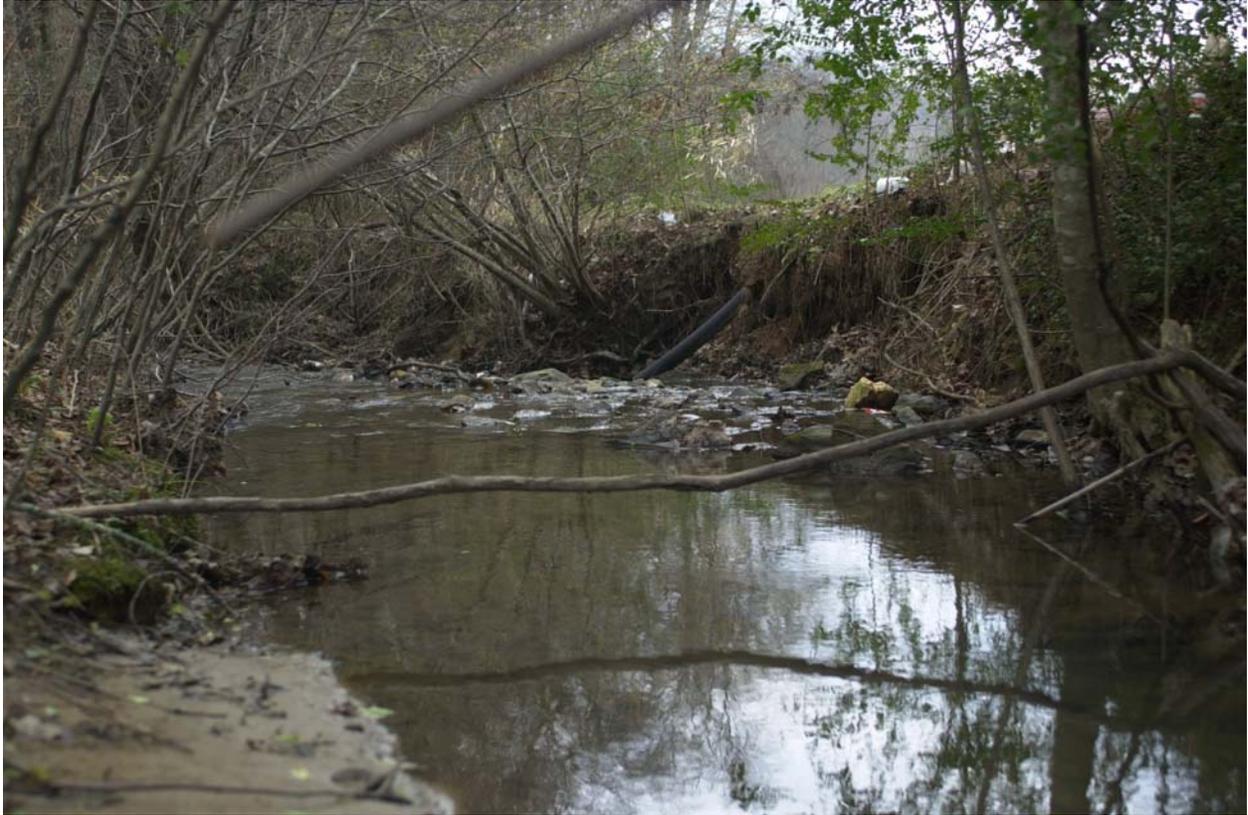
Photograph taken near Bowling Alley on SR 515, facing south
Note channel incision with unstable banks.

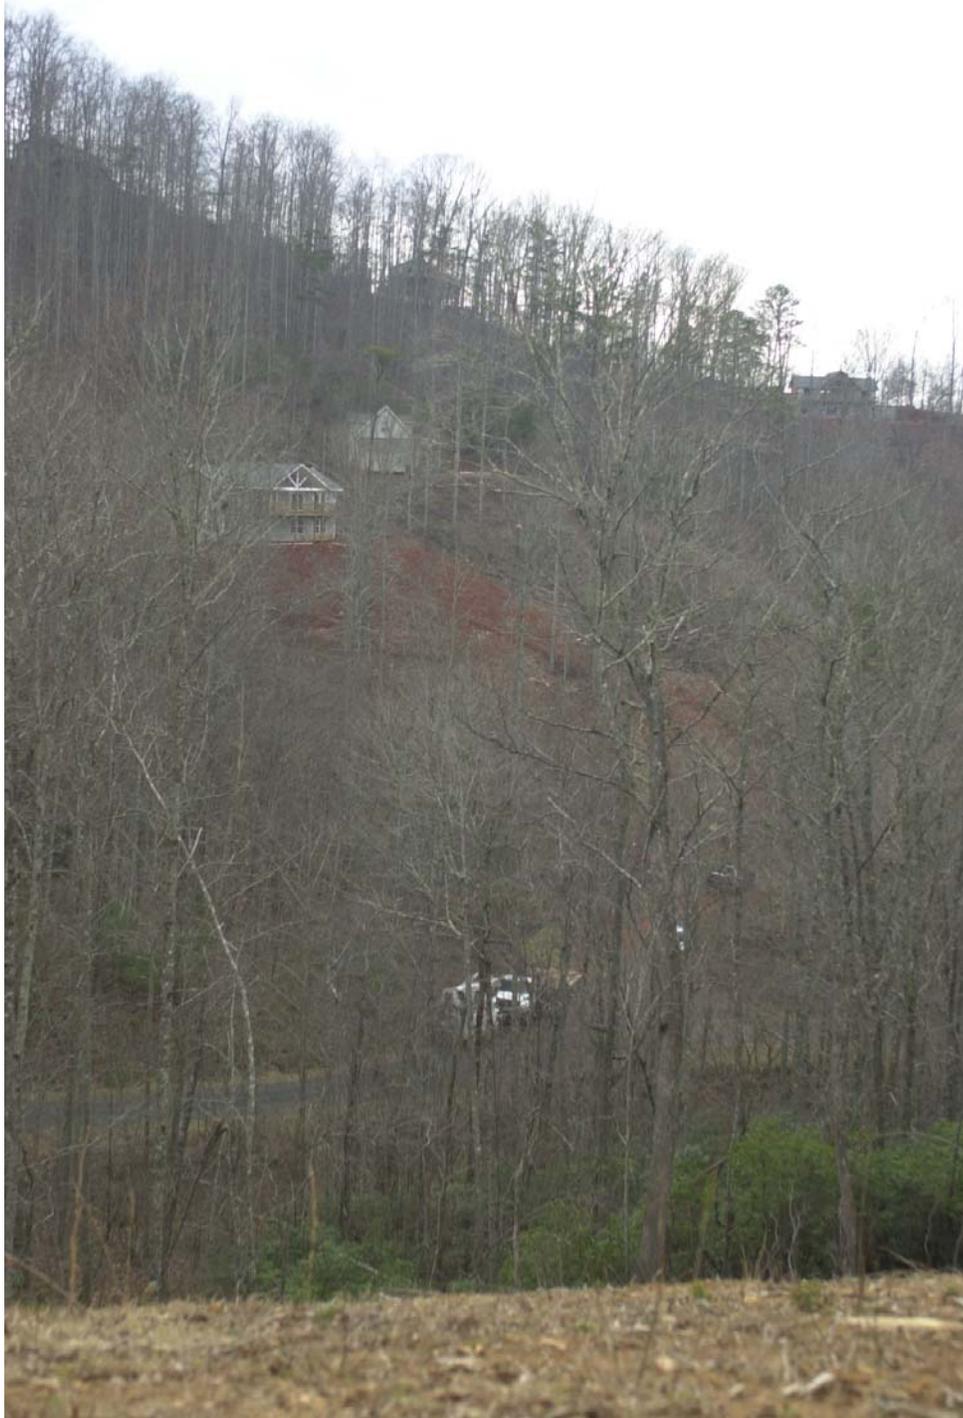
Photograph taken from Old Zebulon Gap Rd., facing south
Note development on steep slopes and ridgelines.

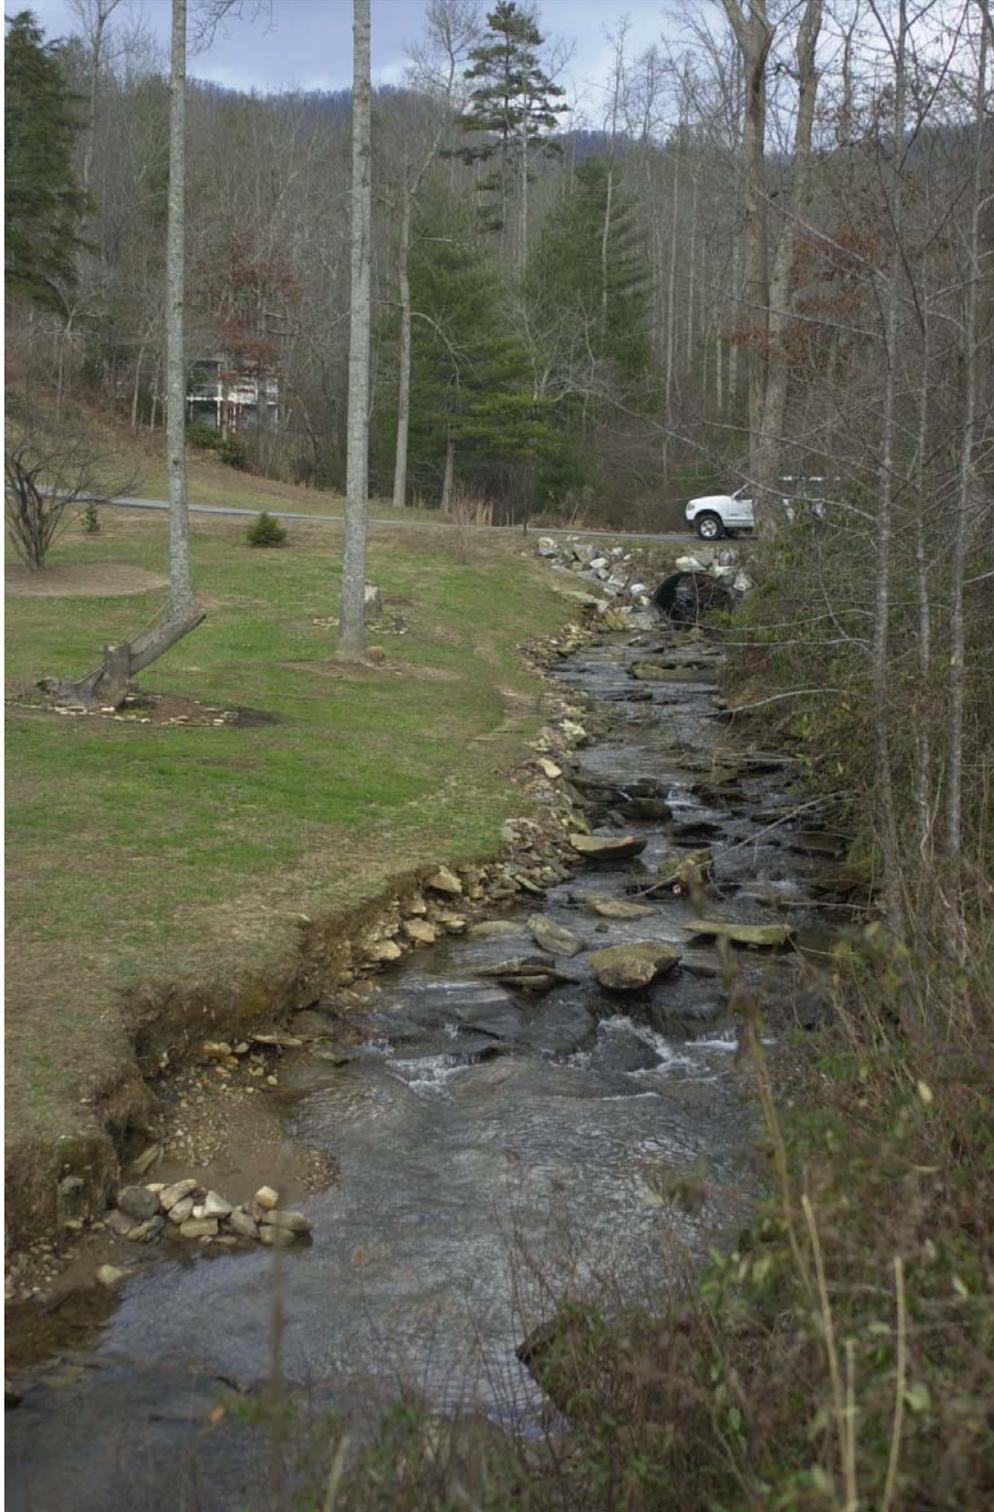
Photograph taken from Smokey Estates Rd., facing north
Note cleared vegetation along right stream bank with low cut grass along streambank and bank erosion.

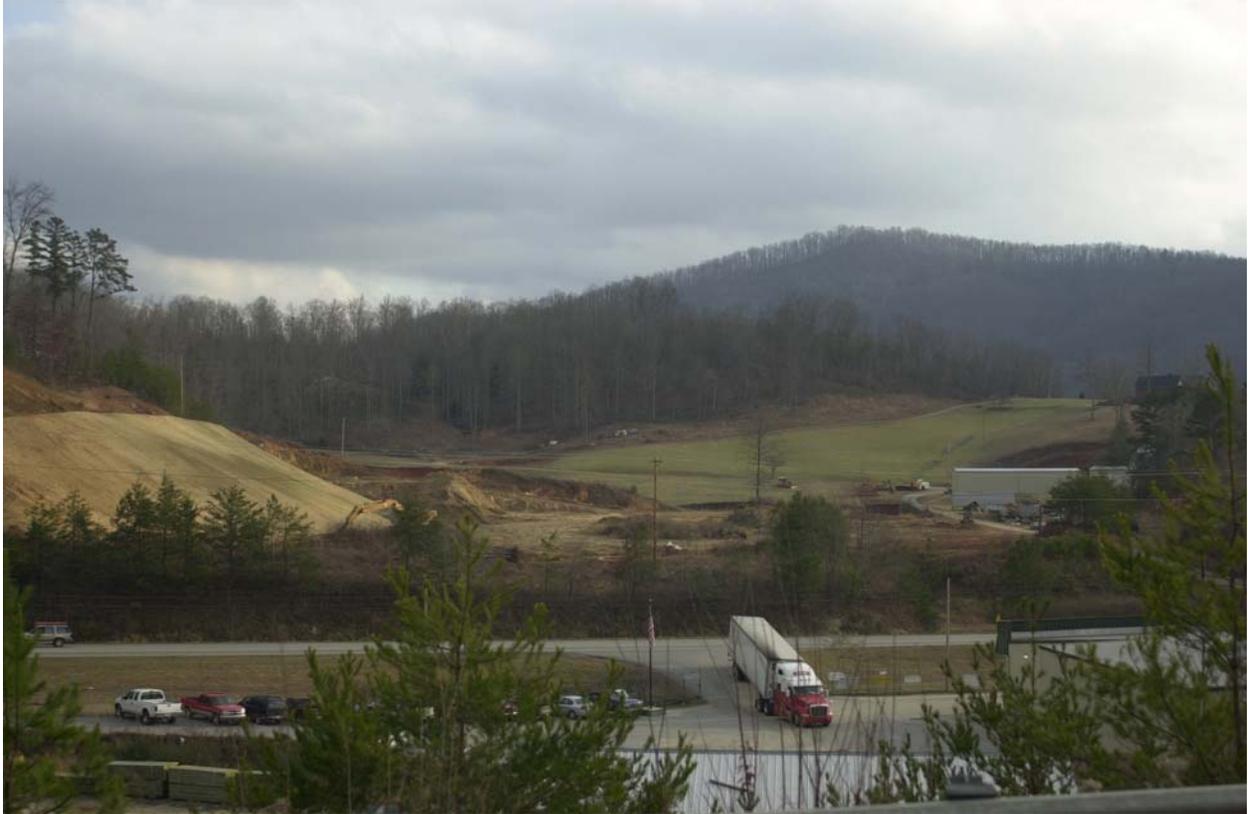
Photograph taken from Weaver Rd., facing east
Note land disturbing activity, hydro-seeded banks, and well vegetated incline in background.

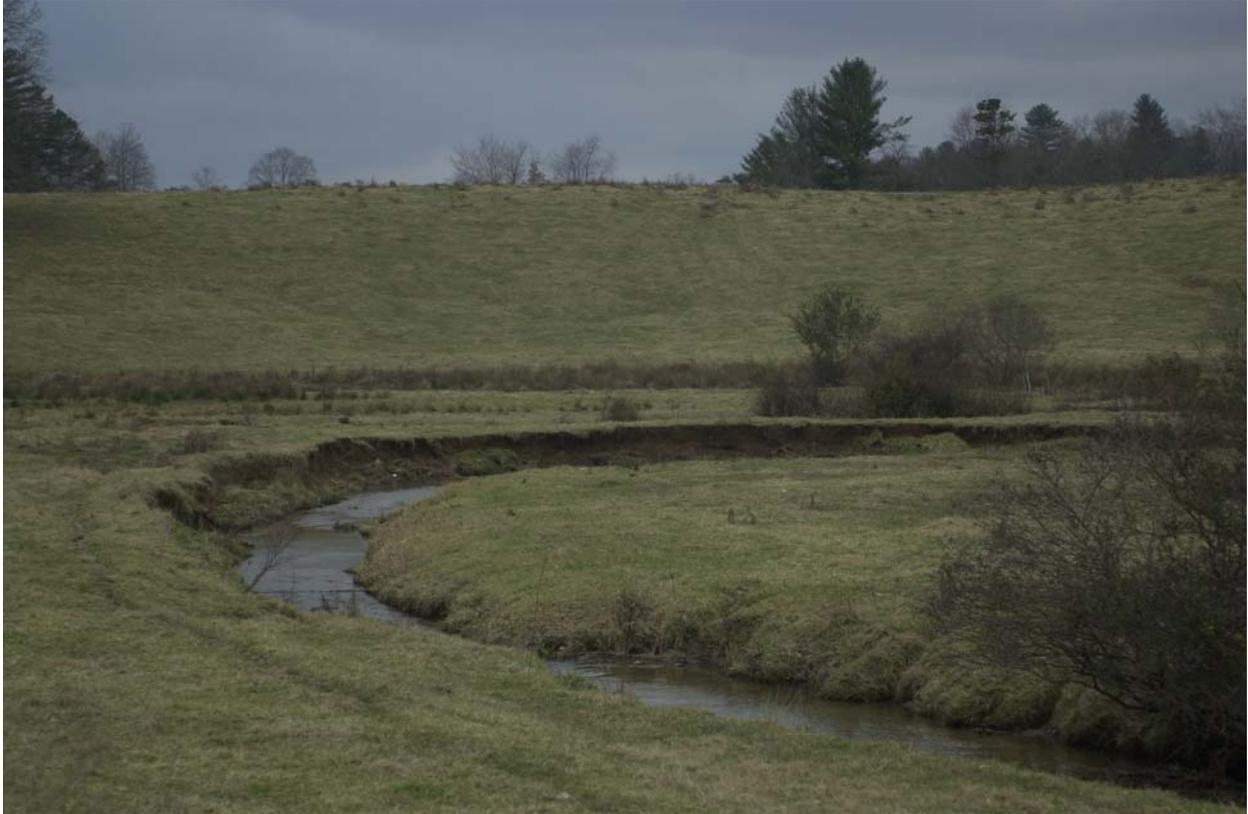
Photograph taken from Mamory Gardens Dr. and Butternut Creek, facing south
Note bank instability.

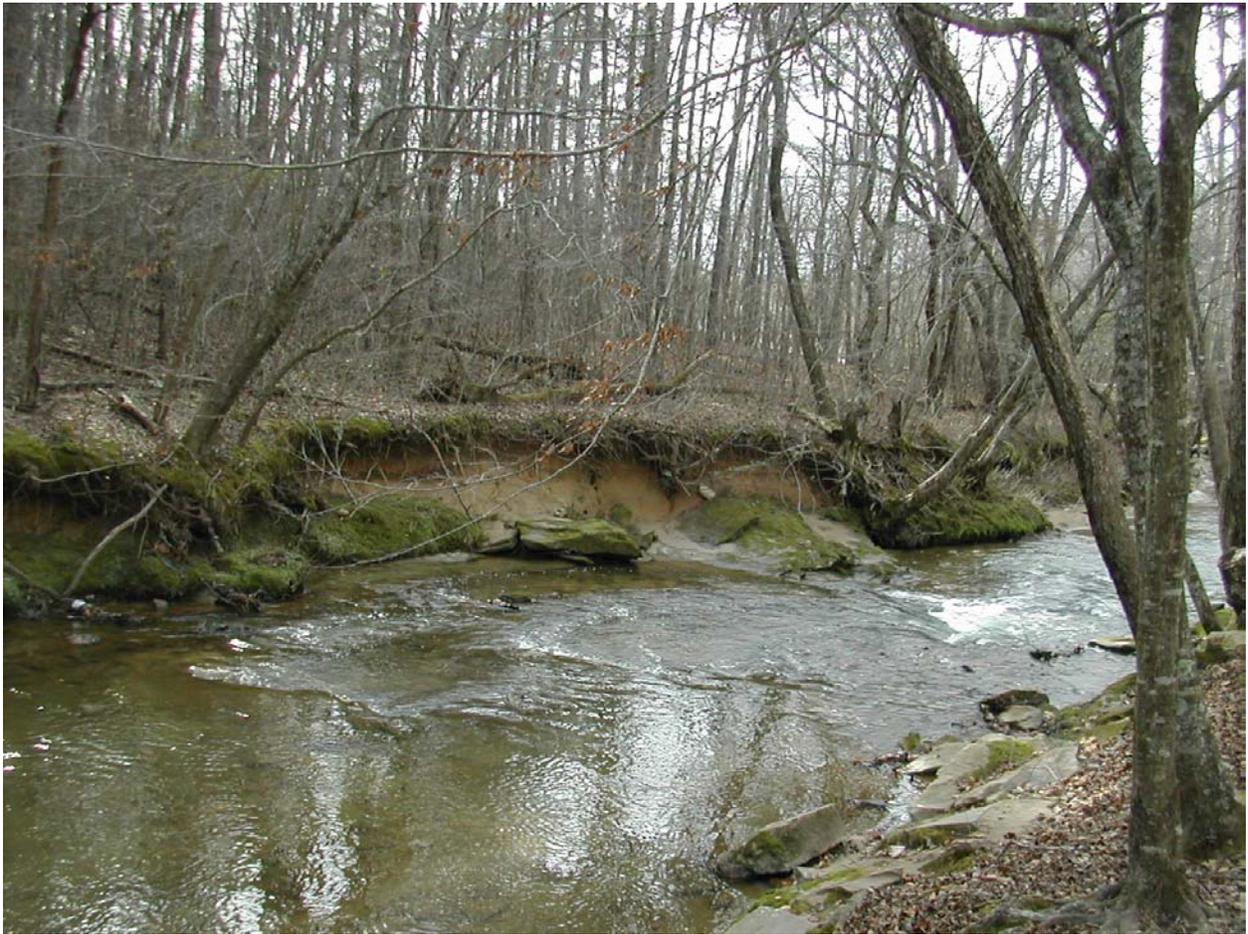
Butternut Creek at Meeks Park, facing south.
Note channel bank instability.

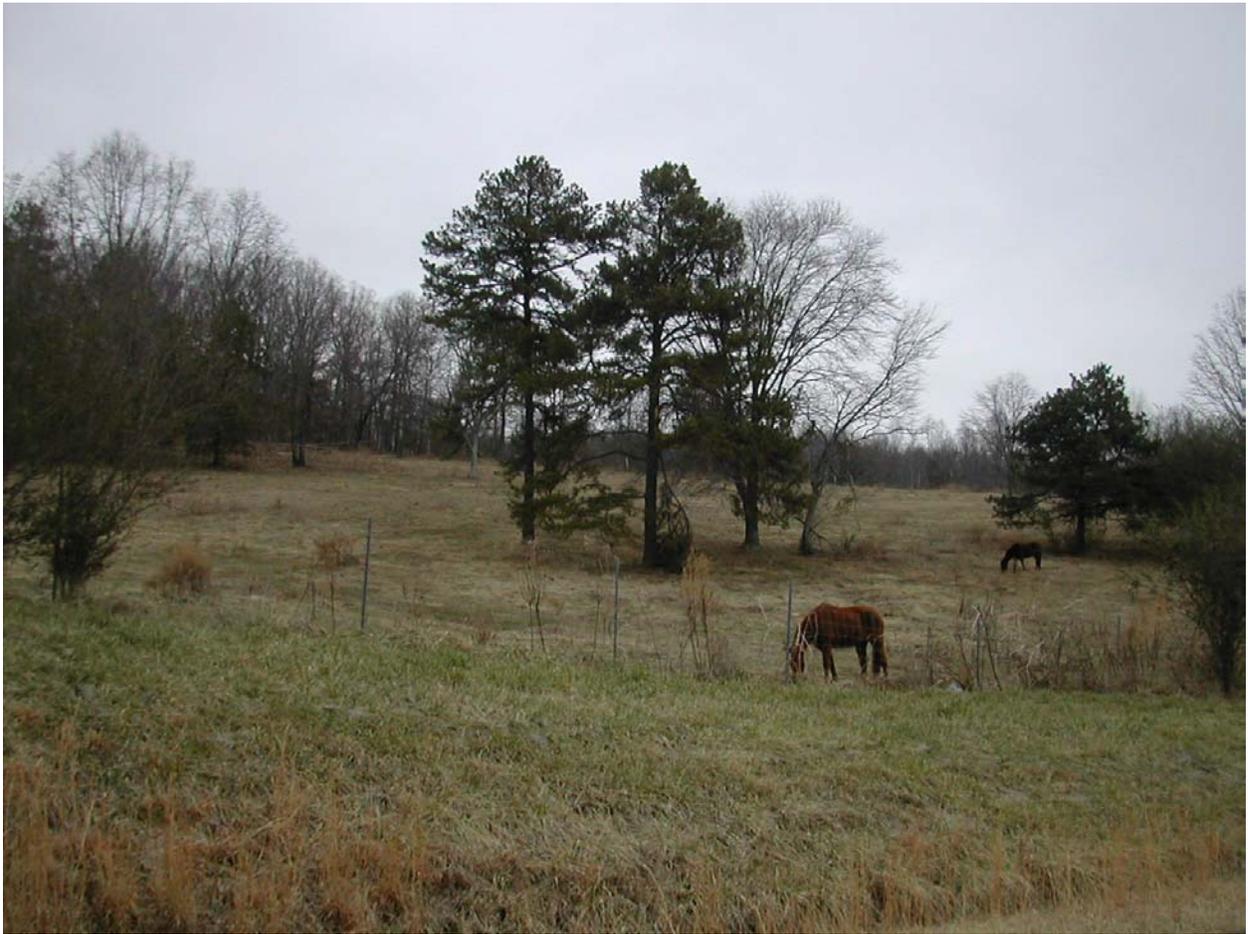
Photograph taken at western crossing of SR 515 over Lower Youngcane Creek, facing north
Note low intensity pasturelands in headwaters of Lower Youngcane Creek watershed.

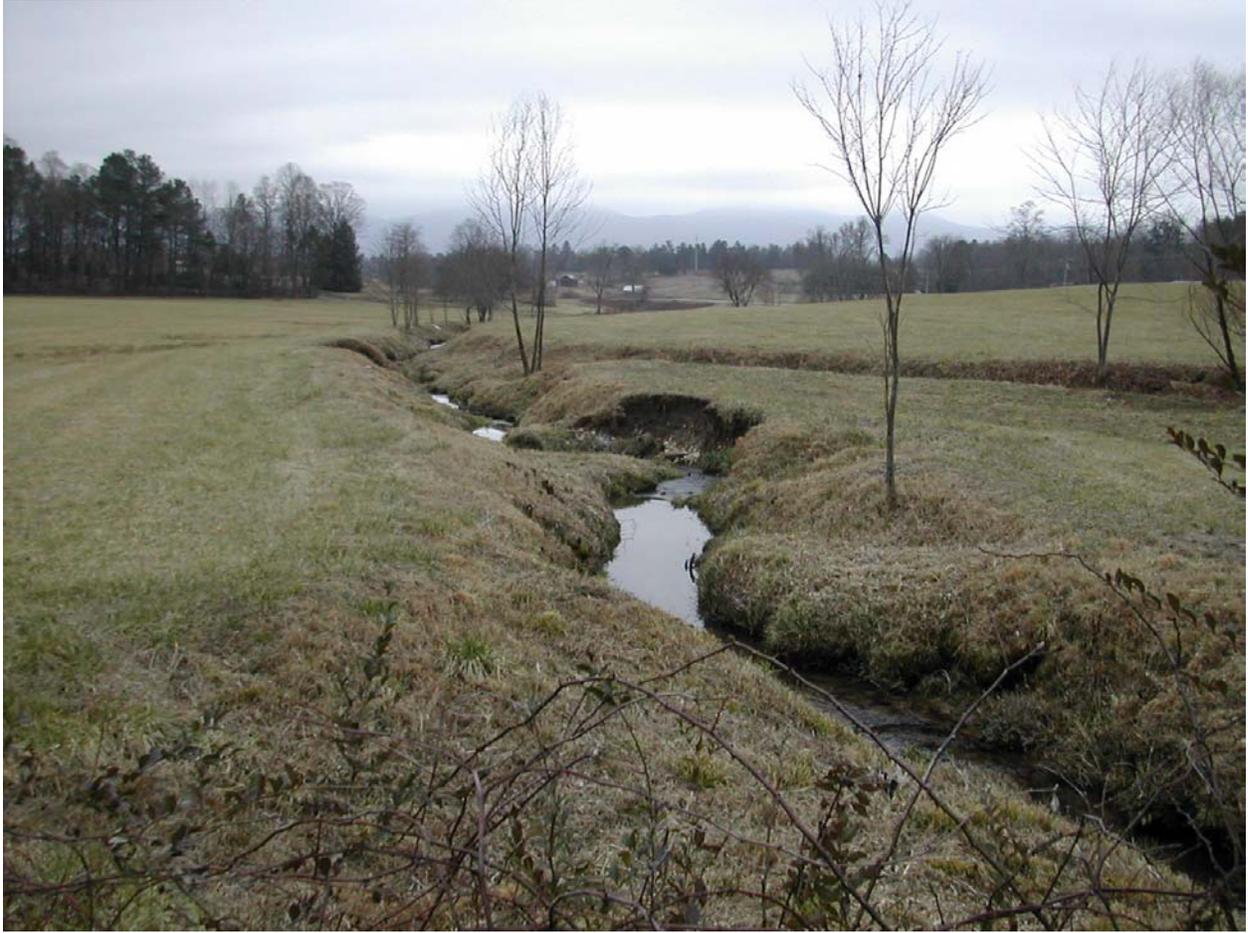
Photograph taken from crossing of Sandalwood Rd. over Lower Youngcane Creek, facing south
Note channel straightening and reestablishment of natural meander pattern.

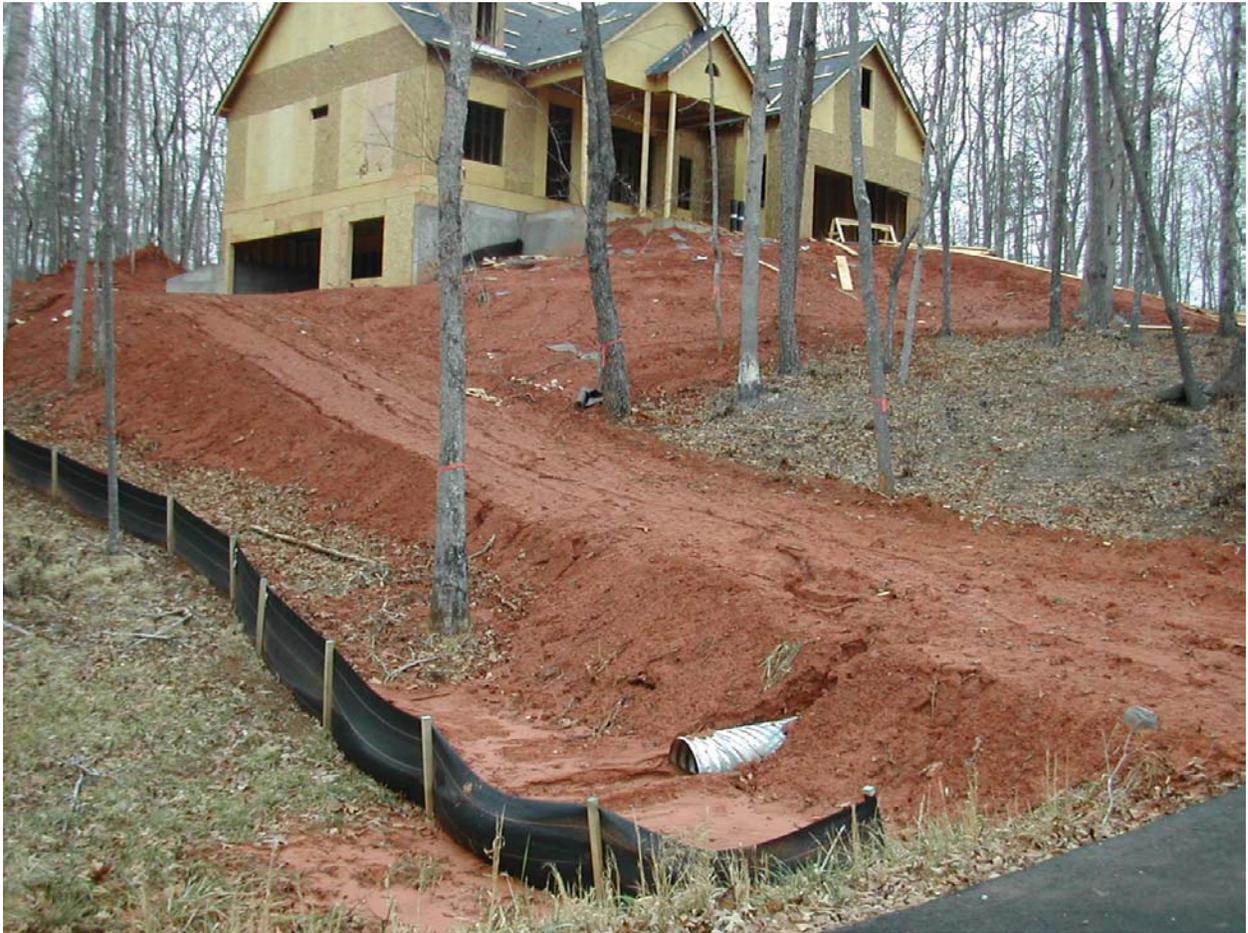
Westwoods subdivision near Sandalwood Rd., facing west
Note heavy sedimentation from residential development.

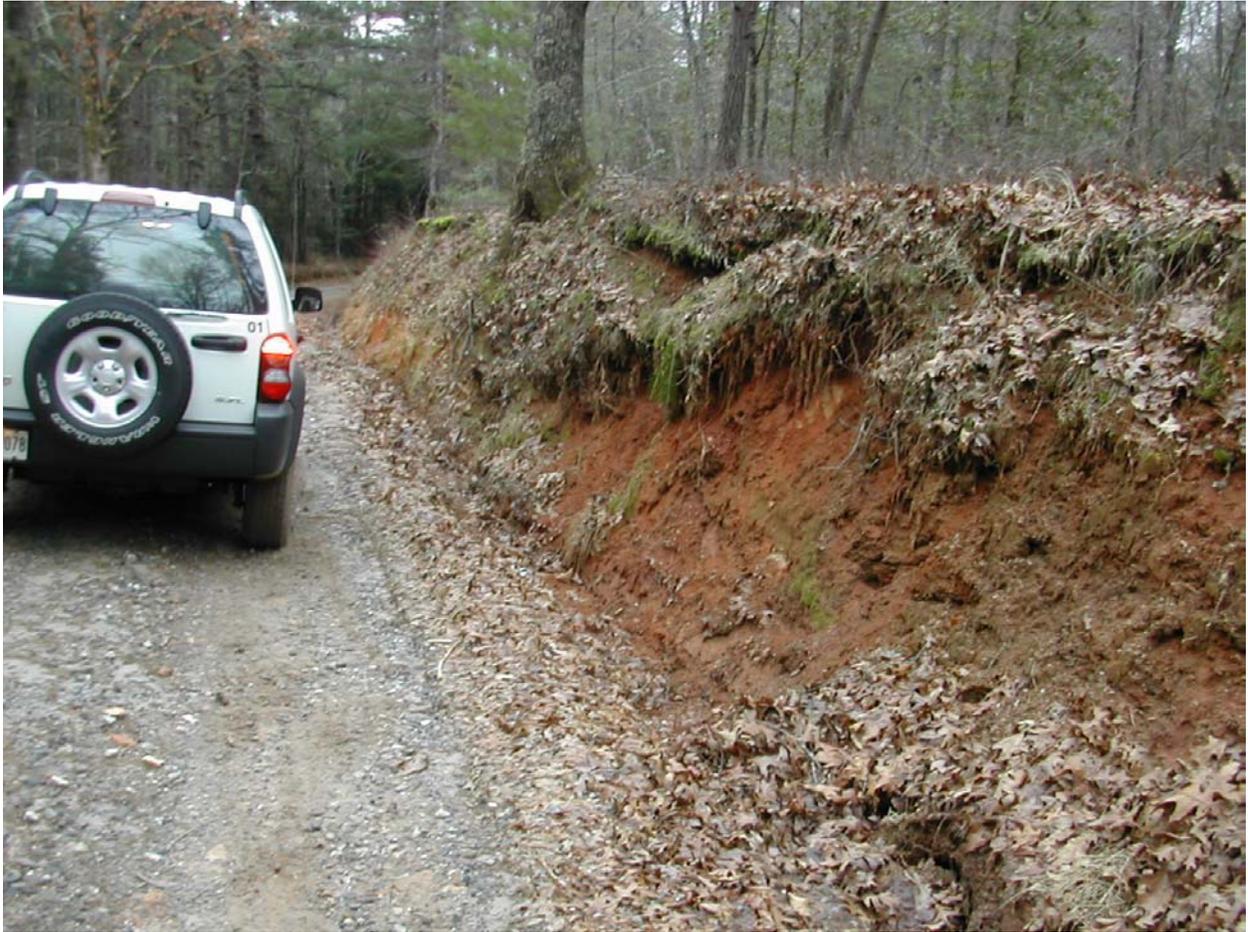
Sandalwood Rd. near eastern crossing over Youngcane Creek, facing east
Note road bank instability and poor ditch maintenance.

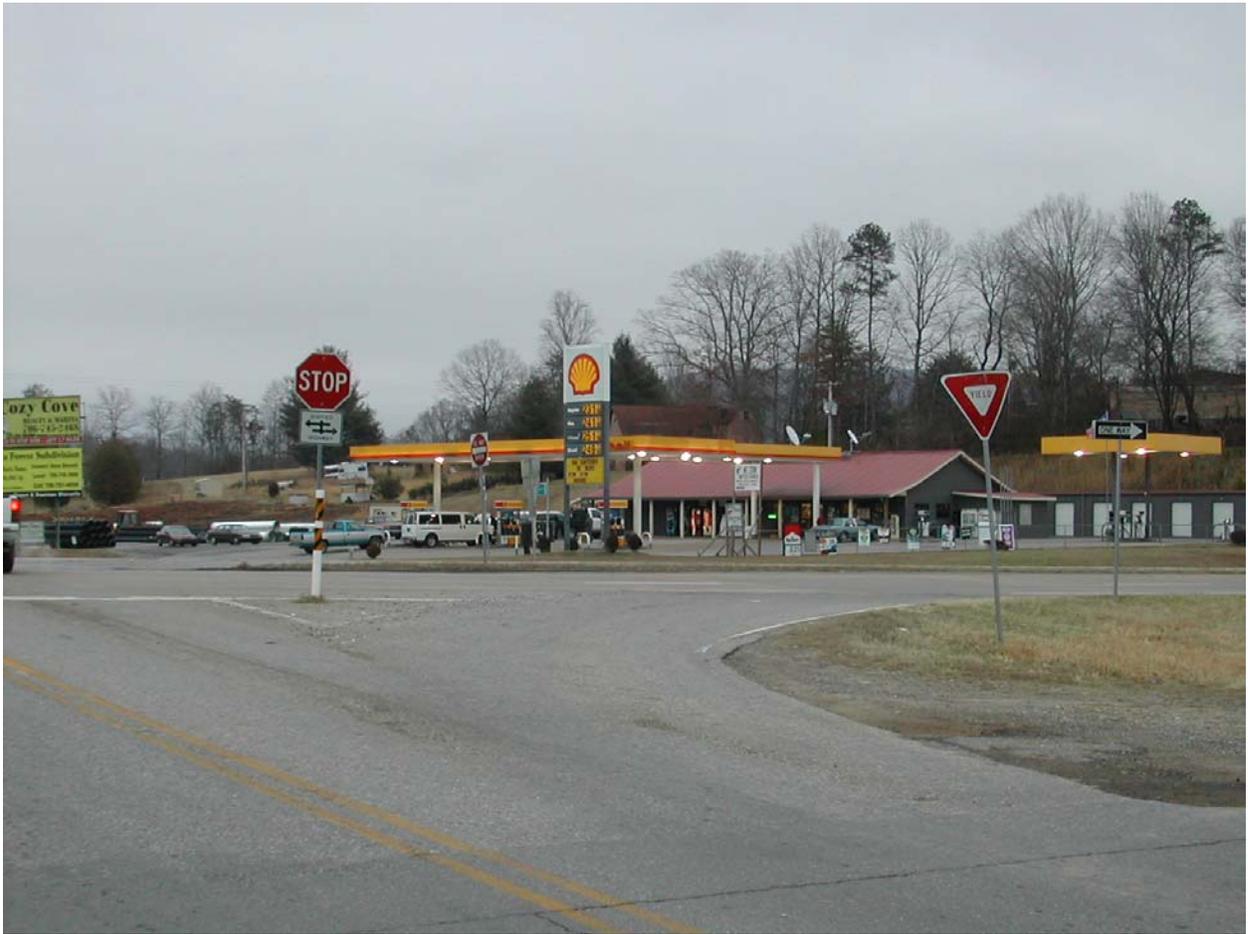
Nottely Dam Rd. at SR 515, facing north
Note commercial development and high extent of impervious surfaces.

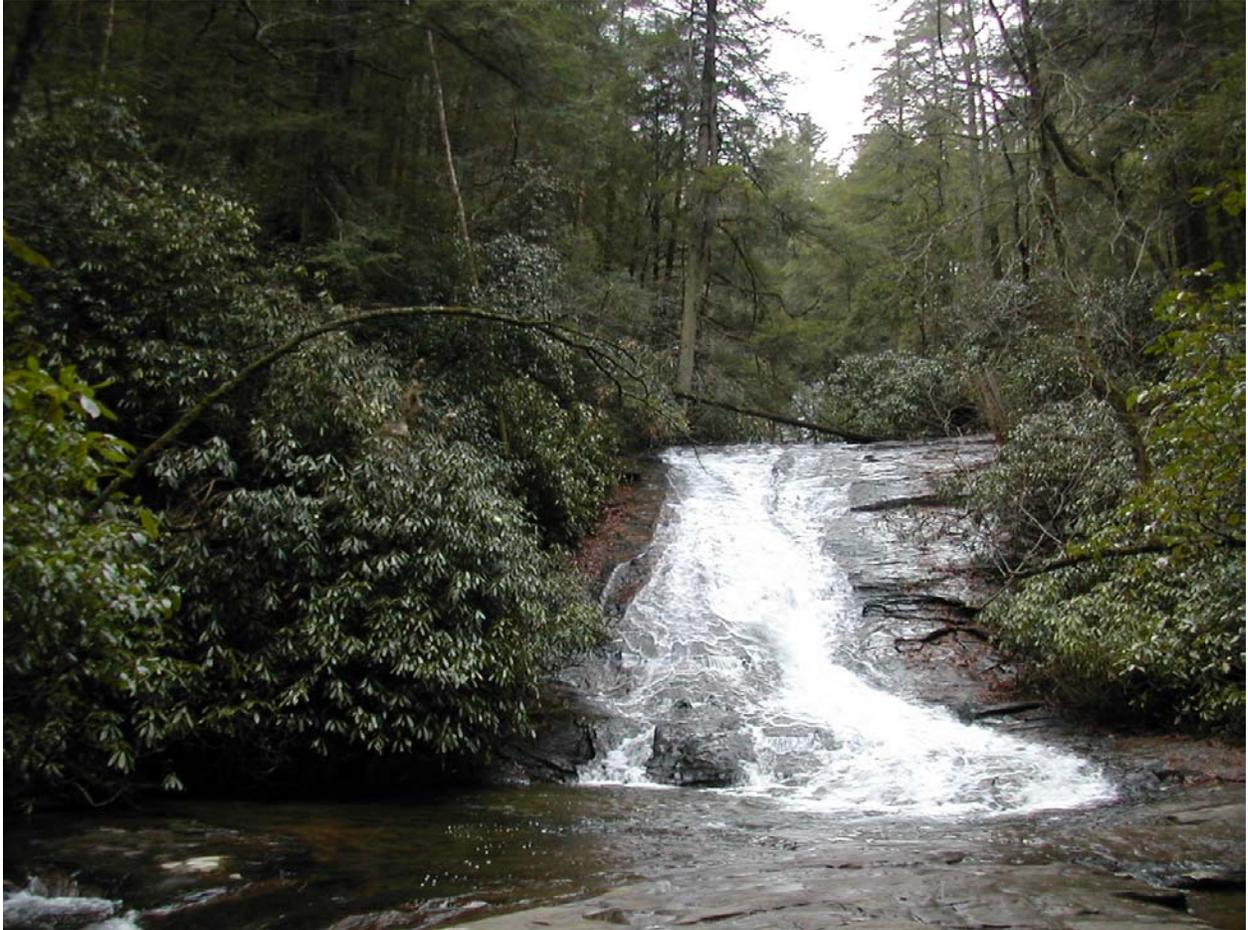
Nottely River Headwaters
Photograph taken at Helton Creek Falls, facing south
Note lands managed by Forest Service

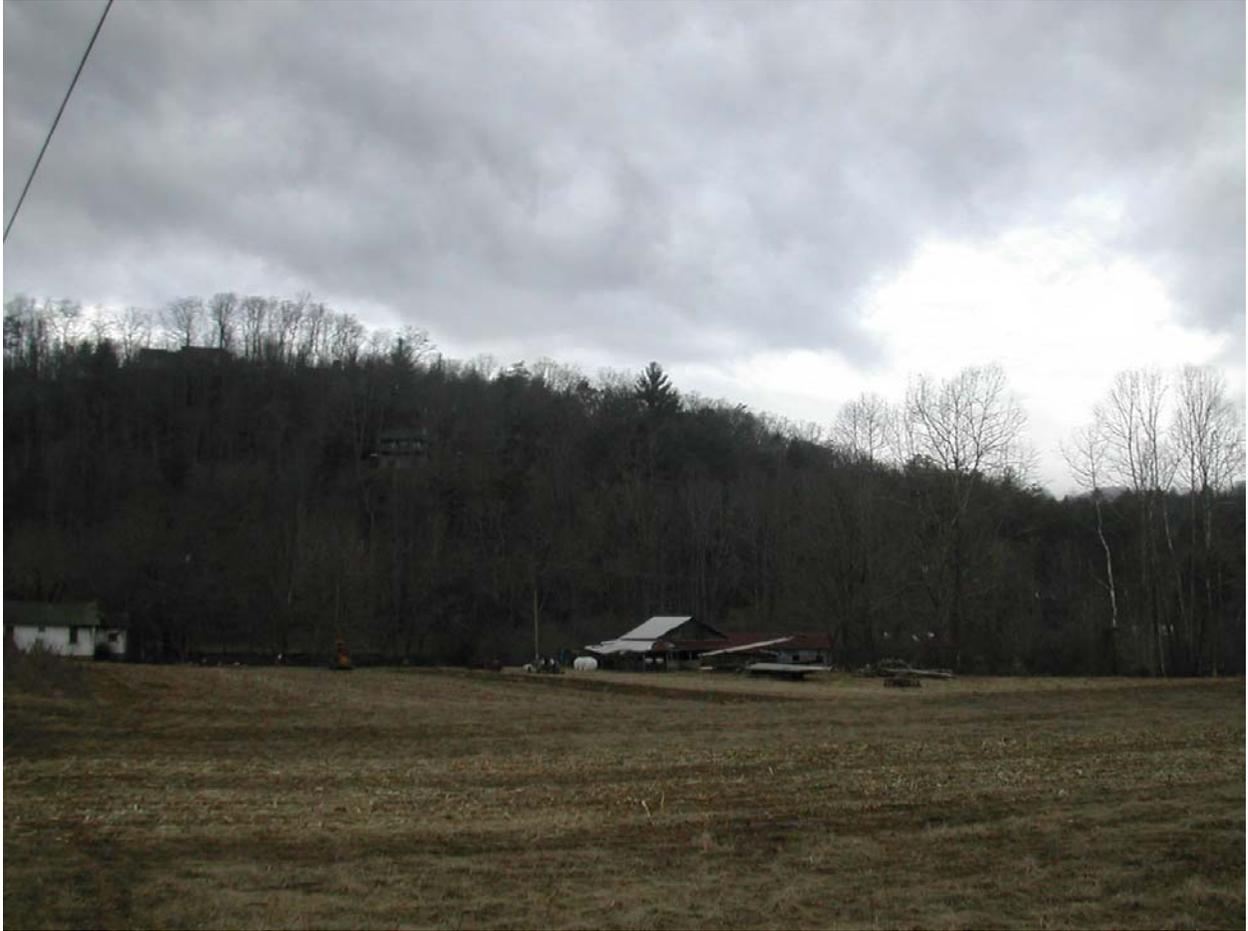
Nottely River Headwaters
Photograph taken near intersection of Richard Russell Scenic Highway
and Craig Rd., facing west.
Note row cropping activity.

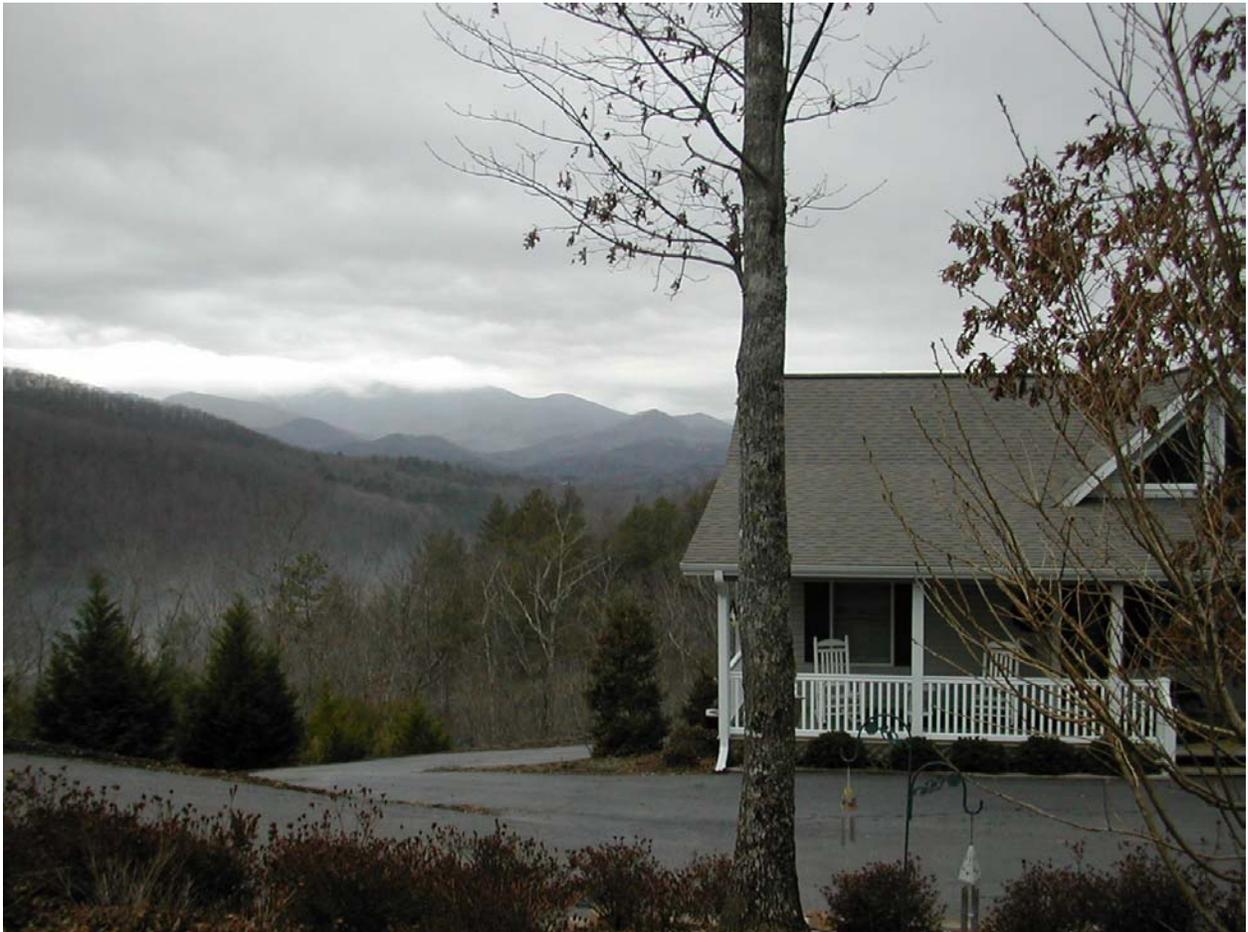
Stink Creek Watershed
Photograph taken from residential neighborhood near Burt Nix Rd., facing west.
Note residential development on steep slopes.

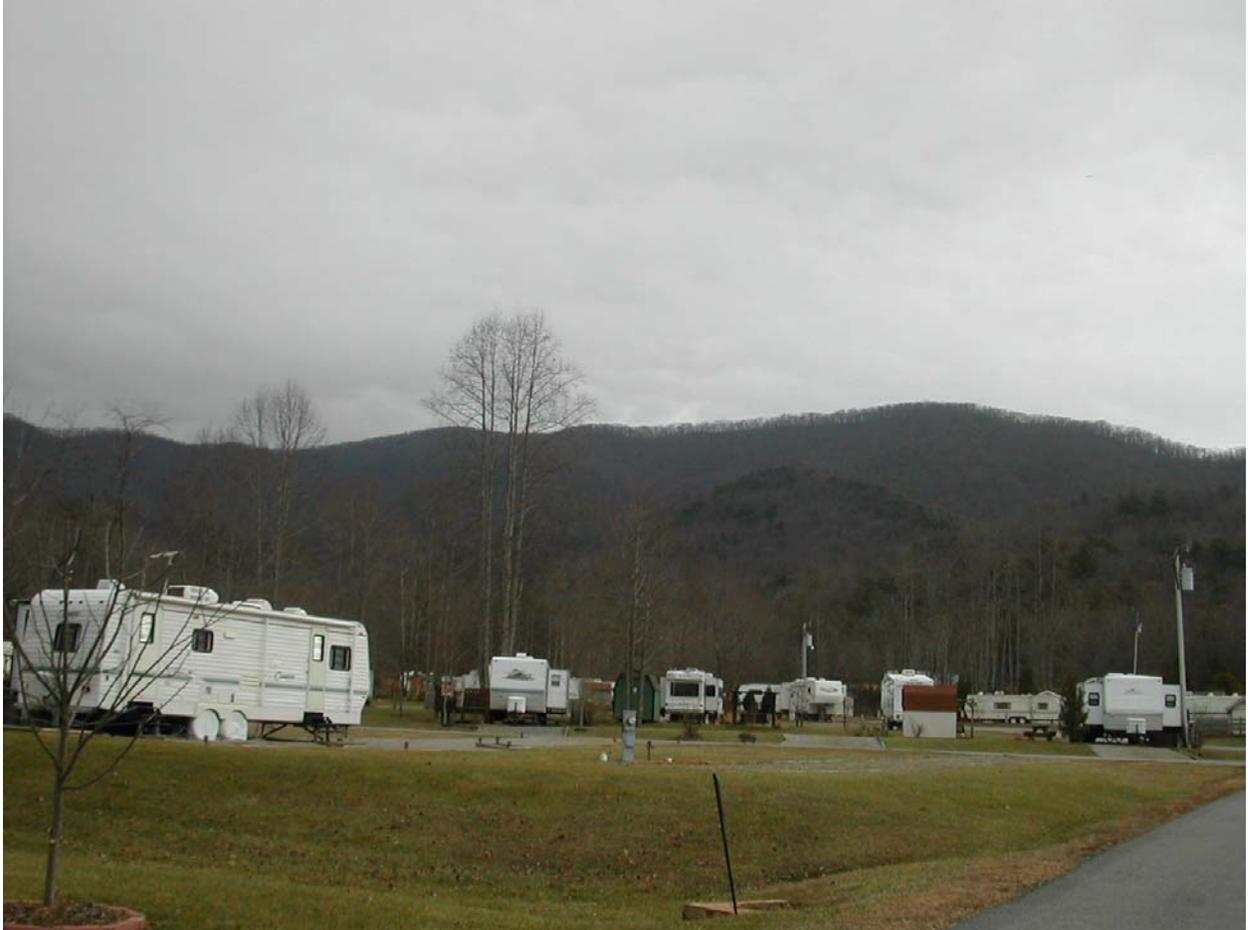
Stink Creek Watershed
Photograph taken from end of Cedar Mountain Trout Farm Rd., facing east.
Note high intensity residential and recreational housing.

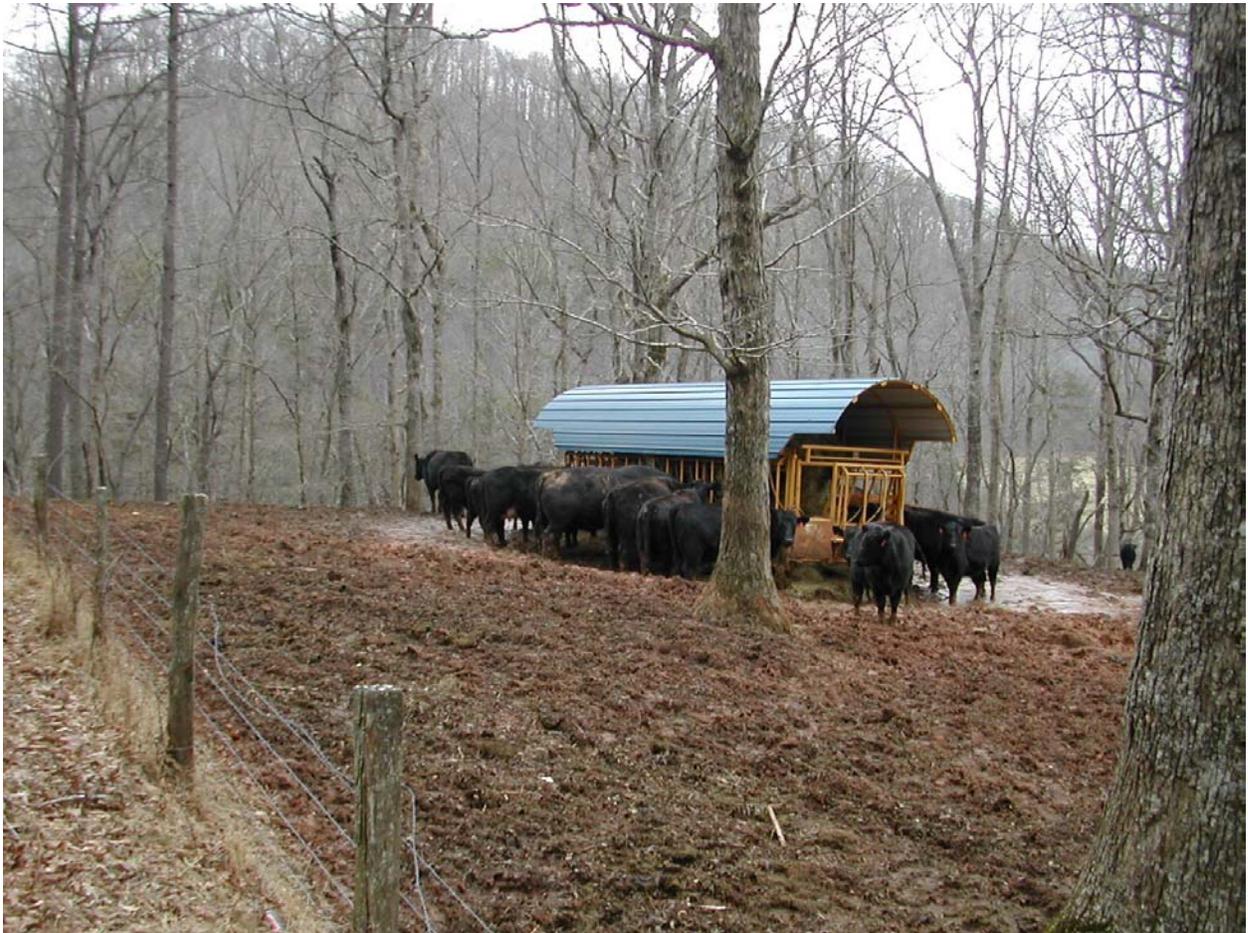
Stink Creek Watershed
Photograph taken from Burt Nix Rd., facing south.
Note high intensity cattle grazing and well placed feed structure away from all waterbodies.

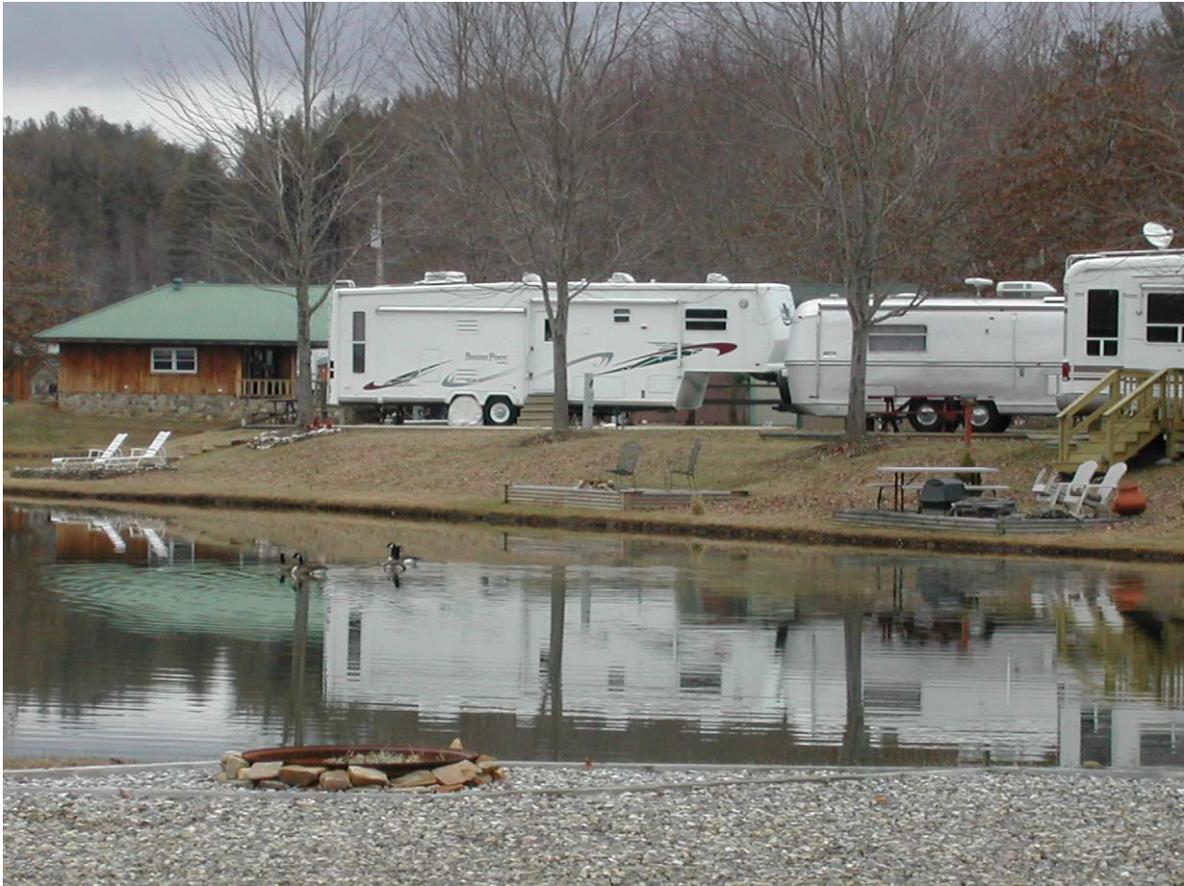
Stink Creek Watershed

Photograph taken from Wolfstake Rd. W. at the Choestoe Falls R.V. Park, facing north.
Note resident Canada Geese (center frame) and domestic pets (far right frame)
directly in and within close proximity to waterbodies.
