STATE OF GEORGIA
TIER 2 TMDL IMPLEMENTATION PLAN REVISION 01
Nottely River and Youngcane Creek Watershed
Tennessee River Basin
April 28, 2006

Local Watershed Governments:
Union County
City of Blairsville

I. INTRODUCTION

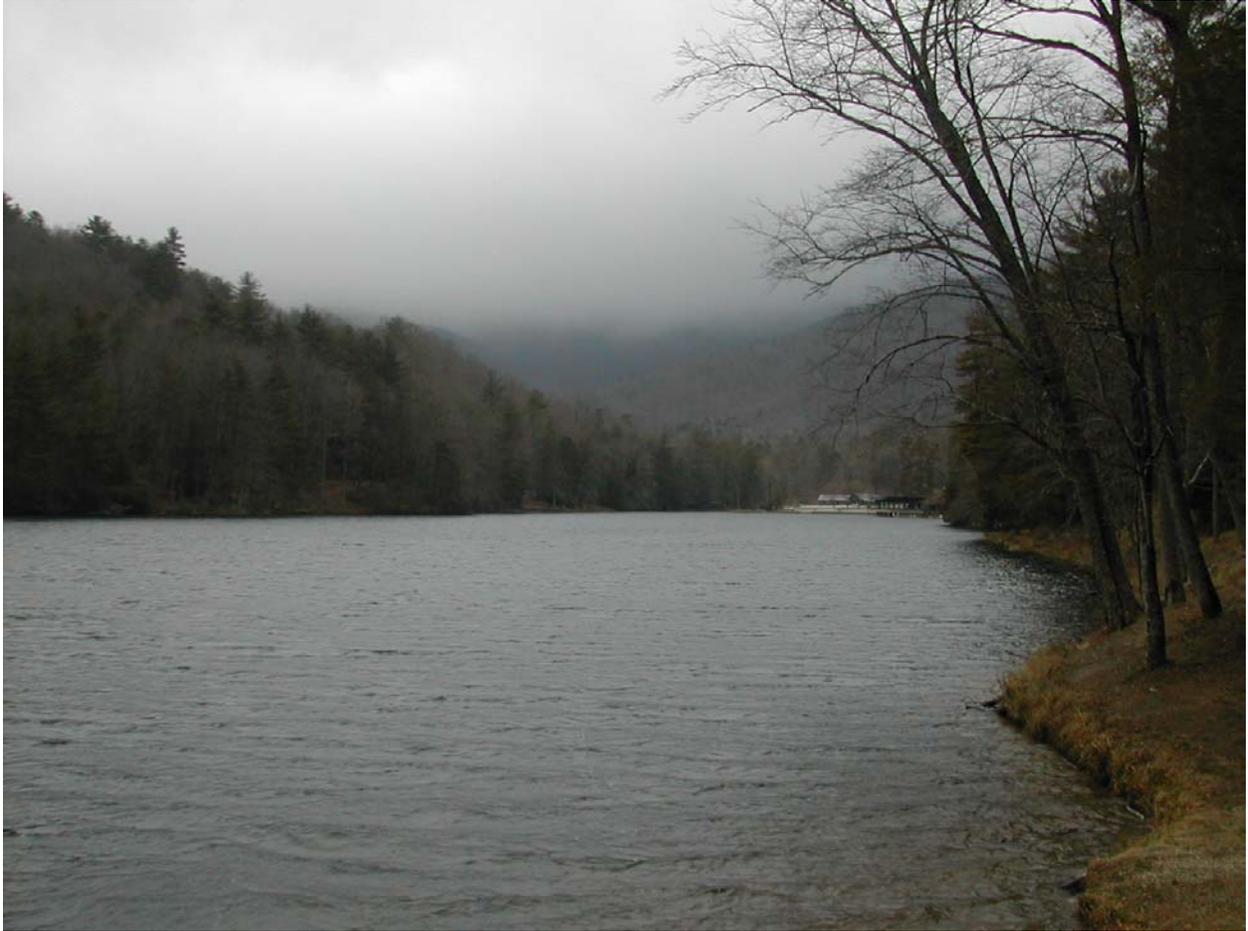
Wolf Fork Watershed
Photograph taken from Lake Trahlyta Dam, facing southwest.
Note intensive recreational area (Vogel State Park).

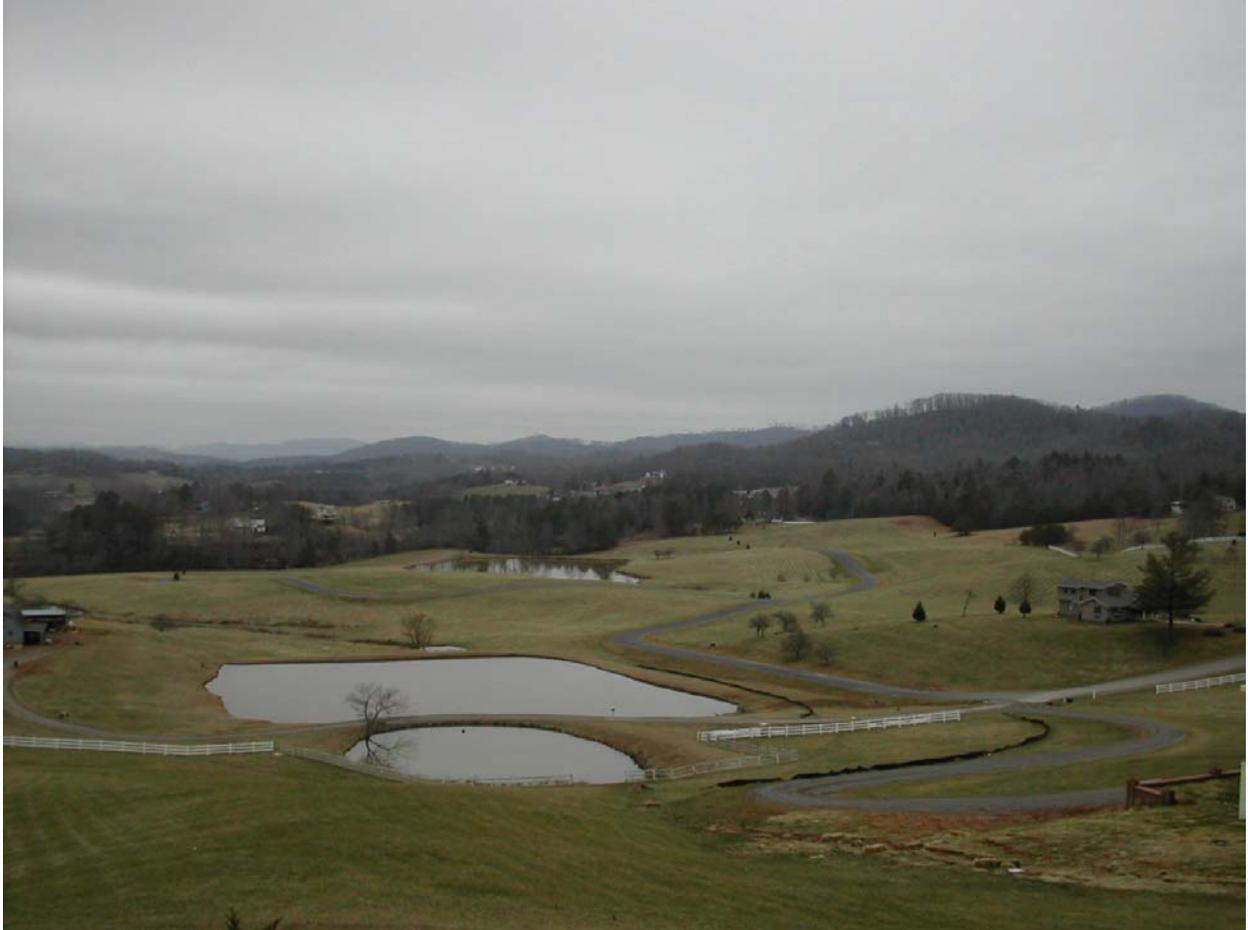
Arkaqua Creek Watershed
Photograph taken from Town Creek School Rd., facing west
Note low intensity agricultural land use.

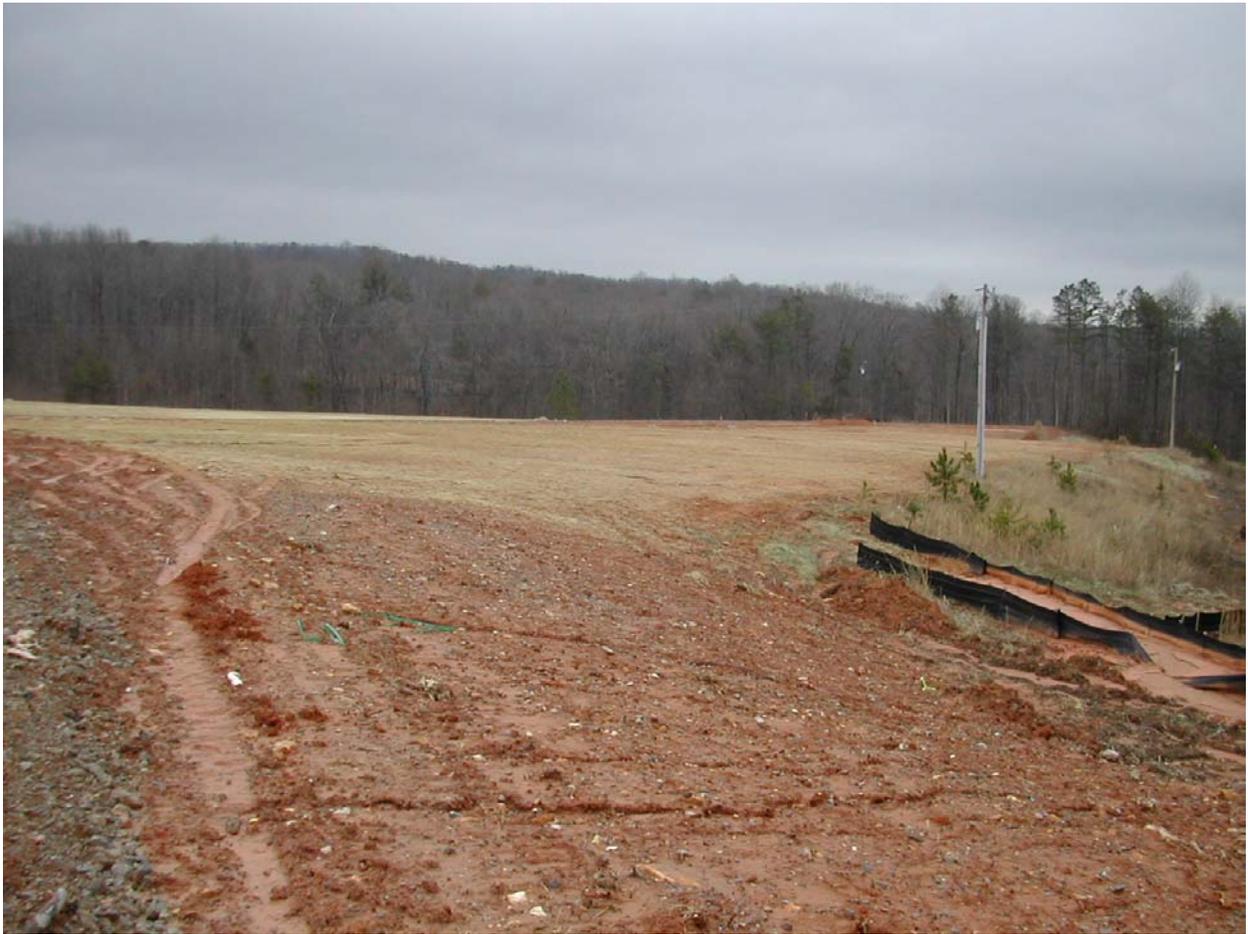
Photograph taken from Elisha Payne Rd., facing west
Note large land disturbing activity and poor erosion control practices.

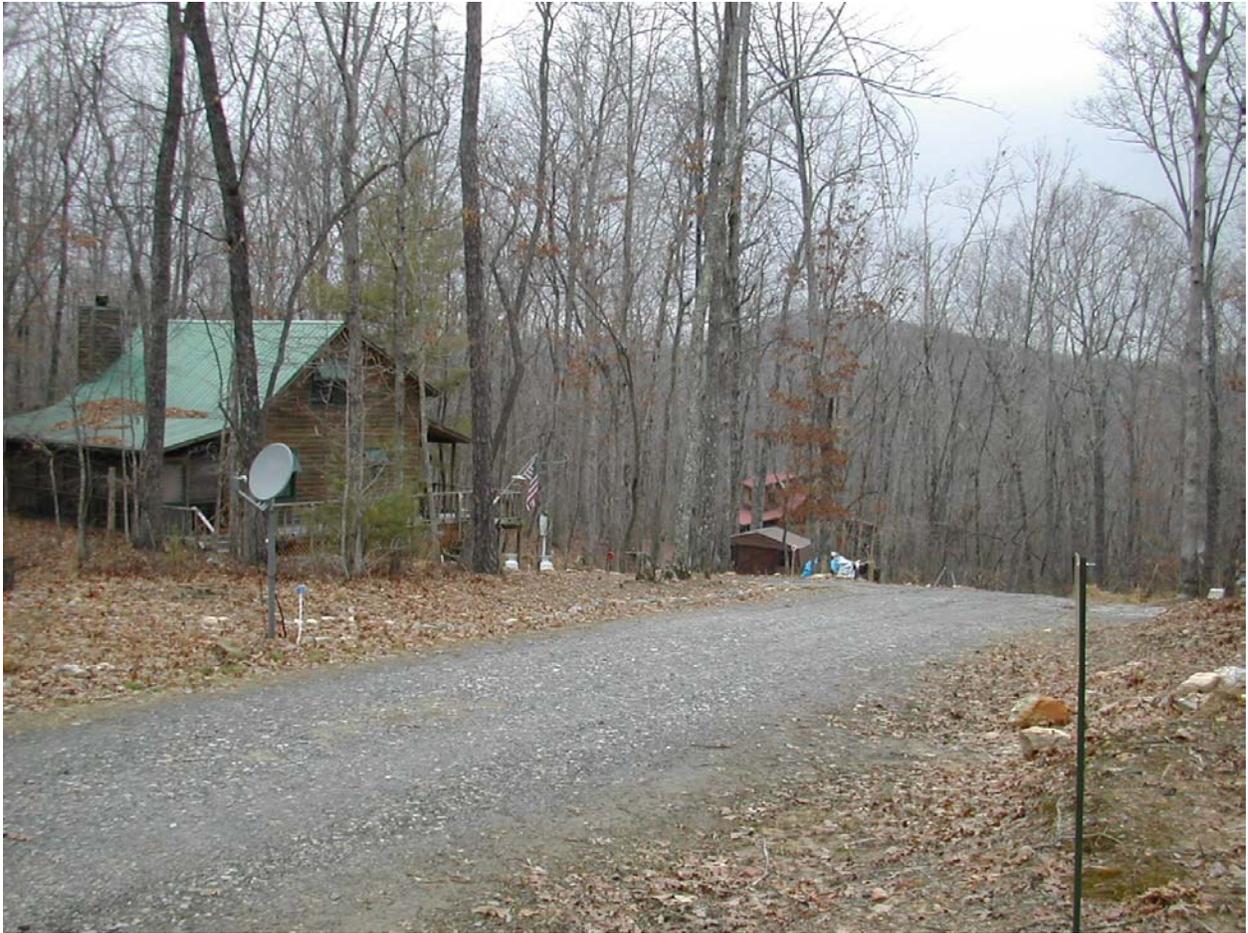
Photograph taken from Elisha Payne Rd., facing north
Note low intensity residential development on low to moderate slopes.

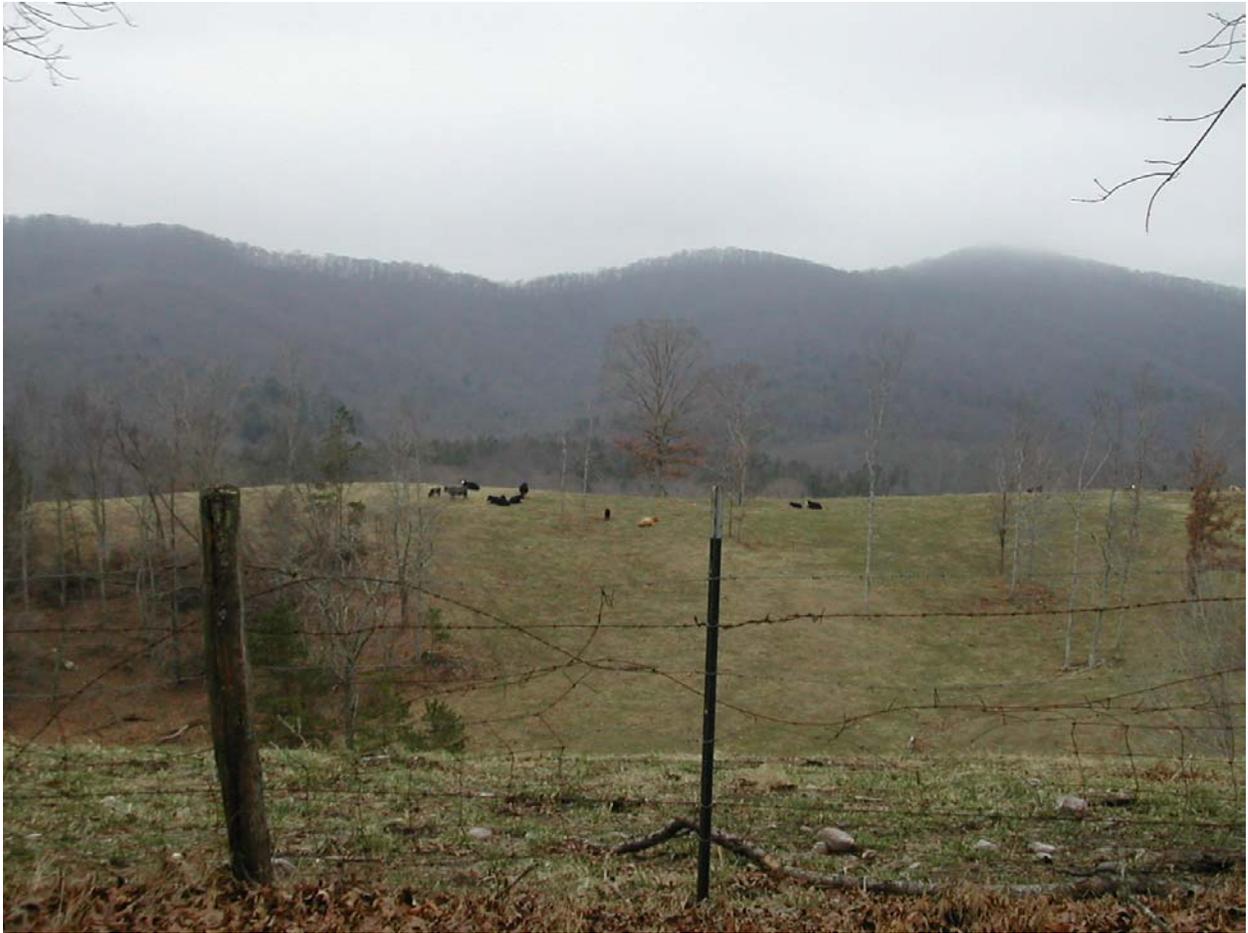
Photograph taken from Huckleberry Hills Rd., facing west
Note low intensity cattle grazing.

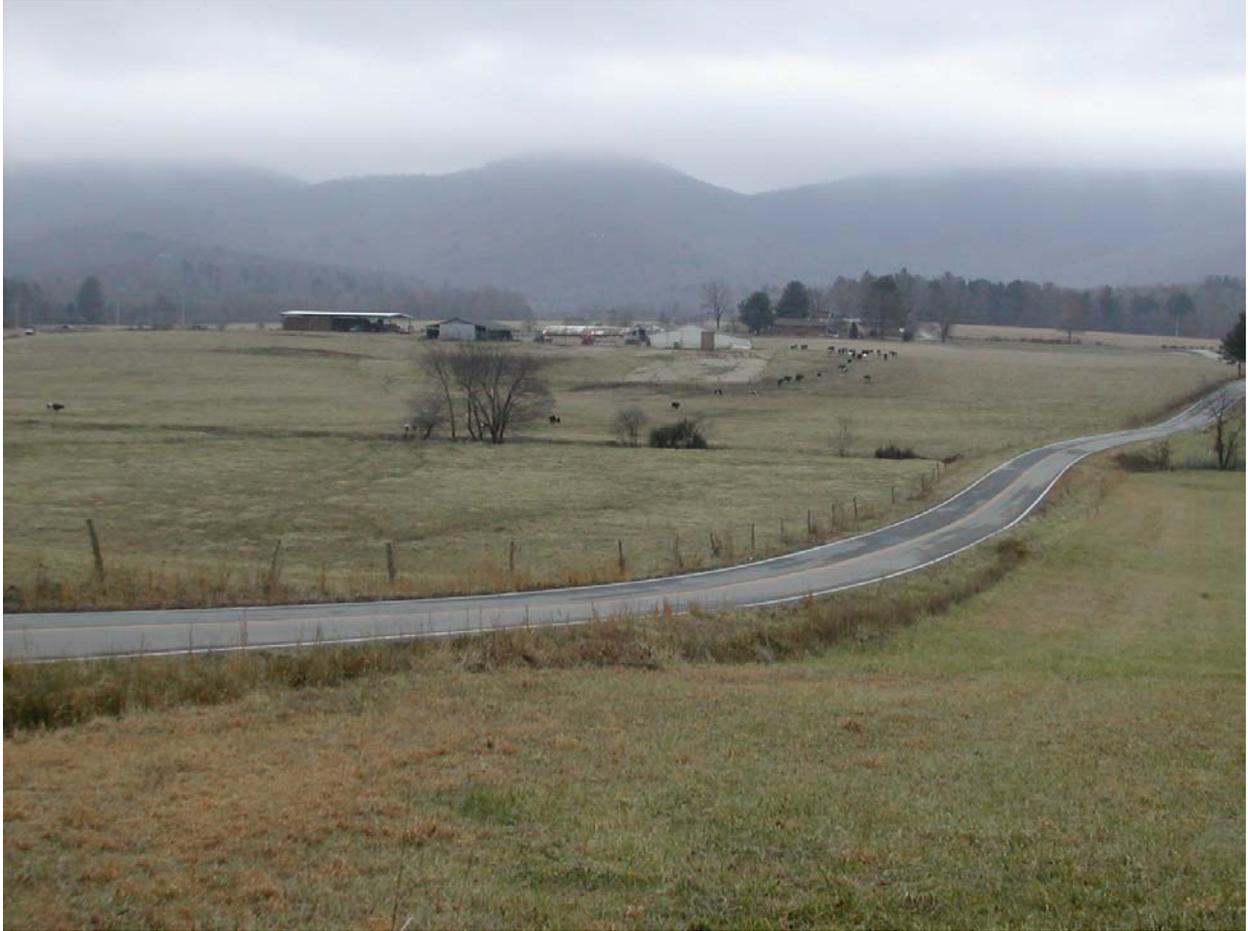
Photograph taken from Philadelphia Church Rd., facing west
Note moderate intensity cattle grazing.

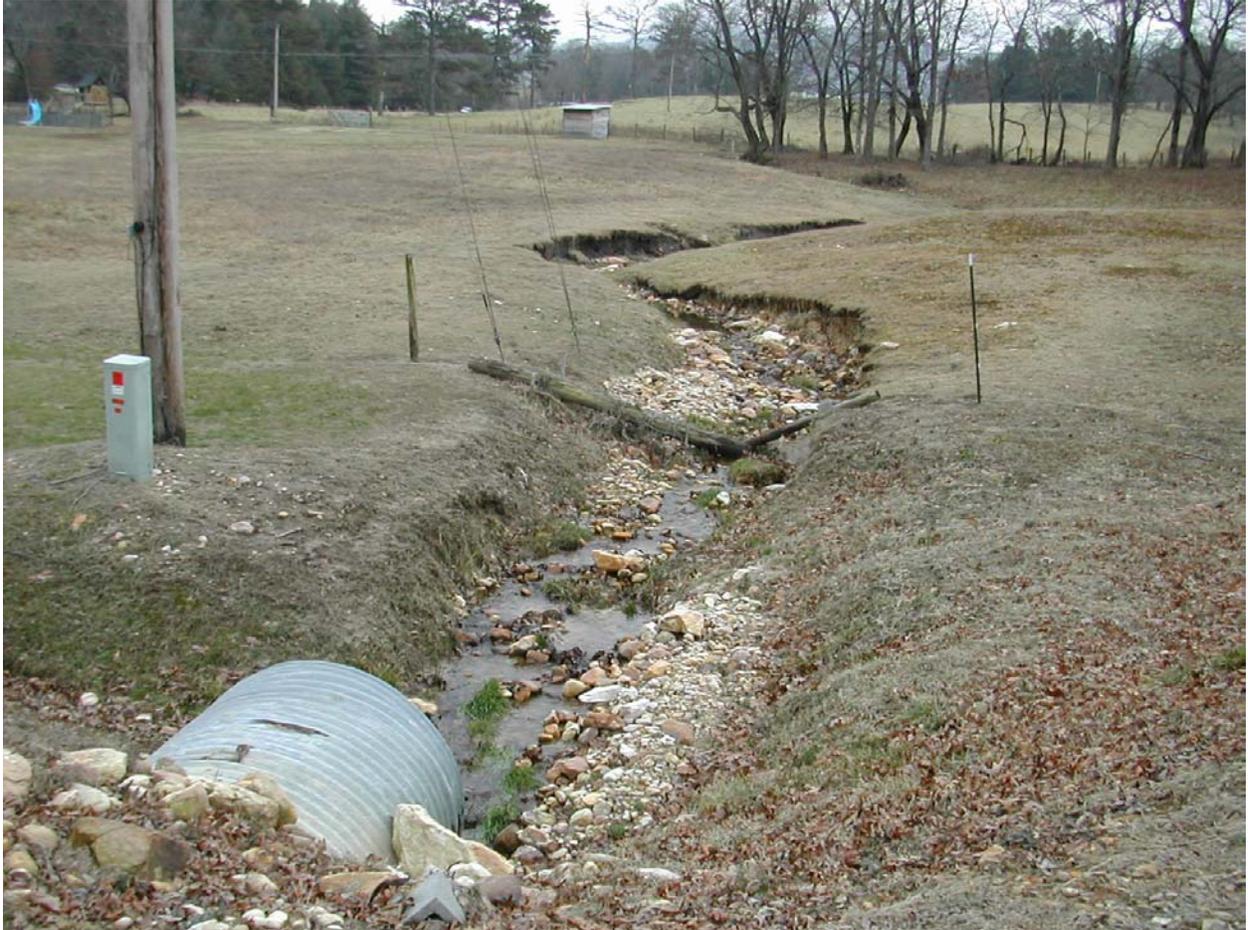
Photograph taken from Blueridge Highway at Little Youngcane Creek, facing west
Note indication bank erosion from high stormwater discharge.

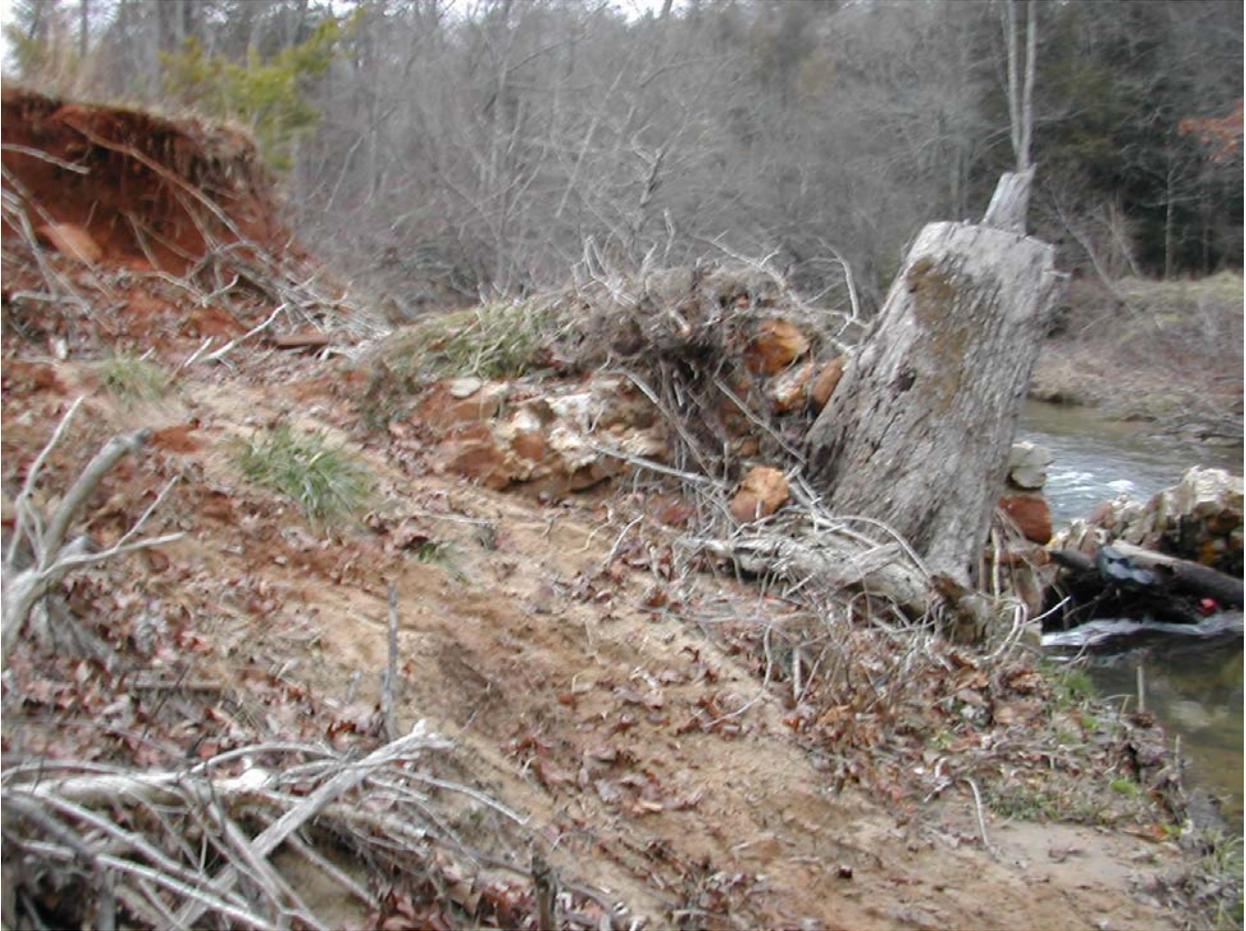
Photograph taken at Youngcane Creek and Ridge Crest Dr., facing north
Note intensive bank erosion.
