**Re: Georgia Power Company – Plant Branch  
Proposed CCR Landfill – Site Acceptability Review Comments  
APL 1579**

Enclosed please find Georgia Power Company's (GPC) response to comments on the Site Acceptability Report (SAR) submitted for the proposed Plant Branch CCR Landfill. The comments were received in a letter dated October 23, 2019, which were generated by EPD's review of the Site Acceptability Report prepared by Geosyntec. Following are each of the comments from the EPD and a written response.

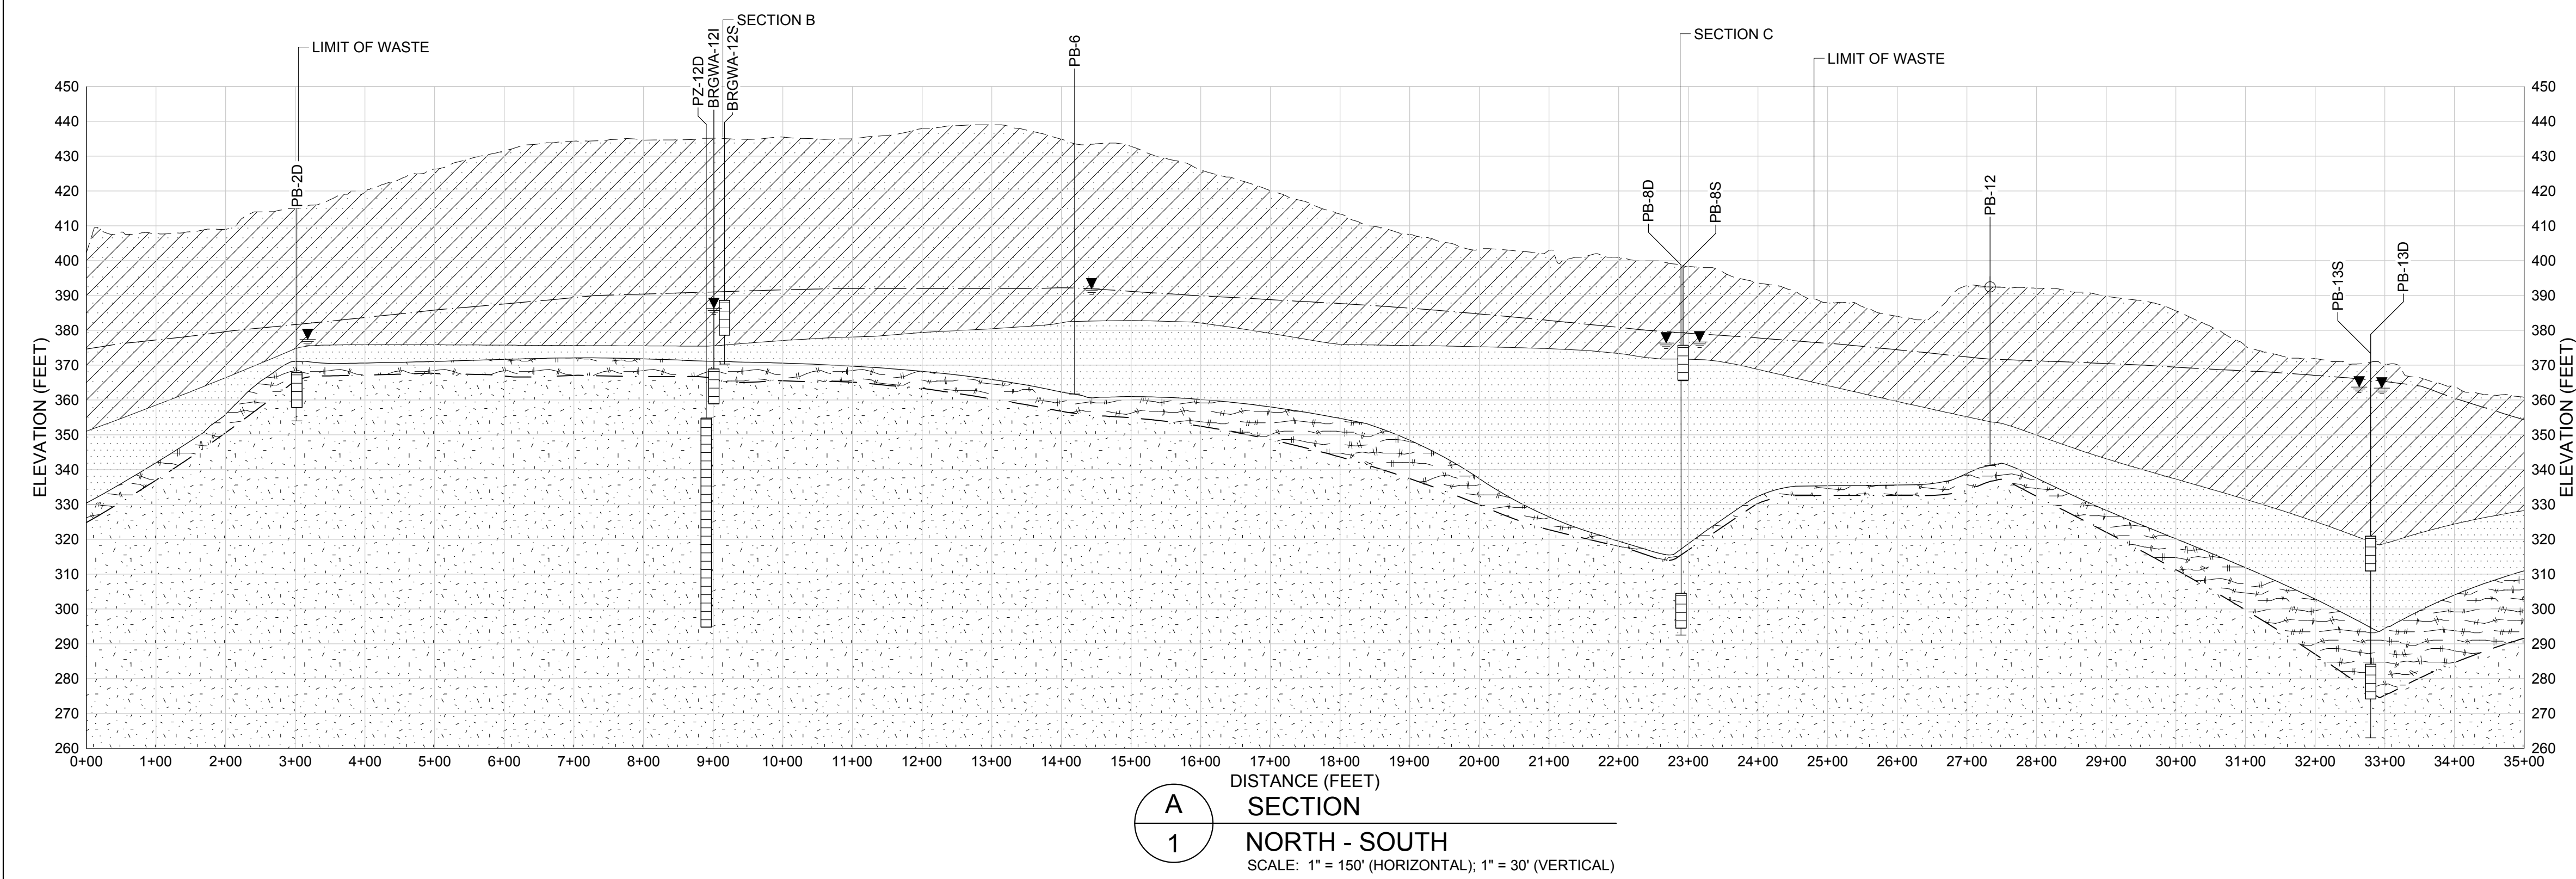
\\CADD\GEORGIA POWER\PLANT BRANCH\GW6364.01\LANDFILL\FIGURES\GW6364-FIG01.R1

FRACTURED GNEISS BEDROCK - WELL BANDED FOLIATED FELDSPATHIC BIOTITE GNEISS WITH LOW-ANGLE FRACTURES AND SOME WEATHERING.

GNEISS BEDROCK - WELL BANDED AND FOLIATED FELDSPATHIC BIOTITE GNEISS WITH VERY FEW TO NO JOINTS OR FRACTURES.

**Response:** The items noted above (bullets 1 to 5) have been addressed and the requested revisions to existing cross-section B, as well as Figures 2-7 and 3-1 have been made. The revised cross-sections and figures are included in Attachment B.

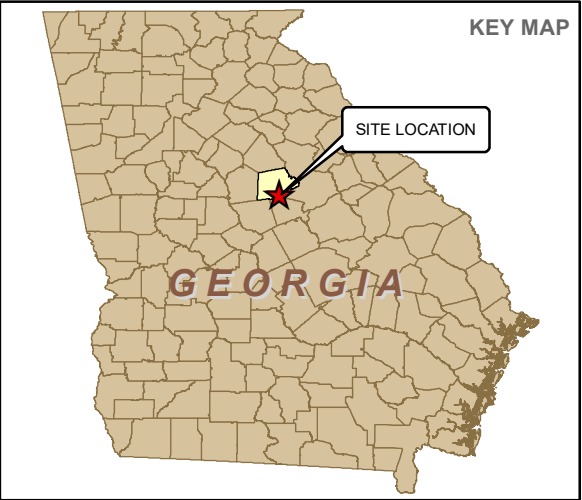
PROJECT  
GROUNDWATER MONITORING PLAN

- NOTES**
- GROUNDWATER SURFACE CONTOUR INTERVAL = 10 FEET
  - GROUNDWATER CONTOURS BASED ON LINEAR INTERPOLATION BETWEEN AND EXTRAPOLATION FROM KNOWN DATA, AND TOPOGRAPHIC CONTOURS. THEREFORE, CONTOURS MAY NOT REFLECT ACTUAL CONDITIONS.
  - PZ-8S\*, PZ-10S\*, PZ-11S\*, PZ-12D\*, AND PZ-49\* DATA NOT USED FOR CONTOURING.
  - AMSL=ABOVE MEAN SEA LEVEL.

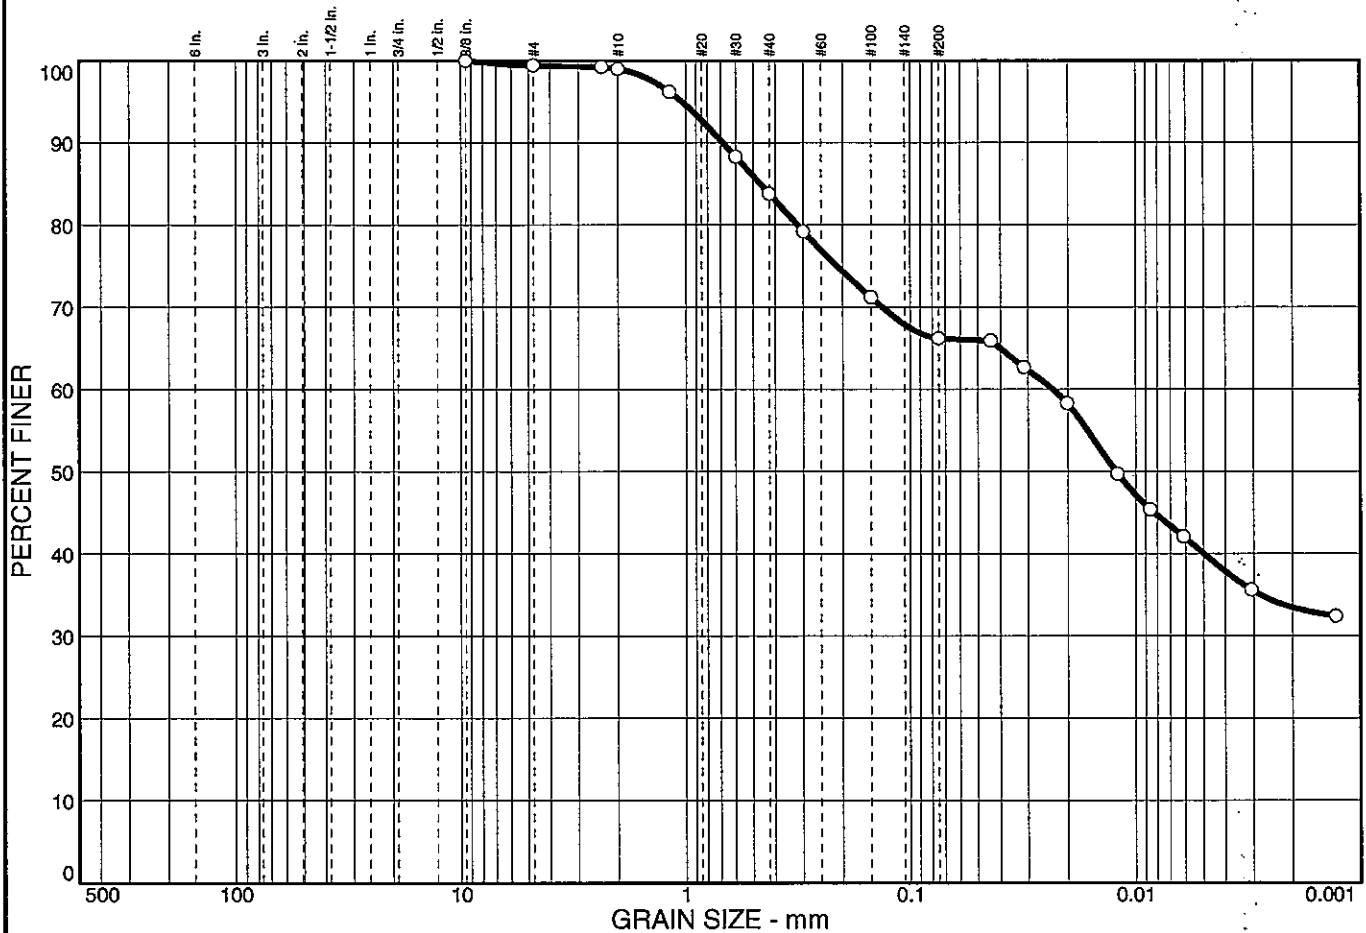
# Particle Size Distribution Report

% COBBLES	% GRAVEL	% SAND	% SILT	% CLAY
0.0	0.6	33.2	26.1	40.1

SIEVE SIZE	PERCENT FINER	SPEC.* PERCENT	PASS? (X=NO)
.375 in.	100.0		
#4	99.4		
#8	99.2		
#10	99.0		
#16	96.2		
#30	88.3		
#40	83.8		
#50	79.2		
#100	71.2		
#200	66.2

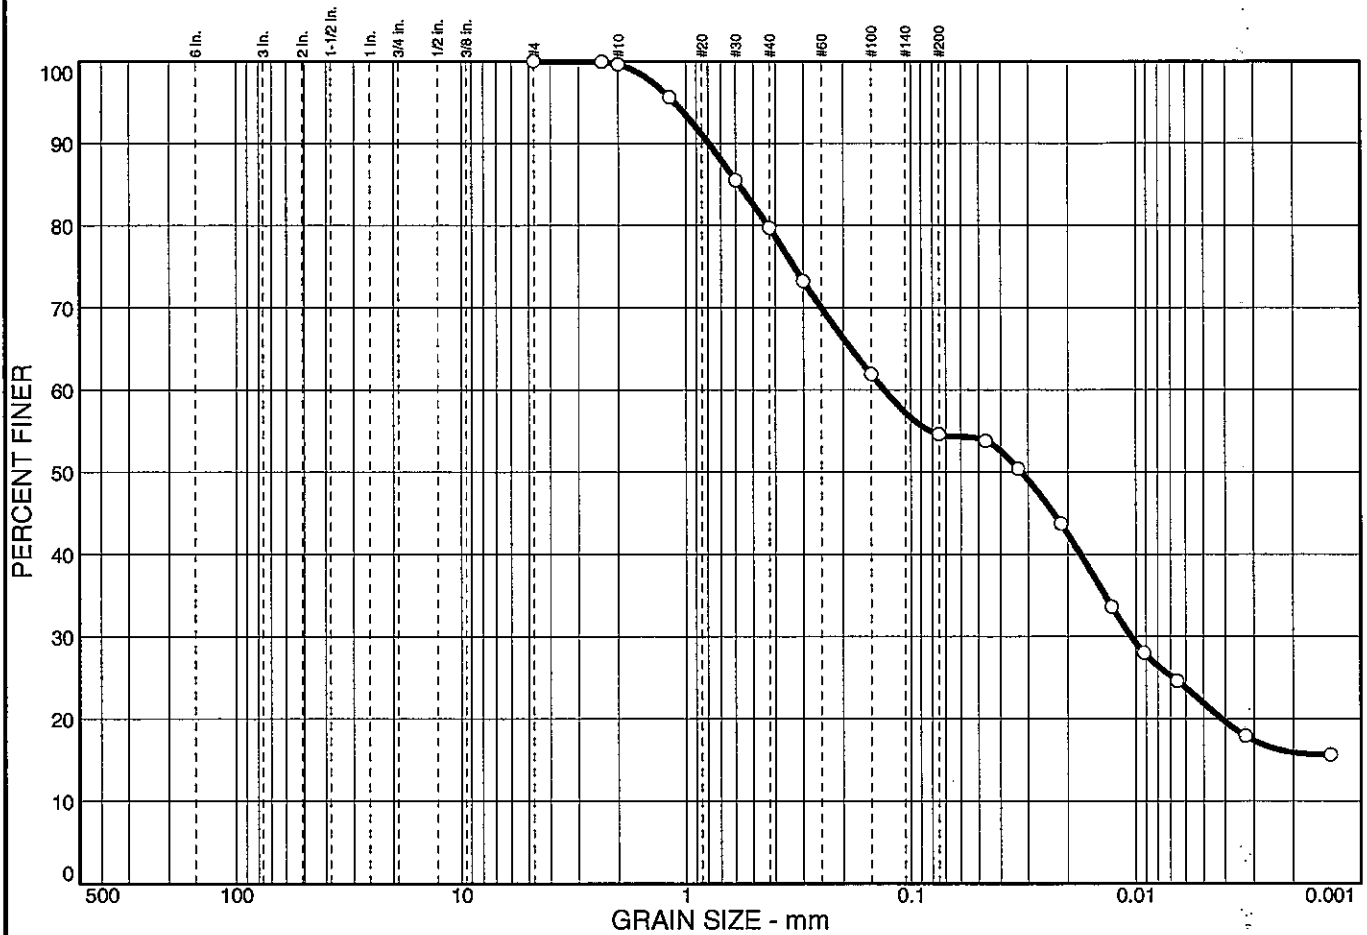
Lab# 8

% COBBLES	% GRAVEL	% SAND	% SILT	% CLAY
0.0	0.0	45.4	32.7	21.9

SIEVE SIZE	PERCENT FINER	SPEC.* PERCENT	PASS? (X=NO)
#4	100.0		
#8	99.9		
#10	99.6		
#16	95.6		
#30	85.5		
#40	79.7		
#50	73.2		
#100	61.9		
#200	54.6

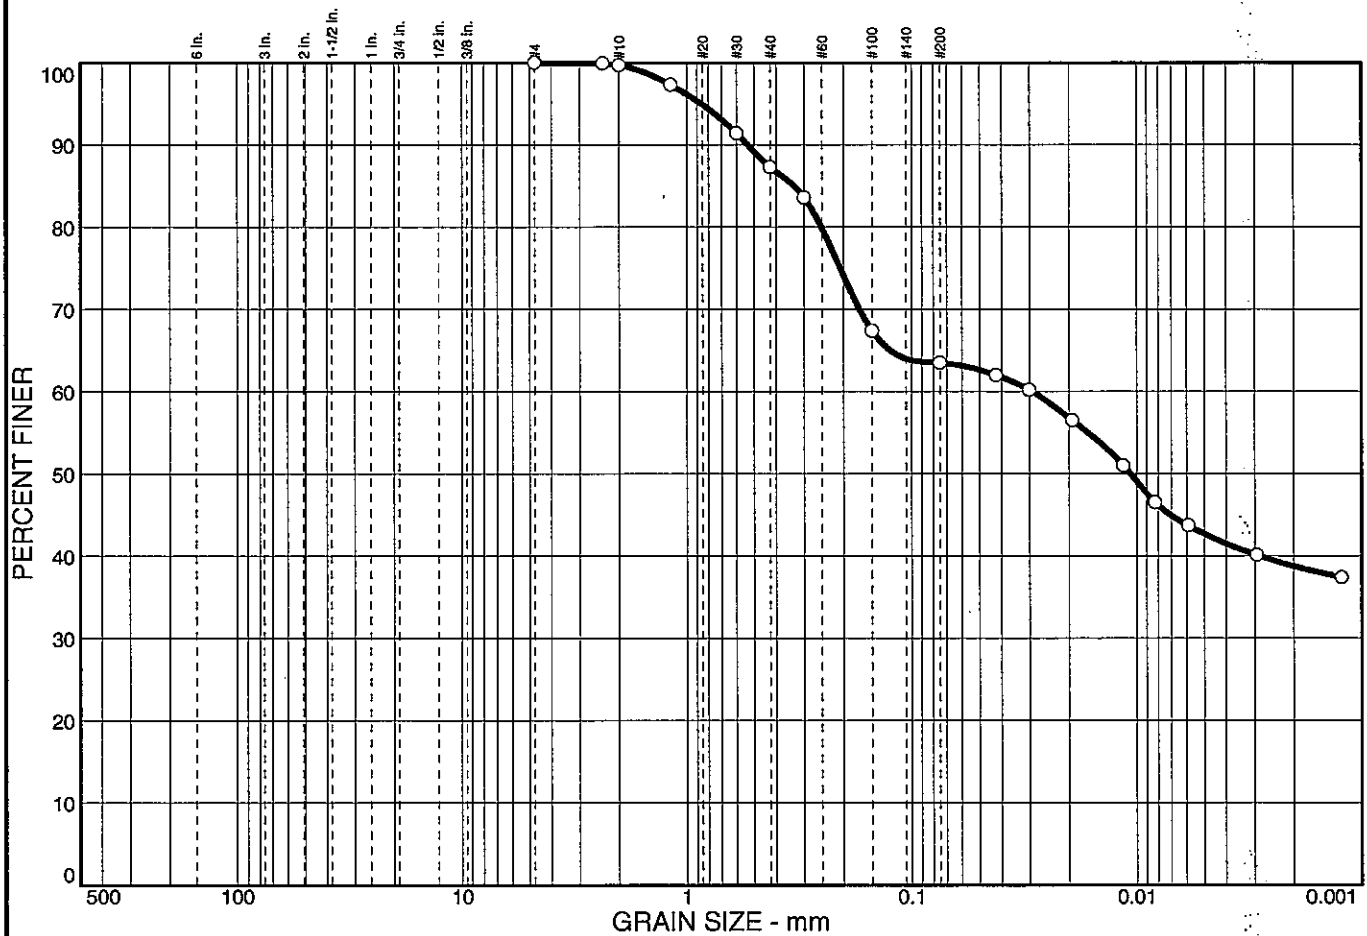
Lab# 11

% COBBLES	% GRAVEL	% SAND	% SILT	% CLAY
0.0	0.0	36.5	20.8	42.7

SIEVE SIZE	PERCENT FINER	SPEC.* PERCENT	PASS? (X=NO)
#4	100.0		
#8	99.9		
#10	99.7		
#16	97.3		
#30	91.4		
#40	87.3		
#50	83.6		
#100	67.4		
#200	63.5
