**Re: 2017 Annual CAMP Inspection Report  
Atlanta Gas Light Company  
Former Manufactured Gas Plant Site  
Rome, Georgia**

Attached please find the Annual Continuing Action Monitoring Plan (CAMP) Inspection for the Atlanta Gas Light Company (AGLC) Former Manufactured Gas Plant (MGP) site located 200 West 1st Street, Rome, Georgia (Site). This survey was completed in accordance with the *Continuing Action Monitoring Plan* dated August 2014 prepared by Burns & McDonnell. Pertinent Site features and the Type 4 and 5 areas included in the CAMP Inspection as shown on Figure 1 (attached). Please note that the wells indicated on Figure 1 were properly abandoned in 2015. Site conditions as observed in the August 2017 survey for the Type 5 and Type 4 parcels are summarized in Tables 1 and 2, respectively. Photographic documentation of Site conditions is included as an attachment.

**FIGURE 1**  
**VRP STANDARDS AND TYPE 5 AREAS**  
**ROME FORMER MGP SITE**  
**WEST 1ST STREET**  
**ROME, GEORGIA**

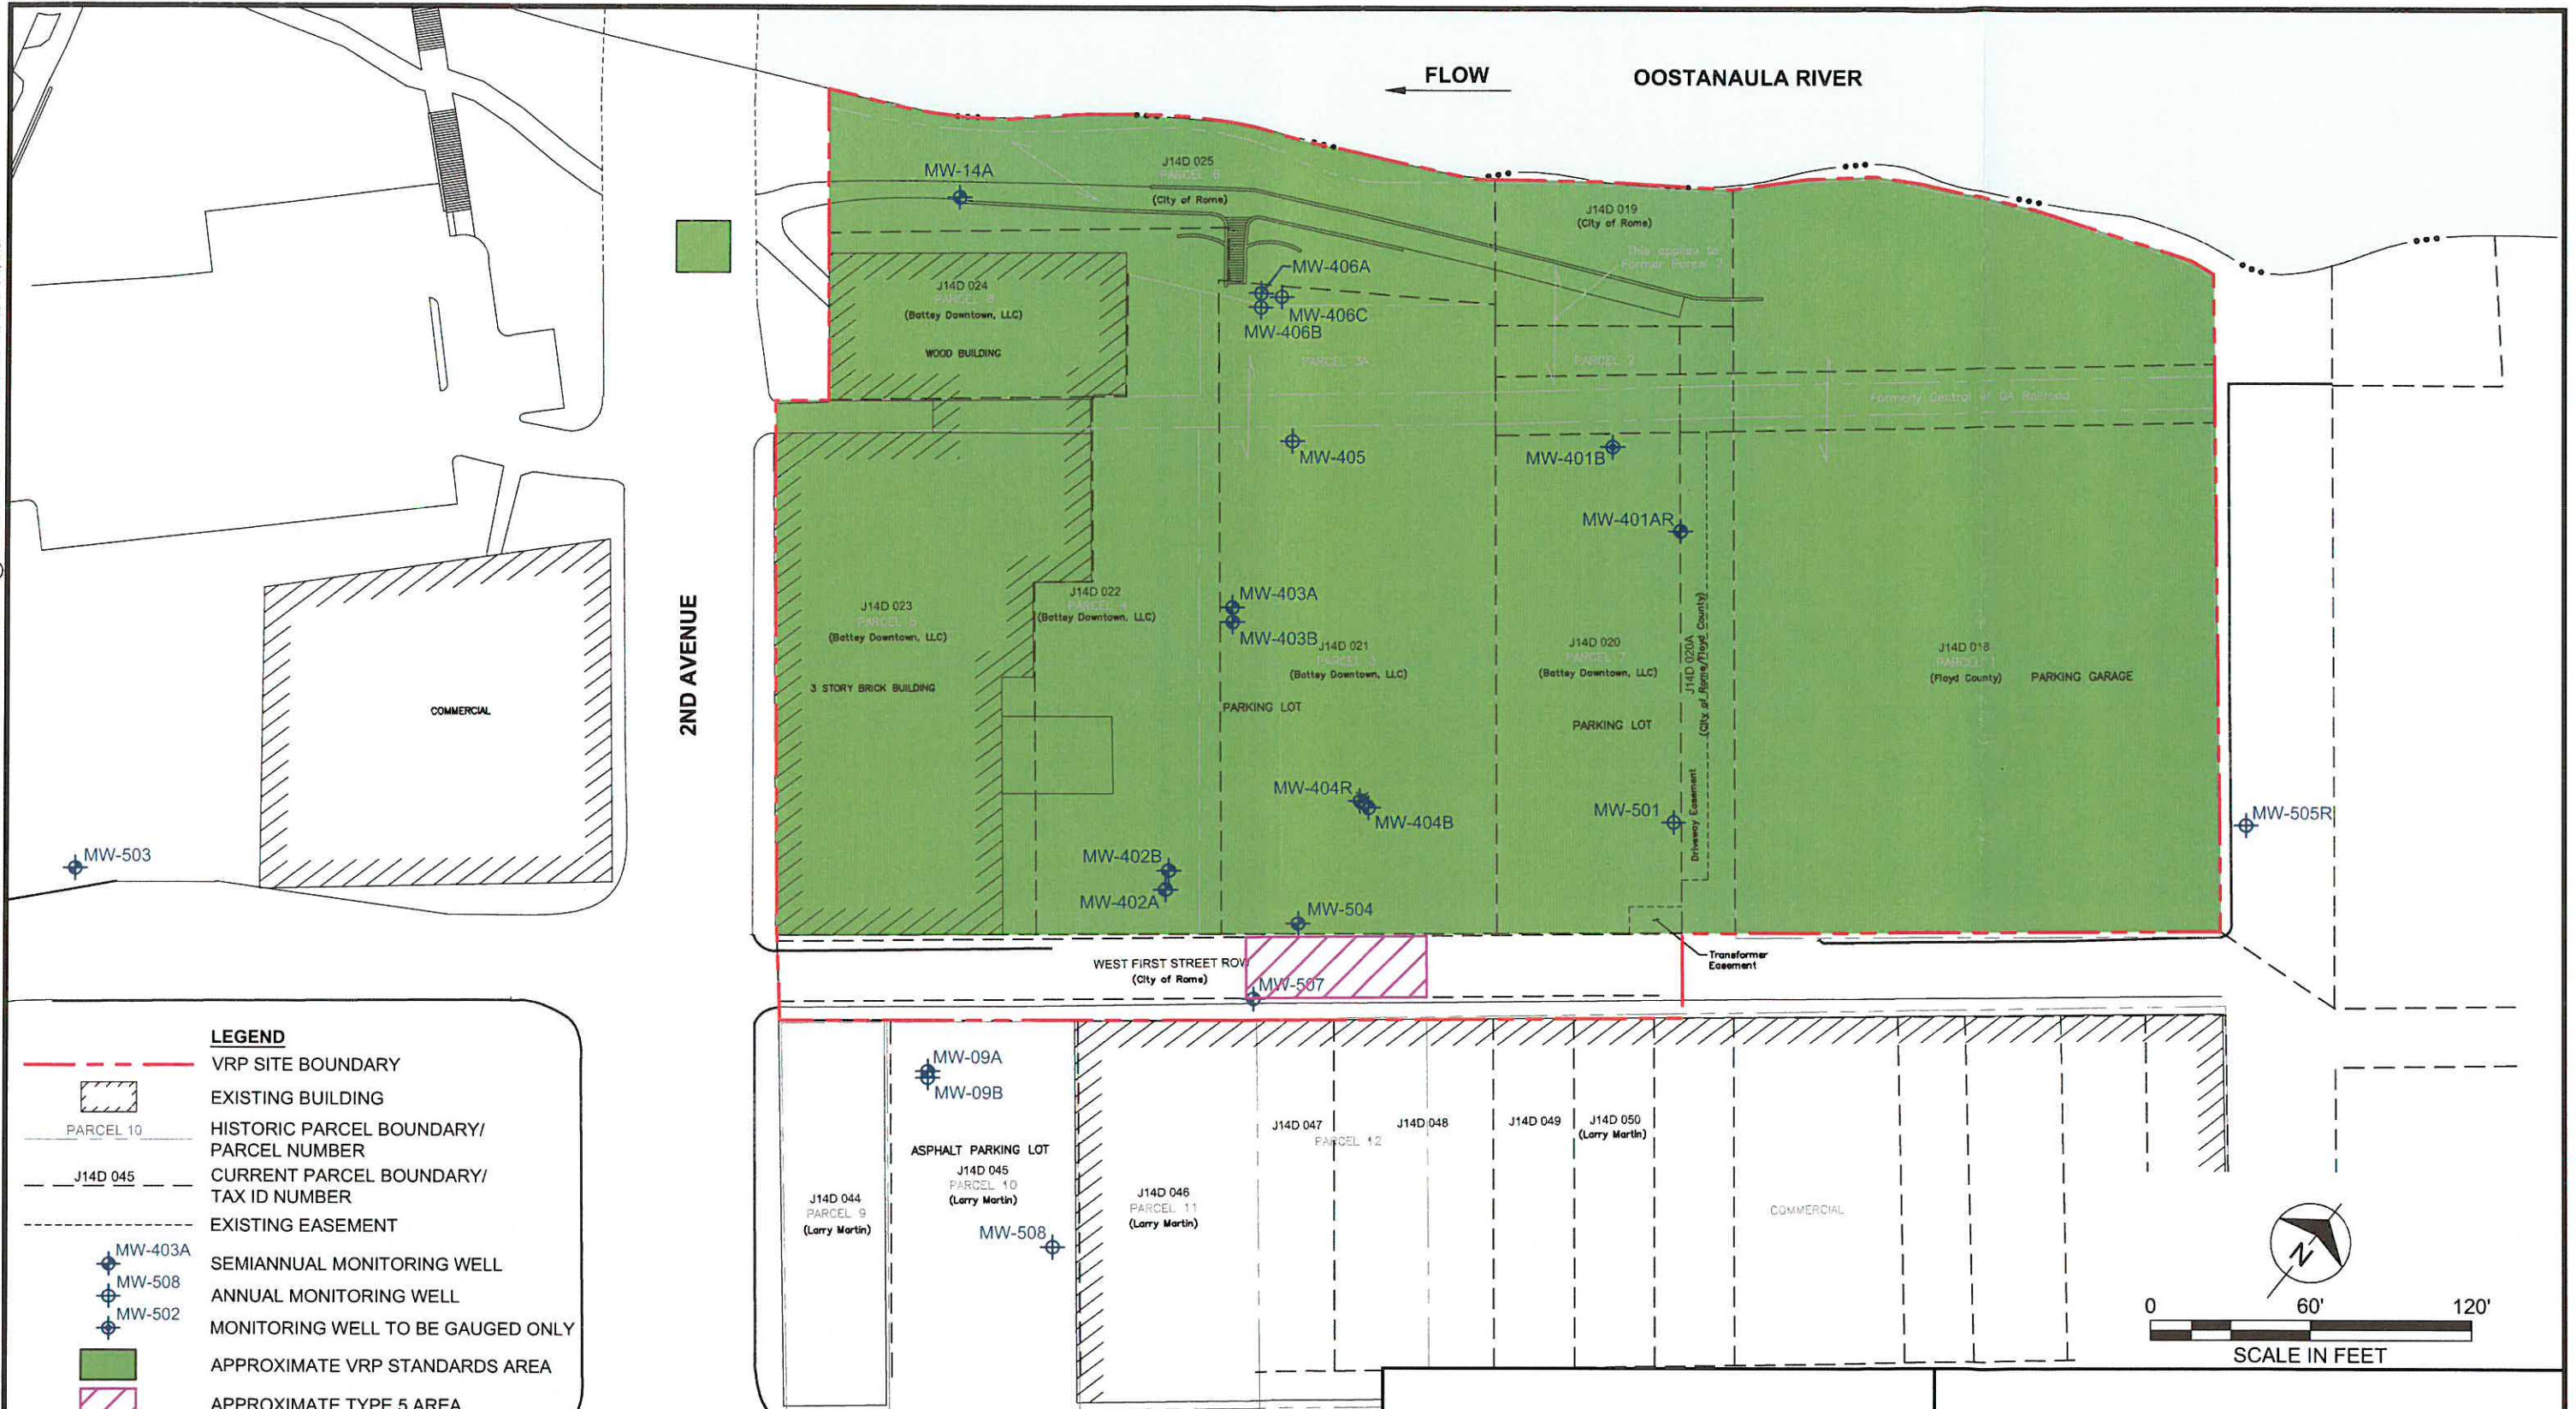
- NOTES:**
- MW-506 Monitoring well paved over by City of Rome
  - Wells designed without the letters "B" or "C" or with an "A" are Shallow Monitoring Wells (e.g. MW-406A, MW-404R, MW-503)
  - Wells designed with the letter "B" are Intermediate Monitoring Wells (e.g. MW-406B)
  - Wells designed with the letter "C" are Deep Monitoring Wells (e.g. MW-406C)
  - "Voluntary Remediation Program (VRP) Standards" refers to those properties that are in compliance with risk-based clean-up goals developed as part of the VRP remediation plan.

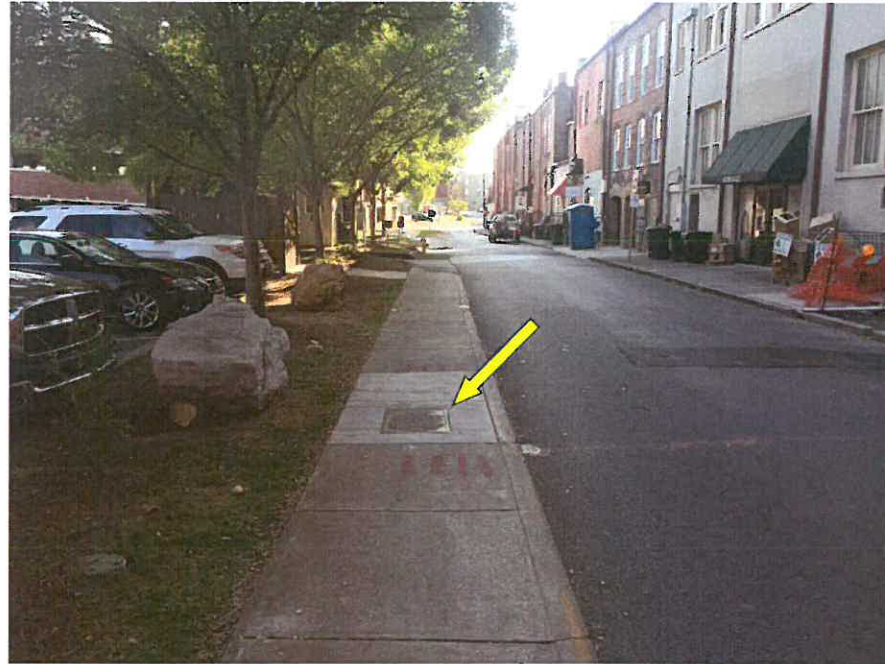
**Photo No.**  
**1**      **Date:**  
8/18/2017

West 1<sup>st</sup> Street and Right-of-Way.

New pavement where Type 5 Marker was installed. MW-507 abandoned in place

Good ground cover, no erosion

No disturbed asphalt

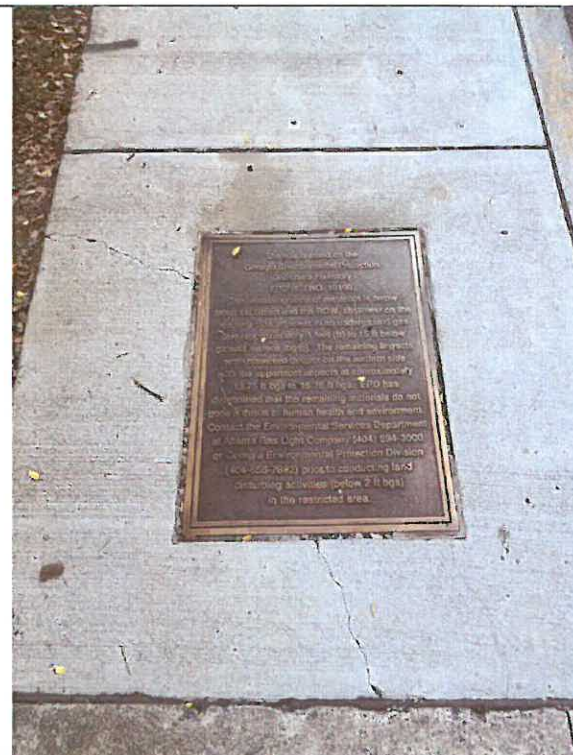
**Photo No.**  
**2**      **Date:**  
8/18/2017

Bronze Type 5 Marker installed July 2015

Marker in good condition

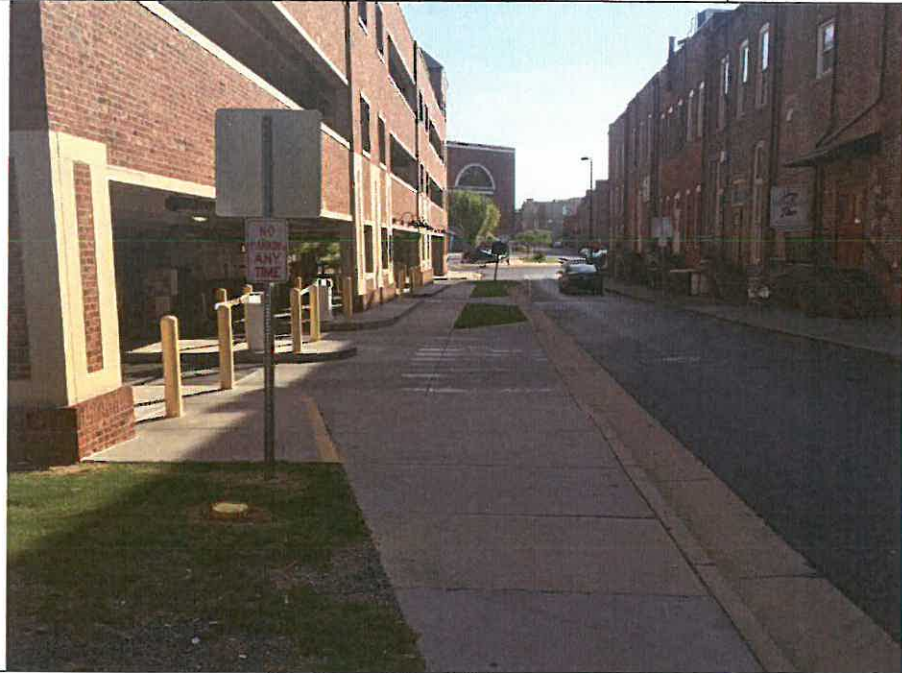
**Photo No.**  
**3**

Parcel 1 along West 1<sup>st</sup> Street

Parcel used as a parking lot

No groundwater use

No erosion concerns

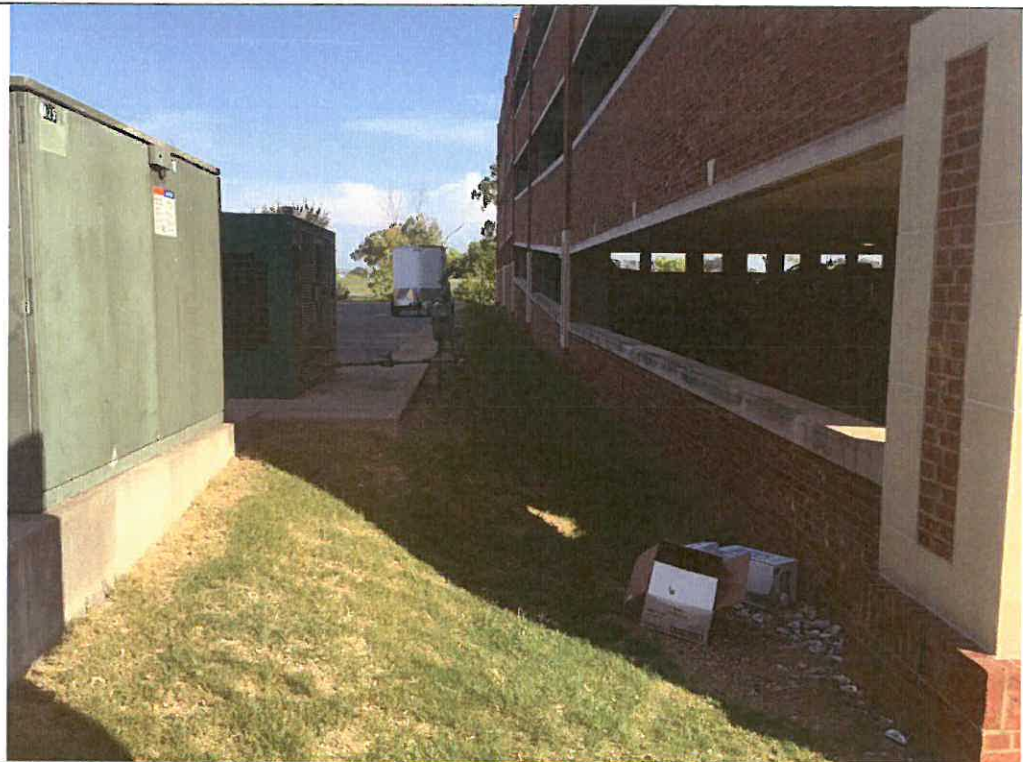
**Photo No.**  
**4**

Parcel 1 adjacent to Parcel 7

Parcel used as a parking lot

No groundwater use

Good grass cover - no erosion concerns

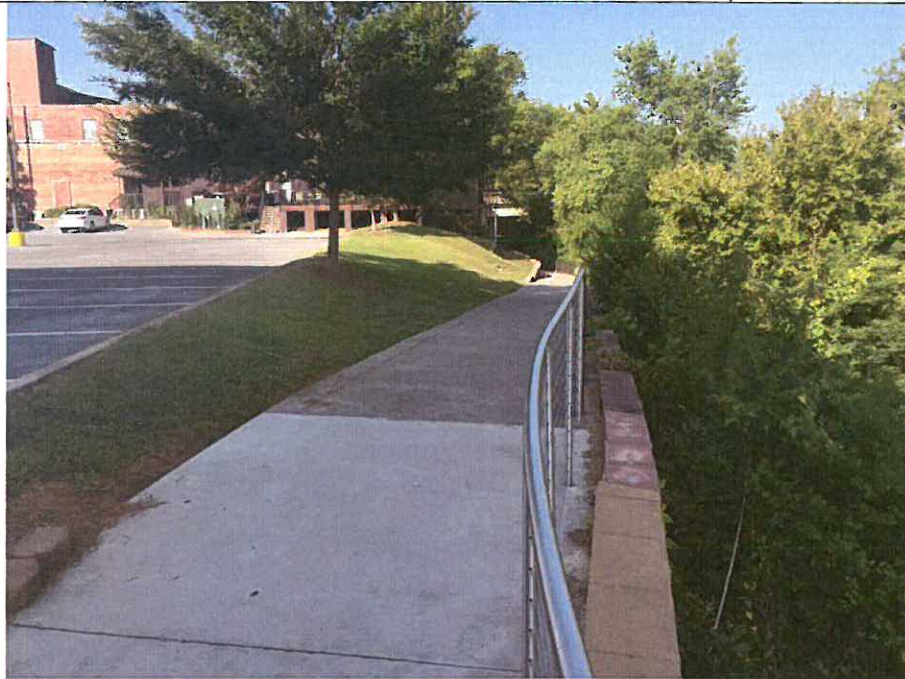
Photo No.  
**5**

Parcel 2 between  
riverbank and walking  
trail

No groundwater use

Good vegetation cover -  
no erosion concerns

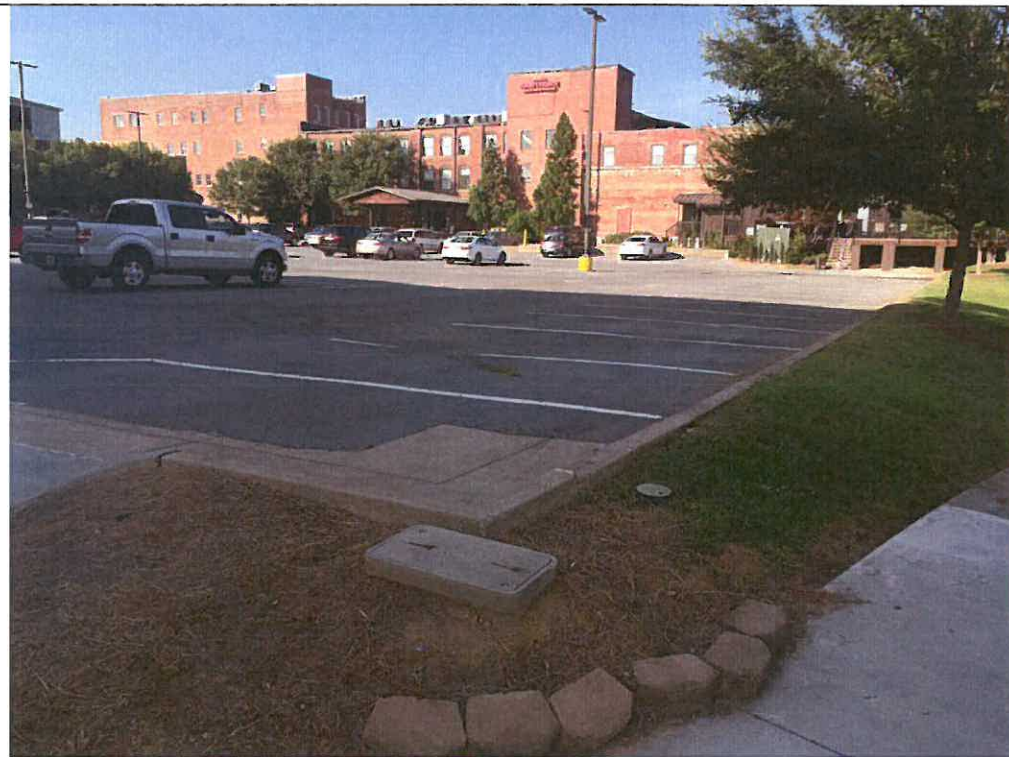
Photo No.  
**6**

Parcel 2 – Parking Lot

No groundwater use

Good grass/mulch  
cover on edge of  
parking lot - no erosion  
concerns

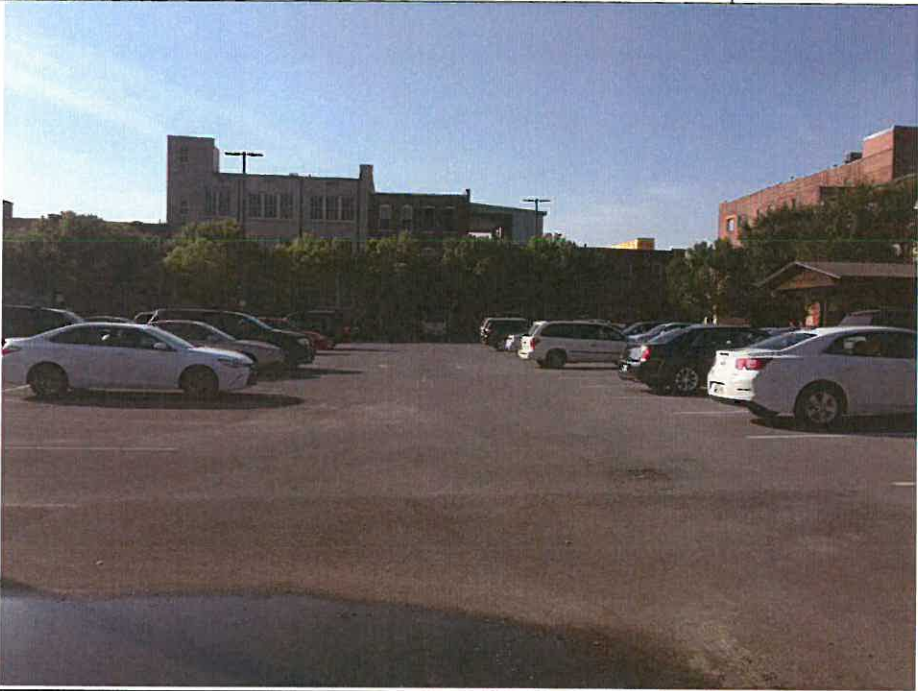
<b>Photo No.</b> 7	<b>Date:</b> 8/18/2017

<b>Direction Photo Taken:</b>  Facing SE		
<b>Description:</b>  Parcel 3 – Parking Lot  No groundwater use  Asphalt cover – no erosion concerns

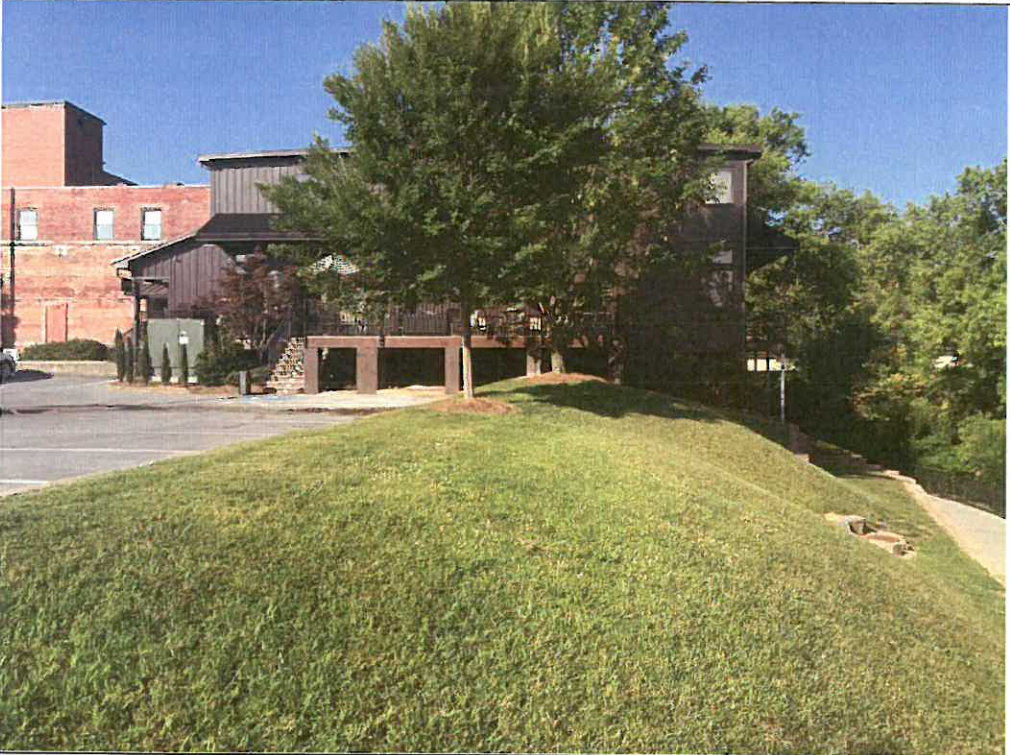
<b>Photo No.</b> 8	<b>Date:</b> 8/18/2017

<b>Direction Photo Taken:</b>  Facing SW		
<b>Description:</b>  Parcel 3A – Grass embankment north of parking lot  No groundwater use  Good grass cover - no erosion concerns

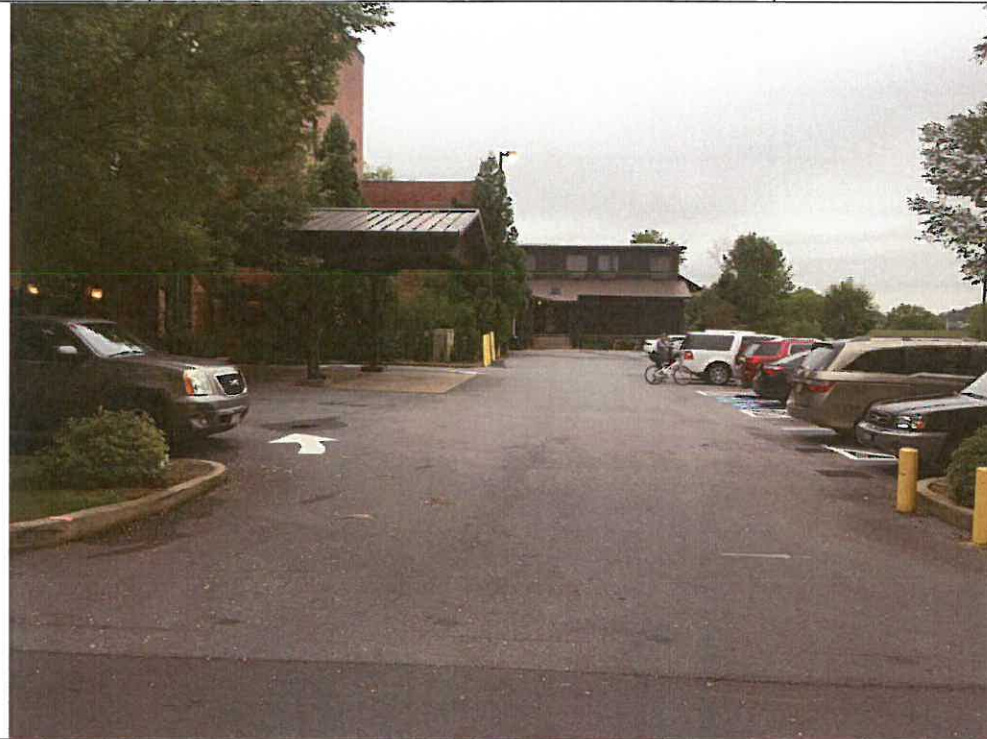
**Photo No.**  
**9**

Parcel 4 – Hawthorne Suites Parking Lot

No groundwater use

Asphalt cover – no erosion concerns

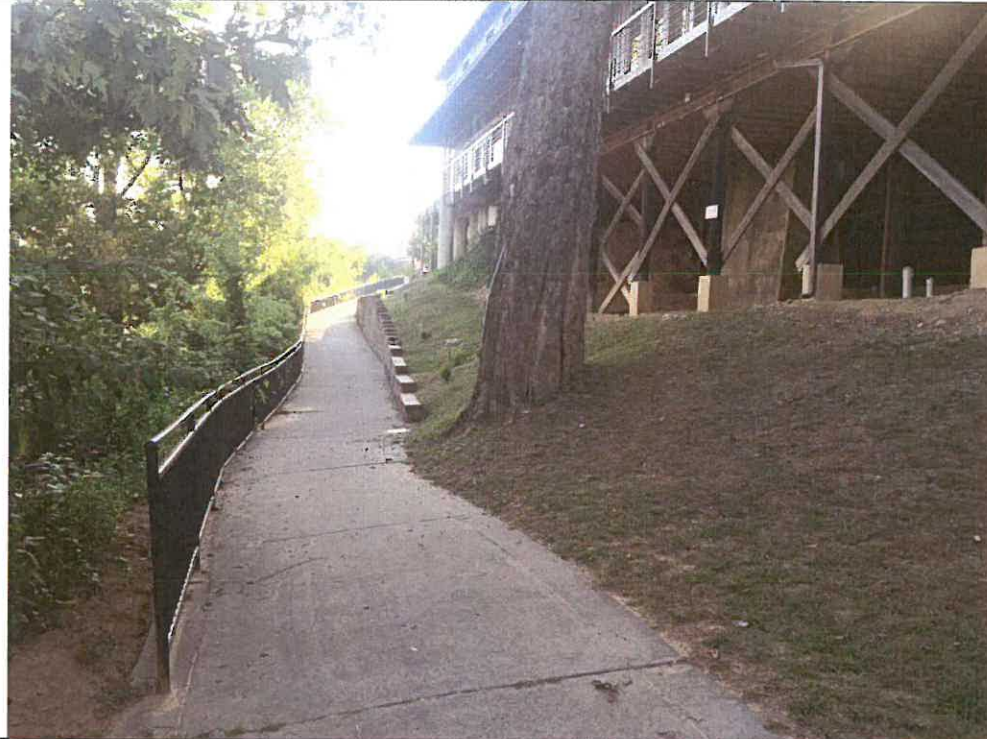
**Photo No.**  
**11**

Parcel 6 – NW of Hawthorne Suites

No groundwater use

Good grass cover - no erosion concerns

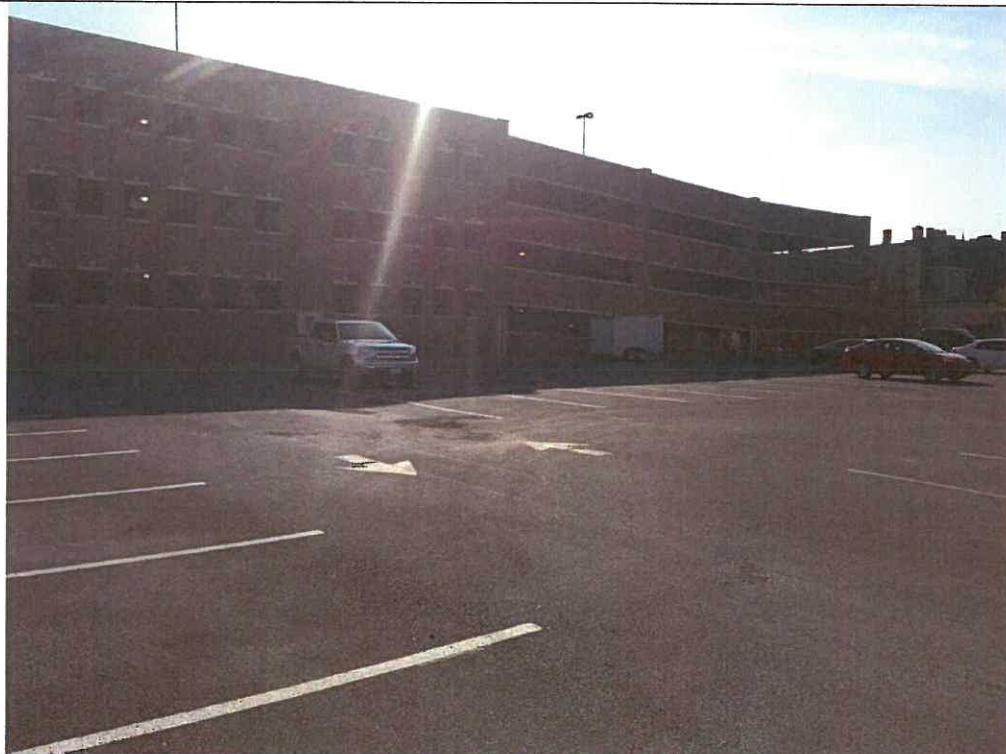
**Photo No.**  
**12**

Parcel 7 – Parking Lot

No groundwater use

Asphalt cover – no erosion concerns

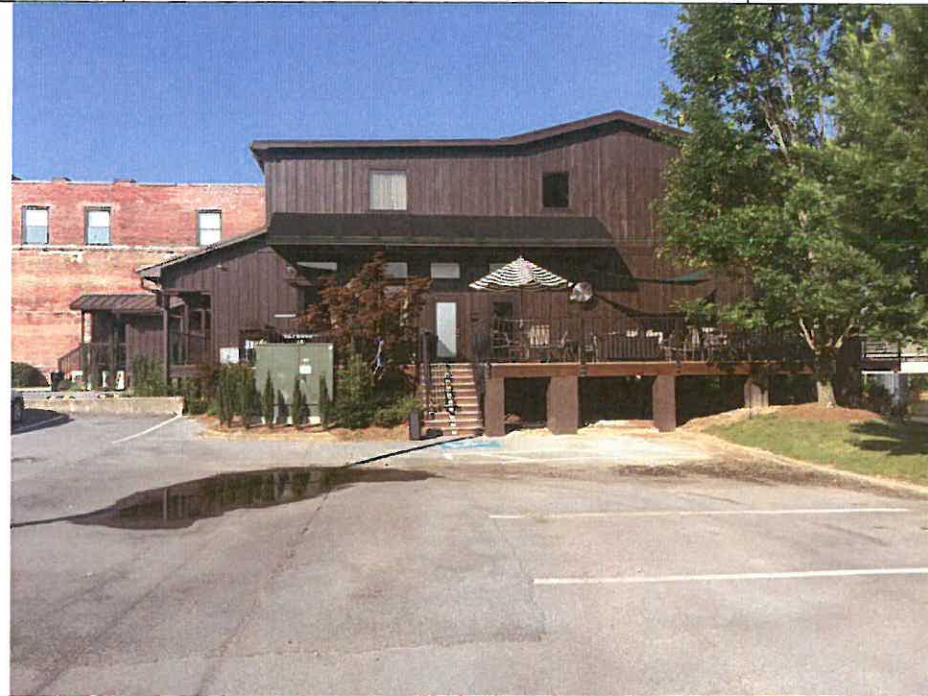
Photo No.  
**13**

Parcel 8 –wooden  
building used as hotel  
space

Not in residential use

No groundwater use

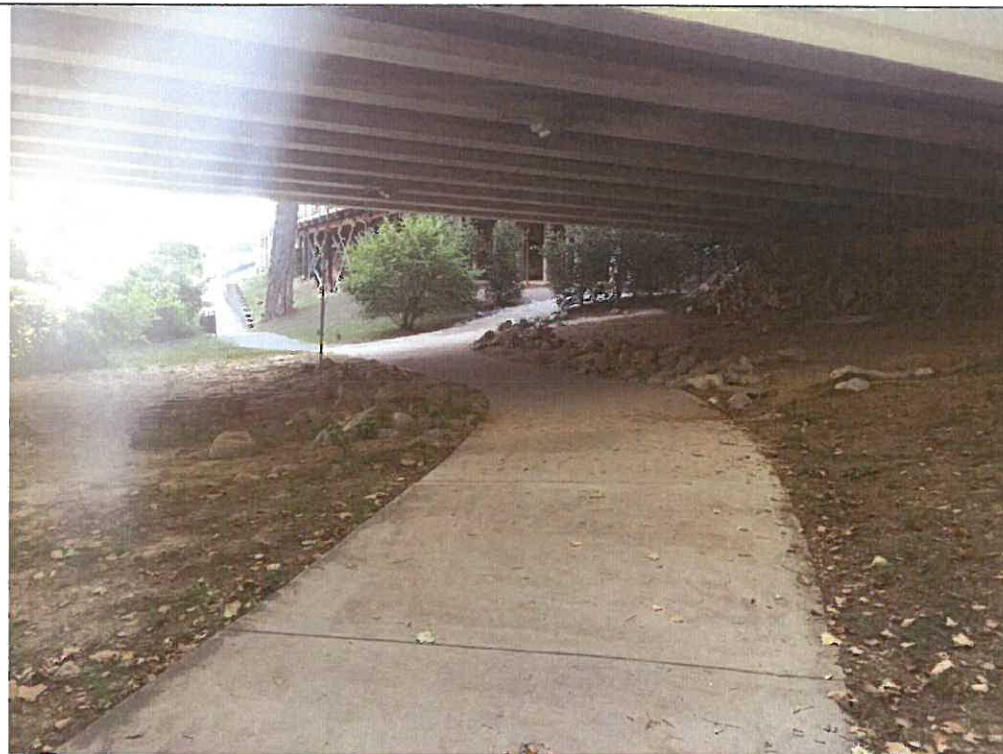
Photo No.  
**14**

All information included within this CAMP Inspection Report is based on a visual inspection of the Site conducted on August 18, 2017. No action is required at this time based on the survey. The right-of-way (ROW) beneath the 2<sup>nd</sup> Avenue Bridge had some bare soil but no signs of erosion as cobbles placed in the area appear to be providing sufficient cover. AGLC will continue monitoring for signs of erosion.

ROW under 2<sup>nd</sup> Ave  
Bridge

No visible signs of  
erosion – some bare  
soil but rock cover  
appears to be  
preventing any erosion

Continue to monitor for  
signs of erosion
