**Nine-Element Watershed Management Plan
for the
Augusta Canal (HUC-12 #030601060601)
Butler Creek (HUC-12 #030601060602)
and
Beaverdam Ditch (HUC-12 #030601060607)
Watersheds
in Savannah River Basin**

**Augusta-Richmond County
Columbia County**

July 2018

**Environmental Protection Division of the Department of Natural Resources,
State of Georgia**

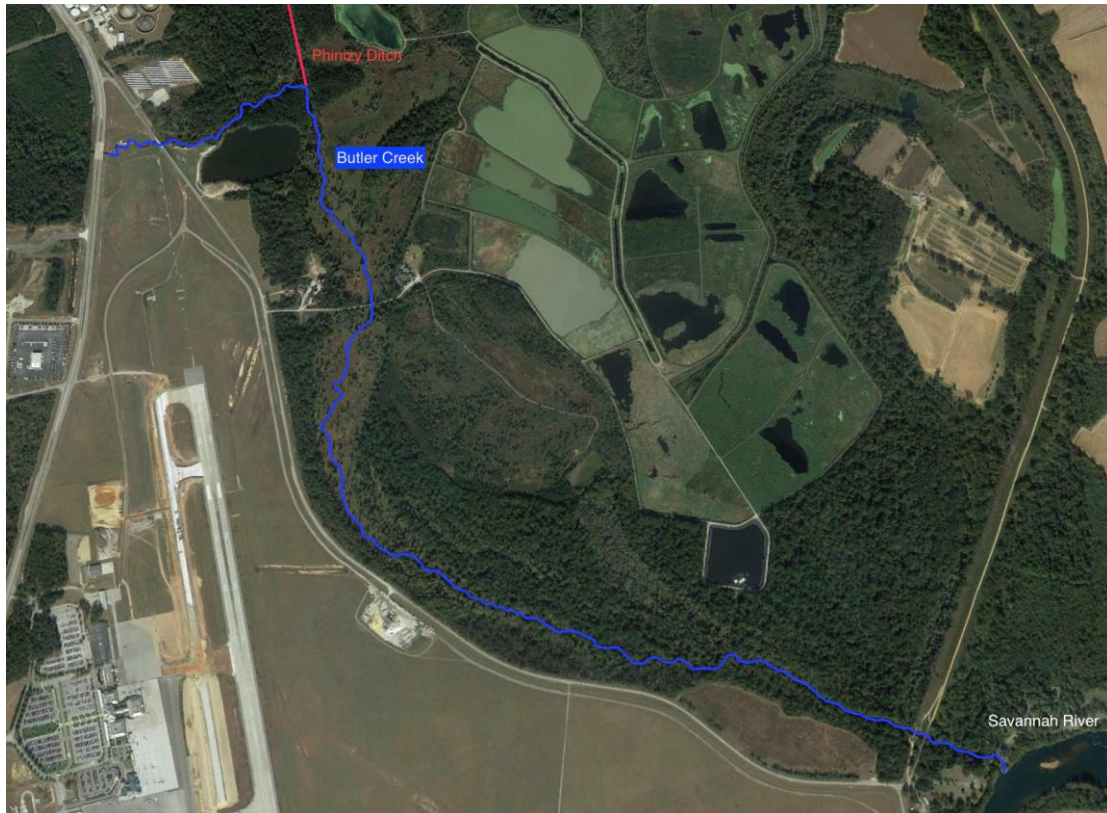
Figure 1: Butler Creek (in blue) from its confluence with Phinizy Ditch (shown in red) to the Savannah River is listed as not meeting FC criterion.

Constructed wetland cells receive tertiary-treated wastewater from the Augusta-Richmond Messerly Water Treatment Plant. These cells can be distinguished in the aerial photograph shown in Figure 1. Water flowing through the wetland cells collects in a final pond and is discharged via a short ditch into Butler Creek at a location 100 yards from its confluence with the Savannah River.
