# **Watershed Management Plan**

## **Brooklyn Creek**

**The Unified Government of Athens-Clarke County**

**December 2010**

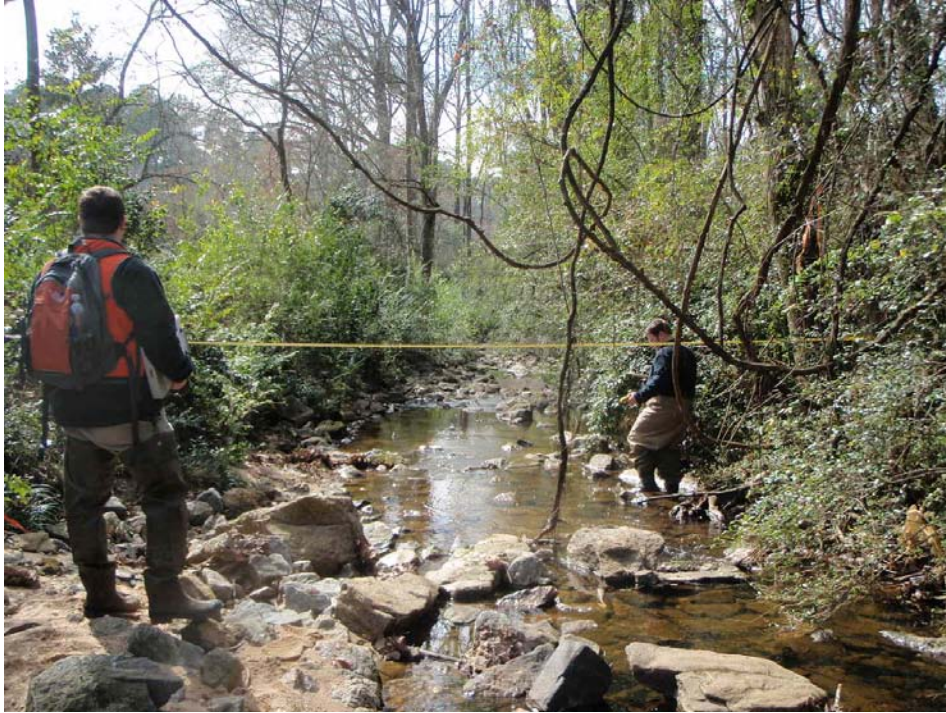
***Photo 3.1.1.1: Stream Assessment of Brooklyn Creek – Taking Bed, Bank, and Buffer Measurements***

Brooklyn Creek near Milledge Circle

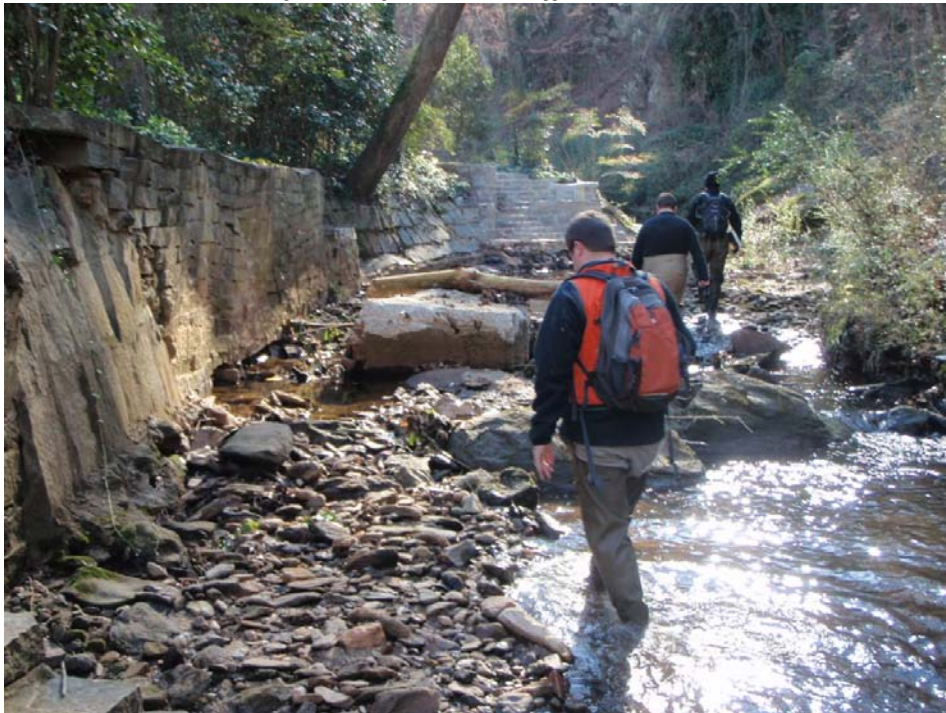
***Photo 3.1.1.2: Stream Assessment of Brooklyn Creek – Buffer Removed to Construct Retaining Wall***

Brooklyn Creek near Fortson Road

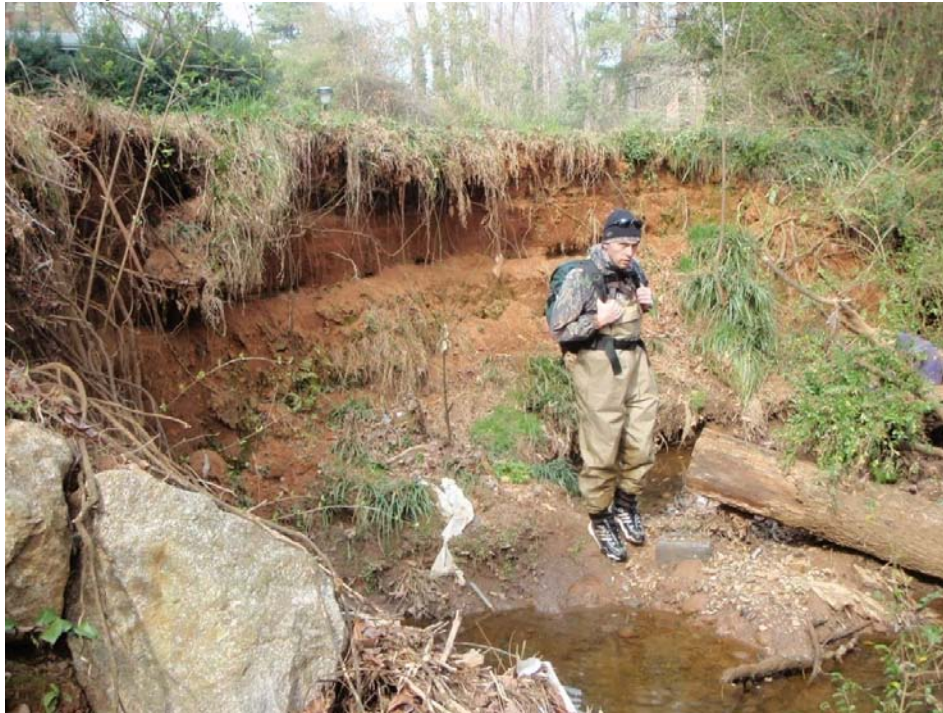
***Photo 3.1.1.3: Heavily Eroded Stream Bank***

Brooklyn Creek near Dudley Drive

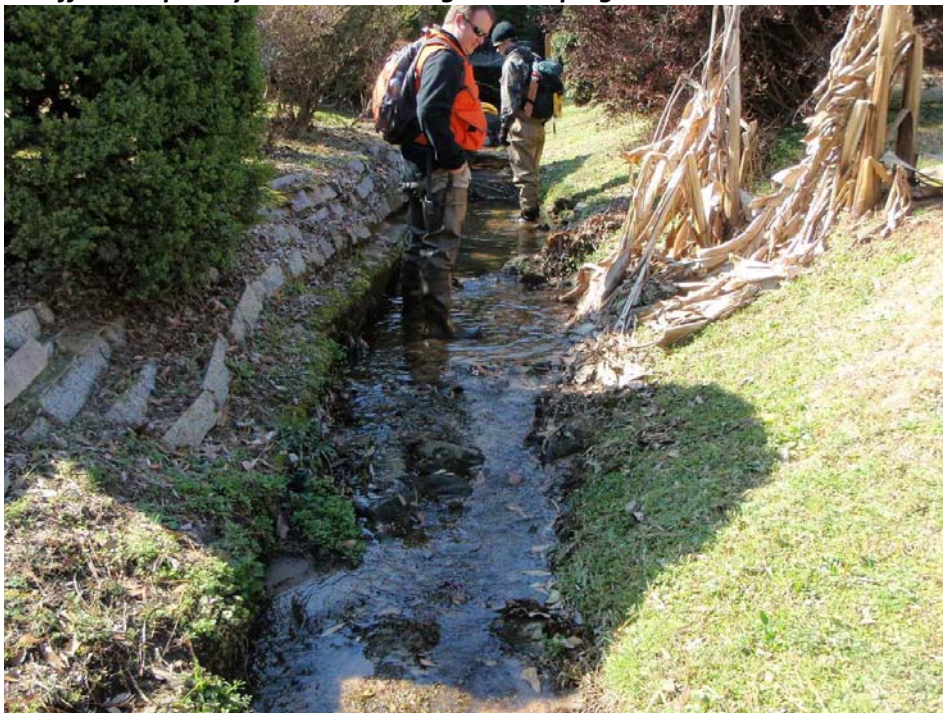
***Photo 3.1.1.4: Buffer Completely Removed During Landscaping***

Brooklyn Creek near King Avenue

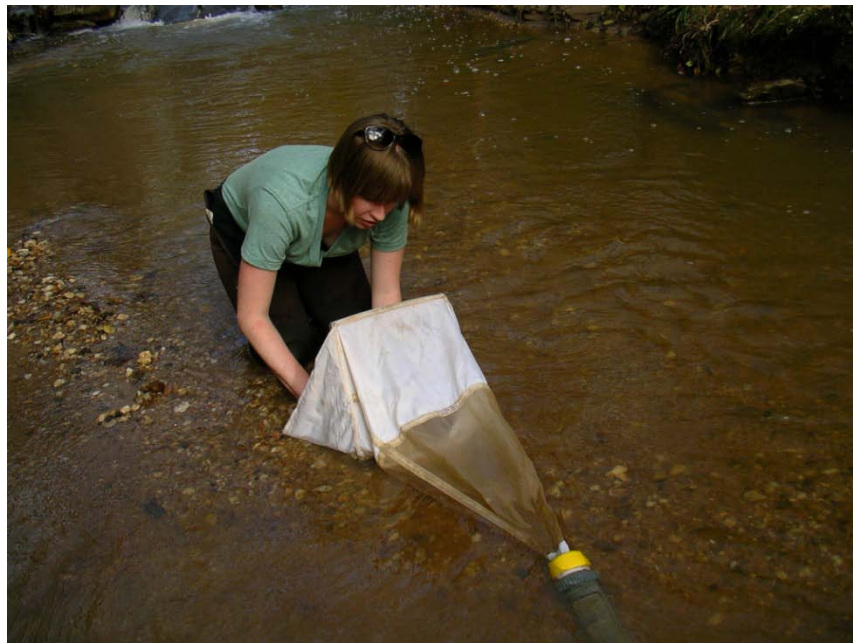
***Photo 3.2.1.2: Macroinvertebrate Sampling***

Macroinvertebrates were collected at three stream sites in Brooklyn Creek, shown in Figure 3.2.2.1, in March of both 2008 and 2009 using a rapid assessment protocol, which is a time saving but scientifically sound way of collecting macroinvertebrate samples. The results from the sampling sites were scored using the *Save Our Streams Program* of the Izaak Walton League of America, which is based on the presence or absence of “sensitive,” “somewhat sensitive,” and “tolerant” types of macroinvertebrates. Numerical scores were used to indicate water quality (excellent > 22, good = 17-21, fair = 11-16, poor < 11).

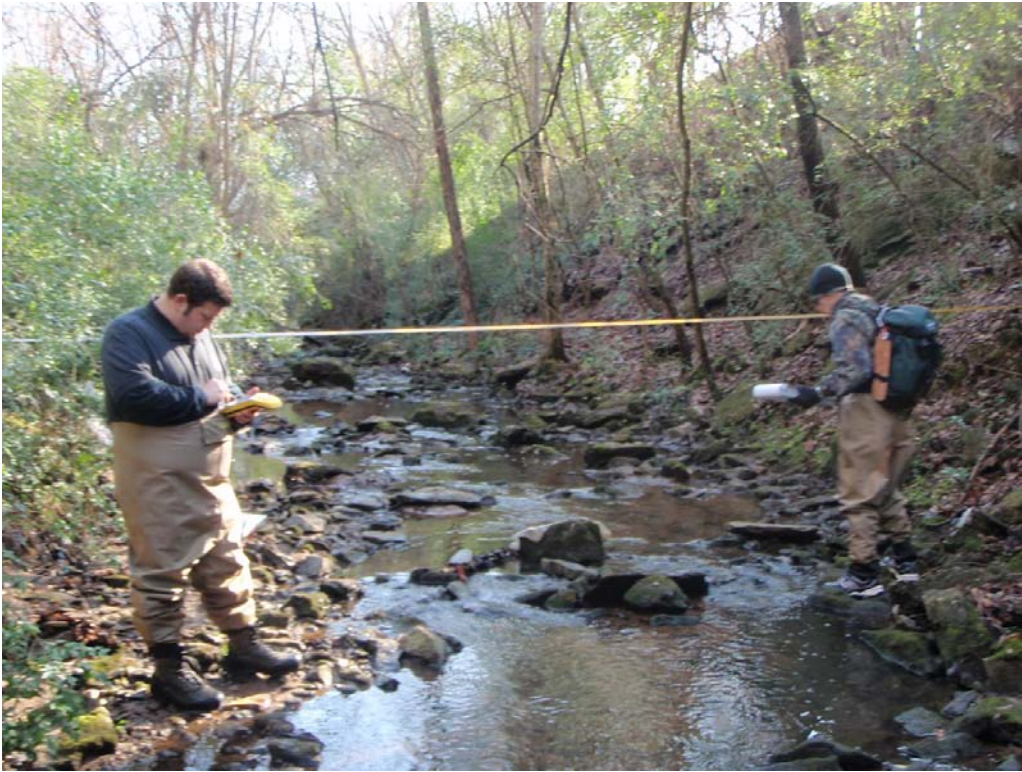
***Photo 3.2.4.1: Good Stream Habitat***

Photos 3.2.4.1 and 3.2.4.2 provide a comparison between good and poor stream habitat. In Photo 3.2.4.1, cobble is present in the bed and there is leaf litter that provides habitat and food for macroinvertebrates. In Photo 3.2.4.2, the bed is choked by sand and the heavily eroded banks provide no habitat.

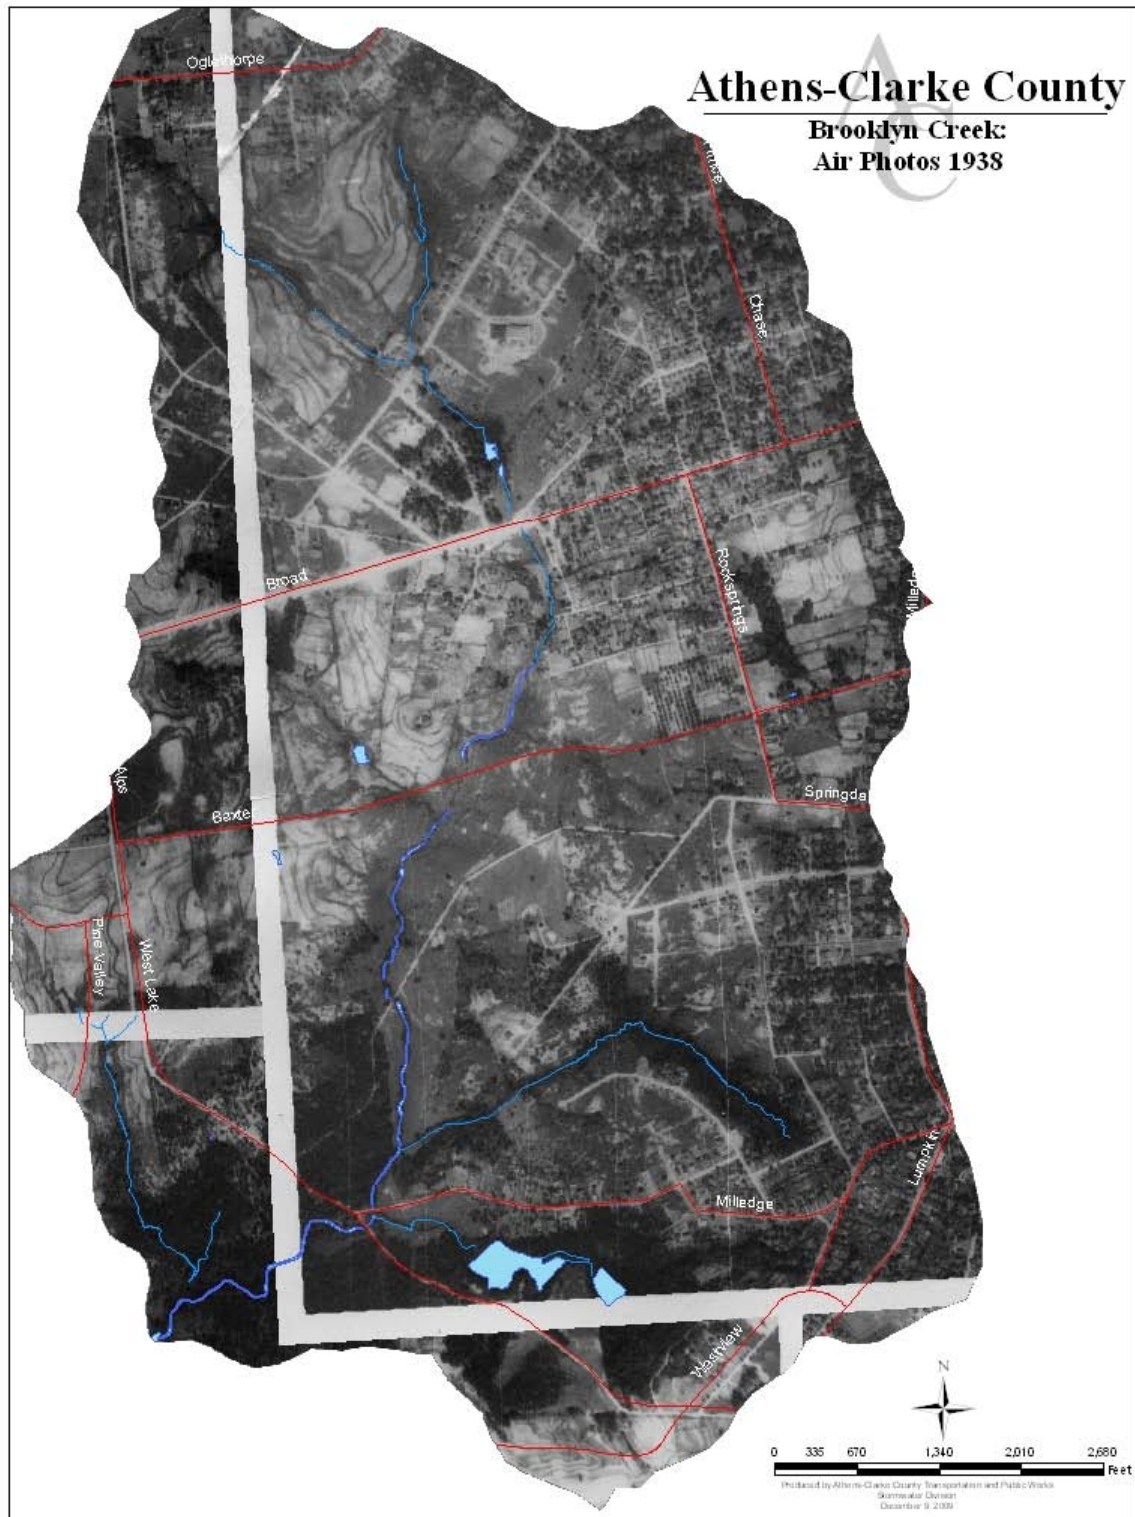
**Figure 3.2.4.1: Brooklyn Creek: 1938**

Brooklyn Creek in 1938. Much of the western part of the basin is agricultural, while residential development is occurring in the eastern and southern portions of the watershed.

Since excess sediment in the stream is the main cause of the stream bed aggradation, it's important to determine where that extra sediment might be coming from. When considering the impacts of sediment, we need to look not only at what is happening in Brooklyn Creek right now, but also at what went on in the Brooklyn Creek basin regarding land use in the past. Review of historical aerial photography (Figures 3.2.4.1 and 3.2.4.2) shows that the Brooklyn Creek basin area was primarily used for agriculture as far back as the early 1800's up until the 1950's. Maps of this area from the 1960s, Figure 3.4.2.3, show further development including multifamily housing in the northern sections of the watershed and low density housing replaced the remaining agricultural areas in the southern sections. By the 1970's and 1980's residential areas dominated the land use of this basin with increasing number of multifamily units built to accommodate the growing University of Georgia population. The effects of past agricultural use on the land often continue to impact local streams even 50 to 100 years after agricultural practices have been abandoned, manifesting as physical and chemical problems in streams (MacTammany, 2004). Refer to the following historical maps to see how land use has changed over time in Brooklyn Creek.

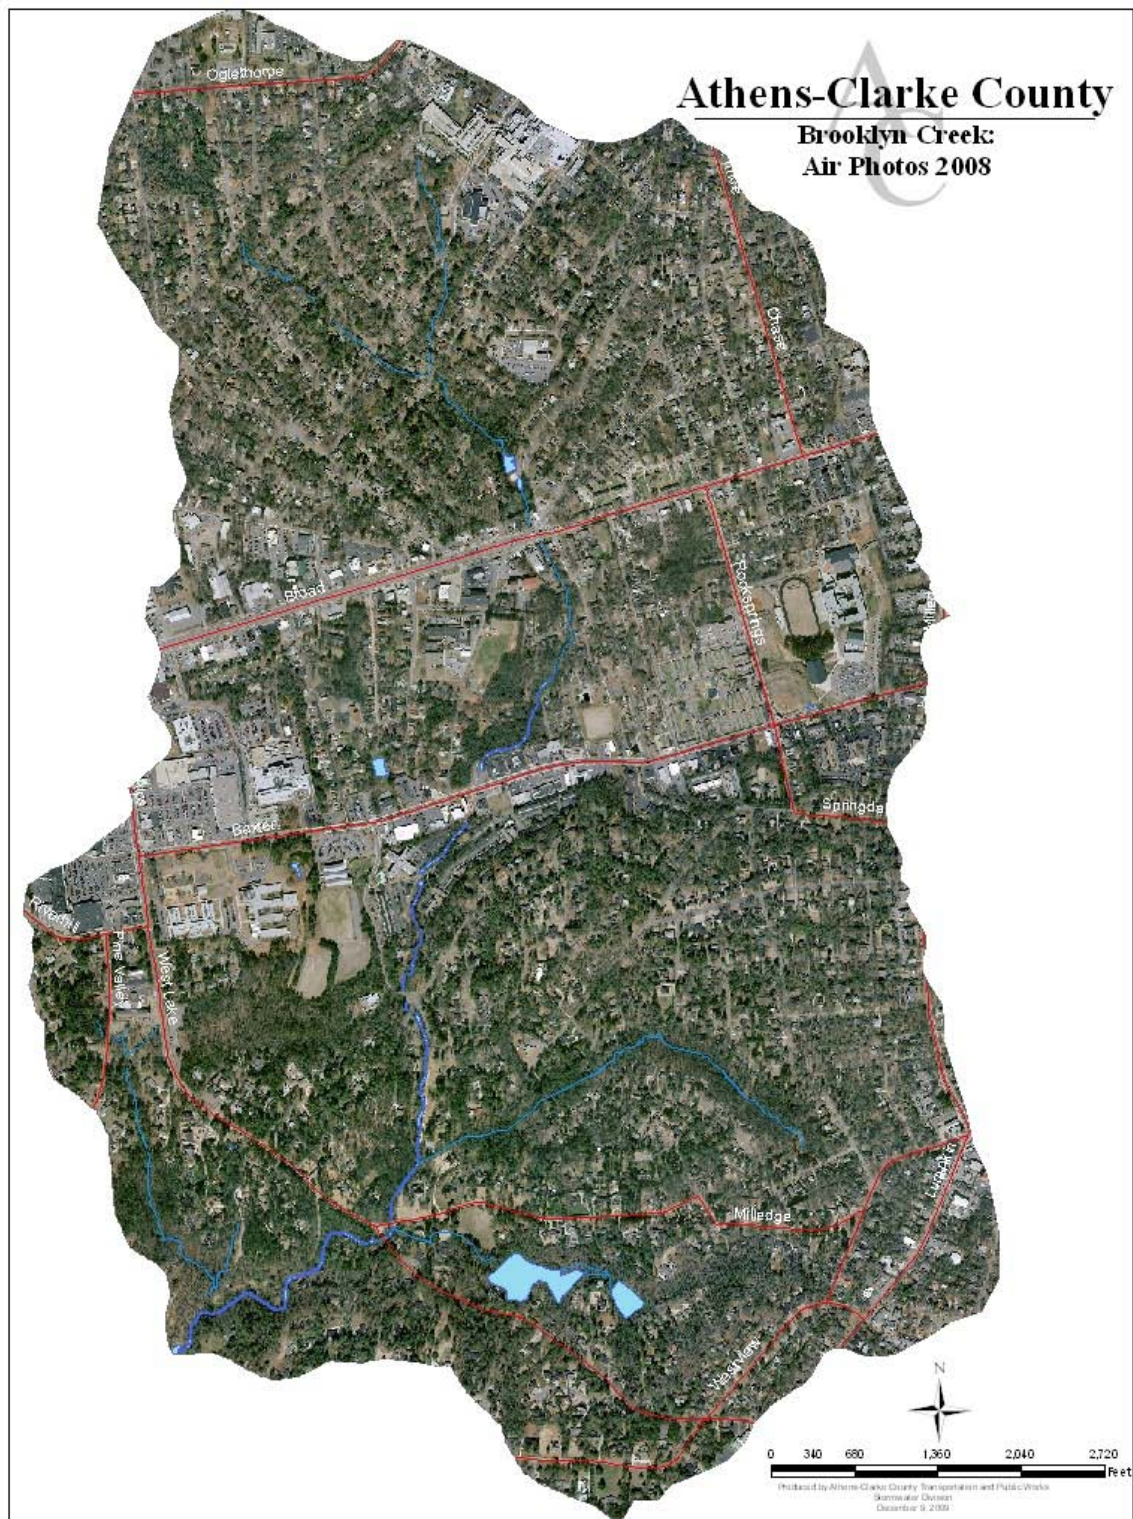
**Figure 3.4.2.4: Brooklyn Creek: 2008**

Brooklyn Creek in 2008. The watershed is largely developed with both commercial and residential development, including the Beechwood Shopping Center, three schools and ARMC hospital.

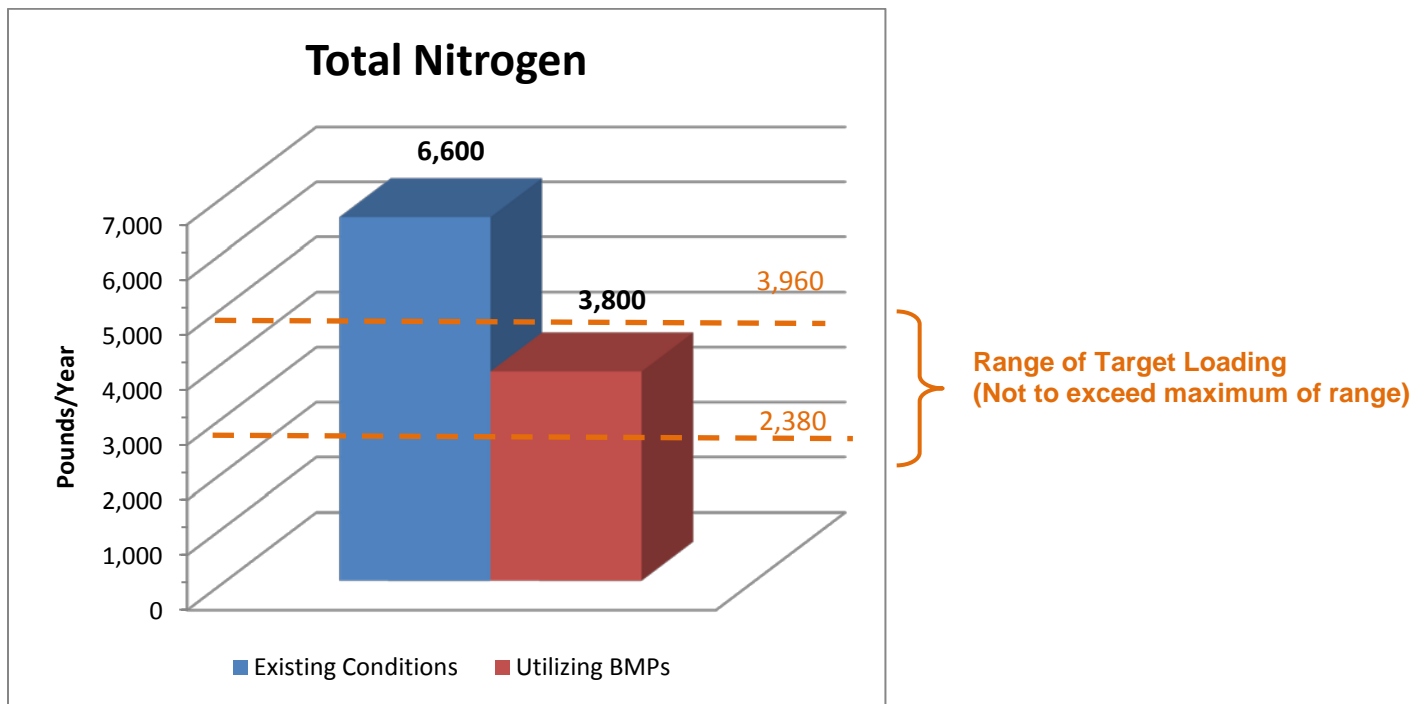
**Figure 4.4.3.1 Total Nitrogen Anticipated Load Reductions**

The watershed improvement strategy in Brooklyn Creek uses centralized BMPs (on publically owned parcels) and distributed BMPs in the most developed, mid-portion of the watershed to reduce pollutant loading, as well as additional water quality BMP retrofits in the remaining watershed catchment areas. These BMPs are also designed to halt upstream and downstream flow impacts. This strategy produces a 43 percent reduction in TN, a 44 percent reduction in TP, and a 27 percent reduction in TSS. Figures 4.4.3.1 through 4.4.3.3 display the load reductions for these constituents. Figures 4.4.3.4 through 4.4.3.6 demonstrate how pollutant loading changes in each catchment of the watershed.

The modeling results below are reported in several ways. First, there are bar graphs comparing annual pollutant loading under existing conditions, the moderate and aggressive strategies, and the target pollutant loading needed to achieve water quality benchmarks. Second, watershed maps compare catchment loading under existing, moderate and aggressive management strategies. As the watershed improvement BMPs are implemented, it will be important to monitor stream conditions to determine how the load reductions achieved affect water quality compared to the water quality benchmarks (to be discussed in Section 4.6).
