Chattanooga Creek

WATERSHED MANAGEMENT PLAN

June 2022

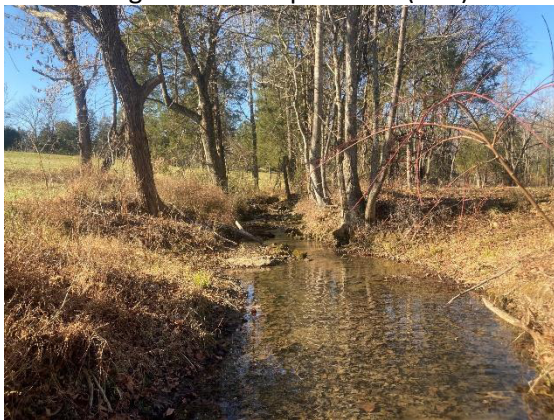
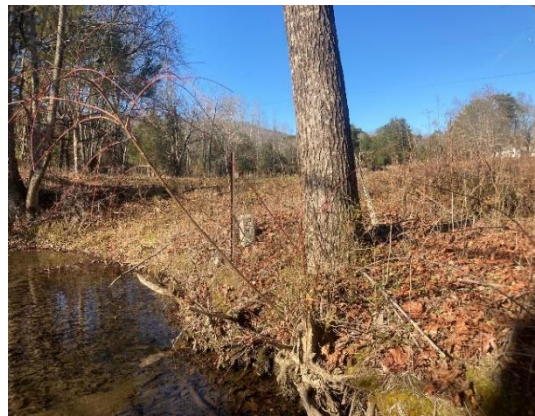
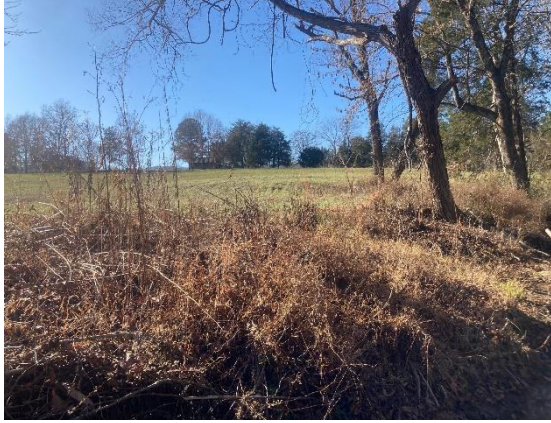
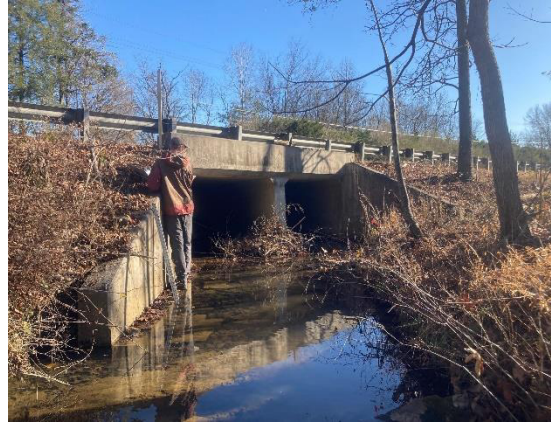
Chattanooga Creek Sample Site 1 (CC1)

found in Attachment C. The visual survey habitat rankings, pebble count results, and photos for each site are shown below.

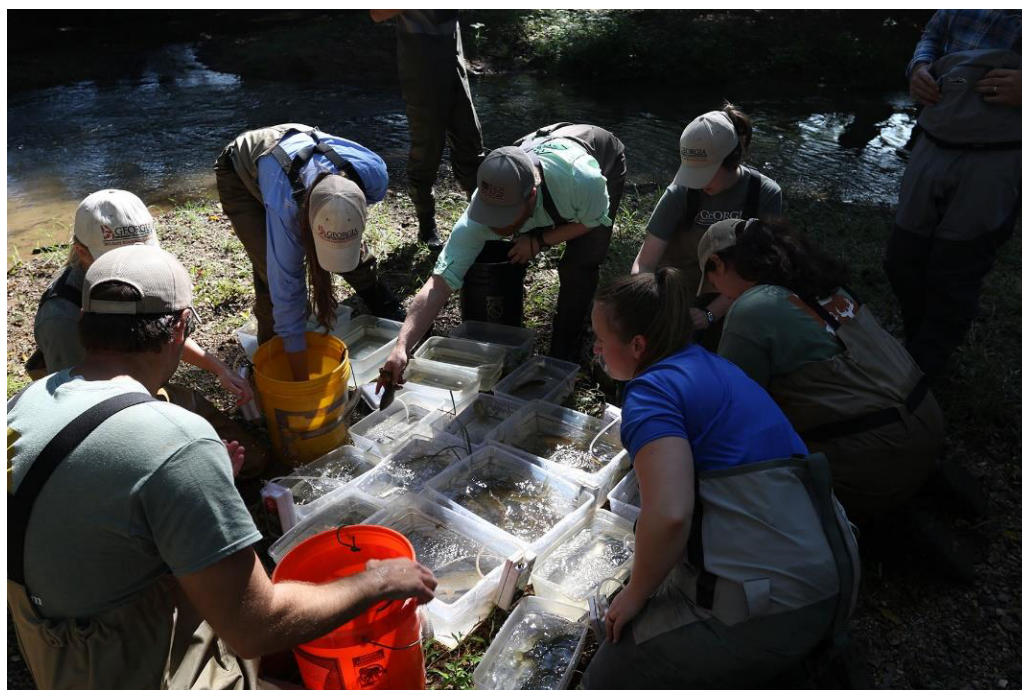
Figure 6 – Fish Sample Collection for IBI Study

A total of 18 fish species in 8 families were collected, 17 of them native species. Total number of individuals was 209, with one redhorse sucker not identifiable to species and not used in IBI analyses. Overall IBI score for Chattanooga Creek was 34, with a ranking as “Fair”.

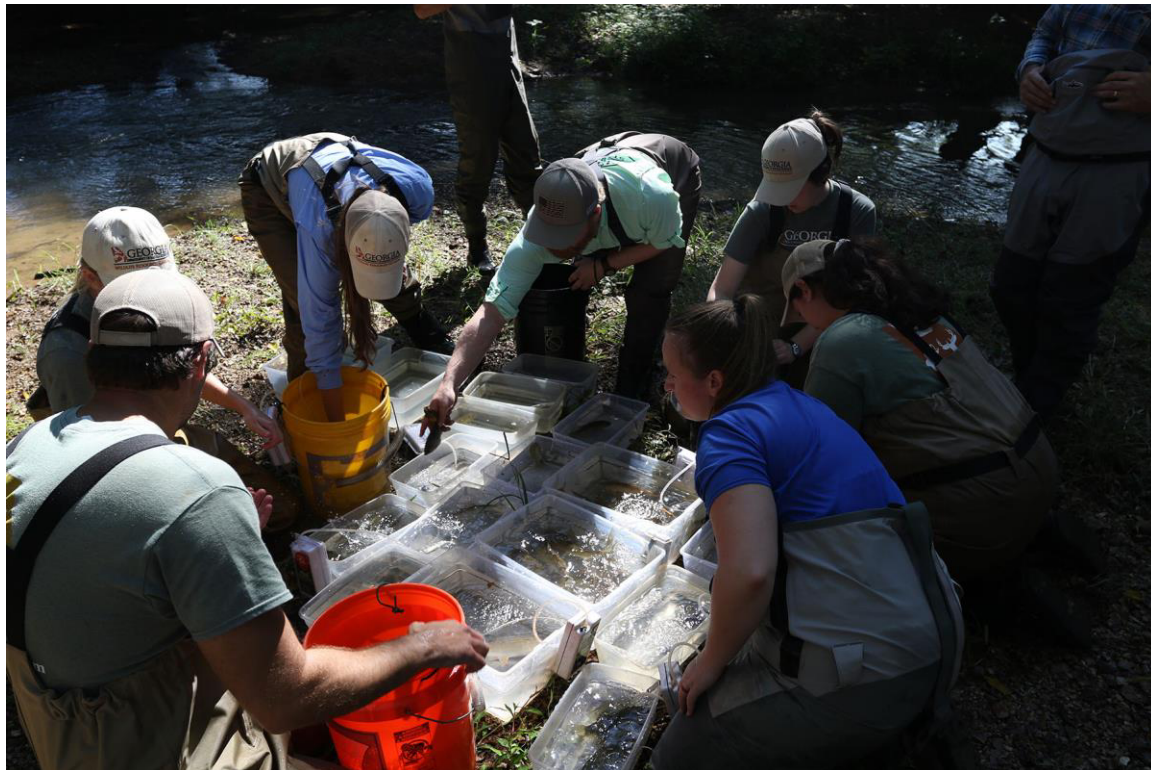
Figure 2. Sorting, identification, and enumeration of fishes during IBI study.

Each stream was sampled at a single site. Backpack shockers and dipnets were used for fish sampling. Fishes were held in containers with fresh creek water and aerators as they were identified to species and counted (Figure 2). Photo vouchers of most fish species were taken (Appendix A). Water quality (temperature (°C) DO (mg/L), conductivity (μS), pH, turbidity (NTU), total dissolved solids (ppm)) was measured using a YSI multiport sonde (electronic probe).

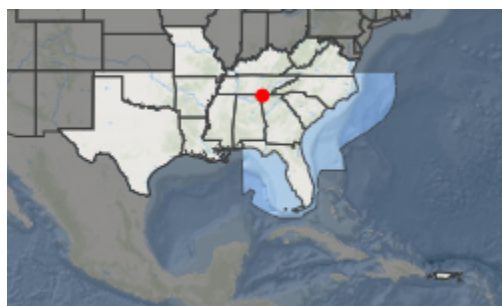
Urban growth

Probability of urbanization by 2060

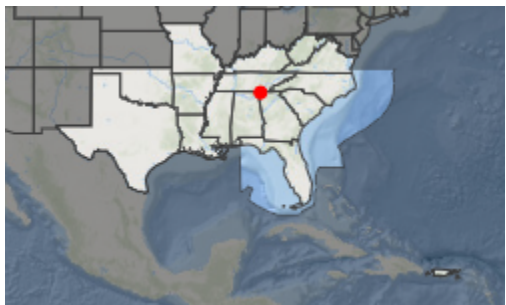
Land protection status

- Managed for biodiversity
- Managed for biodiversity
- Managed for multiple uses
- No known mandate for biodiversity protection

Table 5: Extent of land protection status within Chattanooga Creek WMP_Limestone Valley. Protected areas are derived from the derived from the [Protected Areas Database of the United States](#) (PAD-US v2.1). Note: areas are based on the polygon boundary of this area compared to protected area polygons, rather than pixel-level analyses used elsewhere in this report.
