**VOLUNTARY REMEDIATION PROGRAM  
COMPLIANCE STATUS REPORT**

**GEORGIA POWER COMPANY PLANT KRAFT  
155 Crossgate Road  
PORT WENTWORTH, CHATHAM COUNTY, GEORGIA  
HSI Site 10415**

**Certification of Compliance  
Georgia Power Former Plant Kraft  
(HSI Site 10415)**

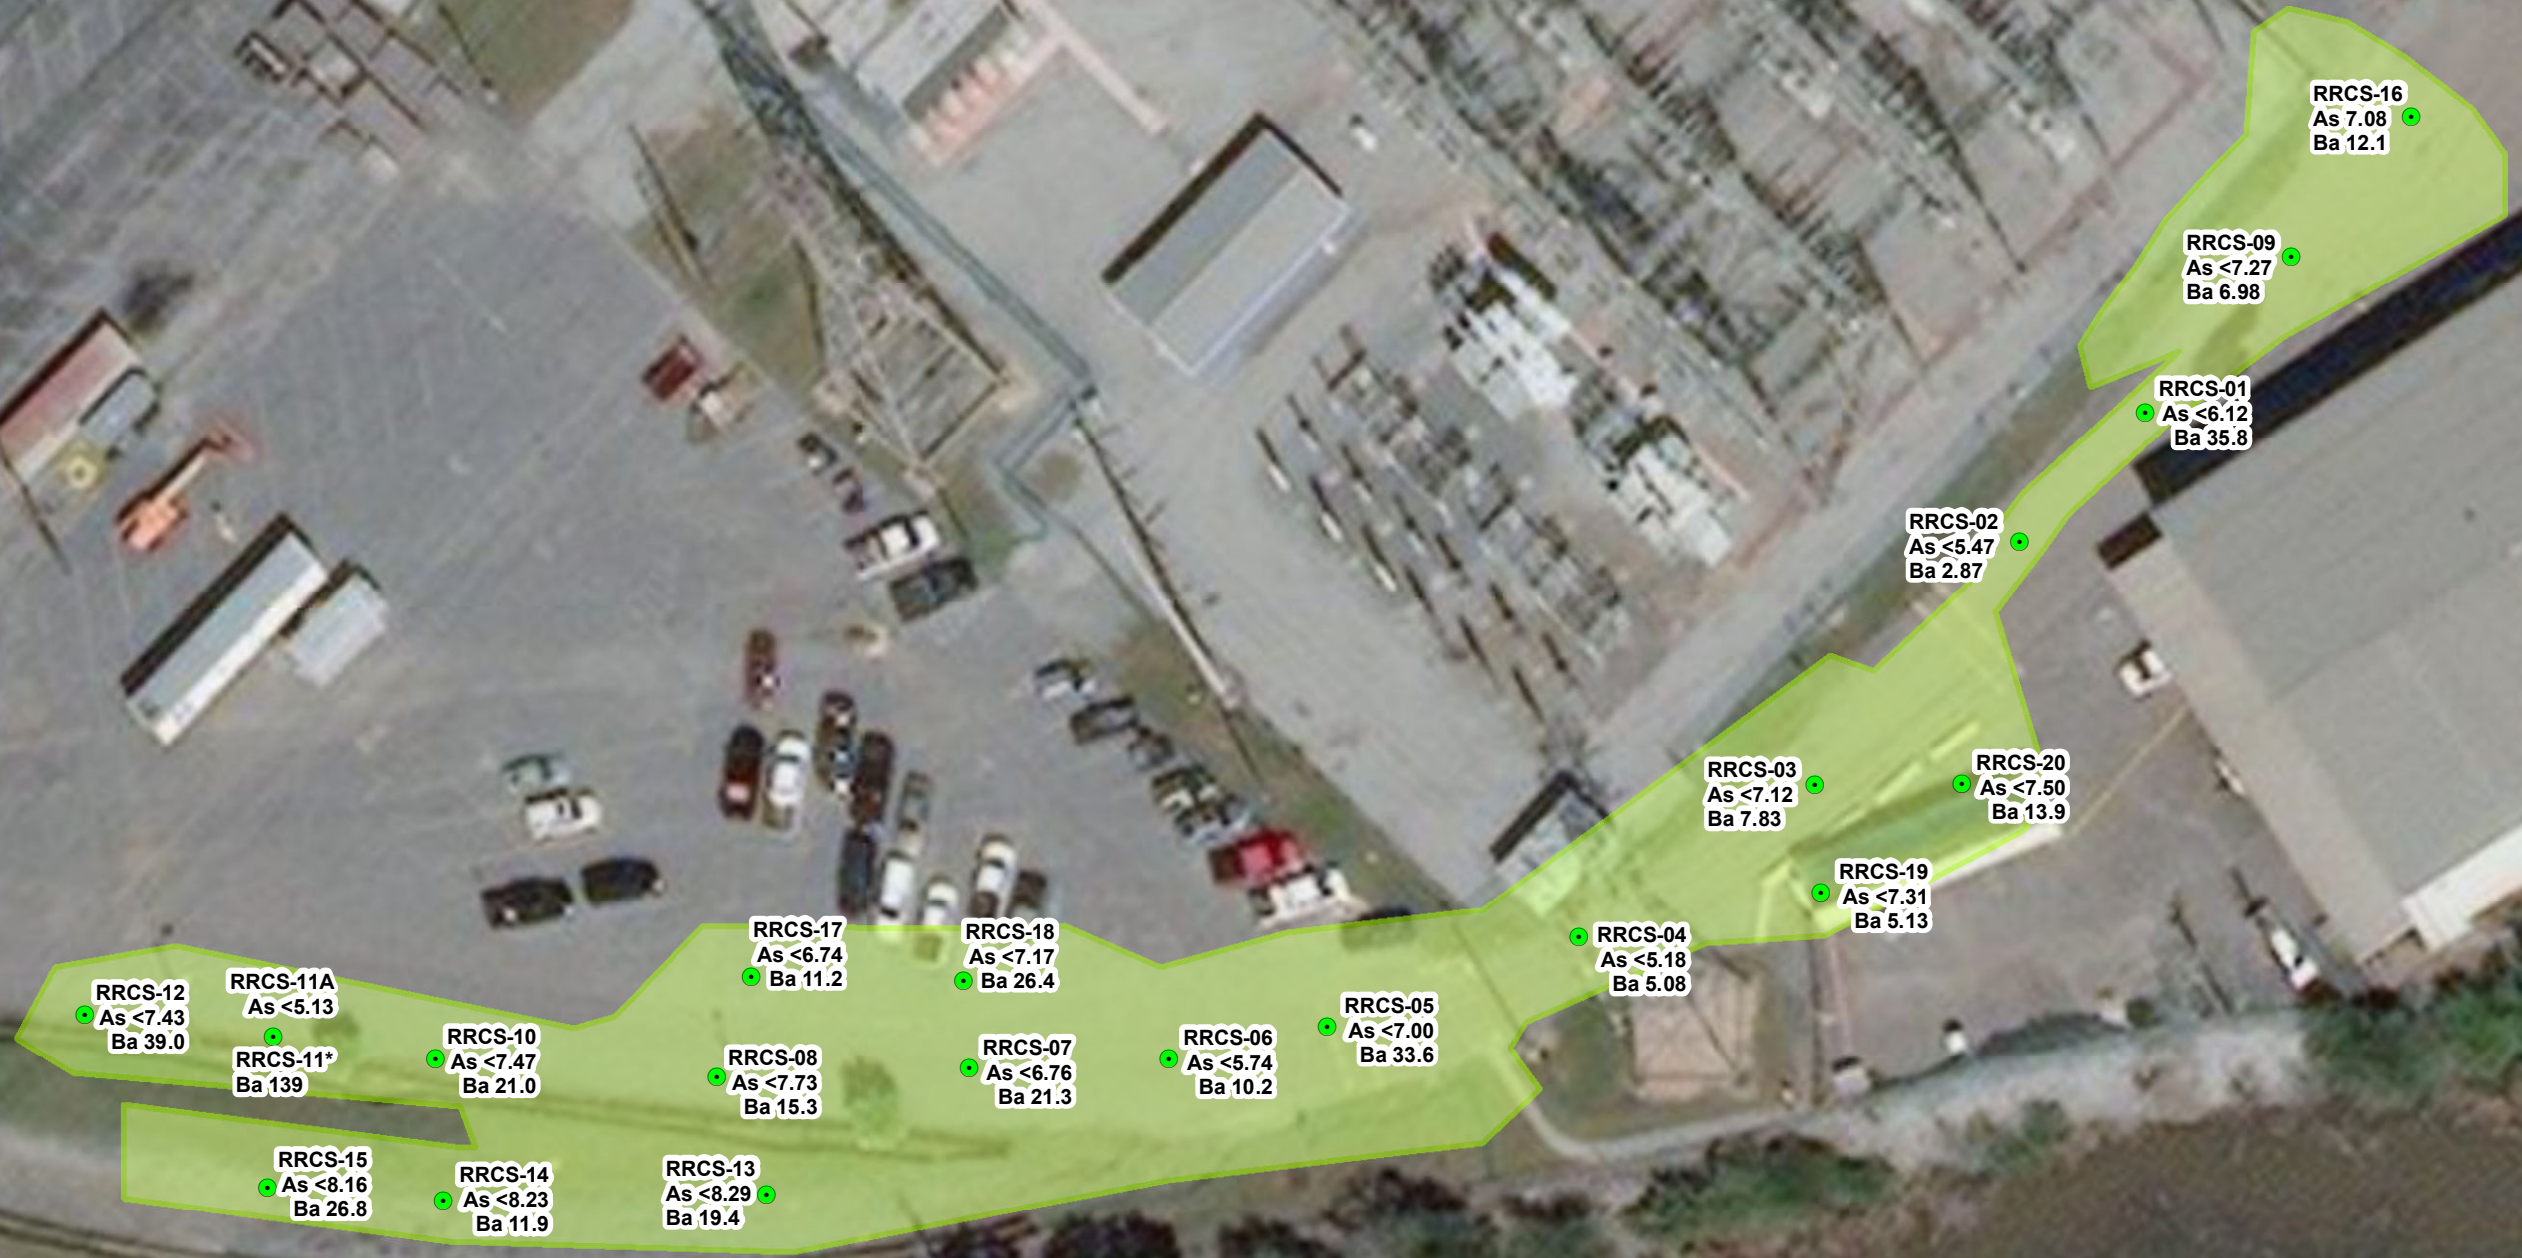
<b>Plant Kraft          Excavation Confirmation          Sample Results          Railroad Area</b>	<b>Figure          15</b>

**Notes:**  
 See Analytical Data Summary Table for greater detail.  
 Analytical results are reported in mg/kg.  
 ≤ indicates the analyte was not detected above the laboratory reporting limit.  
 \* Soil over excavated around sample location in a 15 ft by 15 ft area

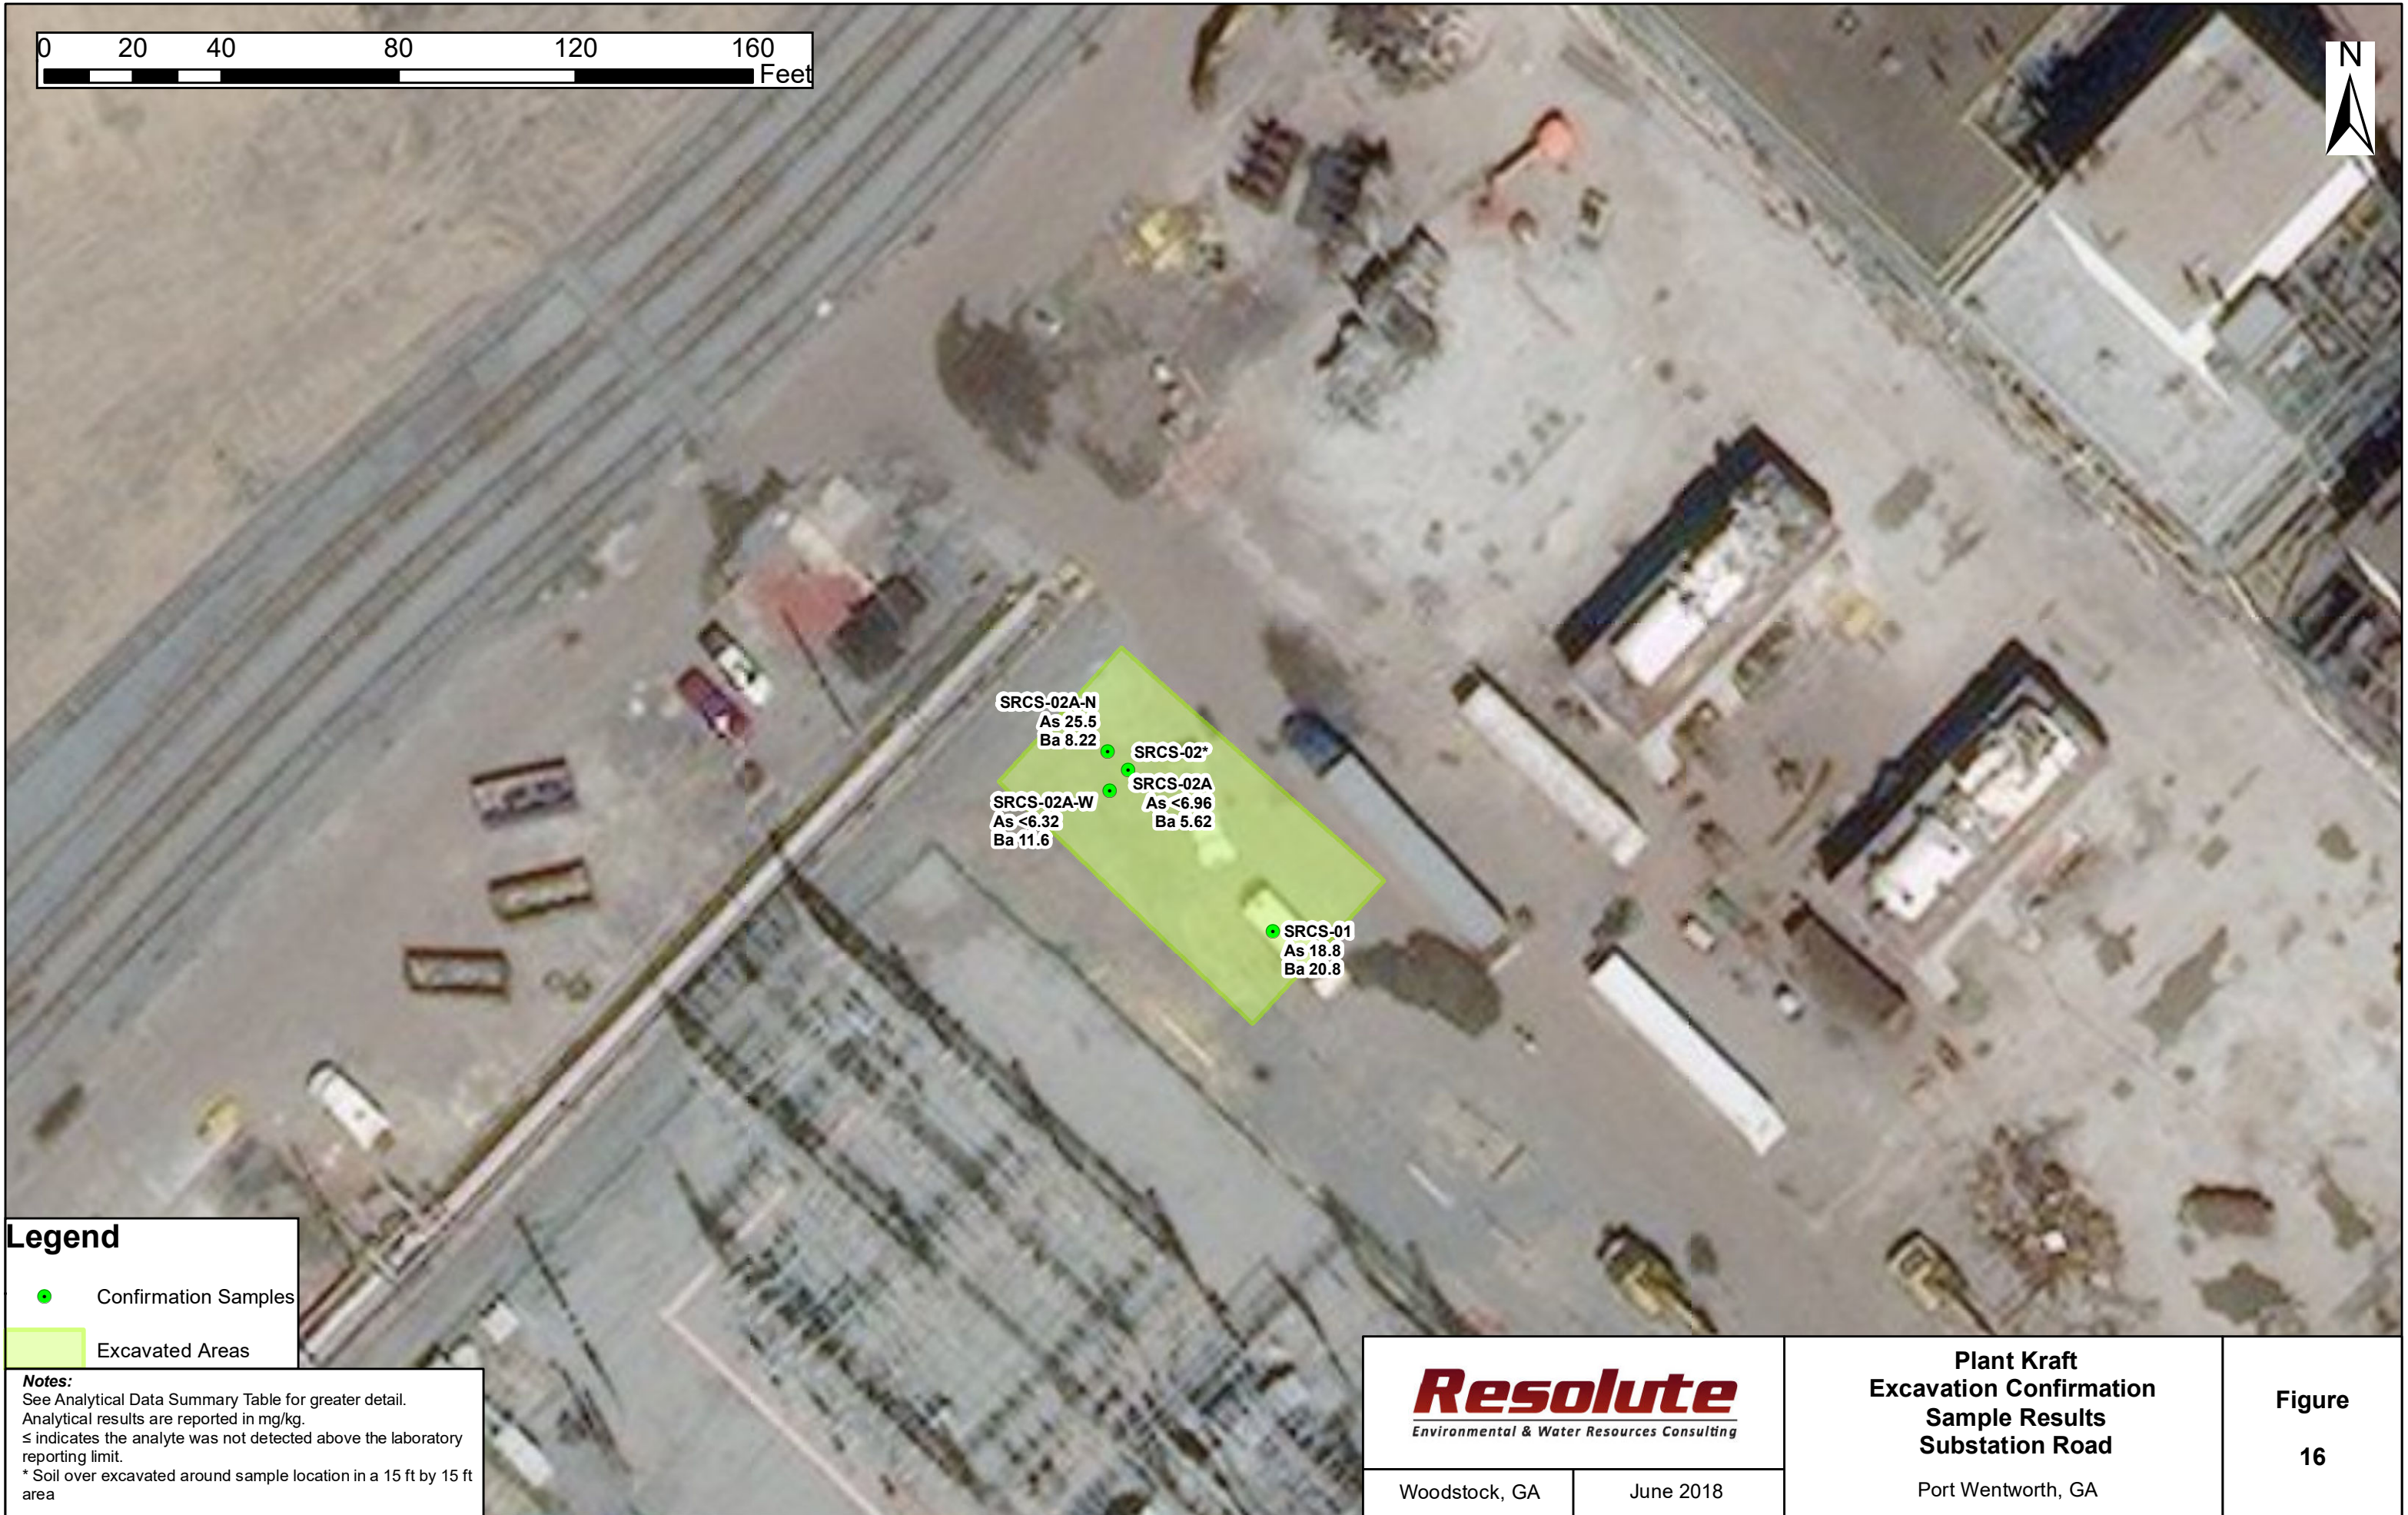
**16**

SRCS-02A-N  
As 25.5  
Ba 8.22

SRCS-02\*

Mill reject material was observed to the northeast of former Substation I. SBX excavated this area, and final excavation confirmation sample results are shown on Figure 16. The samples were placed in laboratory containers for analysis. Analyses performed in this area and results are presented in Table 2. After completion of the soil excavation activities, the soil excavation confirmation sample results were below their respective Type 3 RRS.

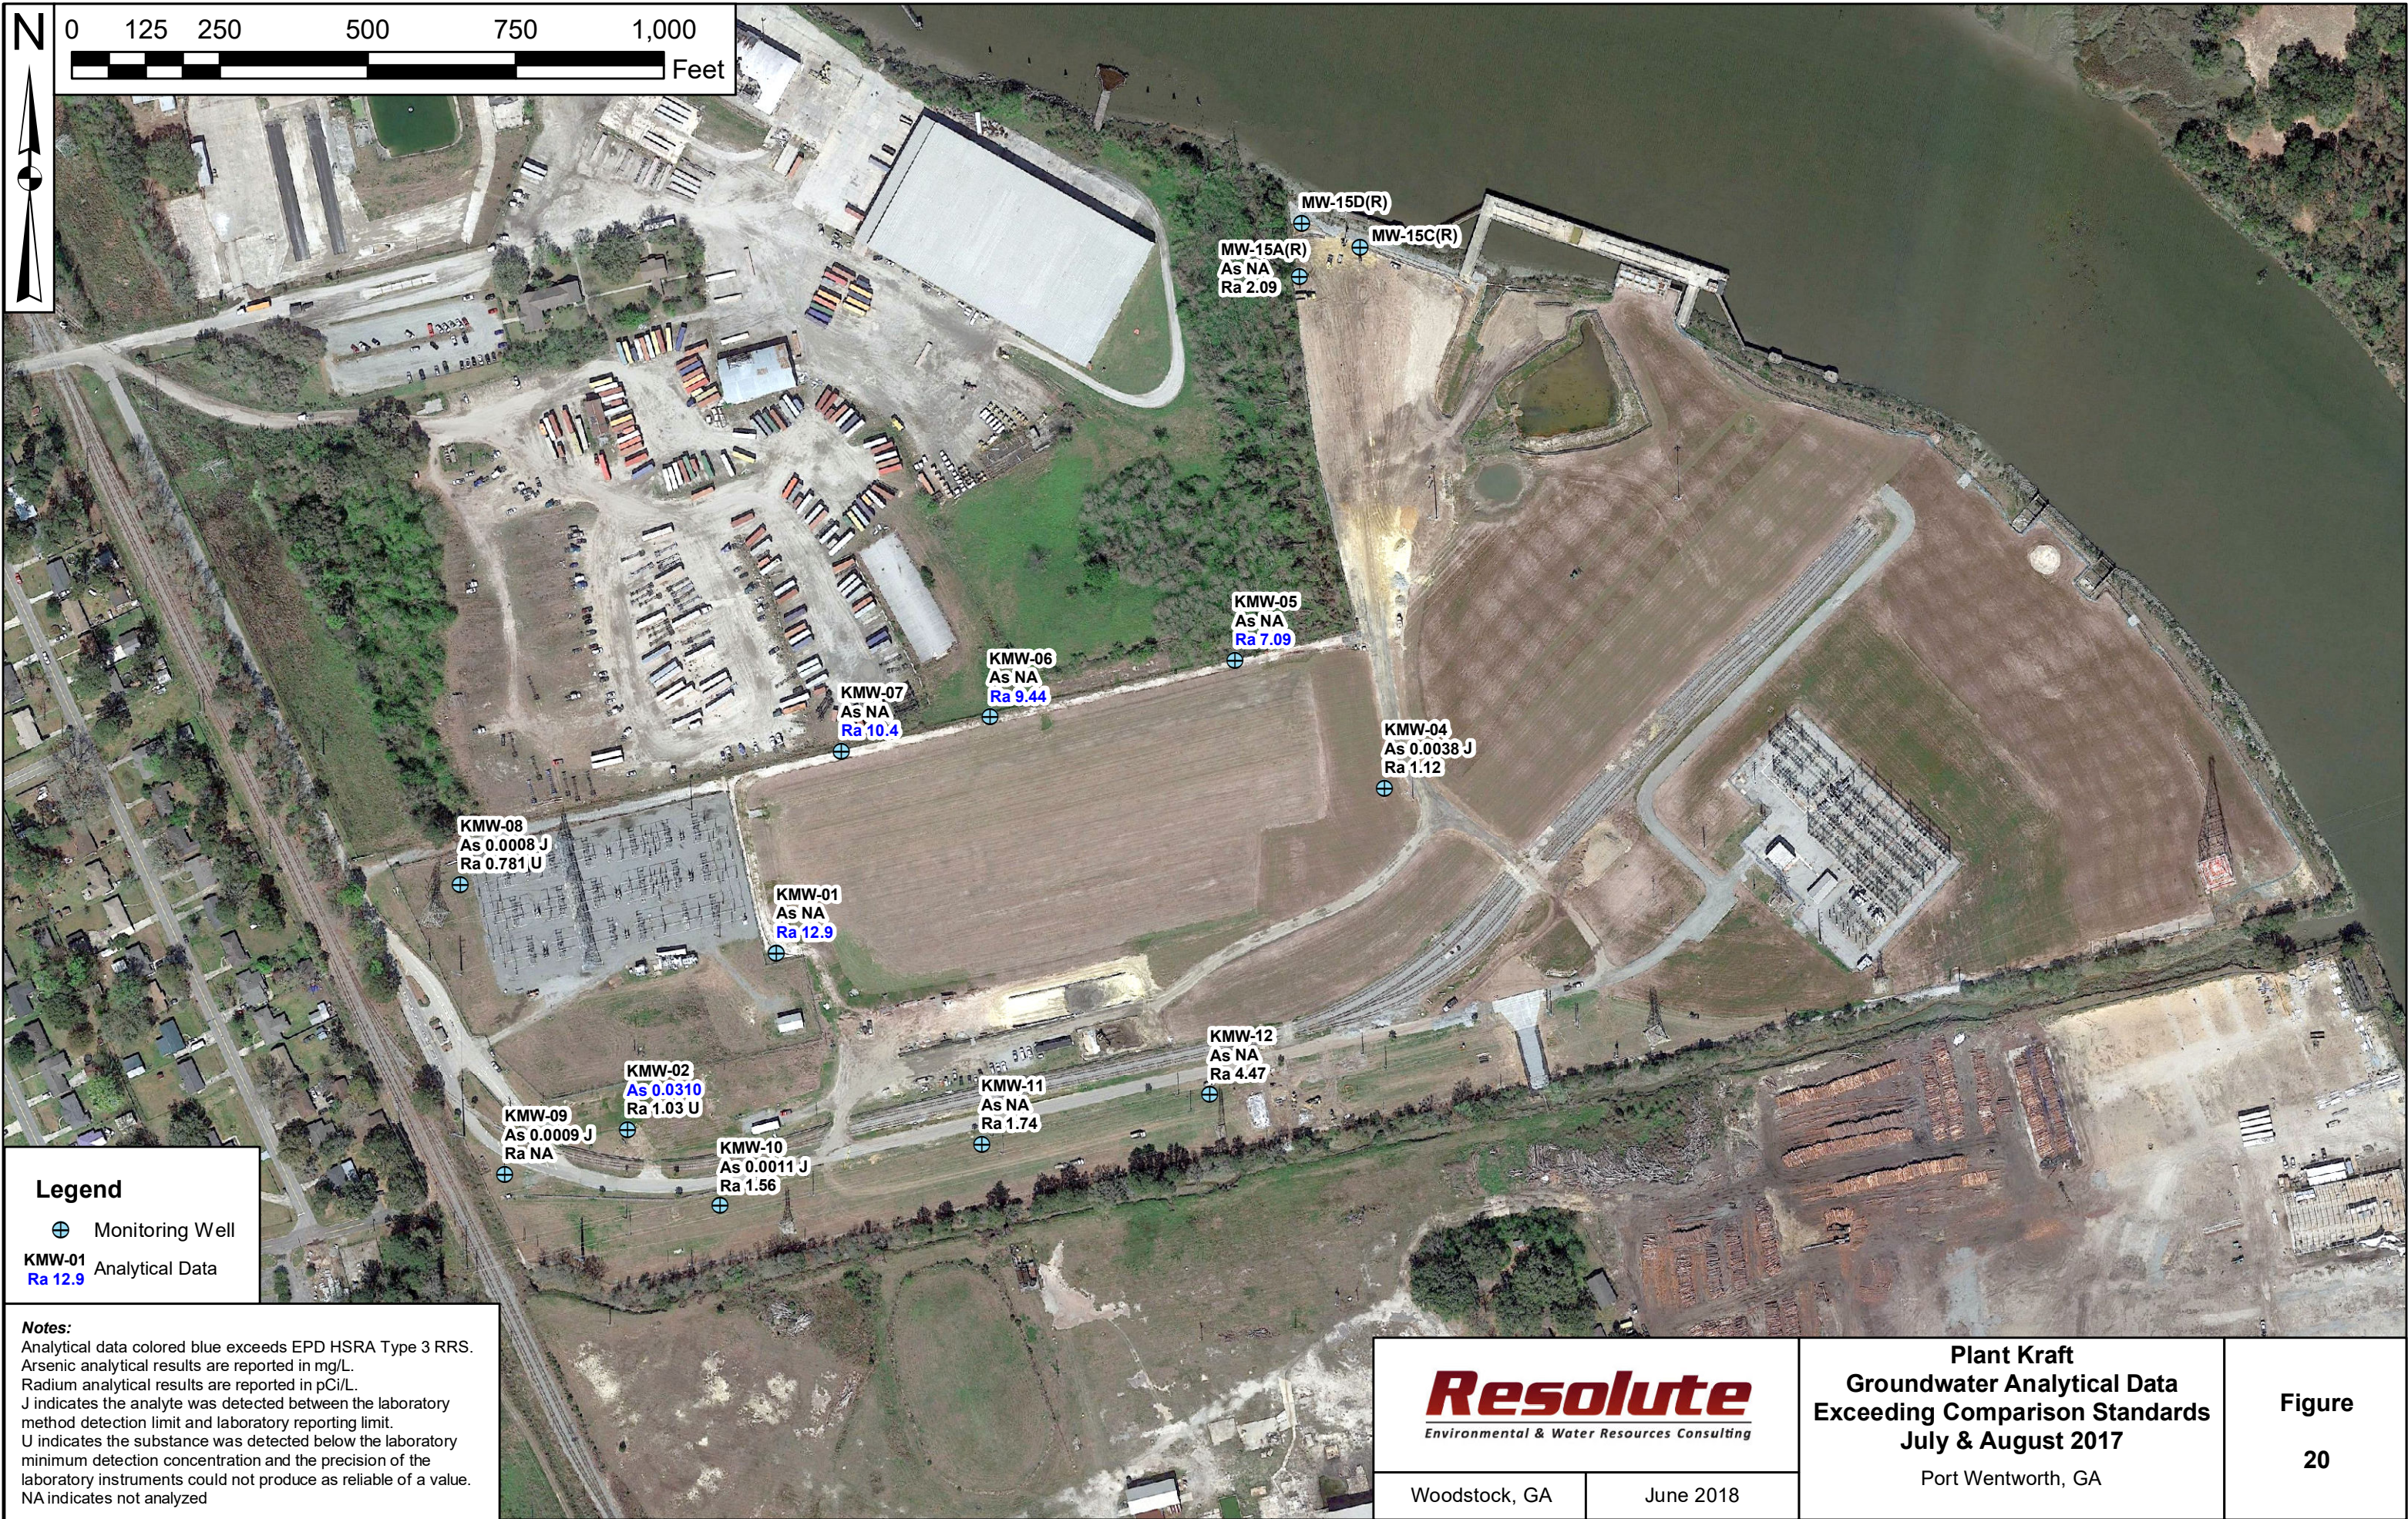
**Figure**  
 20

**Plant Kraft**  
 Groundwater Analytical Data  
 Exceeding Comparison Standards  
 July & August 2017  
 Port Wentworth, GA

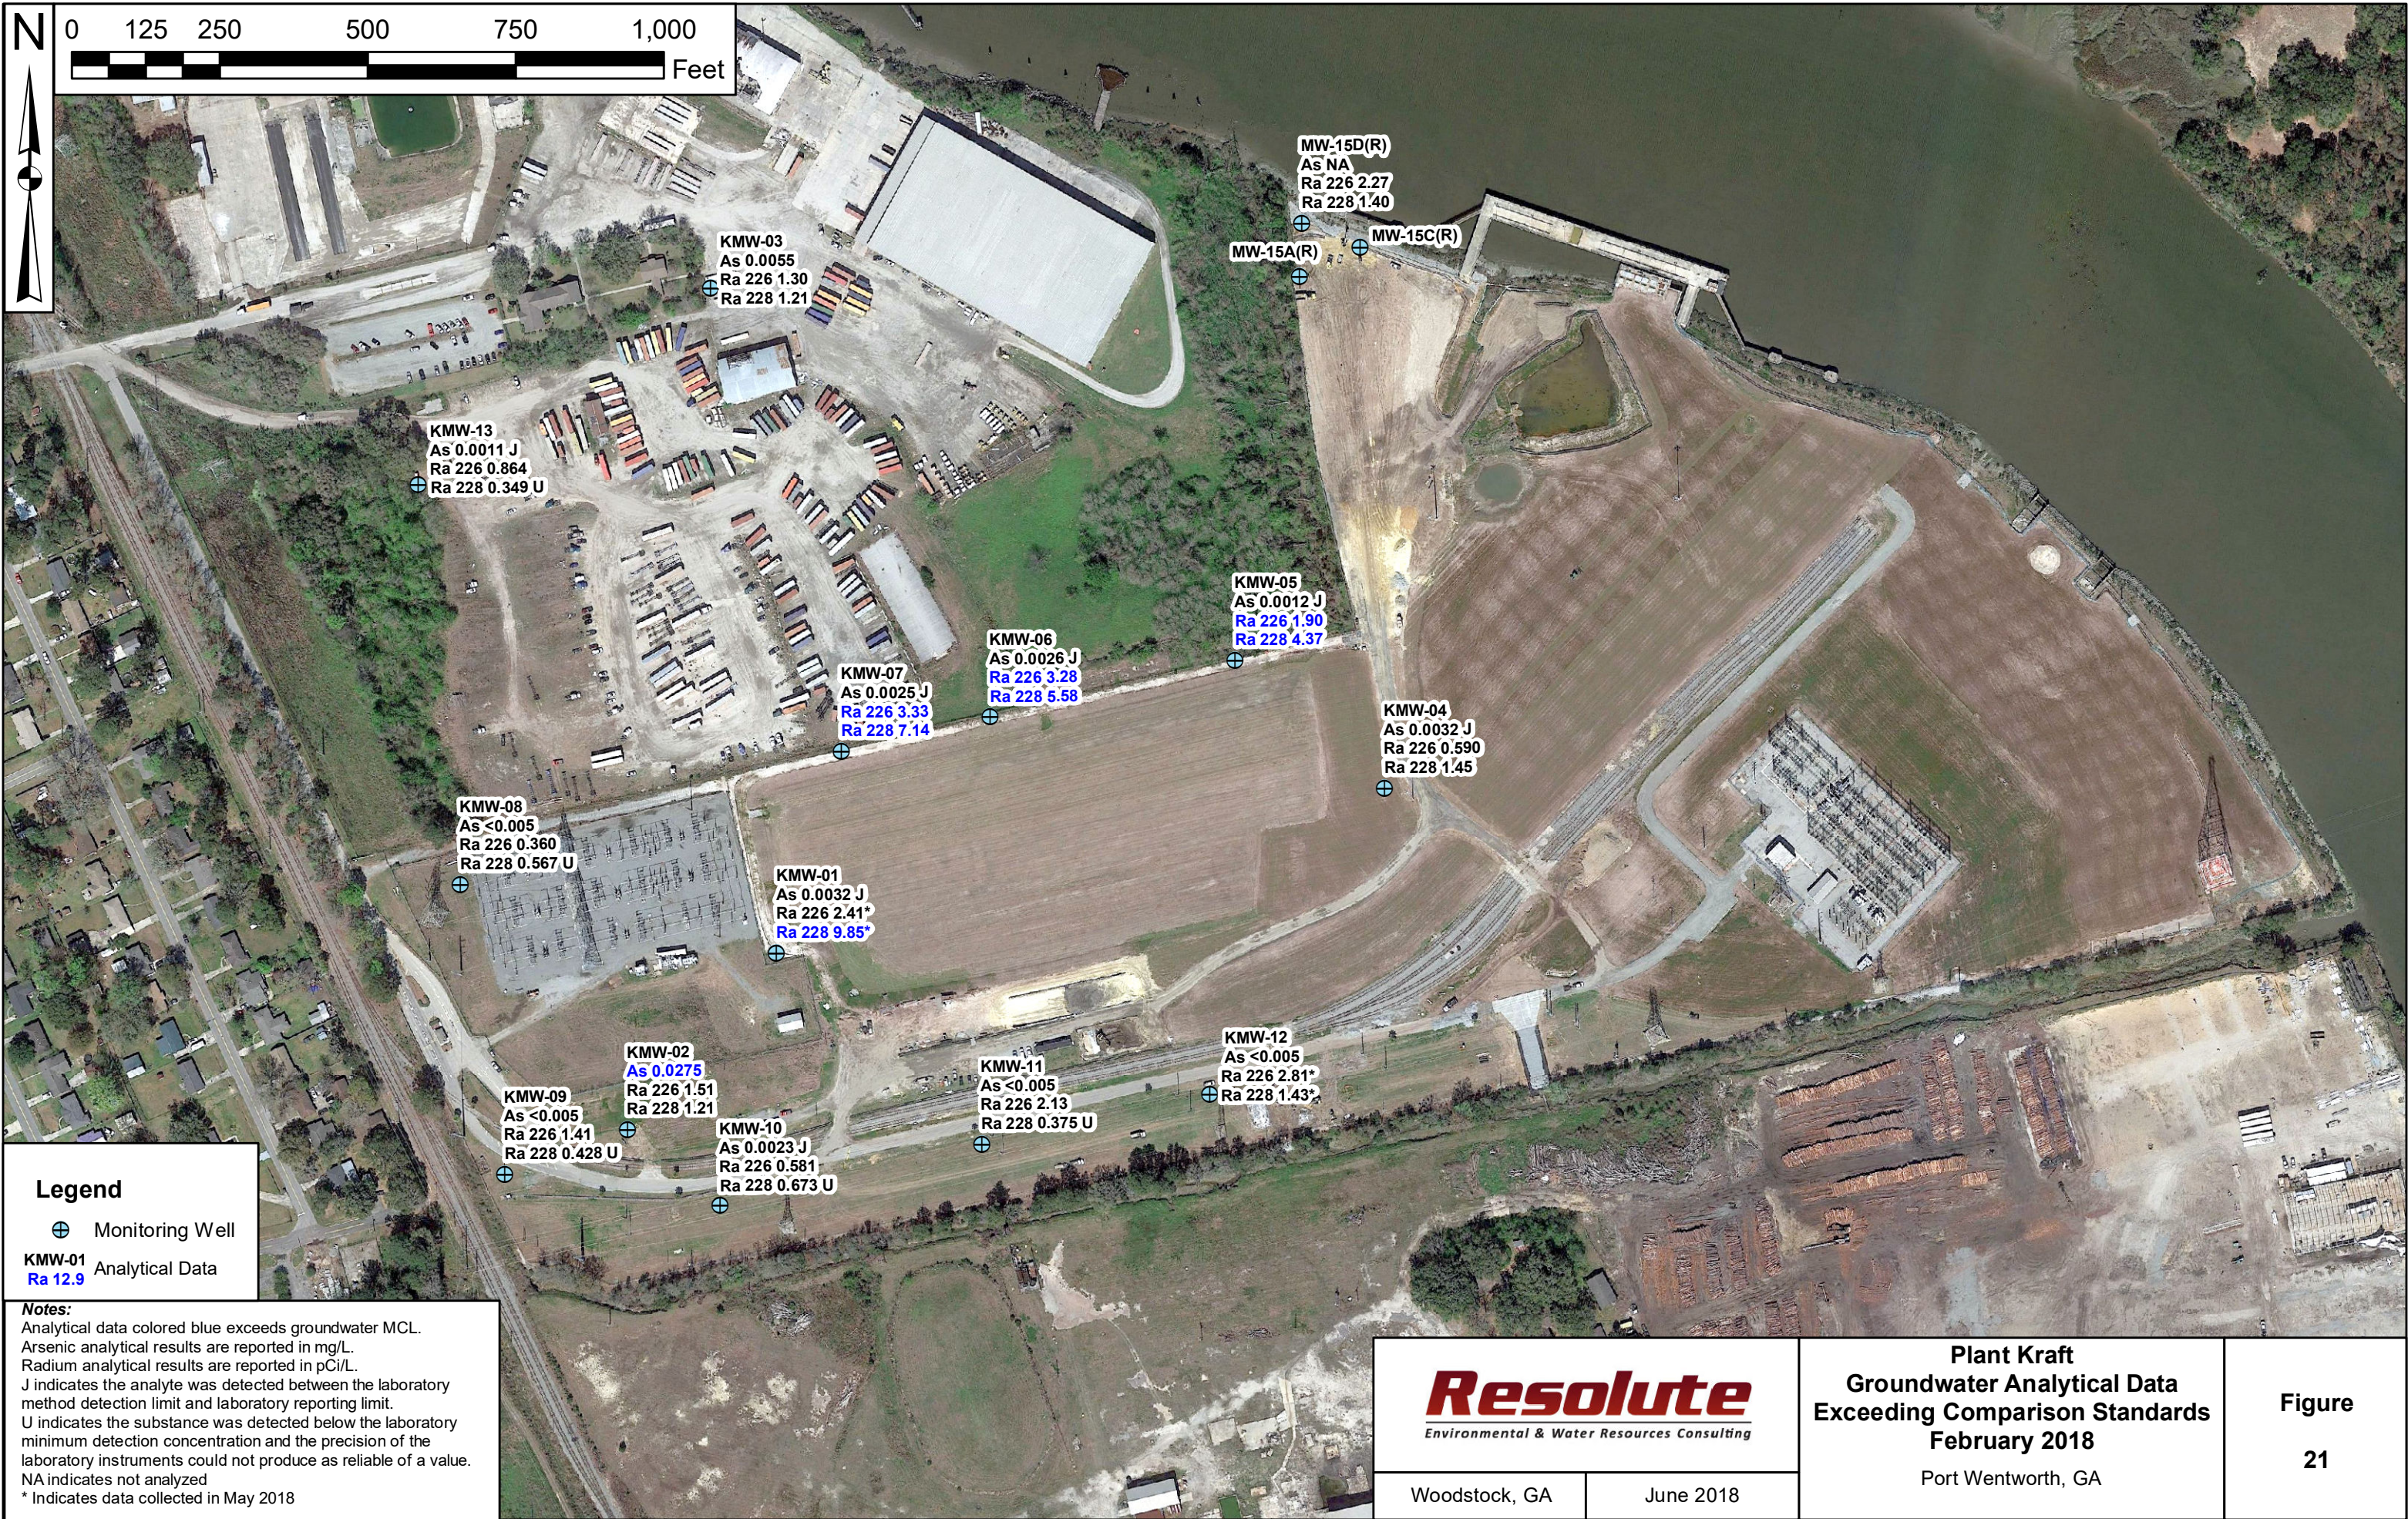
**Figure**  
 21

**Plant Kraft**  
 Groundwater Analytical Data  
 Exceeding Comparison Standards  
 February 2018  
 Port Wentworth, GA

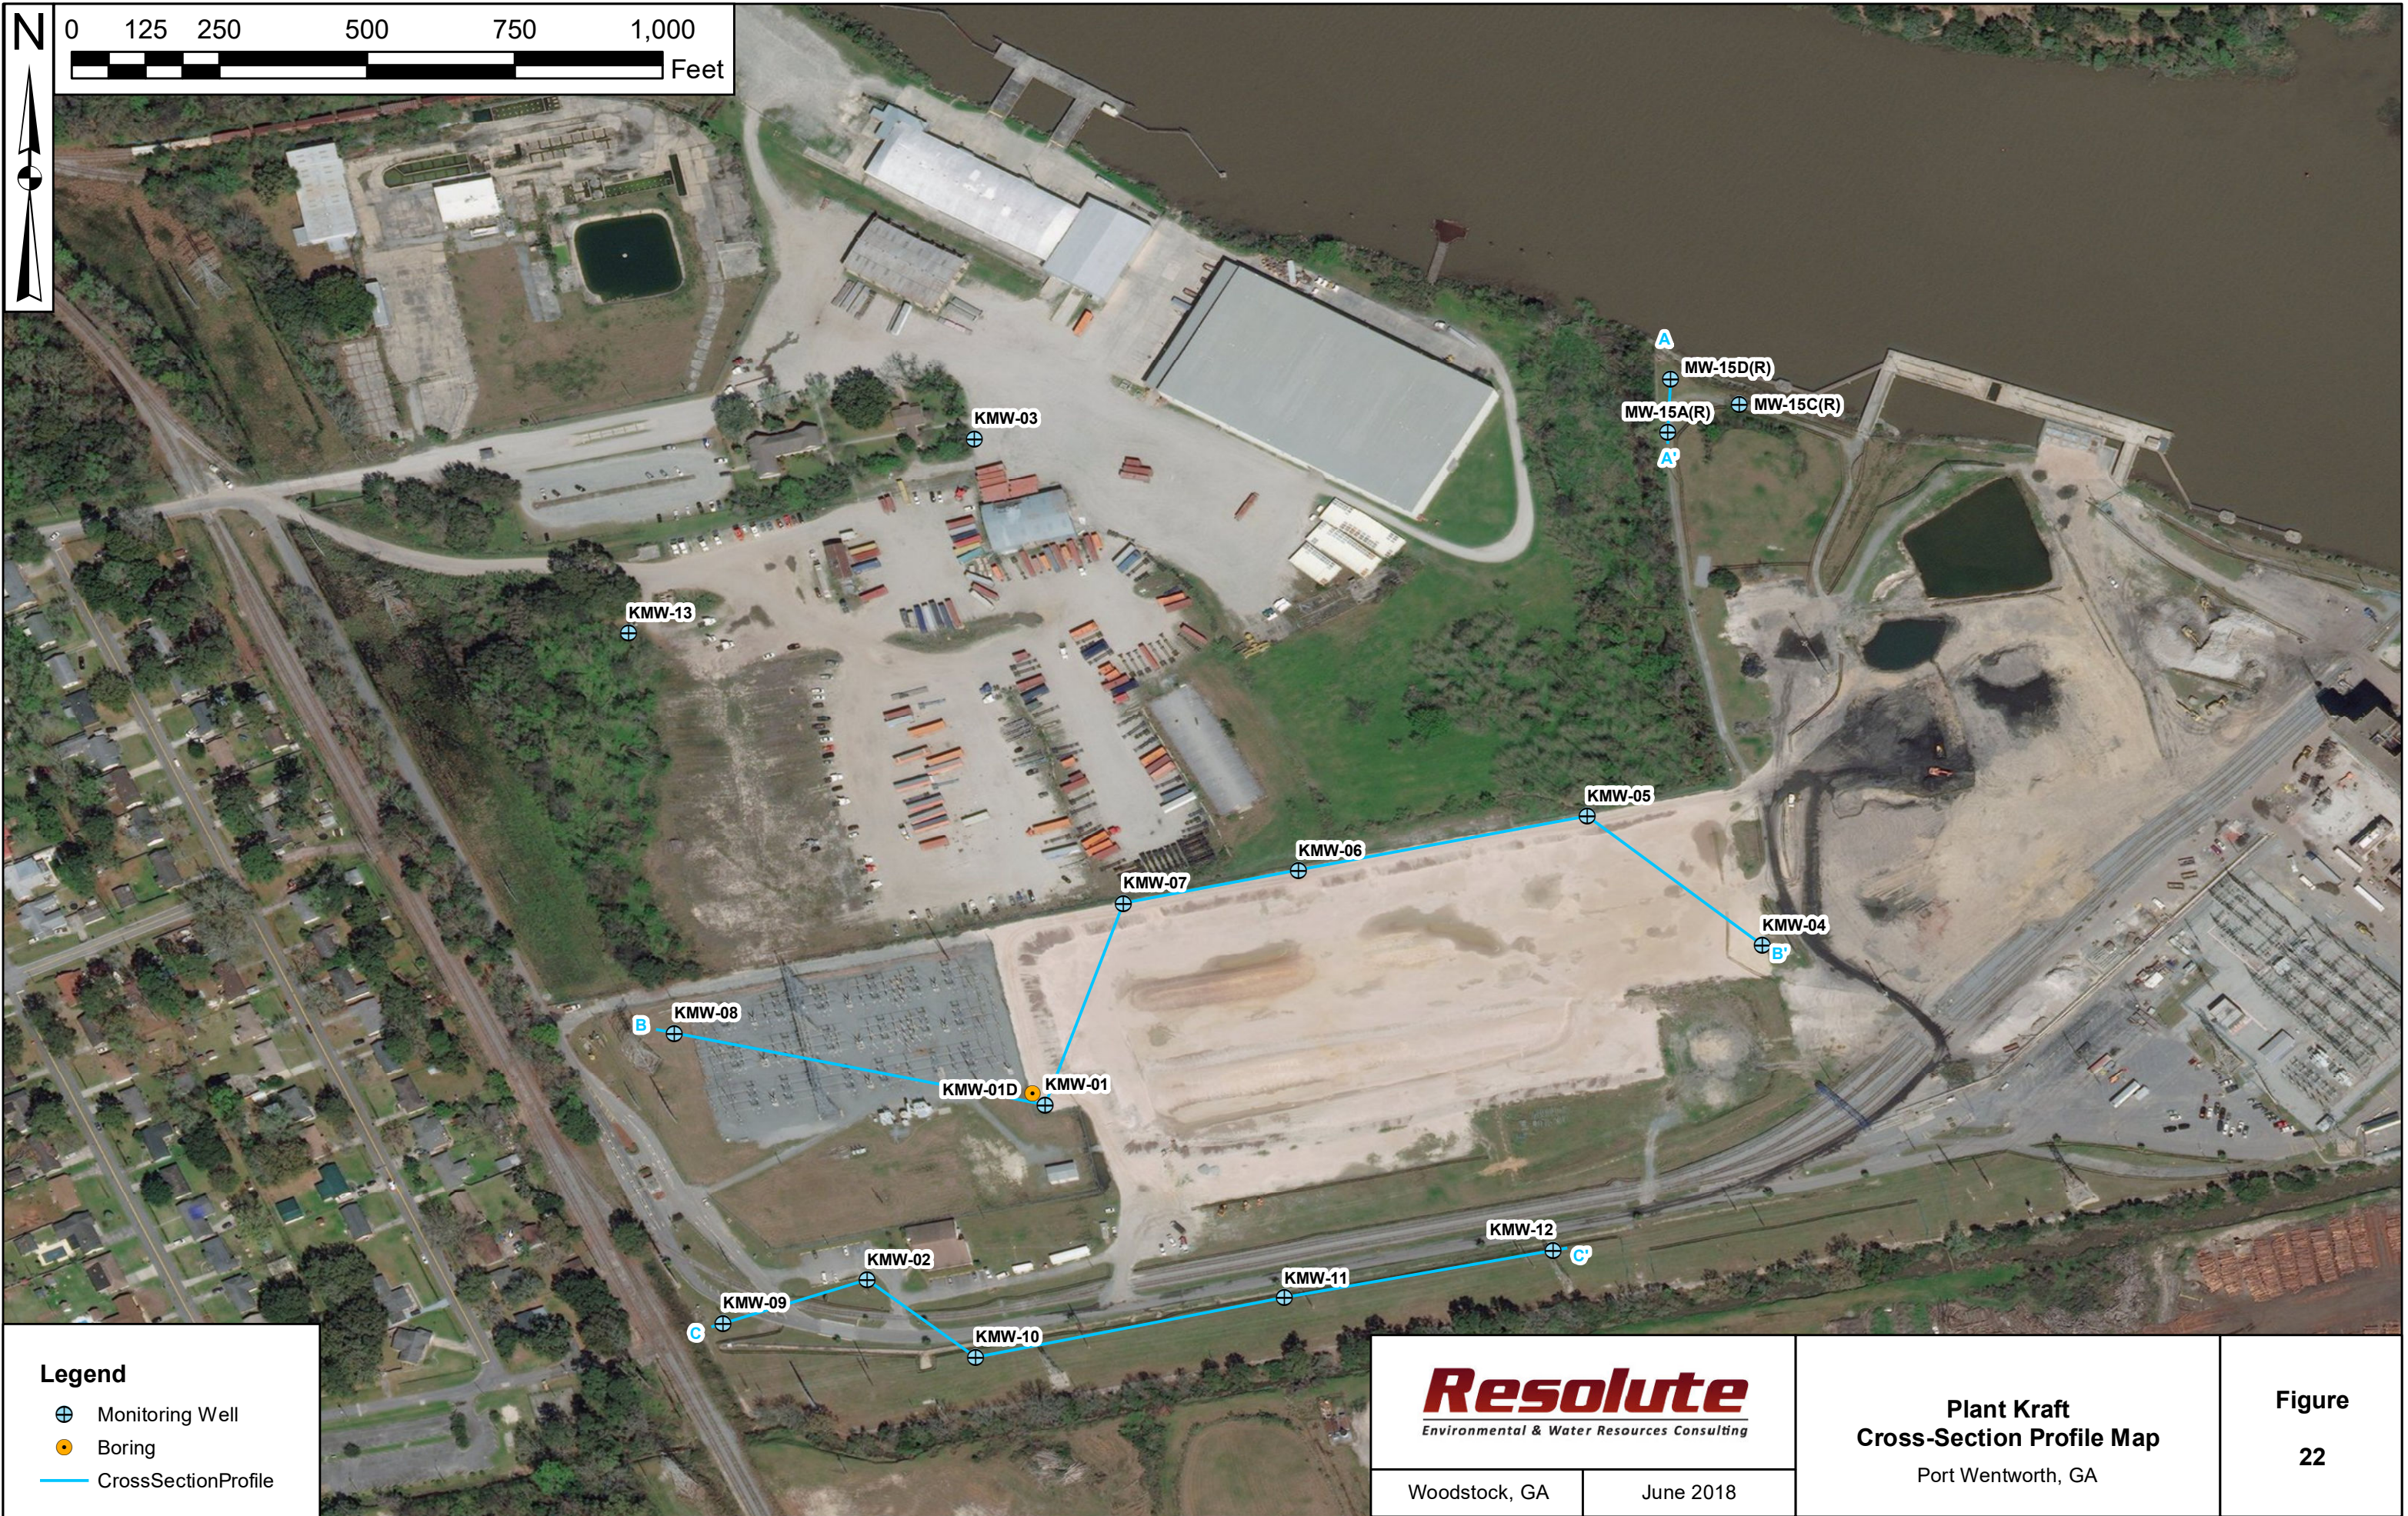
**Figure**  
**22**

**Plant Kraft**  
**Cross-Section Profile Map**  
Port Wentworth, GA

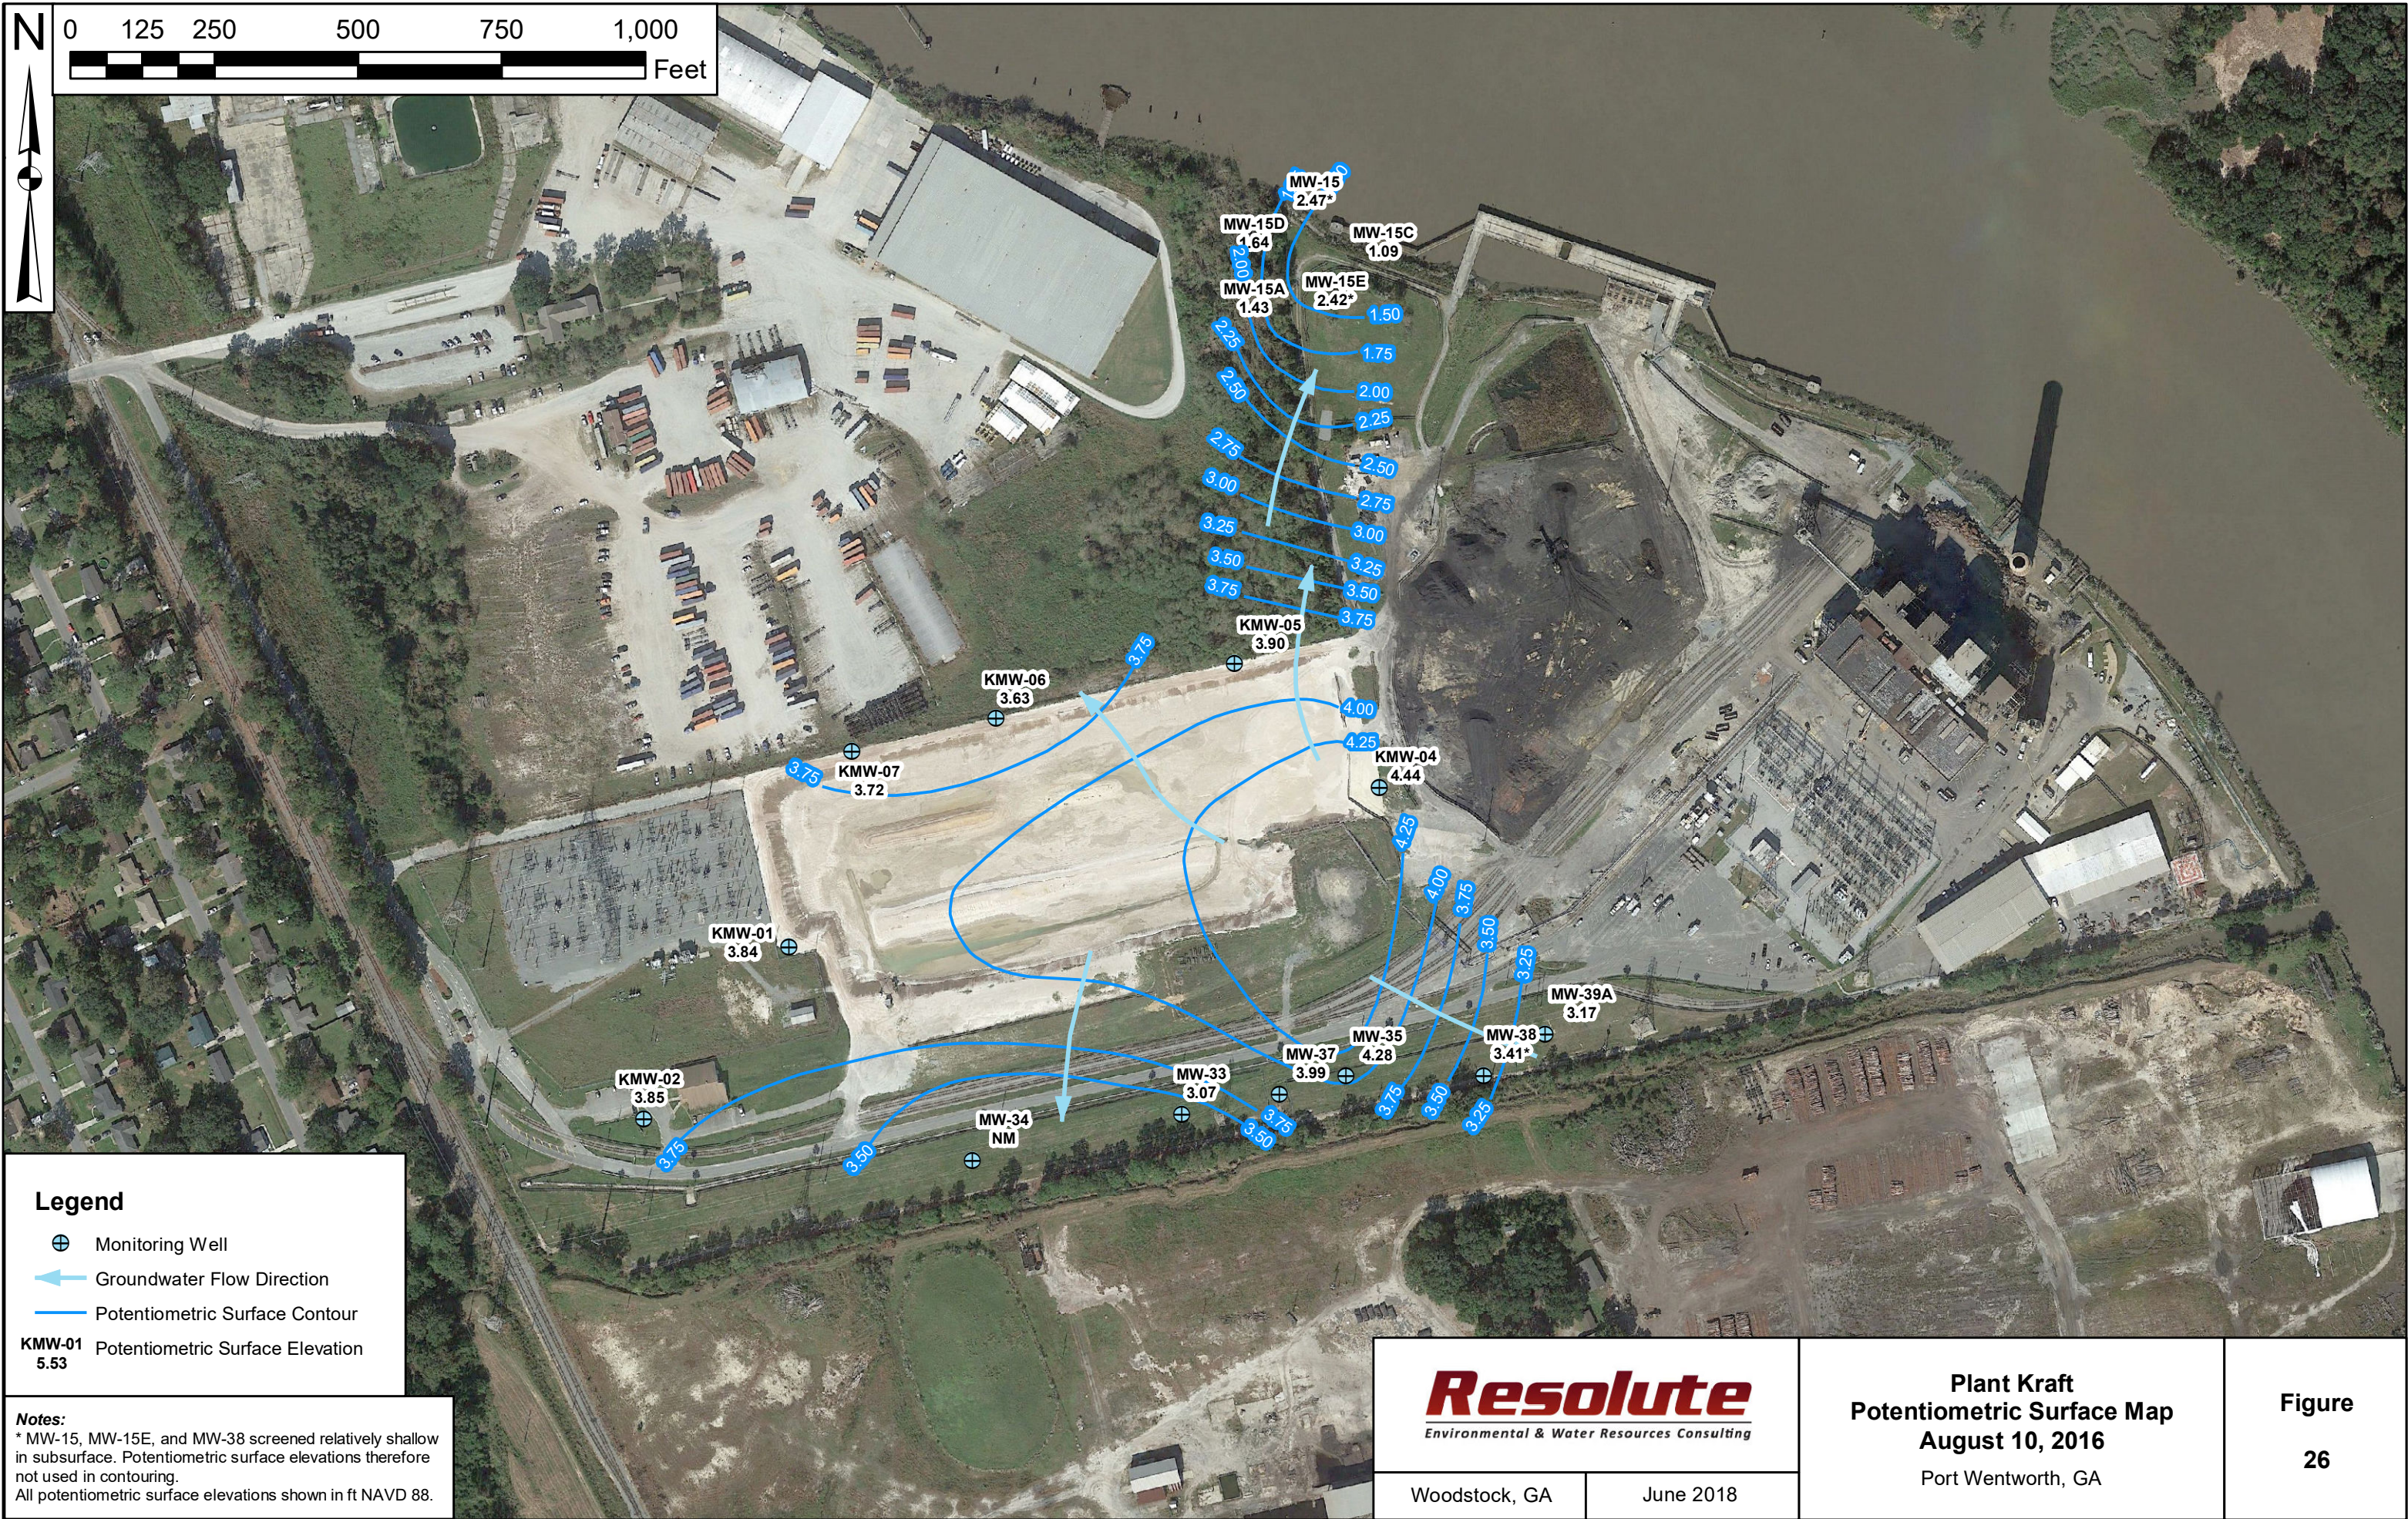
**Figure**  
 26

**Plant Kraft**  
**Potentiometric Surface Map**  
 August 10, 2016  
 Port Wentworth, GA
