**VOLUNTARY REMEDIATION PROGRAM  
COMPLIANCE STATUS REPORT**

**GEORGIA POWER COMPANY PLANT KRAFT  
155 Crossgate Road  
PORT WENTWORTH, CHATHAM COUNTY, GEORGIA  
HSI Site 10415**

**Certification of Compliance  
Georgia Power Former Plant Kraft  
(HSI Site 10415)**

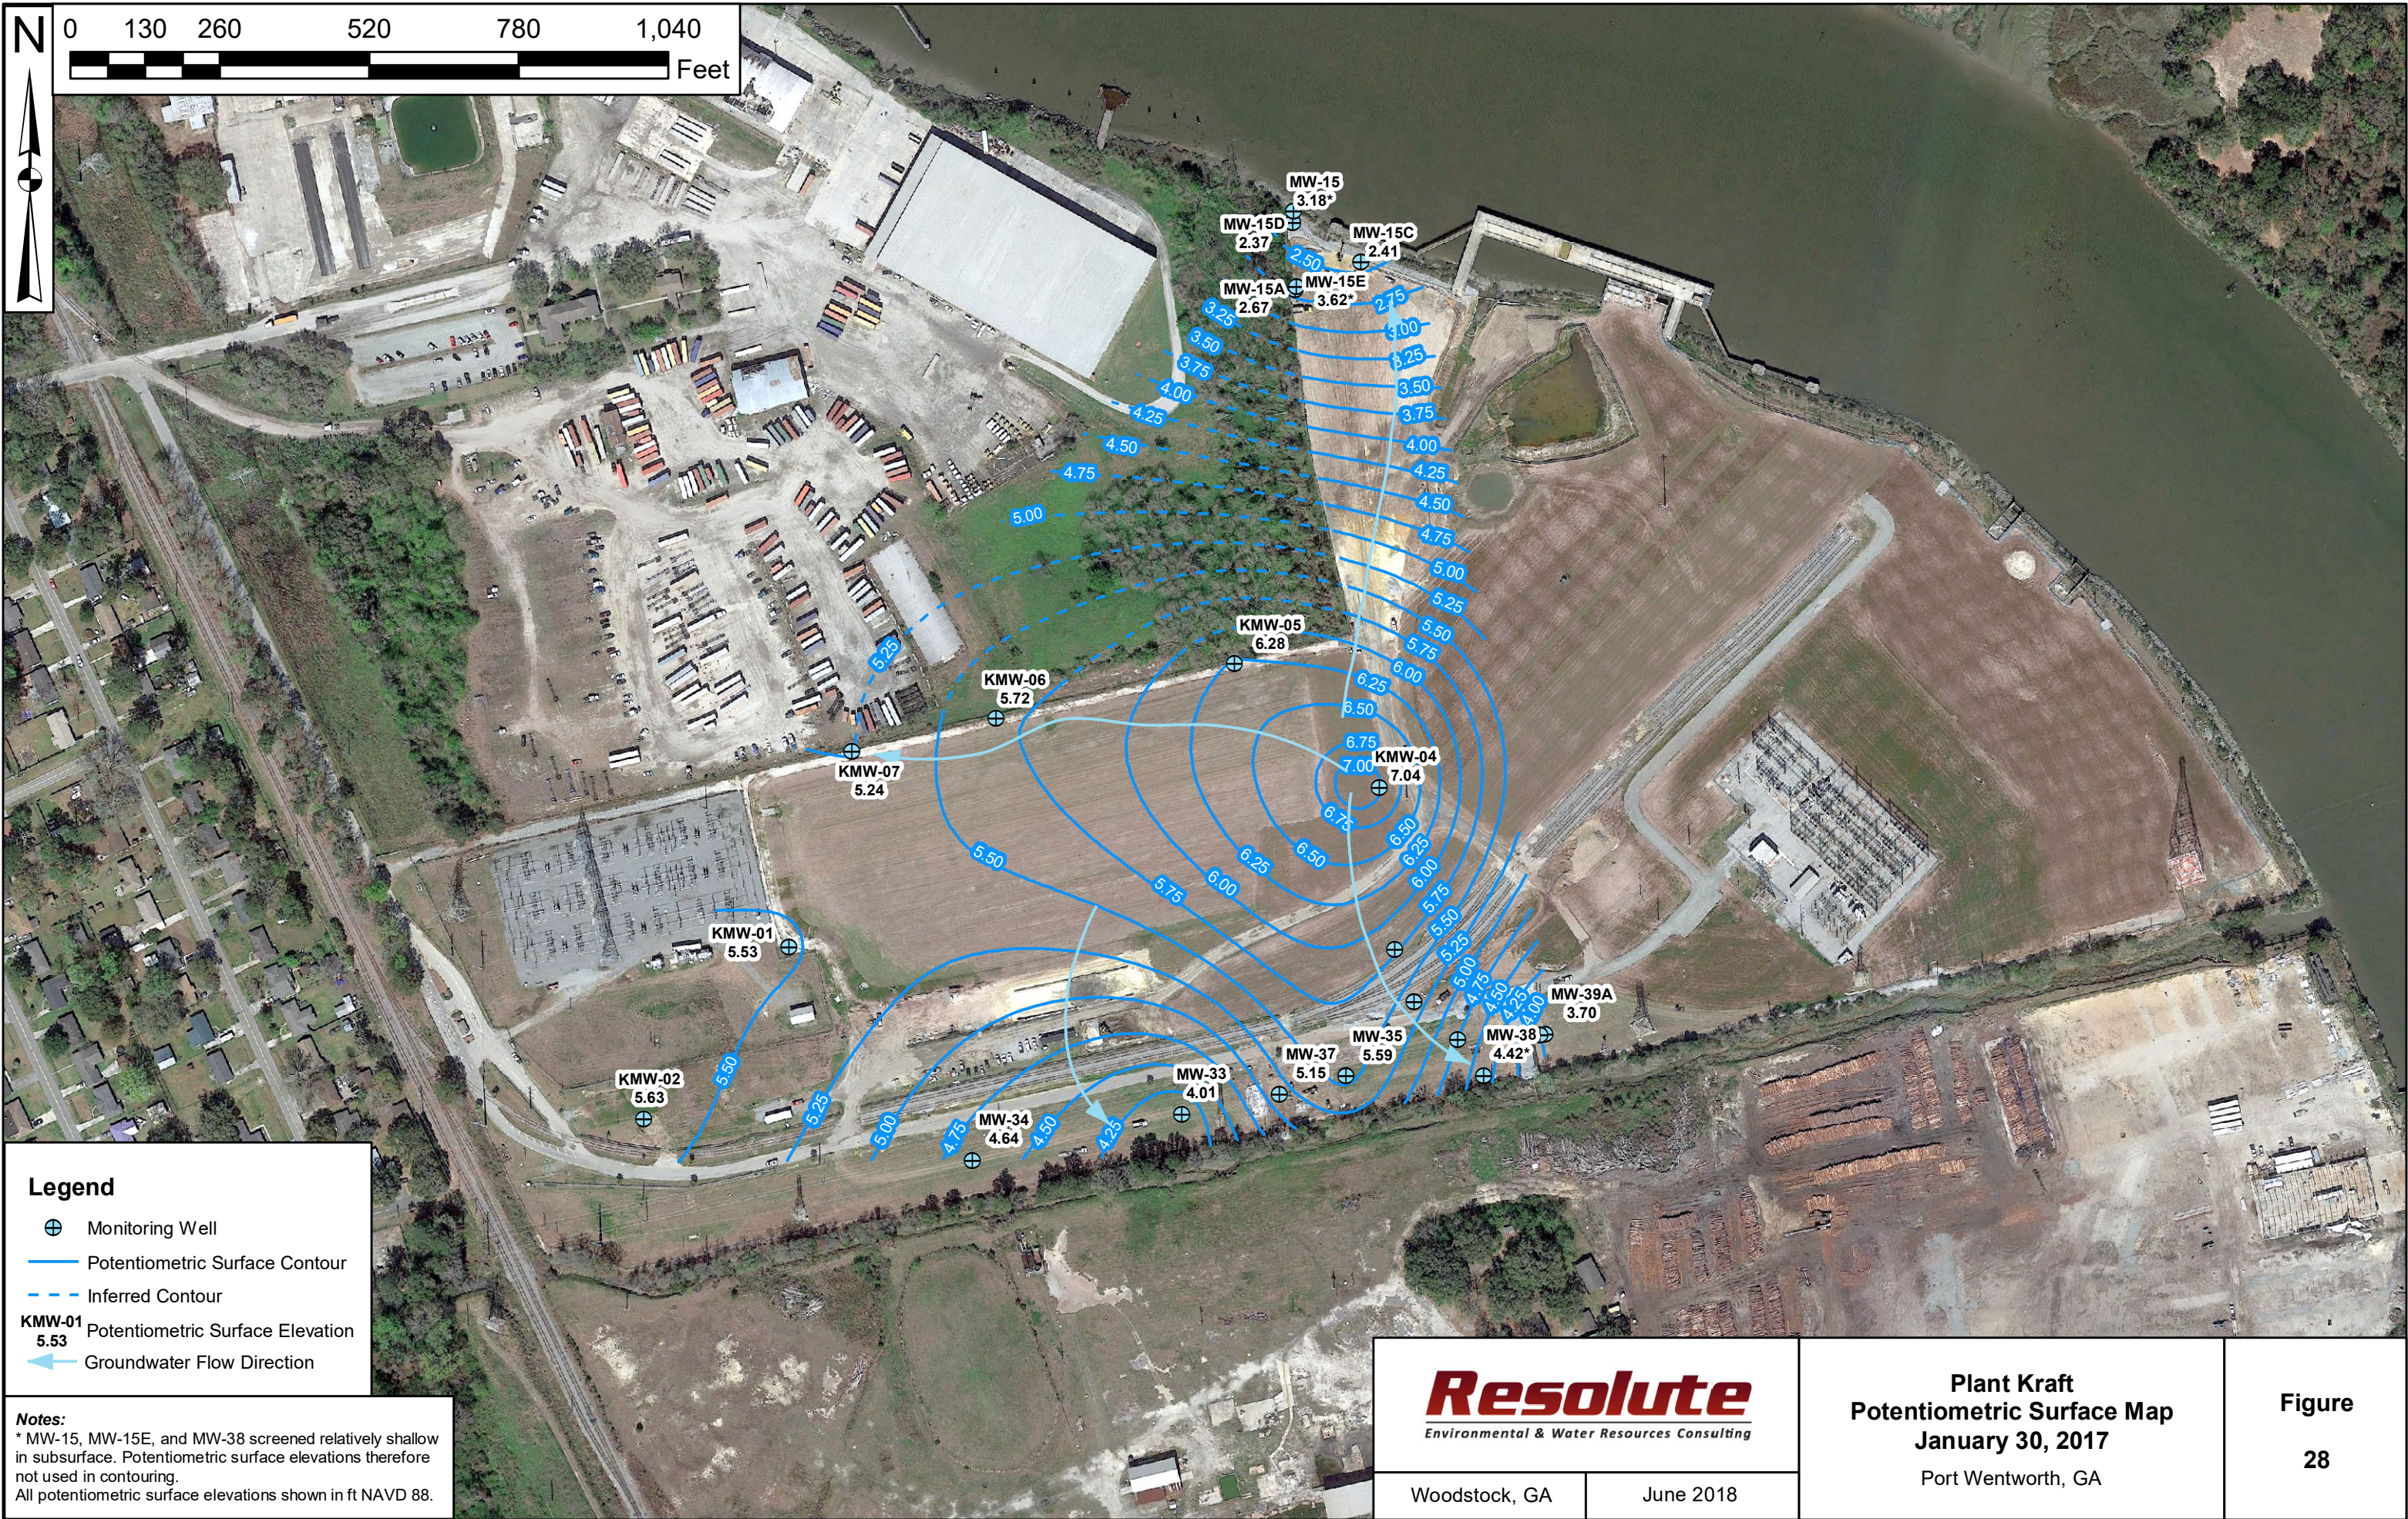
**Figure  
 28**

**Plant Kraft  
 Potentiometric Surface Map**  
 January 30, 2017  
 Port Wentworth, GA

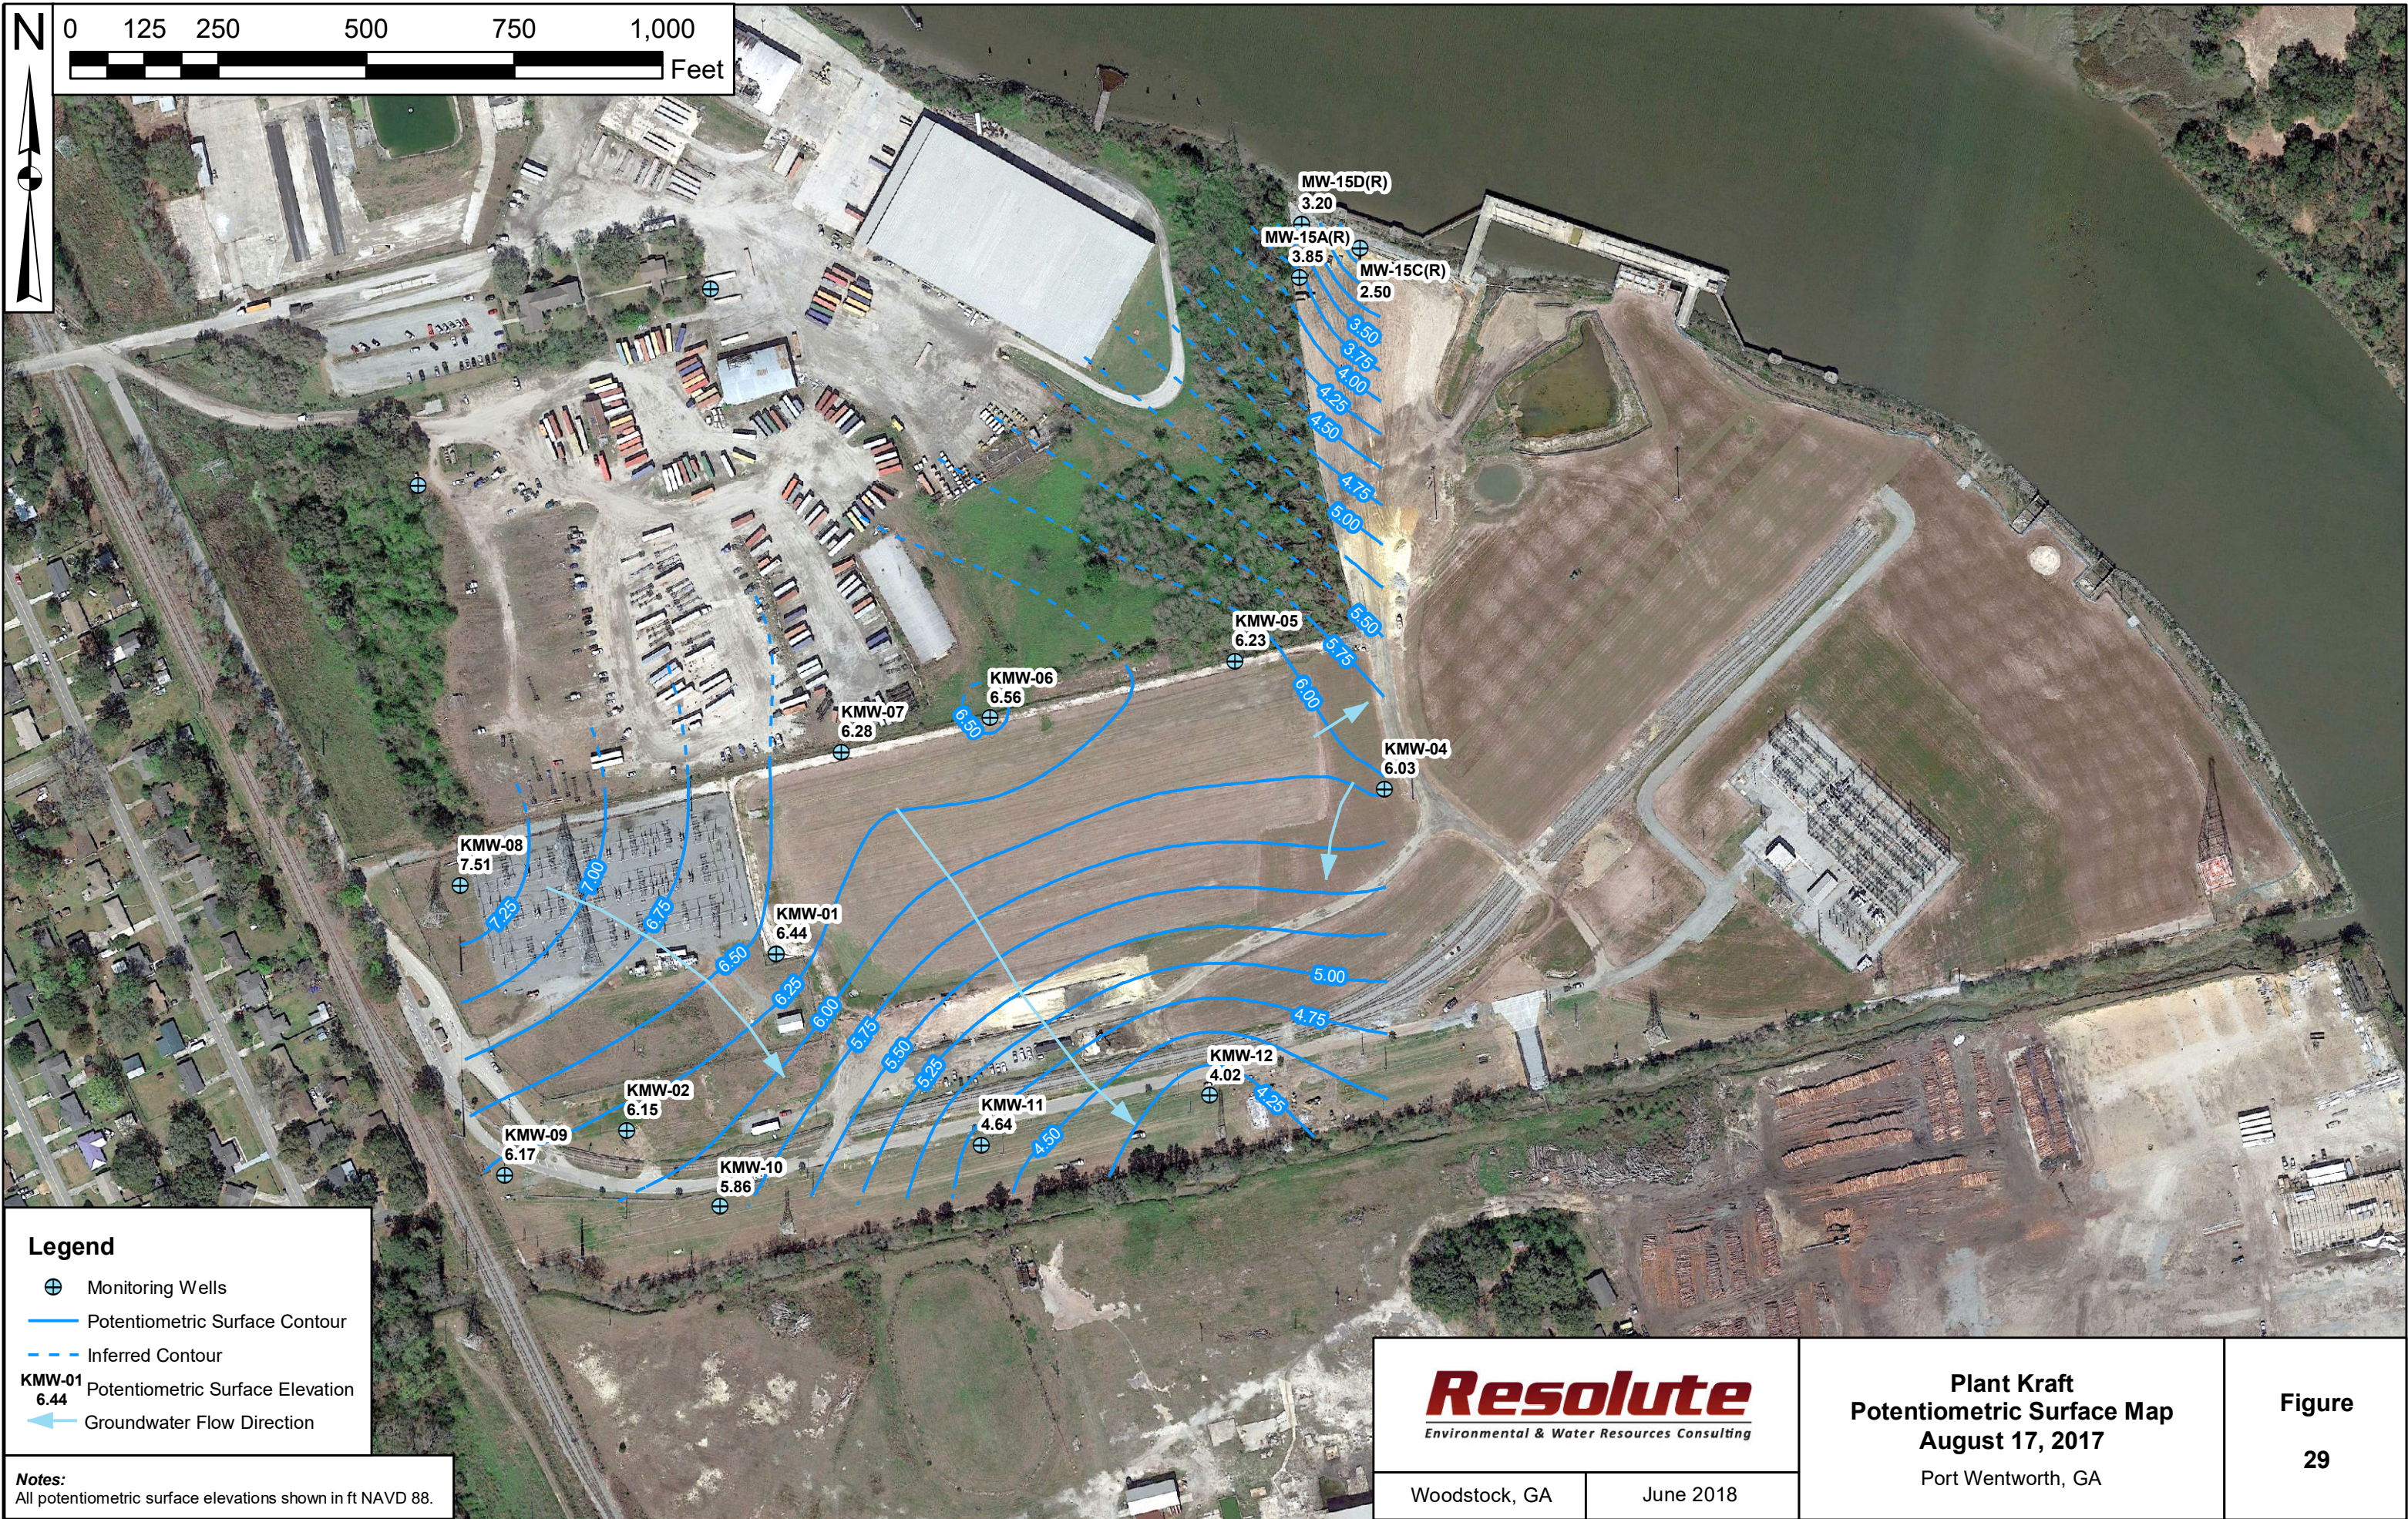
**Figure  
29**

**Plant Kraft  
Potentiometric Surface Map  
August 17, 2017**  
Port Wentworth, GA

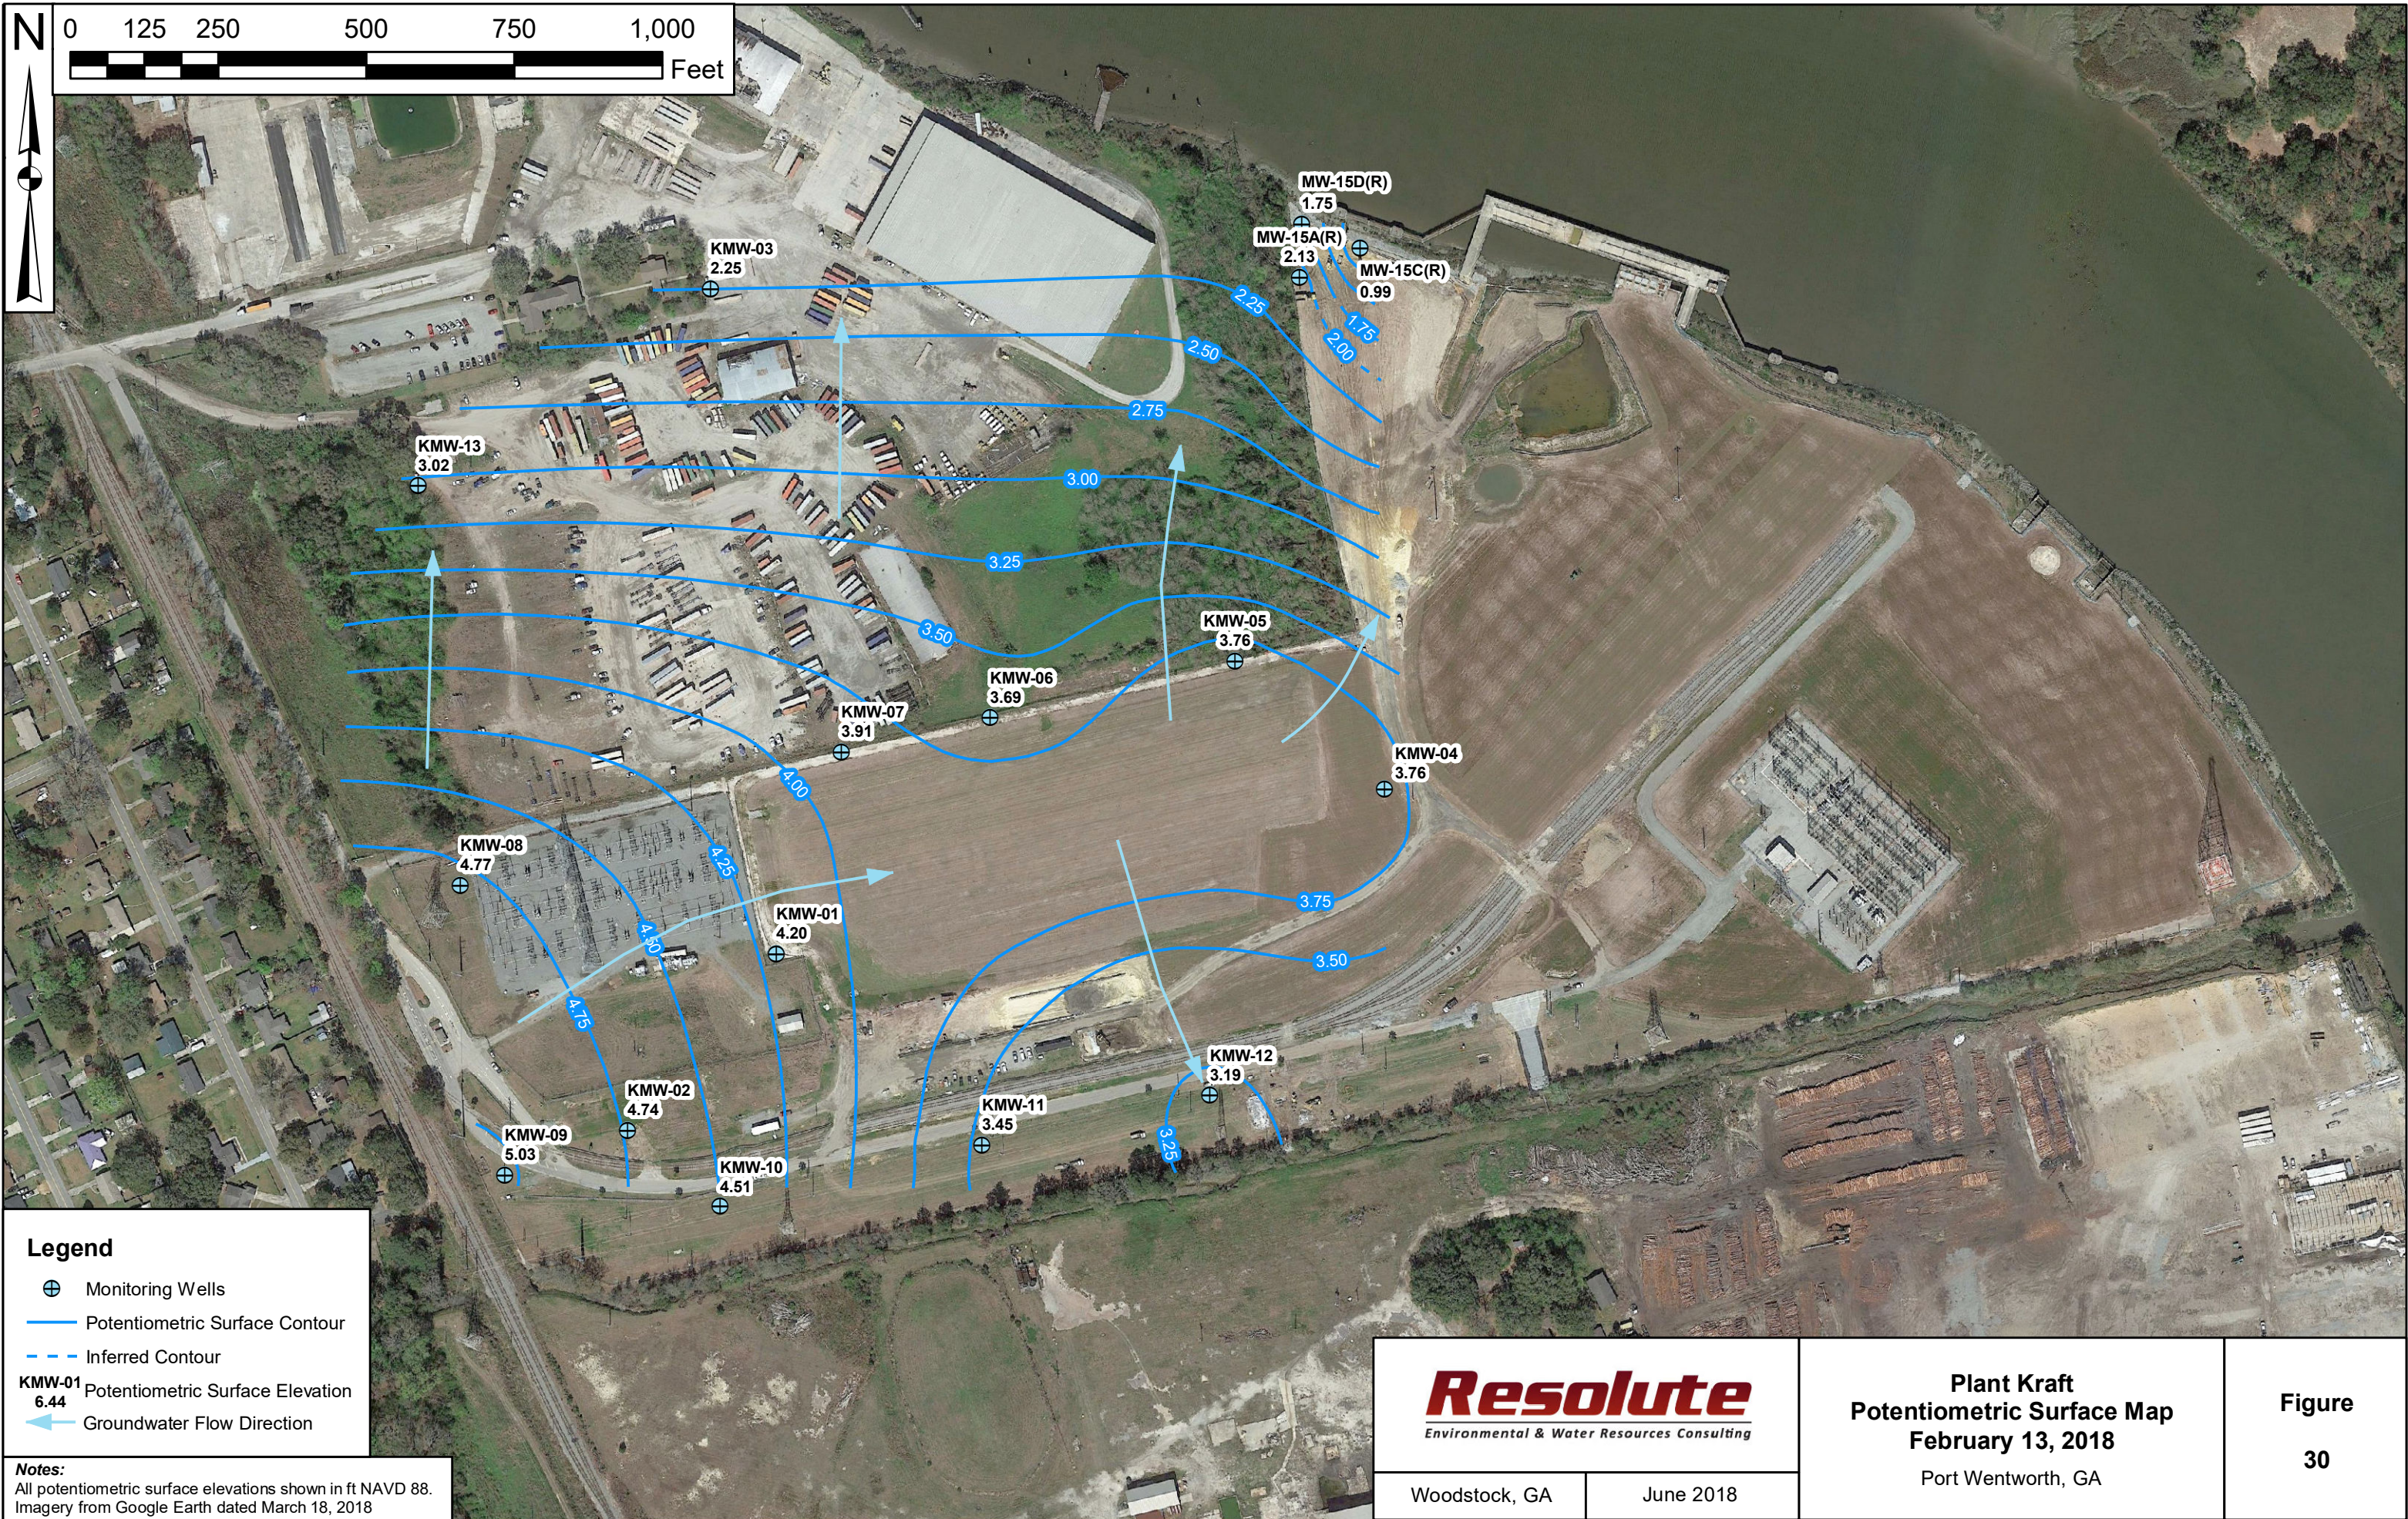
**Figure  
 30**

**Notes:**  
 All potentiometric surface elevations shown in ft NAVD 88.  
 Imagery from Google Earth dated March 18, 2018
