Re: VRP Compliance Status Report
TLC Cleaners
2060 Lower Roswell Road
Marietta, GA 30068

**VOLUNTARY REMEDIATION PROGRAM
COMPLIANCE STATUS REPORT
TLC Cleaners
2060 Lower Roswell Road
Marietta, GA 30068**

VOLUNTARY REMEDIATION PROGRAM COMPLIANCE STATUS REPORT

TLC CLEANERS
2060 Lower Roswell Road
Marietta, GA 30068

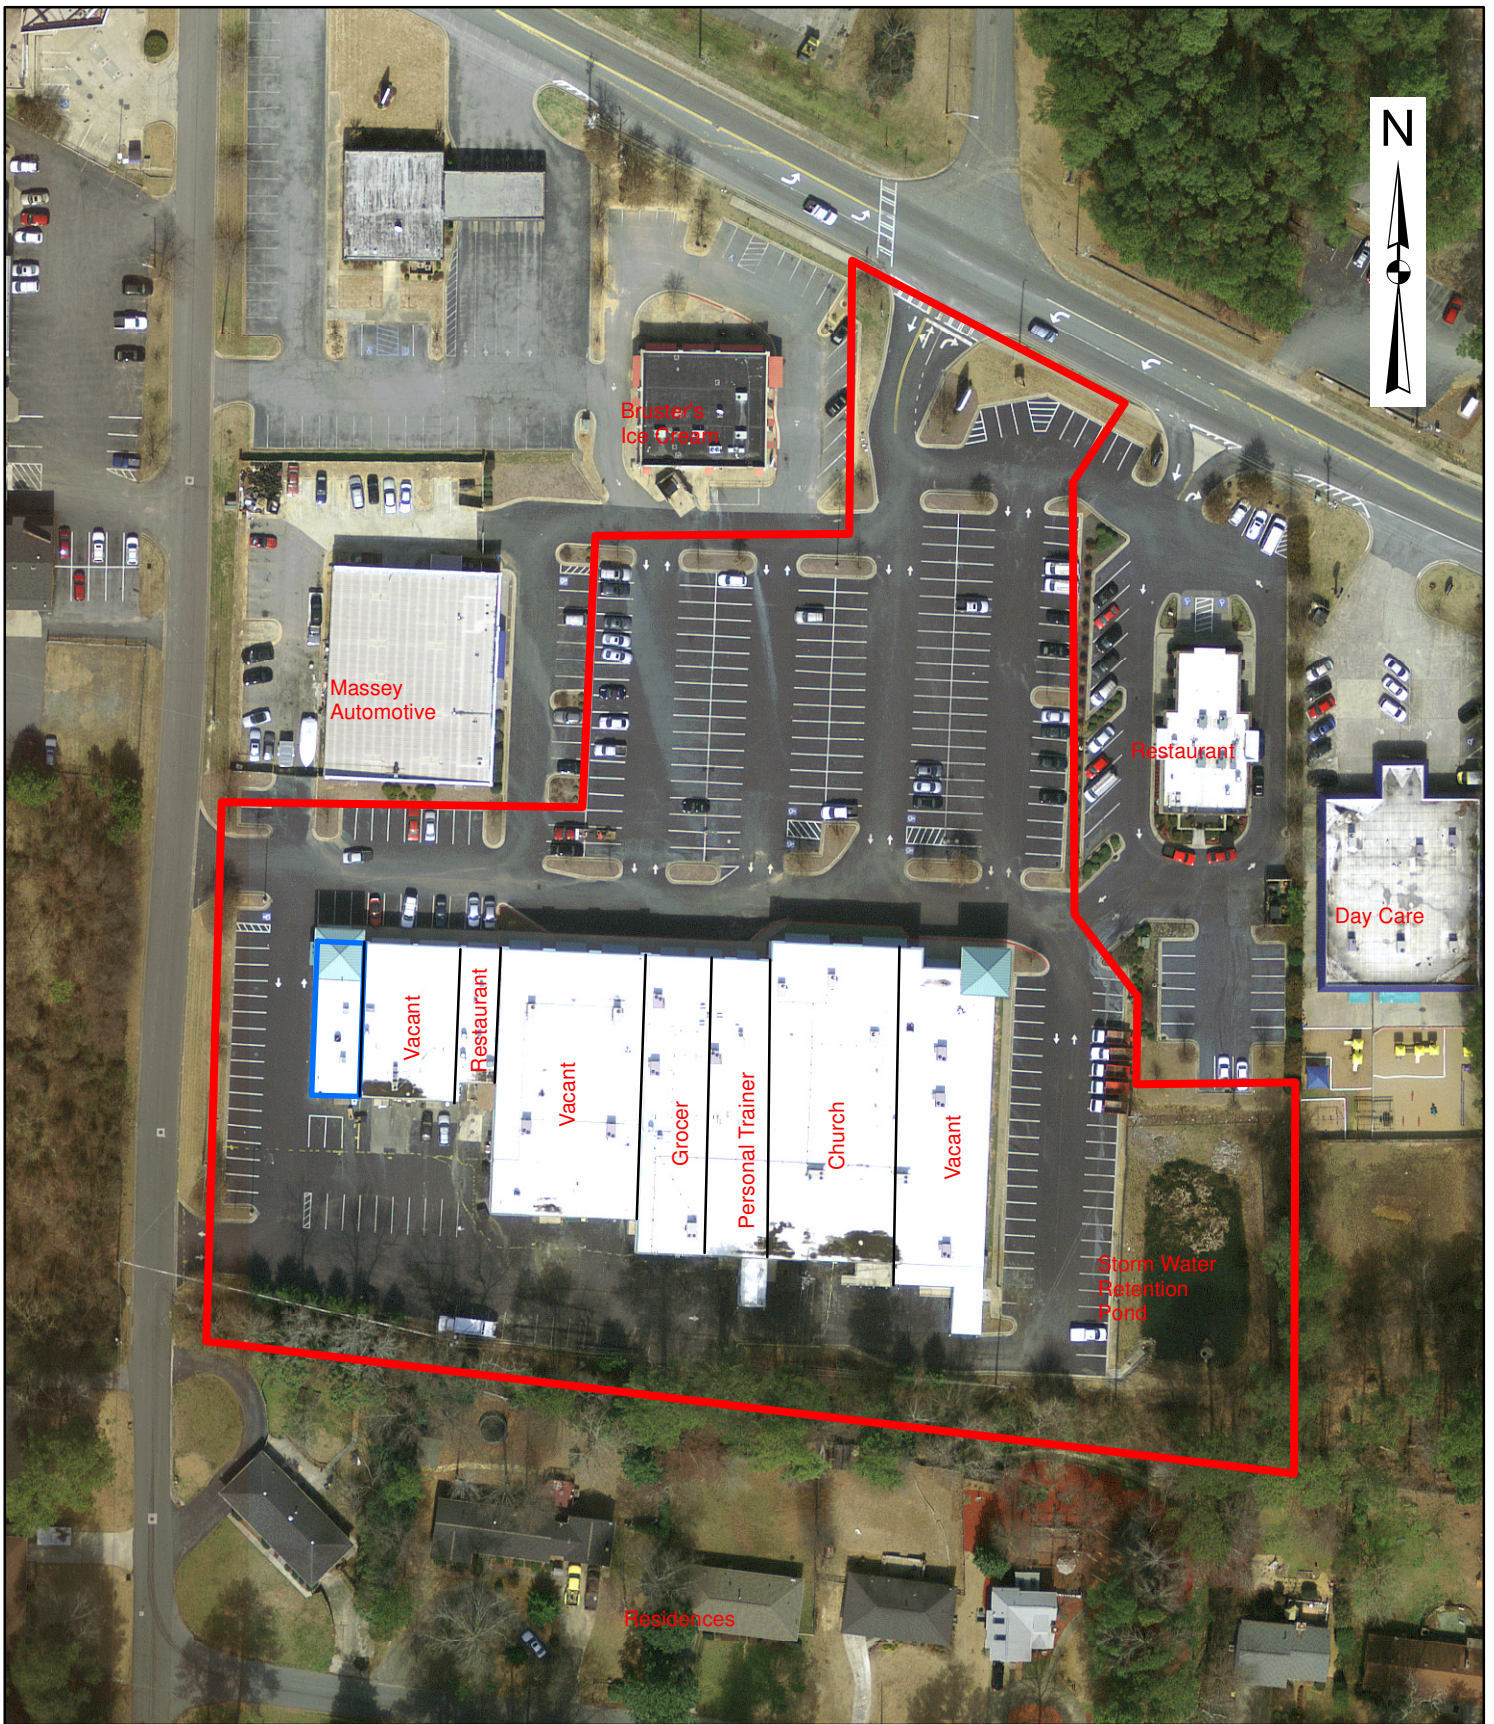
Site Plan
TLC Cleaners
2060 Lower Roswell Rd.
Marietta, GA 30068

Properties immediately adjacent to the Site are shown on Figure 3A and include:

- Towards the North: Massey Automotive, Bruster's Ice Cream, and Sewell Park.
- Towards the East: Zaxby's Restaurant and a day care facility.
- Towards the South: single family residential.
- Towards the West: Shawnee Lane followed by undeveloped, wooded land.

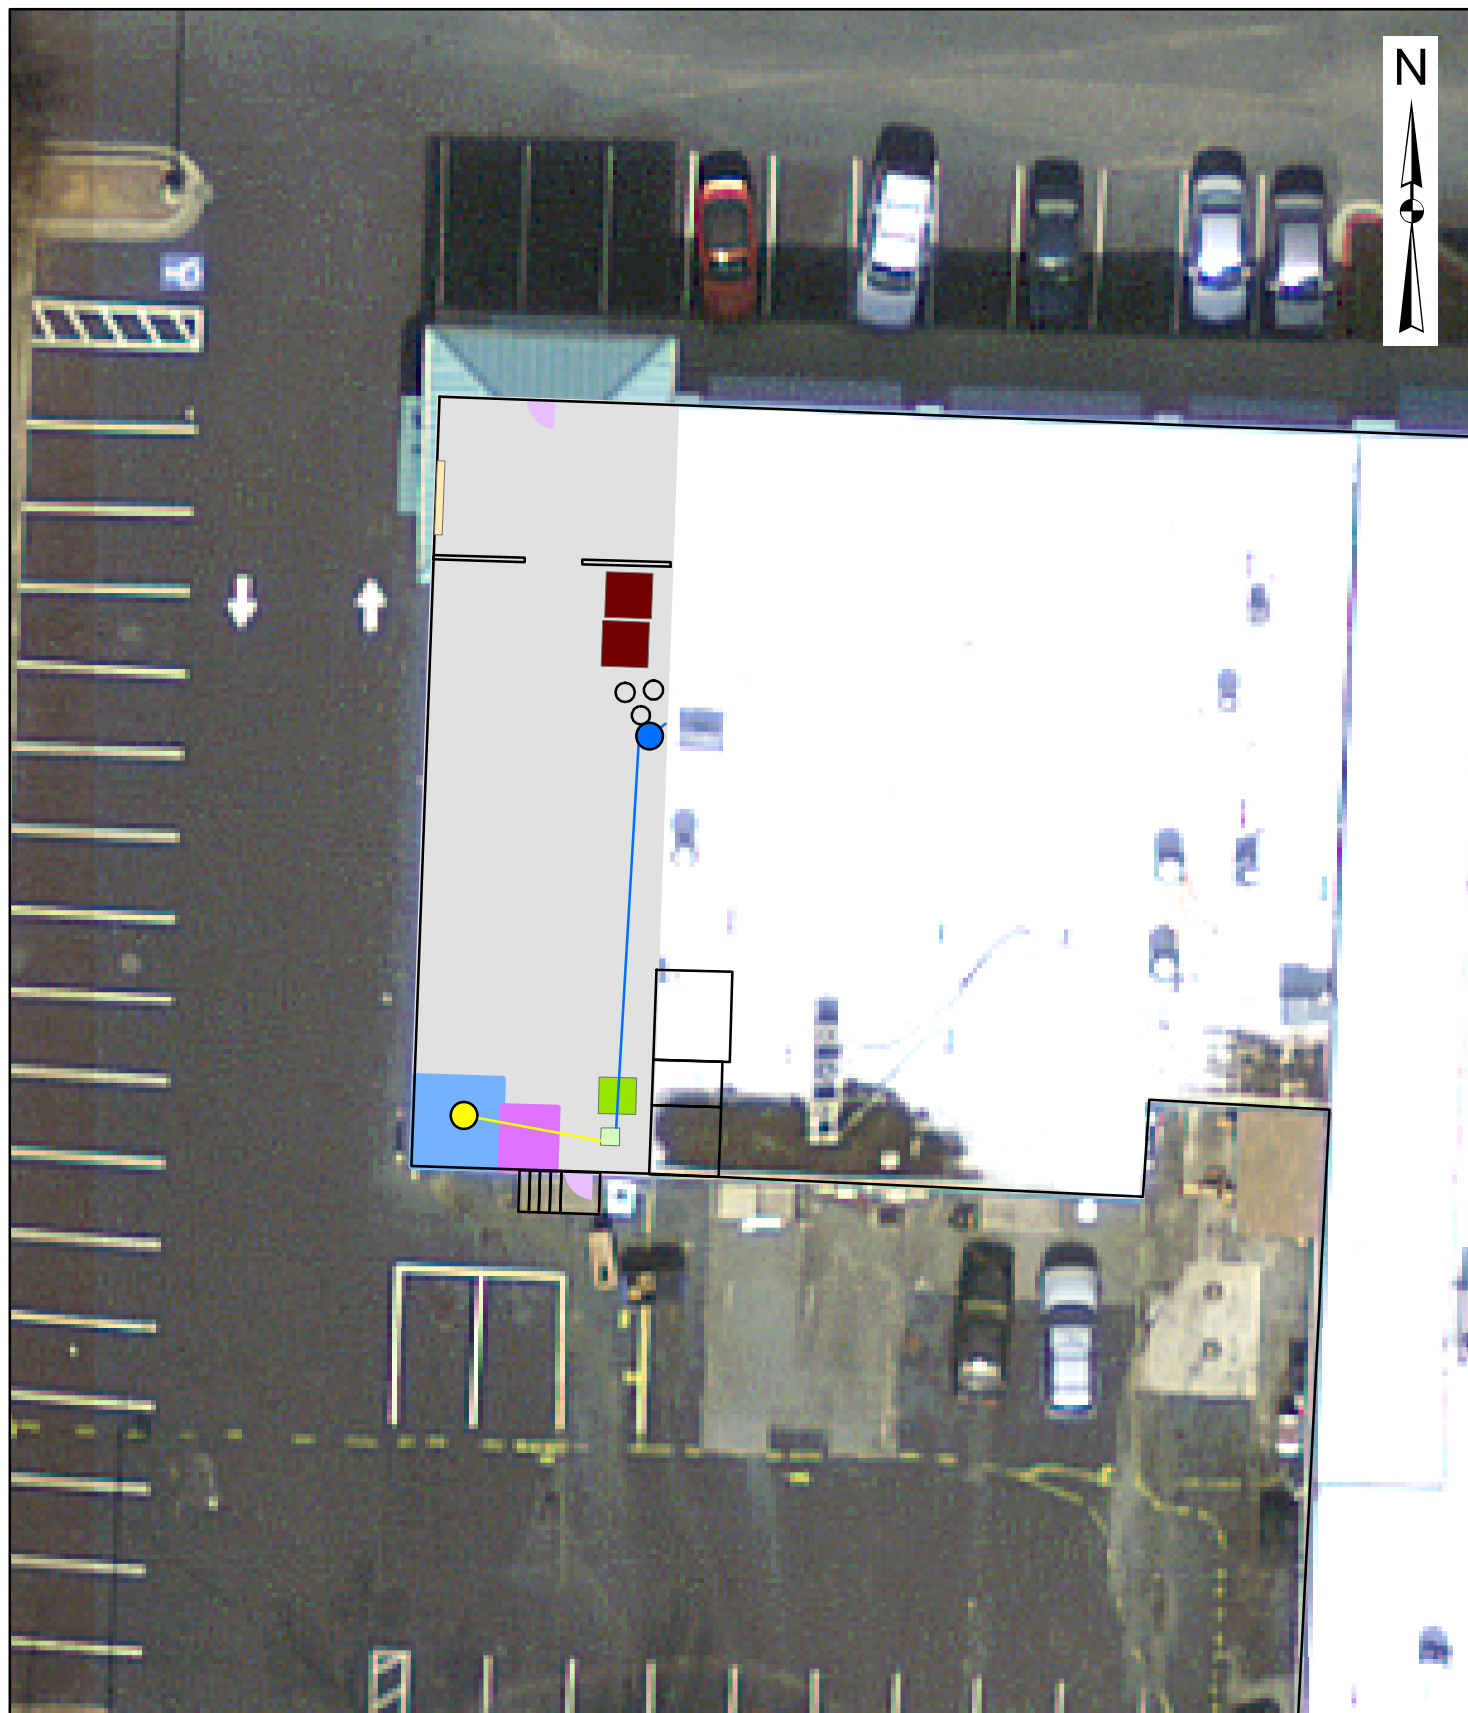
Site Plan- Facility Layout

As shown on Figure 3B, the dry cleaning machines and drum storage were located toward the front of the Facility near a floor drain. The floor drain connected to a drain line which ran to the back of the Facility to a four foot deep concrete-lined sump, i.e., grit trap, where solids could settle, allowing the water to continue to the sanitary sewer line. Based on the soil and groundwater data, the source of the soil and groundwater impact appears to be the dry cleaning operations with the highest soil concentrations located at the base of the grit trap.

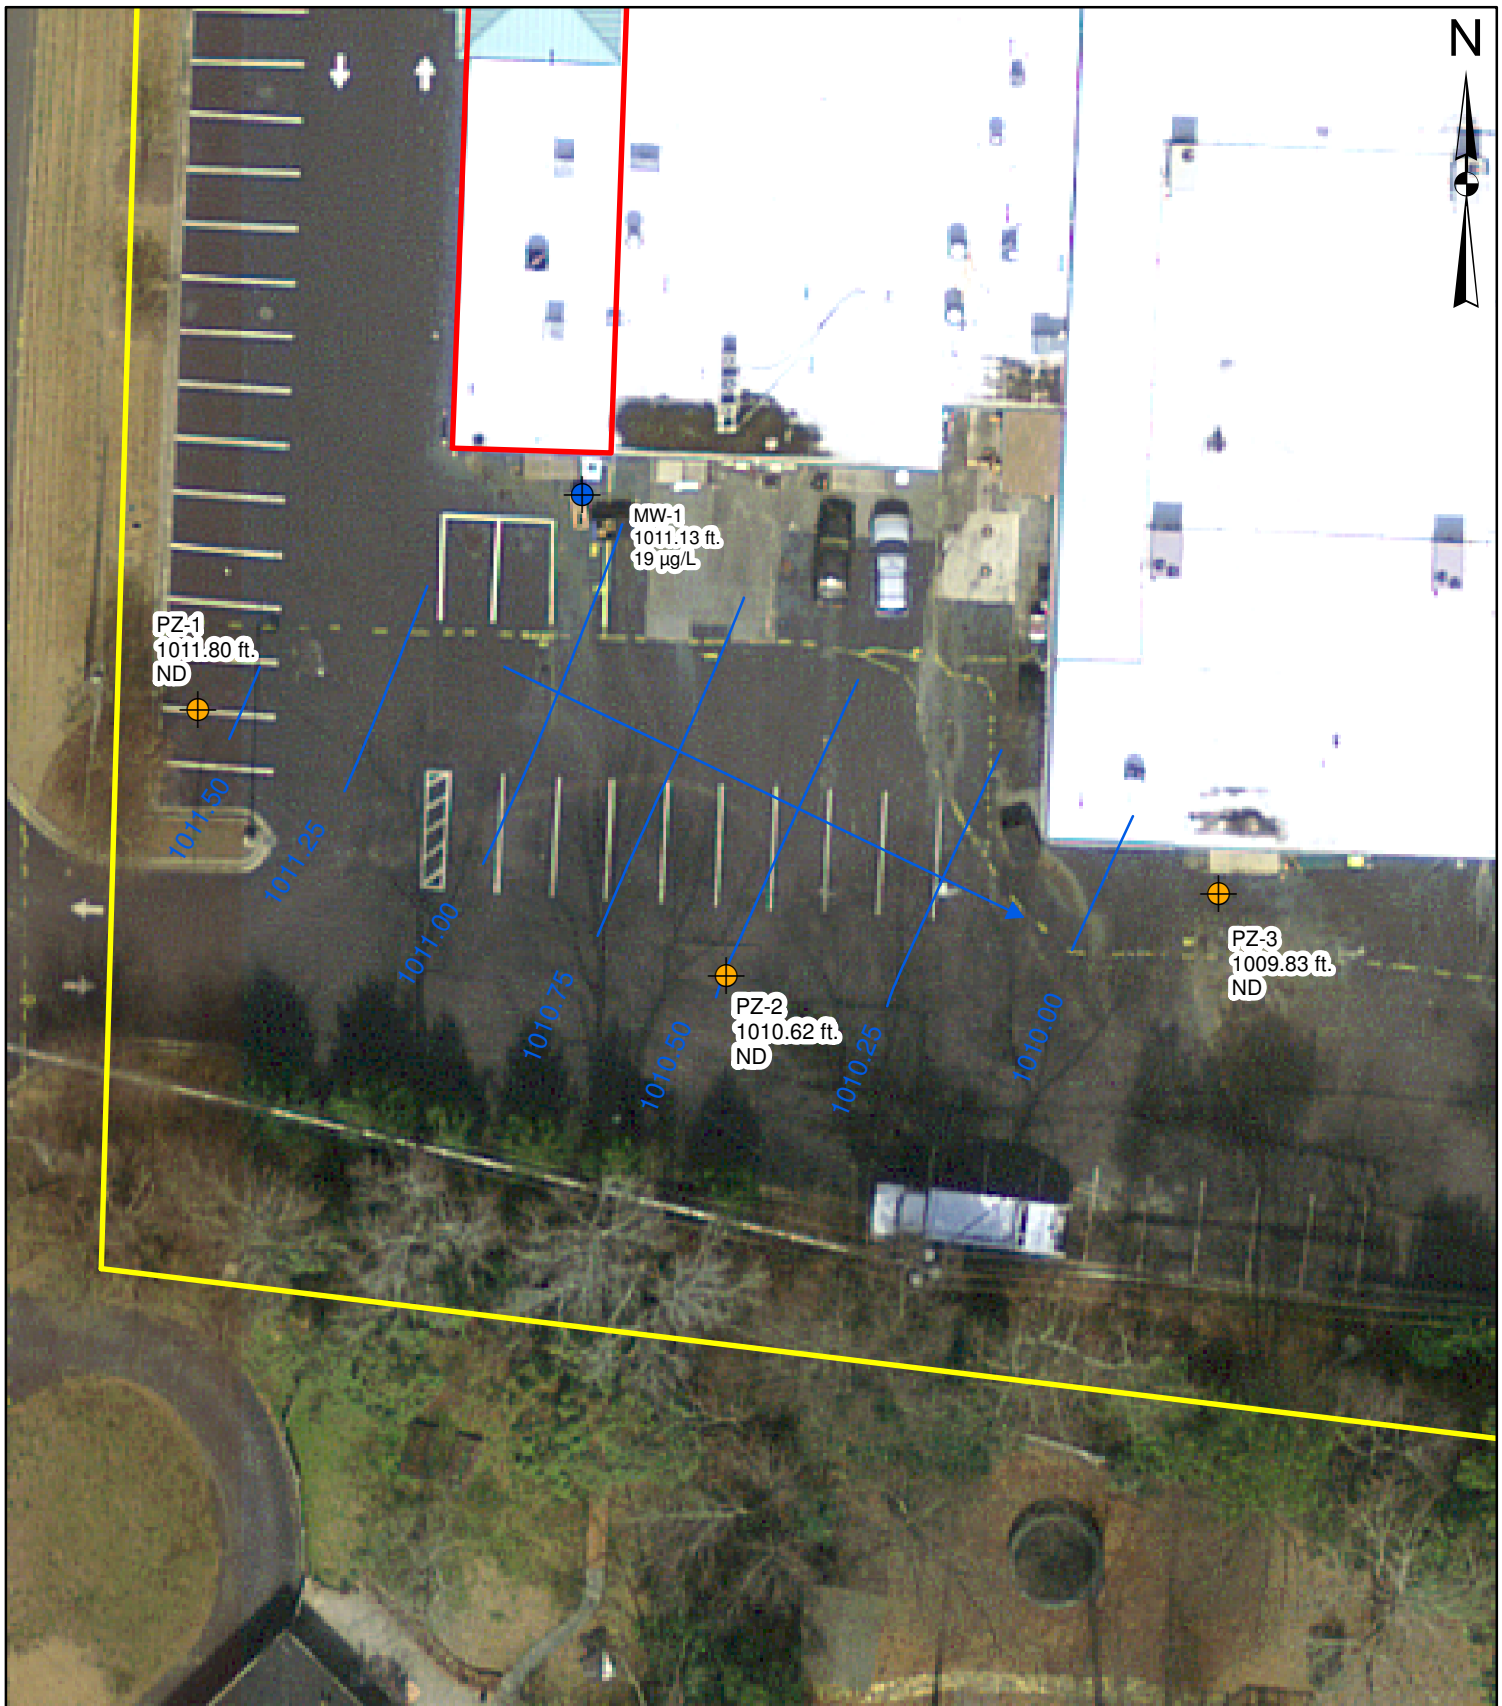
Groundwater Sampling Results and Potentiometric Surface Map (May 2015)

(Table 4). Figure 5 is a potentiometric surface map showing a groundwater flow direction to the east-southeast.

On May 7, 2015, three piezometers (PZ-1 through PZ-3) were installed to the southeast, south, and southwest of monitoring well MW-1 to determine the groundwater flow direction. The locations of the piezometers are shown on Figure 5.

The Site geology has been investigated through the advancement of soil borings and the installation of shallow monitoring wells. Borings have been advanced to depths of 20-25 ft-bgs into saprolite. The soil beneath the Facility consists of silt and clay extending to approximately 10 ft-bgs, and sandy soils were observed below that to a depth of 20 feet. Boring logs are included in Appendix A. Groundwater was encountered at approximately 8 ft-bgs south of the Facility and was determined to flow to the east-southeast (Figure 5).

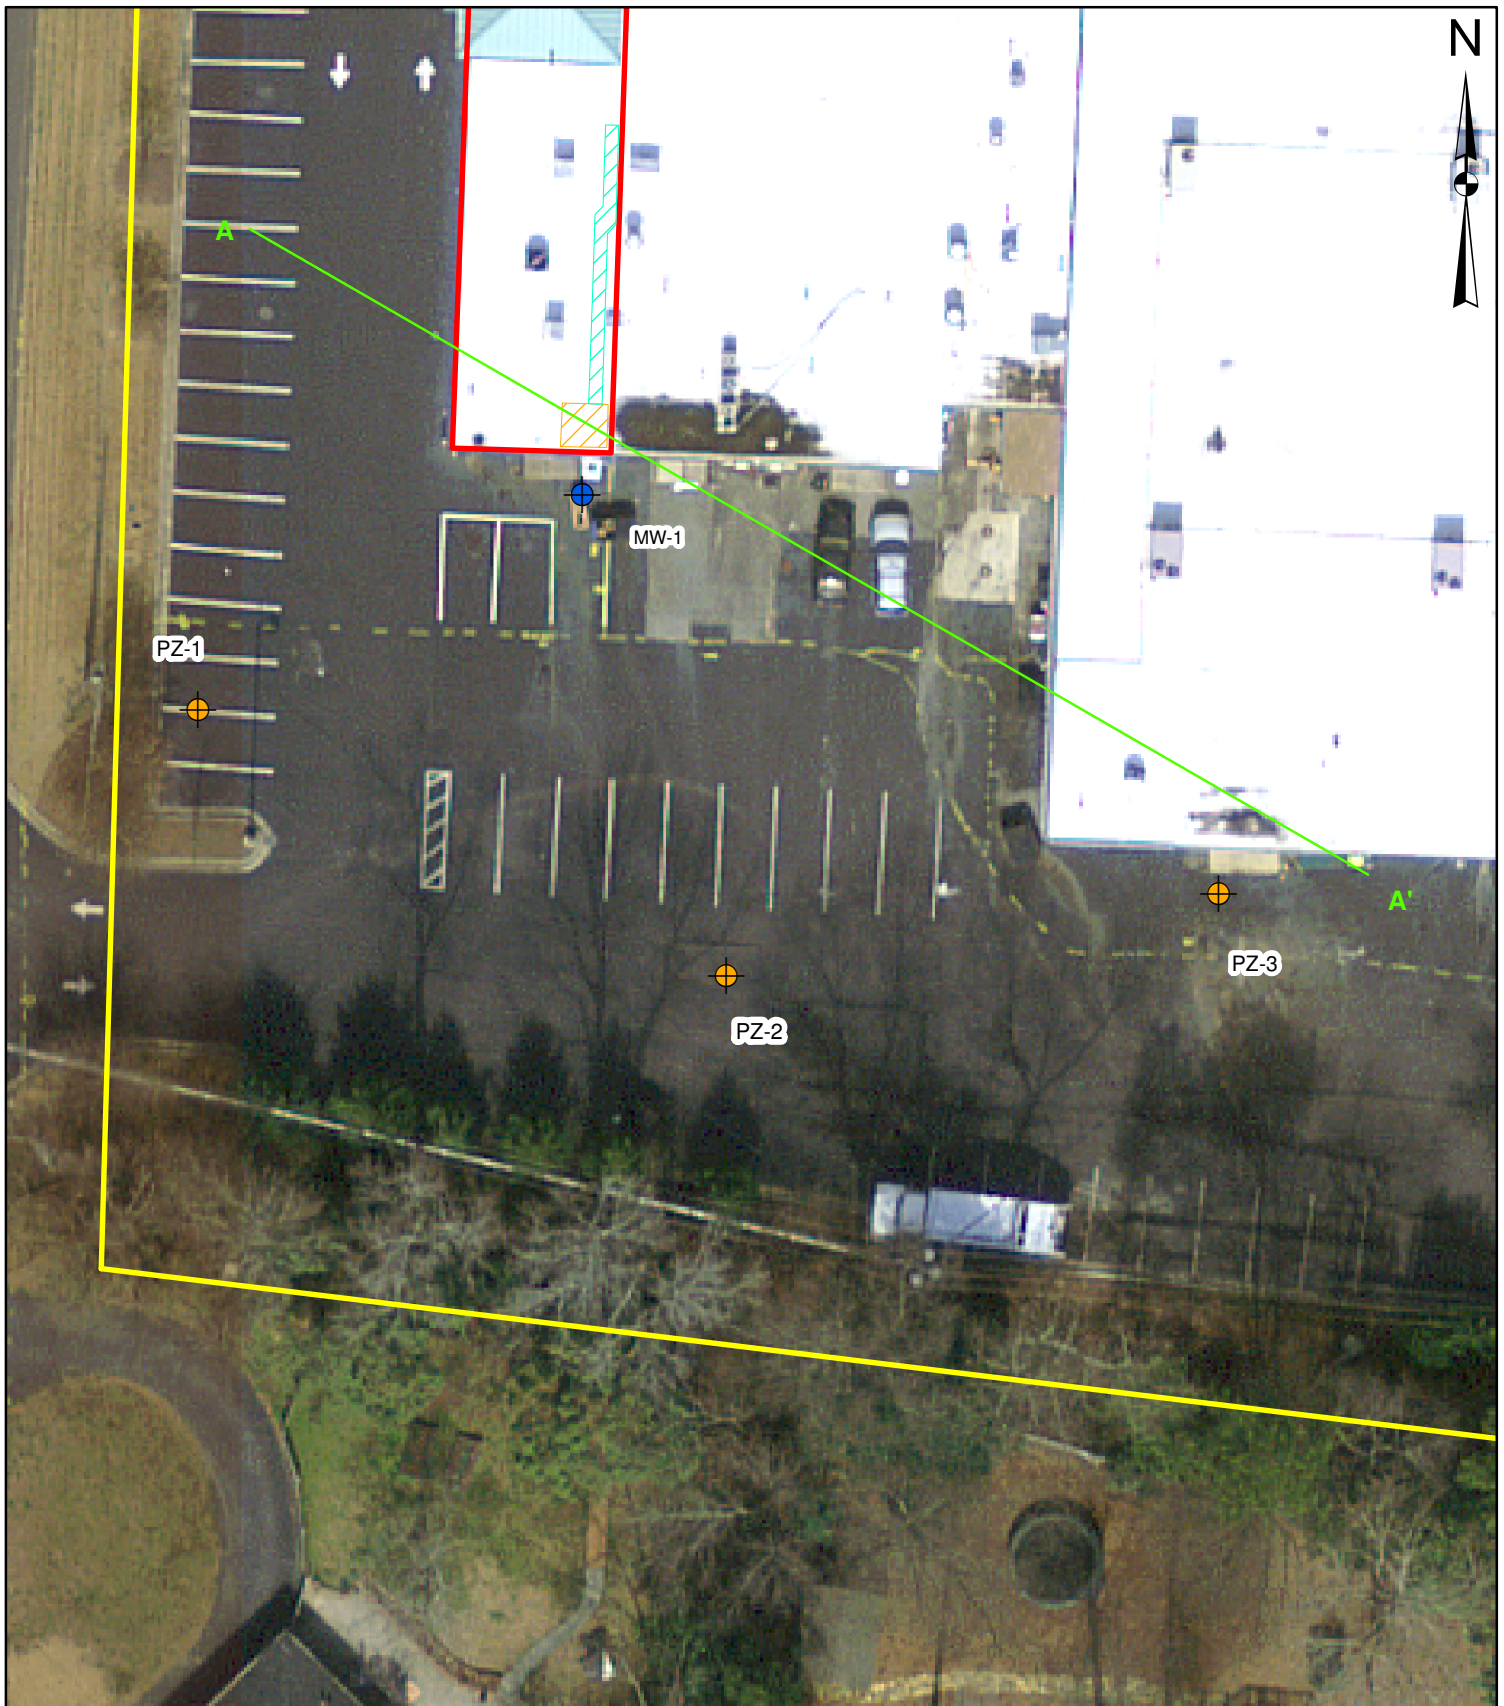
Conceptual Site Model Plan View

Figures 9A and 9B are plan view and profile diagrams depicting the extent of constituents in the subsurface. Viewed in total, these figures give a three-dimensional representation of the Site conditions.
