# **VOLUNTARY REMEDIATION PROGRAM**

## **FINAL COMPLIANCE STATUS REPORT**

**FORMER IMPERIAL CLEANERS  
1233B ALPHARETTA HIGHWAY  
ROSWELL, FULTON COUNTY, GEORGIA  
HSI SITE NO. 10690**

November 12, 2015

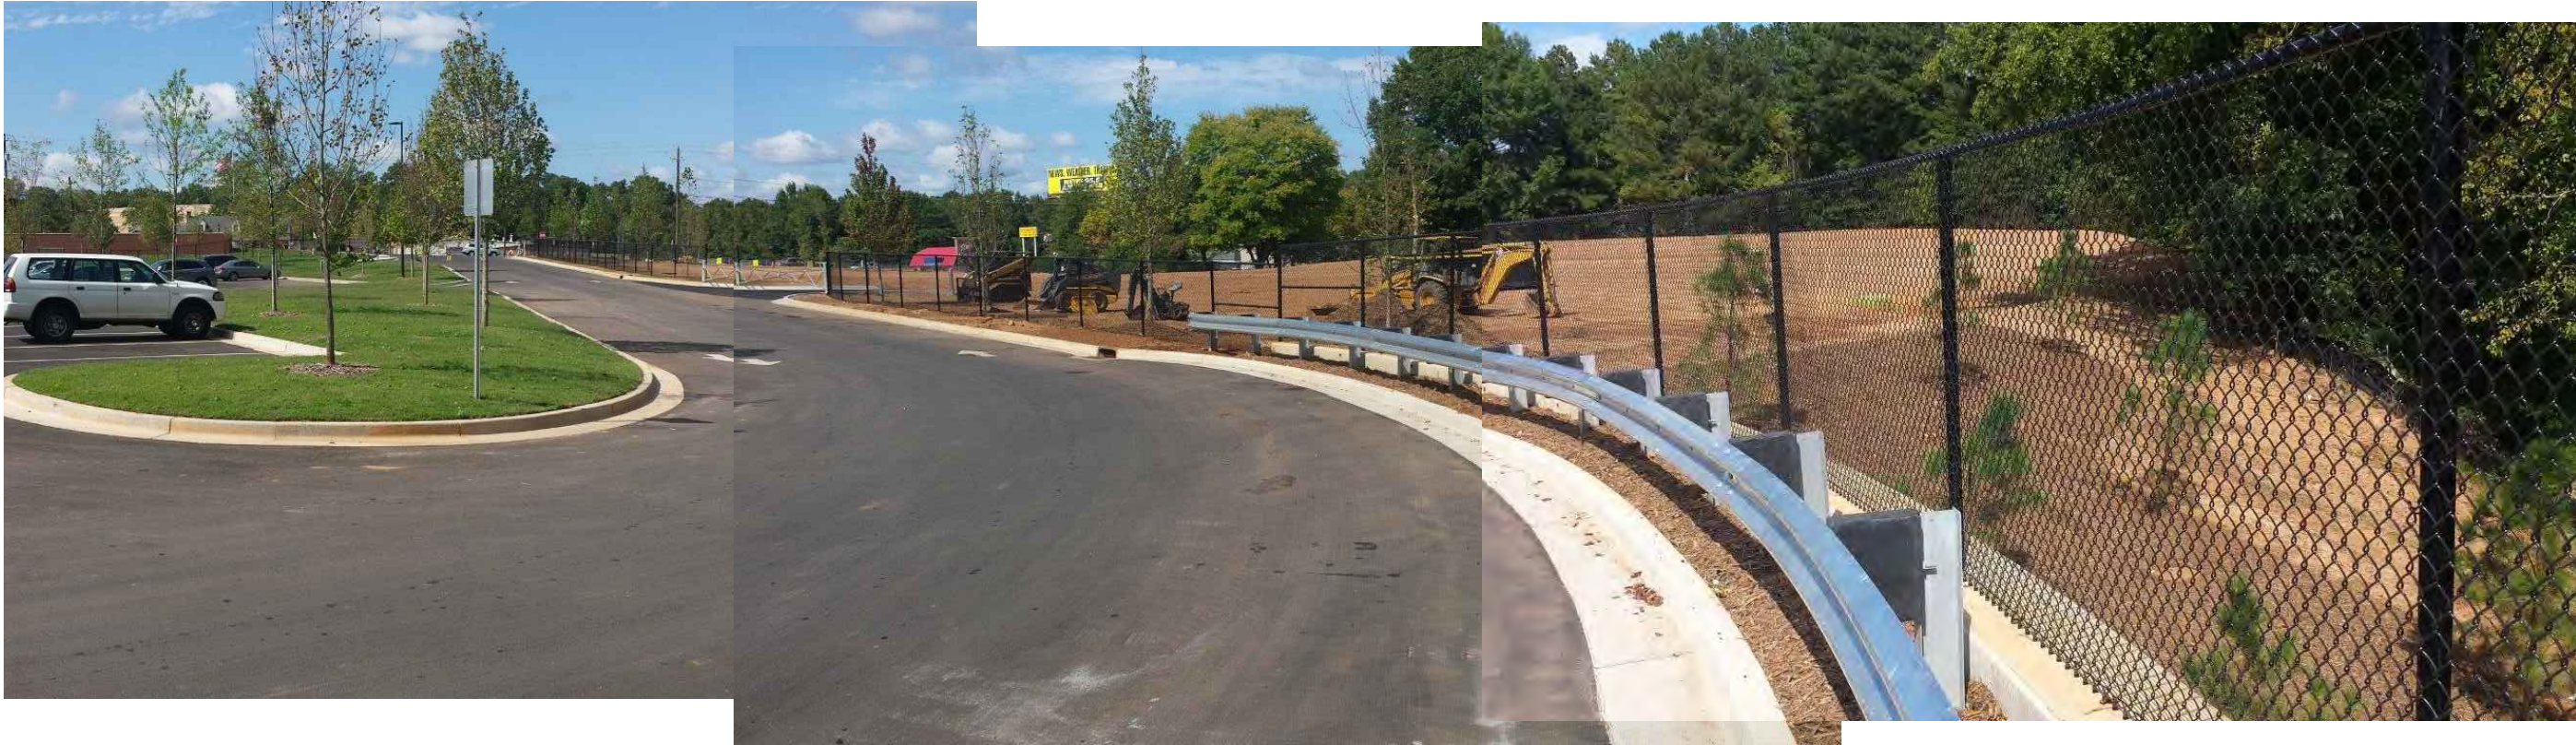
NOTE:  
LOOKING NORTHWEST TOWARD PACEL 2 FROM DRIVEWAY  
OF PARCEL 1 (ESTHER JACKSON ELEMENTARY SCHOOL).  
NOTE SLOPE DOWN TO CREEK ON RIGHT SIDE OF PHOTO.  
FENCE FORMS BOUNDARY OF 2.767-ACRE PARCEL 2.
