Re: Ninth Semi-Annual Progress Report
Drexel Chemical Company; HSI Site No. 10228
120 Cape Road, Cordele, Georgia

This letter report is to serve as the Ninth Semi-Annual Progress Report for the Drexel Chemical Company facility. During the current reporting period we have begun Phase 2 of the remediation plan. Phase 2 of the remediation plan includes excavation of soil on both Drexel and CSX property along either side of an active rail line (see Figure 1). Some excavation of soil has been required in order to facilitate the installation of the shoring along the rail line. Thus, soil excavation has been conducted concurrently with installation of shoring, as appropriate based on the level of shoring installed.

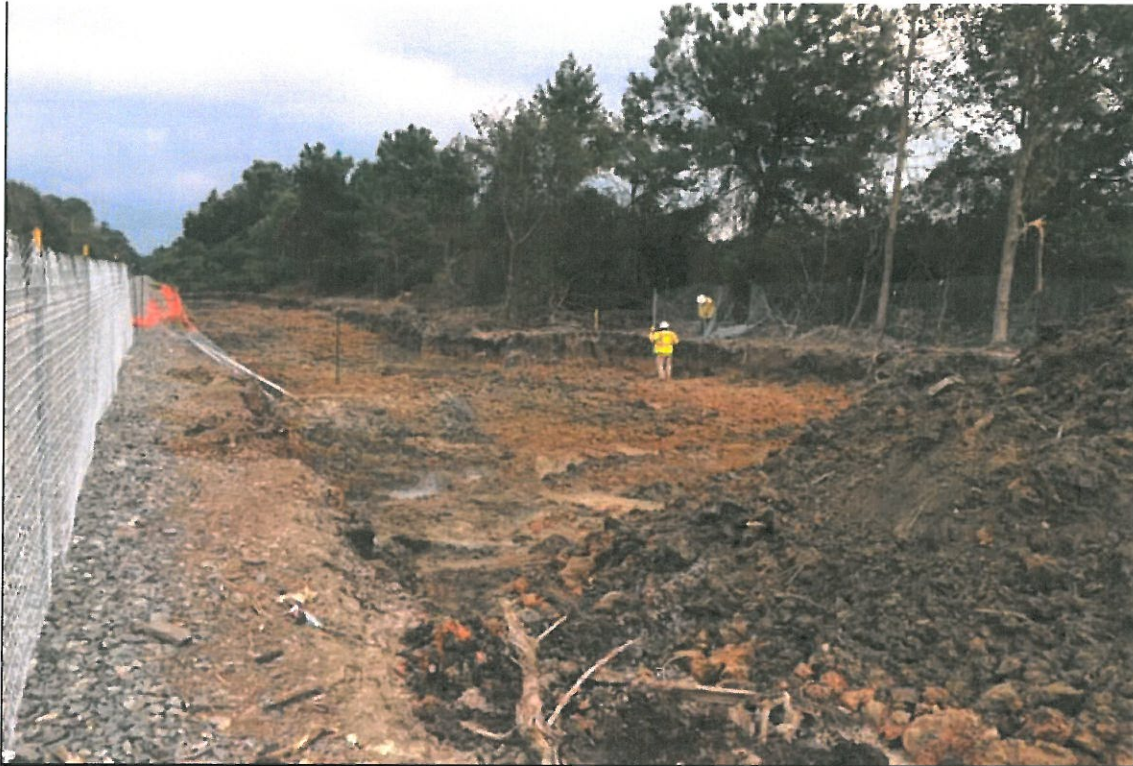
Area 1 excavation completed - facing east

2. Excavation of the eastern swale (Area 1) began on September 16, 2015 and was completed by September 21, 2015 (see Photo 1 on the attached Photo Log). The average depth of excavation was 3.5 feet instead of the planned 2 feet due to wet soil conditions and the need to dig to more dense underlying soil to maintain equipment traffic. This area was backfilled and compacted on September 22-23 (see Photo 2).

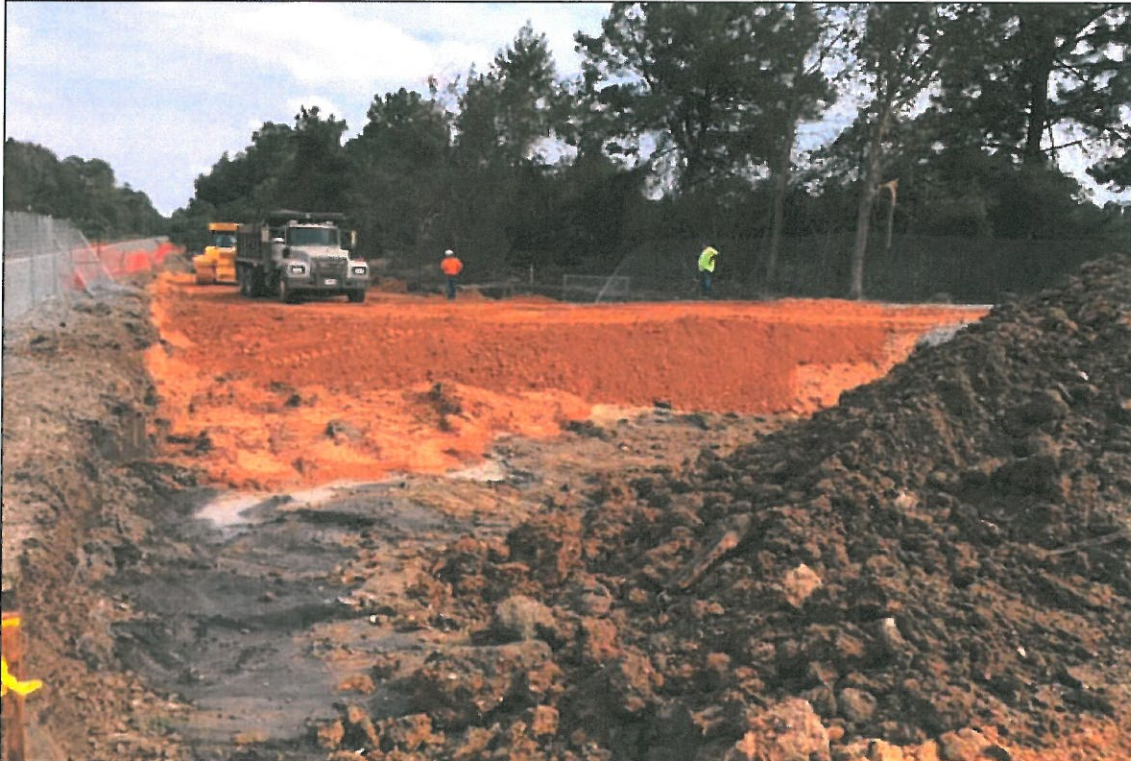
Photo 2

Backfilling and compacting of Area 1 - facing east

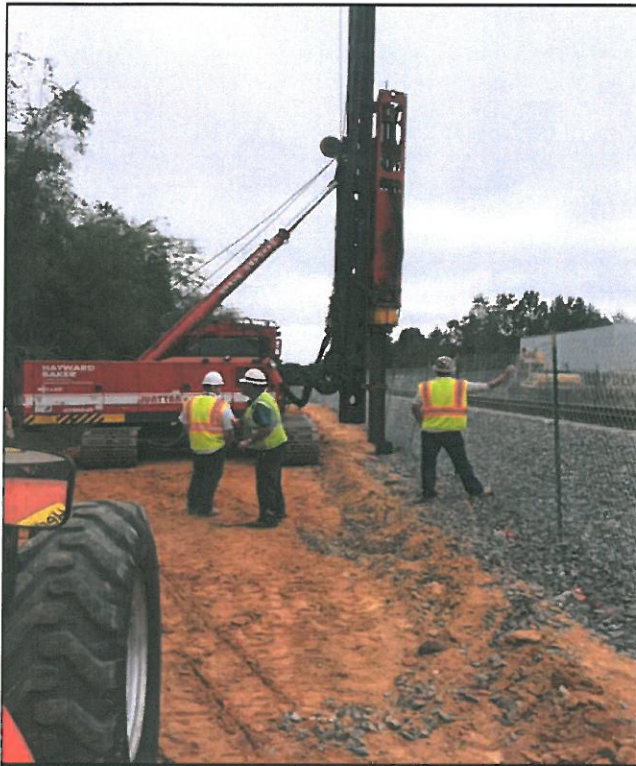
Photo 3

Installing a pile

3. Shoring along the rail line began on September 21. The installation of shoring is on-going. Piles have been installed six feet apart on both sides of the rail line (Photo 3 and 4). Lagging has been installed to a depth of 6 feet south of the rail line and from 5 to 15 feet north of the rail line. Tie backs have been installed at

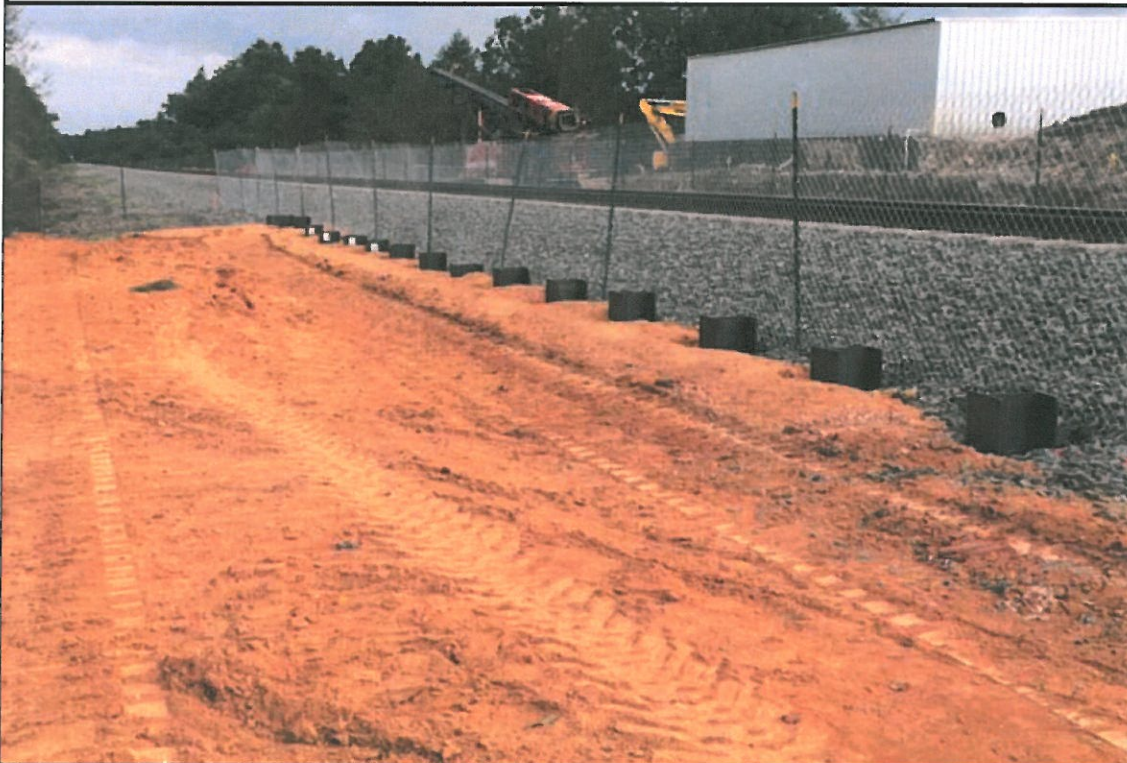
Photo 4

Installed piles on the north side of tracks

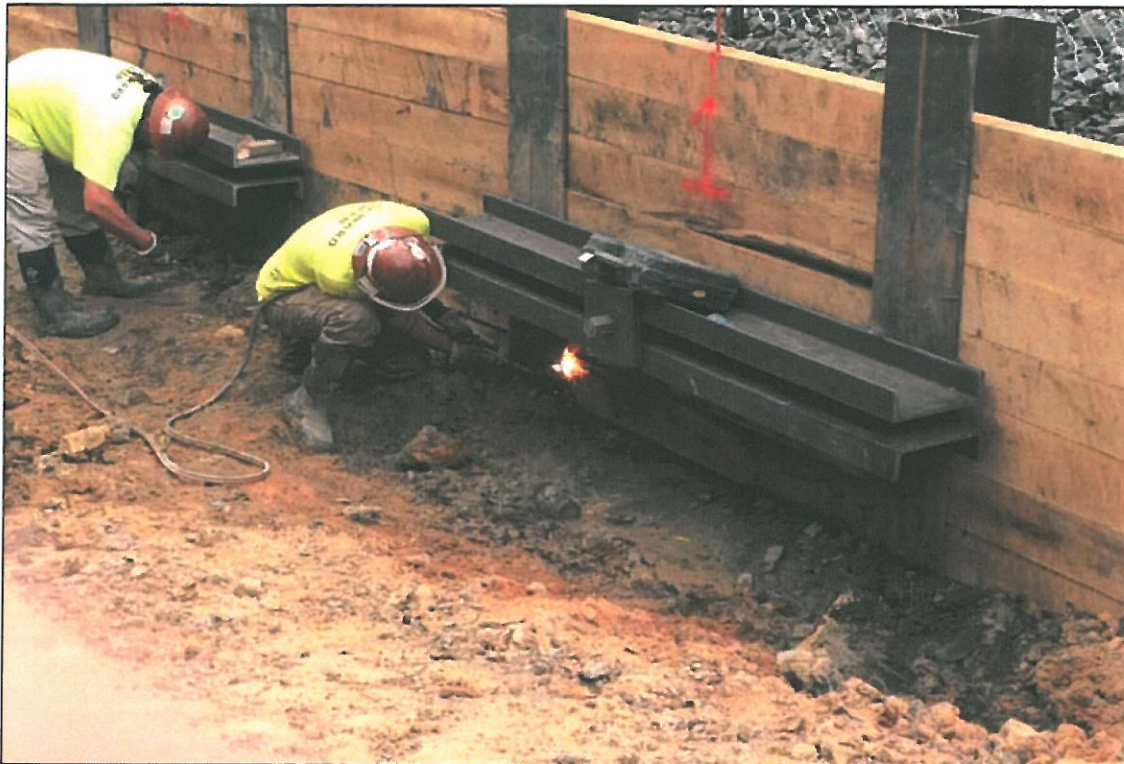
Photo 5

Channel beam and rod installation

the appropriate depths (Photo 5). Ongoing activities include installing the lagging to the design depth of 15 feet on both sides (Photo 6).

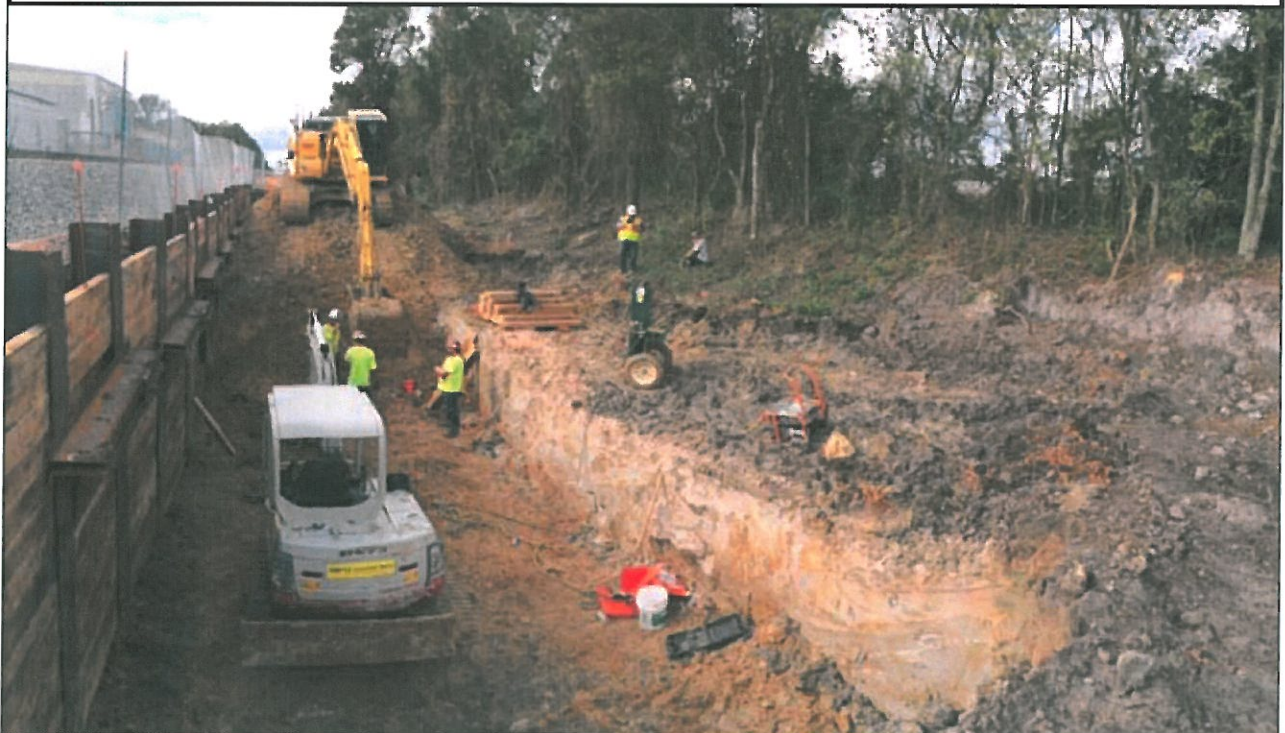
Photo 6

Shoring installed north of rail line as of Oct 29 - facing west

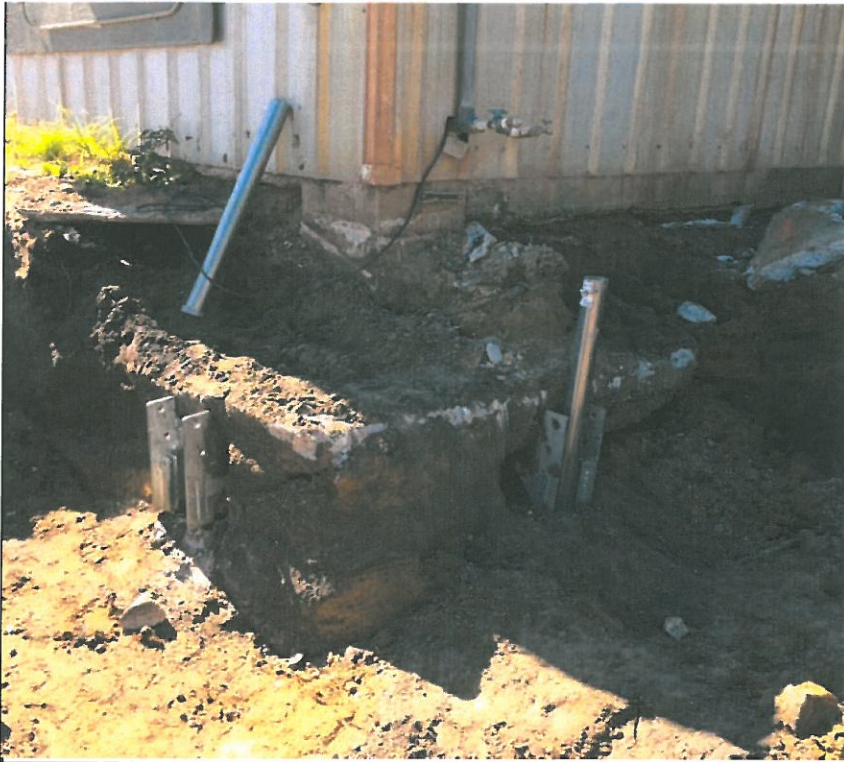
Photo 7

Start of shoring installation at the middle warehouse

4. Shoring of the northeast corner of the middle warehouse on-site was installed the week of October 19 (Photo 7).
5. As a part of the excavations to facilitate shoring, Areas 4 and 9 were completed and Areas 3 and 8 have been excavated to a depth of at least 7 ft.
6. The excavation of Area 2 to 5 ft was finished by October 15 (Photo 8) and backfilling of approximately 90% the area was finished by October 20 (Photo 9). The part not backfilled is still open for installation of shoring.
7. Area 5 was excavated to 2 ft on October 9 (Photo 10).
8. Excavation of Area 6 and the slope area to the east of Area 6 began on October 26 (Photo 11).

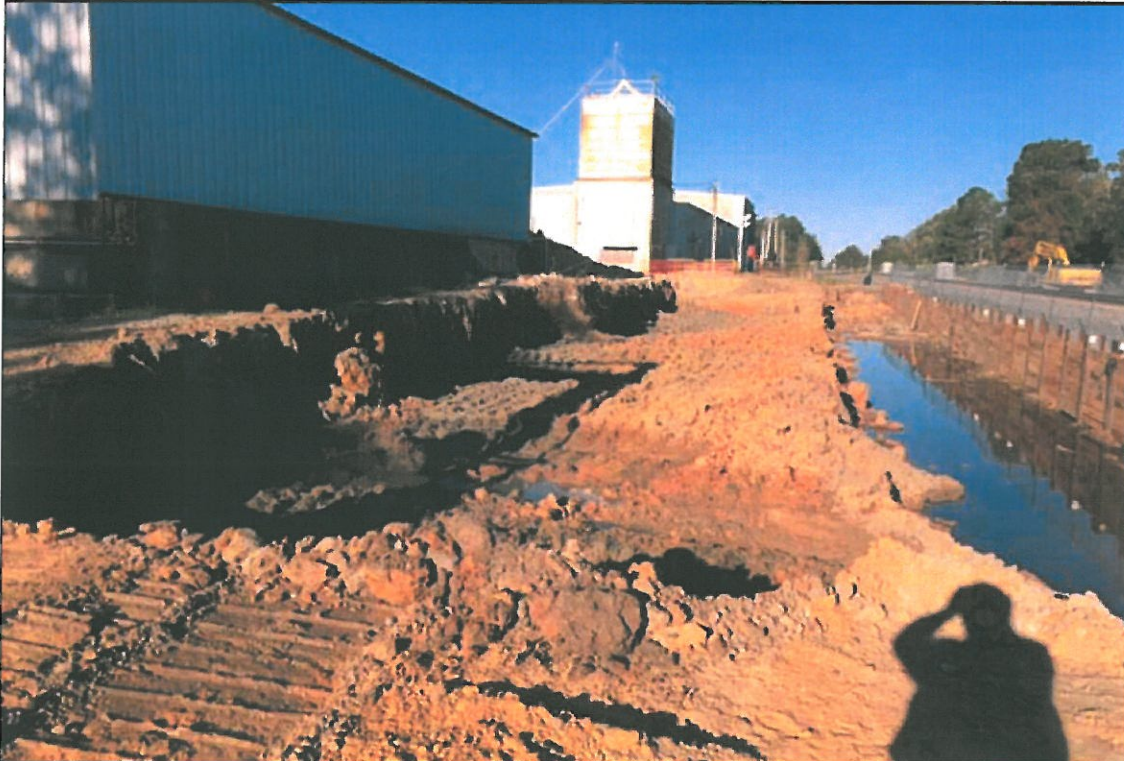
Photo 8

Completed excavation of Area 2

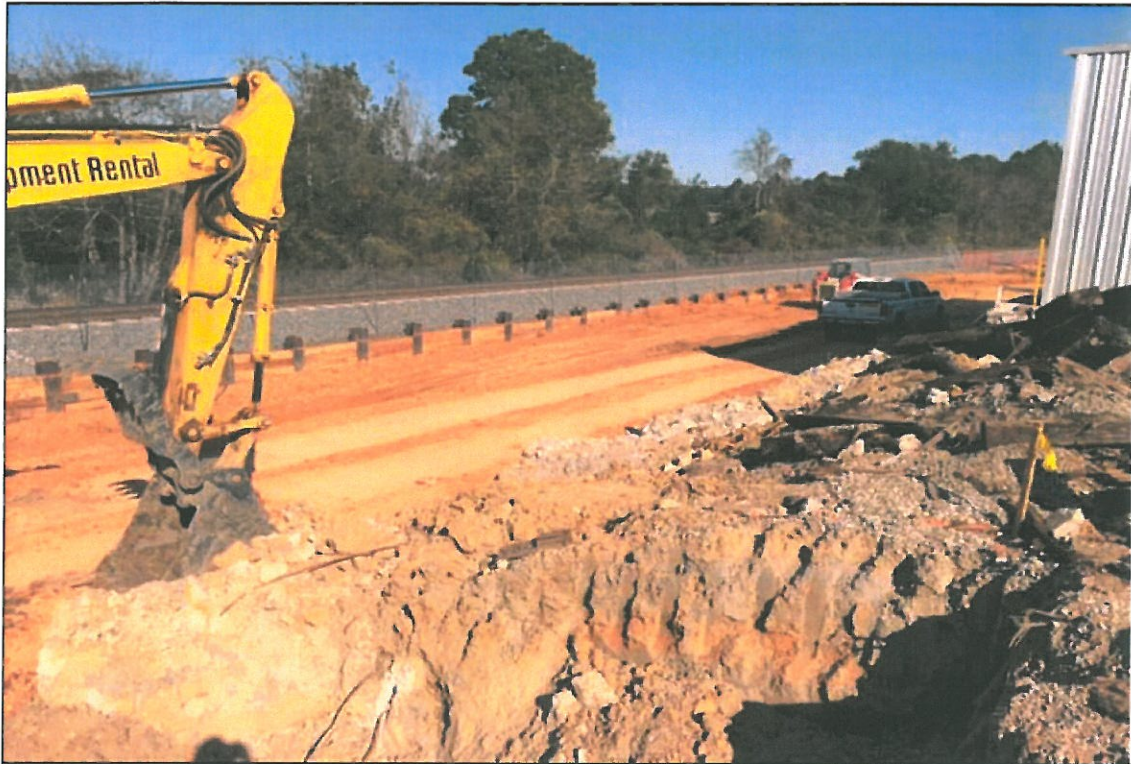
Photo 9

Area 2 during backfilling and compaction

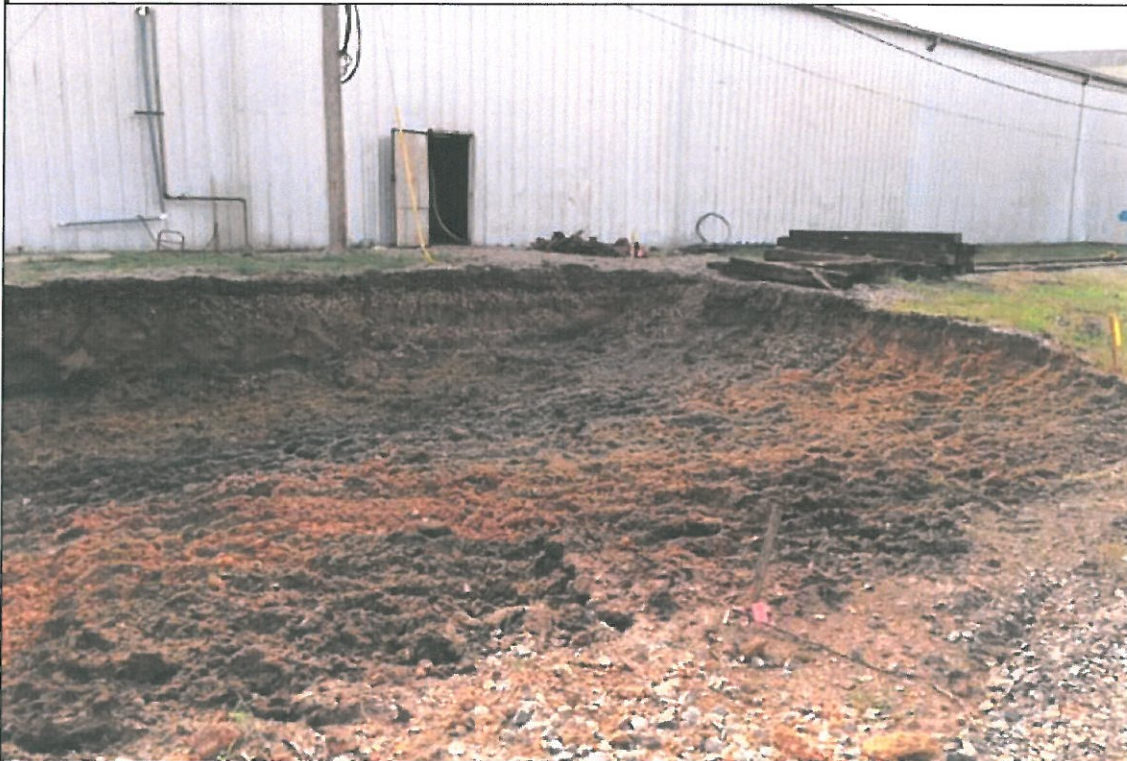
Photo 10

Area 5 after excavation - facing southwest

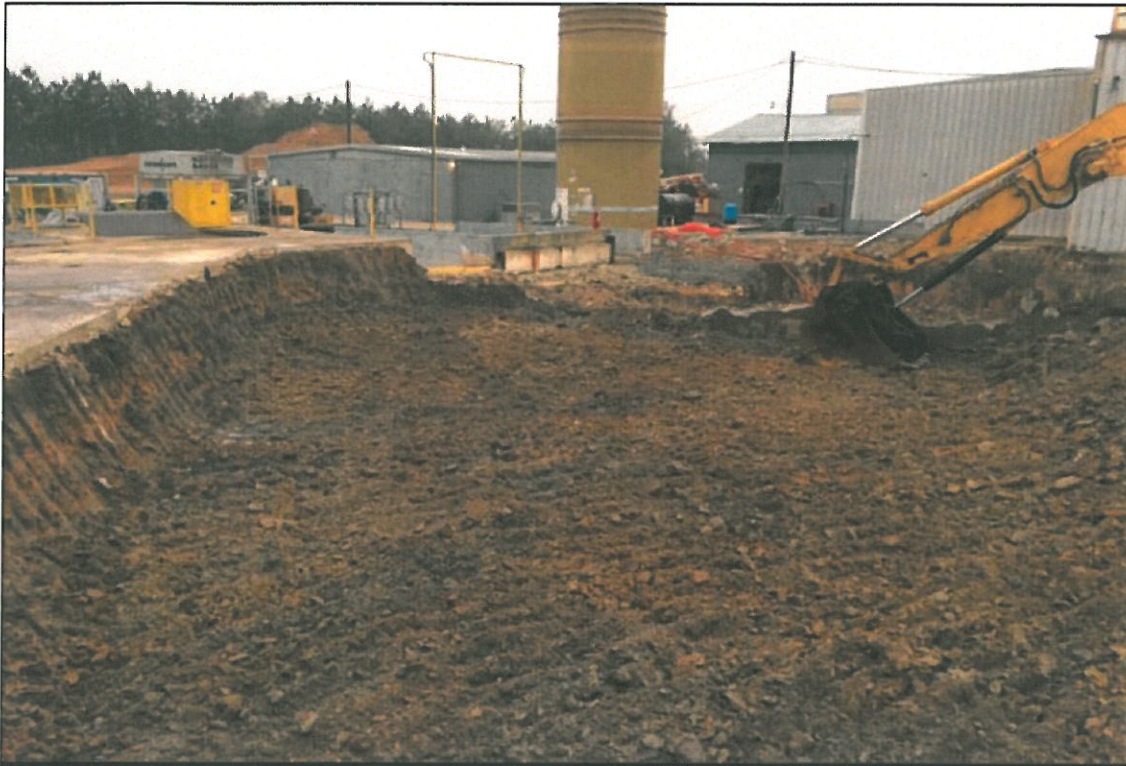
Photo 11

Excavation of Area 6 and Slope Area
