**Re: Semiannual Status Report – January 2014**  
**Voluntary Remediation Program**  
**Former Dry Cleaning Depot, HSI Site No. 10880**  
**Roswell, Fulton County, Georgia**  
**Tax Parcel ID No. 12-1902-0412-049-1**

AEC Report ECC-3051.06

**February 2014**

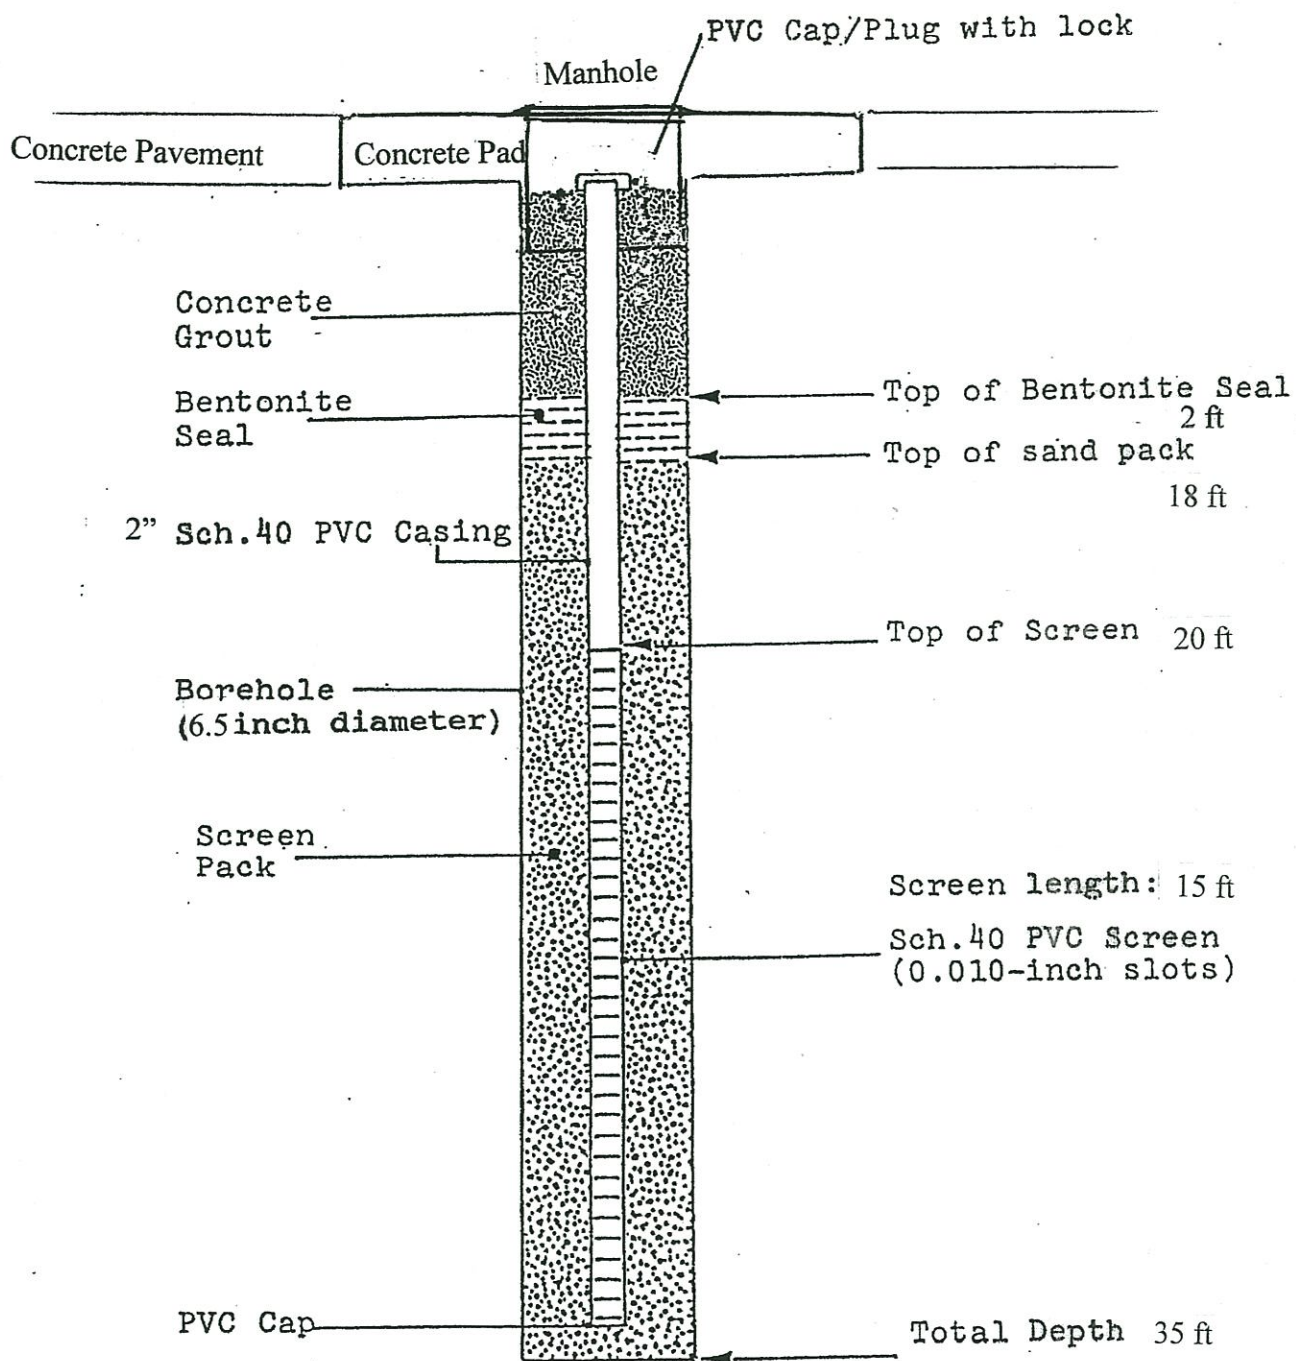
# MONITORING WELL SCHEMATIC DIAGRAM

## FLUSH-MOUNTED MANHOLE WELL COMPLETION

All Depths referenced from Ground Surface

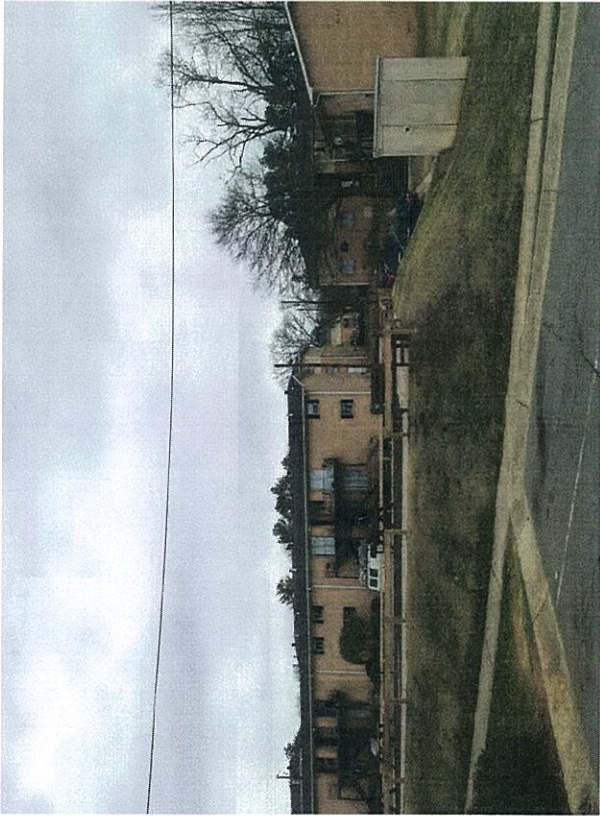
**Photo 5:** View from the center of the site facing north towards the filled in swimming pool and pump house.

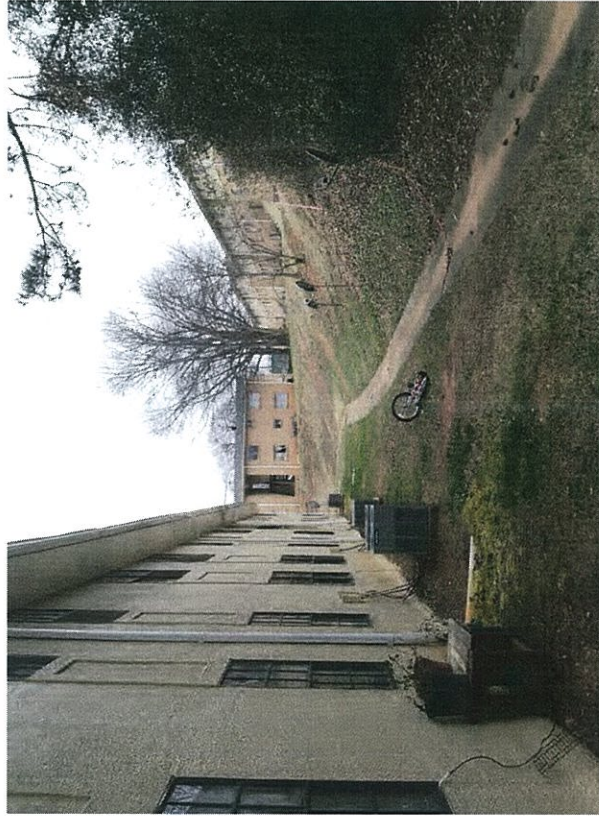
**Photo 15:** View of culvert in the east-central portion of the site, which directs stormwater off-site to the east.

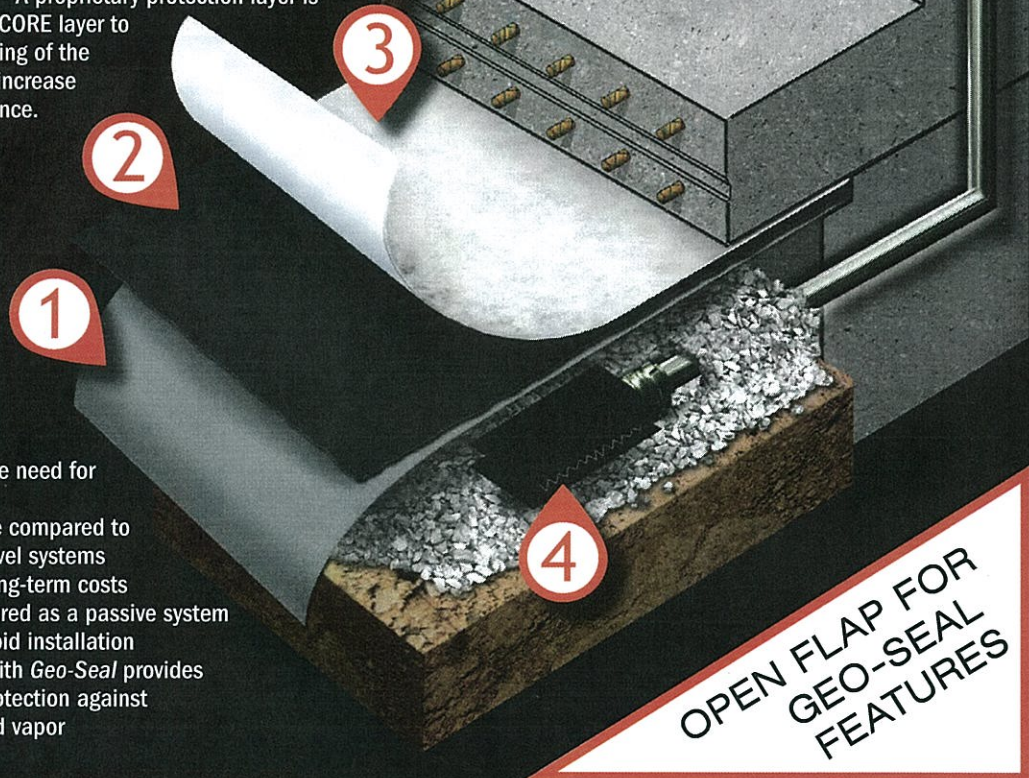
**Geo-Seal® Vapor Intrusion Barrier**  
**02 56 19.13**  
**Fluid-Applied Gas Barrier**  
**Version 1.30**

### **4** Vapor-Vent:

- Eliminates the need for trenching
- Cost-effective compared to pipe and gravel systems
- Eliminates long-term costs when configured as a passive system
- Allows for rapid installation
- When used with *Geo-Seal* provides maximum protection against contaminated vapor
