# **DYKES CREEK WATERSHED MANAGEMENT PLAN**

# Dykes Creek Management Plan

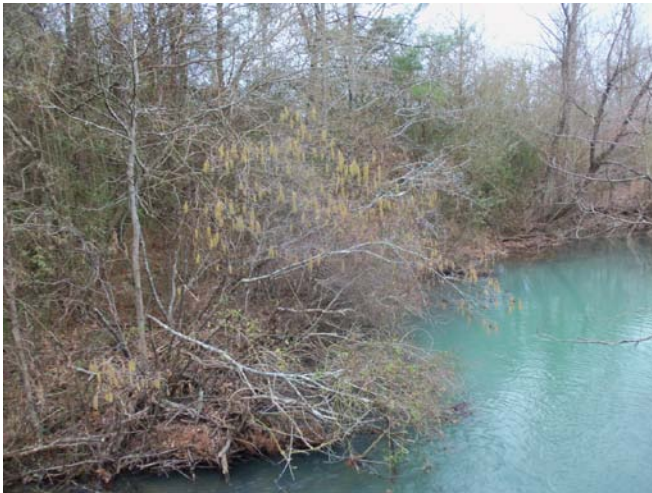
***Figure 2.4. Alder in bloom at Wayside Road crossing of Dykes Creek (DC 8). Note milky appearance of water at this site.***

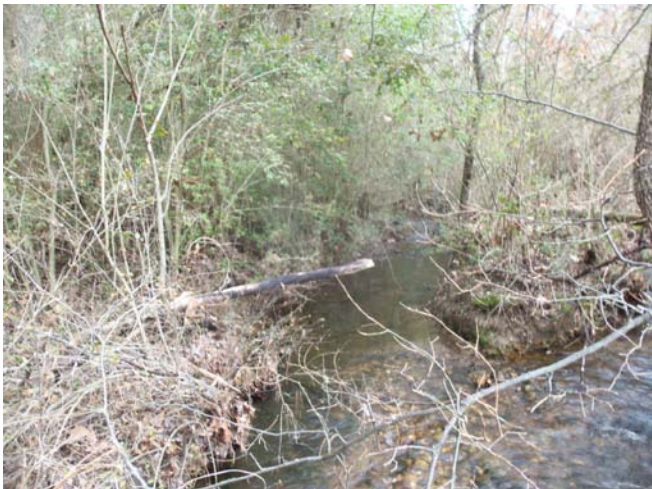
***Figure 2.5. Thick stand of Chinese privet at Gentry Road tributary (DC 5).***

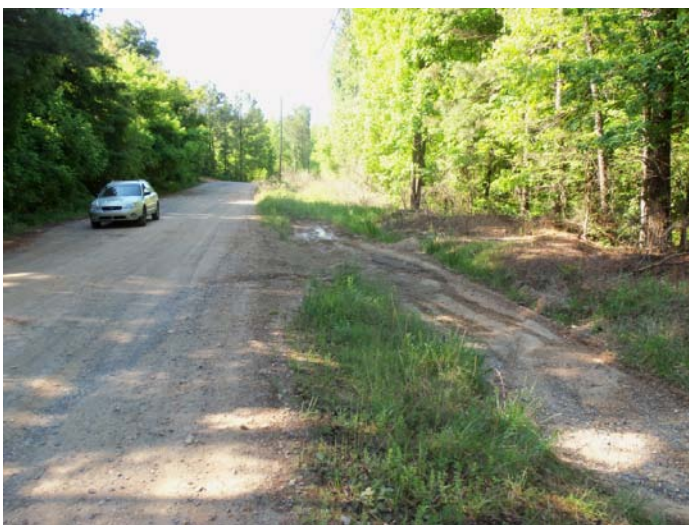
At the very top of the watershed on Armstrong Mountain, off of Firetower Road, is an area of unpaved roads. These roads are not county roads. The area was subdivided in the 1980's, given the name of Shannon Oaks subdivision, and lots were sold. Some of the lots have been built on, but many of them are undeveloped. The main unpaved road leads off of Firetower Road and forms a loop into this wooded area. Two other unpaved roads lead off of it. Mileage in the Dykes Creek watershed of this group of roads is 0.5 miles (the full mileage of these unpaved roads is much greater, but it is outside of the watershed). The roads are very wide in places, as much as 25 feet wide, and are in terrible condition, with steep sections, potholes and no gravel. During wet winter weather it is clear that sediment is moving off the road and into the forest. (See Figure 3.2). Although the headwaters of Dykes Creek do not flow all year round, in February 2014 Dykes Creek was flowing. Homes are located in this area with unpaved drives that also potentially contribute sediment to Dykes Creek and its headwater tributaries. Continuing southward on Firetower Road are more unpaved driveways, some of which are in poor condition.

Figure 3.2. Road in Shannon Oaks Subdivision off of Firetower Road. Note large accumulation of sediment on right from road.

The above discussion has identified several specific fecal coliform and sediment problems in the watershed that could be addressed with structural land management practices. Unpaved roads in the upper watershed could be paved or receive much needed regular maintenance. The old mine tailing sites off East Hermitage Road could be stabilized with grading and vegetation. At least one culvert, the one on East Hermitage Road, could be replaced. The establishment of a cost-share program for the implementation of agricultural BMP's and restoring streamside buffers would be useful in controlling sediment and fecal coliform off of pasture areas. A septic system repair program would help control fecal coliform moving off of residential areas with failing septic systems. Based on US EPA estimates that 10% of septic systems in the US are not working properly, the number of septic systems to fix, 109, was calculated from the 1,085 residential/business structures in the watershed (Figure 3.8).

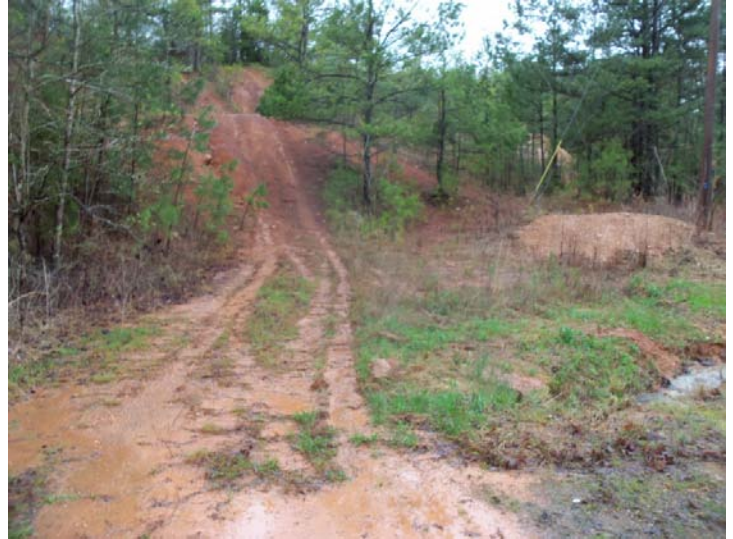
An old bauxite mine site is located along East Hermitage Road. This is a pit mine that filled with water while the mine was still active in the mid 20<sup>th</sup> century. The tailings for the pit are piled on the south side of the road in two areas. Field observations of one of the areas revealed that these tailings have trees growing on them, but much of the ground is bare dirt with gullies (see Figure 3.3). The area that these two piles of tailings cover is about 13.75 acres. Erosion from these sites would enter an unnamed tributary on the east side of the watershed. Materials from these mining sites would not affect the extreme upper reaches of Dykes Creek, including the East Hermitage Road site, because this eastern tributary enters the main branch of Dykes Creek further downstream. Materials moving off this site would enter the ditch and flow into a tributary of Dykes Creek.

*Figure 3.3. Old bauxite mine tailings site off East Hermitage Road.*

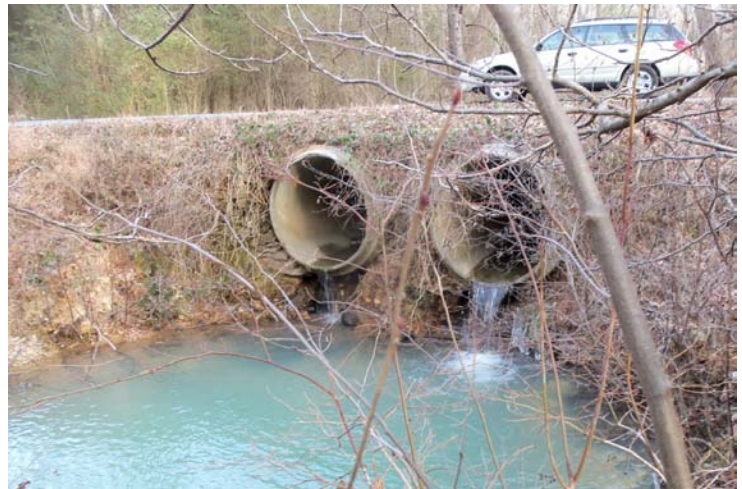
The stream crossing on East Hermitage Road is a double culvert in poor condition (Figure 3.4). The area underneath the culvert has eroded out so that water flows underneath the culvert. The culvert is overshot so that a plunge pool has been created and the banks are eroded. The culvert needs to be replaced and properly aligned so that there is no plunge pool. The ditches leading to this culvert are eroded, although effort has been made to create check dams with riprap. Downstream of the culvert the creek is downcut, probably a result of past timber harvest leading to increased flow in the 20<sup>th</sup> century.

*Figure 3.4. Overshot, failed culvert on E. Hermitage Road. Note the milky appearance of the water.*

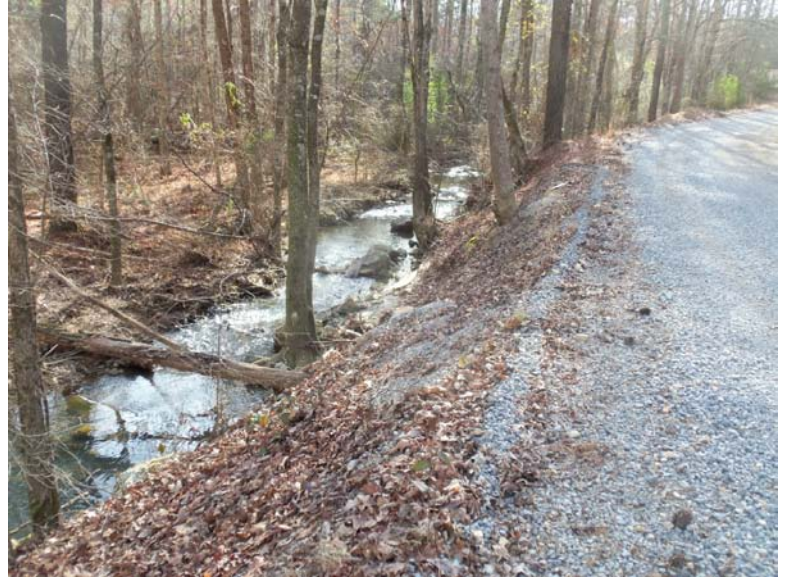
Continuing south on Flowery Branch Road, a section of the road is unpaved, but graveled. This section is 0.9 miles long. The creek is very close to the road for about 50 yards and the gravel is going straight into the creek (Figure 3.5).

*Figure 3.5. Photo showing unpaved section of Flowery Branch Road with gravel washing down the bank into Dykes Creek.*

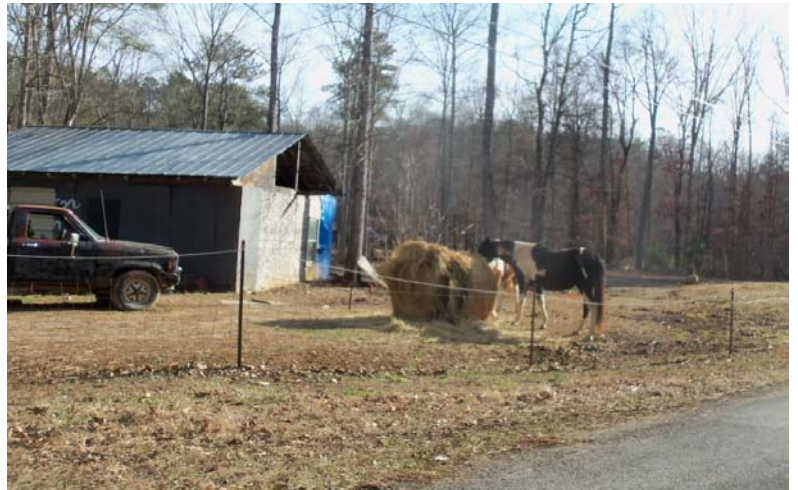
In the Flowery Branch area and other areas in the watershed, hobby farming with animal enclosures near the creek or encompassing the creek is occurring (Figures 3.6). Several large cow pastures area located in the watershed as well.

*Figure 3.6. Hobby farming with horses in pasture with creek flowing through pasture.*

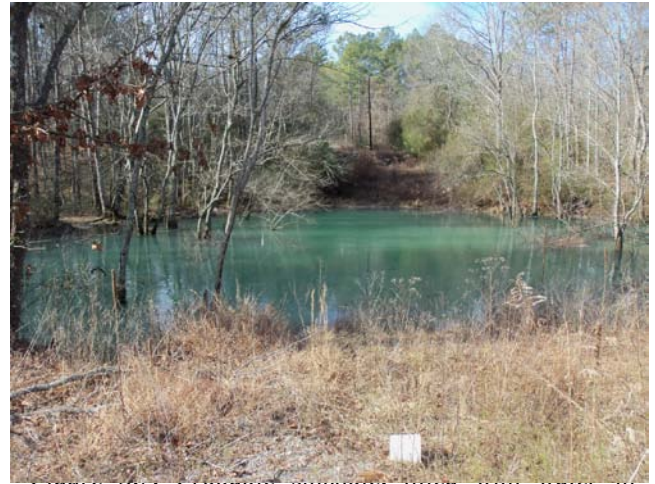
*Figure 3.4.1: Excess sediment, picked up in water, in January 2014, on Dykes Creek at Gentry Road Bridge.*

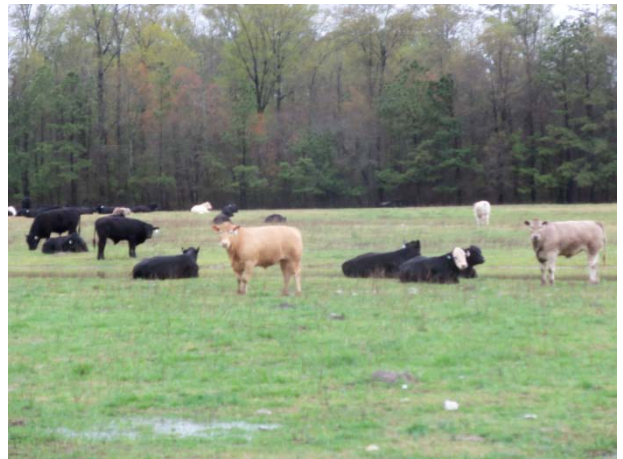
Table 4.1 shows the overall population of livestock in the two counties in which Dykes Creek watershed lies. According to land use data provided in the state document for listing Dykes Creek as impaired (GA DNR EPD 2009), and shown in Table 2.3 of this document, the agricultural land use is 22.4%. Percentage of agricultural land use is 16.7% from the GLUT data shown in Table 2.3. These percentages seem low, but presence of livestock on the creek and its tributaries is evident as discussed above in Section 3.3 (Figure 4.1). During storm sampling events in March 2014 and April 2014, *E. coli* was not as high in the uppermost part of the watershed where it is more wooded and where there is almost no pasture (see Table 3.7). This suggests that wildlife alone are not to blame for the high fecal coliform values. Agricultural sources of fecal coliform are probably significant. Fecal coliform is probably washing off the various pasture areas in the middle area of the watershed. Pastures near and on the creek could be a source of sediment as well.

Figure 4.1. Cows in pasture on Wayside Road.
