Figure 1. Facility Location Map  
Permit Renewal Application  
Union Carbide Corporation  
UCC Woodbine, Camden County, Georgia

**Figure 3. Landfill (SWMU 1) Topographic Map**  
 Union Carbide Corporation  
 UCC Woodbine, Camden County, Georgia

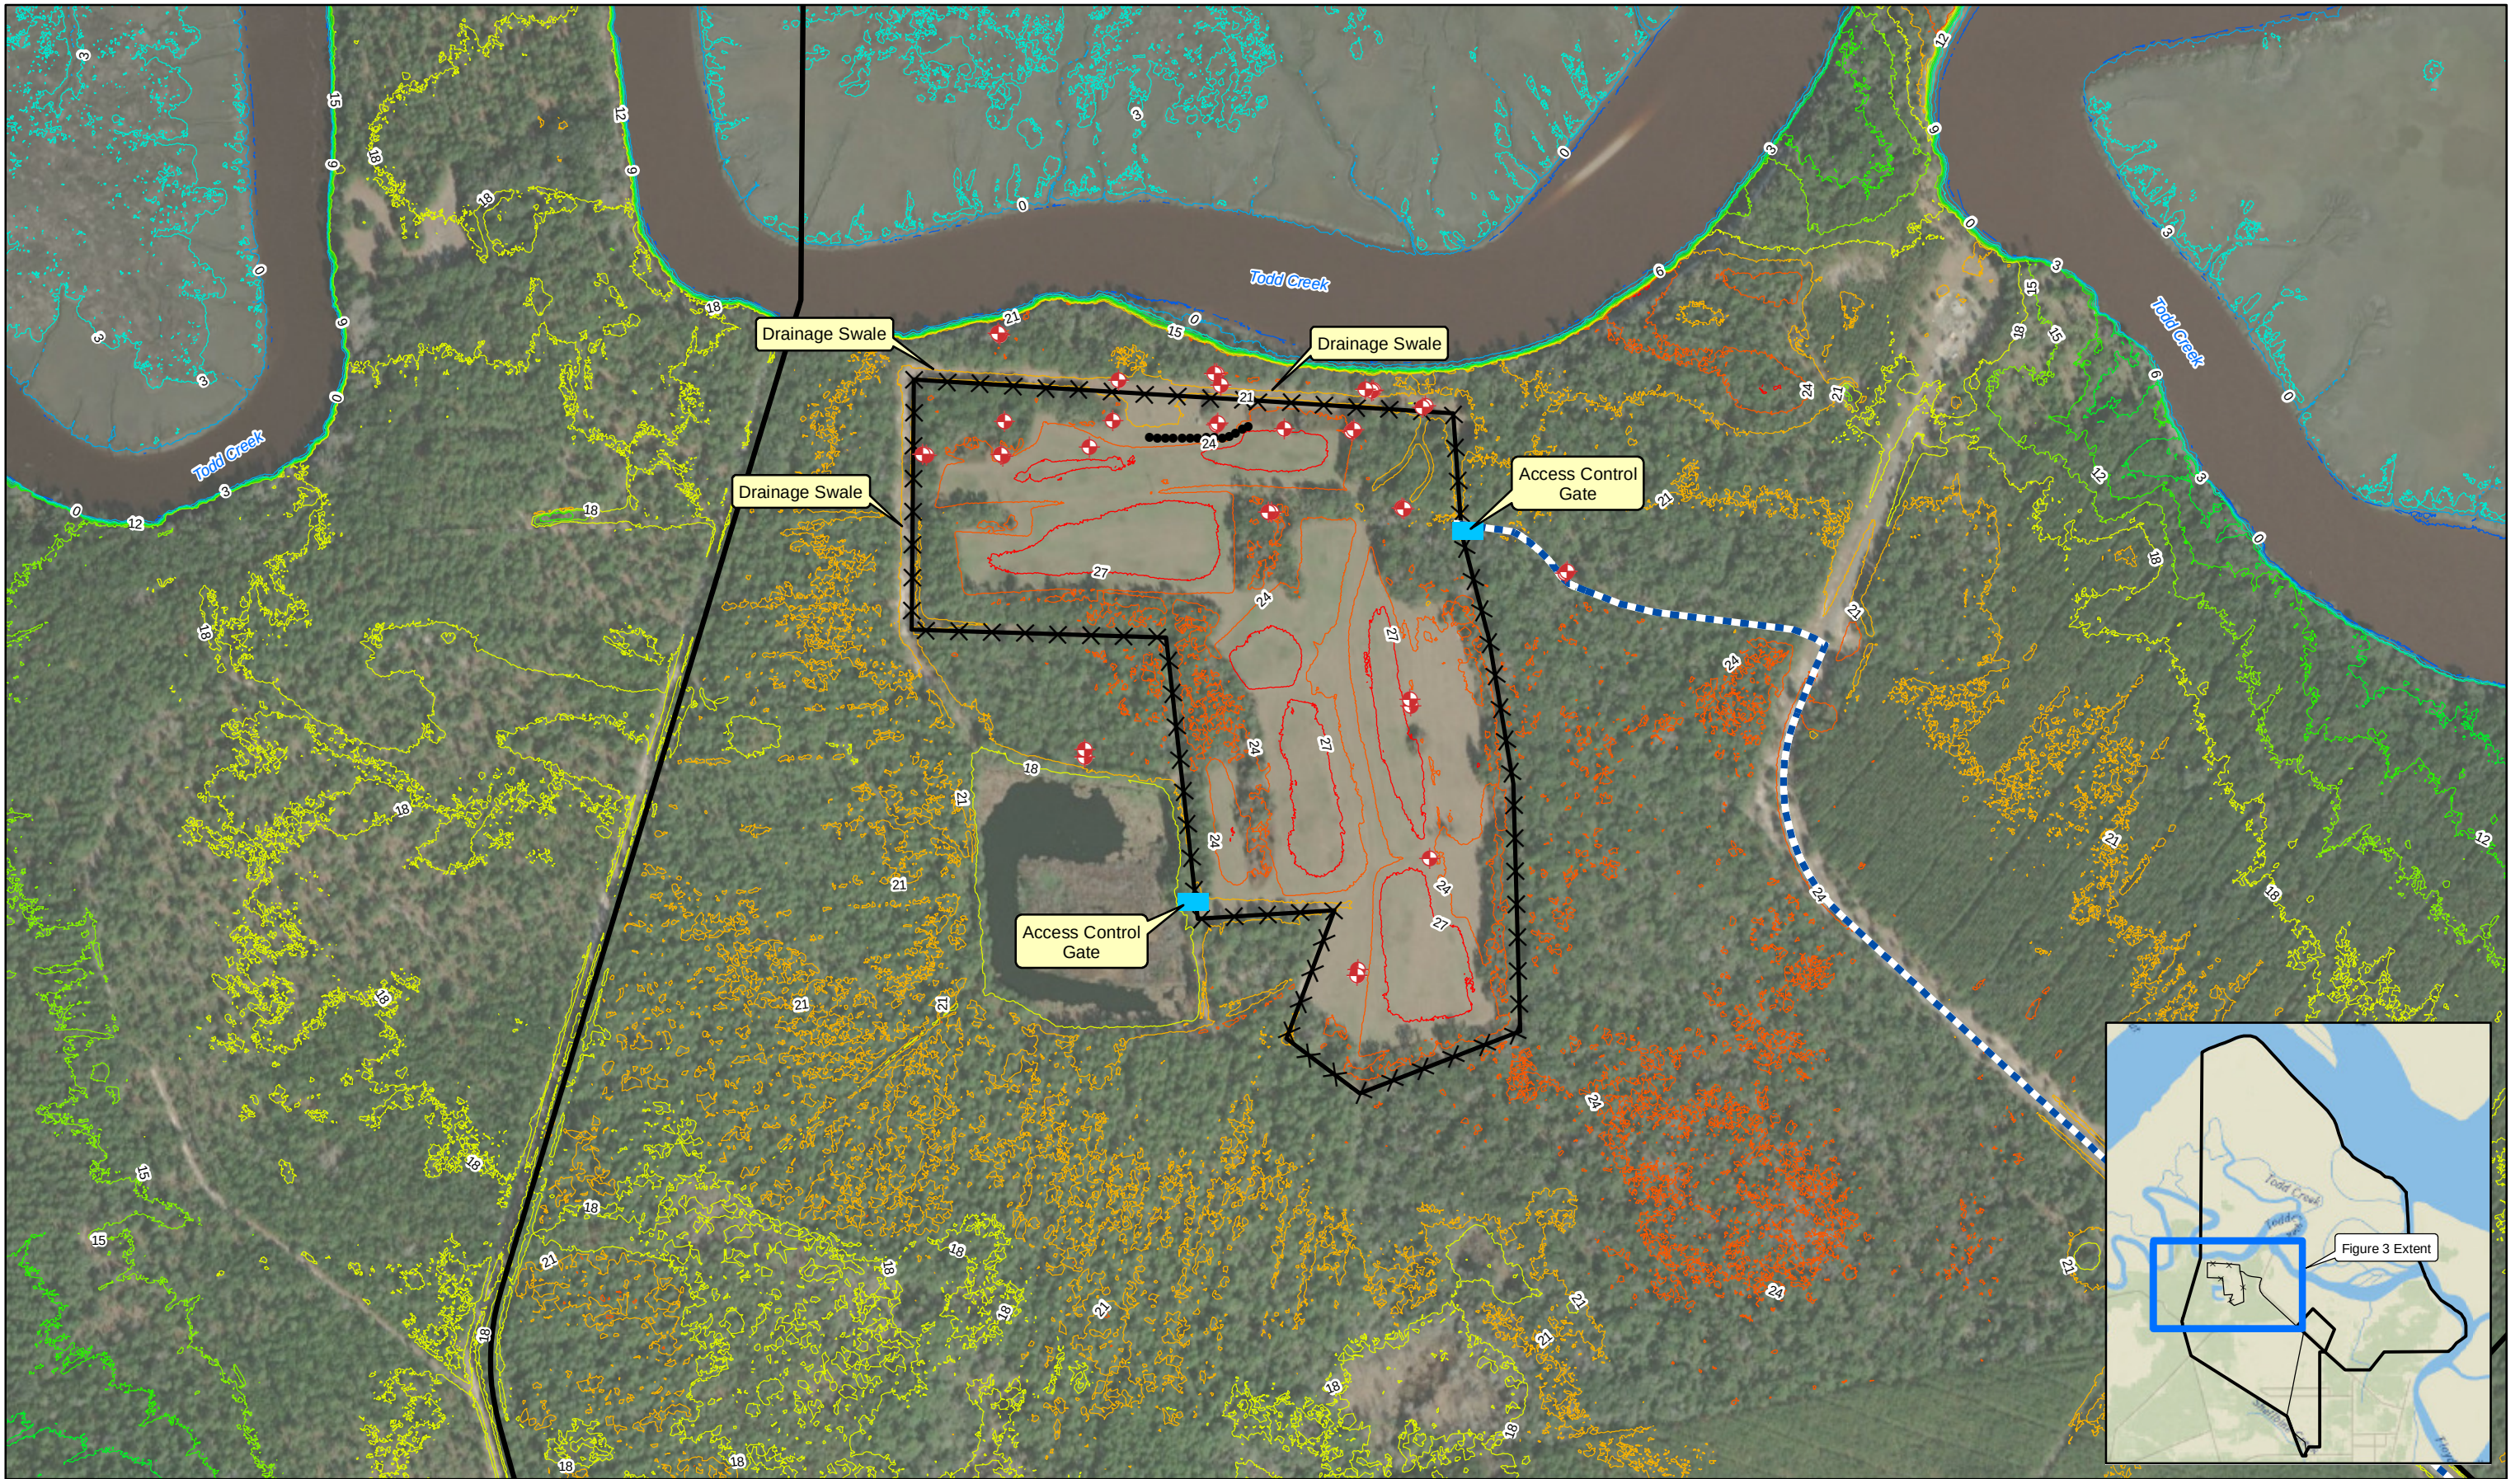
**Notes:**  
 1. ESRI Aerial from ArcGIS Online, Dated 1/21/2020  
 2. Topographic contour data source: 2010 Coastal Georgia Elevation Project Lidar Data

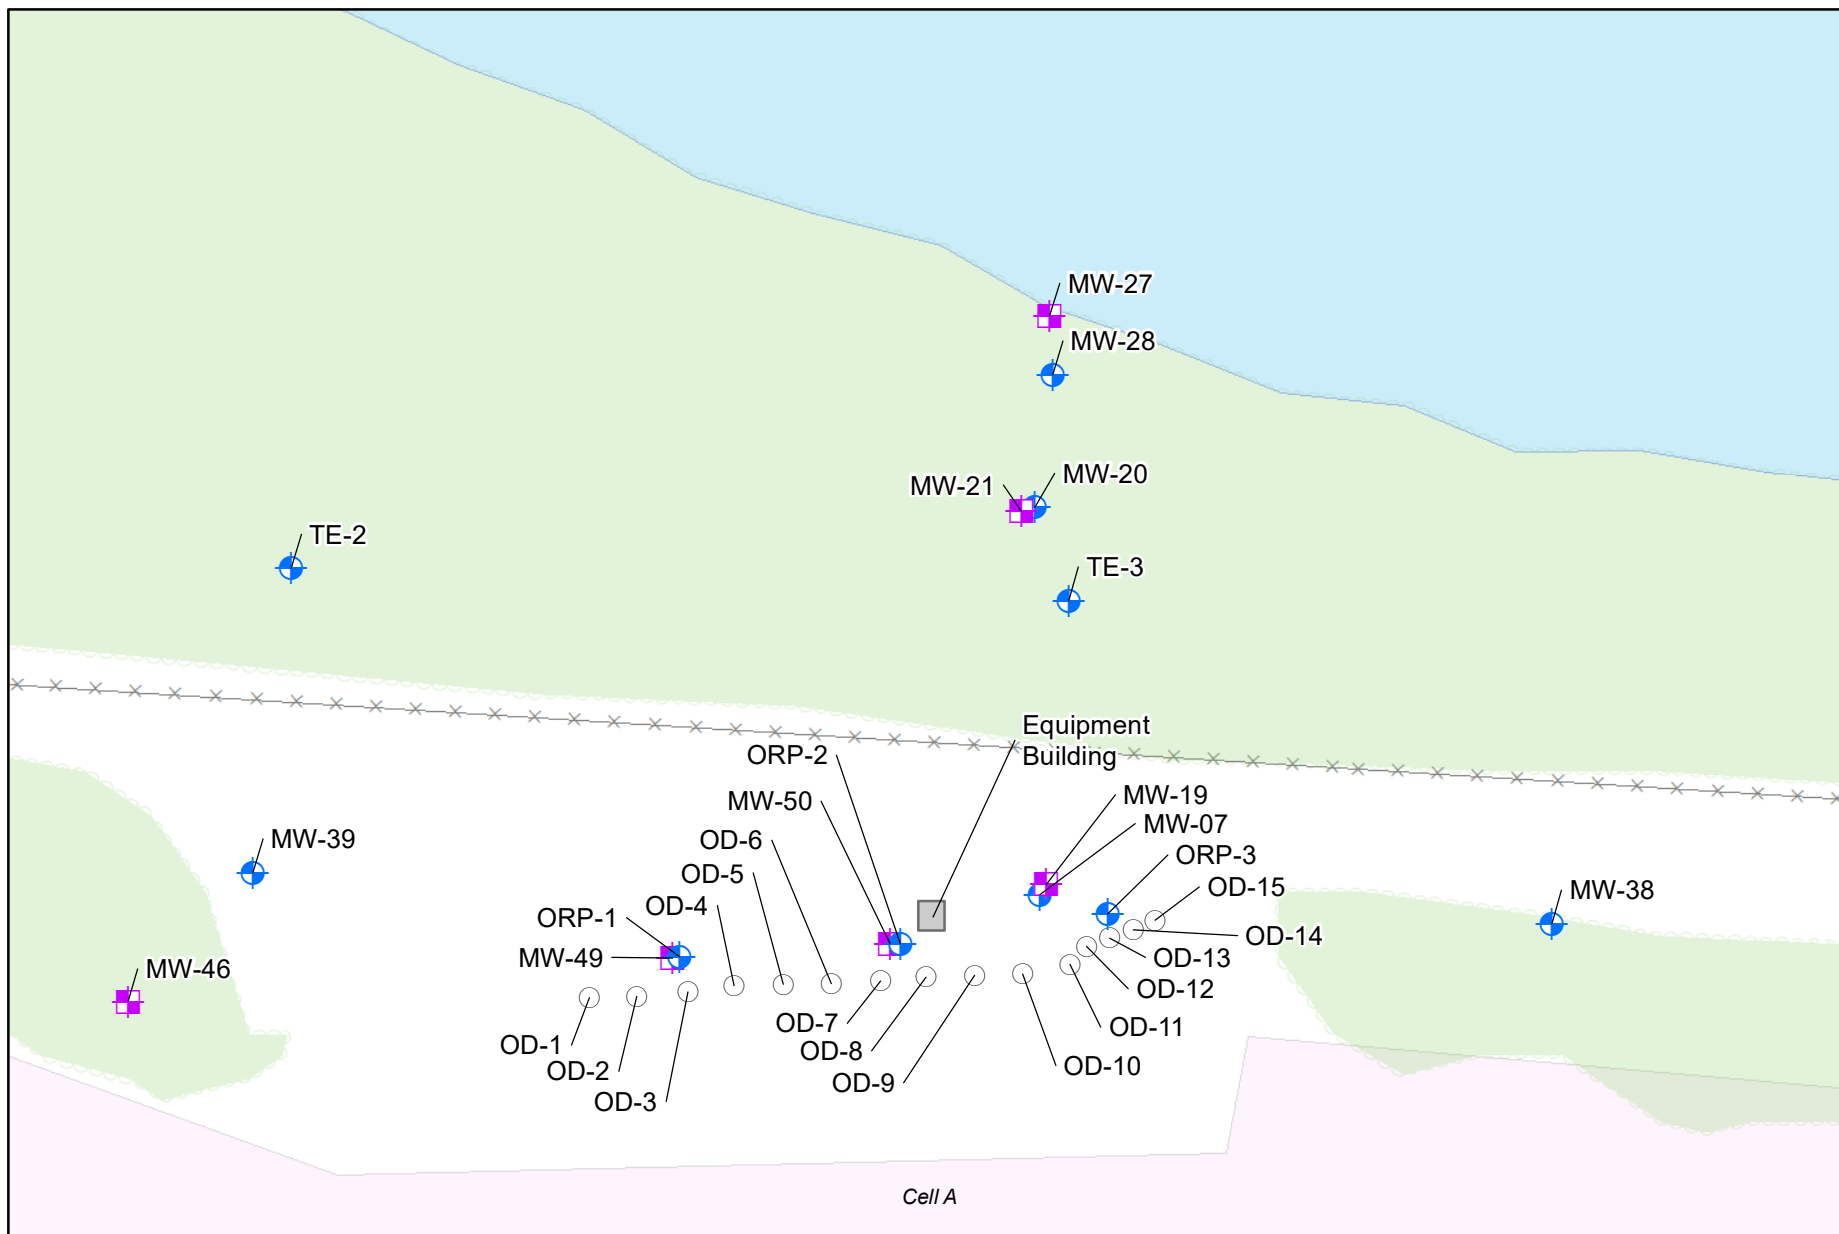
**Figure 8. iSOC System Layout**  
 Union Carbide Corporation  
 UCC Woodbine, Camden County, Georgia

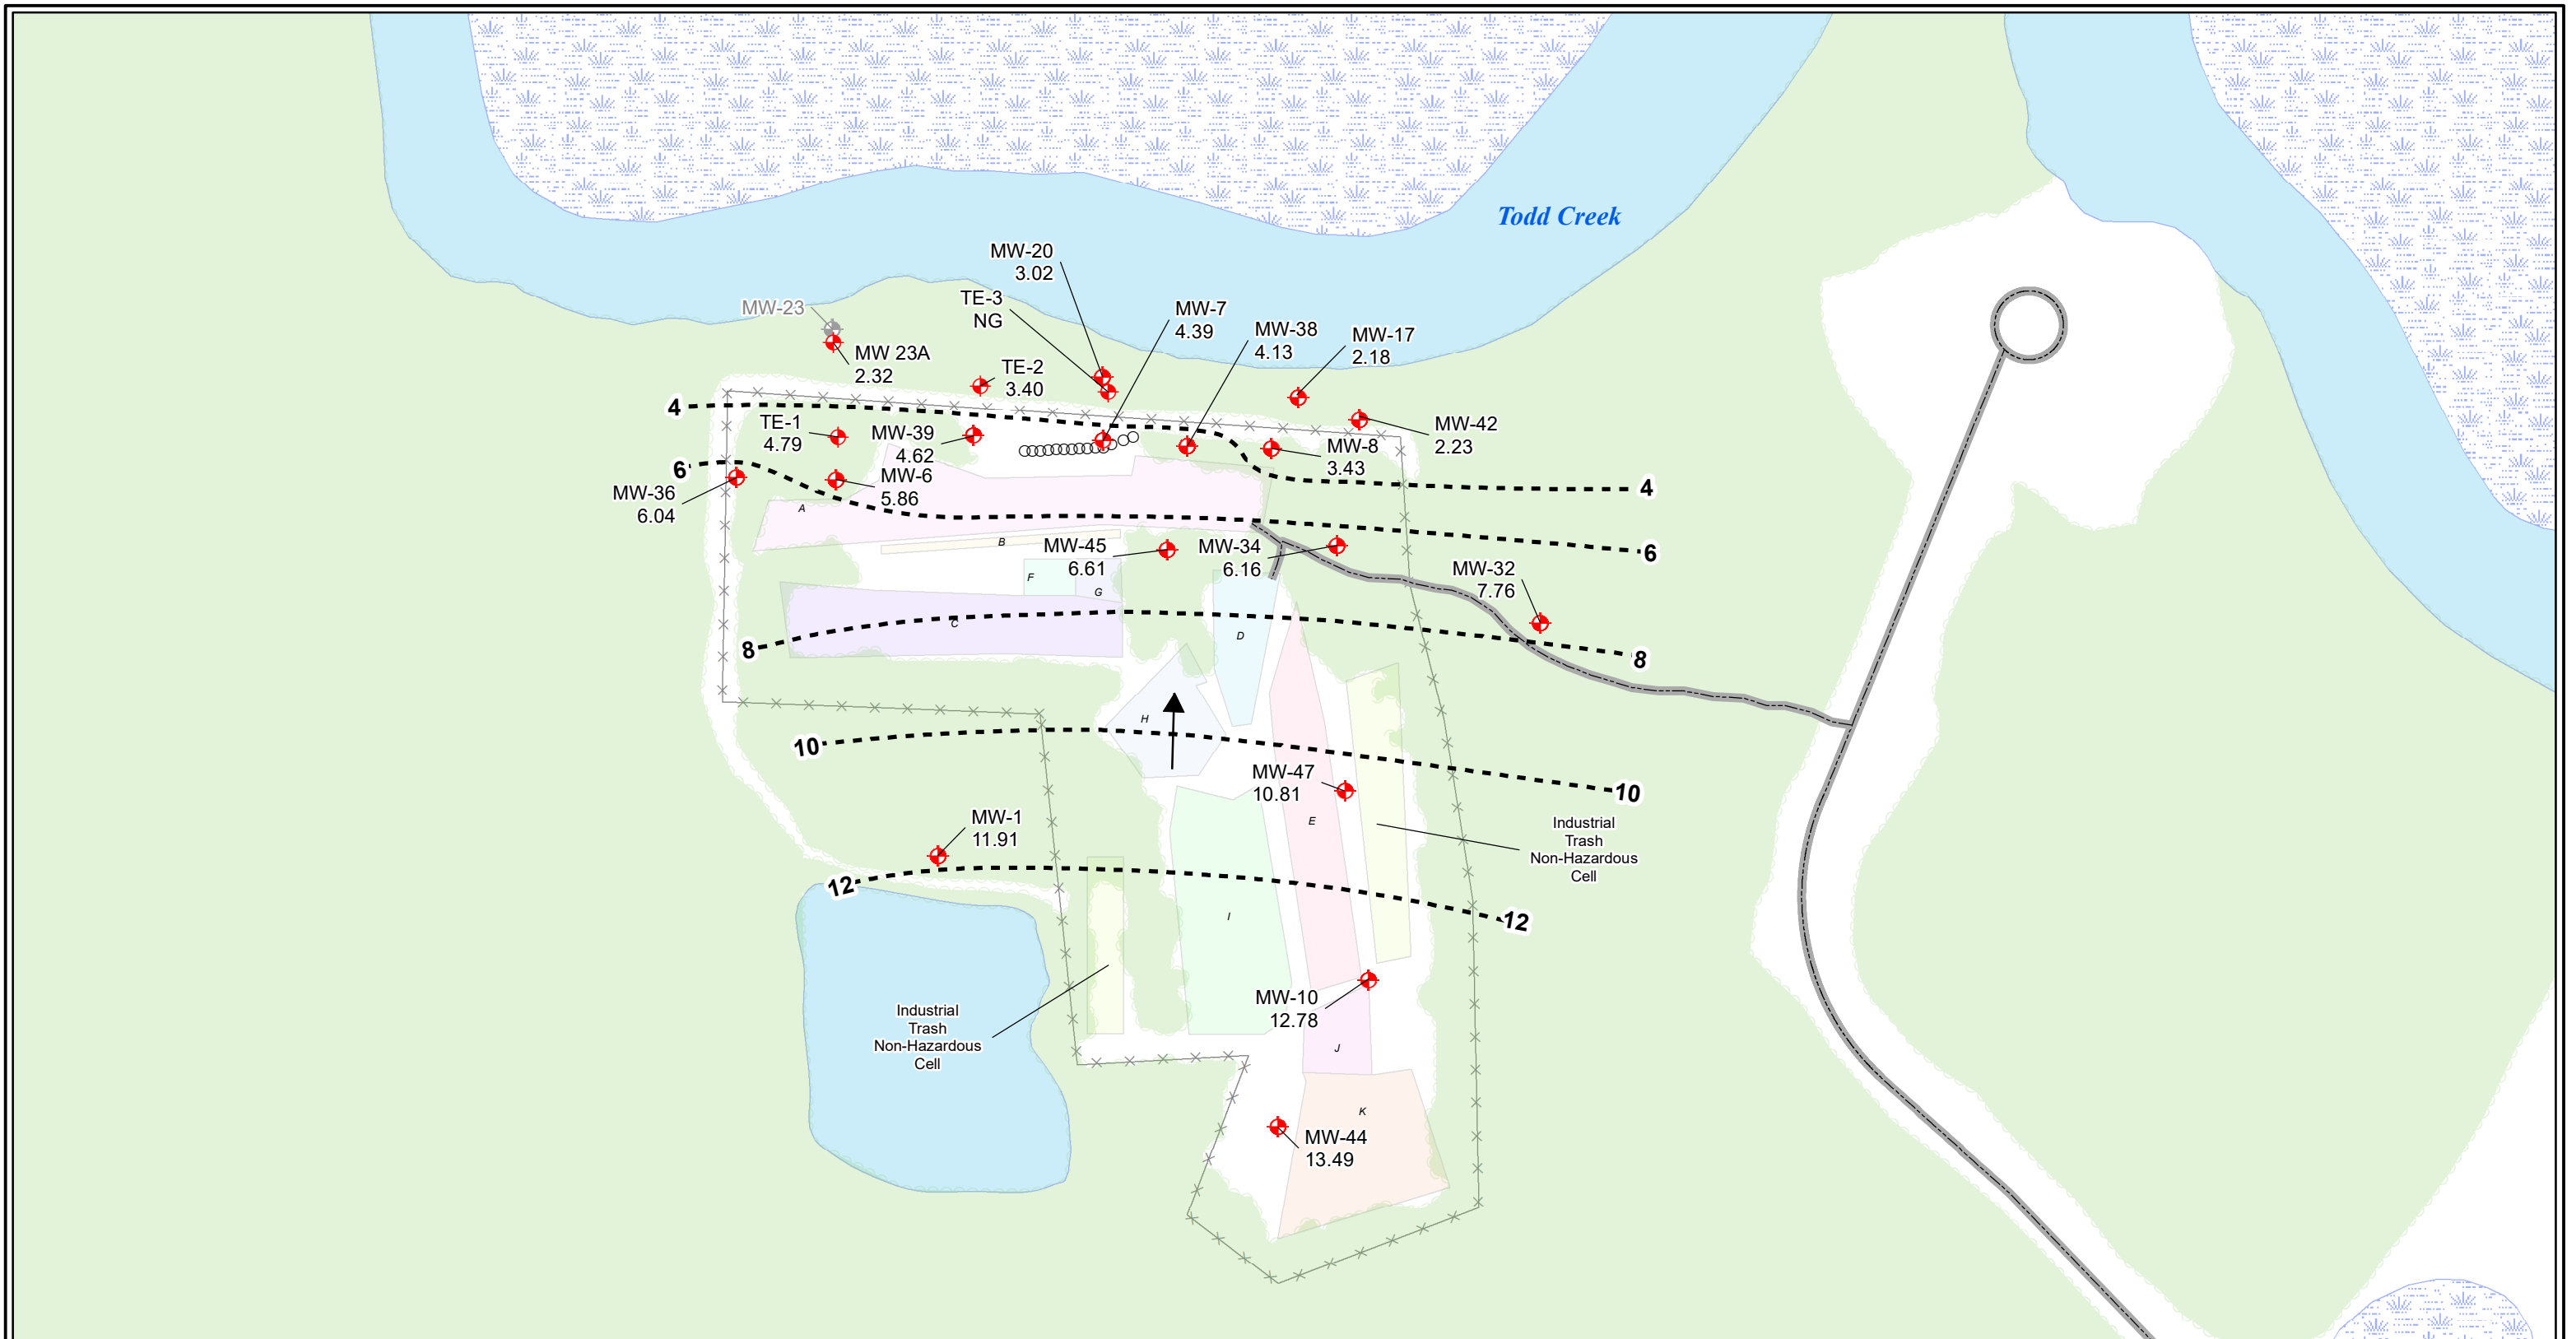
9

**NOTES:**  
 1. GROUNDWATER ELEVATIONS ARE IN FEET ABOVE MEAN SEA LEVEL ;  
 MEASURED SEPTEMBER 26, 2022  
 2. NG = NOT GAUGED

## POTENTIOMETRIC SURFACE MAP SHALLOW MONITORING WELLS SEPTEMBER 26, 2022

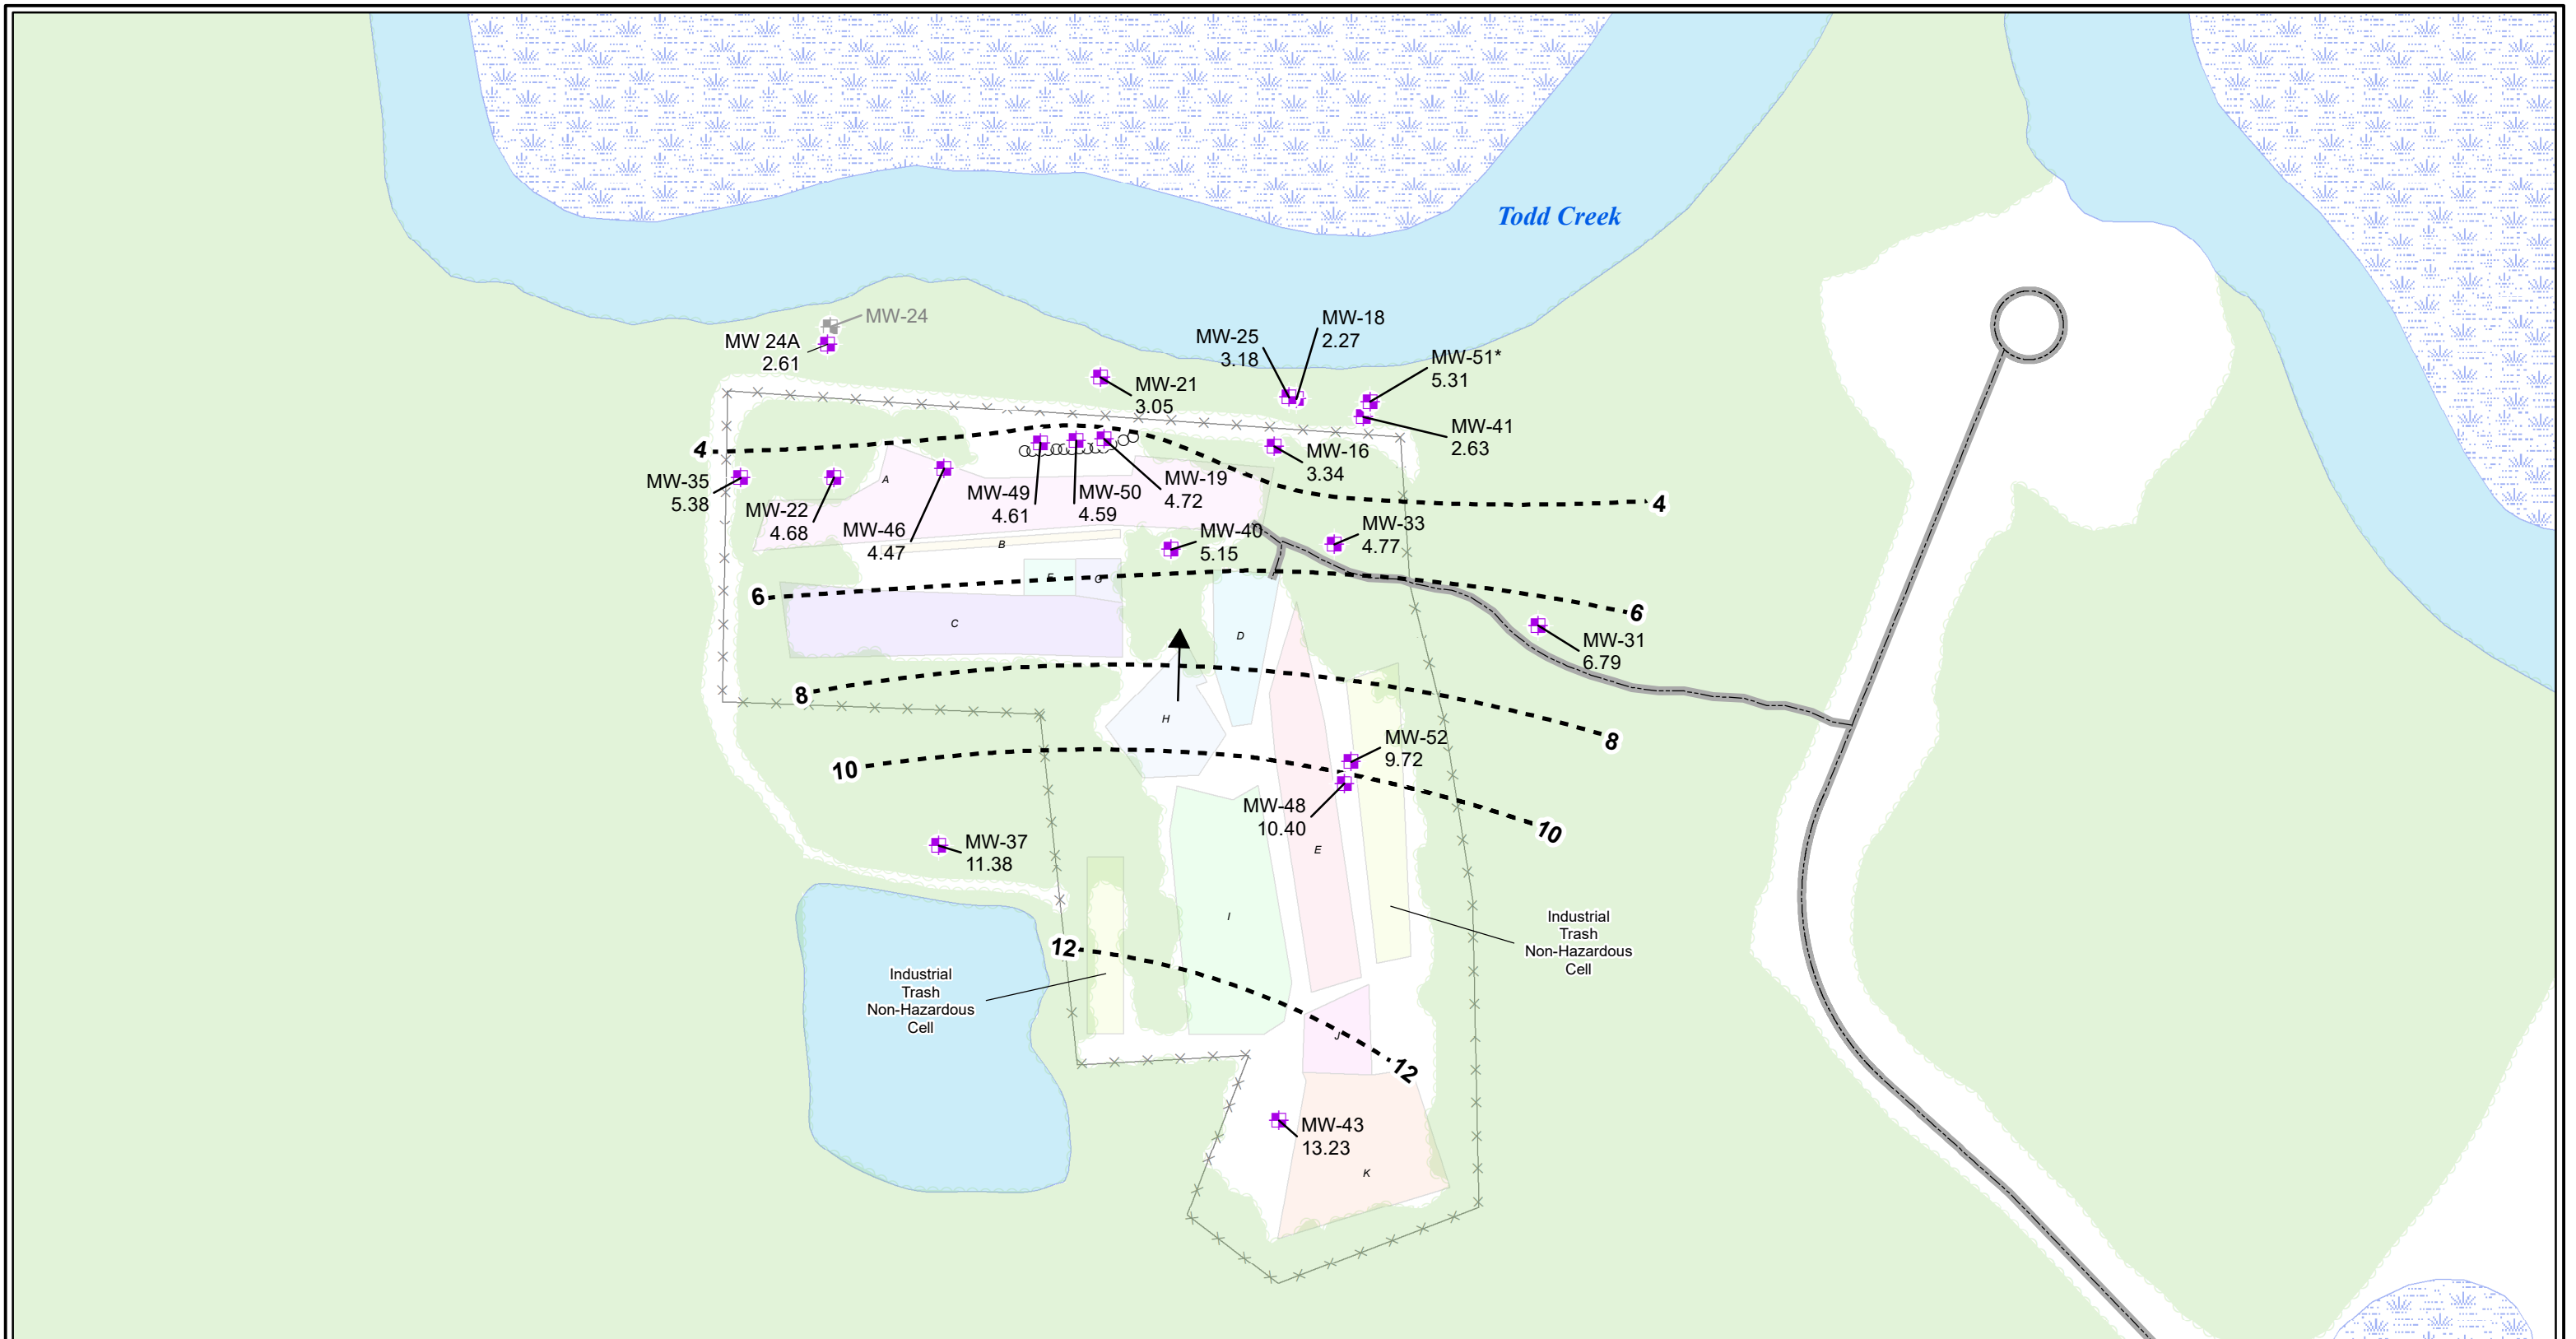
10

NOTES :  
 1. \* = WELLS NOT USED FOR CONTOURING.  
 2. GROUNDWATER ELEVATIONS ARE IN FEET ABOVE MEAN SEA LEVEL ;  
 MEASURED SEPTEMBER 26, 2022.

**POTENTIOMETRIC SURFACE MAP  
 DEEP MONITORING WELLS  
 SEPTEMBER 26, 2022**

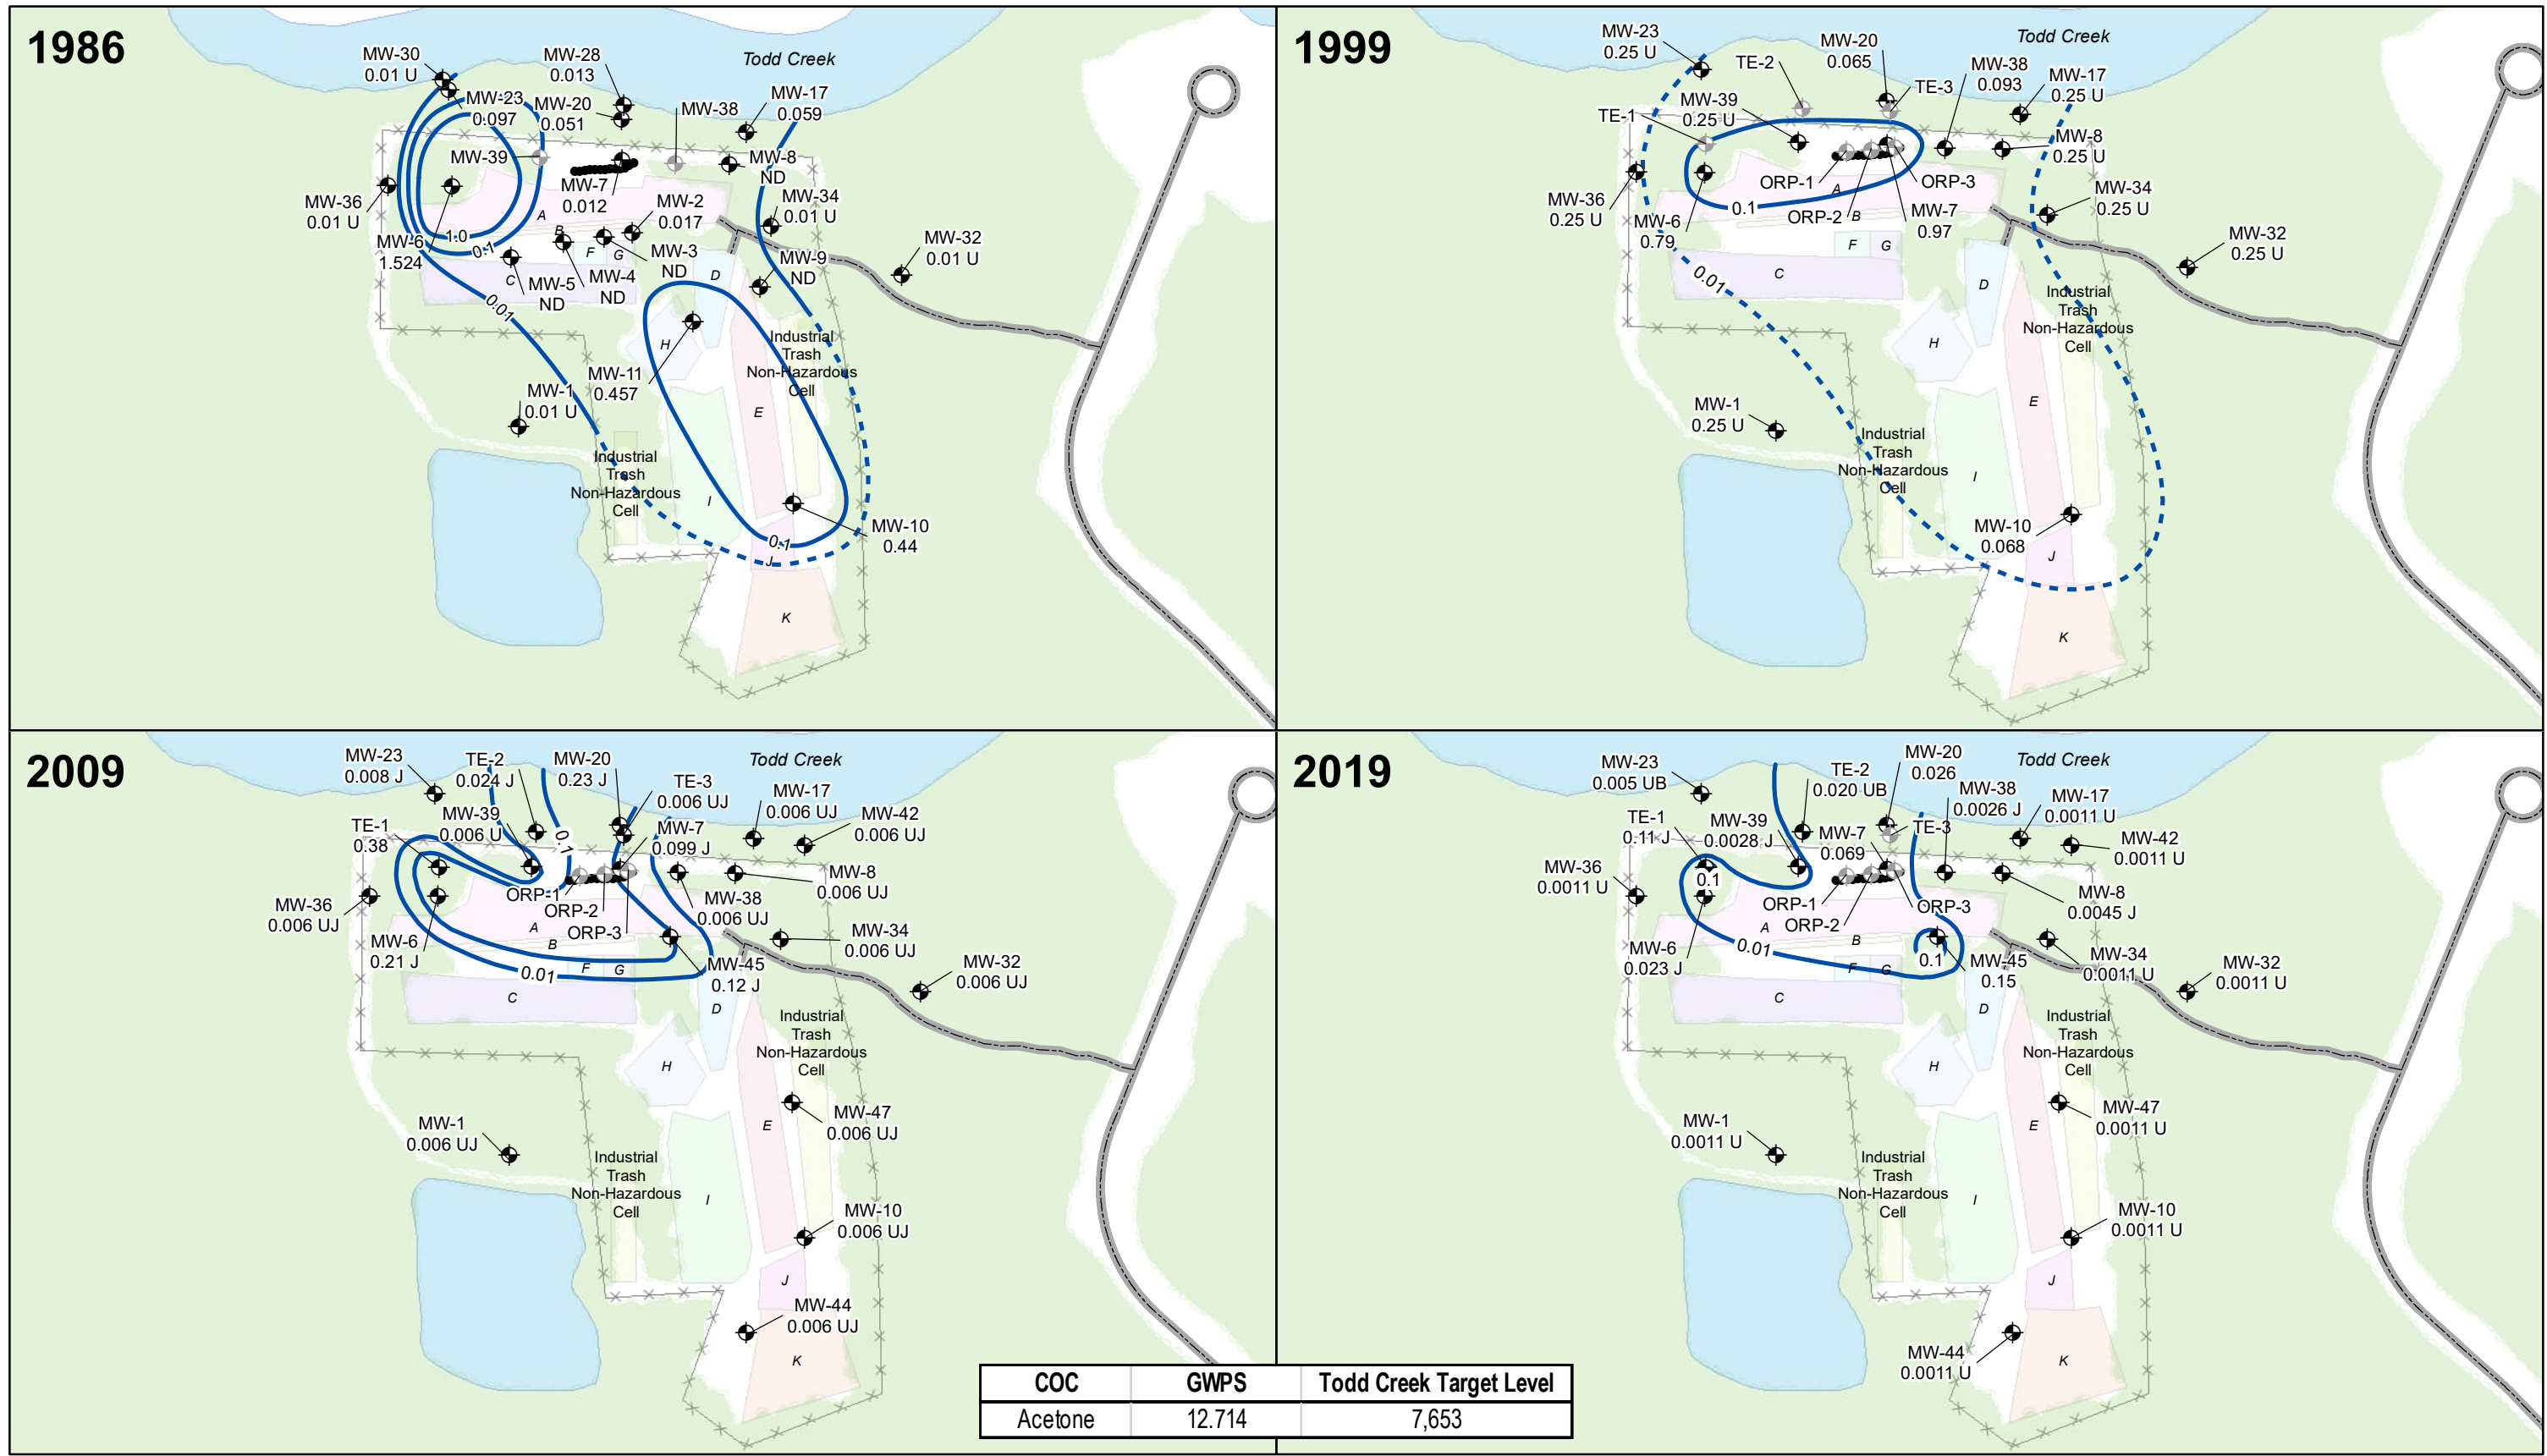
- Groundwater concentrations are shown in milligrams per liter (mg/L).
- Groundwater sampling was conducted in April-August of 1986, November of 1999, and September of 2009 and 2019.
- The detection limit was used in lieu of "BRL" (below reporting limit) for the 1999 data set.
- Due to the elevated detection limit in 1999, the 0.01 contour was inferred based on the 1986 plume.
- The detection limit for 1986 results reported as ND were not found.
- All features shown currently exist but did not exist in each timeframe.
- Contours shown are 1.0, 0.1, and 0.01 mg/L acetone in groundwater.

**Figure 14. 1986, 1999, 2009, and 2019 Acetone in Shallow Aquifer Monitoring Wells**  
 Union Carbide Corporation  
 UCC Woodbine, Camden County, Georgia

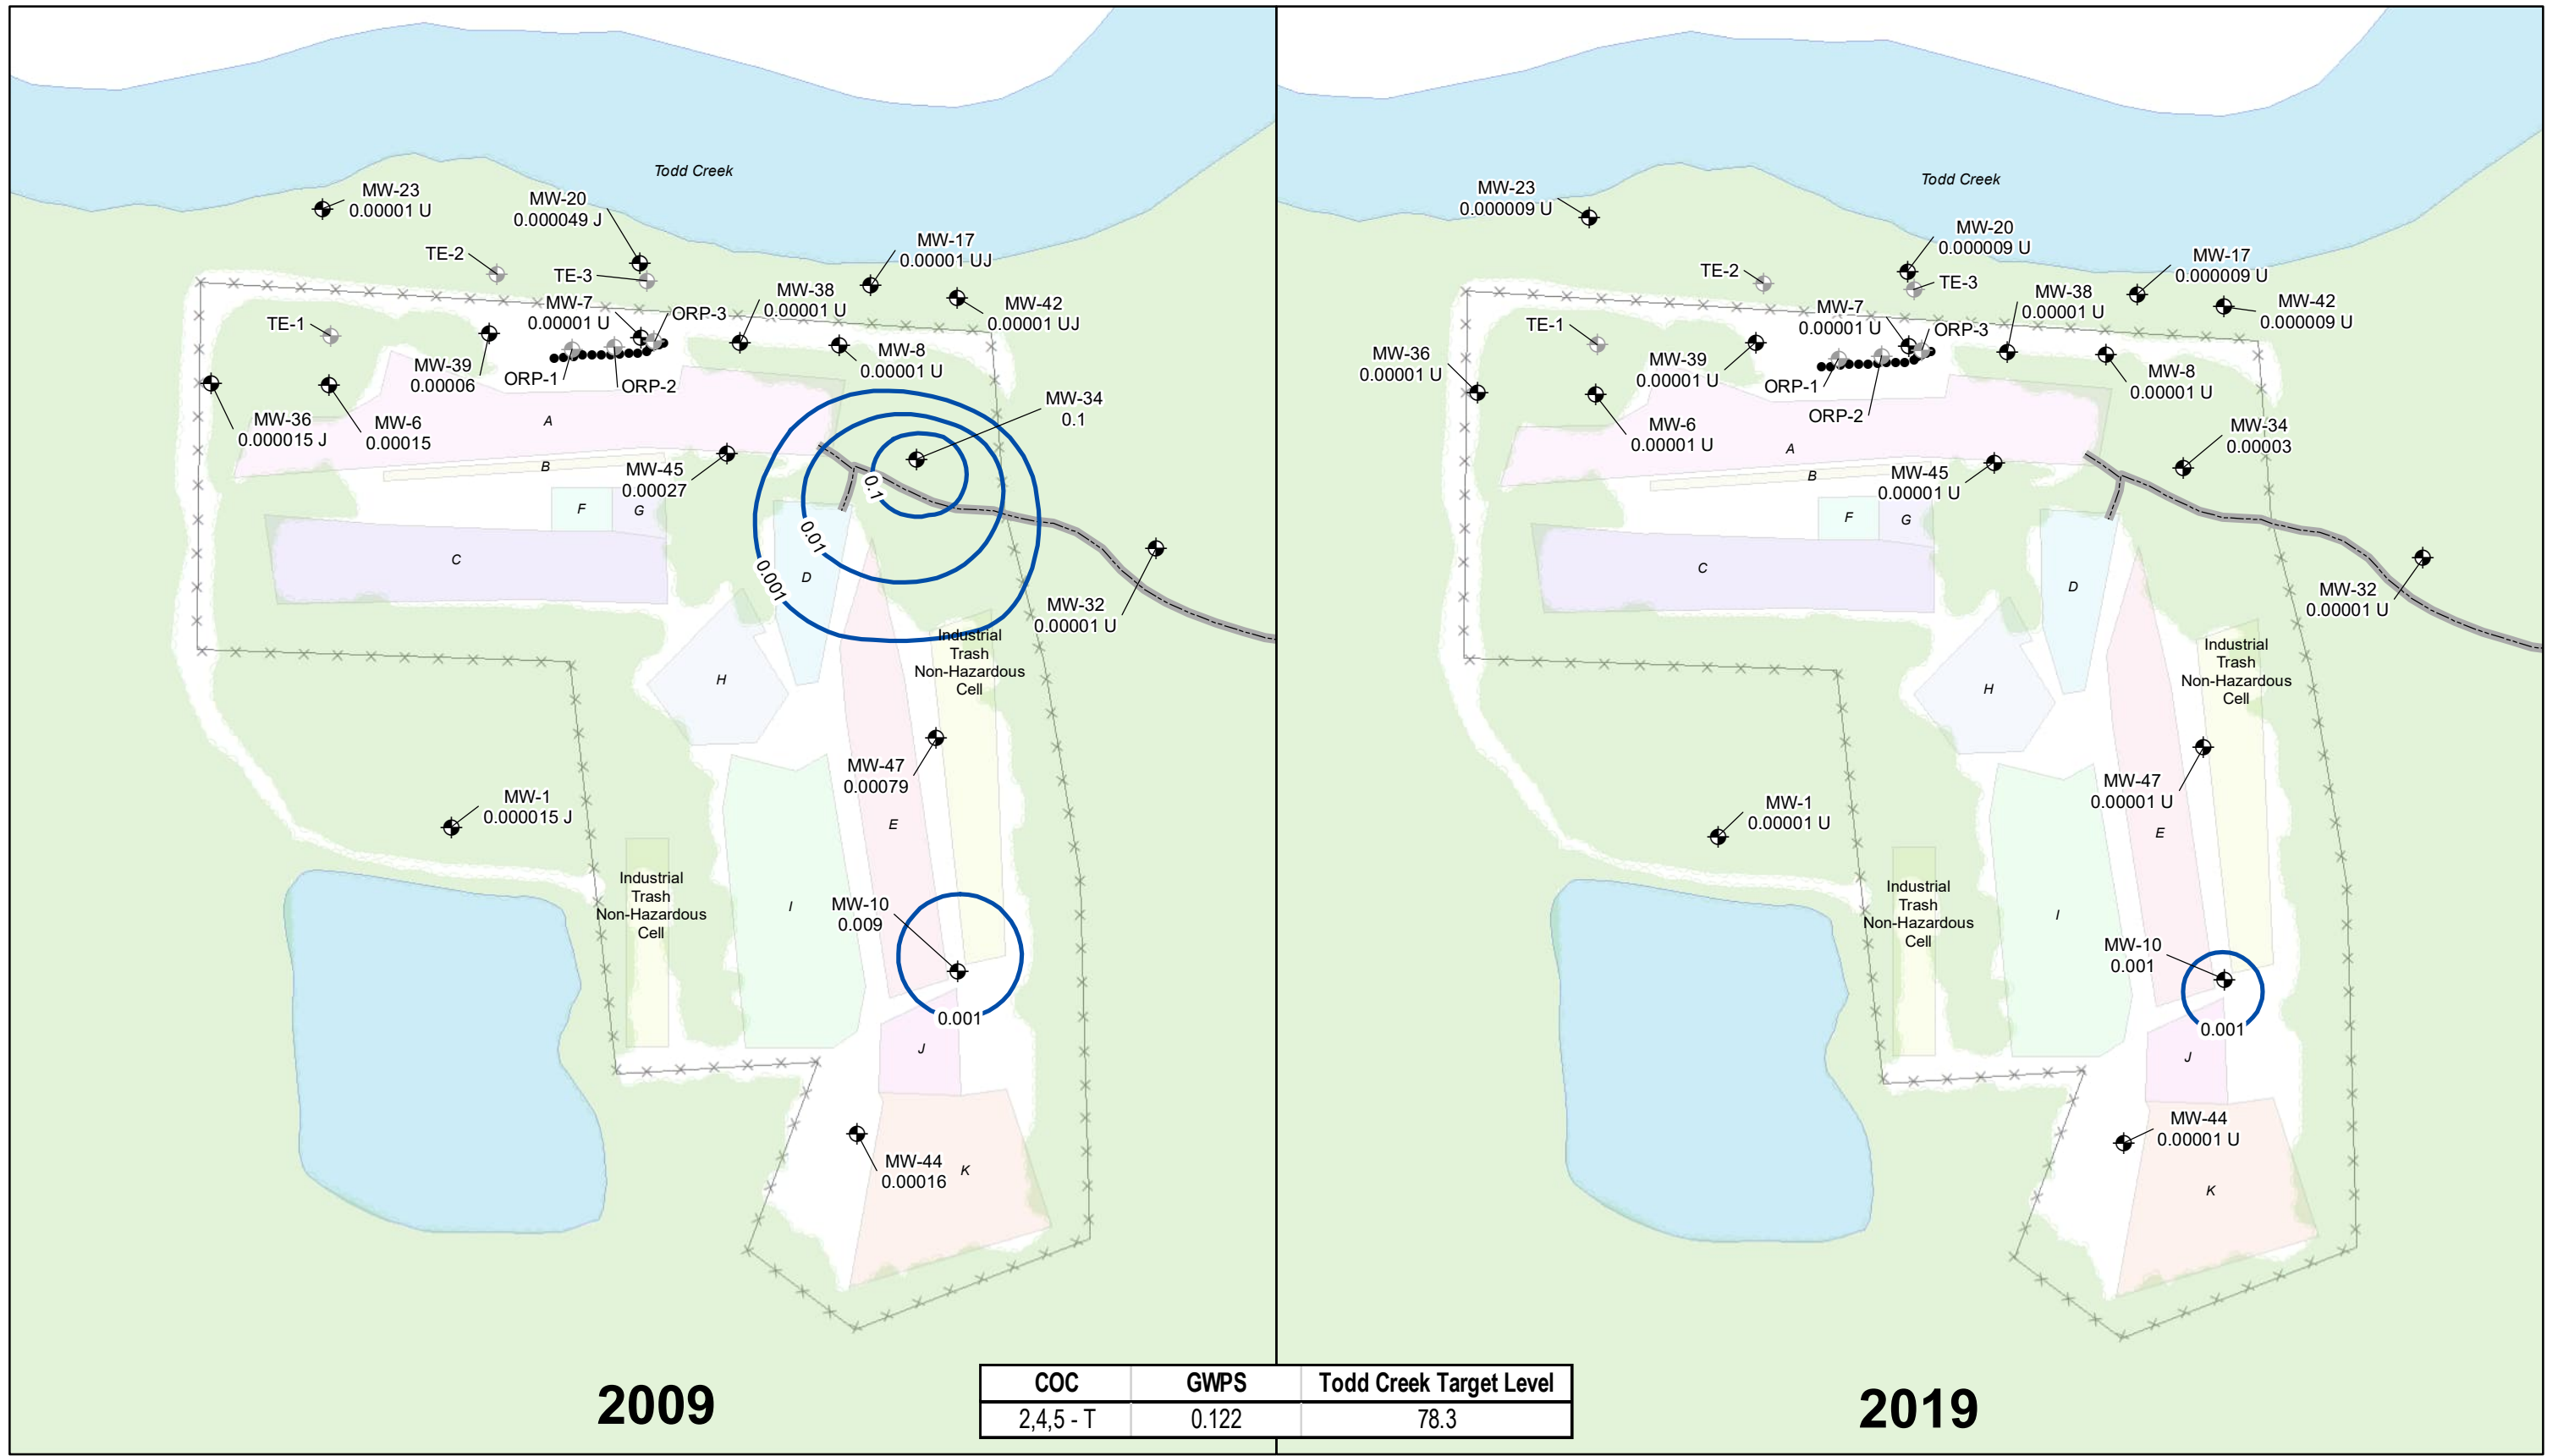
**Notes:**  
 1. Groundwater concentrations are shown in milligrams per liter (mg/L).  
 2. Sampling was conducted in September of 2009 and 2019.  
 3. All features shown currently exist but did not exist in each timeframe.  
 4. Contours shown are 0.1, 0.01, and 0.001 mg/L 2,4,5 -T in groundwater

**Figure 15. 2009 and 2019 2,4,5 - T in Shallow Aquifer Monitoring Wells**  
 Union Carbide Corporation  
 UCC Woodbine, Camden County, Georgia
