Figure 1. Facility Location Map  
Permit Renewal Application  
Union Carbide Corporation  
UCC Woodbine, Camden County, Georgia

**Figure 3. Landfill (SWMU 1) Topographic Map**  
 Union Carbide Corporation  
 UCC Woodbine, Camden County, Georgia

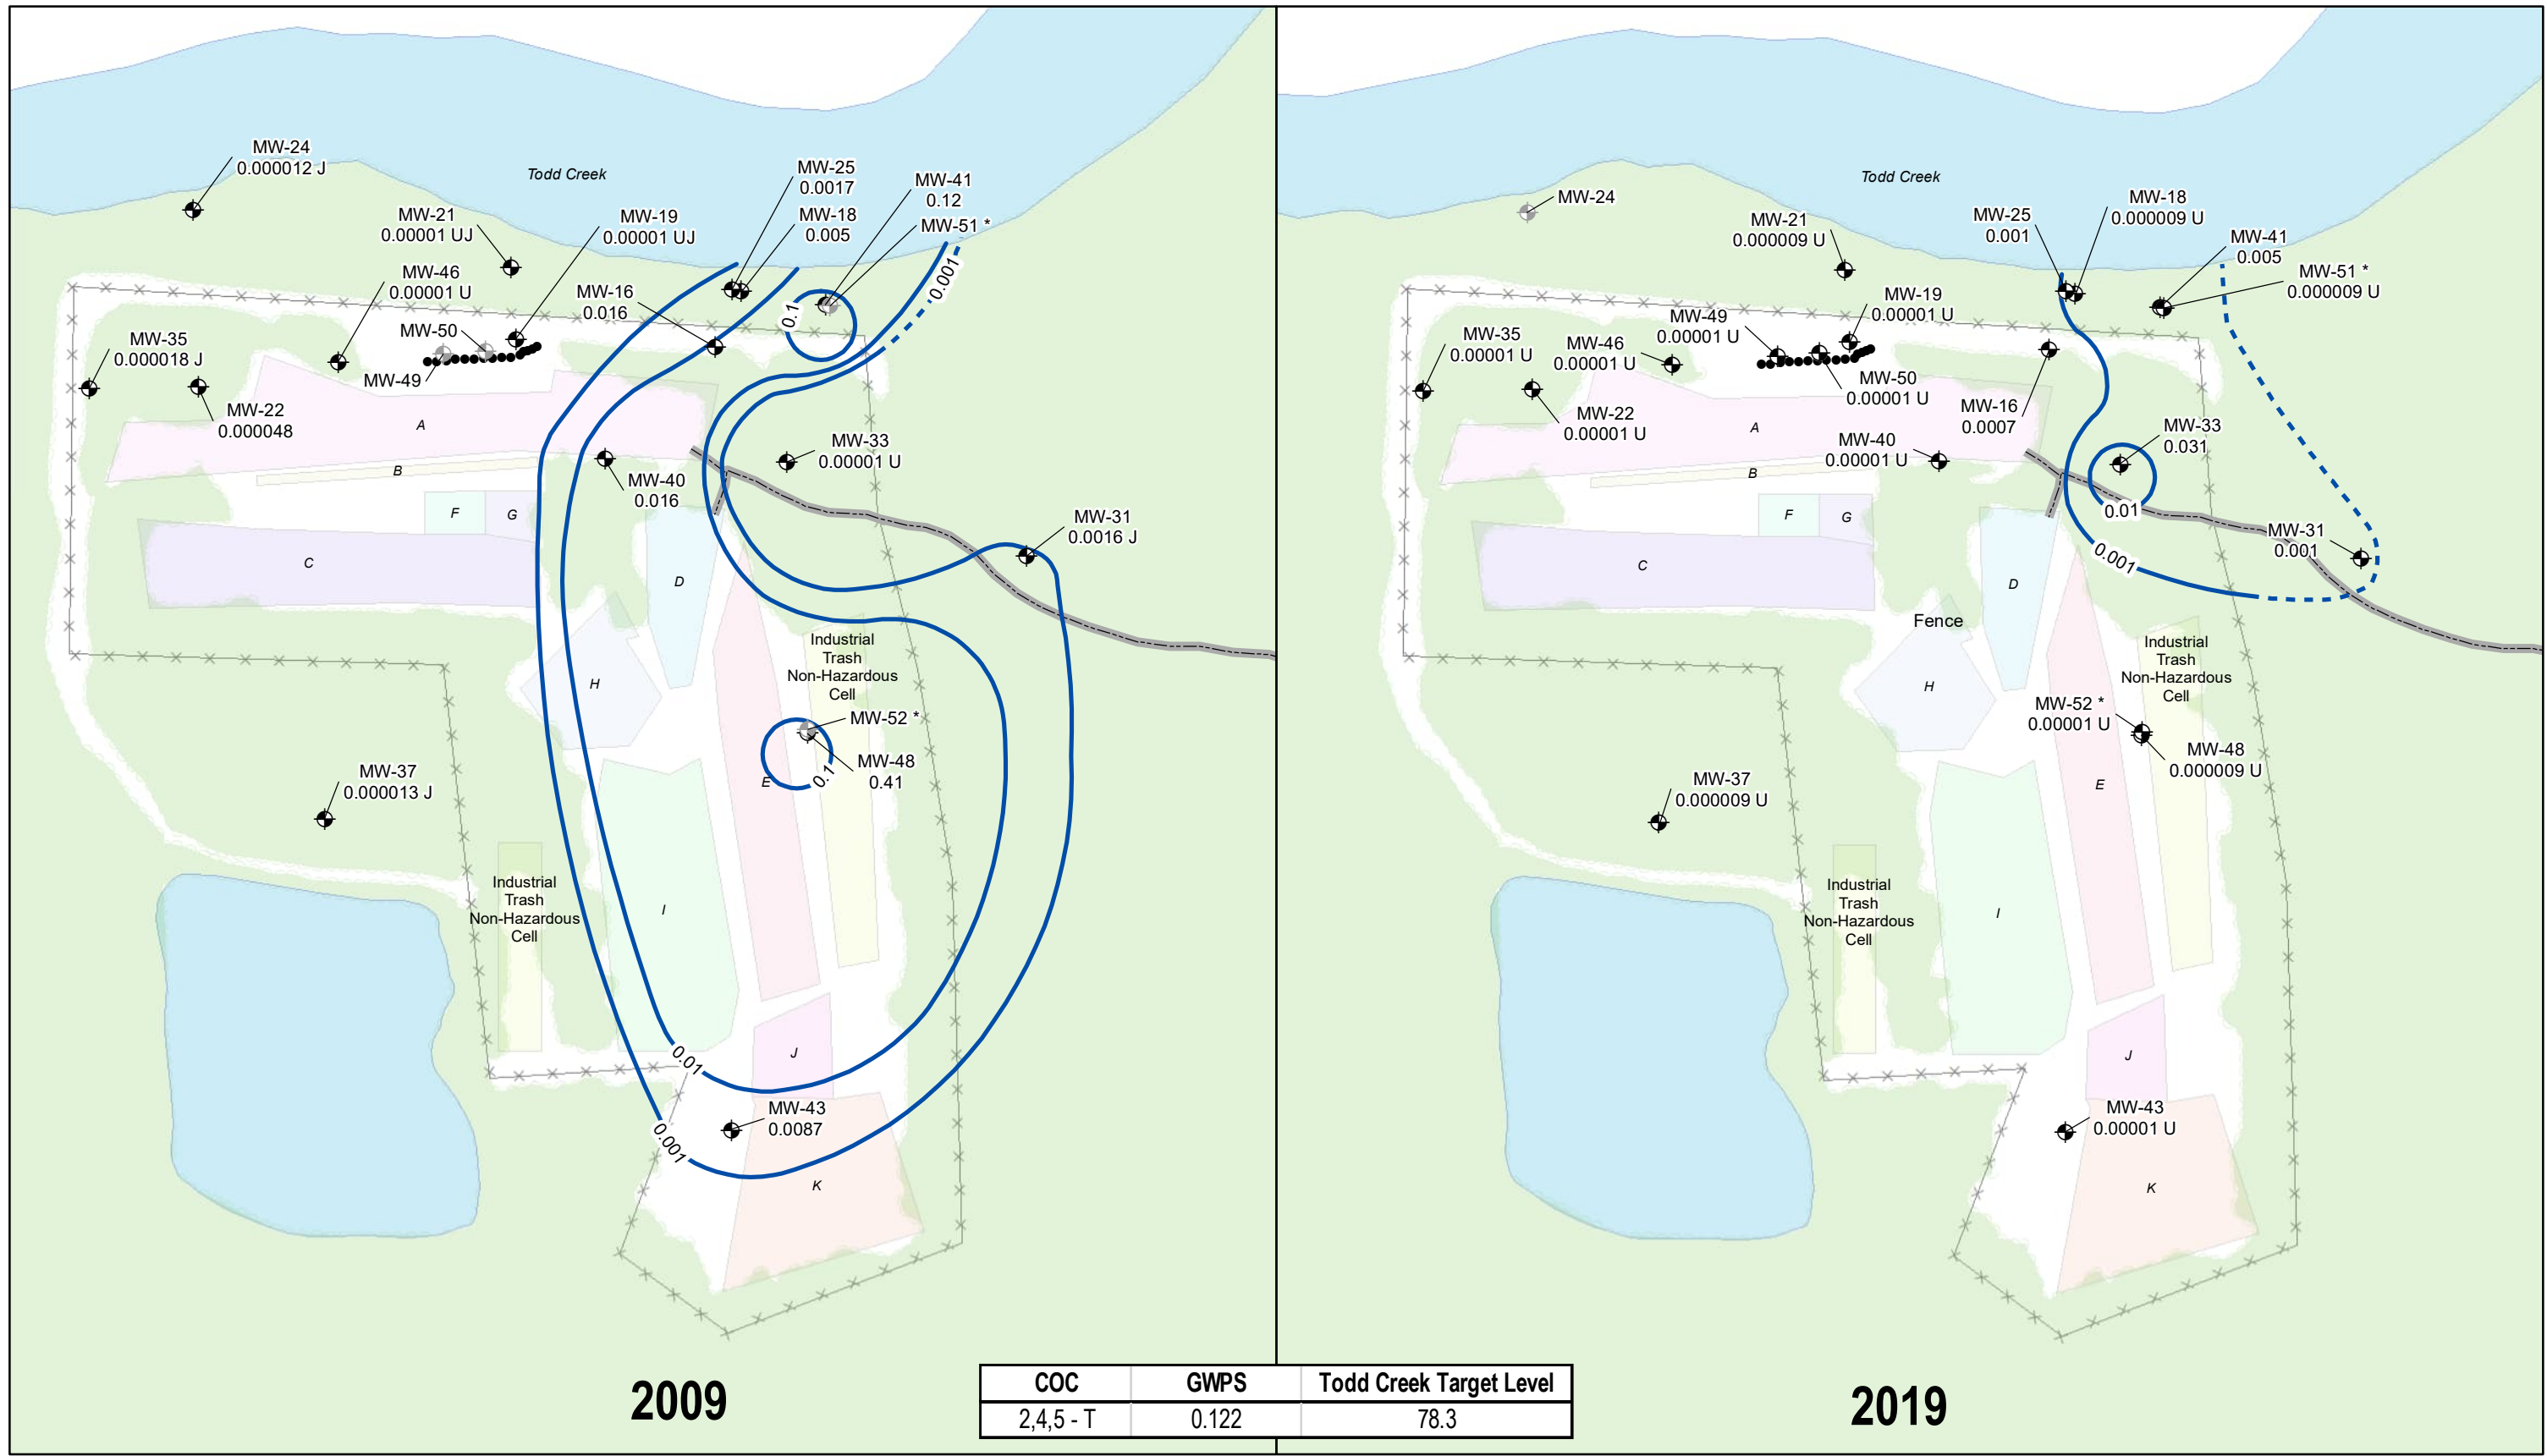
- Notes:**
- Groundwater concentrations are shown in milligrams per liter (mg/L).
  - Groundwater sampling was conducted in September of 2009 and 2019.
  - \* For MW-51 and MW-52, the screen interval at these locations are greater than 80 ft bgs; therefore, the results were not used for contour interpretation.
  - No exceedances of 2,4,5 - T in 2019
  - All features shown currently exist but did not exist in each timeframe.
  - Contours shown are 0.1, 0.01, and 0.001 mg/L 2,4,5 - T in groundwater

**Figure 16. 2009 and 2019 2,4,5-T in Deep Aquifer Monitoring Wells Union Carbide Corporation UCC Woodbine, Camden County, Georgia**

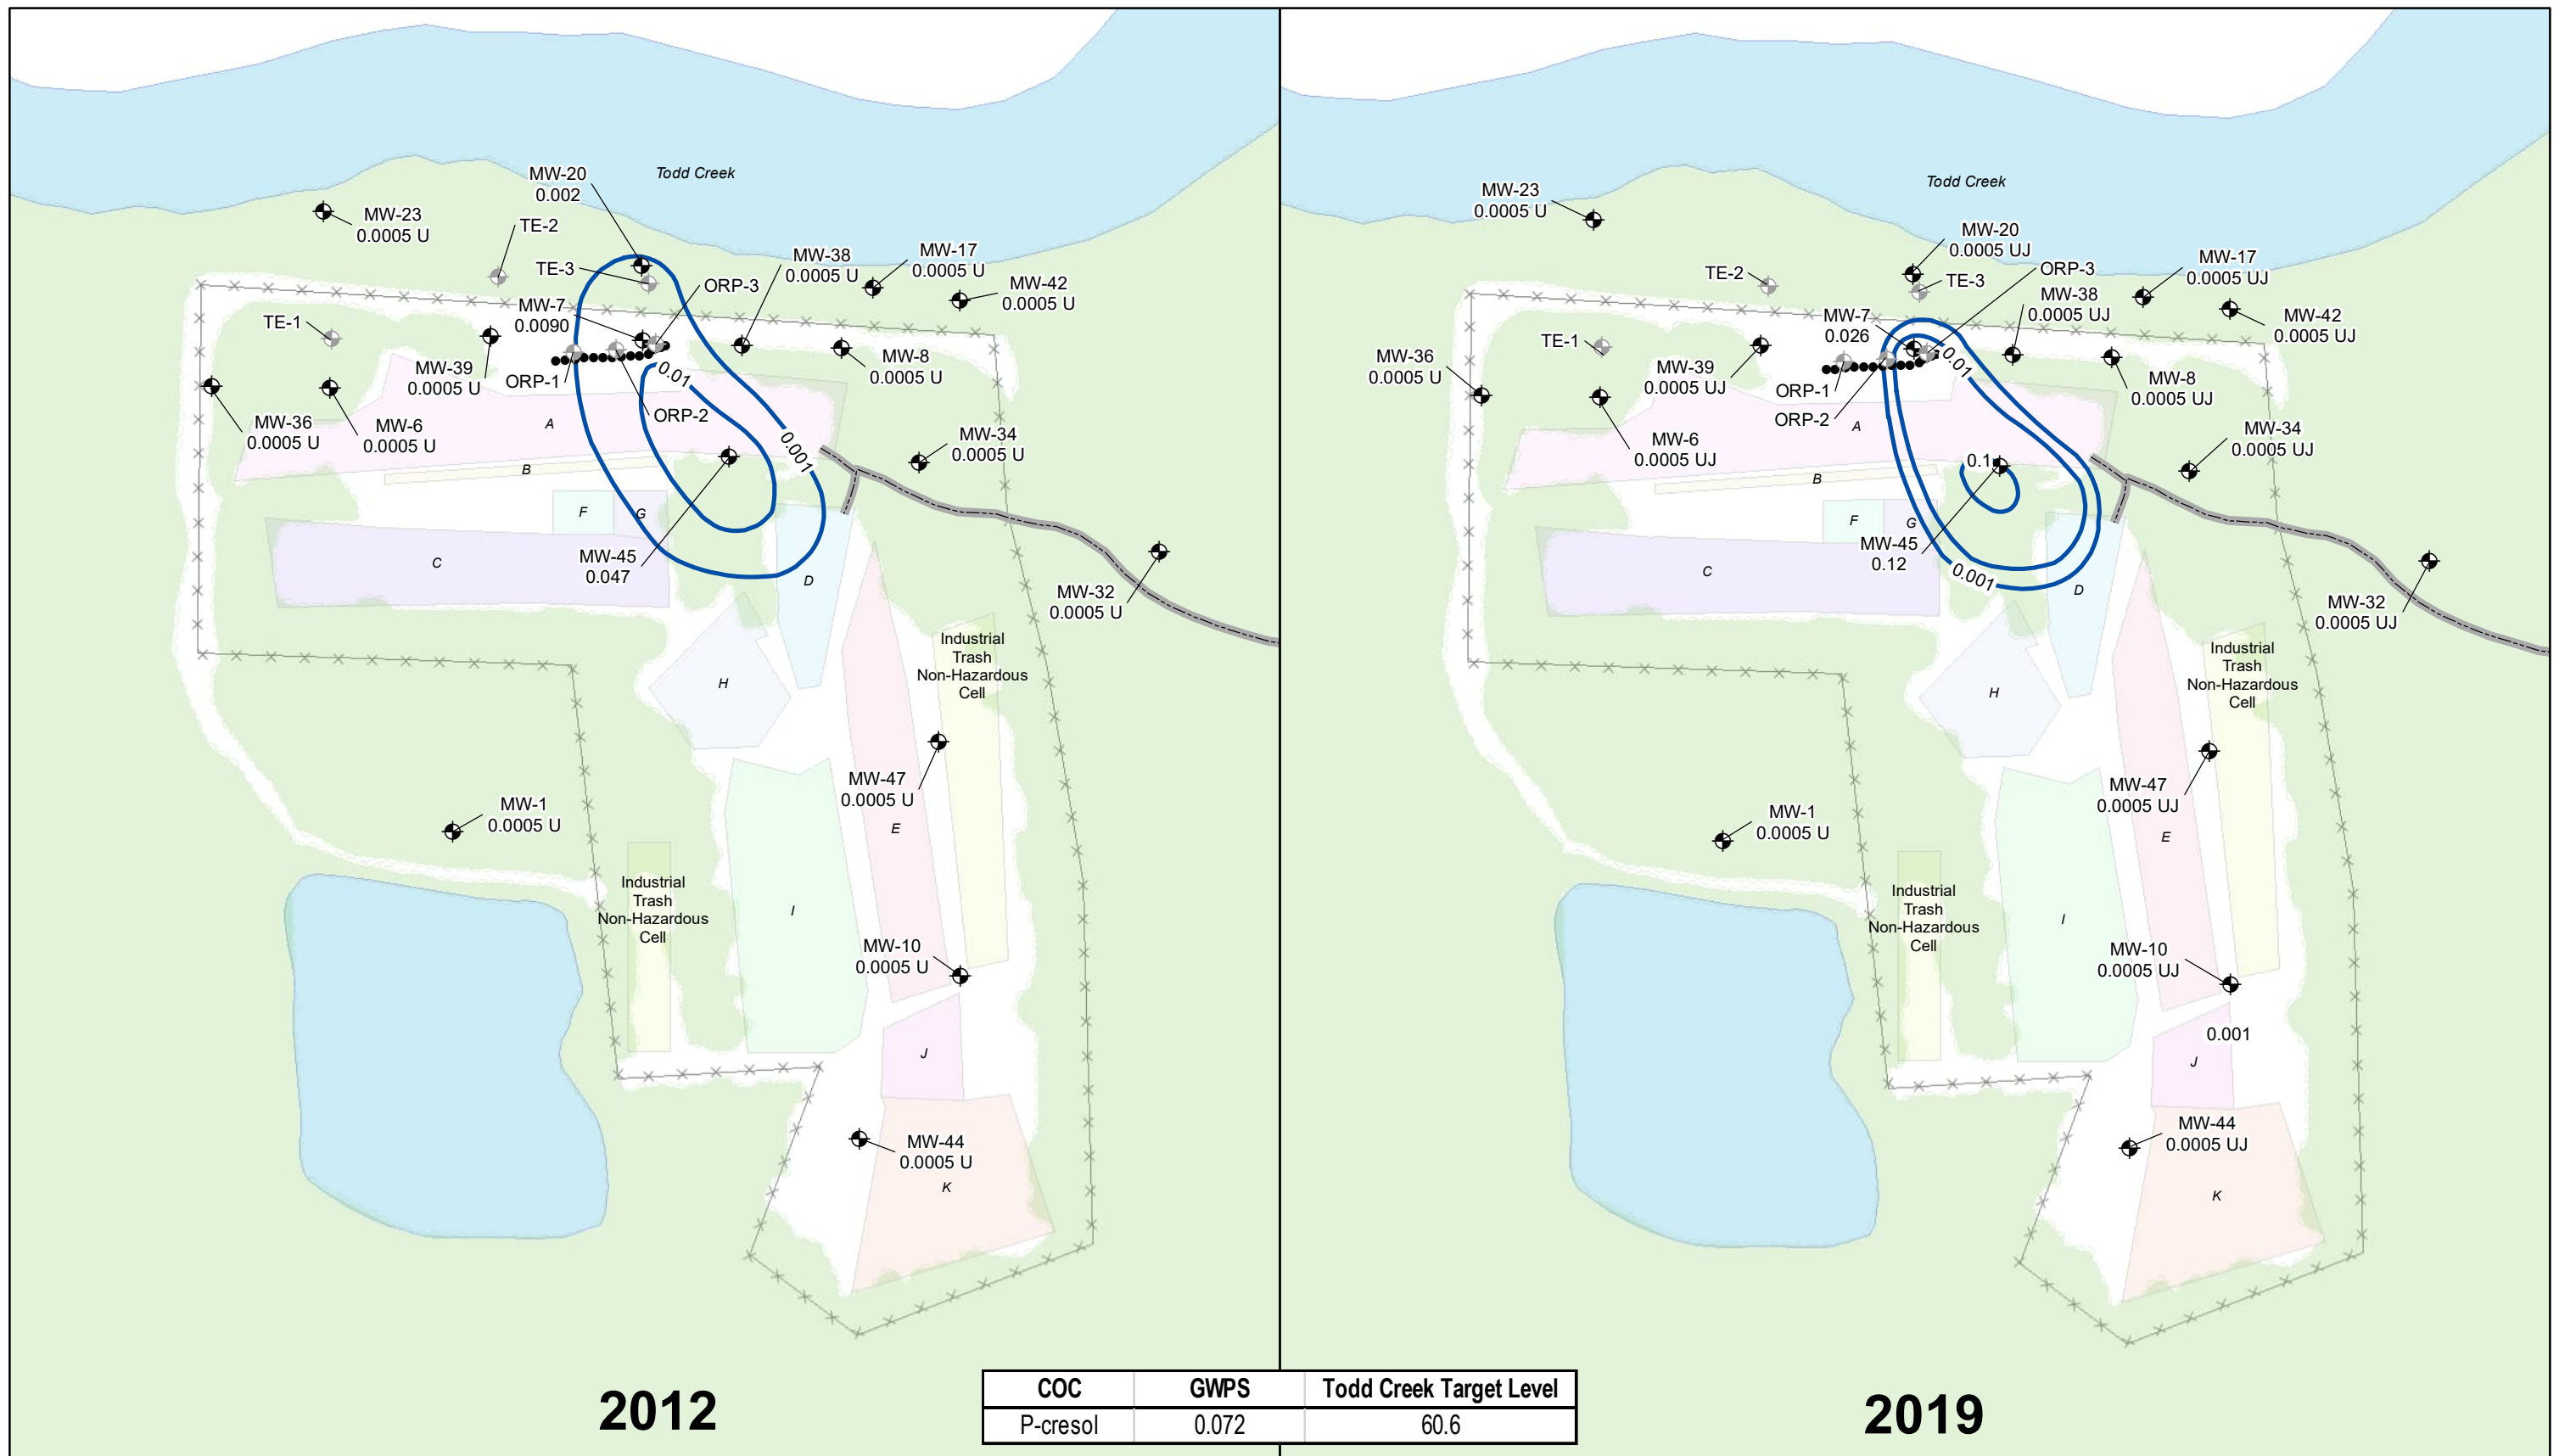
- Notes:**
1. Groundwater concentrations are shown in milligrams per liter (mg/L).
  2. Groundwater sampling was conducted in September 2012 and 2019.
  3. Prior to 2012 m- and p-cresol were not analyzed separately
  4. All features shown currently exist but did not exist in each timeframe.
  5. Contours shown are 0.1, 0.01, and 0.001 mg/L P-cresol in groundwater

**Figure 17. 2012 and 2019 P-cresol in Shallow Aquifer Monitoring Wells**  
 Union Carbide Corporation  
 UCC Woodbine, Camden County, Georgia

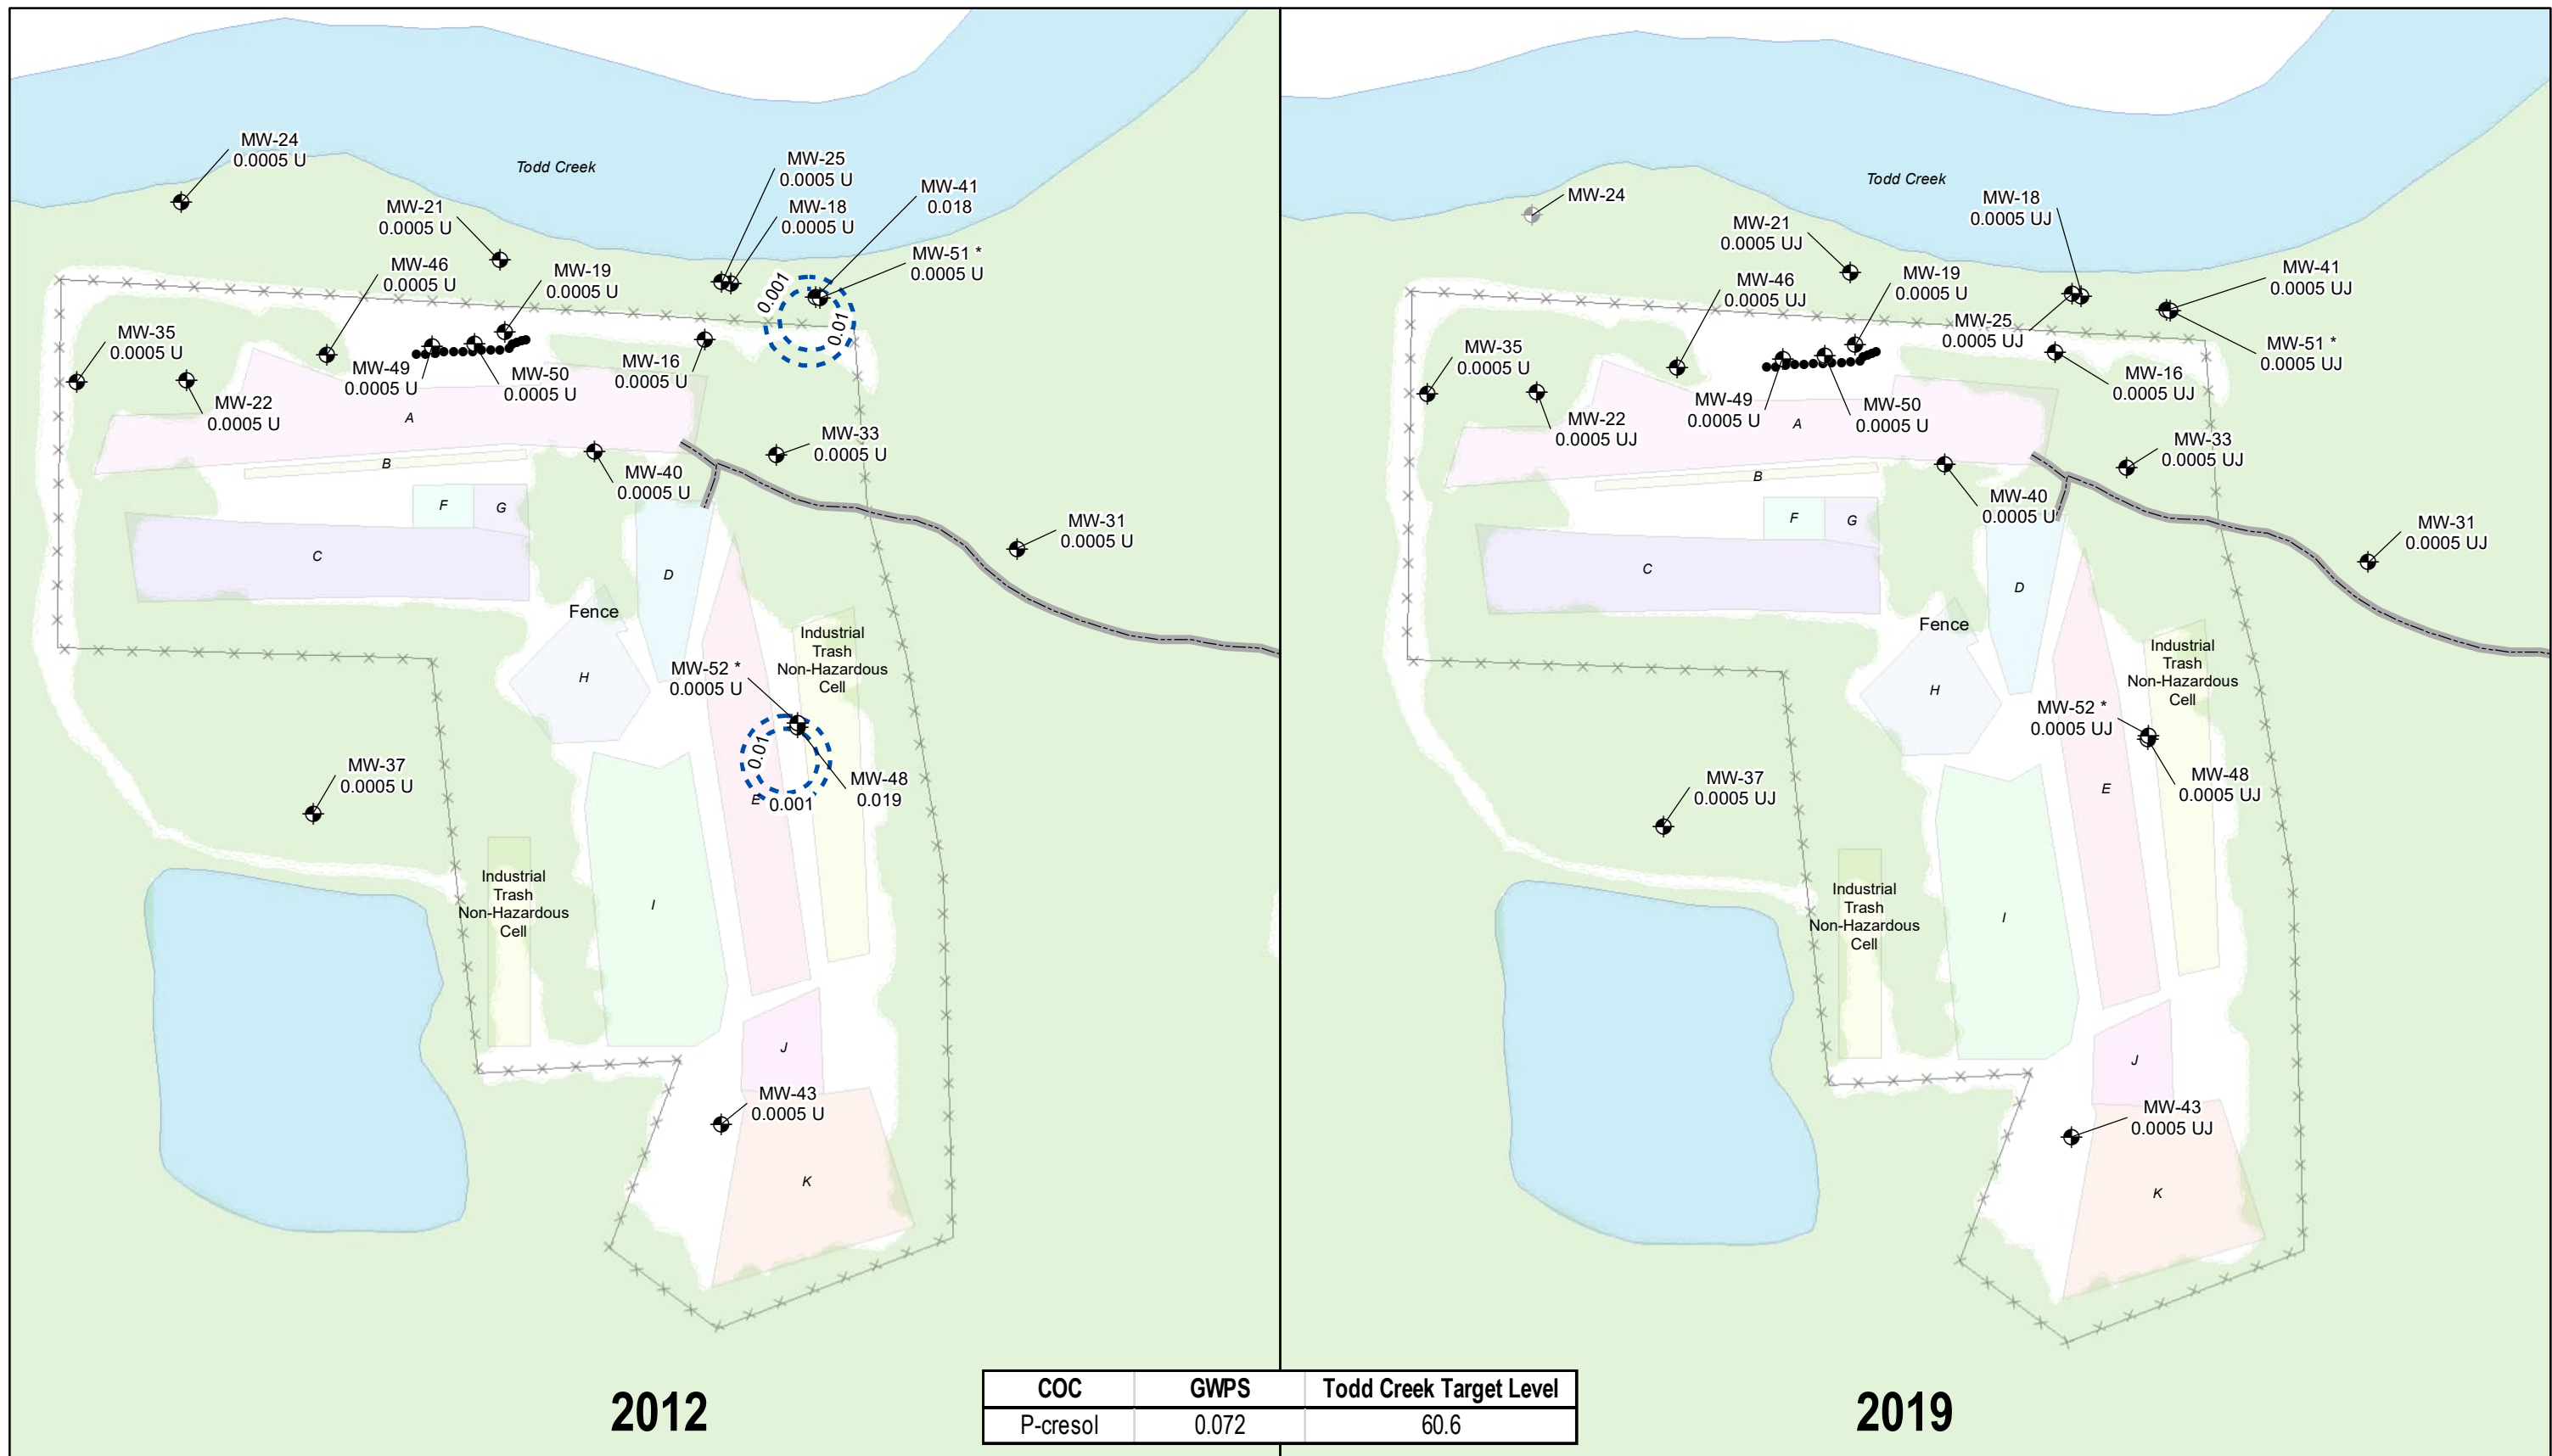
1. Groundwater concentrations are shown in milligrams per liter (mg/L).
2. Groundwater sampling was conducted in September 2012 and 2019.
3. \* For MW-51 and MW-52, the screen interval at these locations are greater than 80 ft bgs; therefore, the results were not used for contour interpretation.
4. P-cresol was not detected in any deep monitoring wells in 2019.
5. Prior to 2012 m- and p-cresol were not analyzed separately.
6. All features shown currently exist but did not exist in each timeframe.

7. Contours shown are 0.01 and 0.001 mg/L P-cresol in groundwater.

**Figure 18. 2012 and 2019 P-cresol in Deep Aquifer Monitoring Wells**  
 Union Carbide Corporation  
 UCC Woodbine, Camden County, Georgia

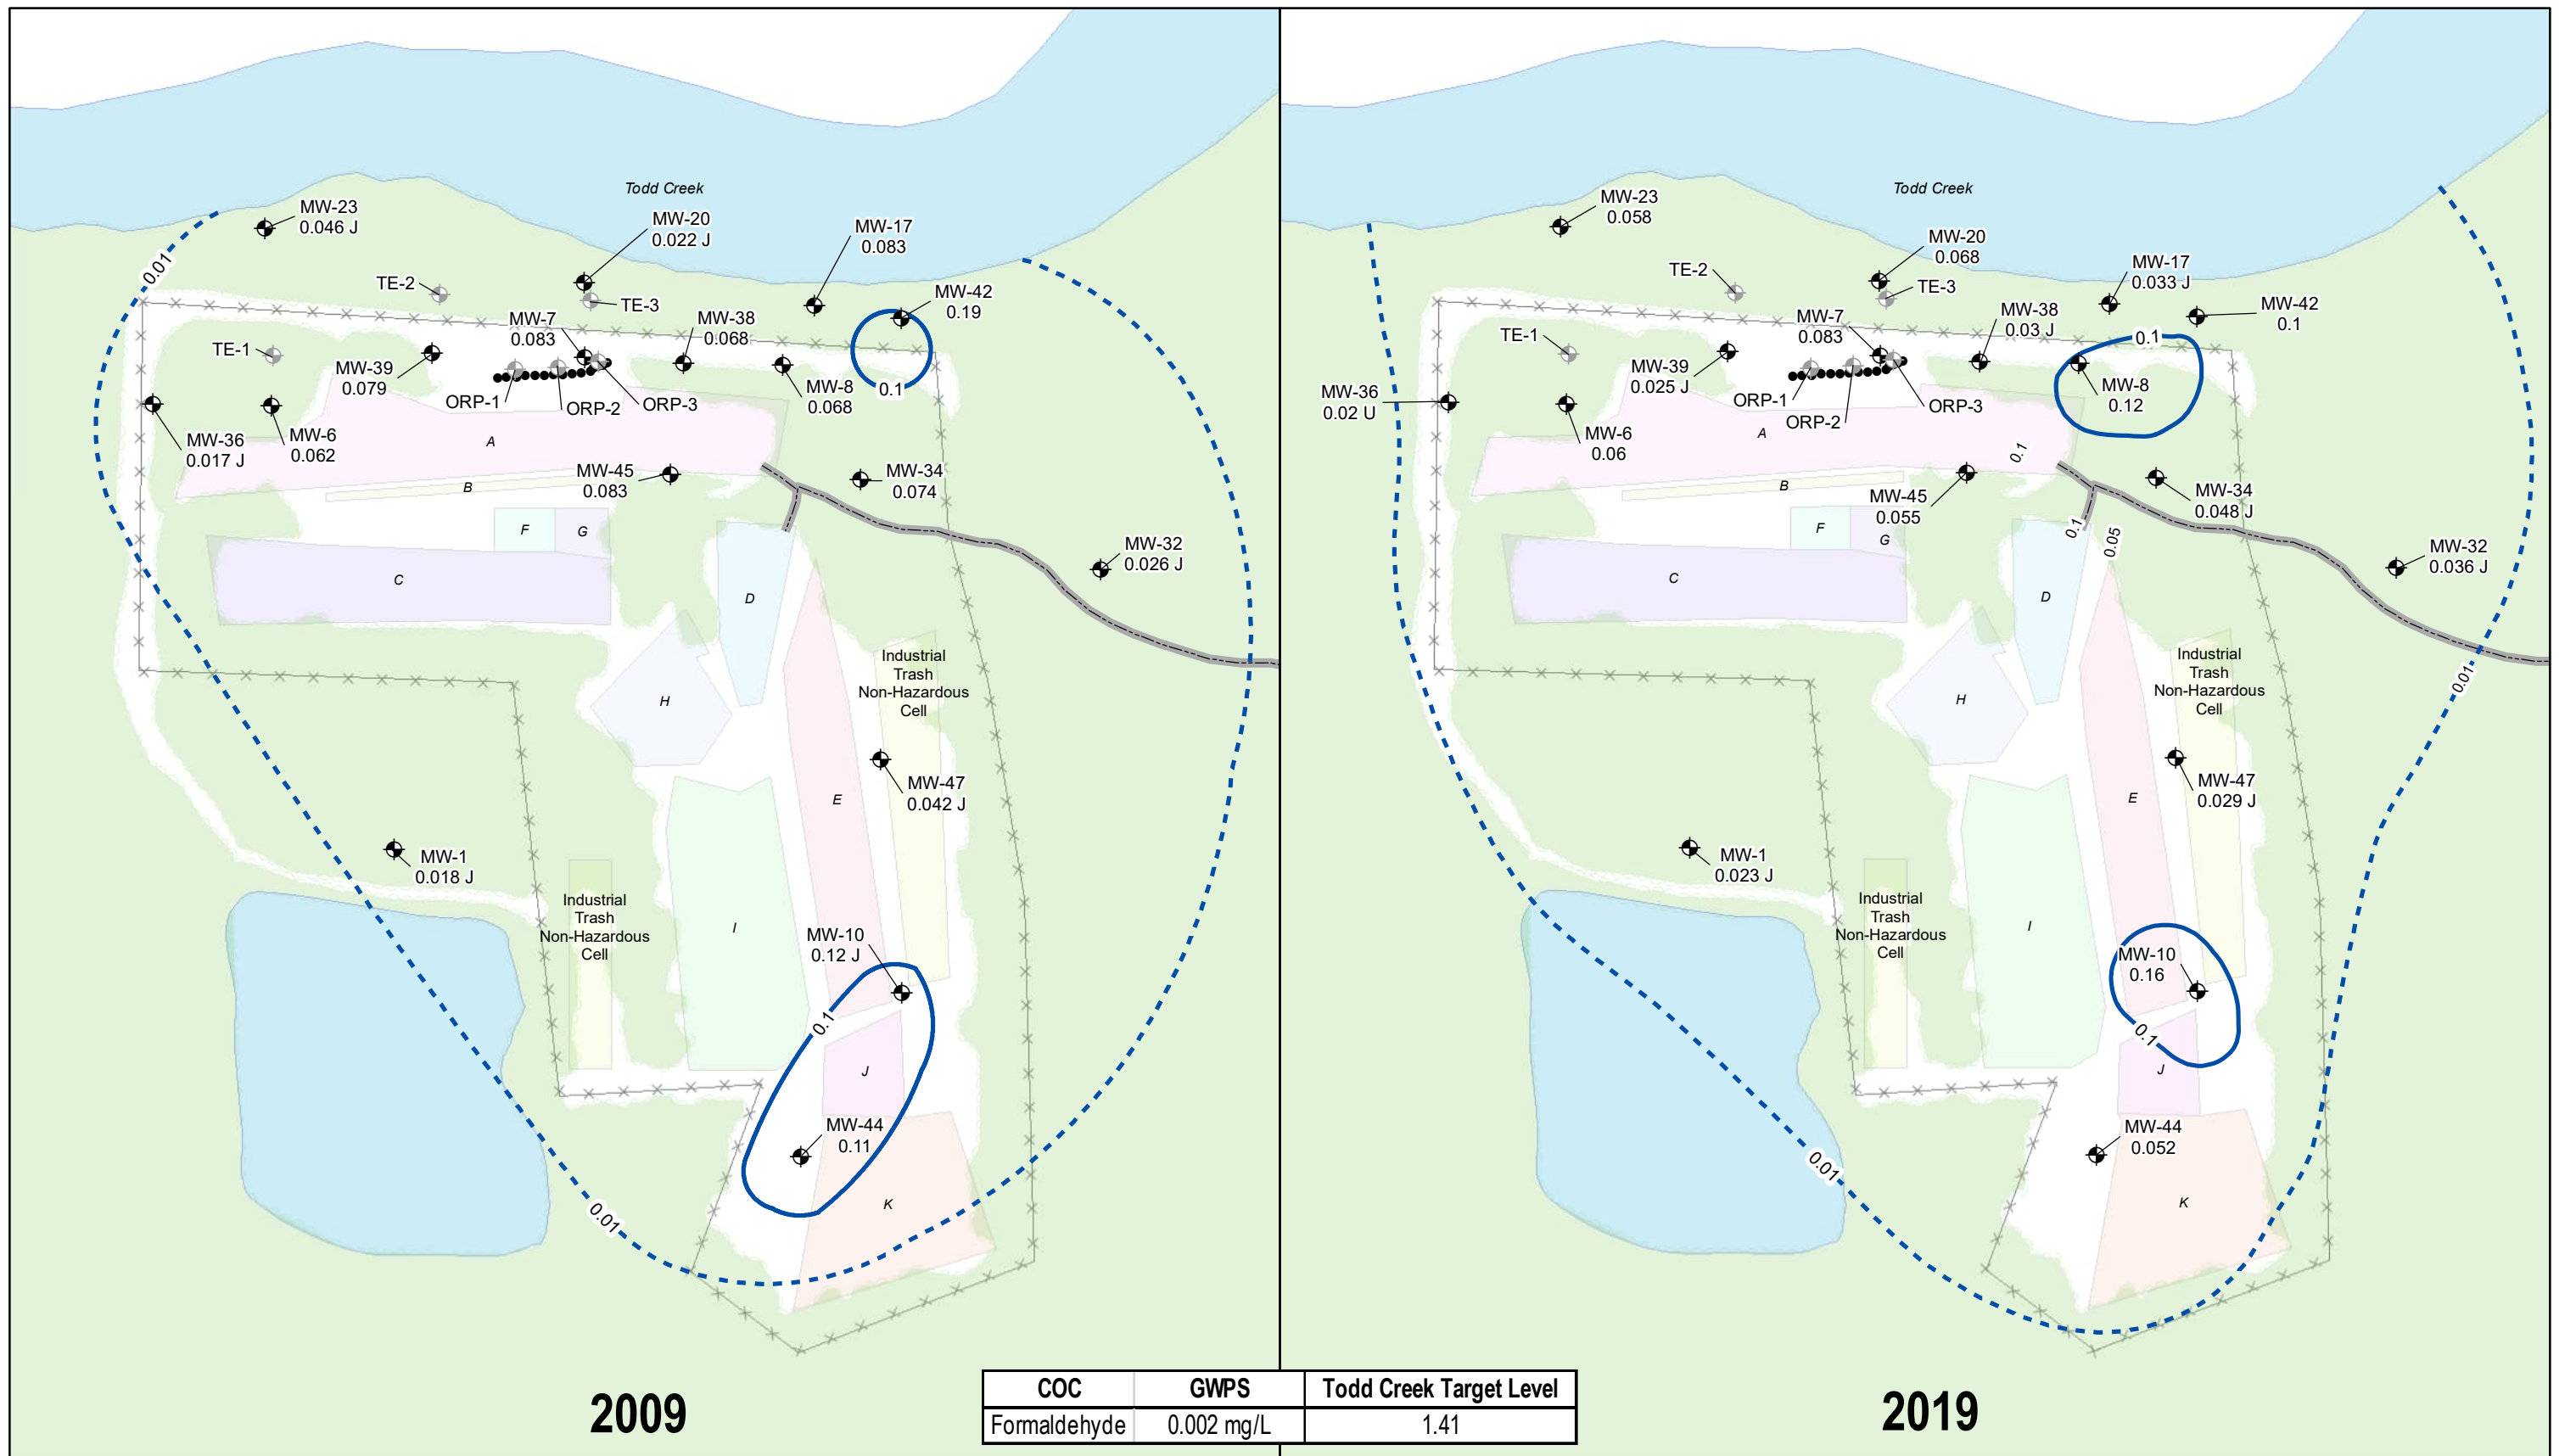
- Notes:**
- Groundwater concentrations are shown in milligrams per liter (mg/L).
  - Sampling was conducted in September of 2009 and 2019.
  - All features shown currently exist but did not exist in each timeframe.
  - Contours shown are 0.1 and 0.01 mg/L formaldehyde in groundwater

**Figure 19. 2009 and 2019 Formaldehyde in Shallow Aquifer Monitoring Wells**  
 Union Carbide Corporation  
 UCC Woodbine, Camden County, Georgia

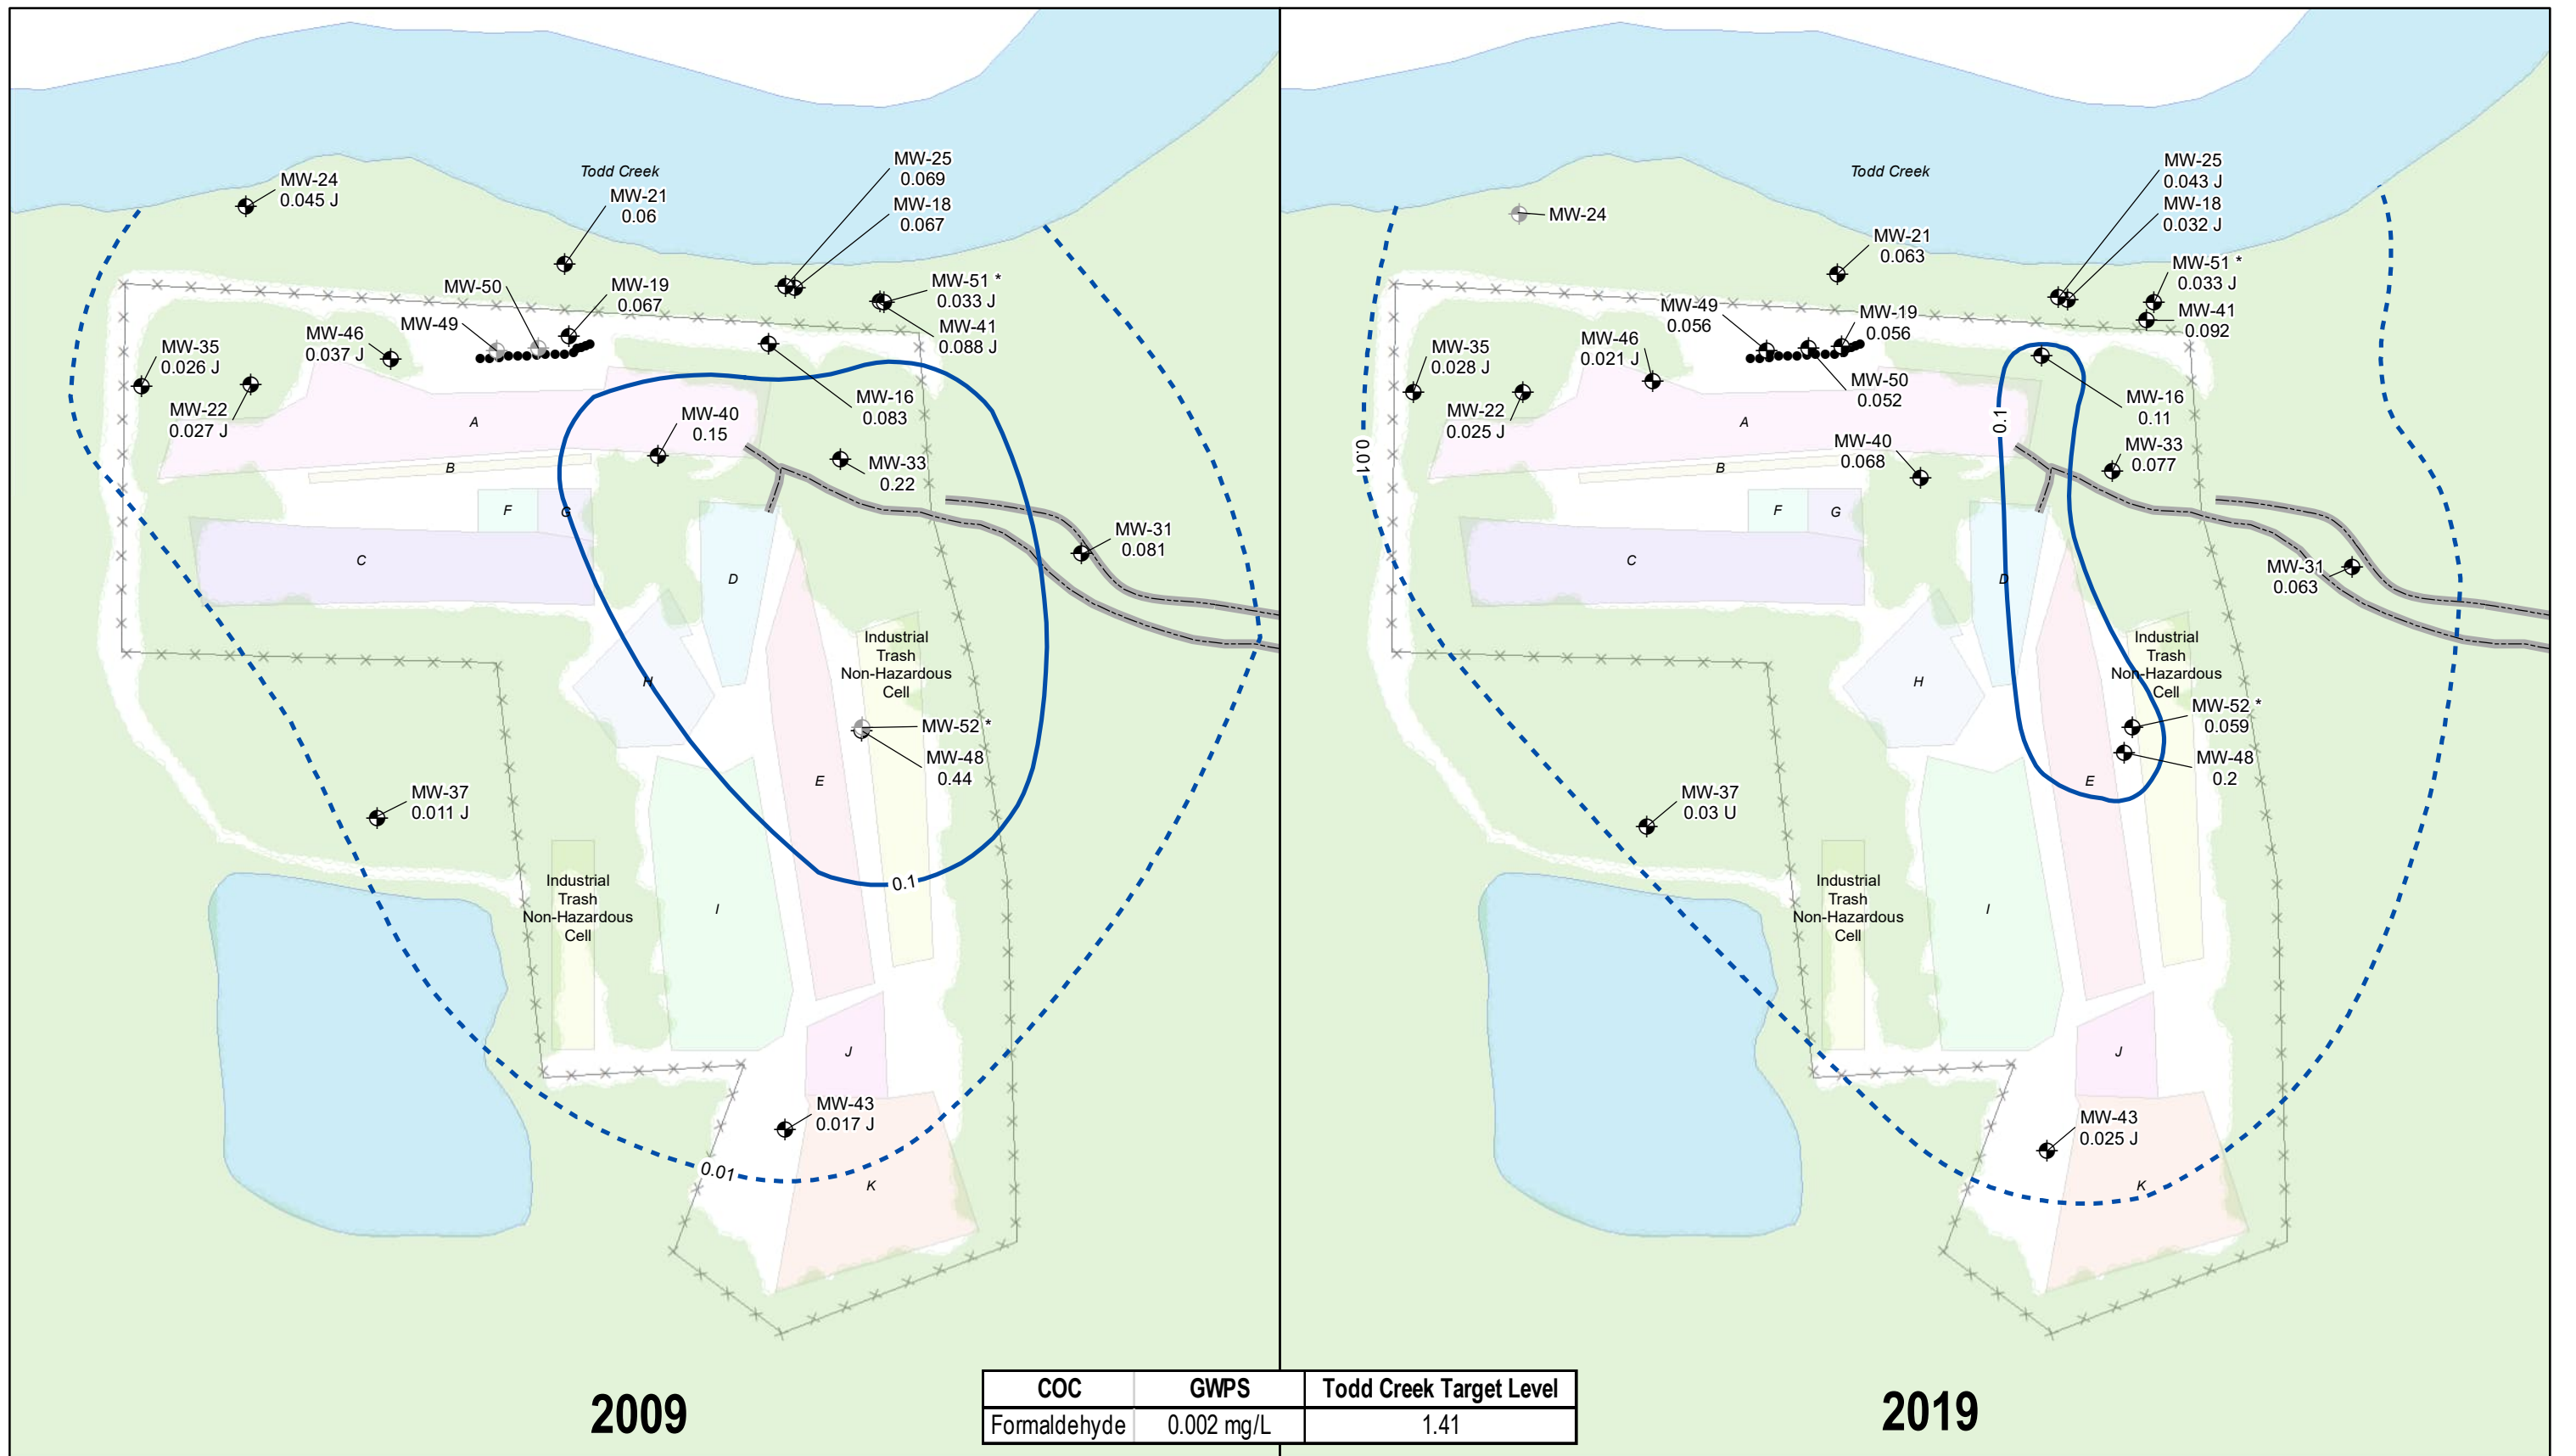
- Notes:**
- Groundwater concentrations are shown in milligrams per liter (mg/L).
  - Groundwater sampling was conducted in September of 2009 and 2019.
  - \* For MW-51 and MW-52, the screen interval at these locations are greater than 80 ft bgs; therefore, the results were not used for contour interpretation.
  - Formaldehyde was analyzed in deep aquifer groundwater wells beginning in 2006.
  - All features shown currently exist but did not exist in each timeframe.
  - Contours shown are 0.1 and 0.01 mg/L formaldehyde in groundwater

**Figure 20. 2009 and 2019 Formaldehyde in Deep Aquifer Monitoring Wells**  
 Union Carbide Corporation  
 UCC Woodbine, Camden County, Georgia
