Figure 1. Facility Location Map  
Permit Renewal Application  
Union Carbide Corporation  
UCC Woodbine, Camden County, Georgia

**Figure 3. Landfill (SWMU 1) Topographic Map**  
 Union Carbide Corporation  
 UCC Woodbine, Camden County, Georgia

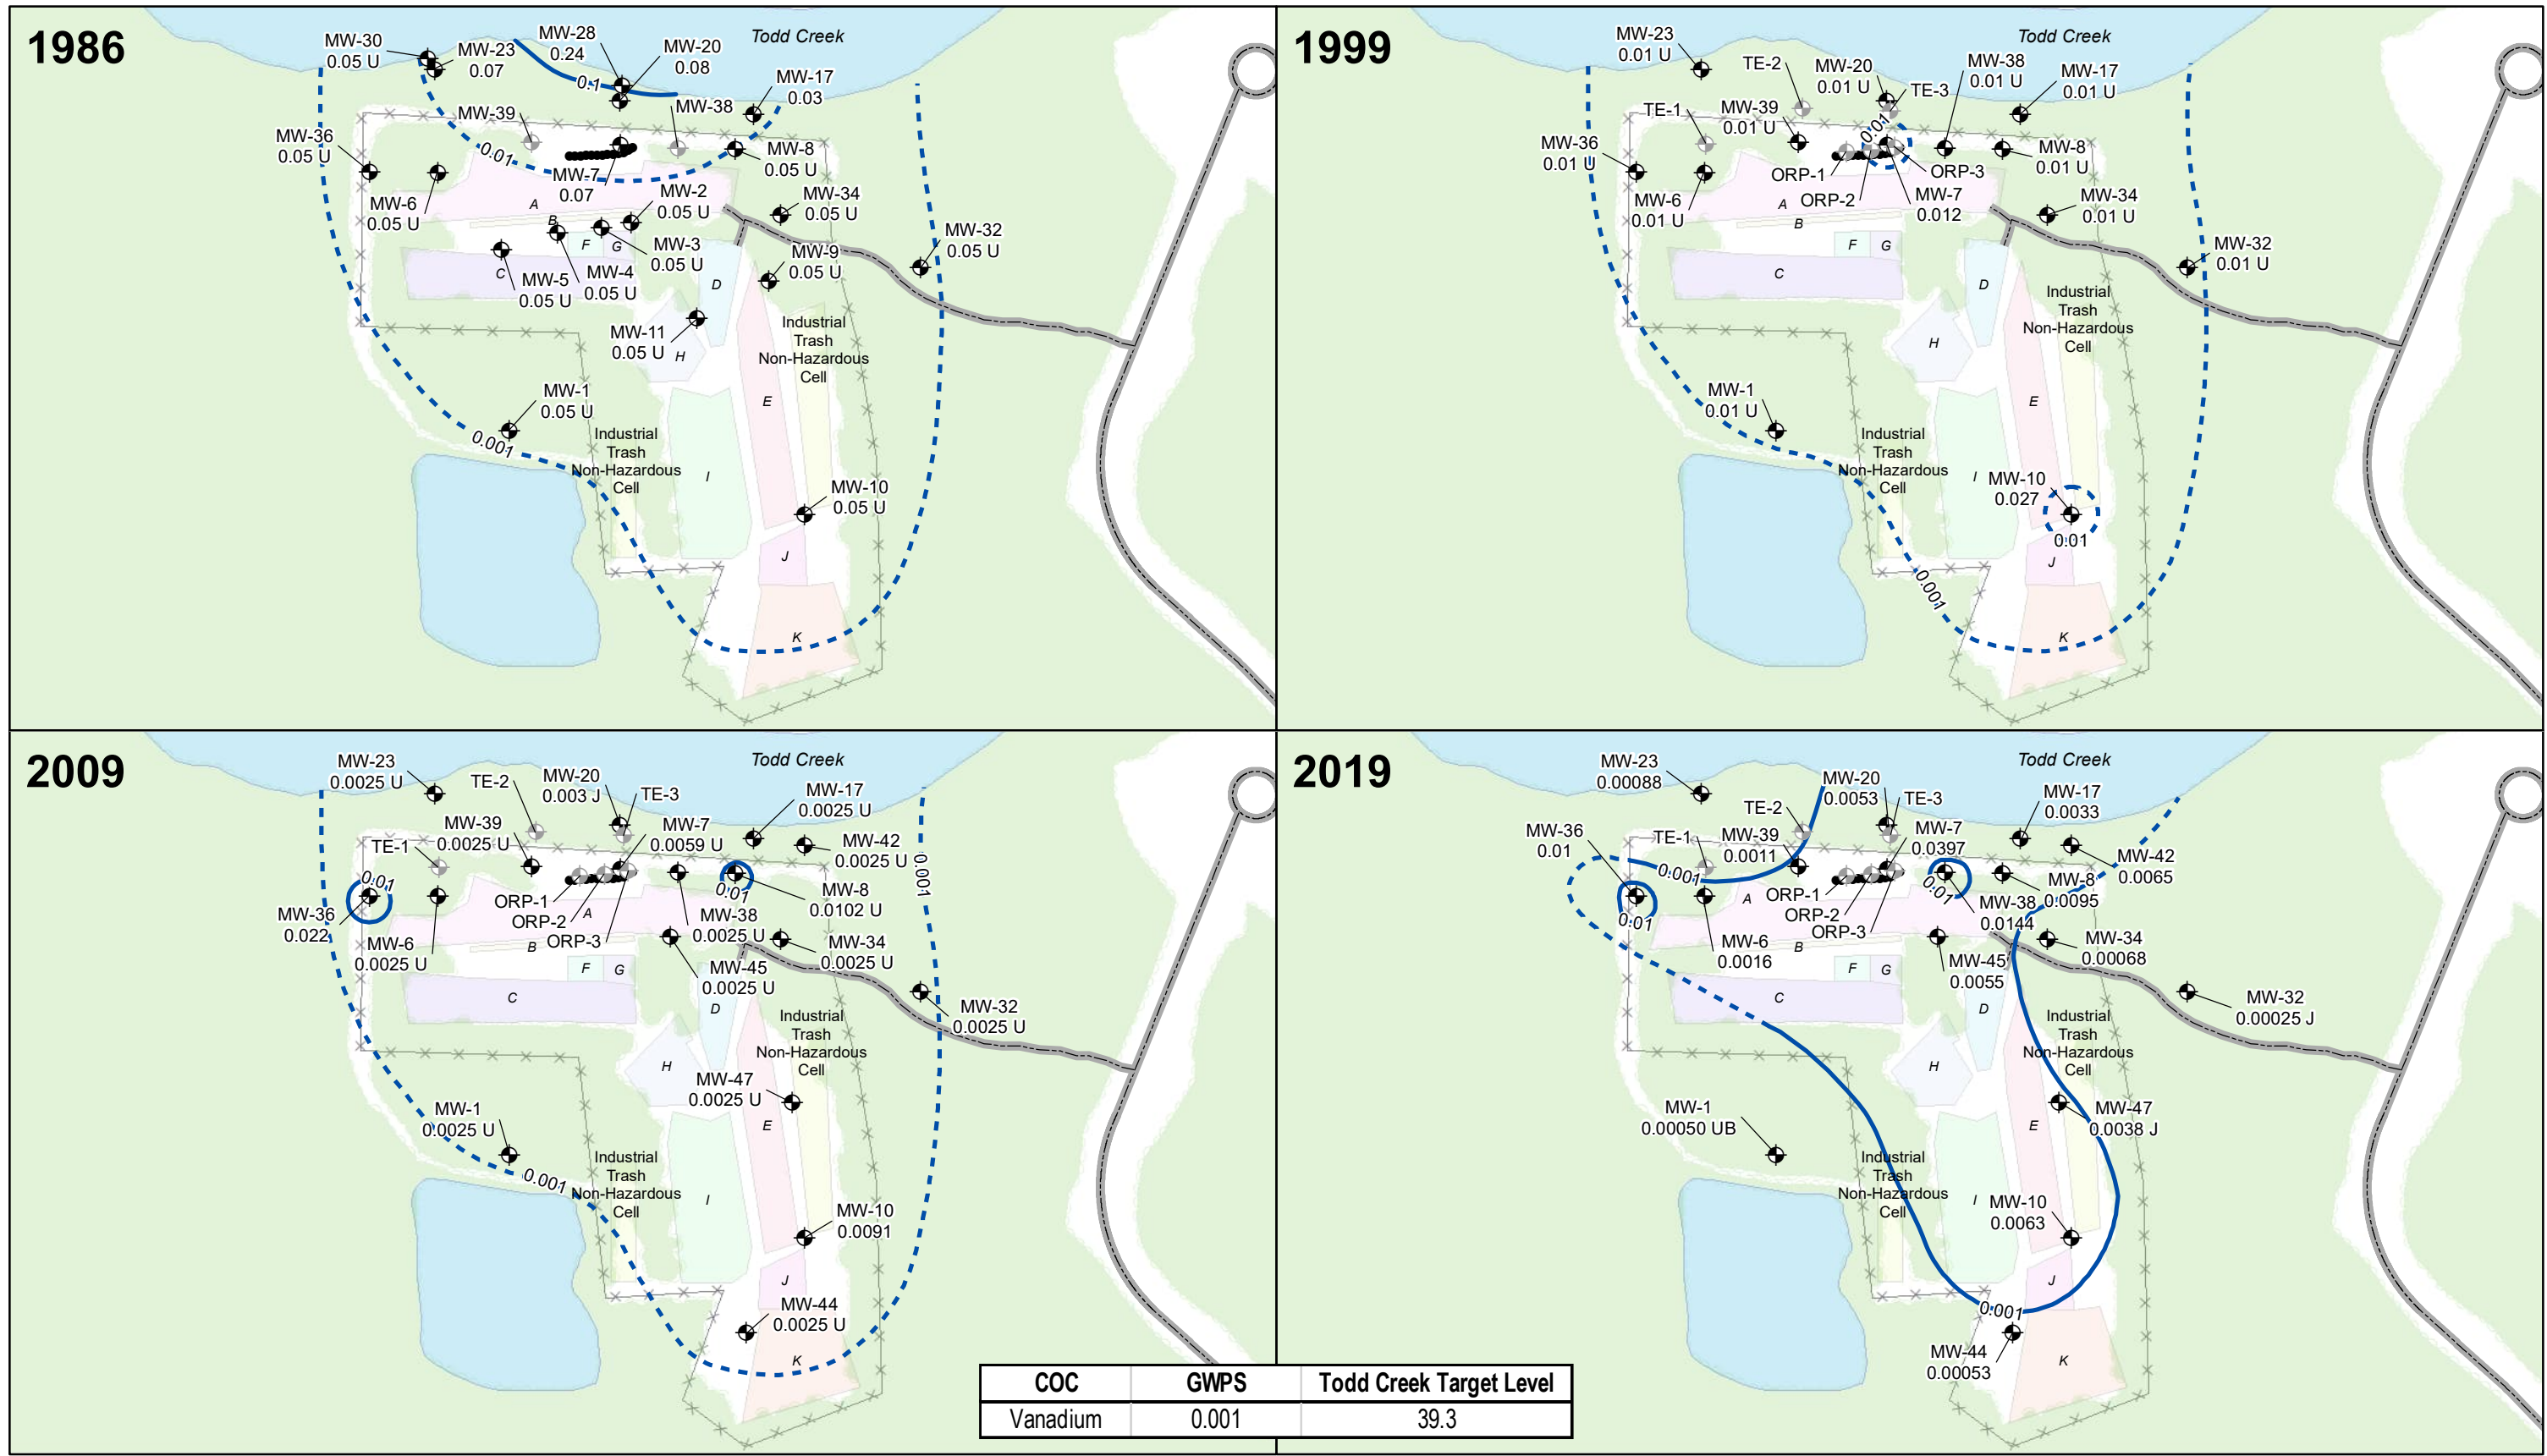
**Figure 21. 1986, 1999, 2009, and 2019 Vanadium in Shallow Aquifer Monitoring Wells**  
 Union Carbide Corporation  
 UCC Woodbine, Camden County, Georgia

**Notes:**  
 1. Groundwater concentrations are shown in milligrams per liter (mg/L).  
 2. Groundwater sampling was conducted in April-August of 1986, November of 1999, and September of 2009 and 2019.  
 3. The laboratory reporting limit was above the GWPS for vanadium in 1986, 1999, and 2009.  
 4. The detection limit was used in lieu of "BRL" (below reporting limit) for the 1999 data set.  
 5. All features shown currently exist but did not exist in each timeframe.  
 6. Contours shown are 0.1, 0.01, and 0.001 mg/L vanadium in groundwater.

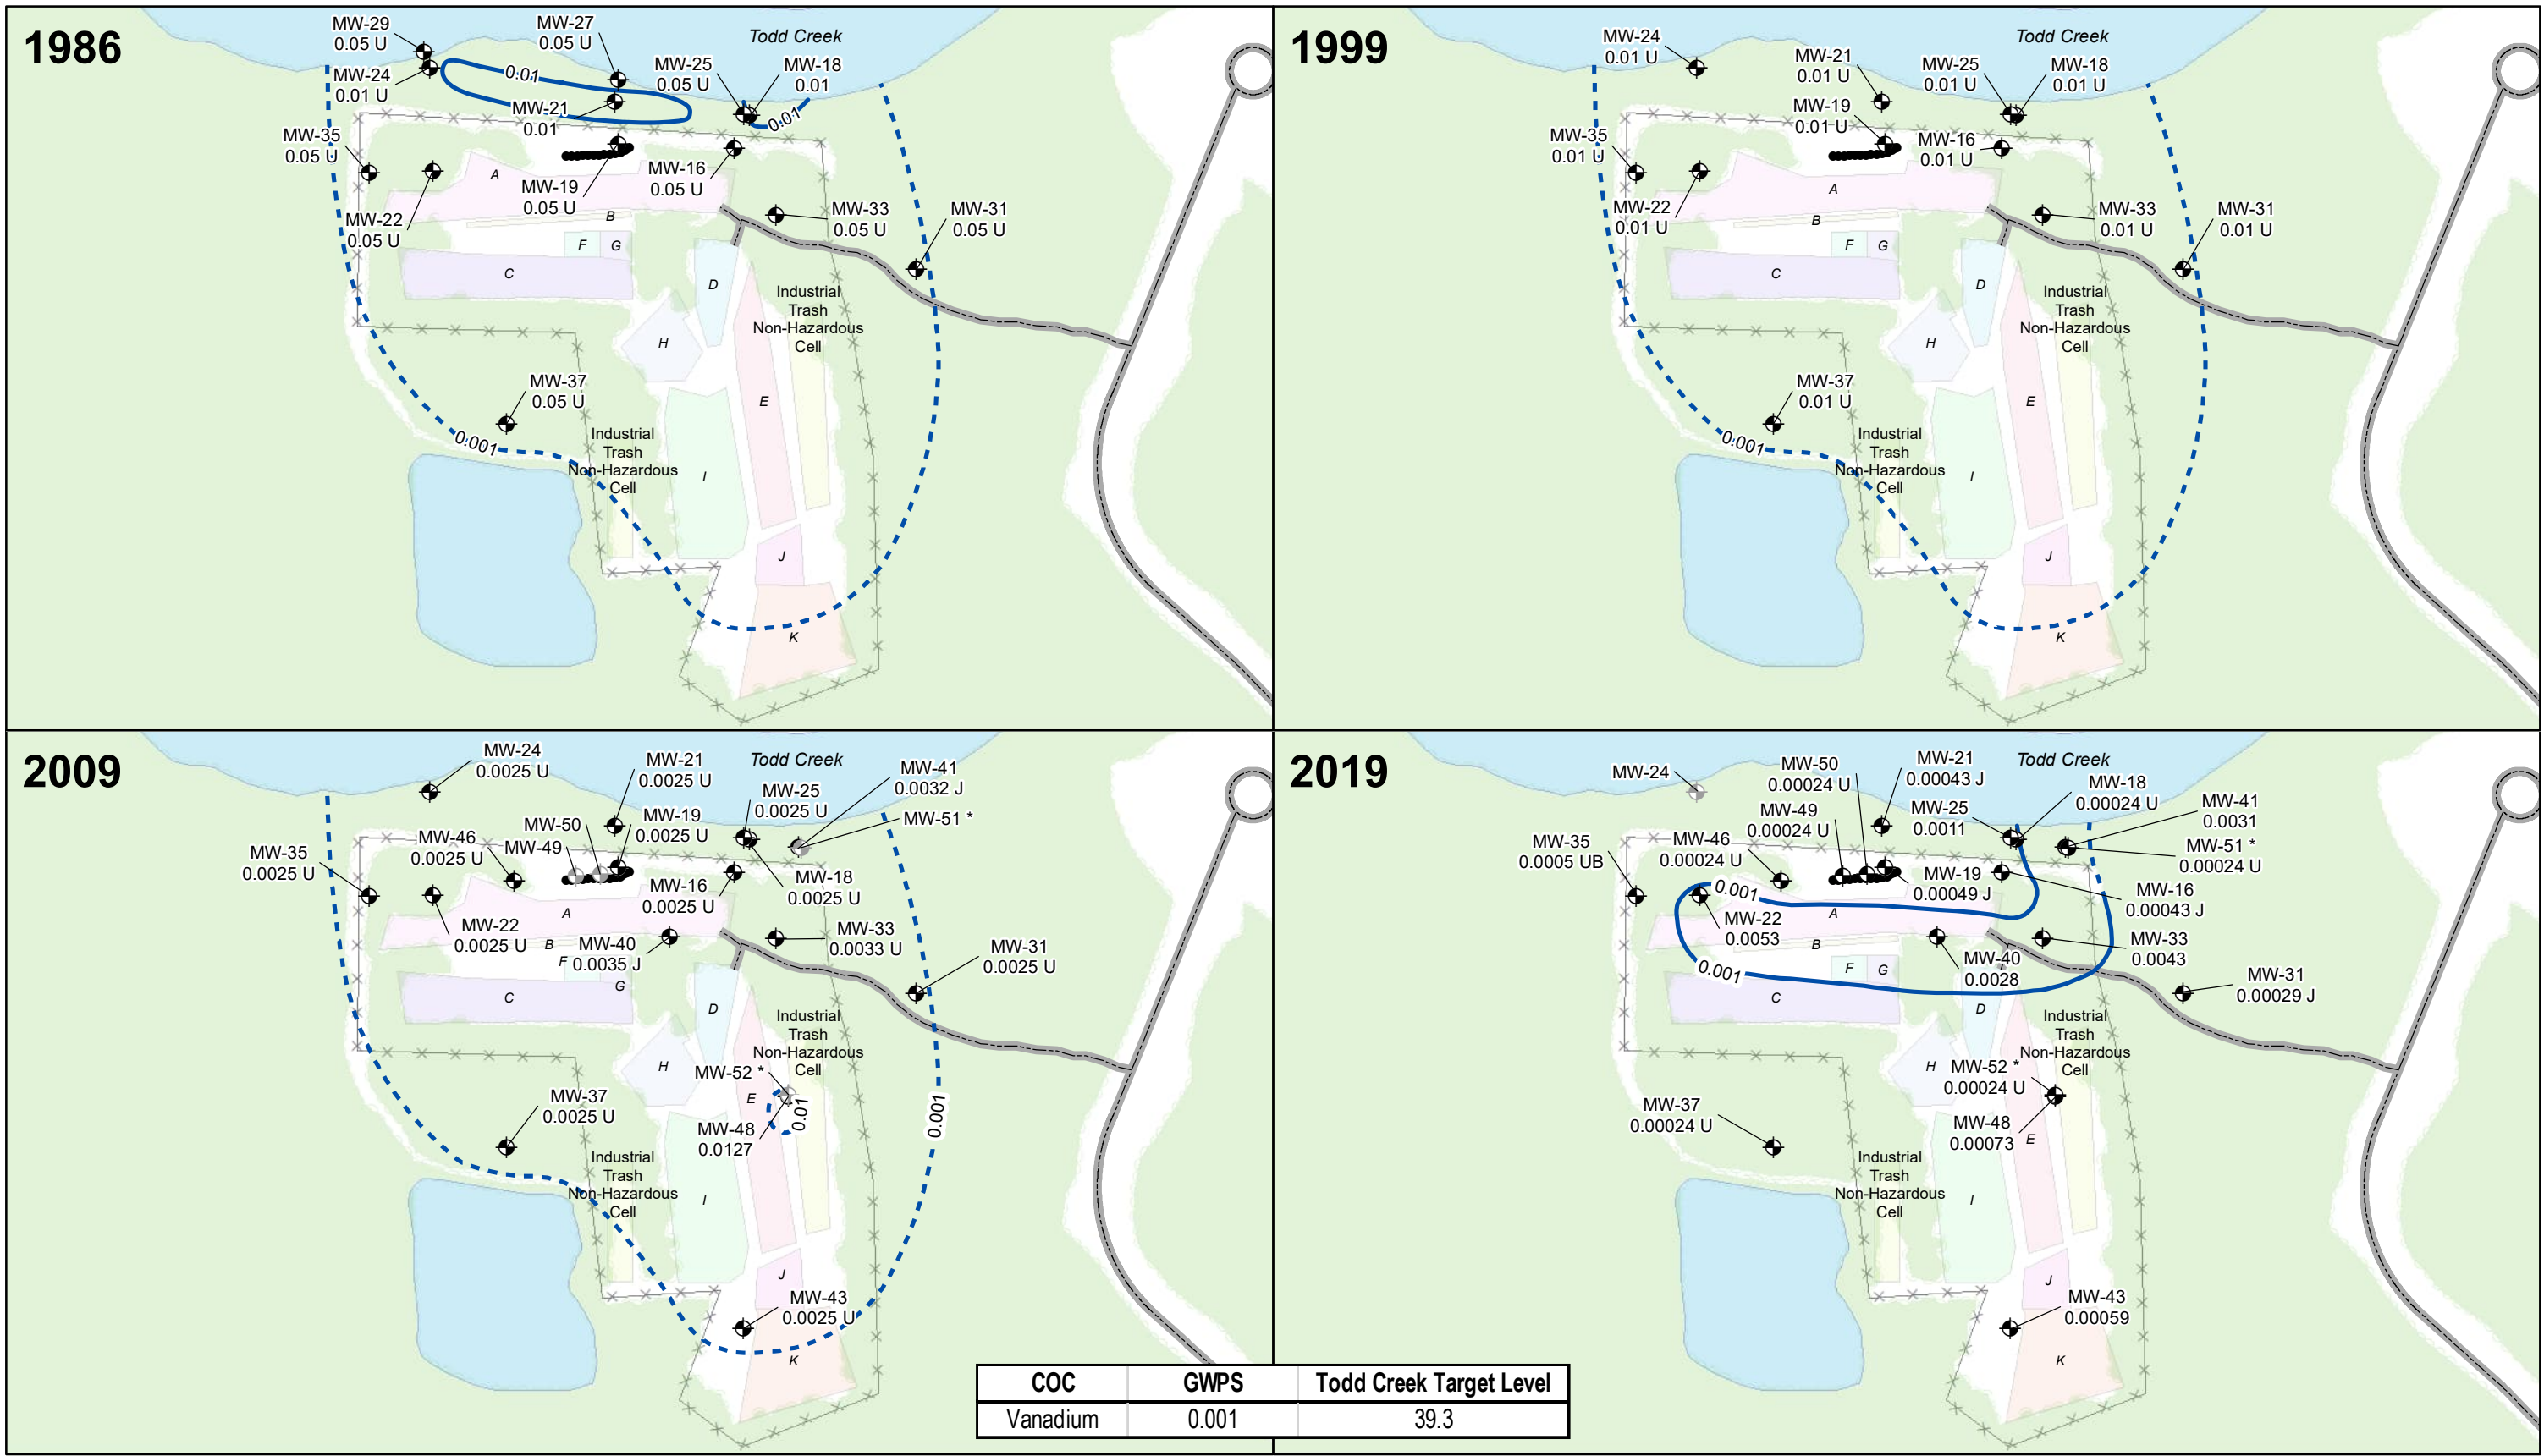
**Notes:**  
1. Groundwater concentrations are shown in milligrams per liter (mg/L).  
2. Groundwater sampling was conducted in April-August of 1986, November of 1999, and September of 2009 and 2019.  
3. \* For MW-51 and MW-52, the screen interval at these locations are greater than 80 ft bgs; therefore, the results were not used for contour interpretation.  
4. The laboratory reporting limit was above the GWPS for vanadium in 1986, 1999, and 2009.  
5. The detection limit was used in lieu of "BRL" (below reporting limit) for the 1999 data set.  
6. All features shown currently exist but did not exist in each timeframe.  
7. Contours shown are 0.01 and 0.001 mg/L vanadium in groundwater

**Figure 22. 1986, 1999, 2009, and 2019 Vanadium in Deep Aquifer Monitoring Wells**  
Union Carbide Corporation  
UCC Woodbine, Camden County, Georgia

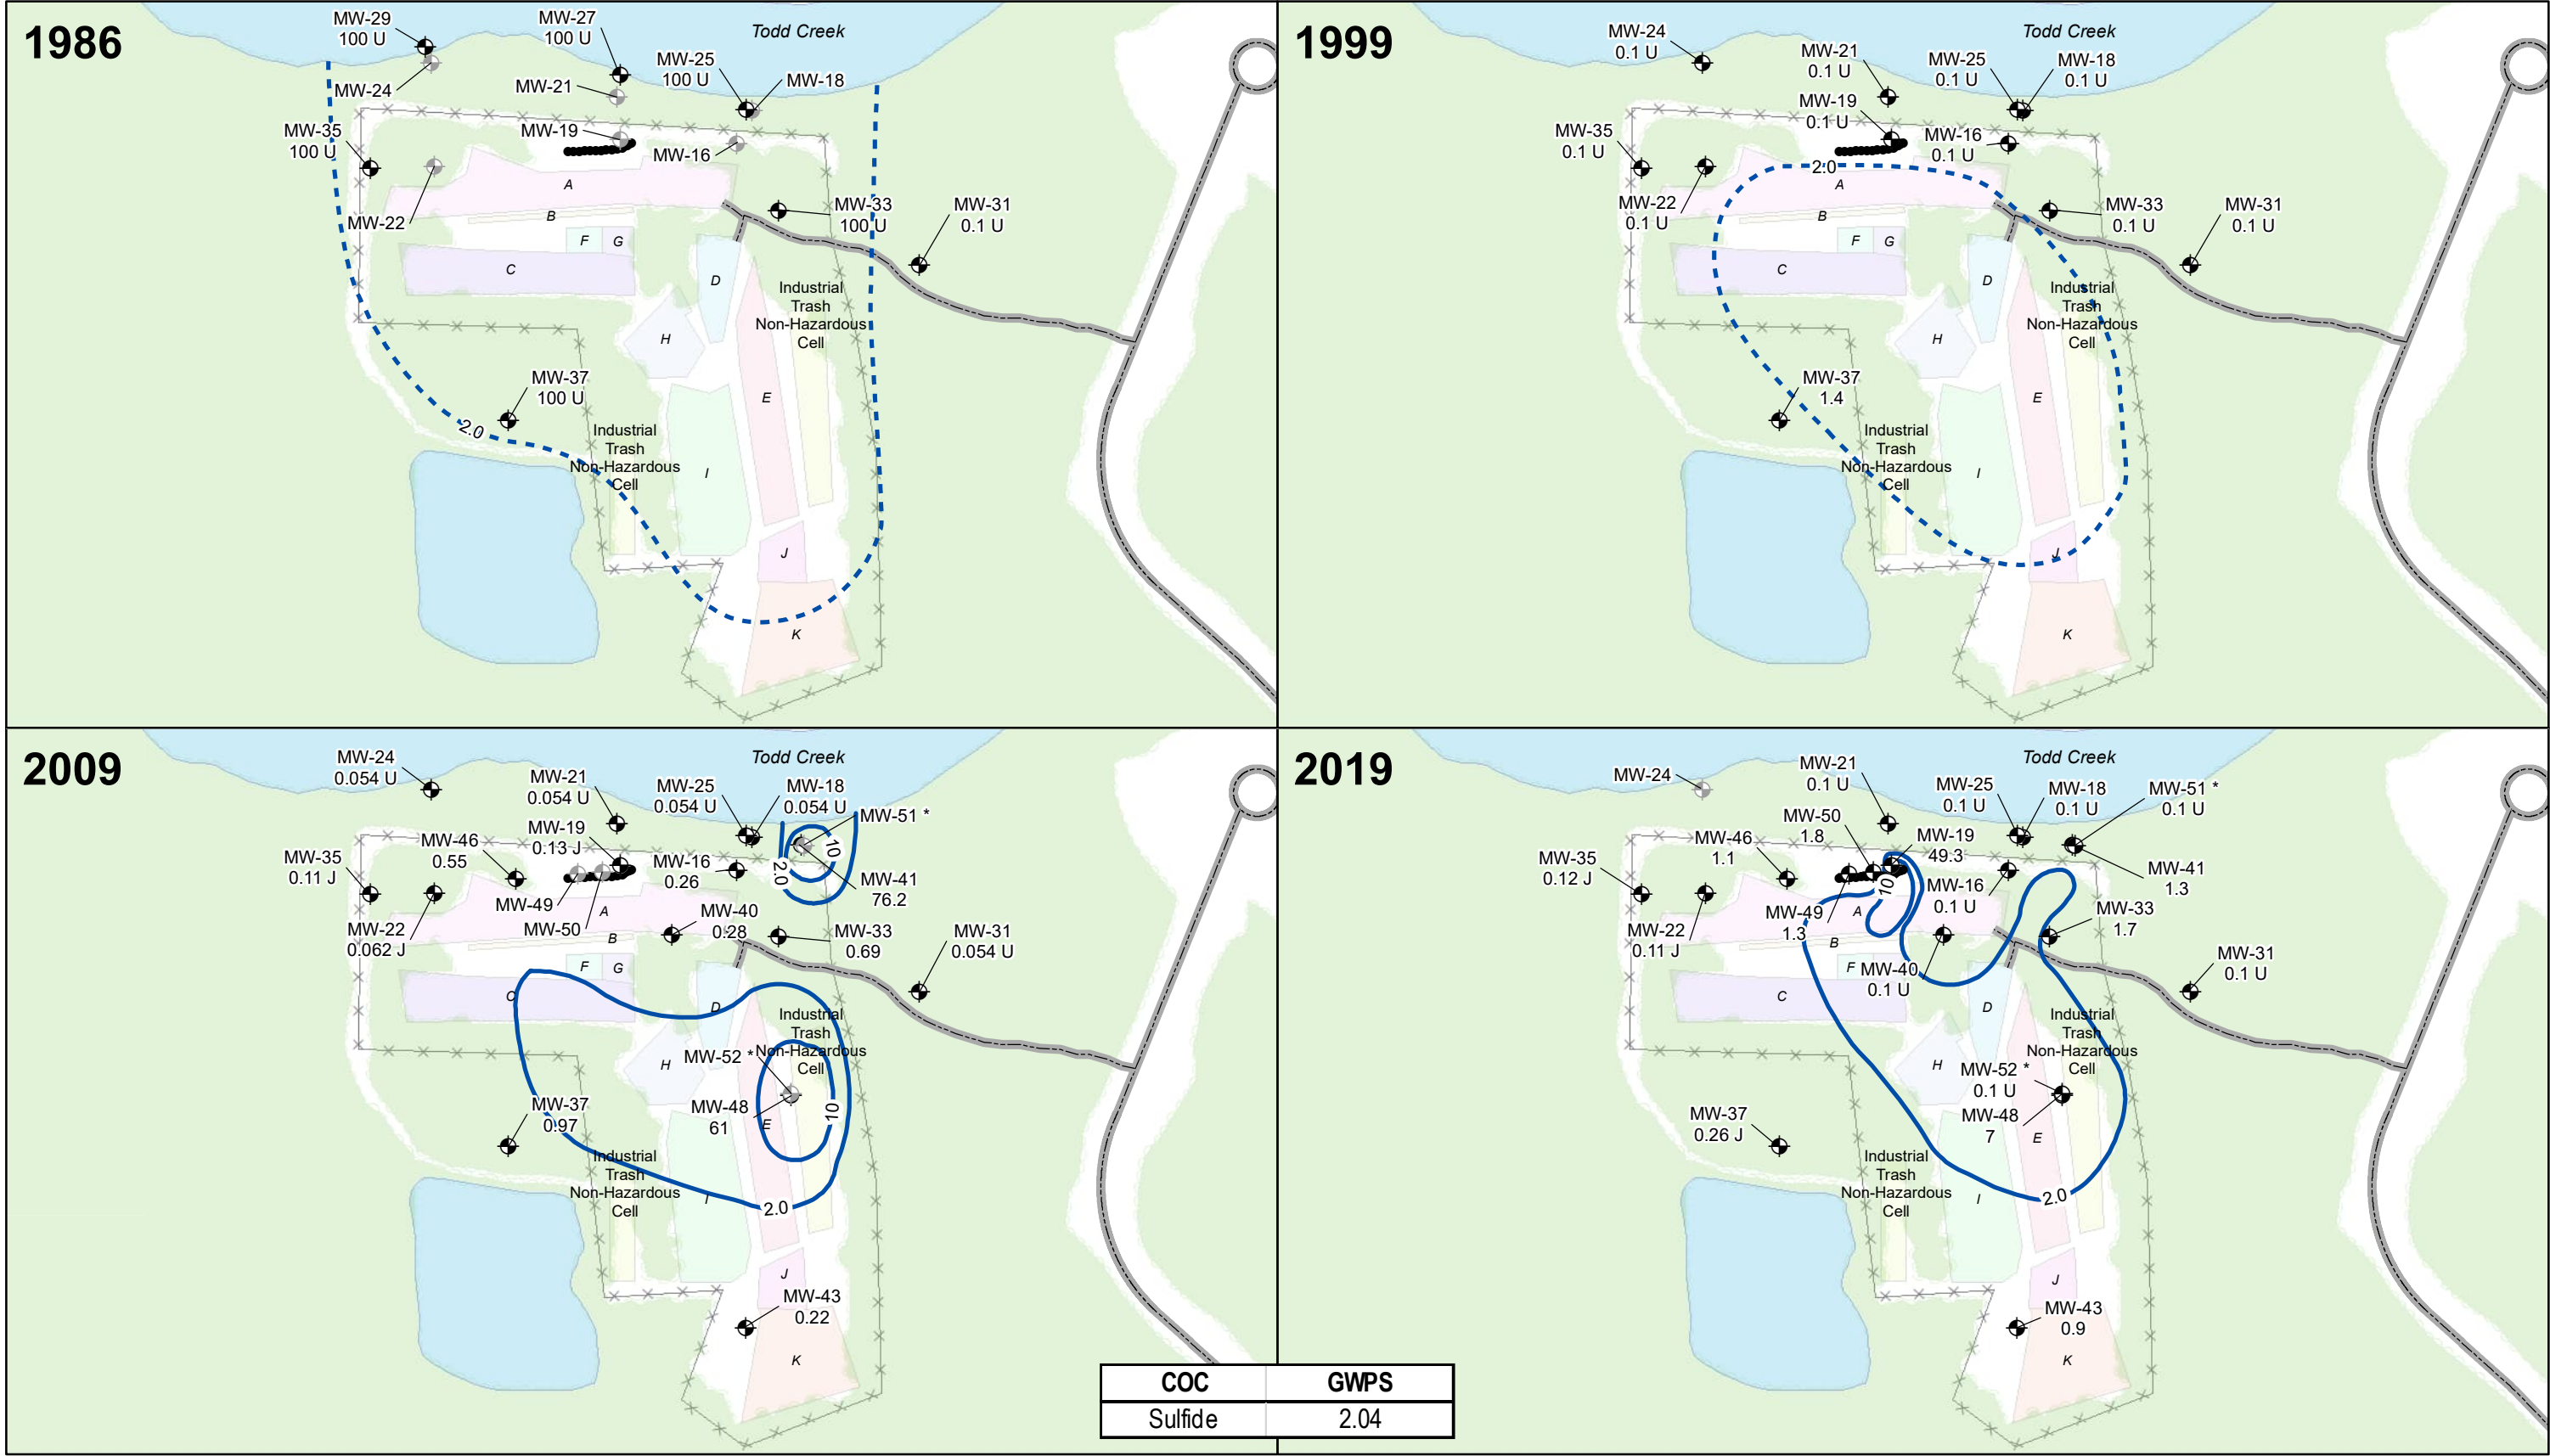
1. Groundwater concentrations are shown in milligrams per liter (mg/L).
2. Groundwater sampling was conducted in April-August of 1986, November of 1999, and September of 2009 and 2019.
3. \* For MW-51 and MW-52, the screen interval at these locations are greater than 80 ft bgs; therefore, the results were not used for contour interpretation.
4. The detection limit was used in lieu of "BRL" (below reporting limit) for the 1999 data set.
5. There is insufficient data available to infer a 10 milligram per liter contour for 1986 and 1999.
6. All features shown currently exist but did not exist in each timeframe.
7. Contours shown are 2.0 and 10 mg/L sulfide in groundwater

**Figure 24. 1986, 1999, 2009, and 2019 Sulfide in Deep Aquifer Monitoring Wells**  
 Union Carbide Corporation  
 UCC Woodbine, Camden County, Georgia

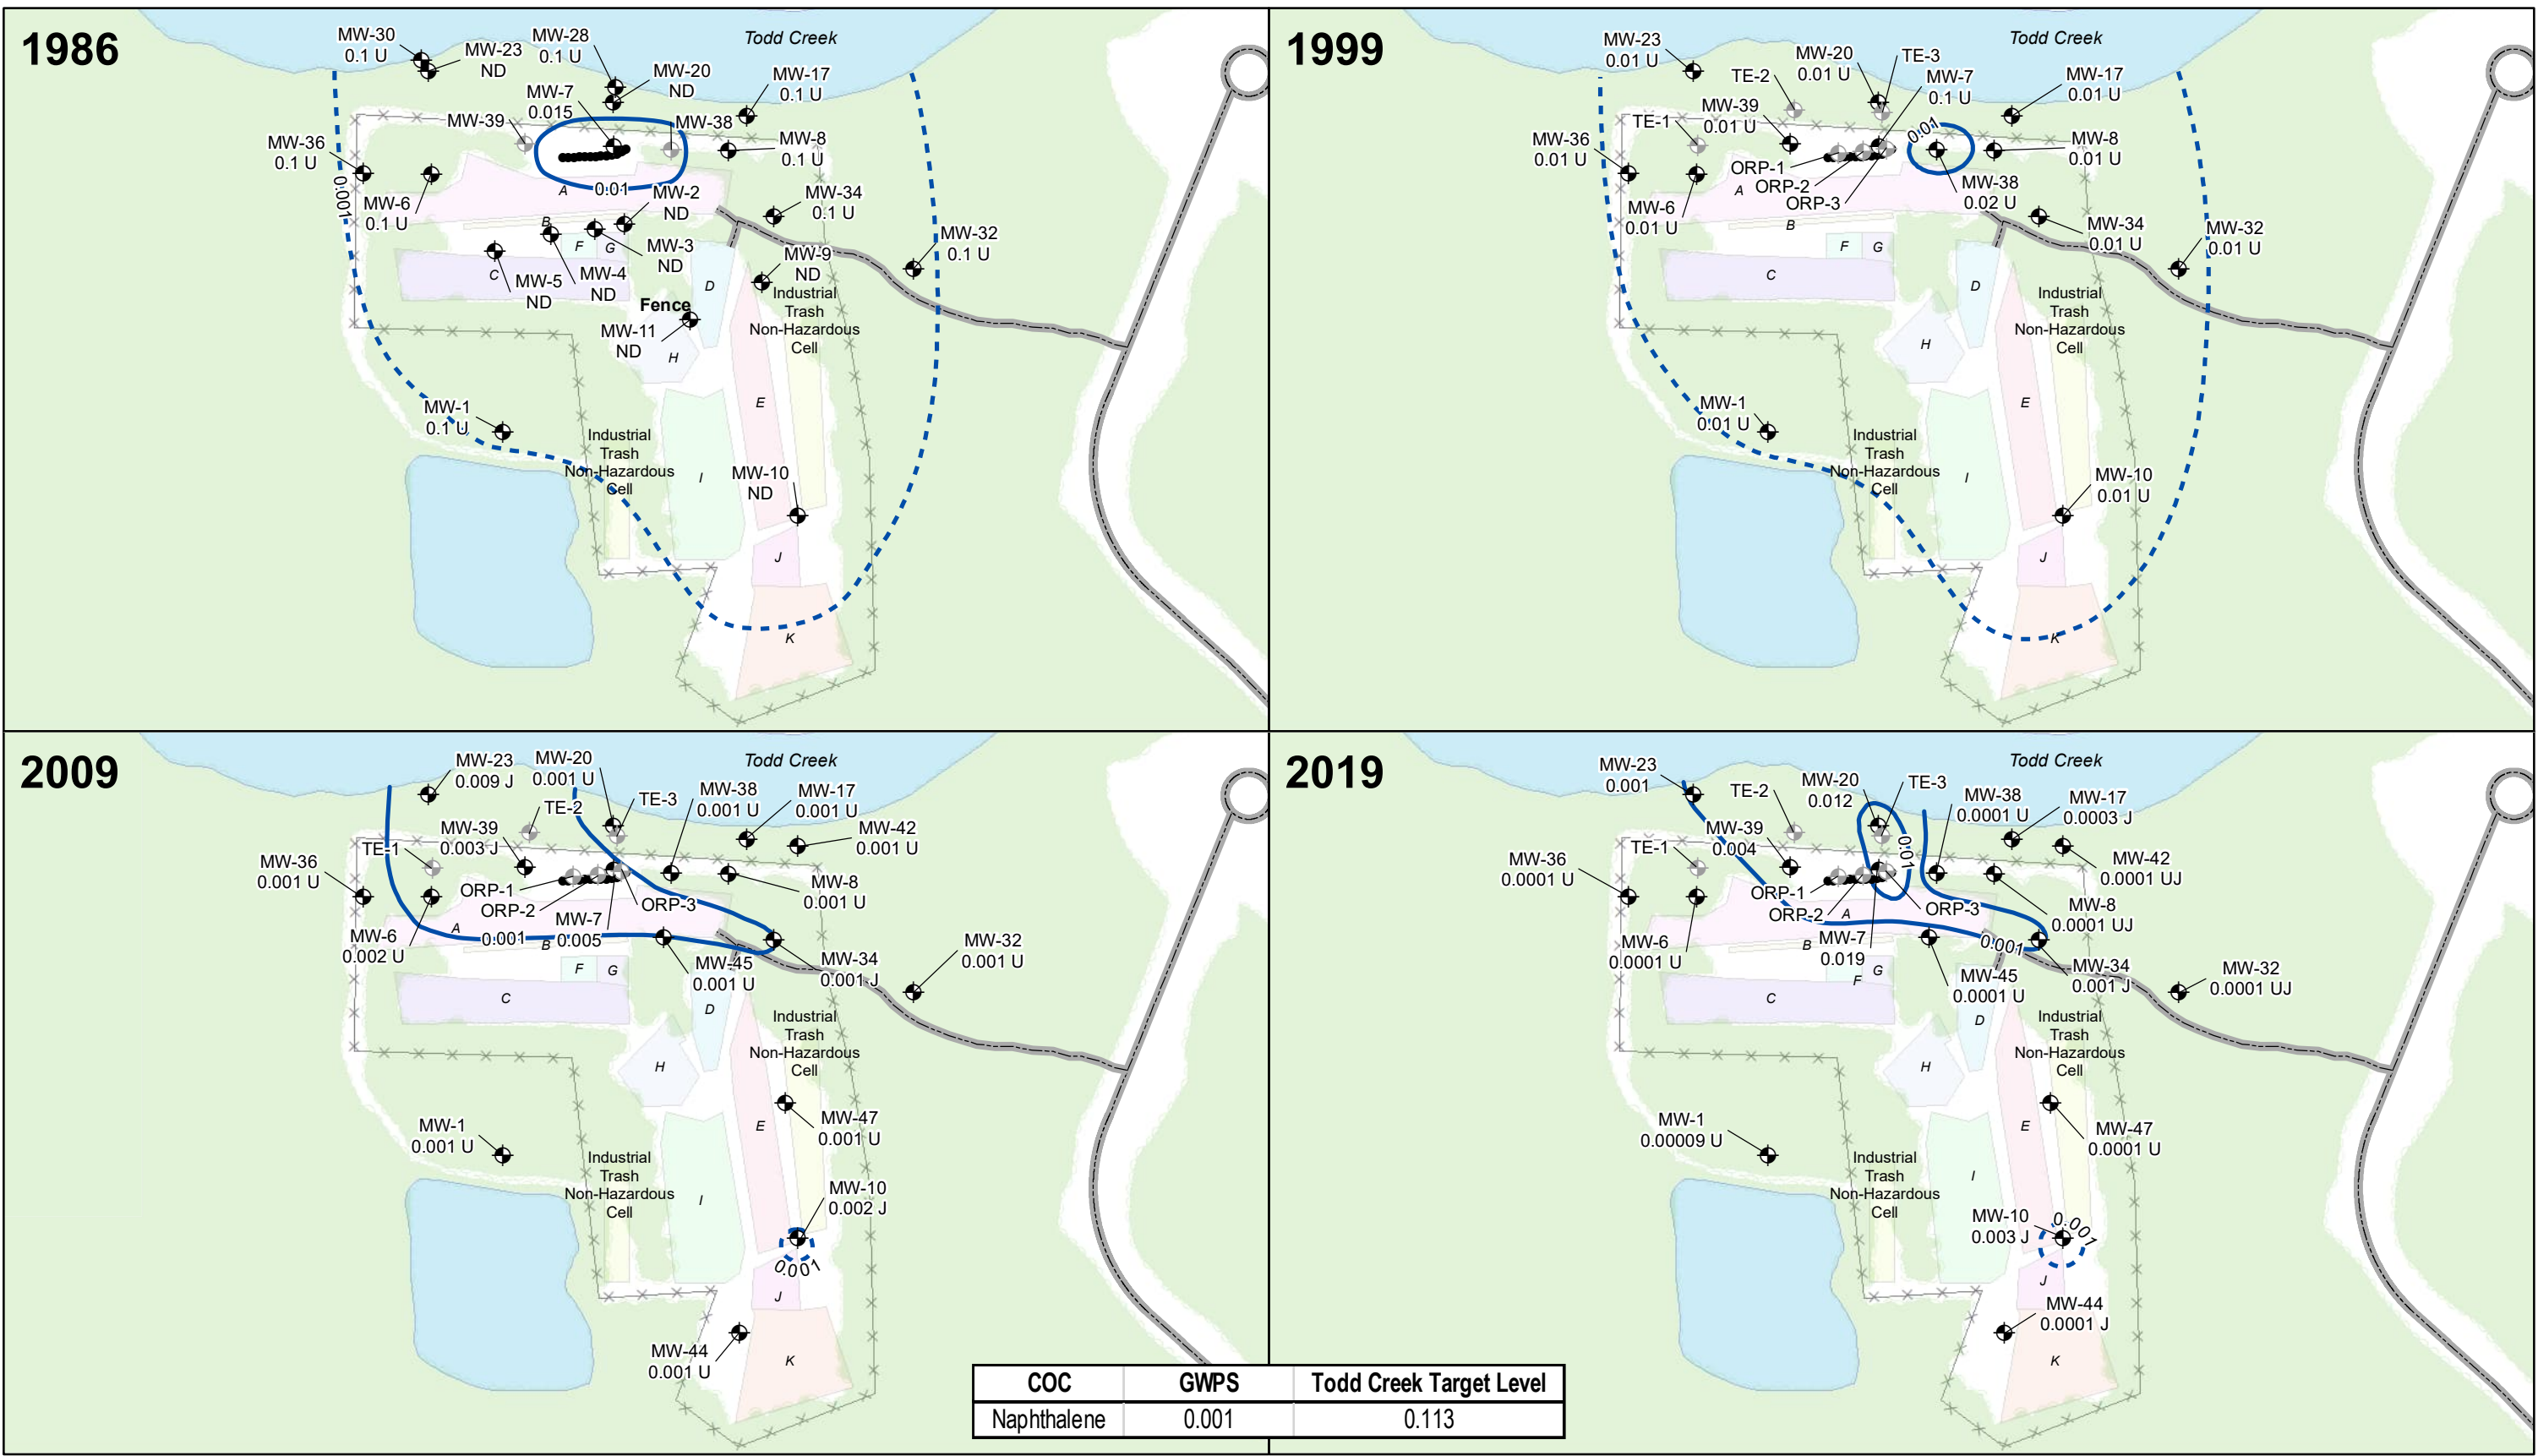
- Groundwater concentrations are shown in milligrams per liter (mg/L).
- Groundwater sampling was conducted in April-August of 1986, November of 1999, and September of 2009 and 2019.
- The detection limit was used in lieu of "BRL" (below reporting limit) for the 1999 data set.
- The laboratory detection limit is above the GWPS for naphthalene in 1986 and 1999.
- The detection limit for 1986 results reported as ND were not found.
- All features shown currently exist but did not exist in each timeframe.
- Contours shown are 0.01 and 0.001 mg/L naphthalene in groundwater

**Figure 25. 1986, 1999, 2009, and 2019 Naphthalene in Shallow Aquifer Monitoring Wells**  
 Union Carbide Corporation  
 UCC Woodbine, Camden County, Georgia

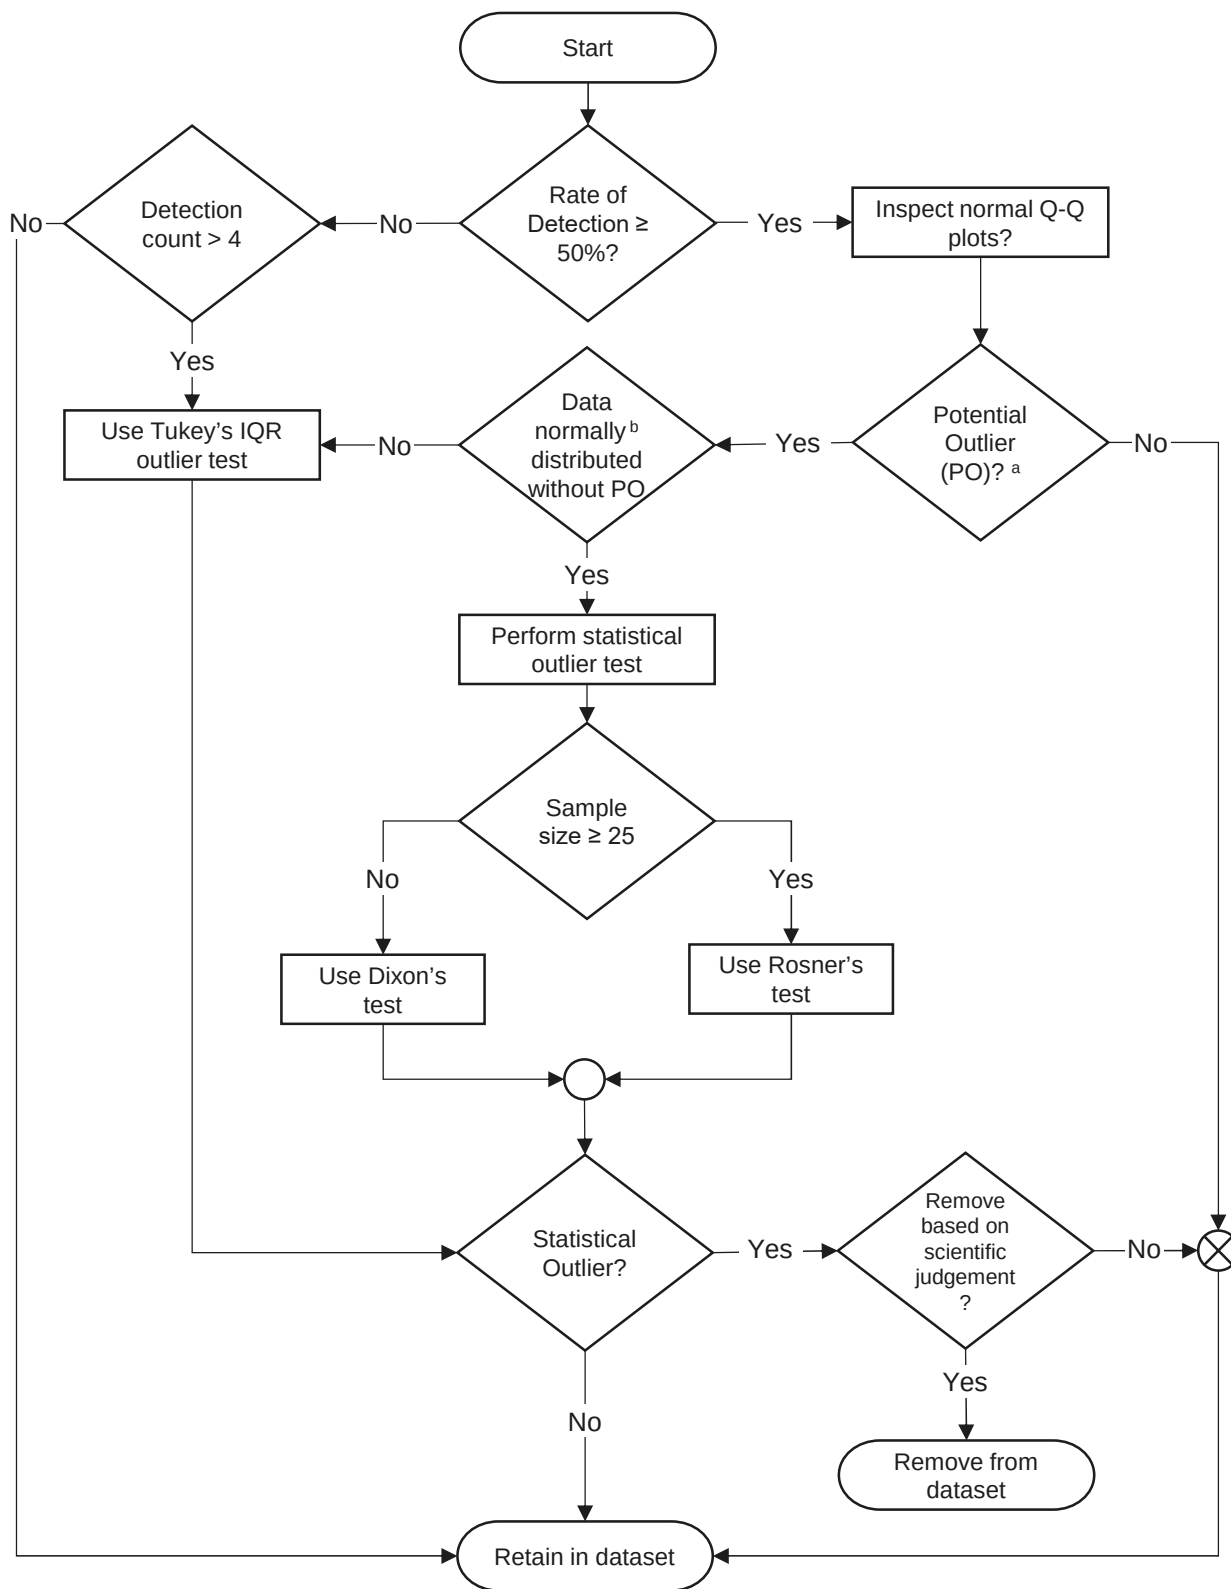
<sup>a</sup> Potential outliers are indicated by large concentration differences between data points and/or deviation from the predominant concentration trend.

**OUTLIER EVALUATION DECISION TREE**

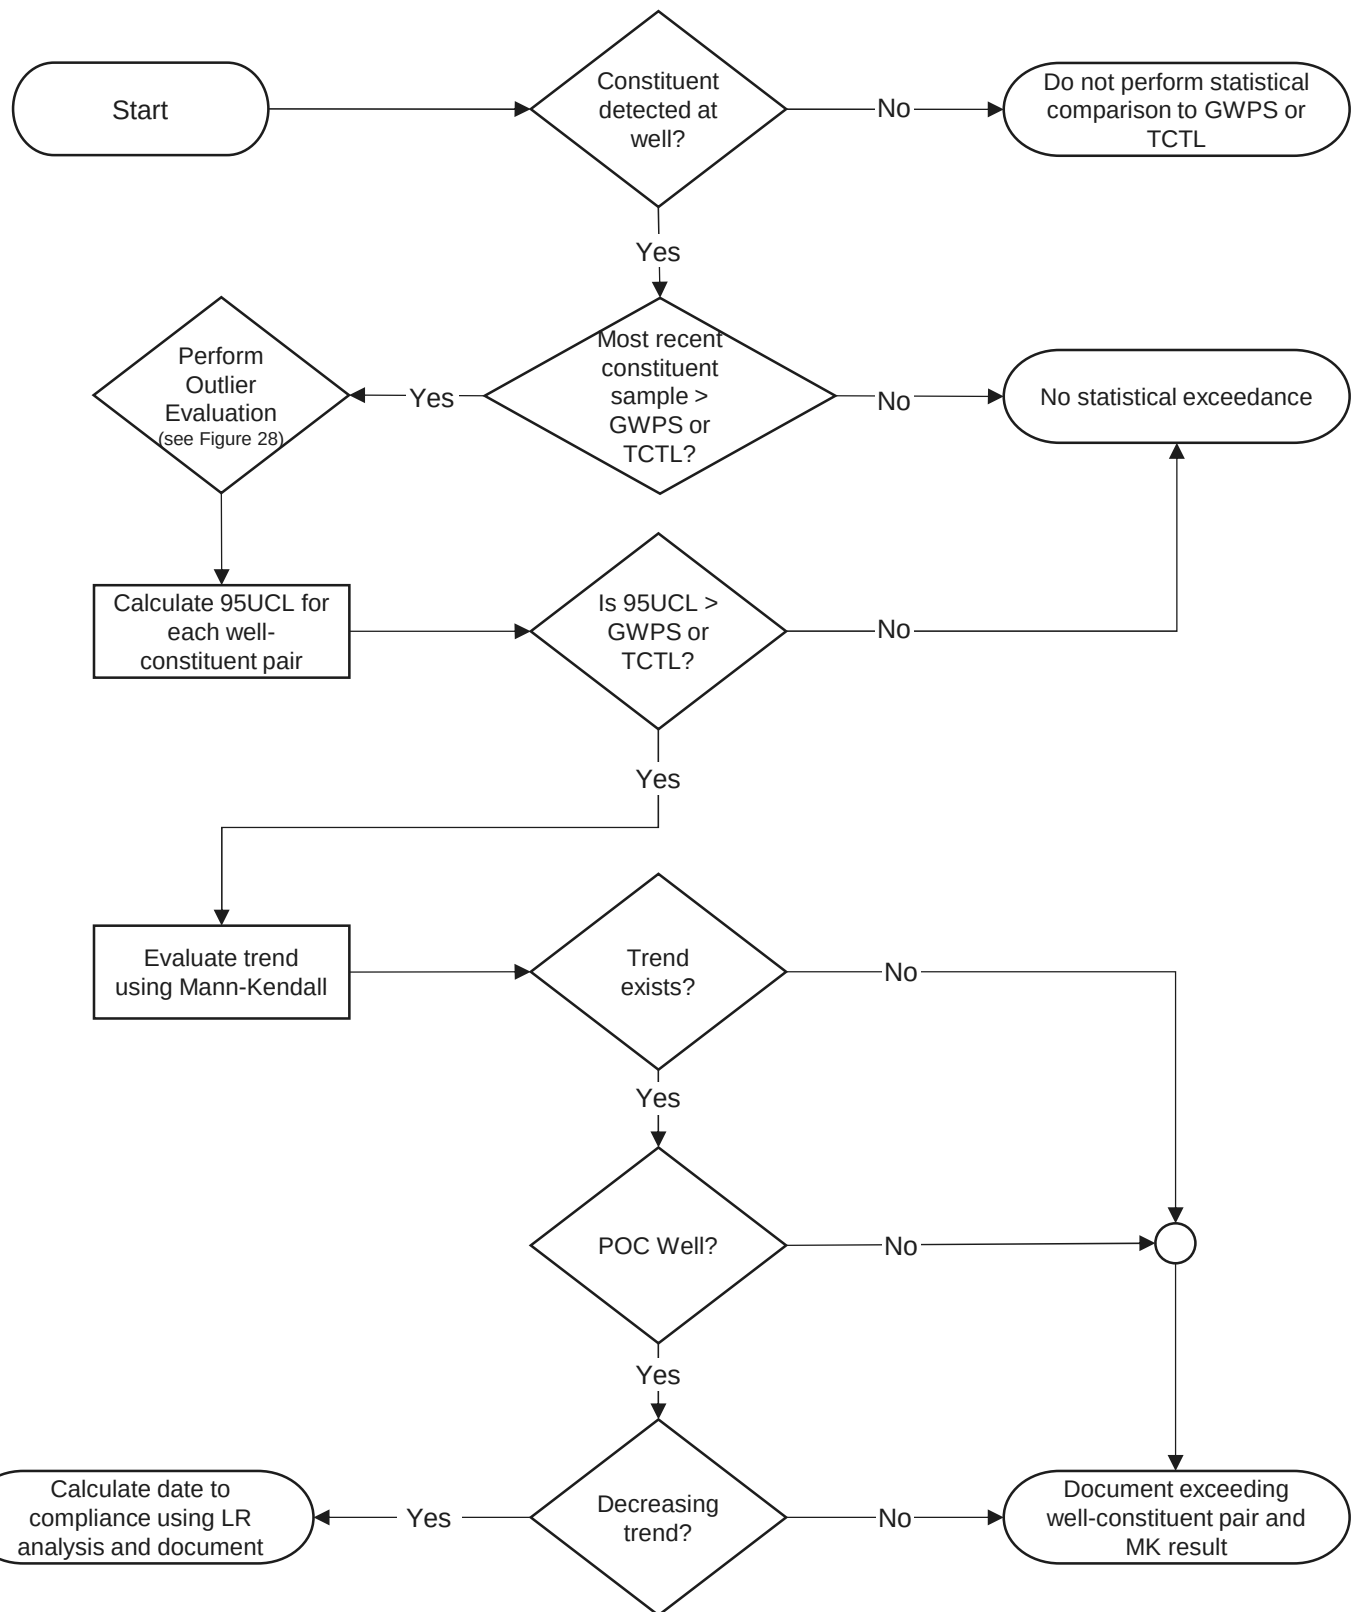
**STATISTICAL COMPARISON DECISION  
 TREE**
