Figure 1. Facility Location Map  
Permit Renewal Application  
Union Carbide Corporation  
UCC Woodbine, Camden County, Georgia

**Figure 3. Landfill (SWMU 1) Topographic Map**  
 Union Carbide Corporation  
 UCC Woodbine, Camden County, Georgia

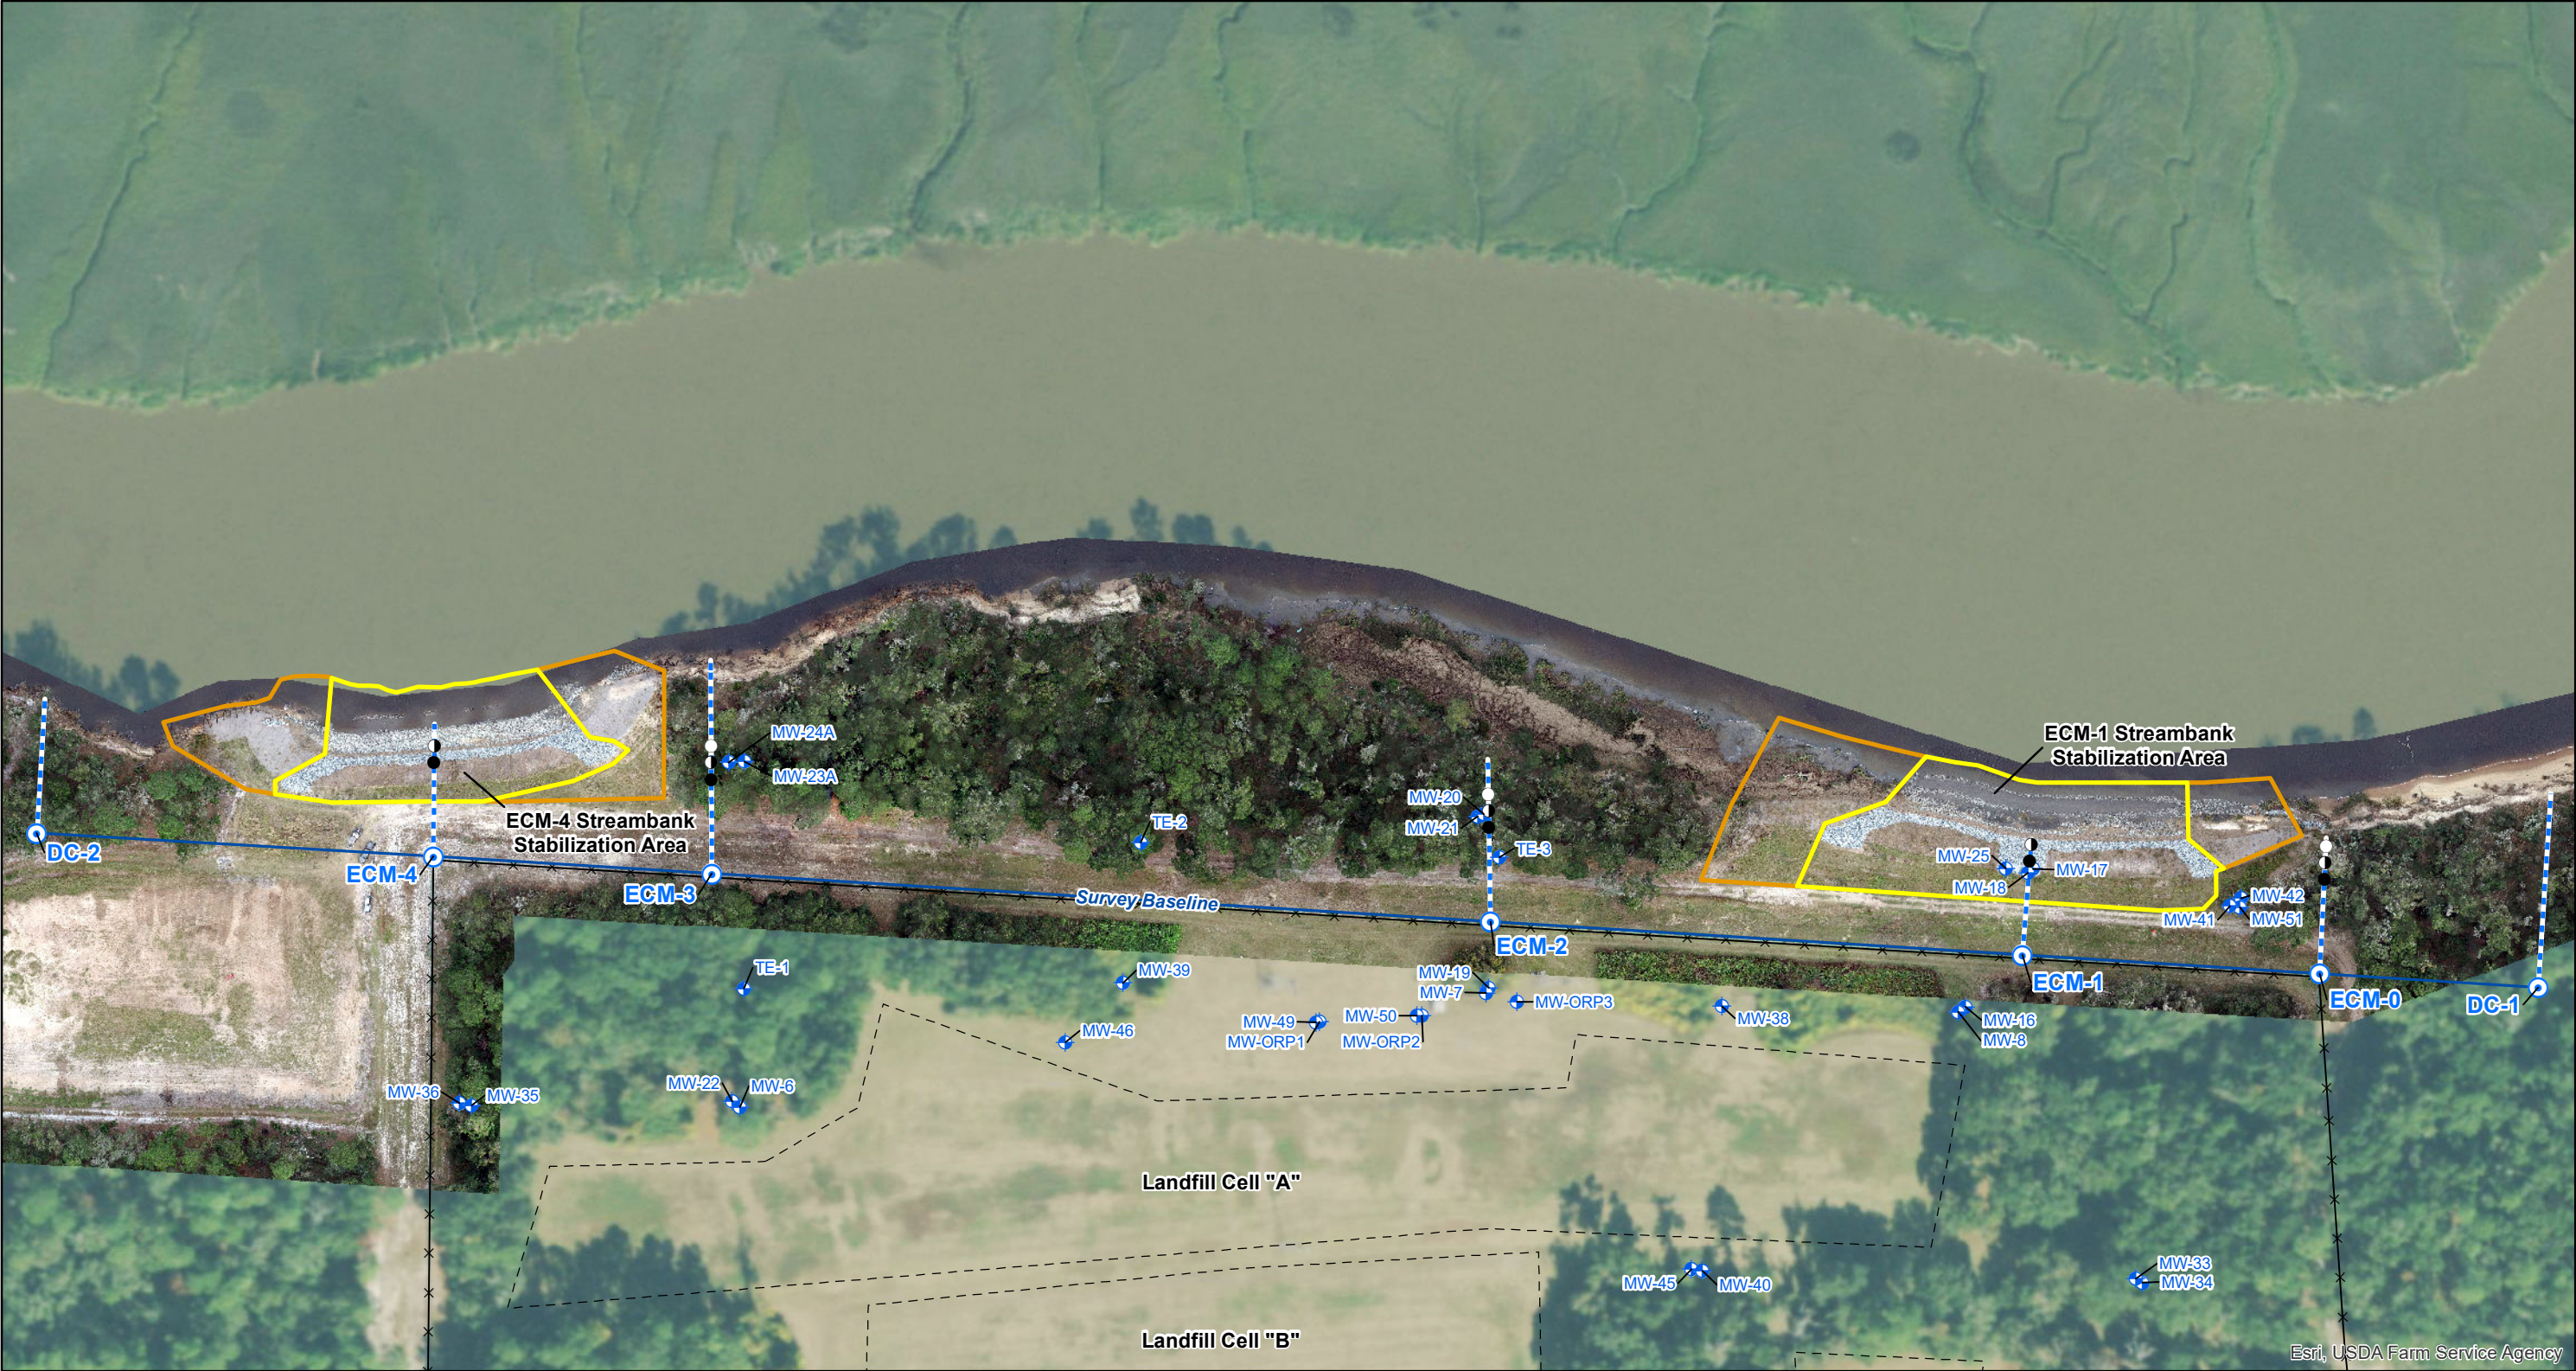
**Figure 31. Streambank Monitoring Area and Features**  
Permit Renewal Application  
Union Carbide Corporation  
UCC Woodbine, Camden County, Georgia

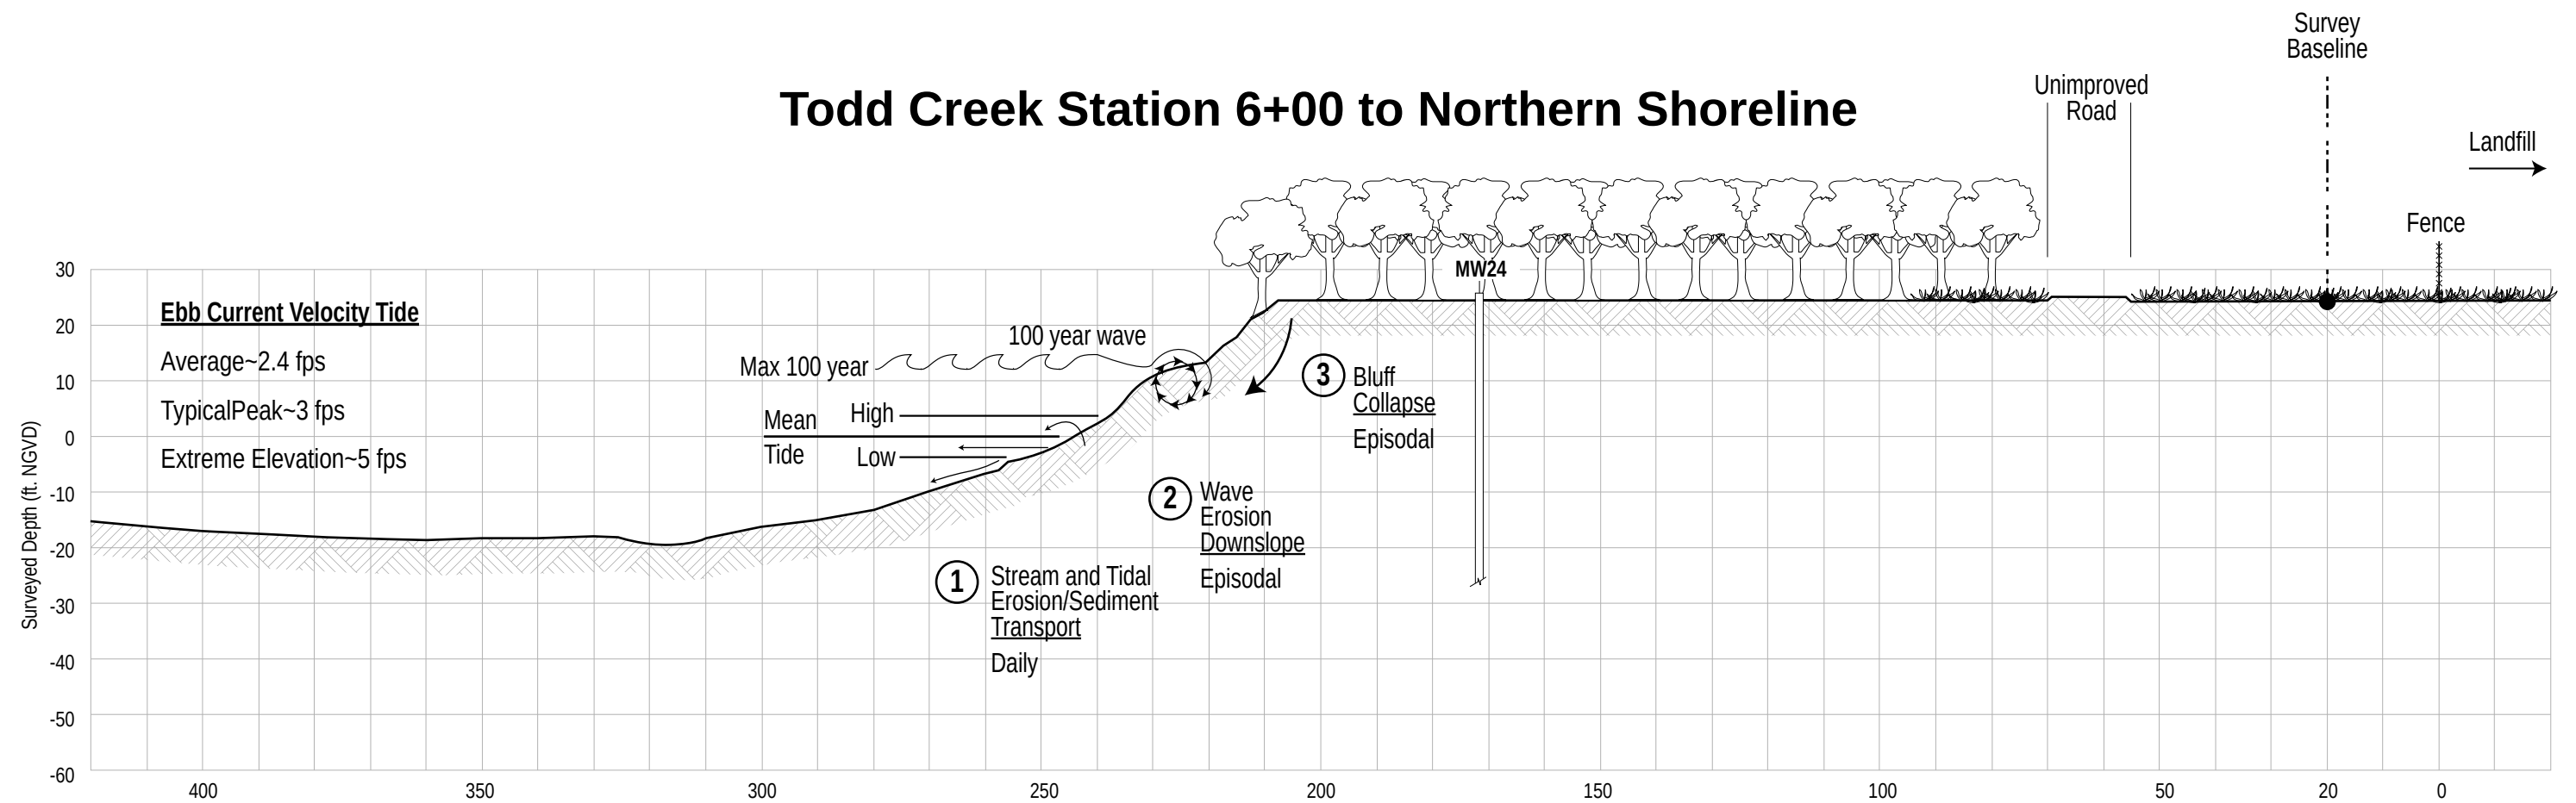
Figure 32. Conceptual Site Model  
 Union Carbide Corporation  
 Woodbine, Georgia

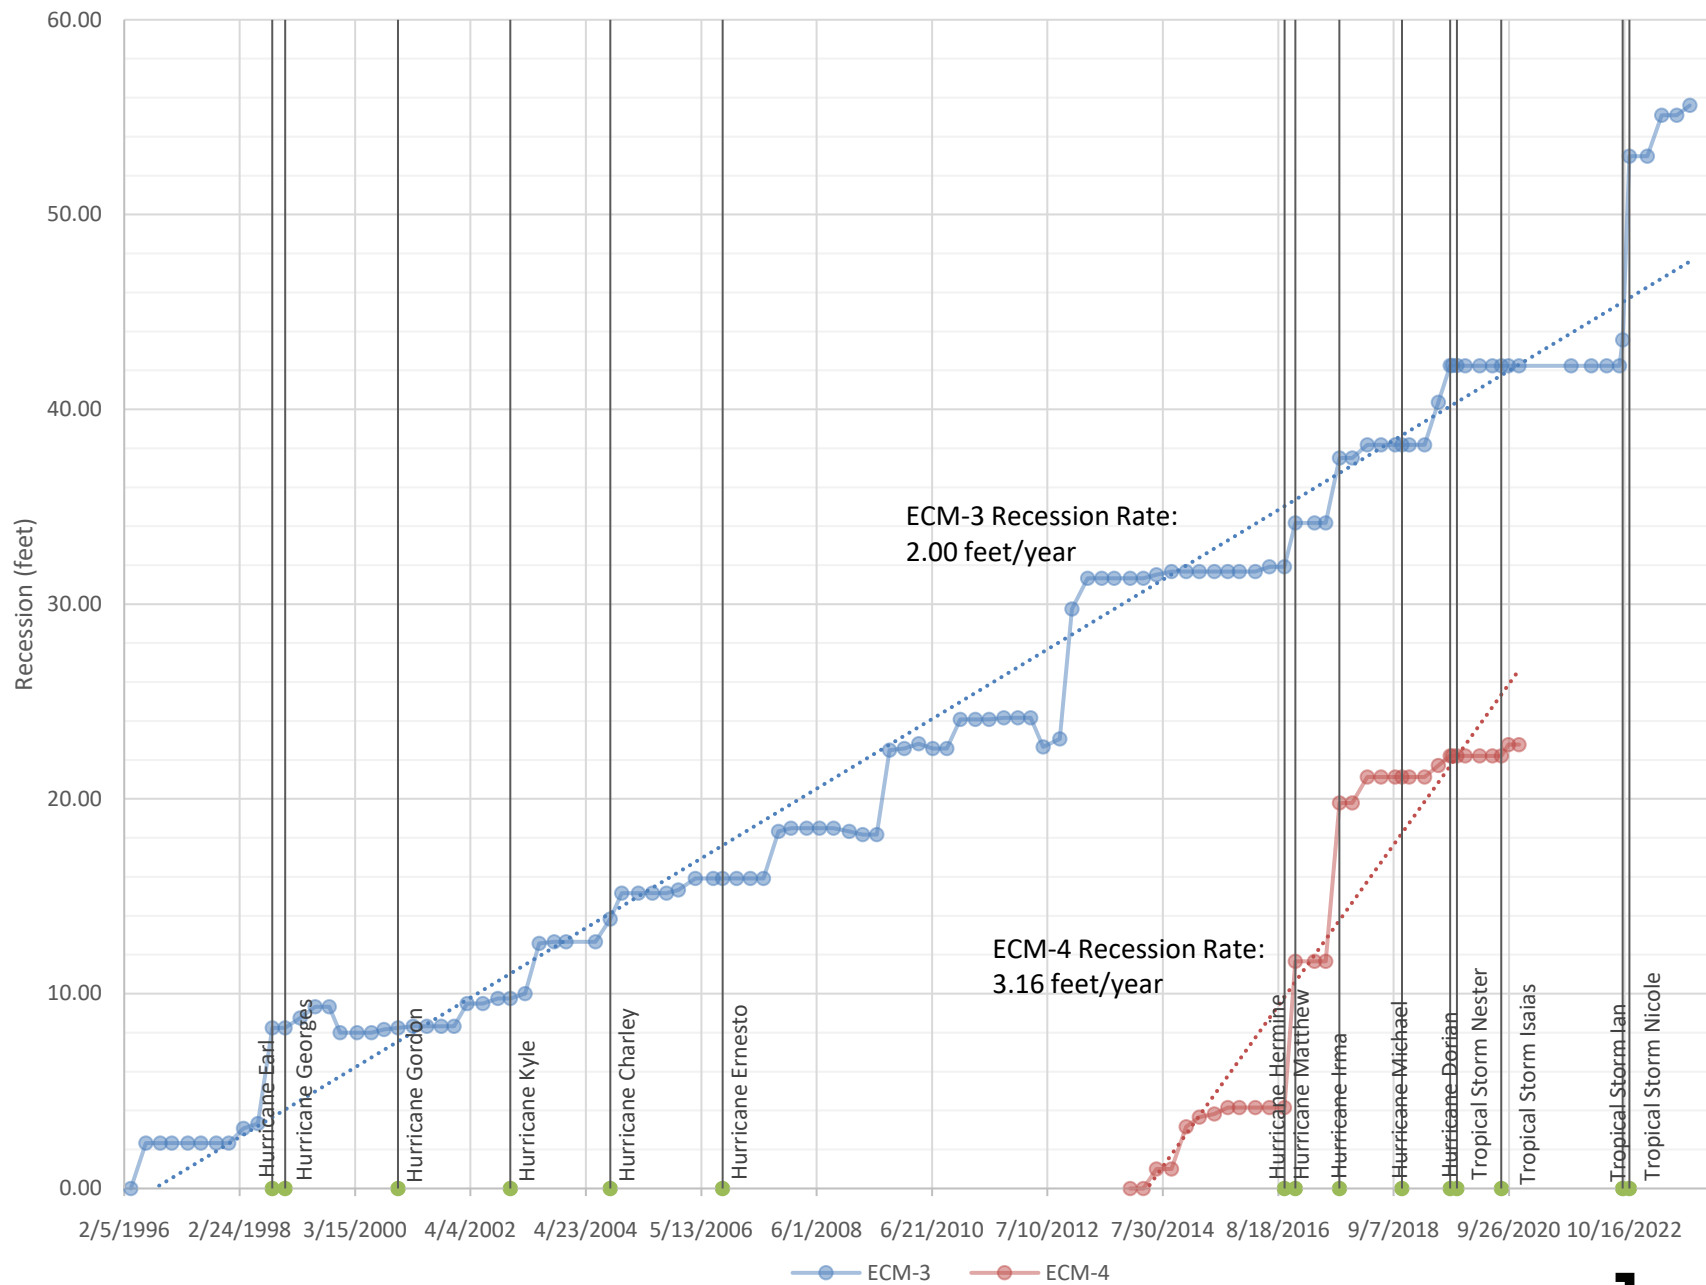
**Figure 33. Recession Rates at ECM-3 and ECM-4**  
 Permit Renewal Application  
 Union Carbide Corporation  
 UCC Woodbine, Camden County, Georgia

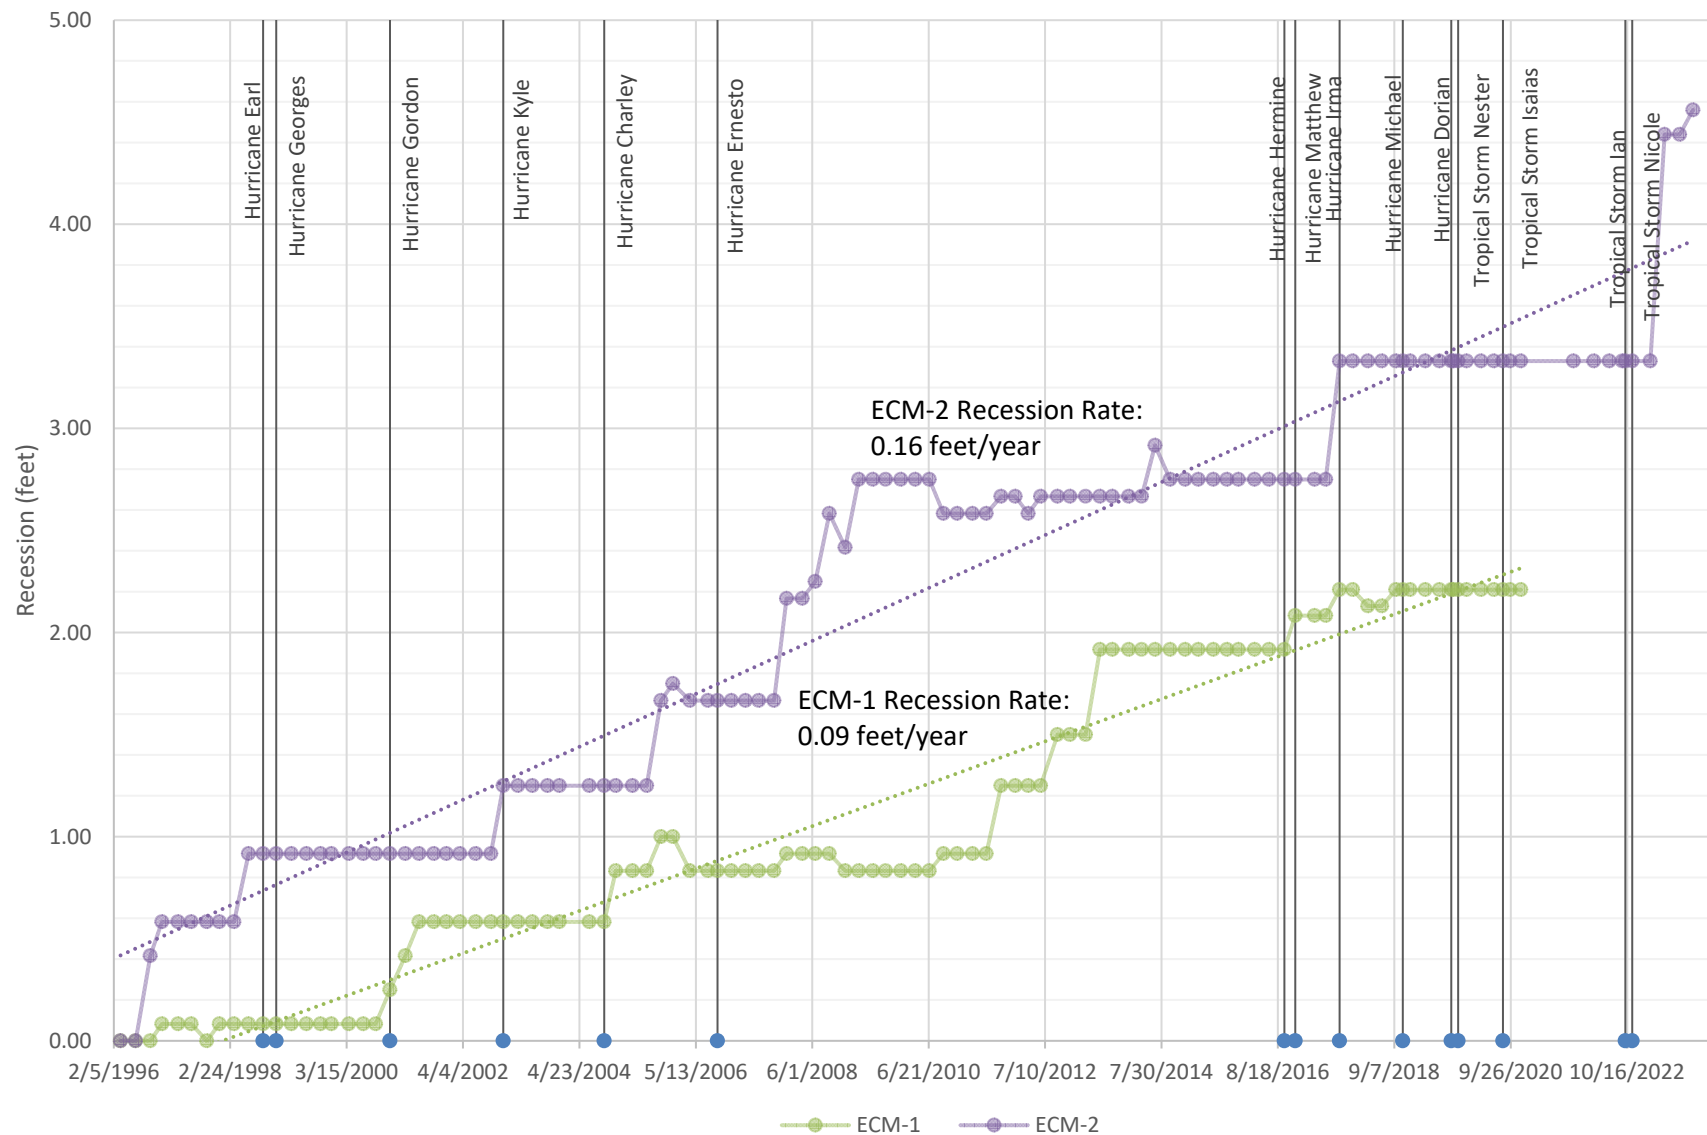
Figure 34. Recession Rates at ECM-1 and ECM-2  
 Permit Renewal Application  
 Union Carbide Corporation  
 UCC Woodbine, Camden County, Georgia

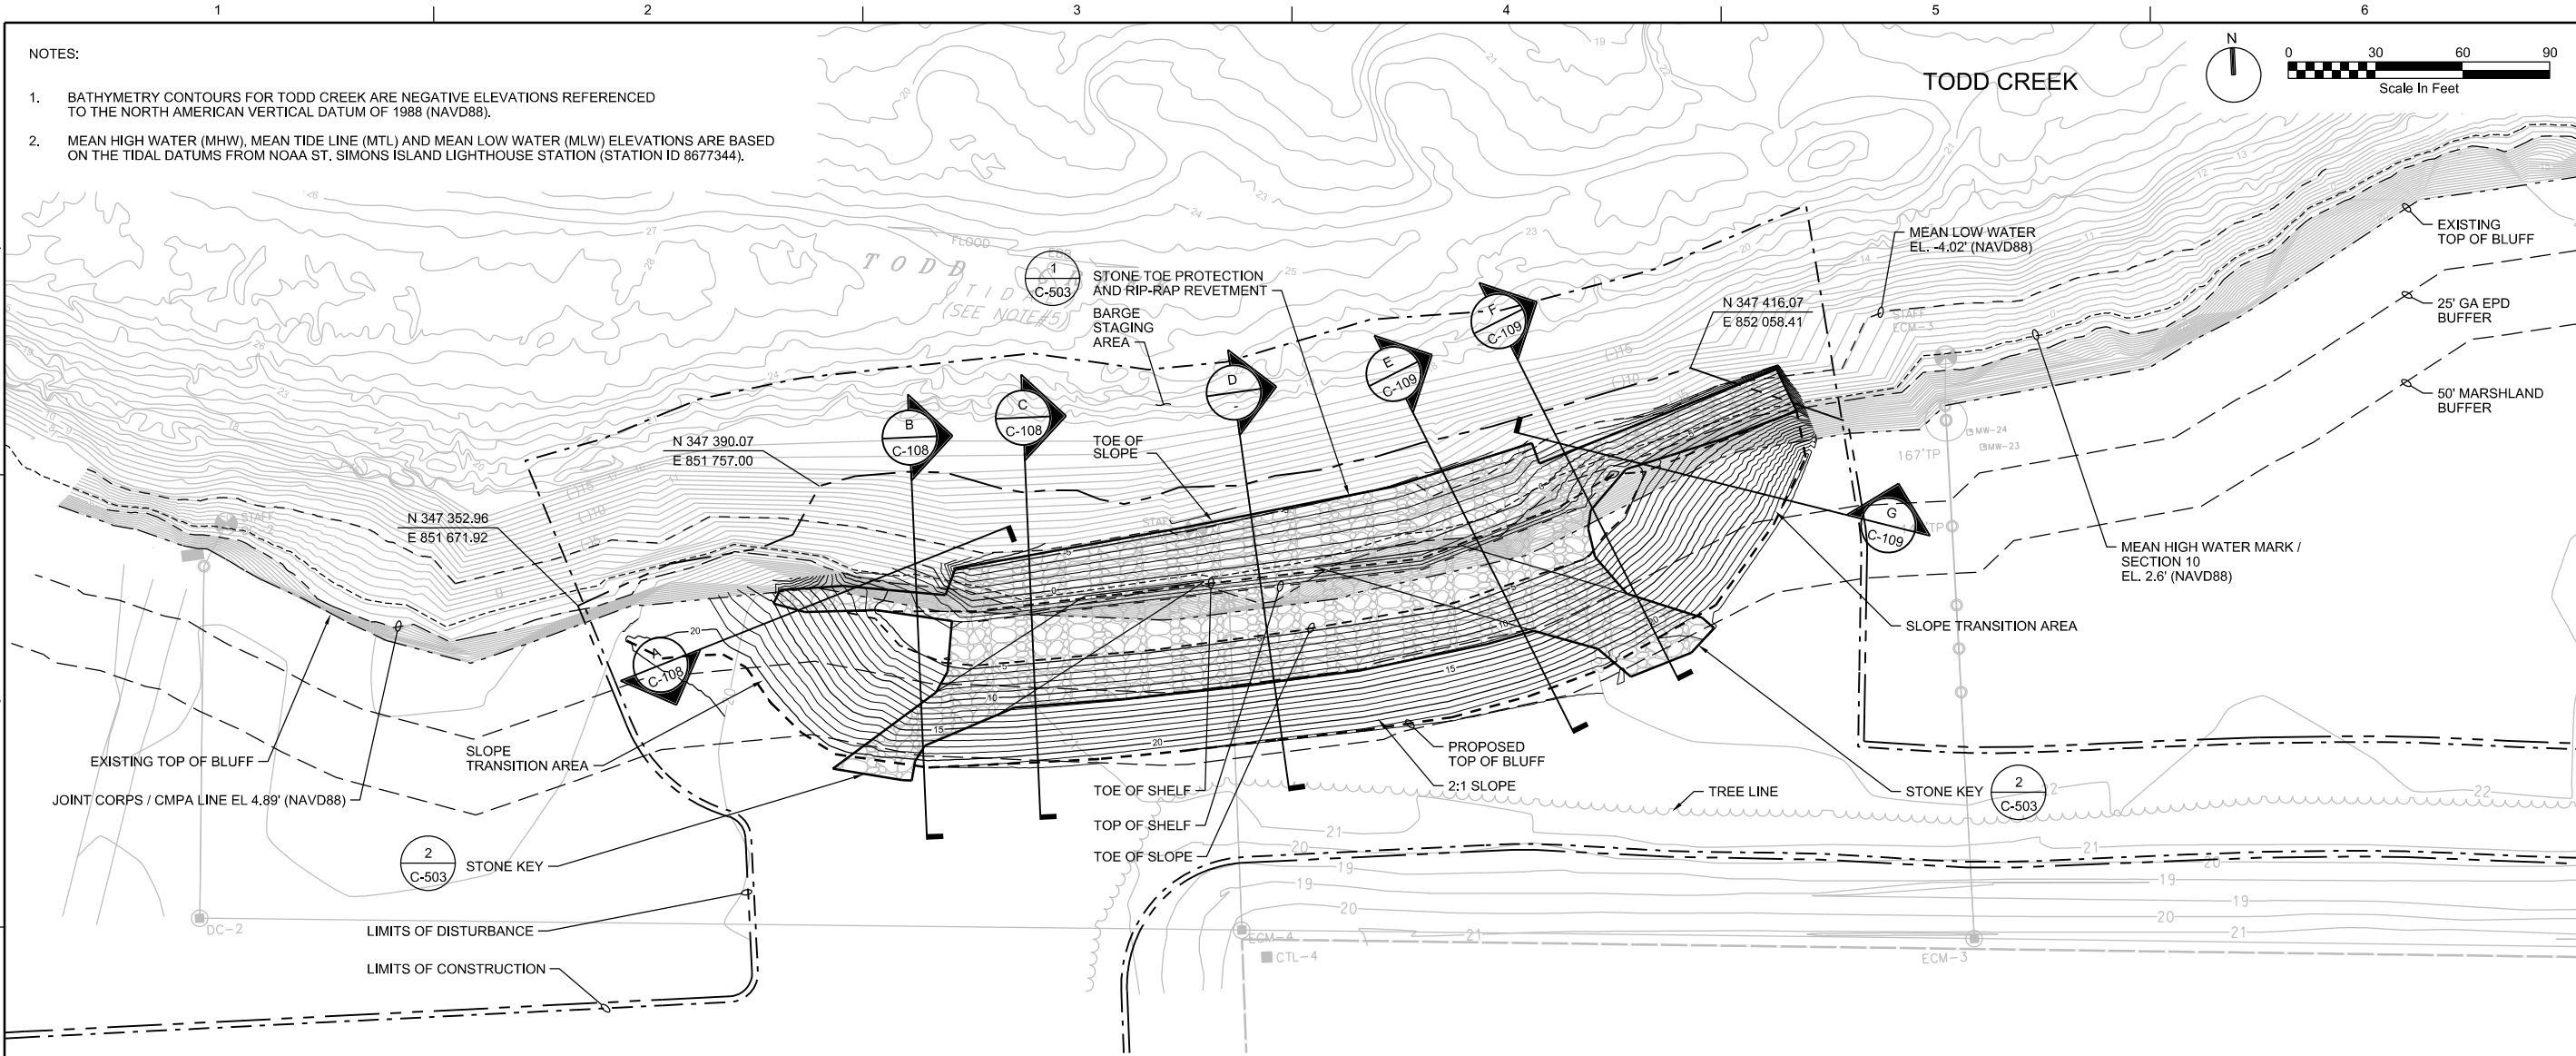
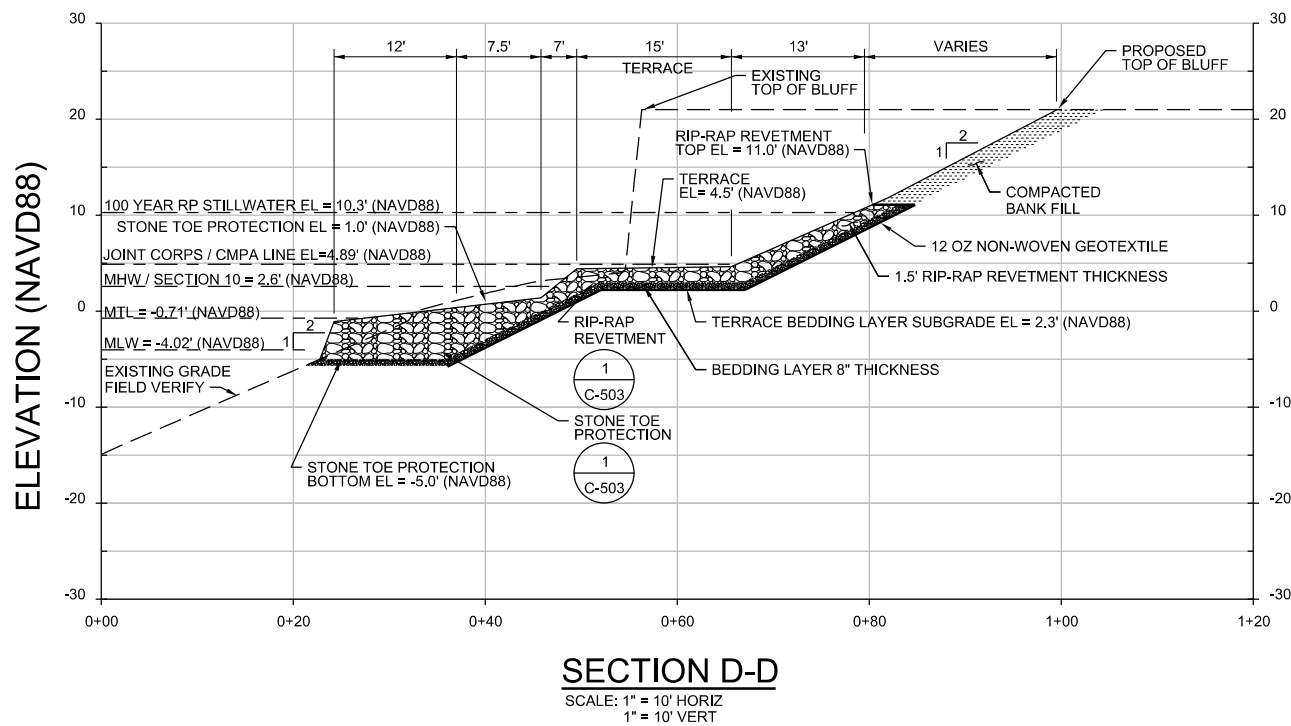
| DWG | C-107 |

Figure 36. ECM-4 Final Stabilization Plan and Section  
Union Carbide Corporation, Woodbine, Georgia

JACOBS  
CIVIL  
ECM-4 STREAM BANK  
FINAL STABILIZATION PLAN  
AND SECTION

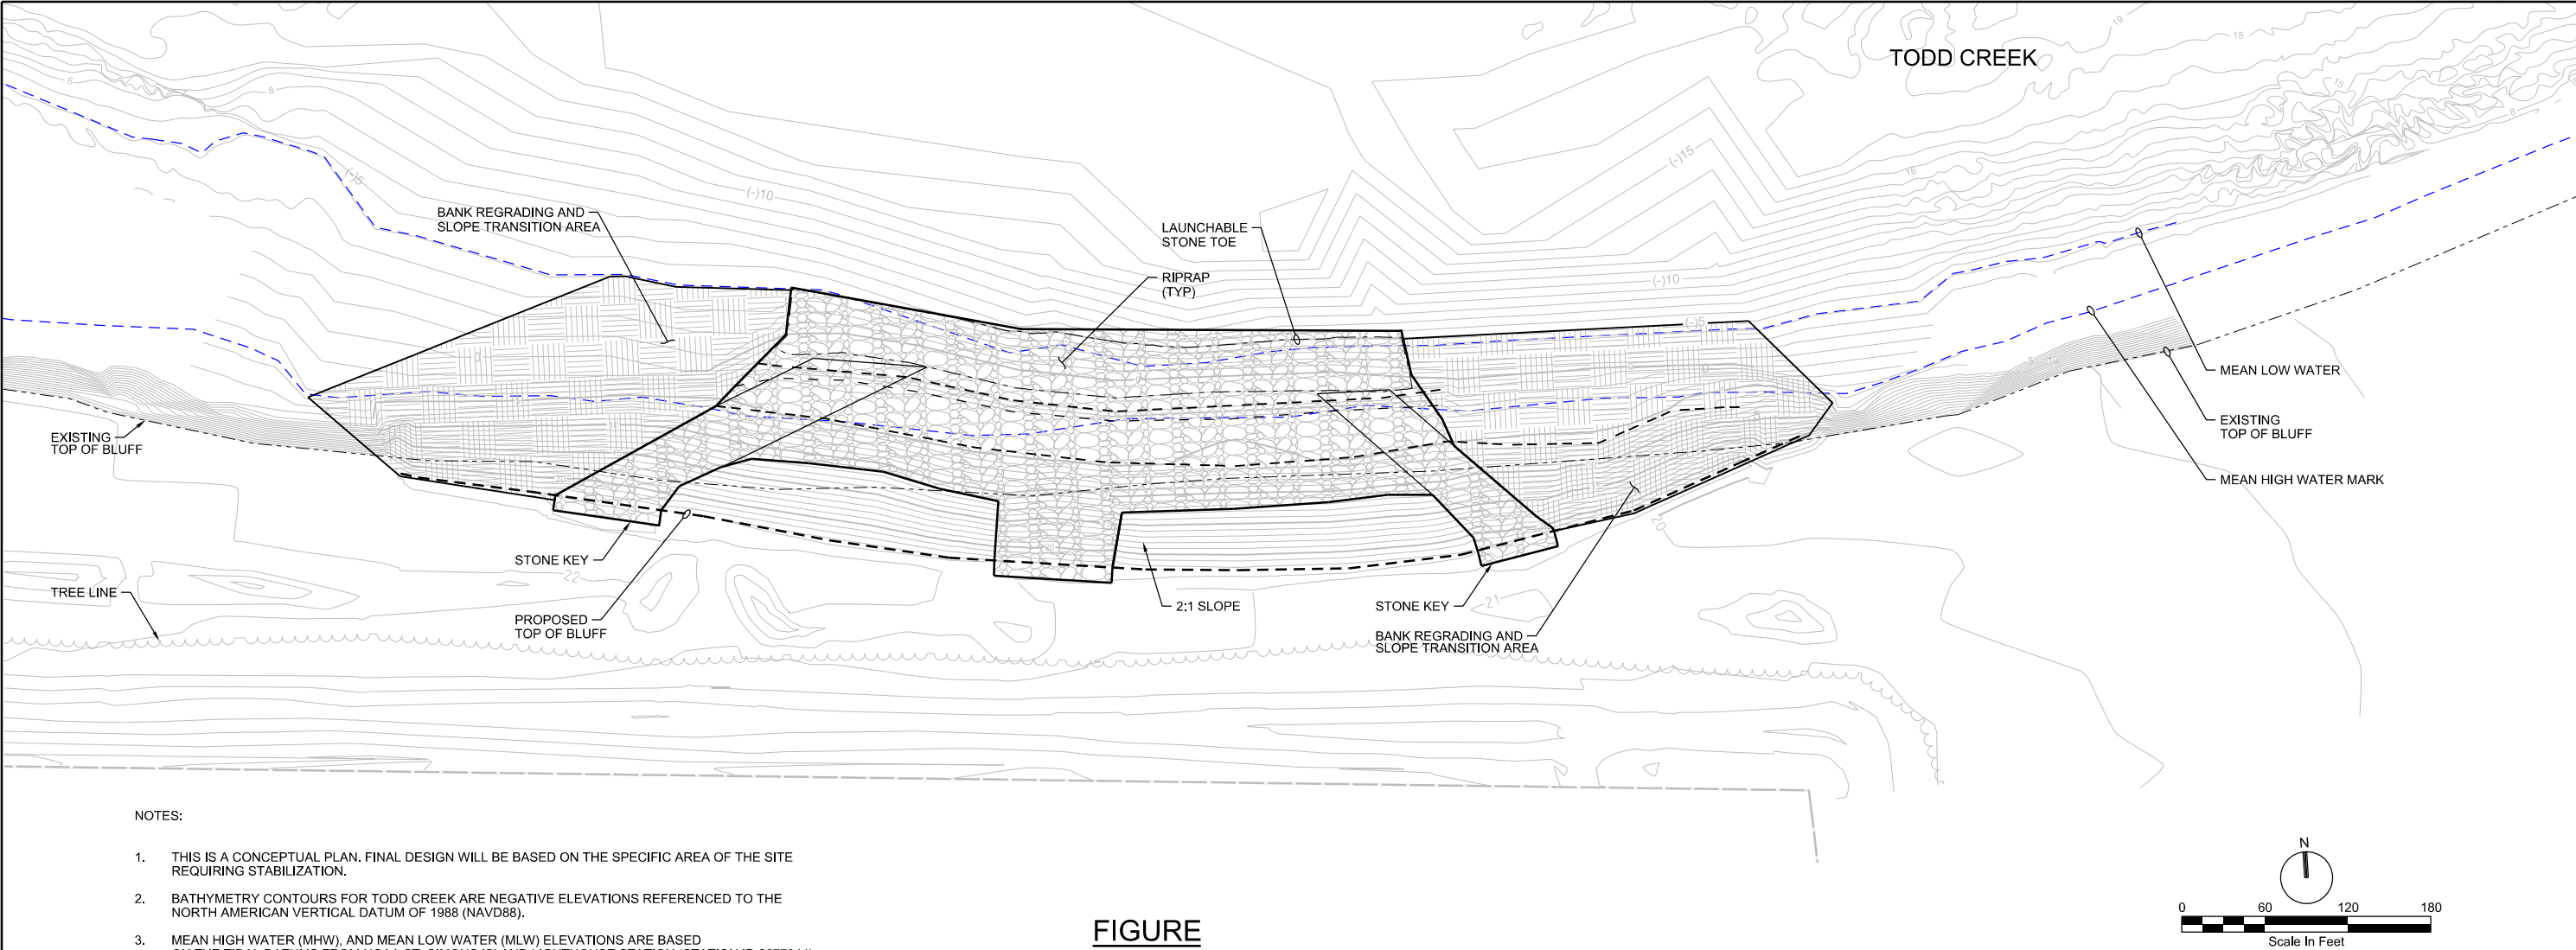
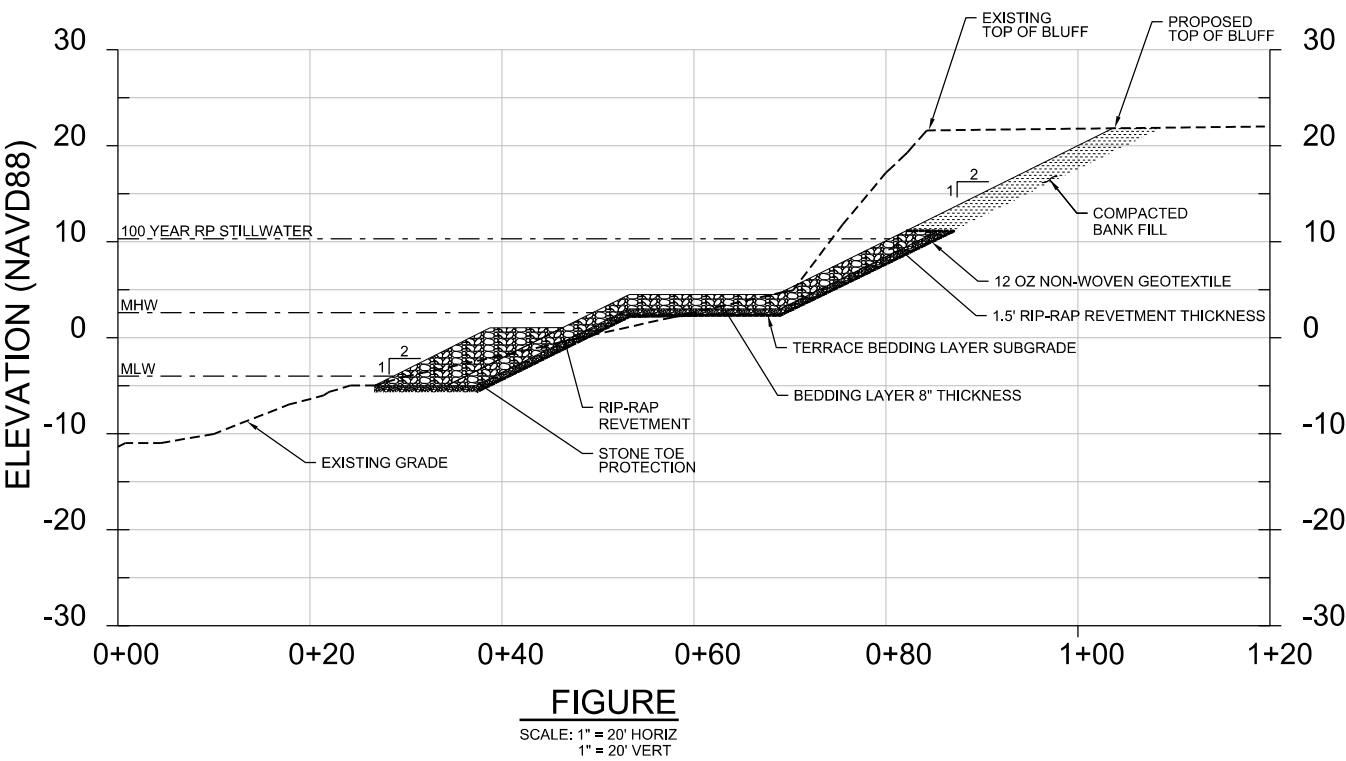
FIGURE 37. CONCEPTUAL PLAN VIEW AND CROSS SECTION OF STREAMBANK STABILIZATION PRIMARY CONTINGENCY UNION CARBIDE CORPORATION UCC WOODBINE, CAMDEN COUNTY, GEORGIA

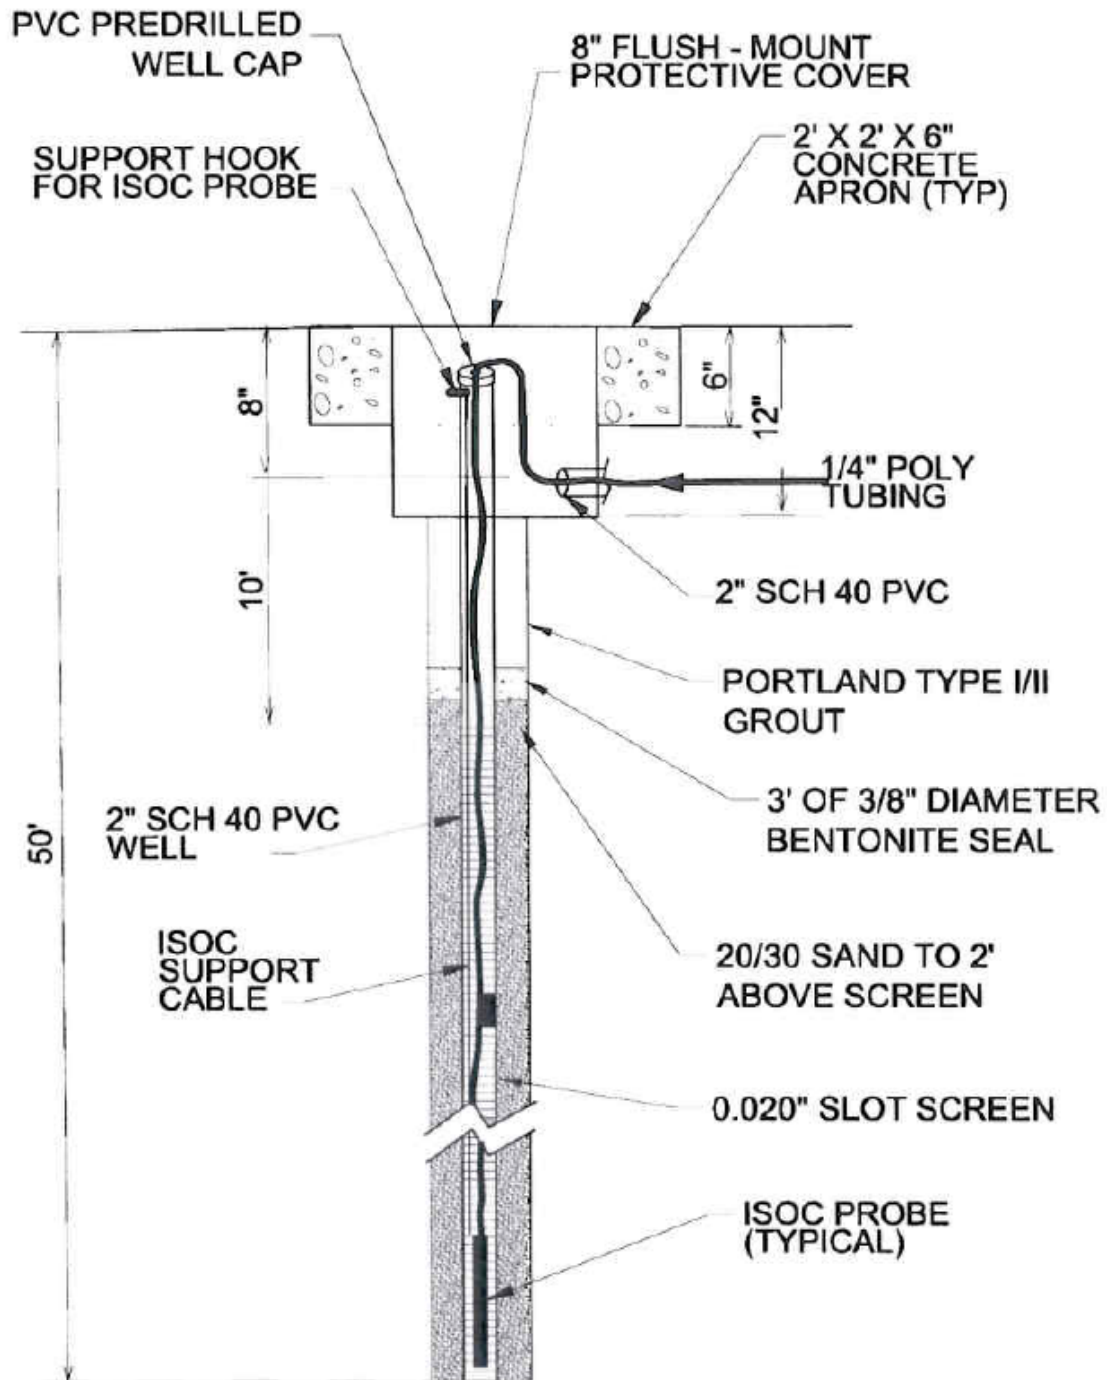
**ISOC PROBE**  
**(TYPICAL OF OD-1 THROUGH OD-15)**  
 NOT TO SCALE

Figure 38. iSOC Well  
 Construction Union Carbide  
 Corporation Woodbine, Georgia

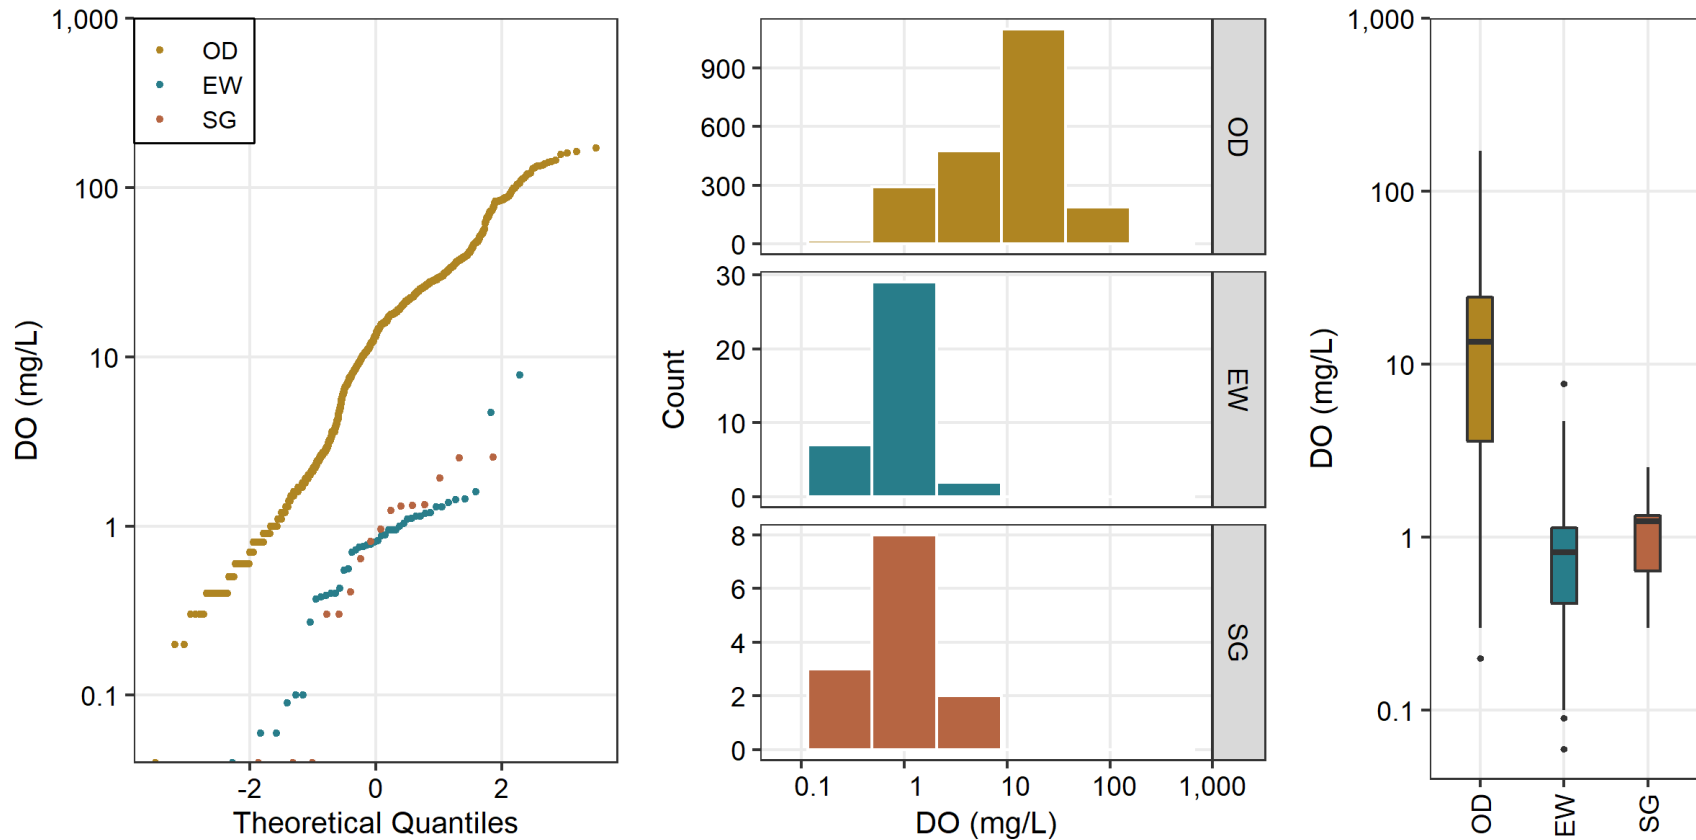
## Dissolved Oxygen Comparison (2017 - 2019) Union Carbide Corporation, Woodbine, Georgia

DO – dissolved oxygen  
 mg/L – milligrams per liter  
 OD – oxygen diffusion wells (OD-1 through OD-15)  
 EW – effectiveness wells (MW-7, MW-19, MW-49, MW-50)  
 SG – side gradient wells (MW-6, MW-8, MW-38, MW-39)

**Figure 39. iSOC Dissolved Oxygen Comparisons**  
*Union Carbide Corporation*  
*Woodbine, Georgia*

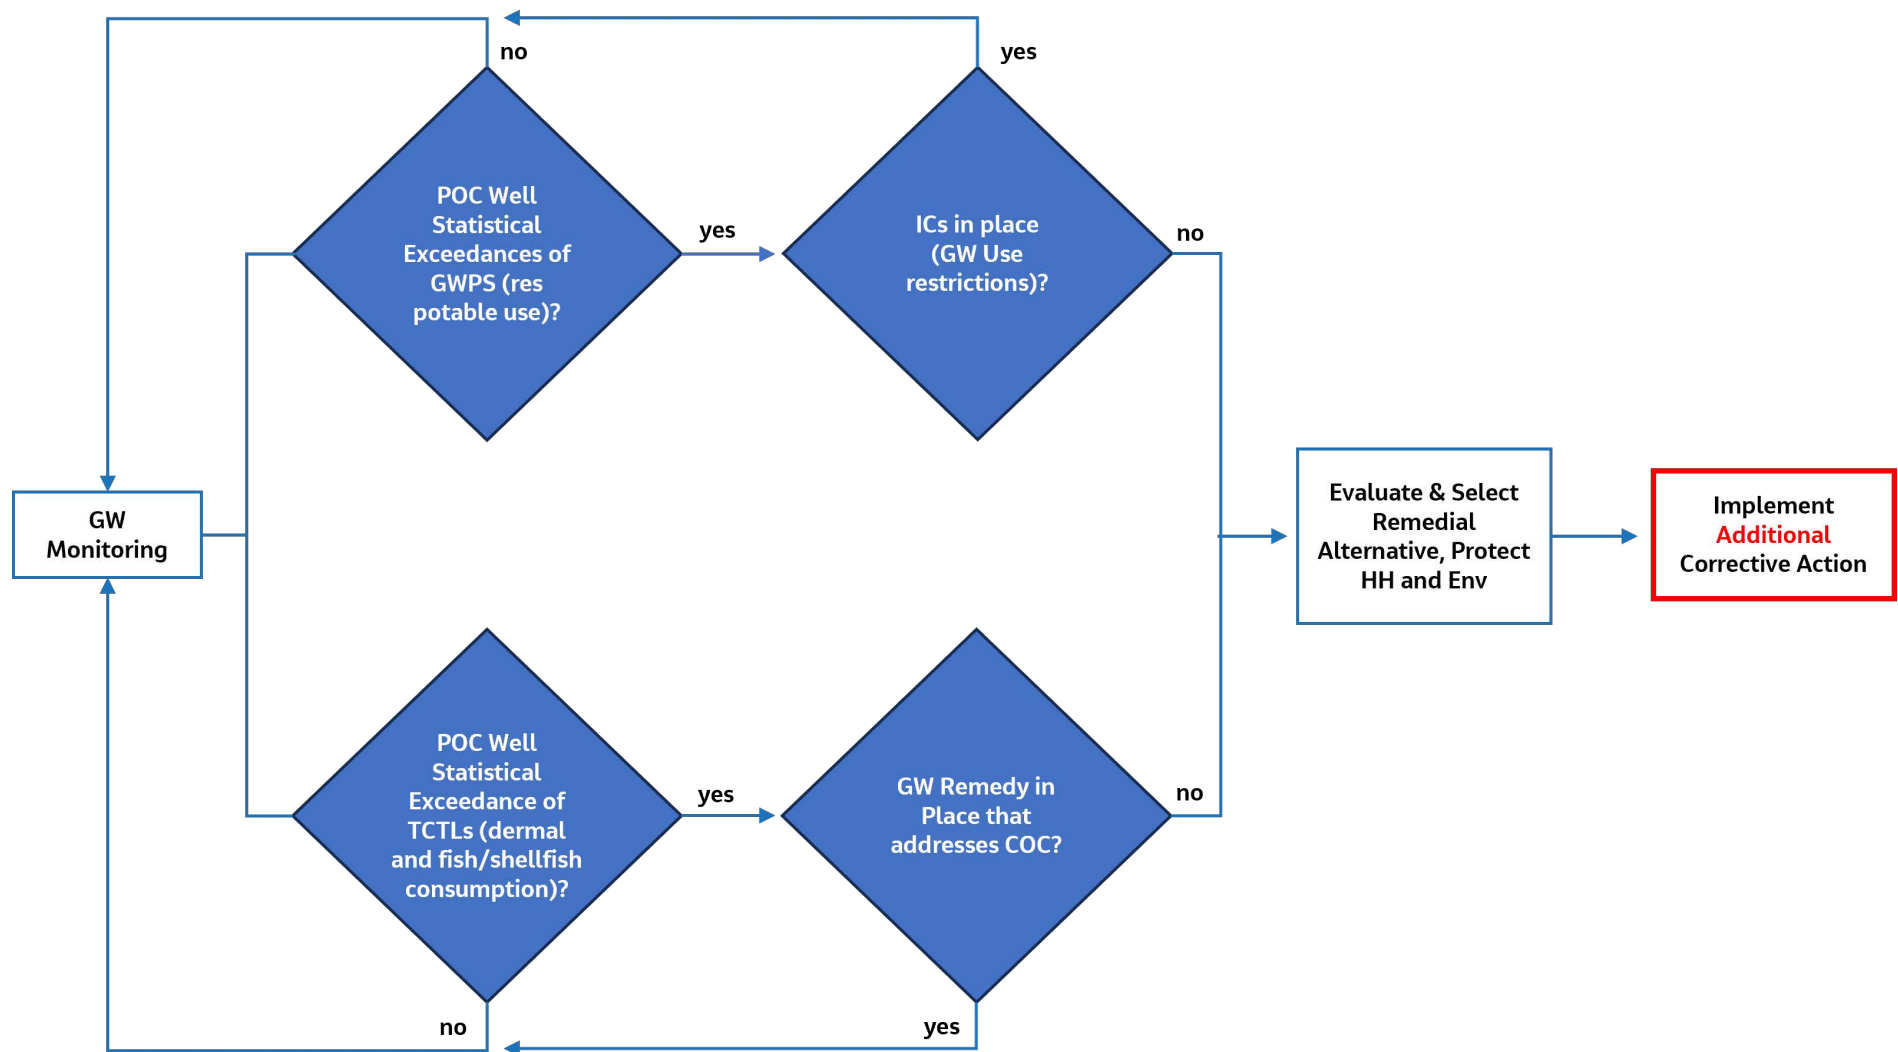
Figure 40. Process for Triggering Corrective Action for Groundwater  
 Permit Renewal Application  
 Union Carbide Corporation  
 UCC Woodbine, Camden County, Georgia
