Figure 1. Facility Location Map  
Permit Renewal Application  
Union Carbide Corporation  
UCC Woodbine, Camden County, Georgia

**Figure 3. Landfill (SWMU 1) Topographic Map**  
 Union Carbide Corporation  
 UCC Woodbine, Camden County, Georgia

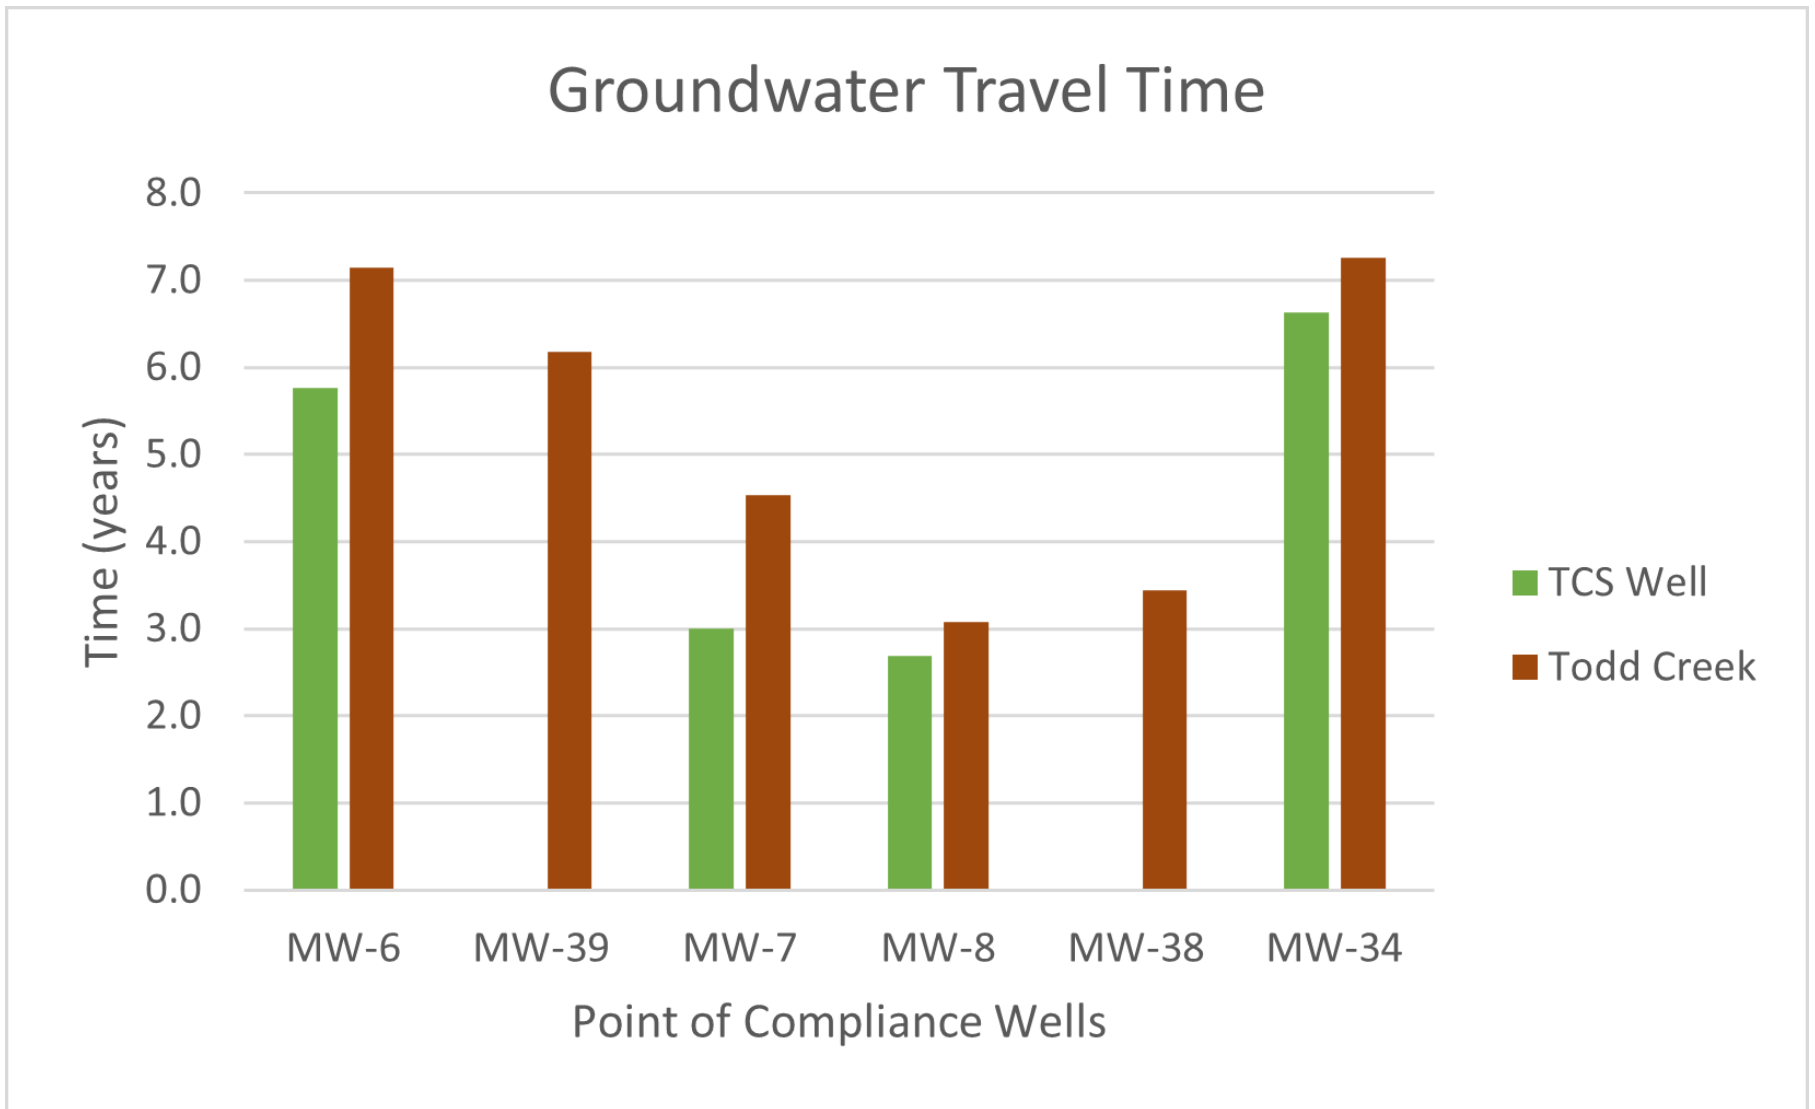
Note: Travel time is in years from the Point of Compliance (POC) Well to the nearby Todd Creek Sentinel (TCS) Well or Todd Creek.

**Figure 41. Groundwater Travel Time from POC Wells to TCS Wells and Todd Creek**  
Union Carbide Corporation  
Woodbine, Georgia

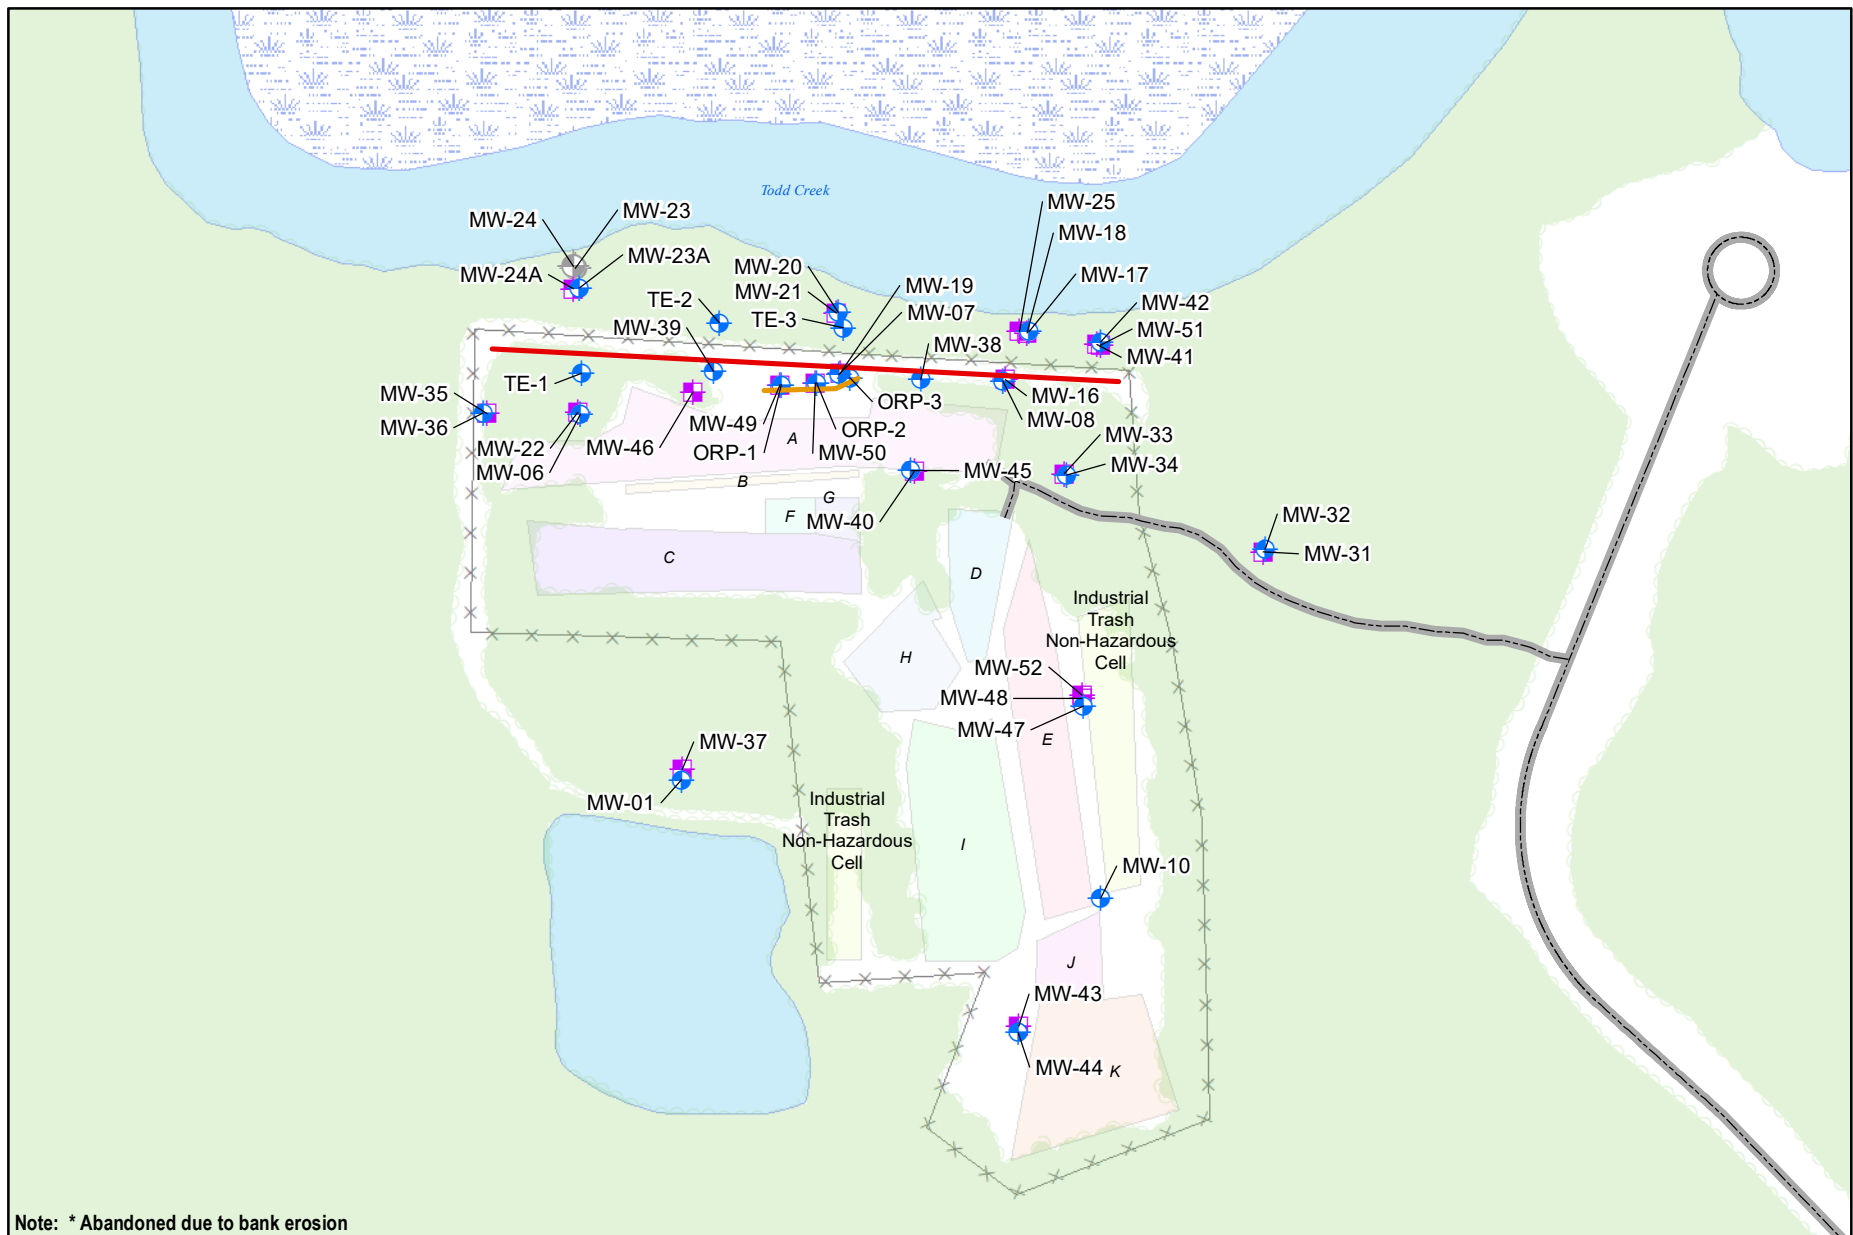
**Figure 42. Groundwater Corrective Action Location**  
 Union Carbide Corporation  
 UCC Woodbine, Camden County, Georgia
