Gum Swamp Creek Watershed Management Plan

December 2014

**Prepared by:
Pine Country Resource Conservation and Development Council, Inc.
1905 Martin Luther King Drive
Soperton, Georgia 30457**

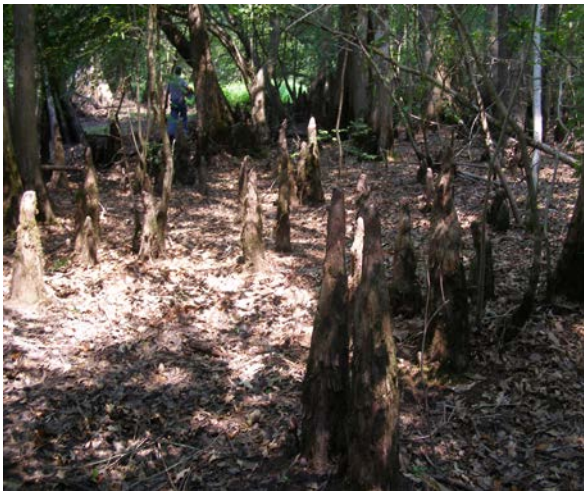
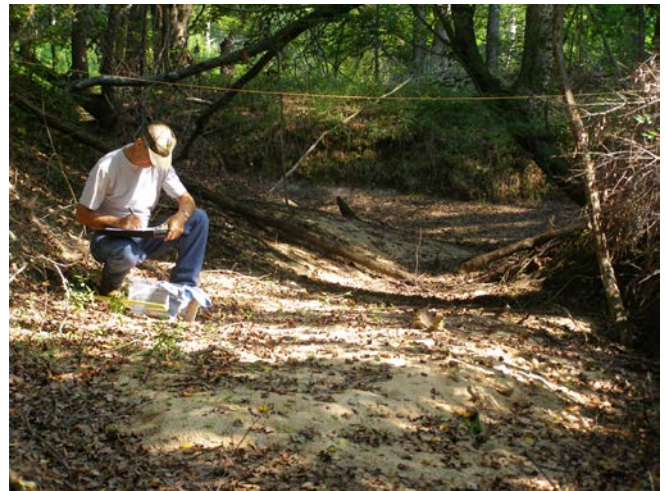
Drought conditions at the beginning of this project are evidenced by the completely dry streambeds - July 2012

Water quality monitoring according to the monitoring plan was anticipated to provide data that would assist in identifying the impacts of sediment loading. However due to extended drought during the initial monitoring period, there was no streamflow, and therefore no opportunity to collect water quality data for monitoring from June through December 2012. Subsequent rainfall events did generate streamflow and monitoring has progressed normally as initially planned in the monitoring plan.

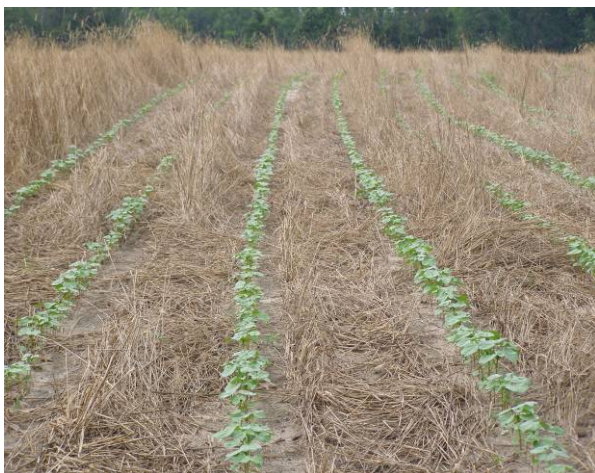
Conservation tillage with a good cover crop

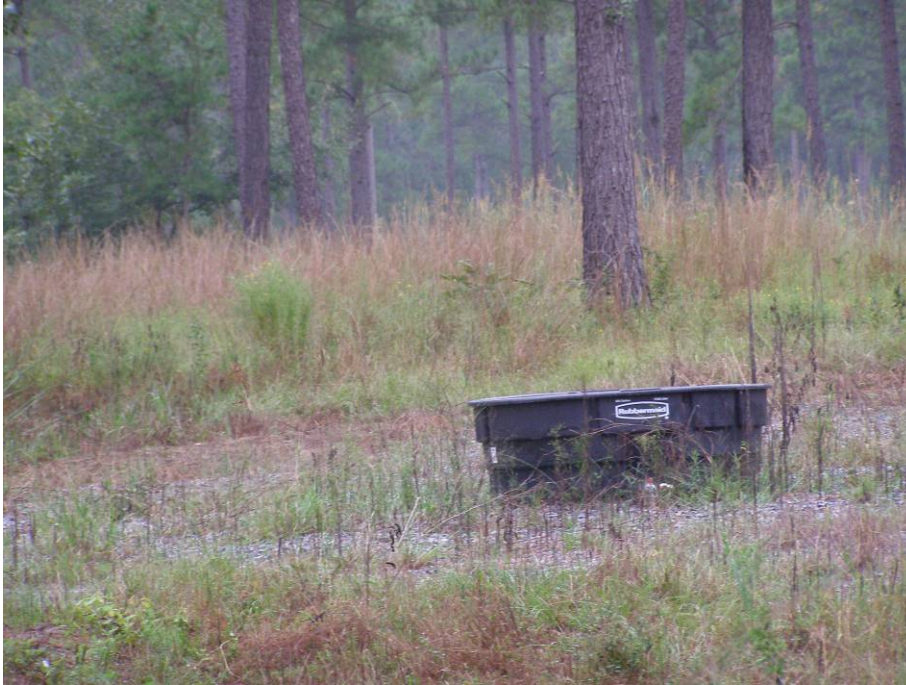
A livestock watering facility installed to meet water requirements and get livestock out of the stream in a newly established silvopasture.

Farm Bill programs have provided significant funding to undertake other activities such as fencing out livestock from stream areas and providing alternative water sources. Removing livestock from stream areas can have a positive effect on stream bank stabilization and vegetation. Additionally, there are other reductions related to nutrients and fecal coliform.

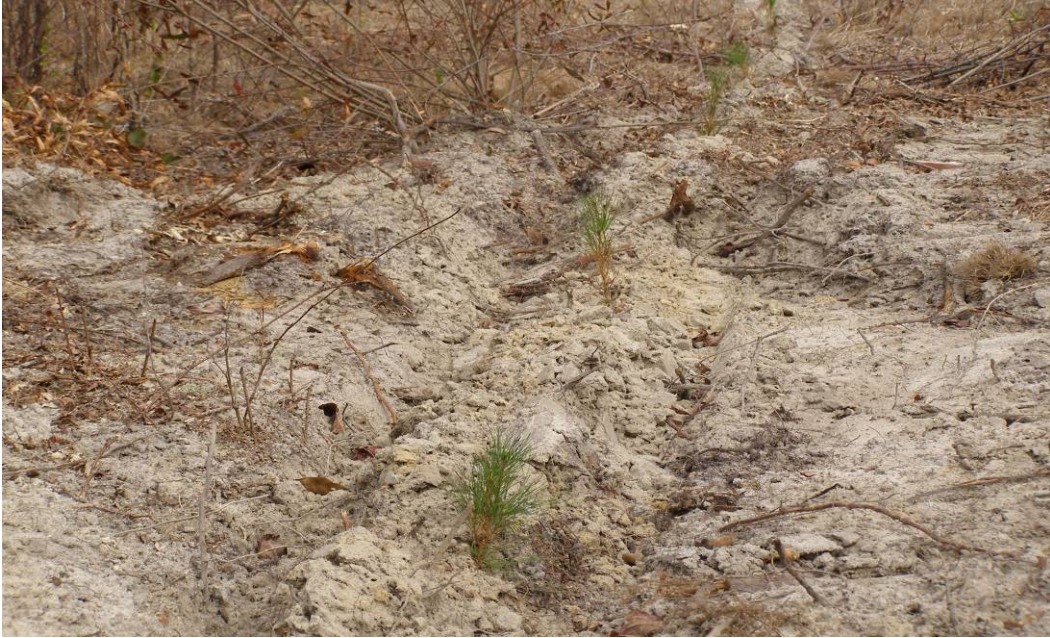
Pine trees planted on a site that has received minimal site preparation activity to disturb the soil.

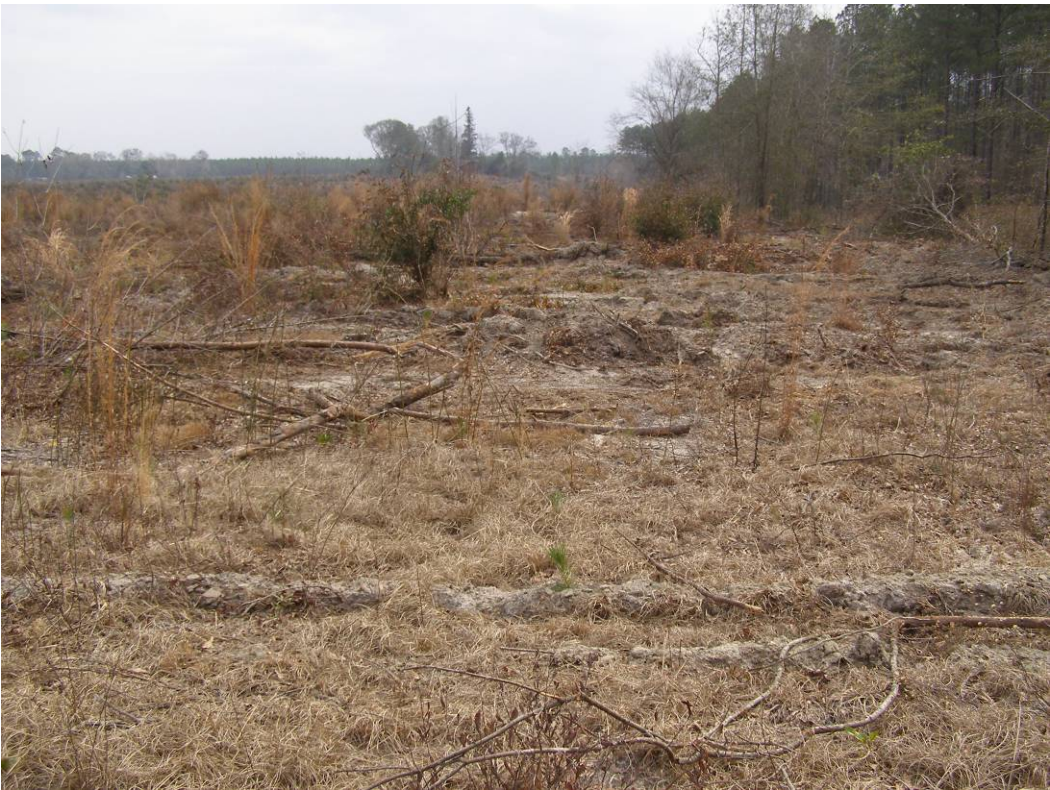
This clearcut forestland has been chemically site prepared and planted with a V-blade dozer with minimal soil disturbance.

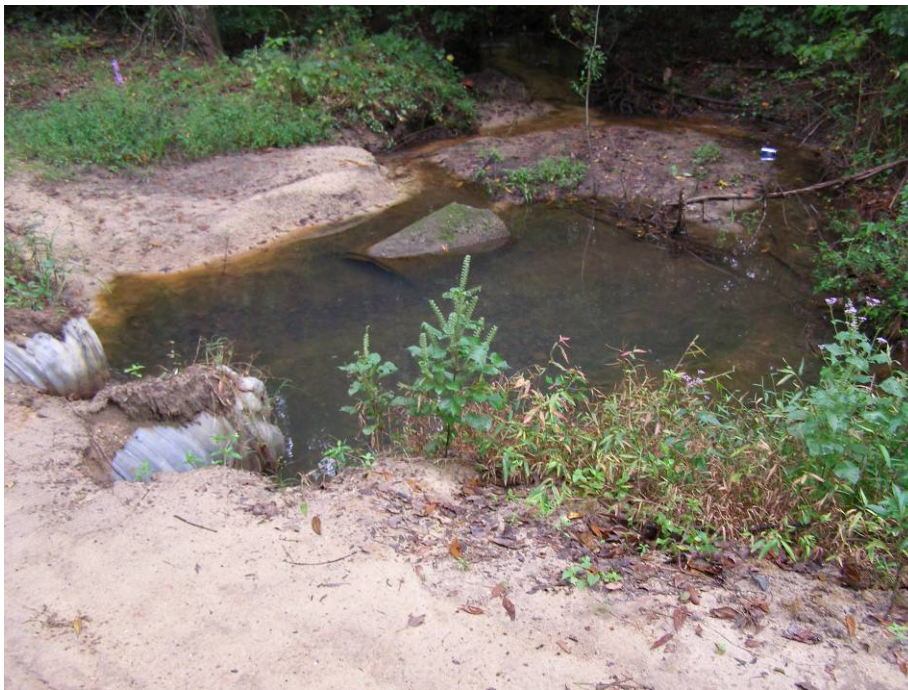
Poor outlet protection causing erosion, sedimentation and pipe failure.

Another source of sediment is improperly sized culverts at road crossings. When a storm event takes place, and a culvert is too small, water overtops the road and in some cases washes the road away. The resultant sediment then becomes part of the load in the stream as it is generally infeasible to try and recover it.

The spring of 2013 yielded several rainfall events in close proximity dumping approximately 15 inches of rain in the county. A review of some of the unpaved roads in the county revealed specific problems in the watershed that contribute to sediment loading. Most of these situations were not “new” problems, but rather have been repetitive issues with major rainfall/runoff events. Lack of right-of-way and private property concerns severely limit potential solutions in many cases. Some other situations can be improved with properly sized culverts, rip rap, and protected outflows.

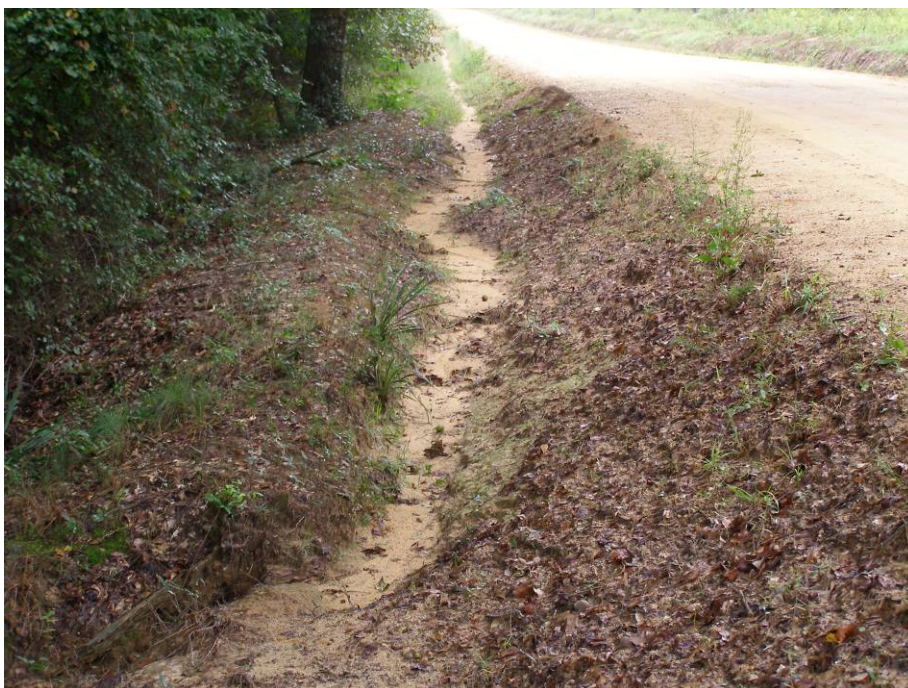
Water travelling down long slopes erodes the ditch bank and carries sediment to the outlet.

There are over 60 miles of unpaved roads in the Gum Swamp watershed. Many of these roads have been in place since the county was settled, and have eroded to grades below the elevation of adjacent lands. When a runoff event occurs, oftentimes water and sediment cannot be diverted off of the road until it approaches a stream crossing. Typical maintenance of the road surface involves the use of motor graders to reshape ditches, bring soil material up onto the road surface, and re-crown the road. Where possible, turnouts are used to try and get water and sediment off of the road before it reaches the stream, but this is not always possible.

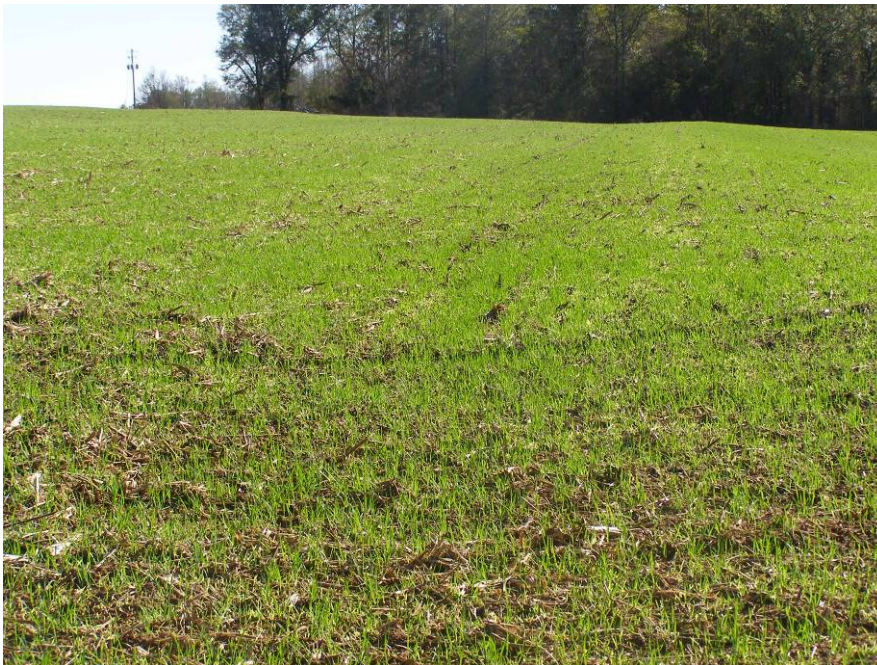
The use of cover crops and crop residue are effective methods to control erosion.

Many conservation measures are very effective at controlling sedimentation and are utilized by farmers. Practices such as conservation tillage, crop residue management, cover crops, field borders and contour farming offer many benefits.

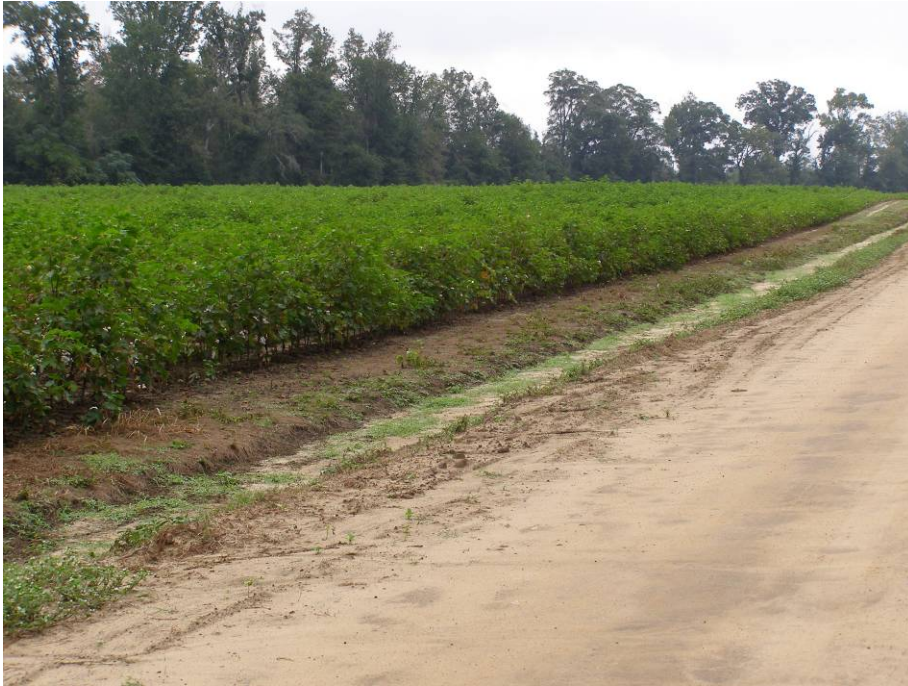
A vegetated filter strip or buffer could reduce sedimentation from this cropland field directly adjacent to the unpaved road.

Field borders, especially along county unpaved roads, could provide extensive benefits. However, there are very few examples of where this practice is in place at the present time. Some barriers to implementation may be crop prices, land rents, practice establishment, or lack of desire.

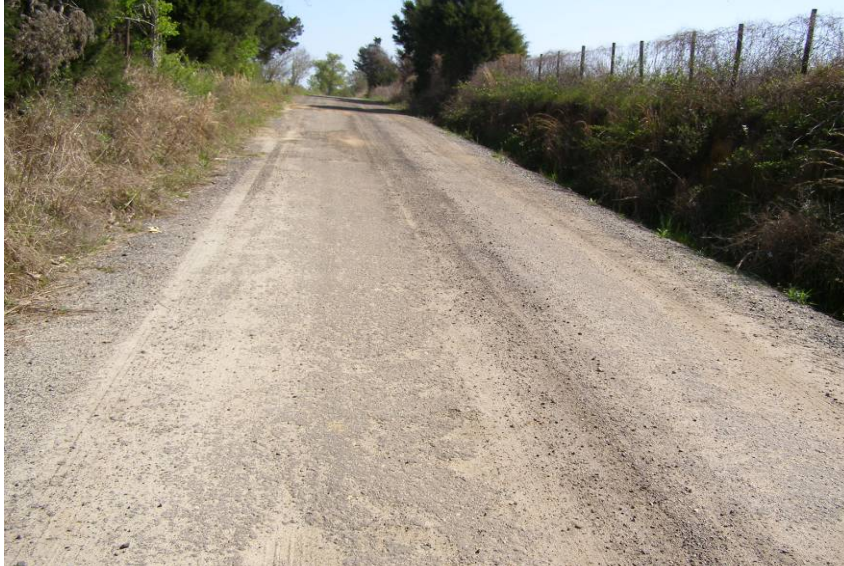
Recycled asphalt road millings placed on this steep clay slope have improved access and reduced sedimentation and maintenance requirements.

There is evidence in the watershed of specific effort to improve conditions where possible. The use of recycled asphalt road millings has had a positive impact in specific areas where it has been placed. Efforts by the County to keep culverts clean and flowing have prevented road blowouts. Attempts have been made to remove sediment out of the stream in certain locations.
