Horse Creek Watershed Management Plan

December 2014

**Prepared by:
Pine Country Resource Conservation and Development Council
1905 Martin Luther King Drive
Soperton, Georgia 30457**

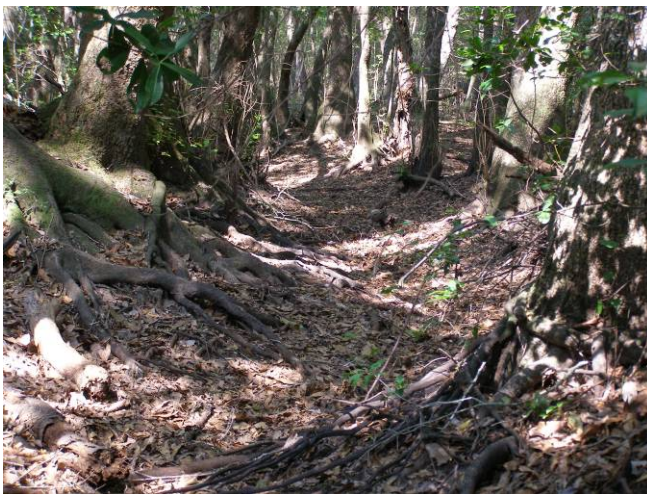
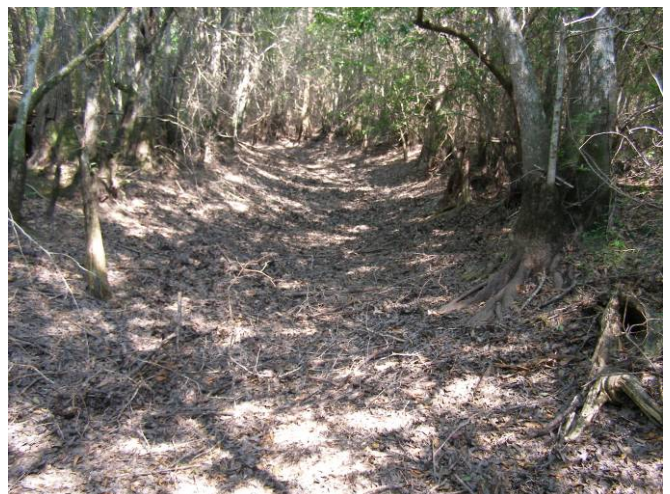
Drought conditions at the beginning of this project are evidenced by the completely dry streambeds - July 2012

Water quality monitoring according to the monitoring plan was anticipated to provide data that would assist in identifying the impacts of sediment loading. However due to extended drought during the initial monitoring period, there was no streamflow, and therefore no opportunity to collect water quality data for monitoring from June through December 2012. Subsequent rainfall events did generate streamflow and monitoring has progressed normally as initially planned in the monitoring plan.

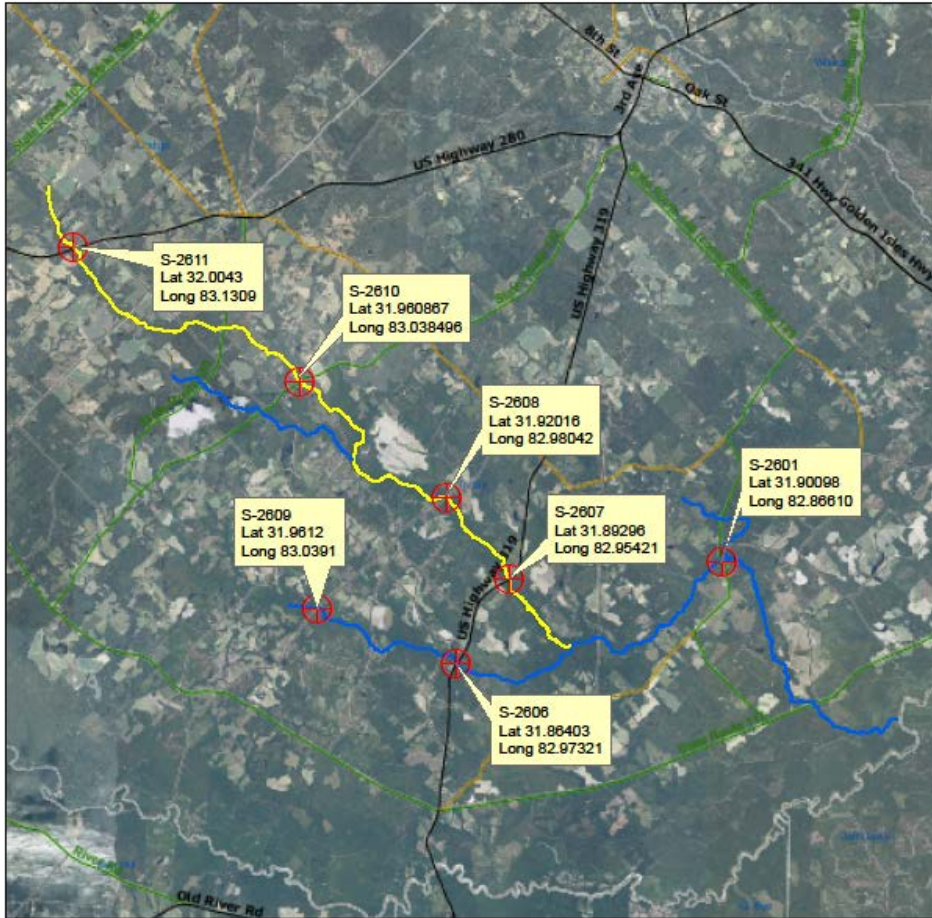
**SQAP Map
Horse Creek**

- Unimpaired/Tributaries
- Horse Creek Impaired
- County Boundary
- ⊕ Monitoring Sites

- S-2601. Horse Creek at Hwy 149
- S-2606. Alligator Creek at Hwy 441
- S-2607. Horse Creek at Hwy 441
- S-2608. Horse Creek at China Hill Road
- S-2609. Alligator Creek at China Hill Road
- S-2610. Horse Creek at Hwy 132
- S-2611. Horse Creek at Hwy 280 – Dodge County

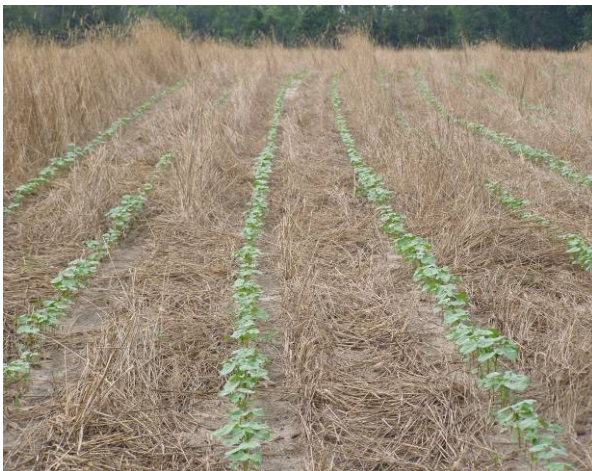
Conservation tillage with a good crop residue cover.

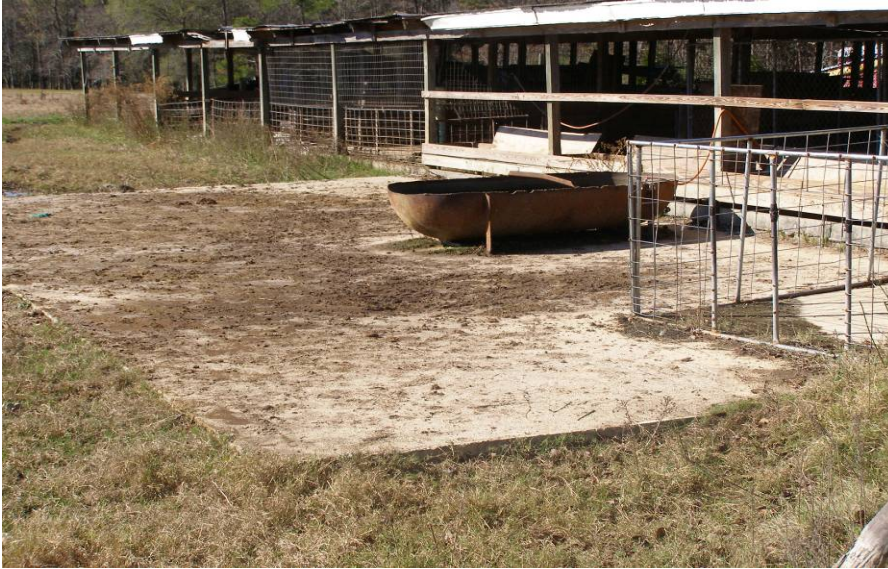
Livestock watering facility to meet water requirements and get livestock out of the stream.

Farm Bill programs have provided significant funding to undertake other activities such as fencing out livestock from stream areas and providing alternative water sources. Removing livestock from stream areas can have a positive effect on stream bank stabilization and vegetation. Additionally, there are other reductions related to nutrients and fecal coliform.

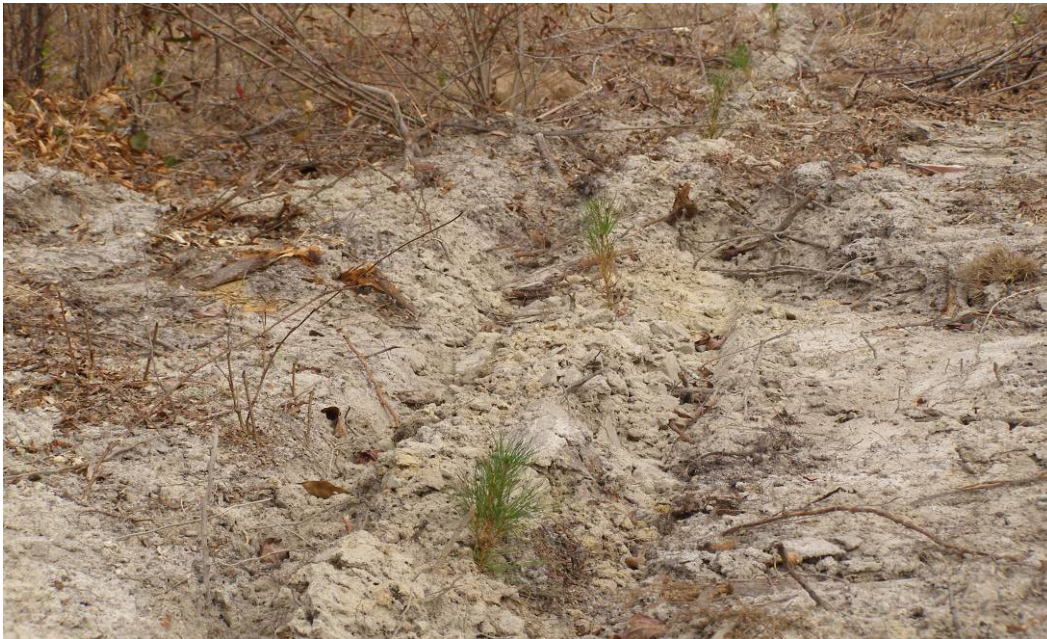
Pine trees planted on a site that has received minimal site preparation activity to disturb the soil.

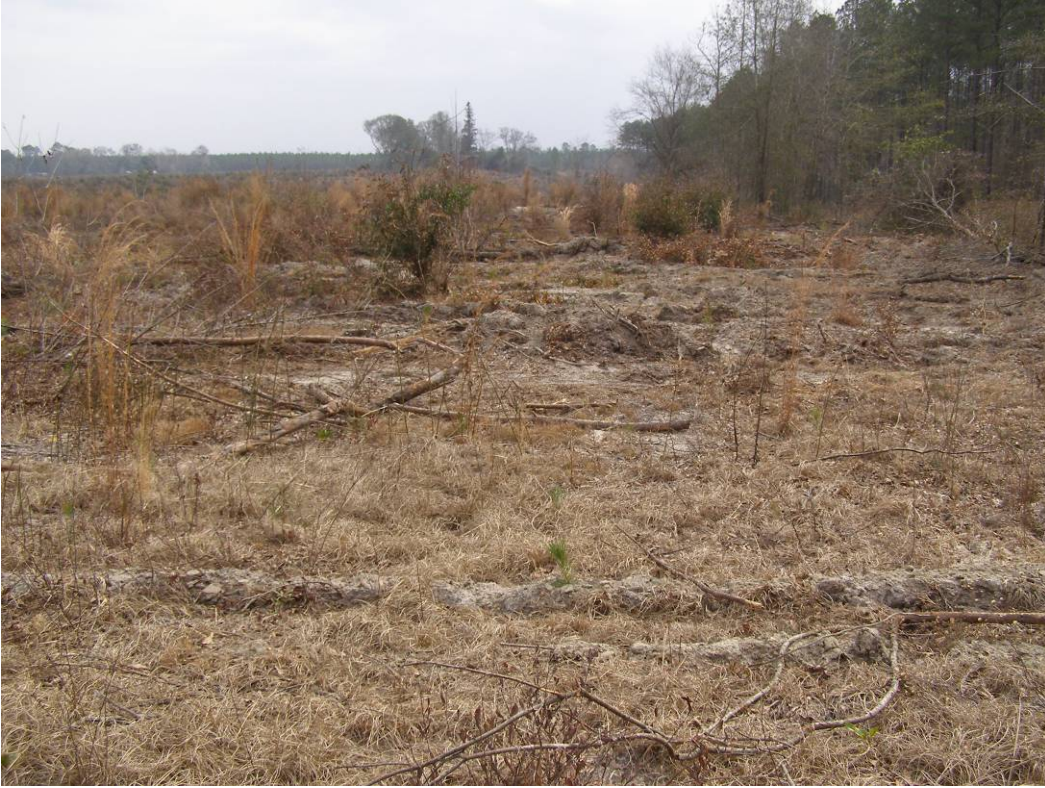
This clearcut forestland has been chemically site prepared and planted with a V-blade dozer with minimal soil disturbance.

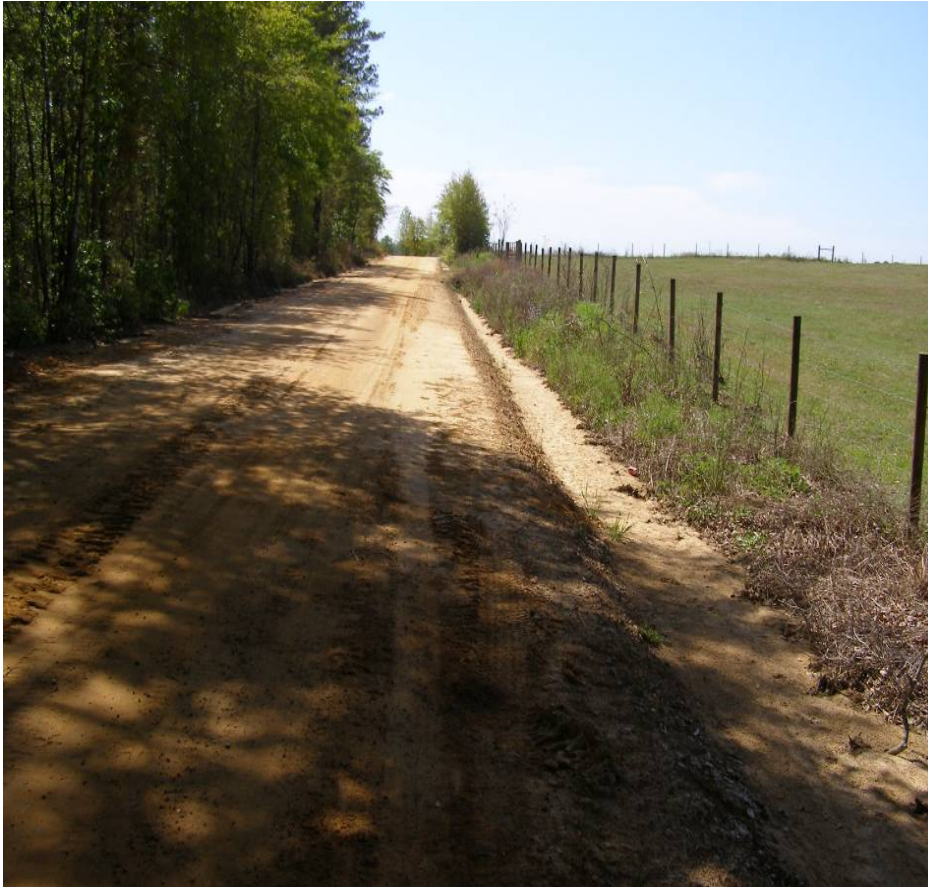
Water traveling down a long slope will be discharged at the stream channel

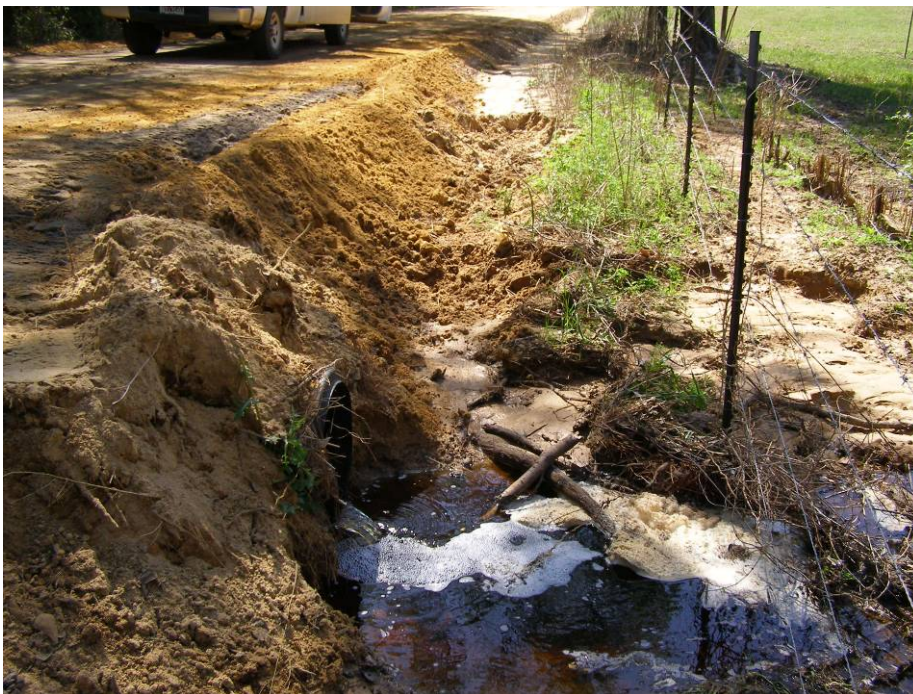
This pipe was recently placed after this crossing washed out following a storm event.

The pipe is currently undersized, but represents a typical "fix".

Another source of sediment is improperly sized culverts at road crossings. When a storm event takes place, and a culvert is too small, water overtops the road and in some cases washes the road away. The resultant sediment then becomes part of the load in the stream as it is generally infeasible to try and recover it.

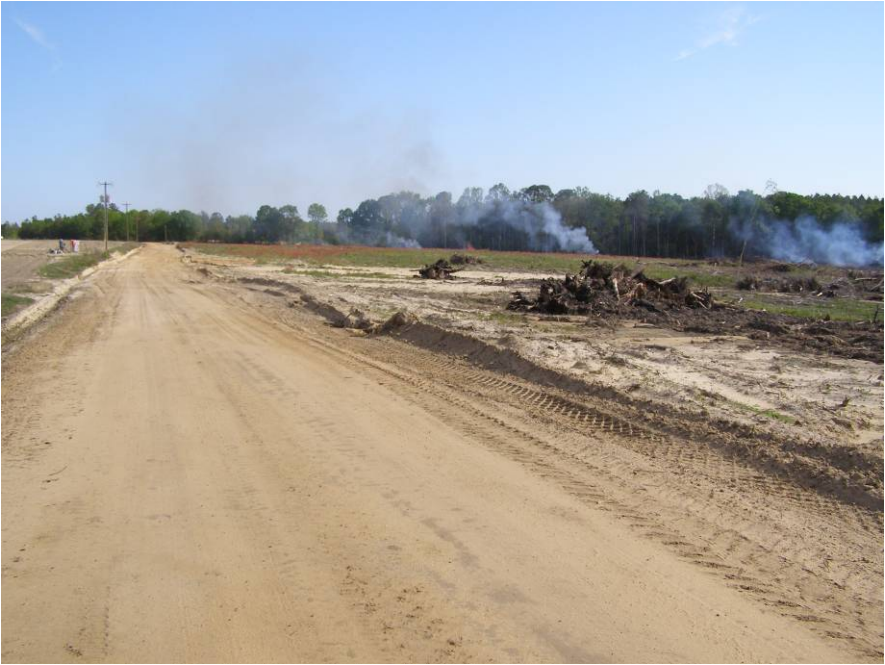
The county road is receiving sediment from an adjacent land clearing operation. The landowner and county are working to resolve the problem.

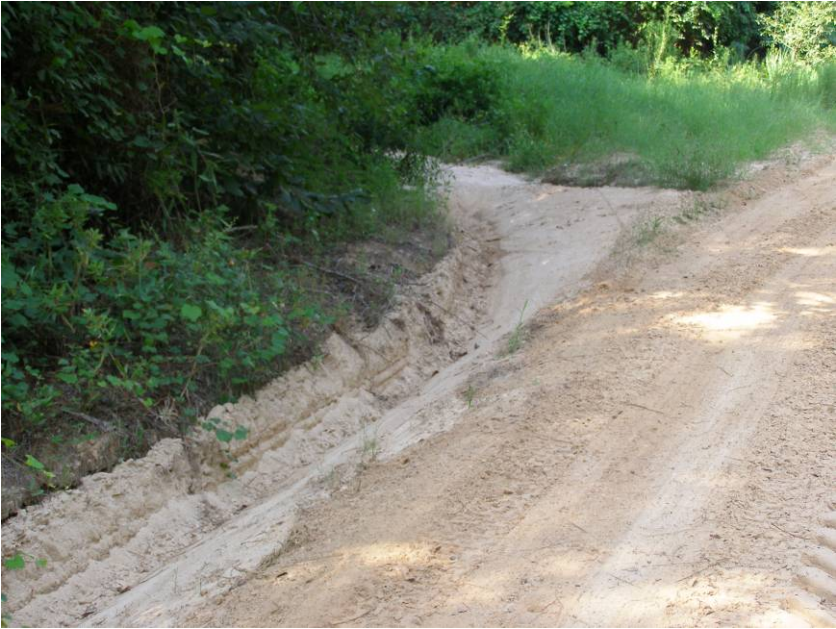
An example of a water turnout at the bottom of the hill that directs the water into the stream.

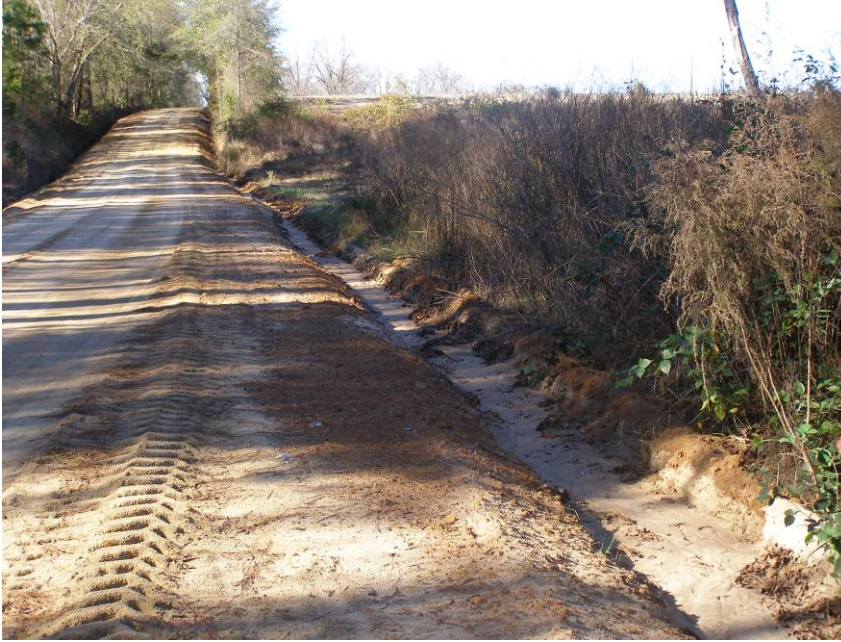
Like many roads, the roadbed elevation is lower than the surrounding area. Water and sediment can only travel in the ditches until it reaches the stream at the bottom of the hill.

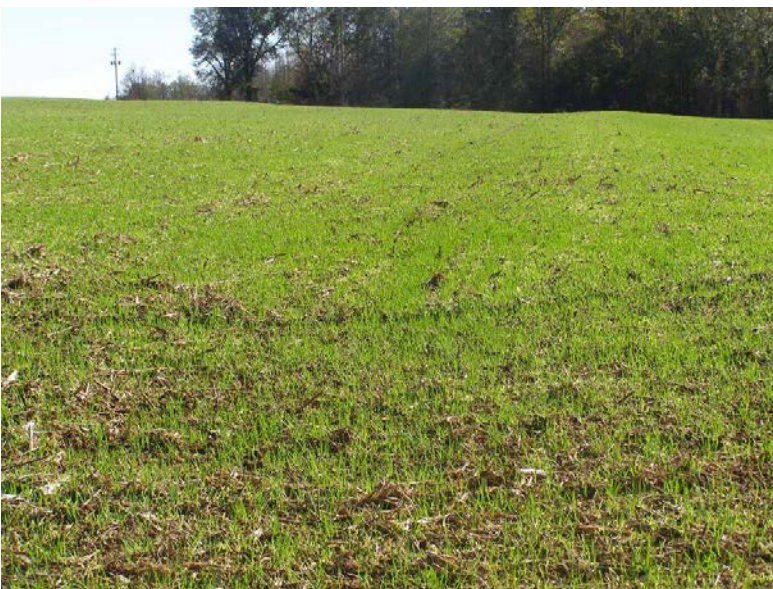
The use of cover crops and crop residue are effective methods to control erosion.

Many conservation measures are very effective at controlling sedimentation and are utilized by farmers. Practices such as conservation tillage, crop residue management, cover crops, field borders and contour farming offer many benefits.

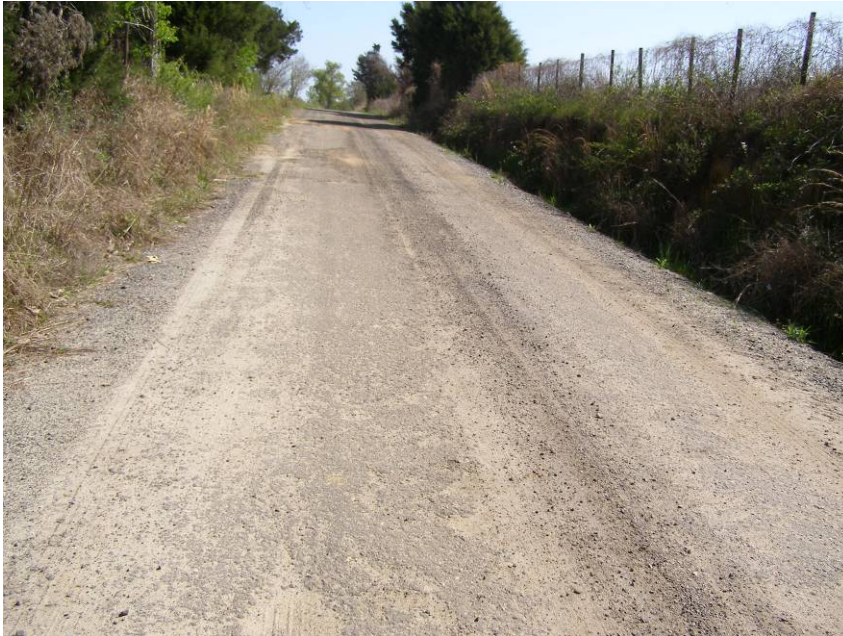
Recycled asphalt road millings placed on this steep clay slope have improved access and reduced sedimentation and maintenance requirements.

There is evidence in the watershed of specific effort to improve conditions where possible. The use of recycled asphalt road millings has had a positive impact in specific areas where it has been placed. Cleaning out culverts to improve water flow has prevented road blowouts. There even has been an attempt to remove sediment out of the stream in certain locations.
