# Lookout Creek Watershed Management Plan

A Local Stakeholder and Georgia EPD Approved Plan that Outlines the Framework for Improving Water Quality in Lookout Creek

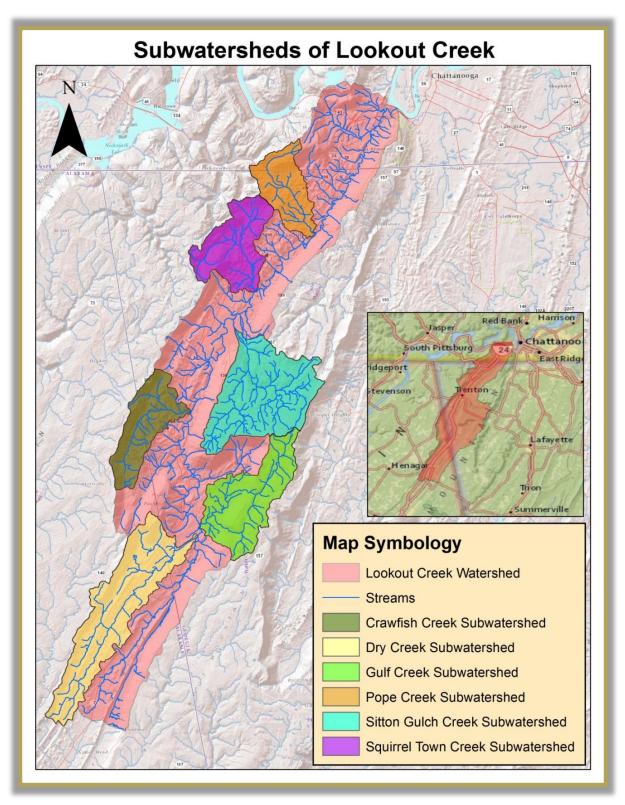
Figure 2.1.b. The Lookout Creek Watershed with the subwatersheds of significant tributaries outlined and identified.

Lookout Creek originates as East Fork Lookout Creek and West Fork Lookout Creek, which come together just before flowing from Alabama into Georgia. It flows northeast following Lookout Valley in between Lookout and Sand Mountains. In Georgia, the valley is fairly narrow, especially in the upper watershed, although some meandering of Lookout Creek takes place. As the fairly narrow, linear nature of the watershed suggests, few major tributaries exist in the watershed. In Georgia, direct named tributaries to Lookout Creek include from upstream to downstream: Dry Creek, Gulf Creek, Hurricane Creek, Allison Creek, Crawfish Creek, Town Creek, Sitton Gulch Creek, McClain Branch, Squirrel Town Creek, McCollum Branch, Pope Creek, and Wauhatchie Branch. The subwatersheds of the creeks (more significant than branches) are contained in Figure 2.1.b.

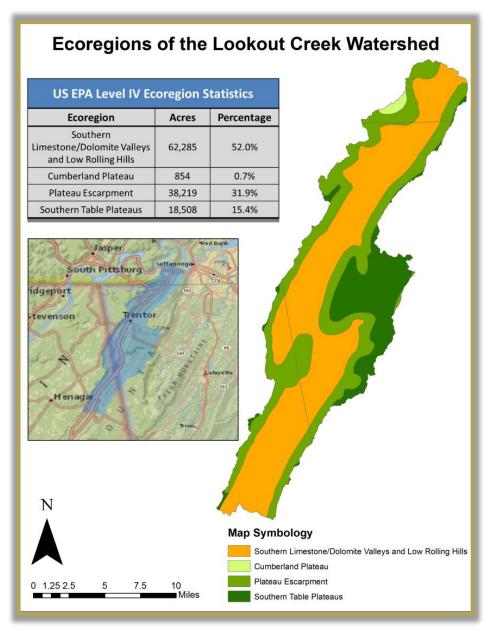
Figure 2.1.c. The Lookout Creek Watershed showing the locations of ecoregions within its borders.

The Lookout Creek Watershed contains portions of two Level III Ecoregions, the Ridge and Valley and the Southwestern Appalachians, which are depicted in Figure 2.1.c. The valley floor is part of the Ridge and Valley Ecoregion, which is generally characterized by relatively low-lying, northeast-southwest trending ridges and valleys. Geological materials vary and include limestone, dolomite, shale, siltstone, sandstone, chert, mudstone, and marble. The region is also known for a diverse collection of aquatic habitats, as well as species of fish and other aquatic life. The portions of the Lookout Creek Watershed on the slopes and plateaus are part of the Southwestern Appalachians Ecoregion, which includes the Cumberland Plateau.

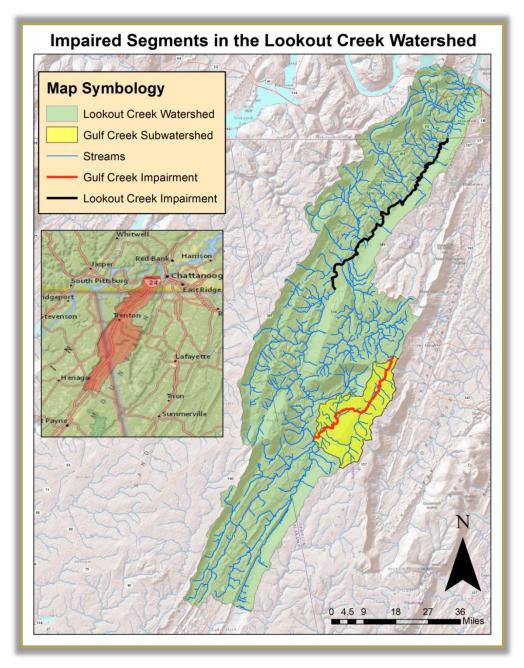
Figure 3.1.a. A map displaying the impaired segments found within the Lookout Creek Watershed.

Sampling of water quality and biota, specifically fecal coliform counts and fish assemblages in this case, in the Lookout Creek Watershed has resulted in the placement of two stream segments on the Georgia Integrated 303(d)/305(b) List for failure to meet state criteria. These impaired stream segments account for approximately 20 miles of streams in the Georgia portion of the watershed. On Lookout Creek, the impaired segment is due to fecal coliform bacteria violations and occurs in the lower watershed (Figure 3.1.a.; Table 3.1.b.). On Gulf Creek, an impacted biota impairment stems from a poor Index of Biotic Integrity (IBI) score, which was revealed during local fish sampling endeavors by Georgia DNR.

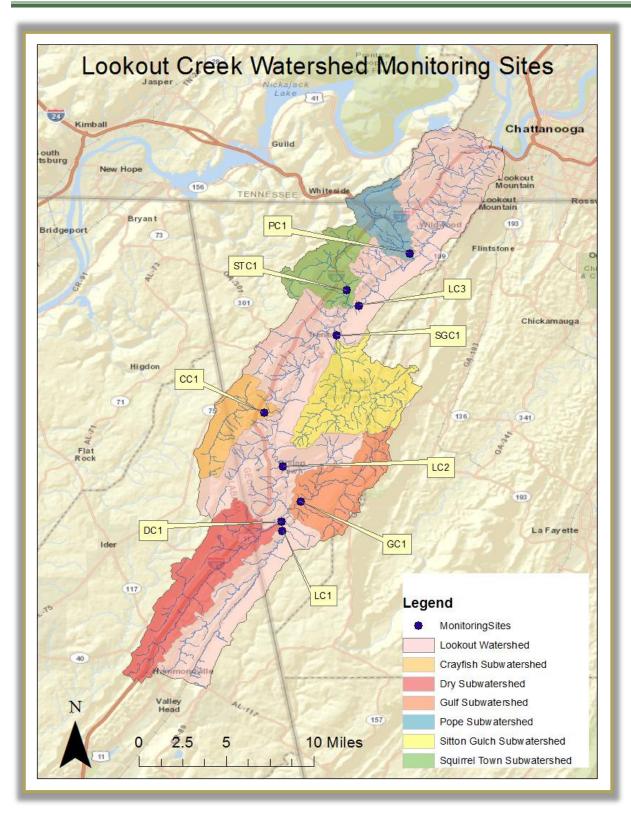
Figure 3.3.a. A display of the locations of the nine sample sites used during targeted monitoring in the Lookout Creek Watershed.

- Lookout Creek Site 1 (LC-1) at Old Cloverdale Road: 34.710739, -85.527256
- Lookout Creek Site 2 (LC-2) at Newsome Gap Road: 34.764975, -85.526422
- Lookout Creek Site 3 (LC-3) at Creek Road: 34.898106, -85.463961
- Dry Creek Site 1 (DC-1) at Cloverdale Road: 34.718381, -85.528075
- Gulf Creek Site 1 (GC-1) at Mason Road: 34.735513, -85.511776
- Crawfish Creek Site 1 (CC-1) at Highway 11: 34.808487, -85.542187
- Sitton Gulch Creek Site 1 (SGC-1) at Piney Road: 34.870379, -85.490061
- Squirrel Town Creek (STC-1) at New England Road: 34.910831, -85.473737
- Pope Creek Site 1 (PC-1) at Pope Creek Road: 34.940887, -85.421703

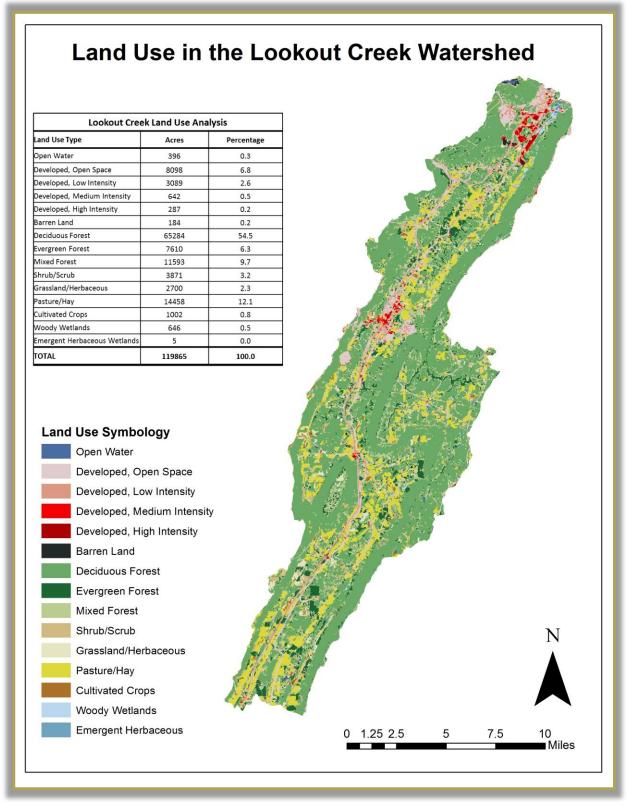
Figure 3.4.a. A map displaying the Lookout Creek Watershed's more prominent land uses and their percentages within the watershed. More detailed definitions of land uses are listed in Appendix C.

The Lookout Creek Watershed is dominated by forest, which accounts for over 70% of watershed land use. Parcels managed as forest are located throughout the watershed, but especially on the plateaus and slopes of Lookout and Sand Mountains. A moderate percentage of land (12.1%) and its resources are also devoted to livestock production in the Georgia portion of the watershed, especially within Lookout Valley. Other land uses are variable (and revealed in Figure 3.4.a.), yet primarily reflect the rural nature of the watershed. The county seat, Trenton, and especially Lookout Valley in the Tennessee portion of the watershed represent more developed areas. Much of the residential land use in the watershed occurs in the areas in and surrounding these communities as well as the communities of Wildwood and Rising Fawn. Residences are also consistently scattered along highways and county roads. In addition, Interstate 59, a four lane highway connecting Chattanooga and Birmingham runs through the center of the watershed through Tennessee and Georgia. All of the land use types outlined likely exert some contribution to the current water quality conditions in the watershed, although significant variation in NPS contributions per land use exists from parcel to parcel depending on management.

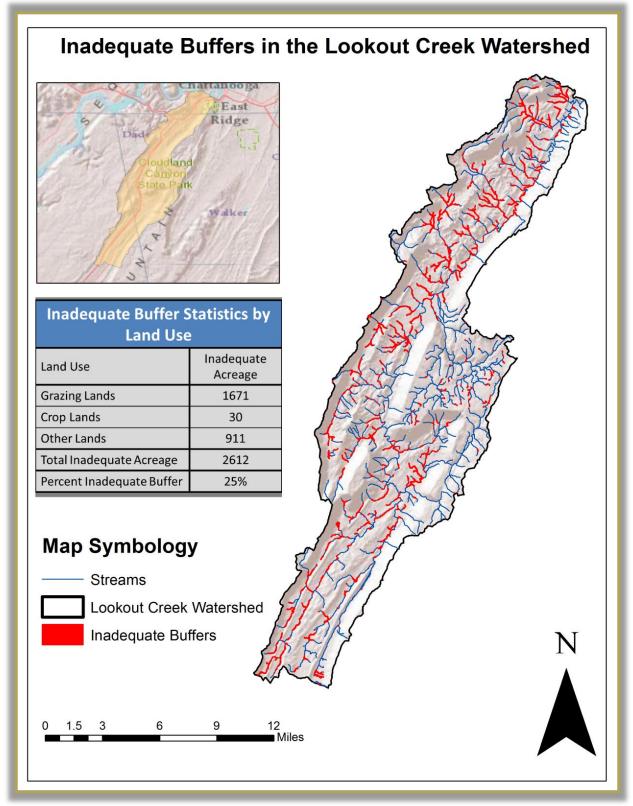
Figure 3.5.a. A map depicting the areas found to have insufficient riparian buffers (in red) within the Lookout Creek Watershed.

The stream buffer analysis was conducted using GIS software and recent aerial imagery. The purpose of this analysis was to identify areas of inadequate vegetation within a 100 foot buffer of all streams. Every tributary was analyzed with the software and aerial imagery (viewed with the naked eye), to confirm insufficient buffers. The areas having insufficient riparian zones are depicted in red in Figure 3.5.a. The percentage of inadequate buffer was also calculated and included. This information was used for estimating the technical and financial assistance needed to de-list the impaired segments (discussed later).

The buffer analysis shows several areas within the watershed lacking in riparian buffers. These areas include Dry Creek and upper Lookout Creek, Gulf Creek, lower Lookout Creek, and several tributaries in the lower watershed toward and within Tennessee. Much of this acreage lies on grazing lands where a lack of riparian buffers when combined with cattle access can increase bank erosion, and thus sediment introduction, into the Lookout Creek system. Improving these buffers would reduce bank erosion and sedimentation issues and improve water quality within the watershed.

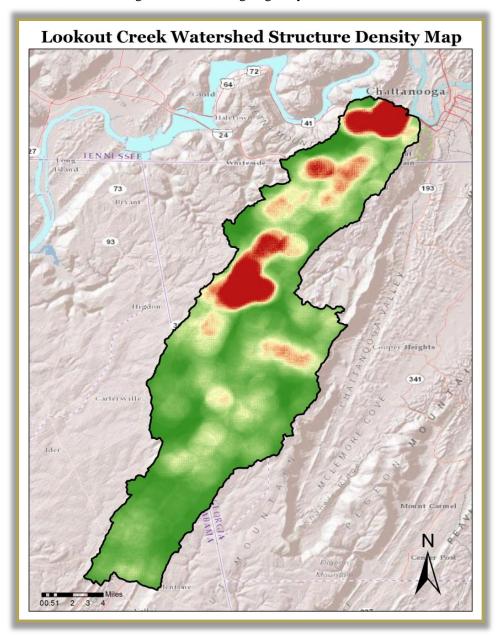
Figure 3.6.a. An image depicting the distribution of structures found in the Lookout Creek Watershed. Red depicts a high density area, whereas green reflects low density areas.

Additional GIS analysis was conducted to investigate the number of structures that occur within the watershed. This analysis generated the map in Figure 3.6.a. and the information in Table 3.6.a. Outside of the immediate Trenton area and the Lookout Valley area (at the northern end of the watershed), which are accommodated by sewer, the density of structures can be used to represent where septic systems are numerous and ultimately were fecal coliform contributions from failed septic systems may be significant. These data indicate that septic system contributions to fecal coliform counts may potentially be significant on the outskirts of Trenton, in the Rising Fawn area, along Highway 136, and in the Wildwood area.

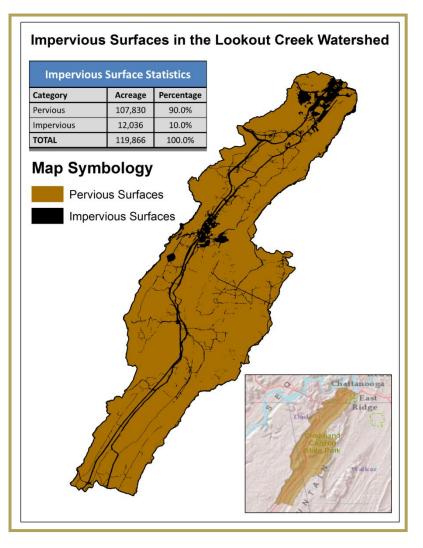
Figure 3.7.a. An image depicting impervious surfaces in the watershed have increased stormwater runoff.

Impervious surface cover was also investigated as an indicator of development and consequently where stormwater runoff has increased over This investigation was time. intended to provide some insight as whether development is a to contributor to the impairments, as well as consider the potential need for additional stormwater practices management as additional and development ensues. Impervious surface cover in the watershed is shown in Figure 3.7.a. The map indicates that the areas of Trenton and Lookout Valley in Tennessee will likely continue to encroach on the rural nature of the watershed over Although the data is from time. 2006, little development has occurred since as a result of the recent housing bubble and recession.

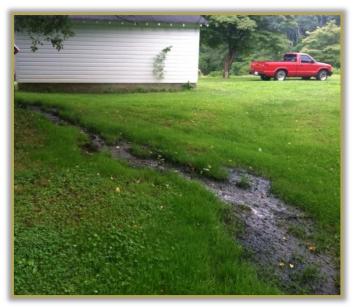
Figure 4.1.c. A failing septic system can introduce pathogens into nearby streams. This system has effluent surfacing in the yard, the vast majority of which drains into a nearby tributary.

With more than 5,000 septic systems in Dade County, stakeholders also identified failing septic systems as a probable contributor to the fecal coliform load in the watershed. Targeting these issues in the watershed should lead to water quality improvement, while also helping people in the community. It was decided by the stakeholder group that landowners experiencing septic system failures would likely be motivated to fix the issues, especially if cost-share assistance is available. Considering cost-share programs for septic system repairs have worked in other areas of Northwest Georgia, it seems this practice may again be implemented with success due to being seen as mutually beneficial to both members of the community and water quality improvement goals.

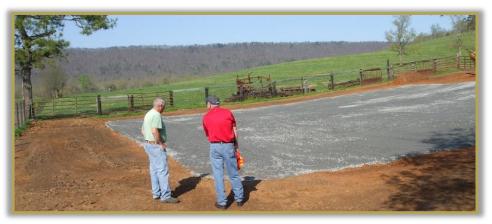
Figure 6.2.a. Constructing heavy use area pads for cattle feeding or watering areas can reduce erosion and sediment loads in the watershed.

Since agricultural activity encompasses a large proportion of land use within the watershed, the LCWRP will include a cost-share program that will help local farmers afford conservation practices that reduce fecal coliform and/or sediment contributions to receiving waters. Many of these practices are also beneficial to landowners which will serve as additional motivation for participation in the program. Most of the agricultural lands within the watershed are used for grazing, so funds need to be available to assist farmers with an interest in voluntary conservation to restrict livestock stream access and provide alternative watering sources. These practices would reduce the fecal coliform load from direct sources and agricultural runoff in the watershed. Projects that address erosion issues will likely include streambank and heavy use area stabilization.

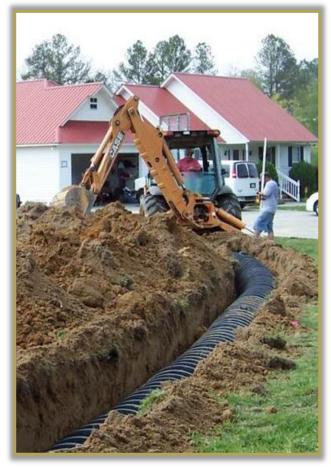
Figure 6.2.b. A septic system repair can reduce the fecal coliform load in streams. A cost-share program can help incentivize costly repairs.

The LCWRP will also include a cost-share program to address failing septic systems, since this issue was determined by the stakeholder group to be a significant contributor to the fecal coliform bacteria load in the watershed. High failure rates are said to occur for several reasons, including poorly percolating soils in some areas, outdated systems, and the low-income financial condition of a portion of the local population. A cost-share program in the area would help to incentivize more of the population to get their systems repaired. Cost-share rates are likely to vary according to the likely contributions of the failed systems to pollutant loads, and in the cases of impoverished families, financial conditions. In addition, greater public demand for septic system repairs will likely result in lower cost-
