Mountain Oak Creek Healthy Watershed Initiative Nine-Step Watershed Management Plan

Middle Chattahoochee River, Harris County, Georgia
May 18, 2018

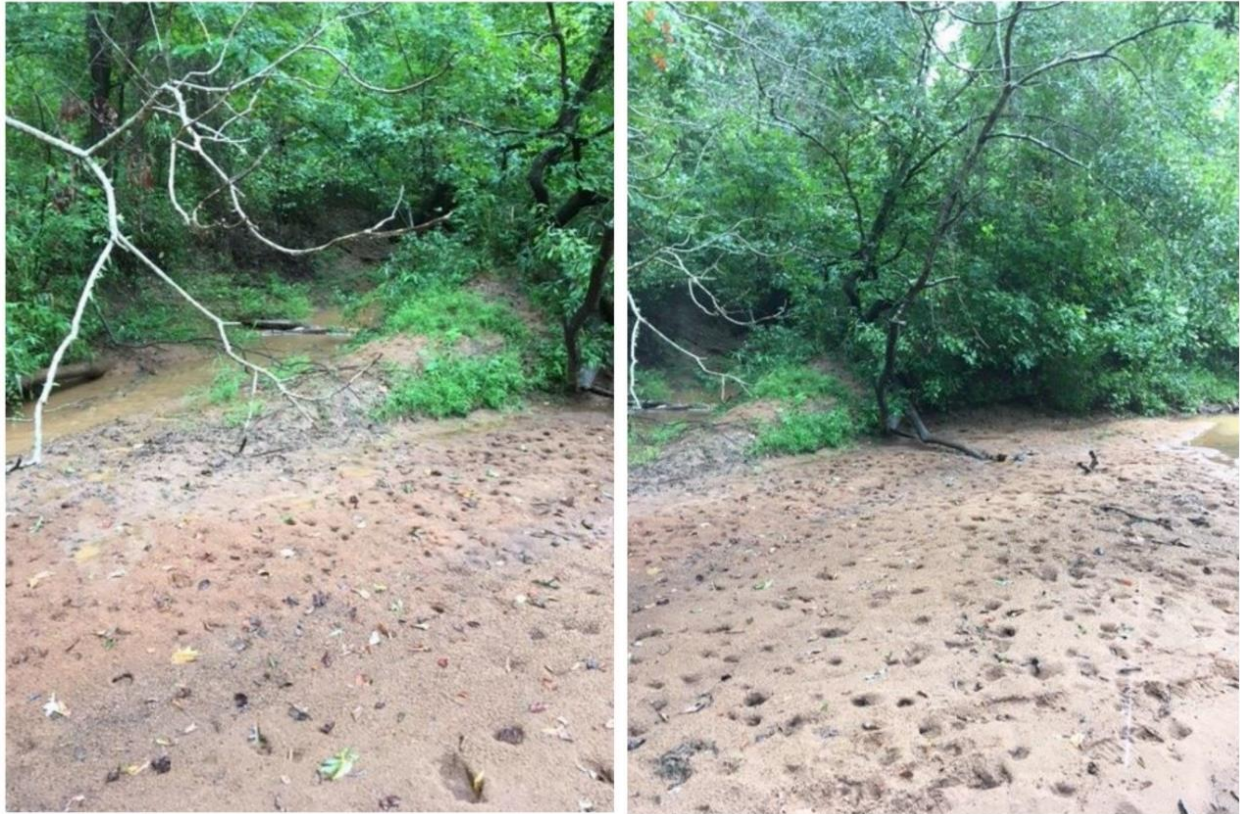
Images 1 and 2. Animal Tracks in Sandbar at Tributary

there is a “background” of fecal coliform due to wildlife. Images 1 and 2 show numerous animal tracks in a sandbar along Mountain Oak Creek.

Creek walks by CWW provided adequate evidence of a variety of wildlife, including the presence of deer, coyotes, raccoons, opossums, and squirrels on Mountain Oak Creek. One beaver dam was observed on Little Creek, a tributary to Mountain Oak Creek. The abundance of deer and small mammals indicate that

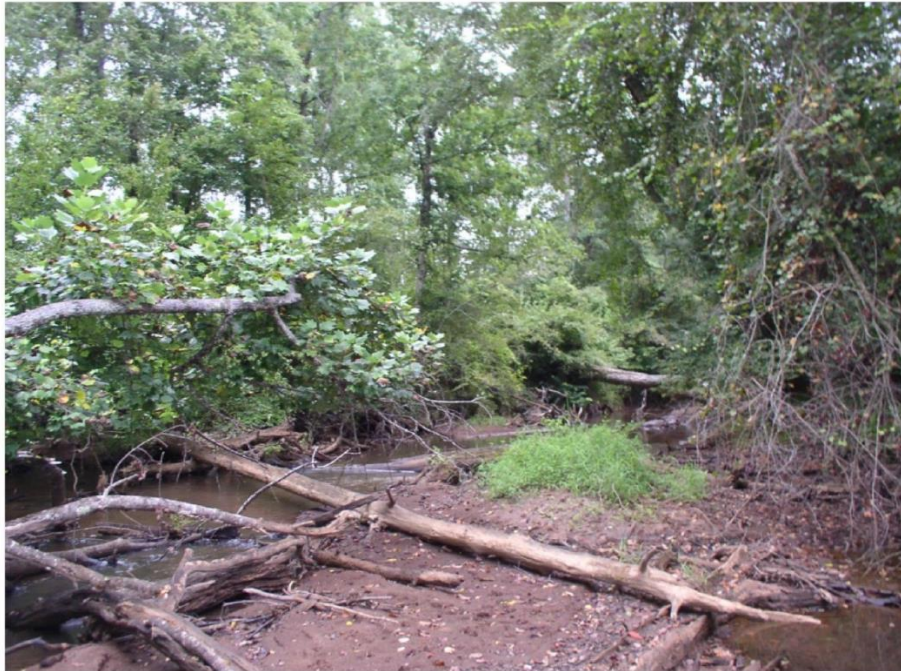
Image 3. Typical Example of Mountain Oak Creek with deteriorated flow path
