REPORT ON
SEMIANNUAL PROGRESS REPORT
FORMER GENERAL TIME FACILITY
ATHENS, GEORGIA

File No. 128752-003
April 2017

Subject: April 2017 Semi-Annual Progress Report #6
Former General Time Facility
100 Newton Bridge Road- Athens, Georgia
HSI Site Number 10355

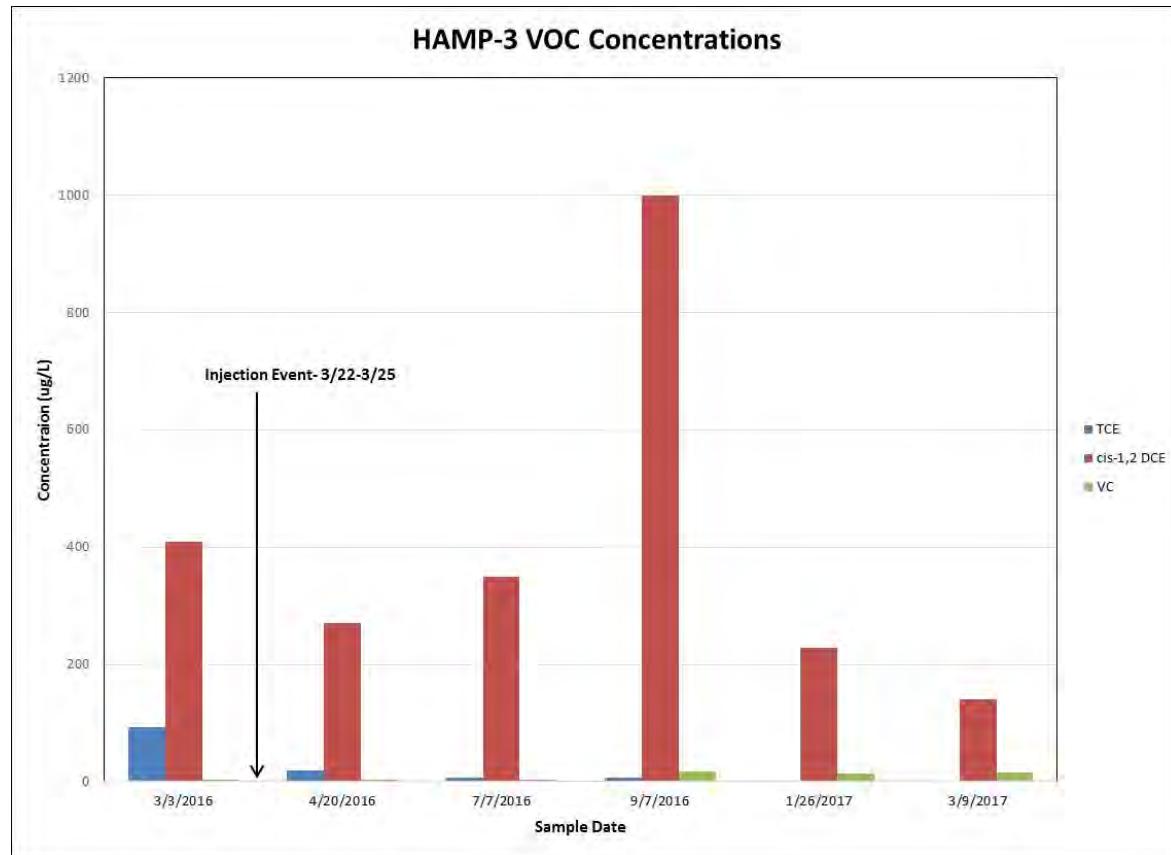
The field parameters measured at HAMP-3 indicate that the treatment zone is expanding over time in the downgradient direction. The redox potential has stabilized around -167 mV, the pH has increased to 7.05 s.u., which is still within acceptable biodegradation ranges, and the dissolved oxygen concentration has decreased to 0.83 mg/L. Geochemical parameters indicate an influence from the injection event, especially in the concentration of TOC and VFAs. Total and ferrous iron indicate that the subsurface is reducing. In addition, TOC has continued to increase from 1900 mg/L in September 2016 to 2290 mg/L in March 2017. Lactic Acid was present at 160 mg/L in September 2016, which indicated influence from nearby injection points. In March 2017, the concentration of lactic acid has decreased to below the

laboratory detection limit of 10 mg/L and the concentration of other fatty acids continue to decrease. The shift of the VFAs indicate a continuous breakdown of the lactate from bacteria in the subsurface. Sulfate remains below the laboratory detection limit of 5 mg/L. Elevated methane concentration of 16,000 ug/L further support reducing conditions.

The VOC concentrations have continued to decrease following the injection event when compared to the baseline event. The concentration of TCE has decreased to below detection limits. Daughter products of TCE have increased following the injection event, indicating that reductive dechlorination is occurring near this well. Cis-1,2-DCE and vinyl chloride have increased between the September 2016 and March 2017 sampling events, however the geochemical conditions in the subsurface remain ideal for biological reductive dechlorination.

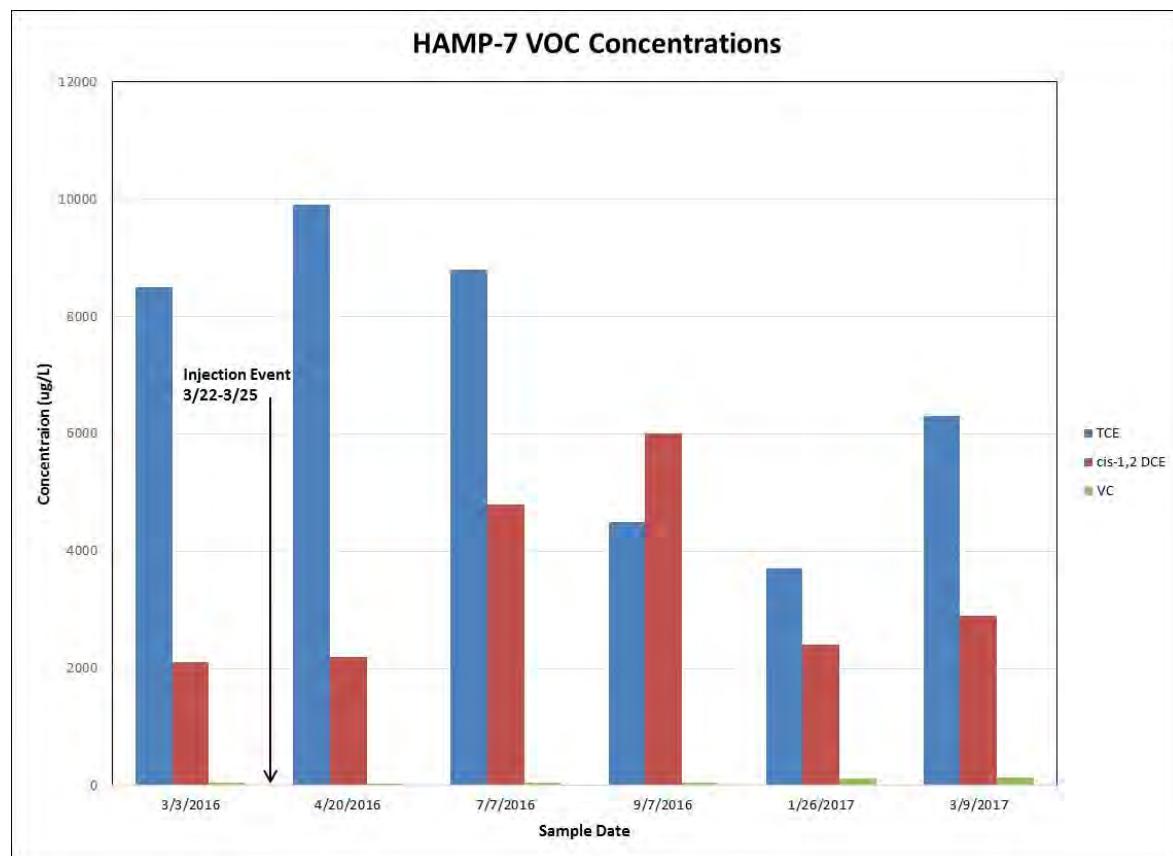
HAMP-7:

The field parameters measured at HAMP-7 indicate that the treatment zone initially expanded into the area surrounding this monitoring point. The redox potential is reducing at -156 mV, pH has become more neutral at 6.90 s.u. and dissolved oxygen concentration has remained low at 0.36 mg/L. Geochemical parameters initially indicated influence from the injection event, especially with iron, TOC, and VFA data. Sulfate has increased slightly from 23.8 mg/L in September 2016 to 25.2 mg/L in March 2017 and the concentration of iron has decreased significantly from 93.0 mg/L in September 2016 to 29.7 mg/l in March 2017. The ratio of ferrous iron to total iron indicates that the subsurface is continuing to be reducing and that enough iron exists to precipitate out any created sulfide in the subsurface. In addition, TOC concentrations have decreased significantly from 955 mg/L in September

2016 to 261 mg/L in March 2017. The decrease in TOC may indicate that the indigenous bacteria are utilizing the electron donor that was injected into the subsurface. In March 2017, the concentration of lactic acid has decreased significantly to below the laboratory detection limit of 10 mg/L and the concentration of other fatty acids continue to decrease with acetic acid, butyric acid and propionic acid at 170 mg/L, 74 mg/L and 350mg/L, respectively. The shift of the VFAs indicate a continuous breakdown of the lactate from bacteria in the subsurface. The VFA data suggests a robust population of bacteria in the subsurface. Ethene concentration of 310 ug/L indicate dehalogenation of vinyl chloride and complete degradation of TCE.

The VOC concentrations indicate stimulated reductive dechlorination near HAMP-7. Overall, TCE has decreased from almost 10,000 ug/L in March 2016 to 6,300 ug/L in March 2017, however the TCE measured in March 2017 has increased from the historical low measured in January 2017. While it appears that aquifer conditions remain favorable for biological degradation, the recent increase in TCE suggests that flux of TCE entering the treatment area is exceeding the rate of degradation and that consideration should be given to injecting additional amendments.

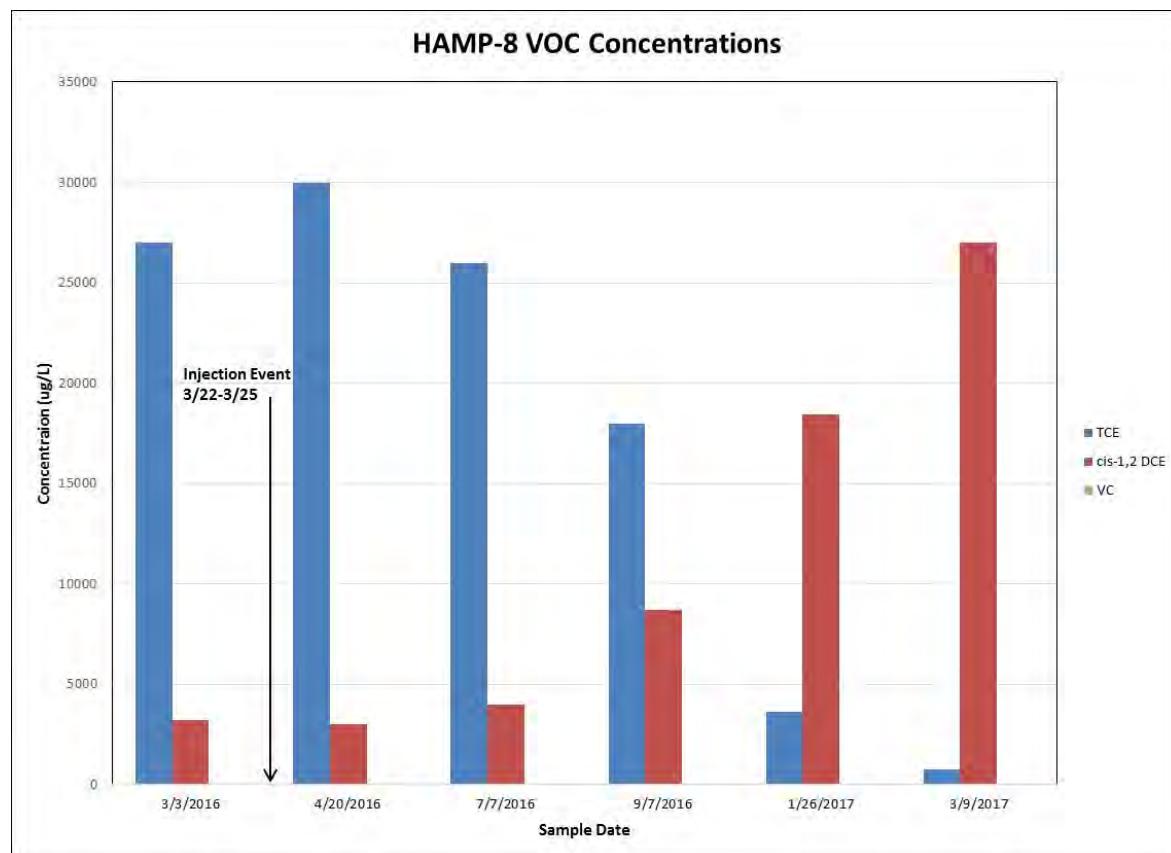
HAMP-8:

The field parameters and geochemical parameters measured at HAMP-8 indicate that the monitoring point continues to experience an influence from the remedial event. The redox potential continues to be reducing at -165 mV, the pH continues to increase at 6.60 s.u., and the dissolved oxygen

concentration remains low at 0.38 mg/L. The concentration of sulfate has decreased and the concentration of ferrous iron has decreased to 12.4 mg/L. The ratio of ferrous to total iron indicates that the subsurface continues to be reducing. In addition, the concentration of TOC has decreased between the September 2016 event and the March 2017 sampling event from 782 mg/L to 156 mg/L in March 2017. VFAs have also decreased and indicate biological activity. Lactic acid was present at 350 mg/L in September 2016 and it is now below detection limits of 10 mg/L. The biological breakdown products of lactic acid are still present at decreased concentrations with acetic acid, propionic acid and butyric acid present at 240 mg/L, below reporting limit of 5 mg/L, and 58 mg/L, respectively. The absence of lactic acid and the presence of breakdown VFAs such as acetic acid and propionic acid indicate biodegradation near HAMP-8.

The VOC concentrations have decreased dramatically during the performance sampling timeframe following the injection event indicating that reductive dechlorination is occurring near HAMP-8. TCE concentrations have decreased from 18,000 ug/L to 760 ug/L, a decrease of 96% and cis-1,2-DCE has increased from 8,700 ug/L in September 2016 to 27,000 ug/L in March 2017. Vinyl chloride was not detected, potentially due to dilution of the sample that resulted in an elevated detection limit of 50 ug/L. The increase in daughter products strongly indicate that biodegradation is occurring near HAMP-8. Additional decreases in TCE and daughter products is expected during subsequent sampling events.

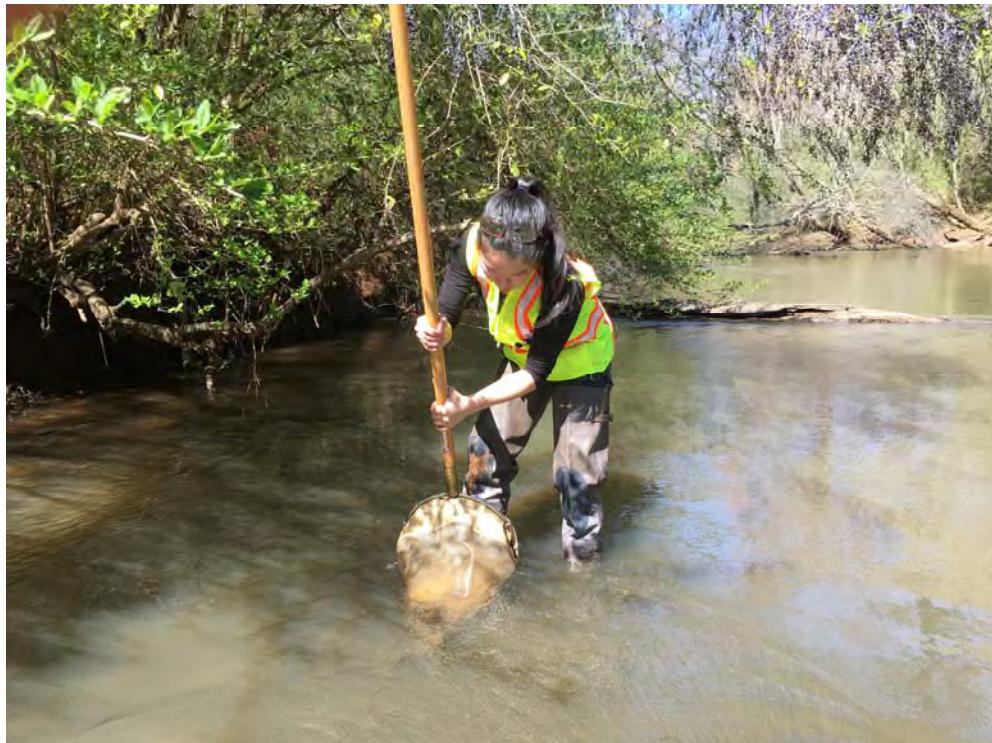
Photograph 1. Station BS-01 (view south from access point), located downstream from discharge point of Unnamed Stream into the North Oconee River. First sample was obtained from snag seen in photograph using a D-frame kick net.

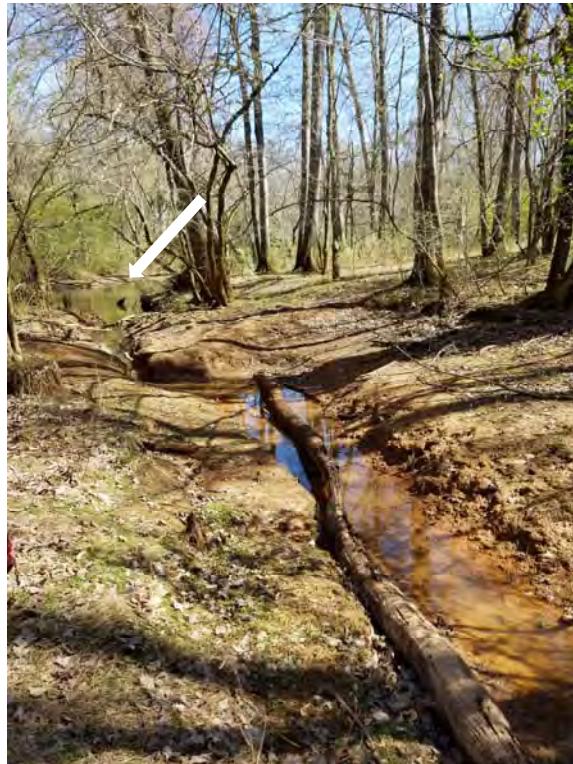
Photograph 10. Station BS-03 (view looking upstream of Unnamed Stream), just west of discharge point of Unnamed Stream into the North Oconee River.

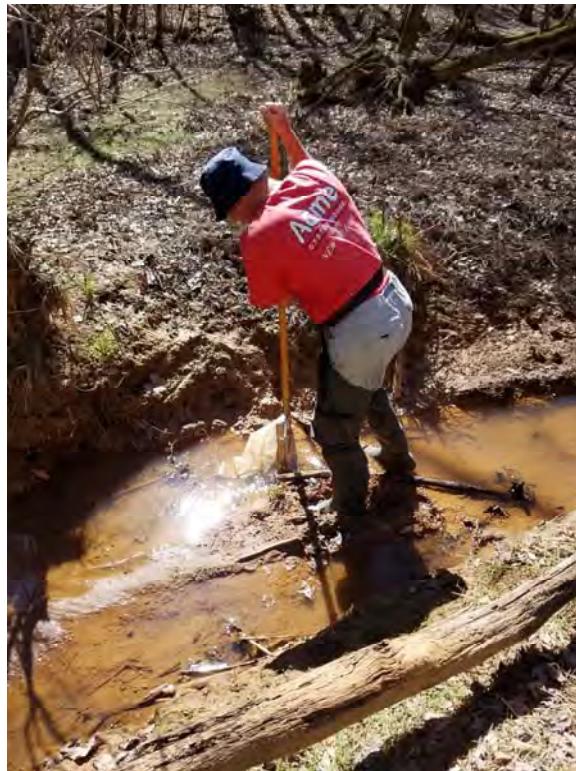
Photograph 12. Station BS-03, biological sample was obtained from substrate bottom and small riffle. Substrate was observed to be poor and water was shallow.

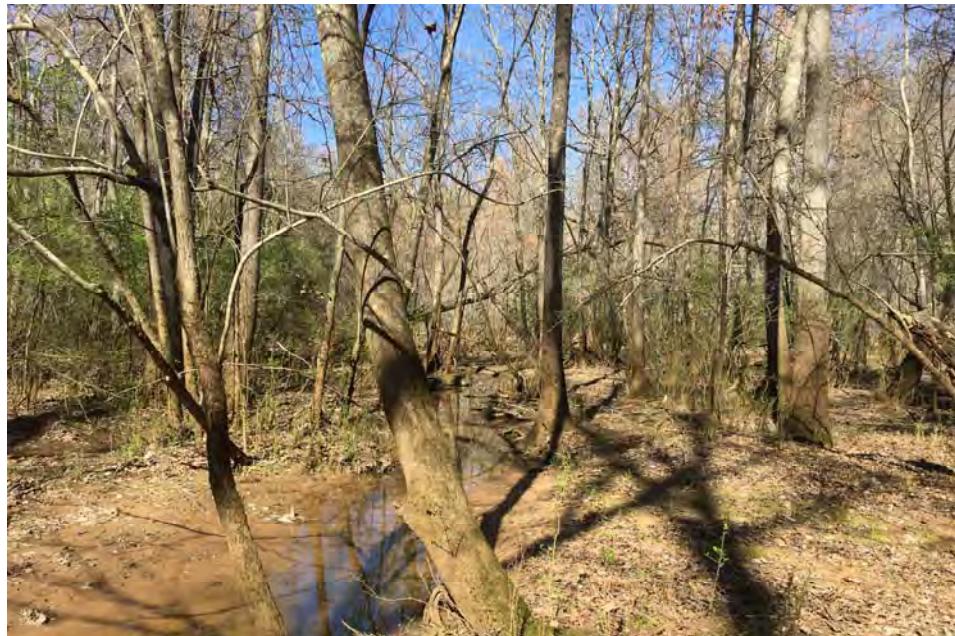
Photograph 14. Station BS-04 (view looking east i.e. downstream of Unnamed Stream), substrate was observed to be very mucky. Samples were obtained from leaf packs.

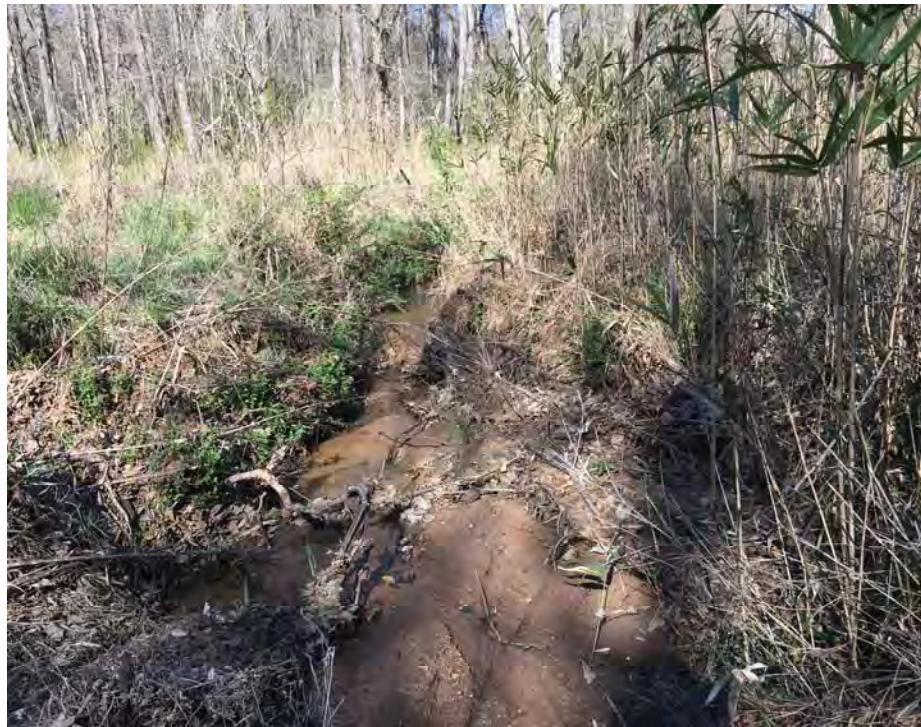
Photograph 15. Station BS-05 (view looking east i.e. downstream of Unnamed Stream), located within the power easement. Heavy sedimentation, due to storm events, was observed. Water was too shallow to obtain macroinvertebrate sample.

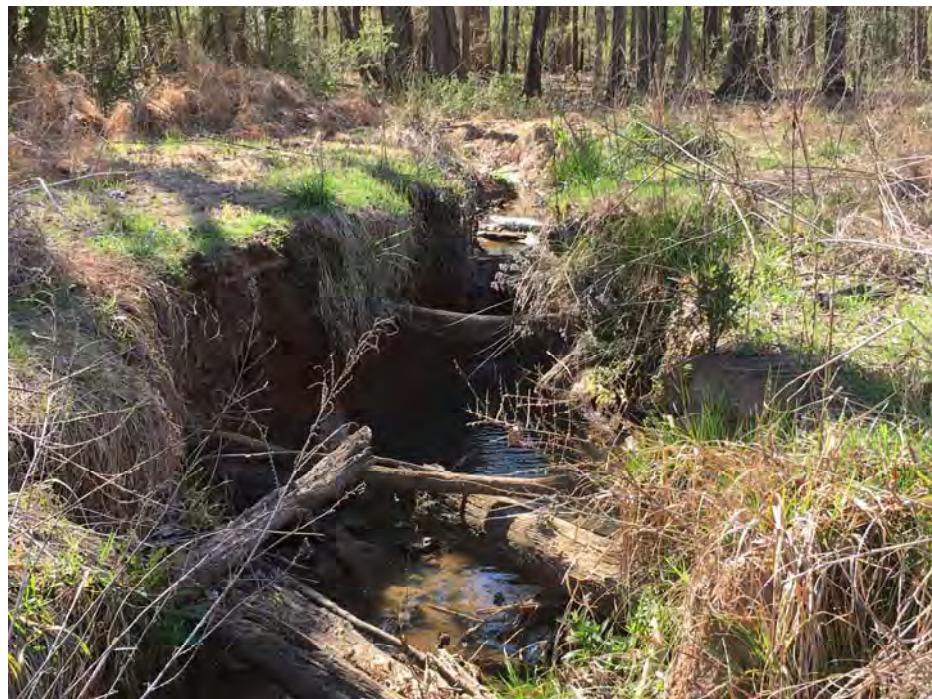
Photograph 16. Slightly upstream of Station BS-05 (view looking west i.e. upstream of Unnamed Stream); note the deeply incised channel due to heavy erosion during storm events.

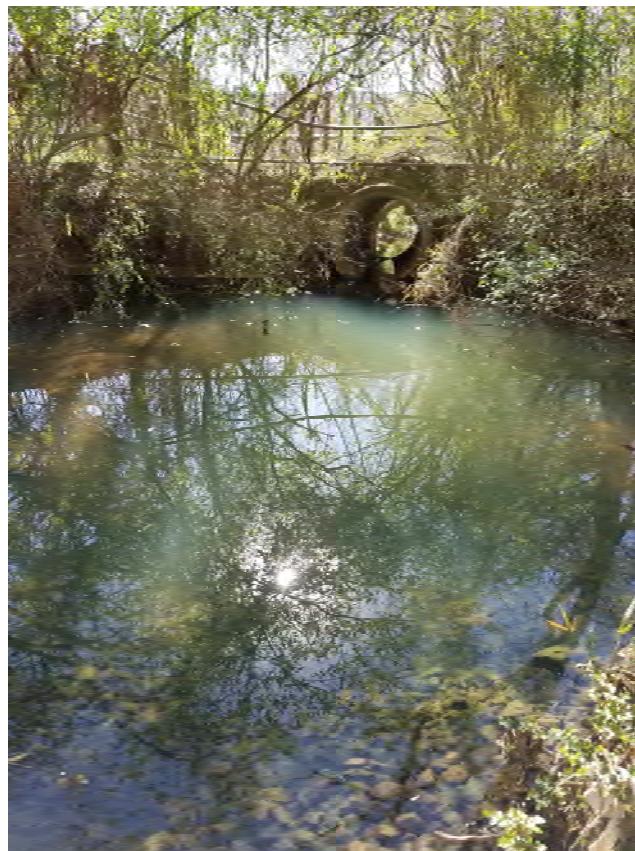
Photograph 17. View (looking upstream) of the culvert where the Unnamed Stream discharges off of the Champion Dairy Pak property.

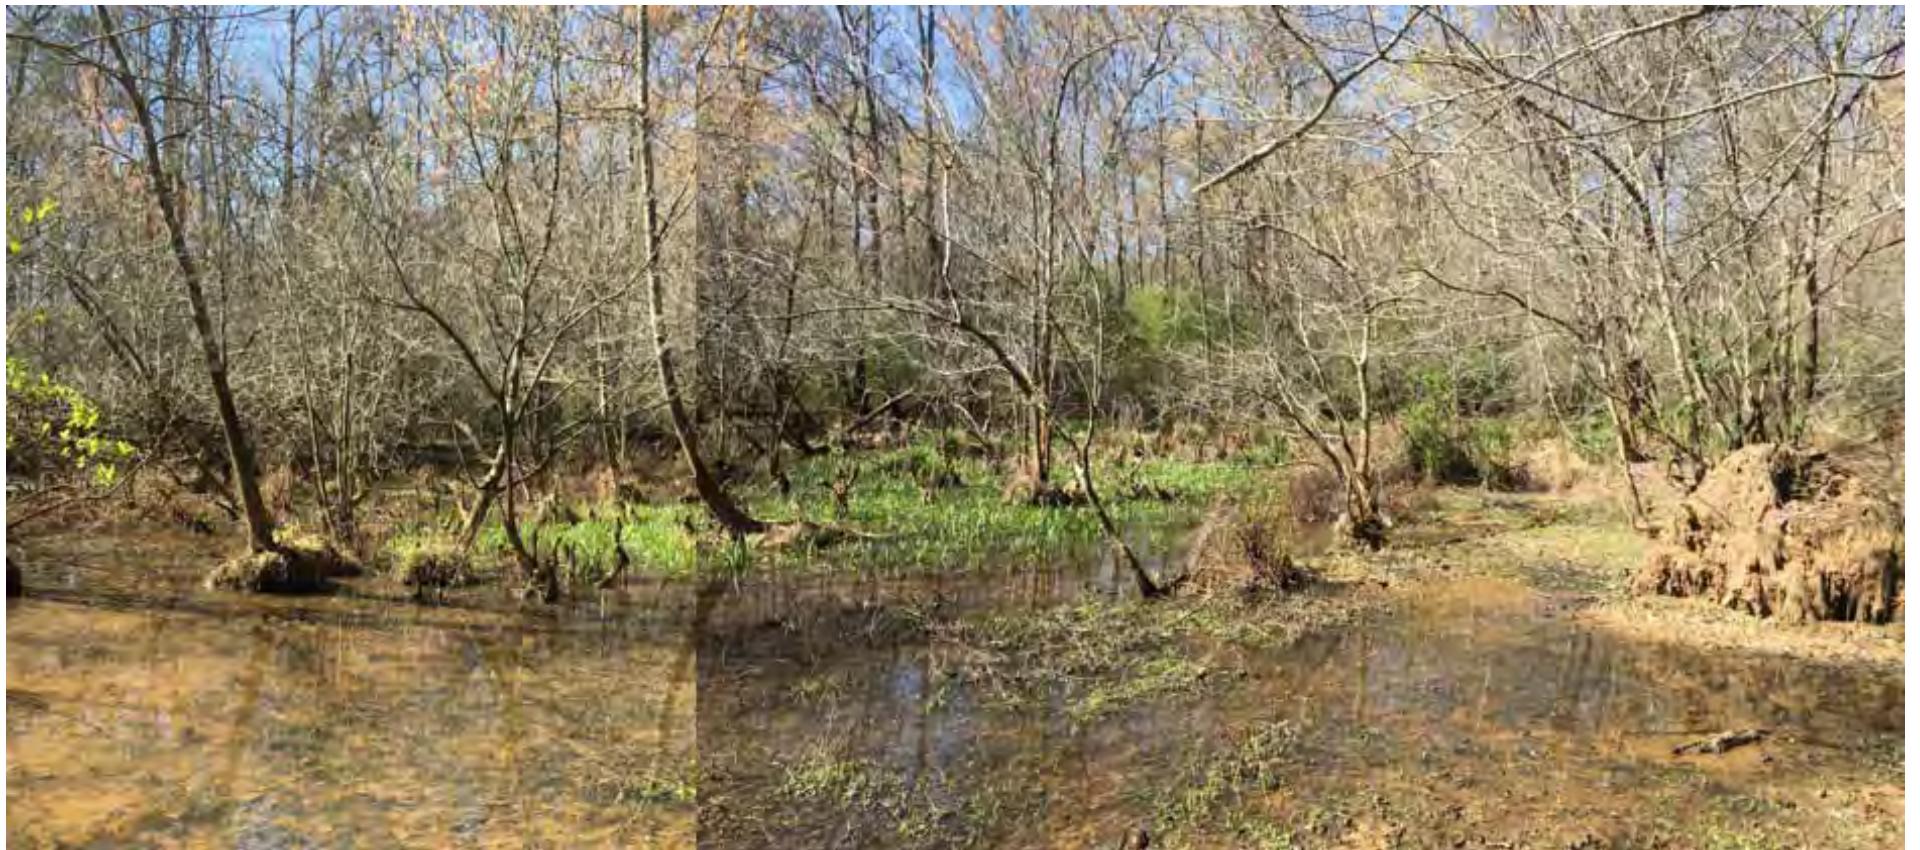
Photograph 18. View of the apparent origin of the Unnamed Stream located adjacent to (northeast) of the Site. The source of this headwater stream is not known but some of the discharge is most likely from suburban runoff.

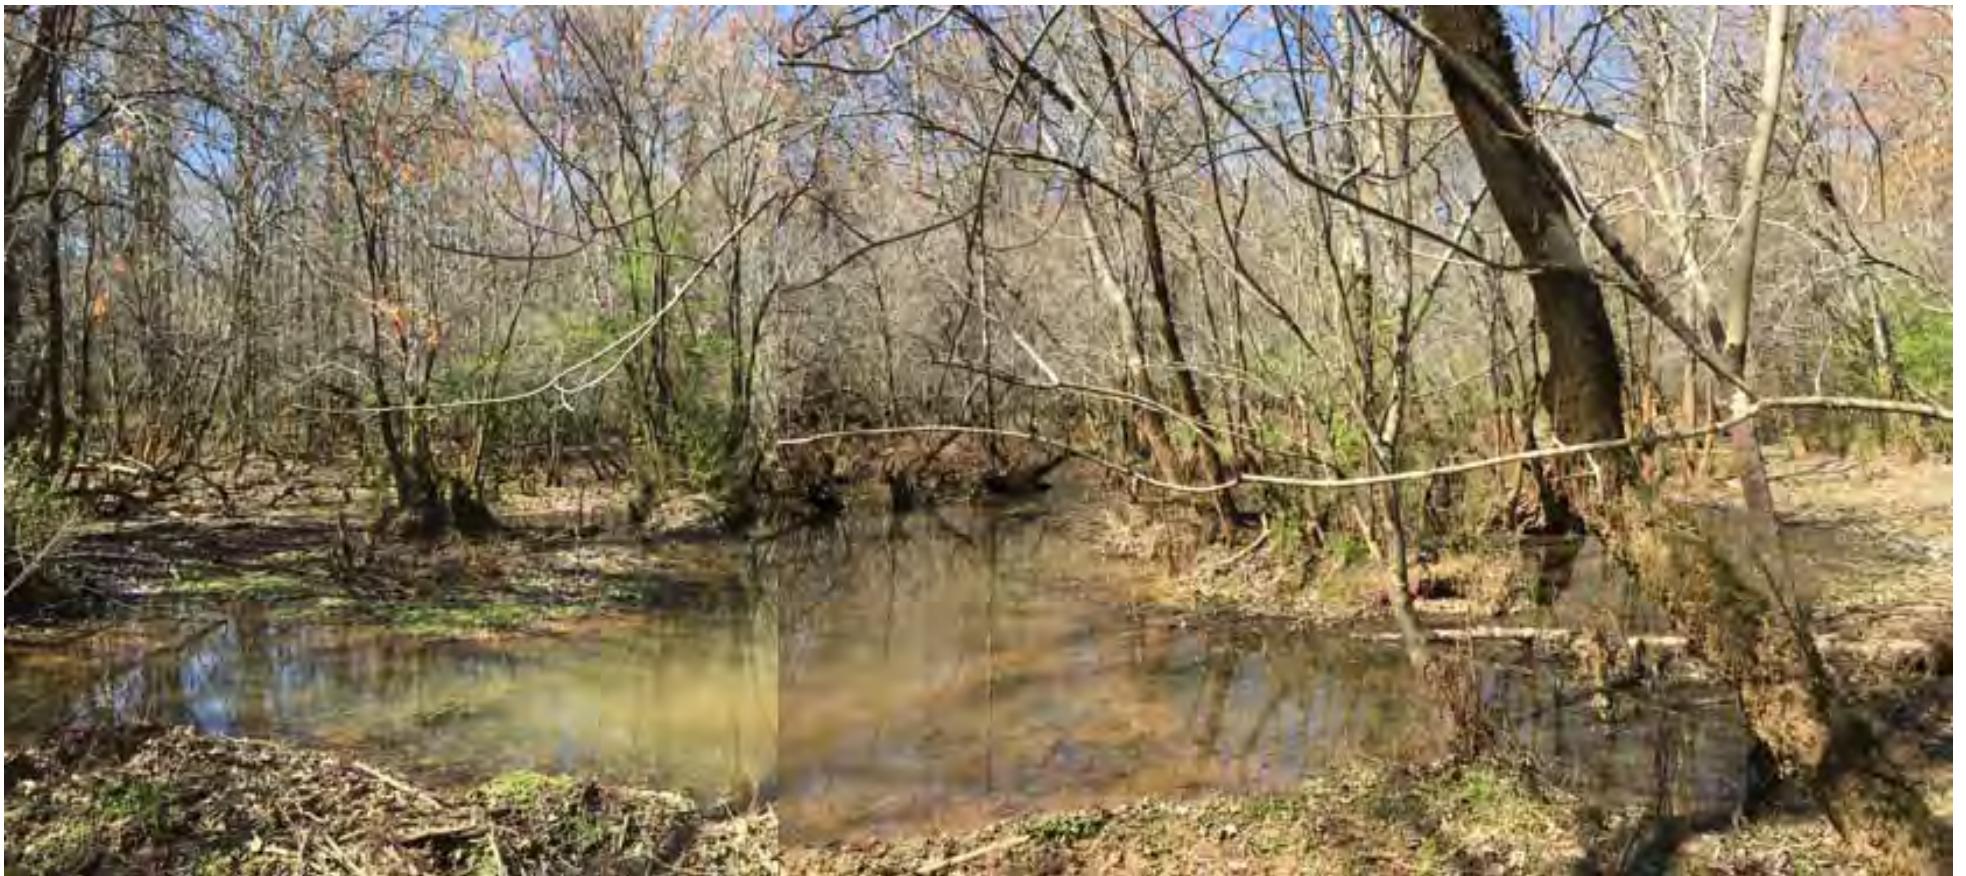
Photograph 19. Composite photograph showing a portion of the Unnamed Wetland located west of BS-02 (slightly upstream of confluence of the Unnamed Stream with North Oconee River). Note the termite mound to the right of the photograph.
