**VOLUNTARY REMEDIATION PROGRAM
PROGRESS REPORT #5
Grantville Mill
41 Industrial Way
Grantville, GA 30220**

January 2018

**VOLUNTARY REMEDIATION PROGRAM
PROGRESS REPORT #5
GRANTVILLE MILL
41 Industrial Way
Grantville, GA 30220**

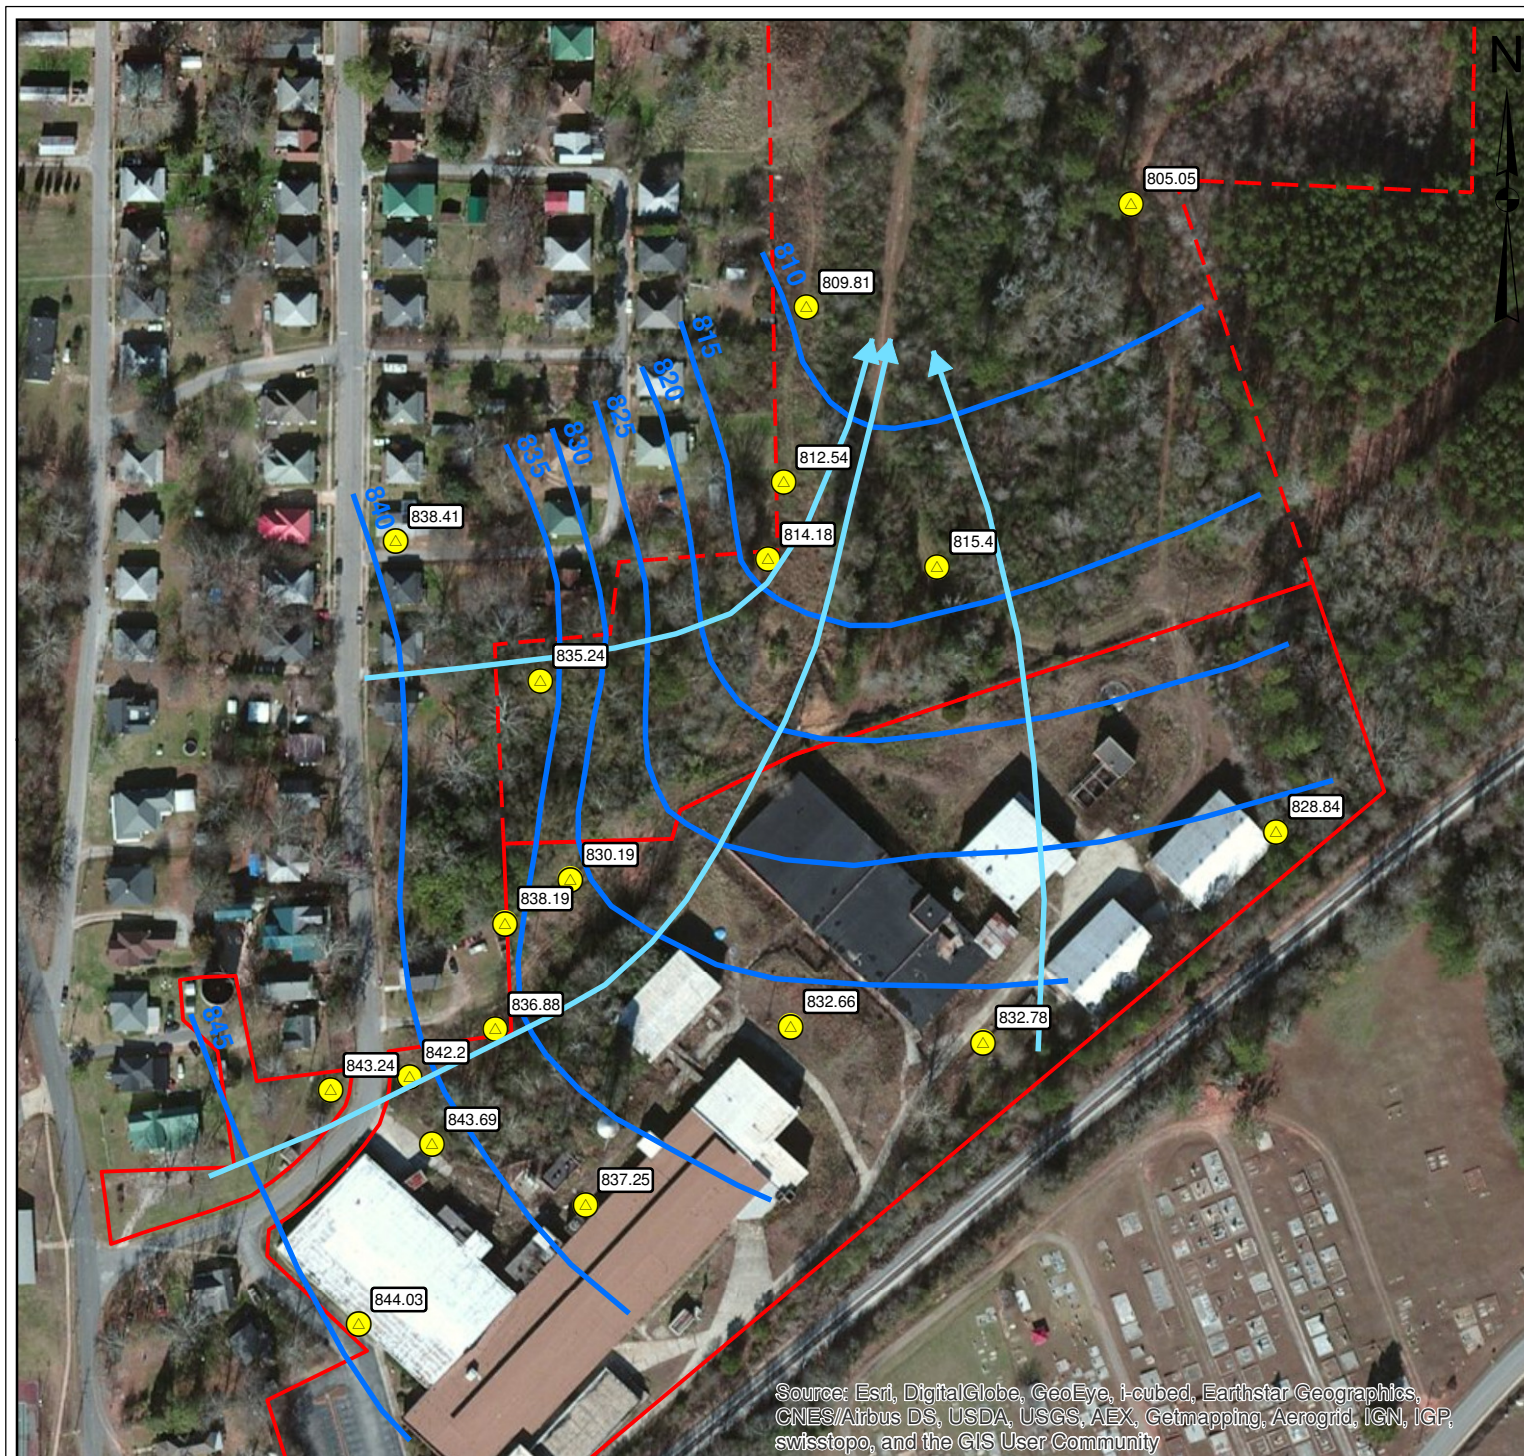
Figure 5
 Site Potentiometric Surface
 and Groundwater Flow Direction
 Grantville Mill
 Grantville, Georgia

Figure Narrative
 Figure depicts Site groundwater flow
 based on the modeled
 potentiometric surface.

Notes
 Groundwater levels measured
 October 31, 2016

The depth to the water table and groundwater flow direction have been updated semi-annually (2014-2016) as additional monitoring wells have been installed to investigate the subsurface condition. All wells are surveyed with respect to the Georgia West State Plane coordinate system with elevation established with respect to ft amsl. Evaluations of groundwater flow to date consistently model flow to the northeast across the CCB parcel then turning to a more northerly direction along the Grantville Mill LLC parcel (Figure 5). This groundwater flow model mimics the ground surface topography as is typical in unconfined strata within the Piedmont. Groundwater flow is expected to continue in a northerly direction beyond MW-2 following the axis of the valley floor.

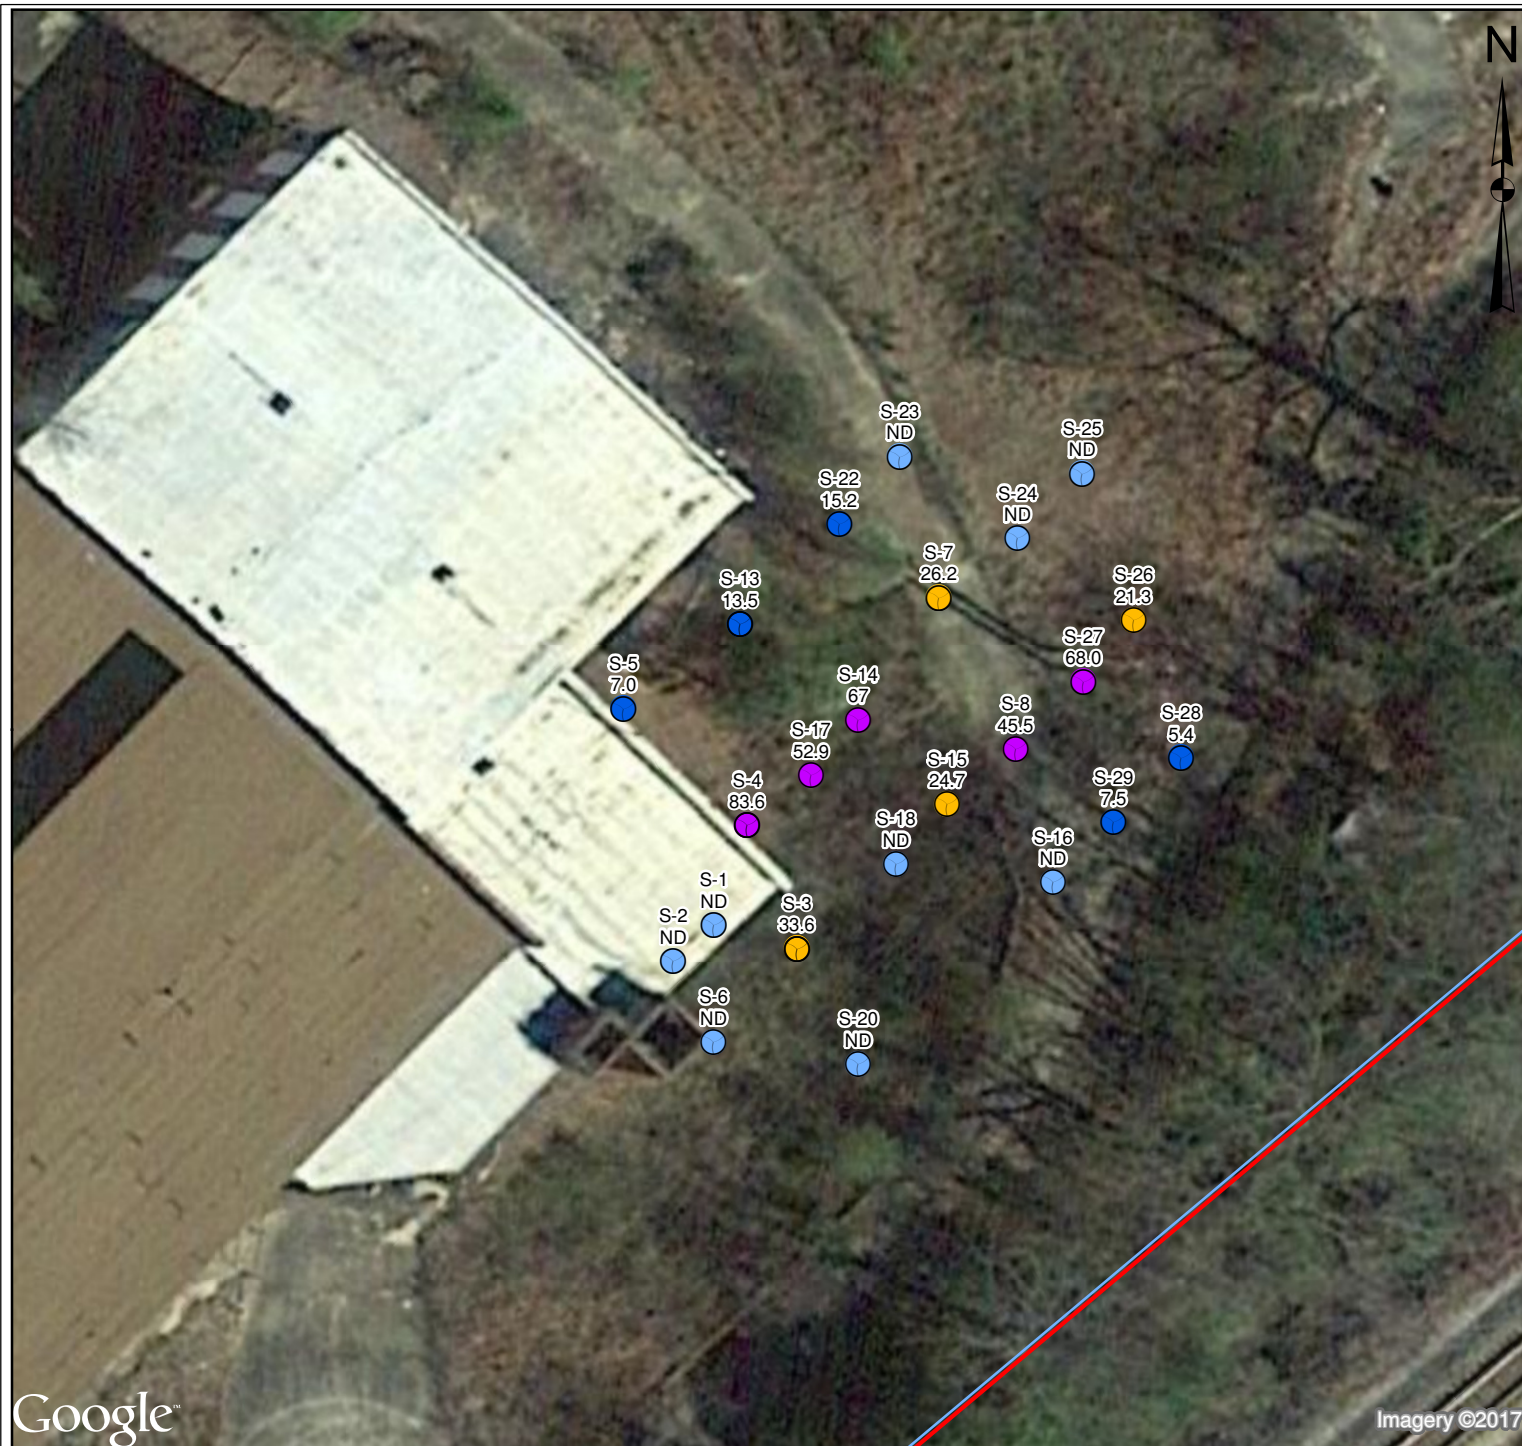
Figure 8b
Arsenic Soil Delineation:
Machinery Area 1-2 ft-bgs

(Figure 8b). Soil from 1-2 ft-bgs is delineated to the residential RRS with a single exception at S-26, which reported arsenic at 21.3 mg/kg, slightly above the residential RRS of 20 mg/kg. The corresponding shallow (< 0.5 ft-bgs) and deep (4 ft-bgs) samples at S-26 are both below the residential RRS.

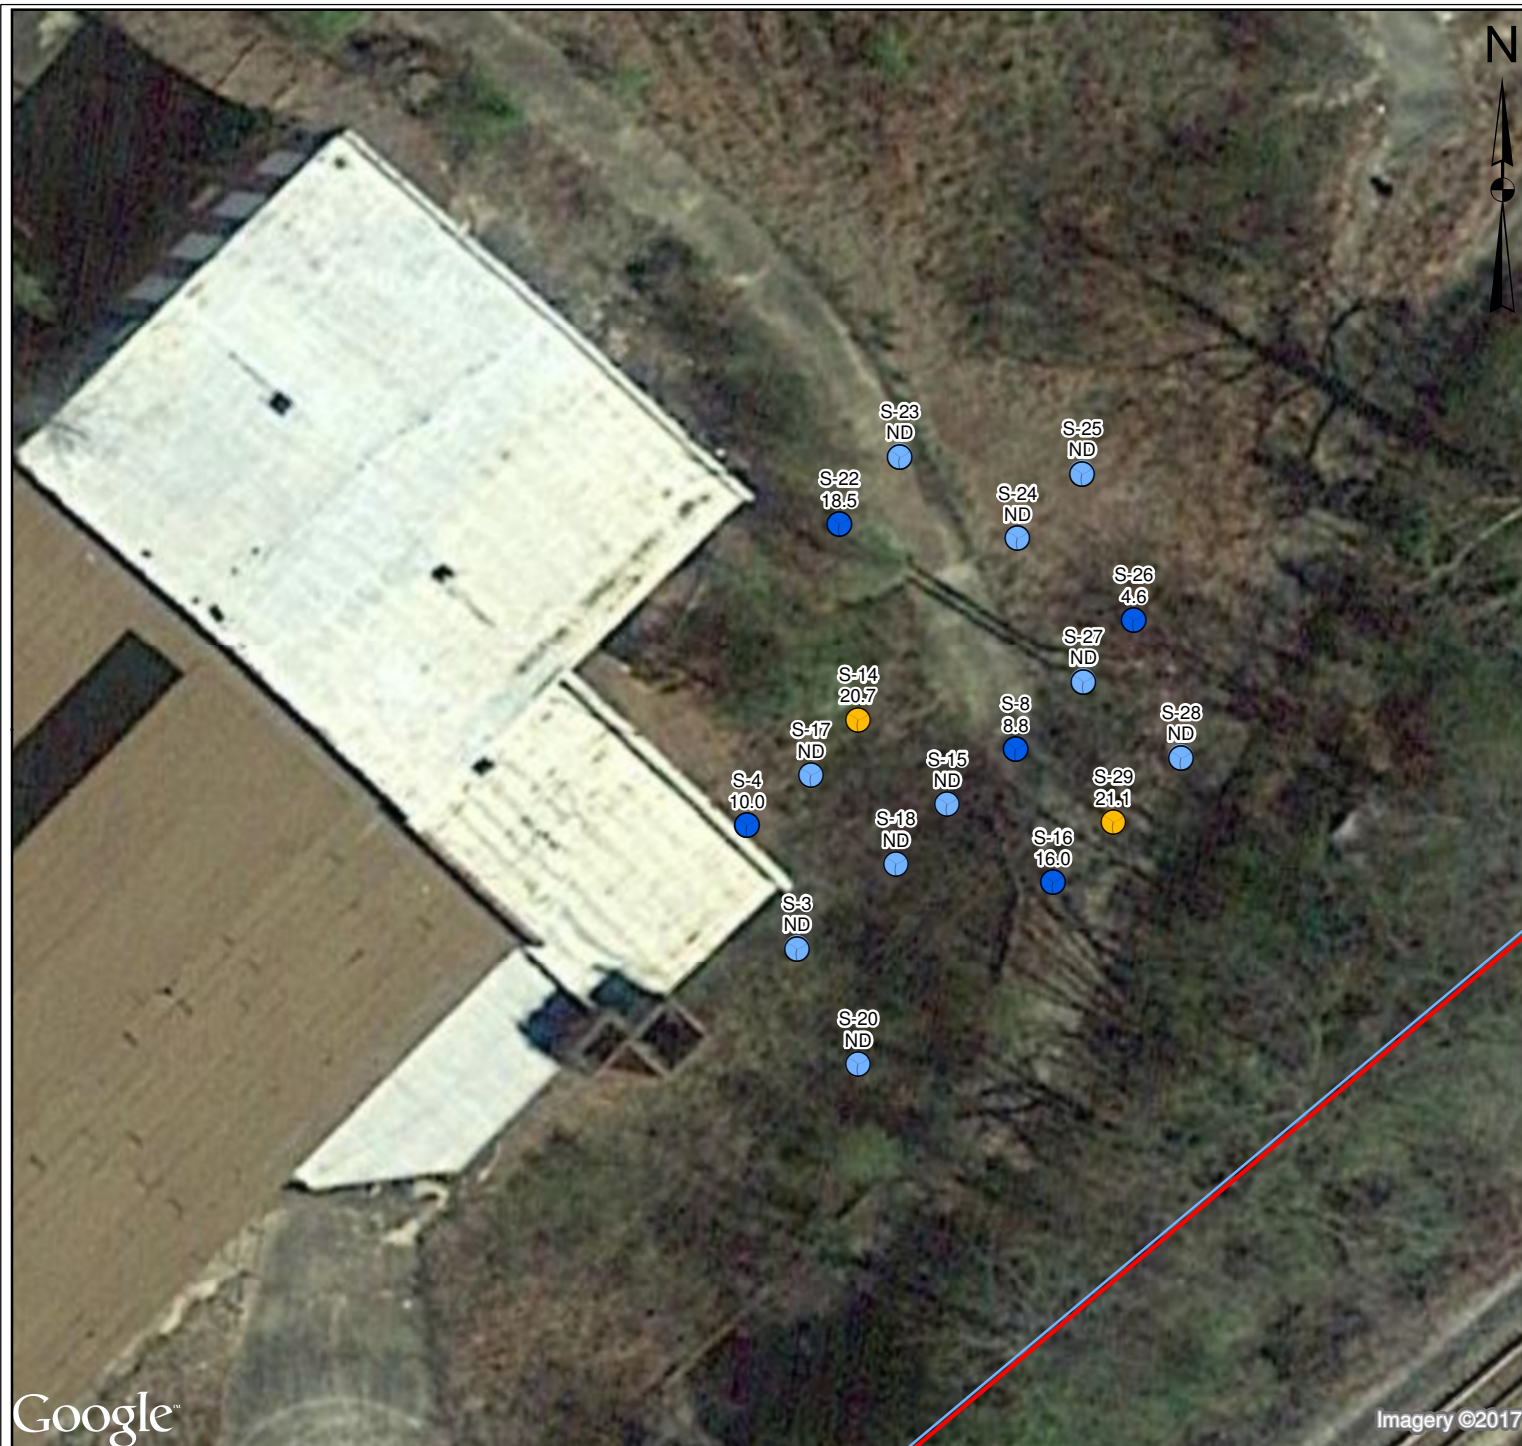
Figure 8c
 Arsenic Soil Delineation:
 Machinery Area 2-4 ft-bgs

Soil from 2-4 ft-bgs exhibits overall lower arsenic concentrations ranging from non-detect to 21.1 mg/kg (Figure 8c). Two samples collected at 4 ft-bgs are reported slightly above the residential RRS at 20.7 mg/kg (S-14) and 21.1 mg/kg (S-29), but below the non-residential RRS of 38 mg/kg. These soil samples are also below the soil depth applied to residential exposure (i.e., 2 ft-bgs)

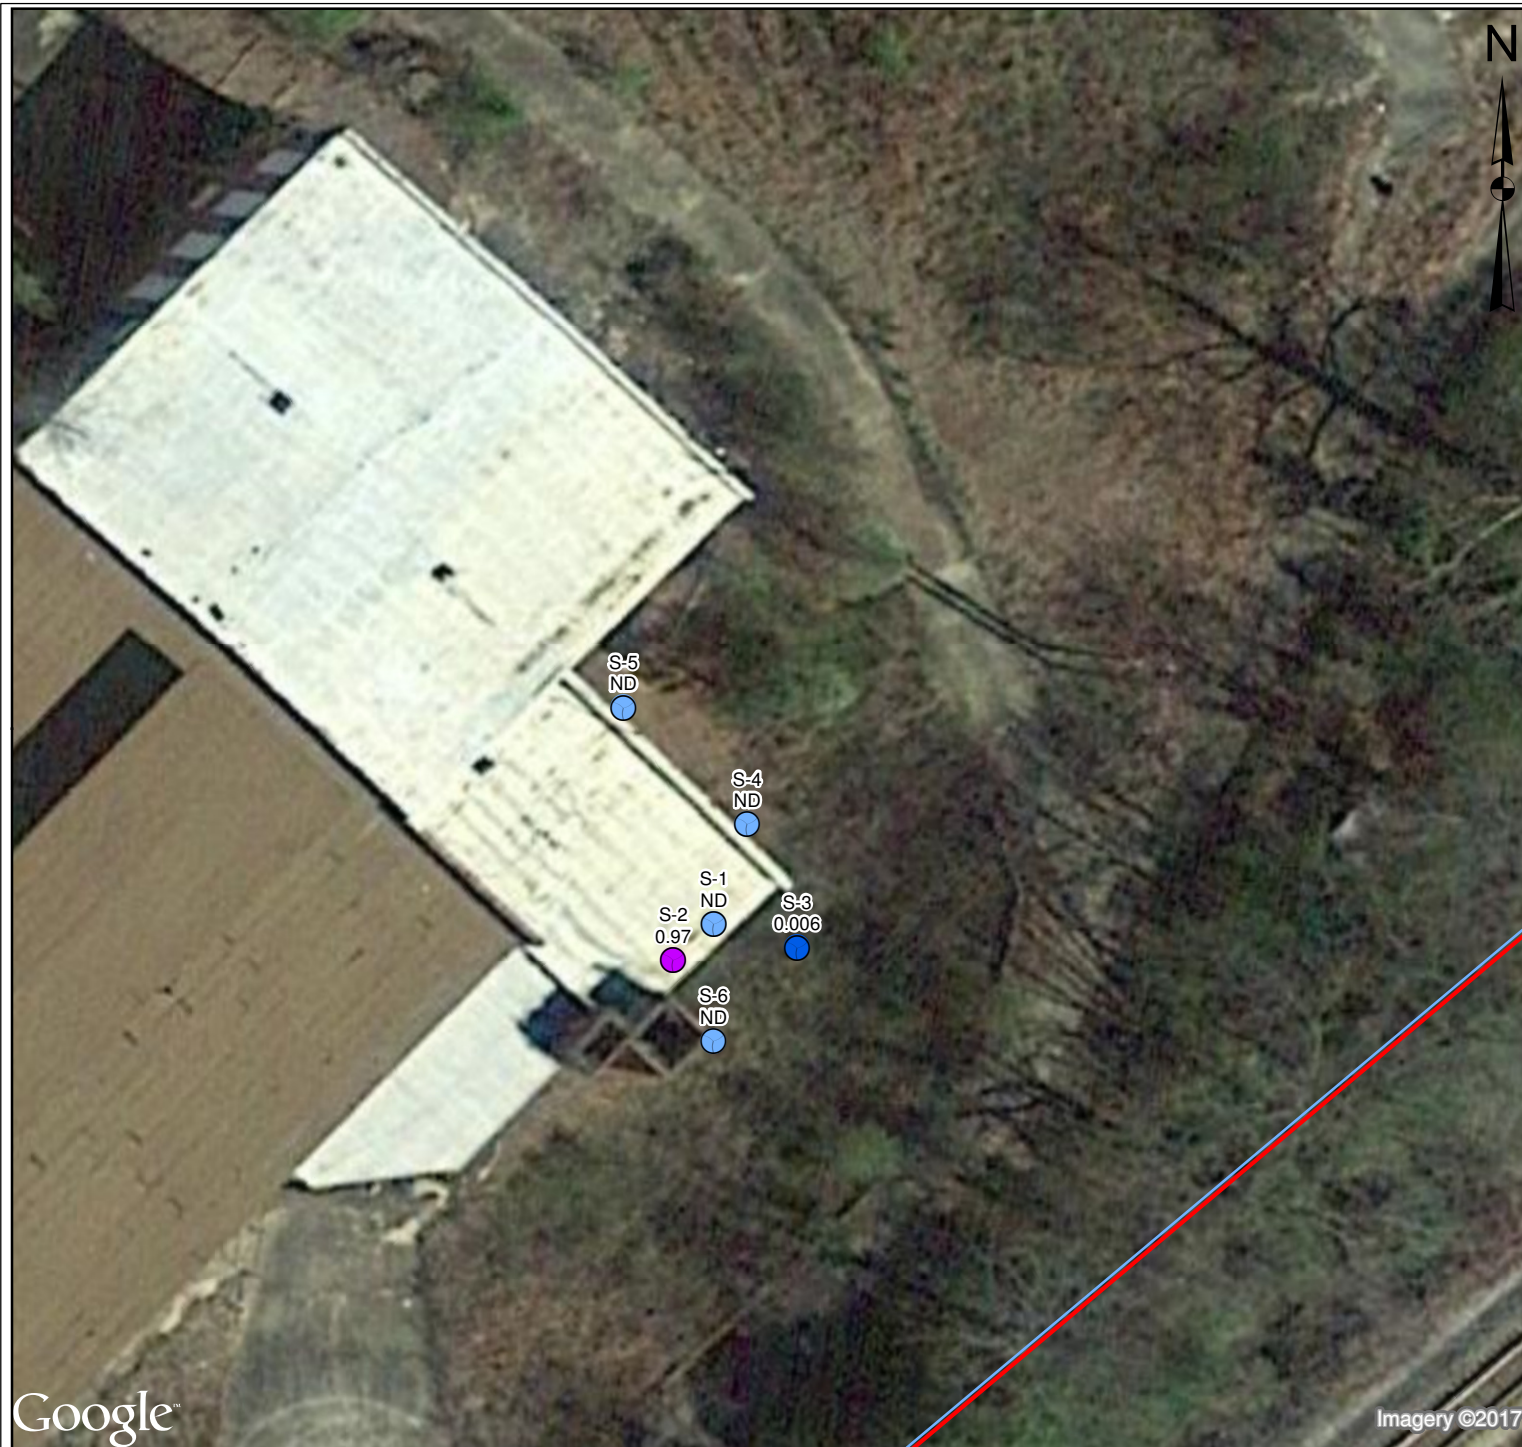
Figure 9a
Benzene Soil Delineation:
Machinery Area 0.5 ft-bgs

Benzene was detected above the residential/non-residential RRS of 0.5 mg/kg in one interior soil sample (S-2) at 0.5 ft-bgs in May 2016 (Figure 9a). The sample was collected from shallow soil adjacent to mechanical equipment. Follow-up delineation sampling performed on June 2, 2017, found benzene to be non-detect or below the residential RRS in the soil surrounding the former machinery area, thus finding the benzene condition limited to the interior of the building. Soil benzene concentrations are non-detect or below the residential RRS in soil samples collected at a depth of 1.0 ft-bgs in the machinery area (Figure 9b).

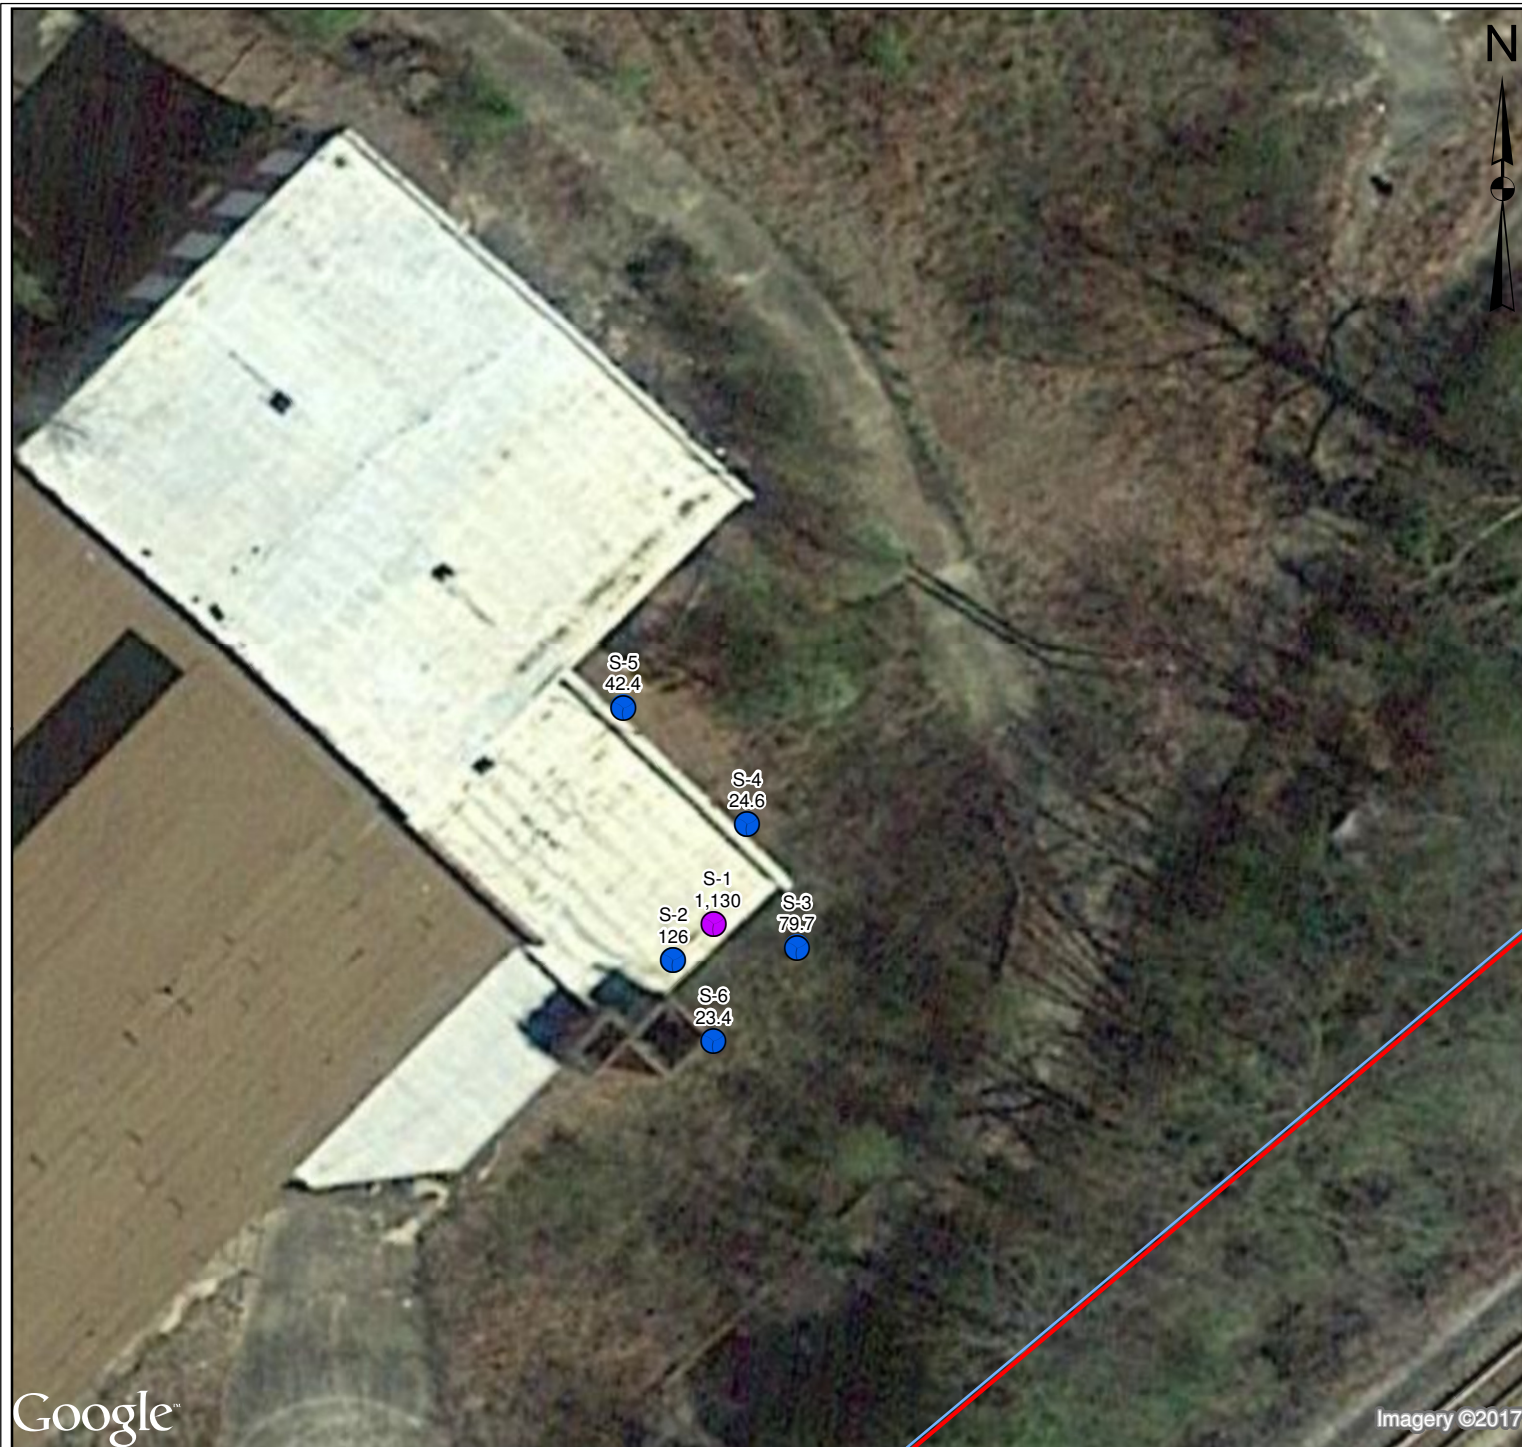
Figure 10a
Lead Soil Delineation:
Machinery Area 0.5 ft-bgs

Lead was detected above both the residential RRS of 270 mg/kg and the non-residential RRS of 400 mg/kg in one machinery area soil sample (S-1) at 0.5 ft-bgs in May 2016 (Figure 10a). Follow-up delineation sampling performed on June 2, 2017, found lead to be below (Figure 10a) the residential RRS in the soil surrounding the former machinery area. Soil lead concentrations are below the residential RRS in soil samples collected at a depth of 1.0 ft-bgs in the machinery area (Figure 10b).
