Third VRP Progress Report July 1 through December 31, 2018

1610 Southland Circle
Atlanta, Georgia

Southland Circle Property
(HSI # 10077)

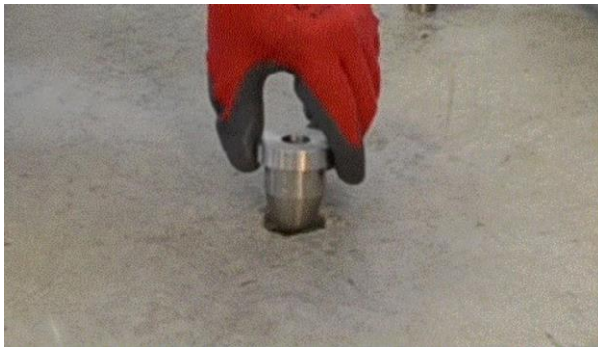
Figure 3. Testing Depth with the Drilling Guide

- 4) Remove cuttings from the hole and place the Drilling Guide in the hole with the conical end down (Figure 3). The hole is sufficiently deep if the flange of the Drilling Guide lies flush with the surface of the slab. Deepen the hole as necessary, but avoid drilling more than 2 inches into the slab, as the threads on the Secure Cover may not engage properly with the threads on the VAPOR PIN®.

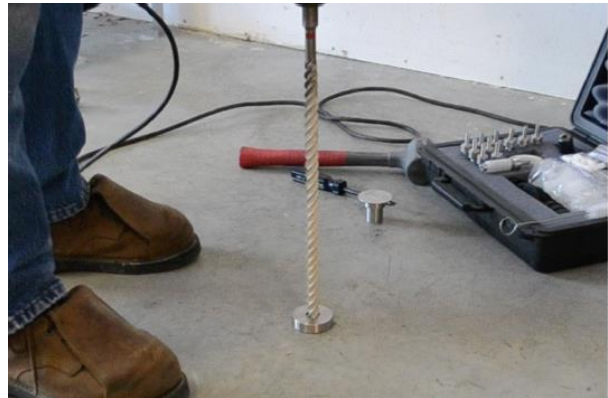
Figure 4. Using the Drilling Guide

- 5) When the 1½-inch diameter hole is drilled to the proper depth, replace the drill bit with a 5/8-inch diameter bit, insert the bit through the Drilling Guide (Figure 4), and drill through the slab. The Drilling Guide will help to center the hole for the VAPOR PIN®, and keep the hole perpendicular to the slab.
- 6) Remove the bit and drilling guide, clean the hole, and install the VAPOR PIN® in accordance with the SOP “Installation and Extraction of the VAPOR PIN®.

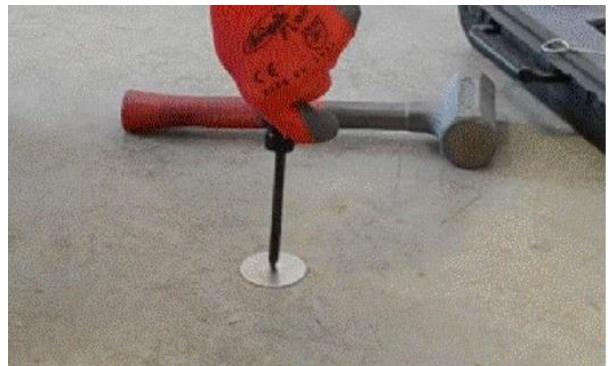
Figure 5. Tightening the Secured Cover

- 7) Screw the Secure Cover onto the VAPOR PIN® and tighten using a #14 spanner wrench by rotating it clockwise (Figure 5). Rotate the cover counter clockwise to remove it for subsequent access.

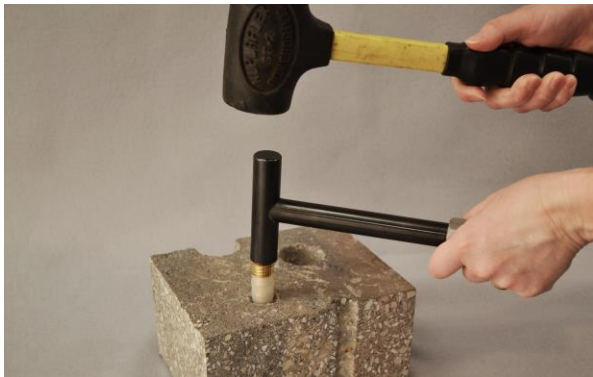
Figure 2. Installing the VAPOR PIN®

- 5) Remove the drill bit, brush the hole with the bottle brush, and remove the loose cuttings with the vacuum.
- 6) Place the lower end of VAPOR PIN® assembly into the drilled hole. Place the small hole located in the handle of the installation/extraction tool over the vapor pin to protect the barb fitting, and tap the vapor pin into place using a dead blow hammer (Figure 2). Make sure the installation/extraction tool is aligned parallel to the vapor pin to avoid damaging the barb fitting.

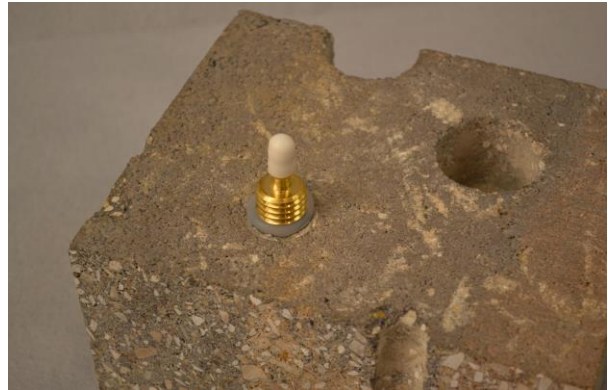
Figure 3. Installed VAPOR PIN®

During installation, the silicone sleeve will form a slight bulge between the slab and the VAPOR PIN® shoulder. Place the protective cap on VAPOR PIN® to prevent vapor loss prior to sampling (Figure 3).

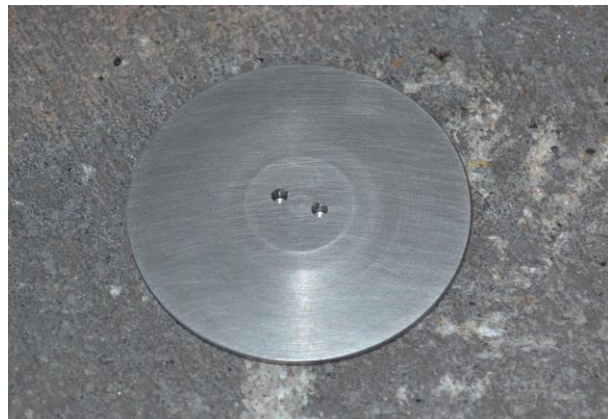
Figure 4. Secure Cover Installed

- 7) For flush mount installations, cover the vapor pin with a flush mount cover, using either the plastic cover or the optional stainless-steel Secure Cover (Figure 4).

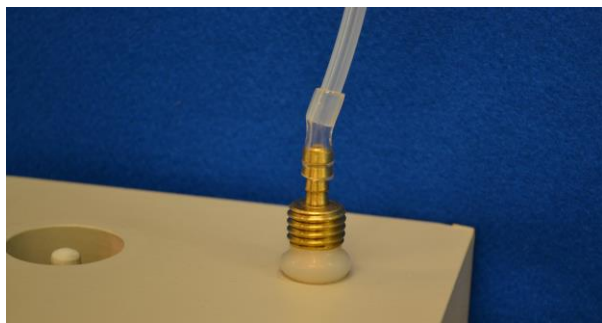
Figure 5. VAPOR PIN® sample connection

Nylaflow tubing (Figure 5). Put the Nylaflow tubing as close to the VAPOR PIN® as possible to minimize contact between soil gas and Tygon™ tubing.

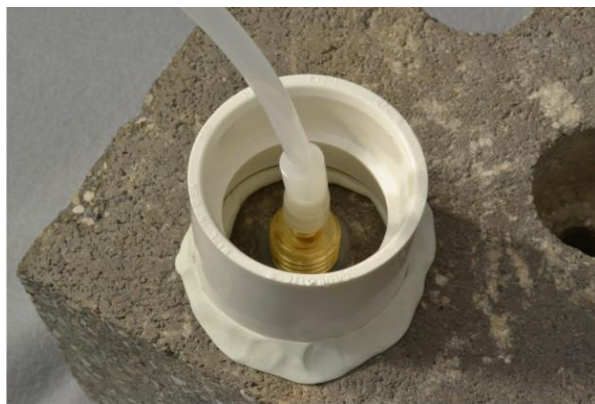
Figure 6. Water dam used for leak detection

10) Conduct leak tests in accordance with applicable guidance. If the method of leak testing is not specified, an alternative can be the use of a water dam and vacuum pump, as described in SOP Leak Testing the VAPOR PIN® via Mechanical Means (Figure 6). For flush-mount installations, distilled water can be poured directly into the 1 1/2 inch (38mm) hole.

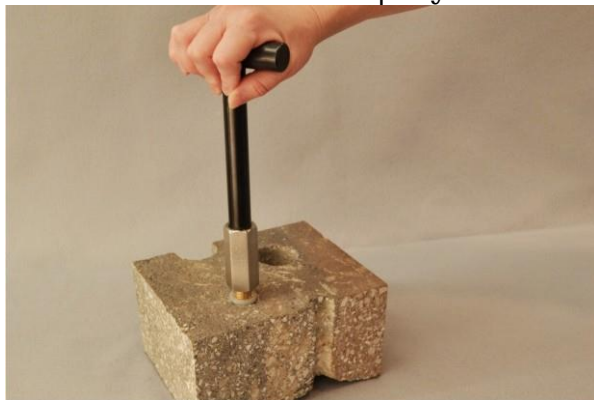
Figure 7. Removing the VAPOR PIN®

1) Remove the protective cap, and thread the installation/extraction tool onto the barrel of the VAPOR PIN® (Figure 7). Turn the tool clockwise continuously, don't stop turning, the VAPOR PIN® will feed into the bottom of the installation/extraction tool and will extract from the hole like a wine cork, DO NOT PULL.
