**VOLUNTARY REMEDIATION PROGRAM  
REVISED COMPLIANCE STATUS REPORT  
FORMER LAFARGE ROAD MARKING, INC.  
East Point, Georgia**

May 2018

# **VOLUNTARY REMEDIATION PROGRAM REVISED COMPLIANCE STATUS REPORT**

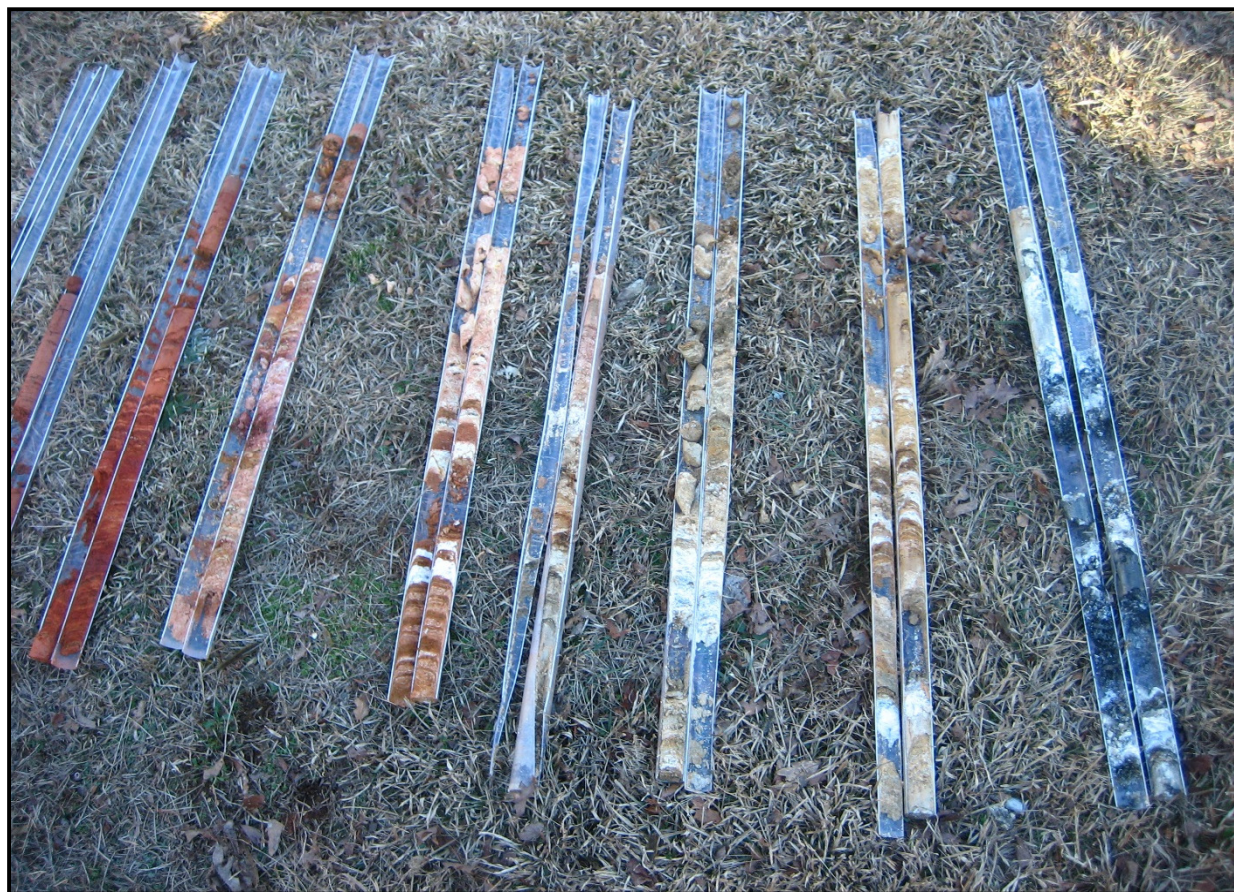
**Photograph of weathering progression of parent crystalline Piedmont rock  
(top of core to the left).**

In the photograph, depth below ground surface goes from shallow to deep starting at the upper left hand corner moving down to the lower right hand corner. In the near-surface portion of the core, the soil is characterized by the unmistakable red clay of Georgia. The red clay transitions to a brown clay and then to a distinct saprolite profile characterized by bands of browns, whites, and yellows, which retain the structure of the parent rock (brown/yellow coloration is a result of oxidation). This transitions to less chemically-weathered material with the same coloration (gray) as the underlying crystalline rock.

Residual soils in the Piedmont formations in Georgia are products of physical and chemical weathering of the underlying parent crystalline bedrock. Weathering generally decreases with depth below the ground surface, with a textural gradation from clay, silt, and sand-sized particles (soil) to saprolite, where the structure of the parent rock is preserved. In other words, the bedding planes and interfaces of decomposed parent rock are maintained. An example of this weathering profile is provided in a soil core shown in the photograph below, taken from a site in Atlanta. (Note Appendix H contains photographs of cores taken from well installation at the Site.)

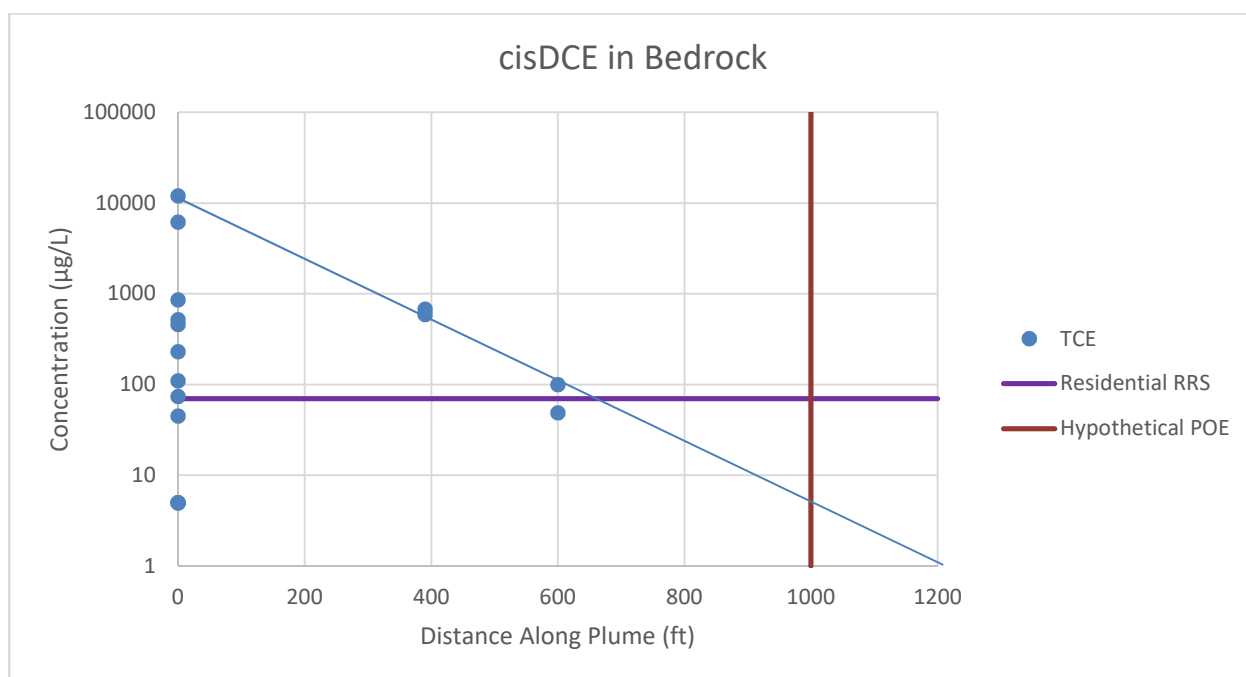
As the plume is mature and stable, current groundwater data (*i.e.*, an empirical model) can be used to evaluate the groundwater condition at the POE. Graphs were generated showing the concentration of TCE along the plume from the release area (the Site). The wells used are shown on Figure 19. The data from 2015-2017 from each well were used. Below are graphs for TCE in saprolite, PWR, and bedrock; and cis-DCE in bedrock. These graphs indicate that the expected concentration at the POE are below the residential RRSs.

More importantly, there is no groundwater exposure as there are no drinking water wells and none will be installed due to the availability of municipal water and the Fulton County ordinance. Although it is not necessary to certify compliance for groundwater at the Site, groundwater meets Residential RRSs at the POE.

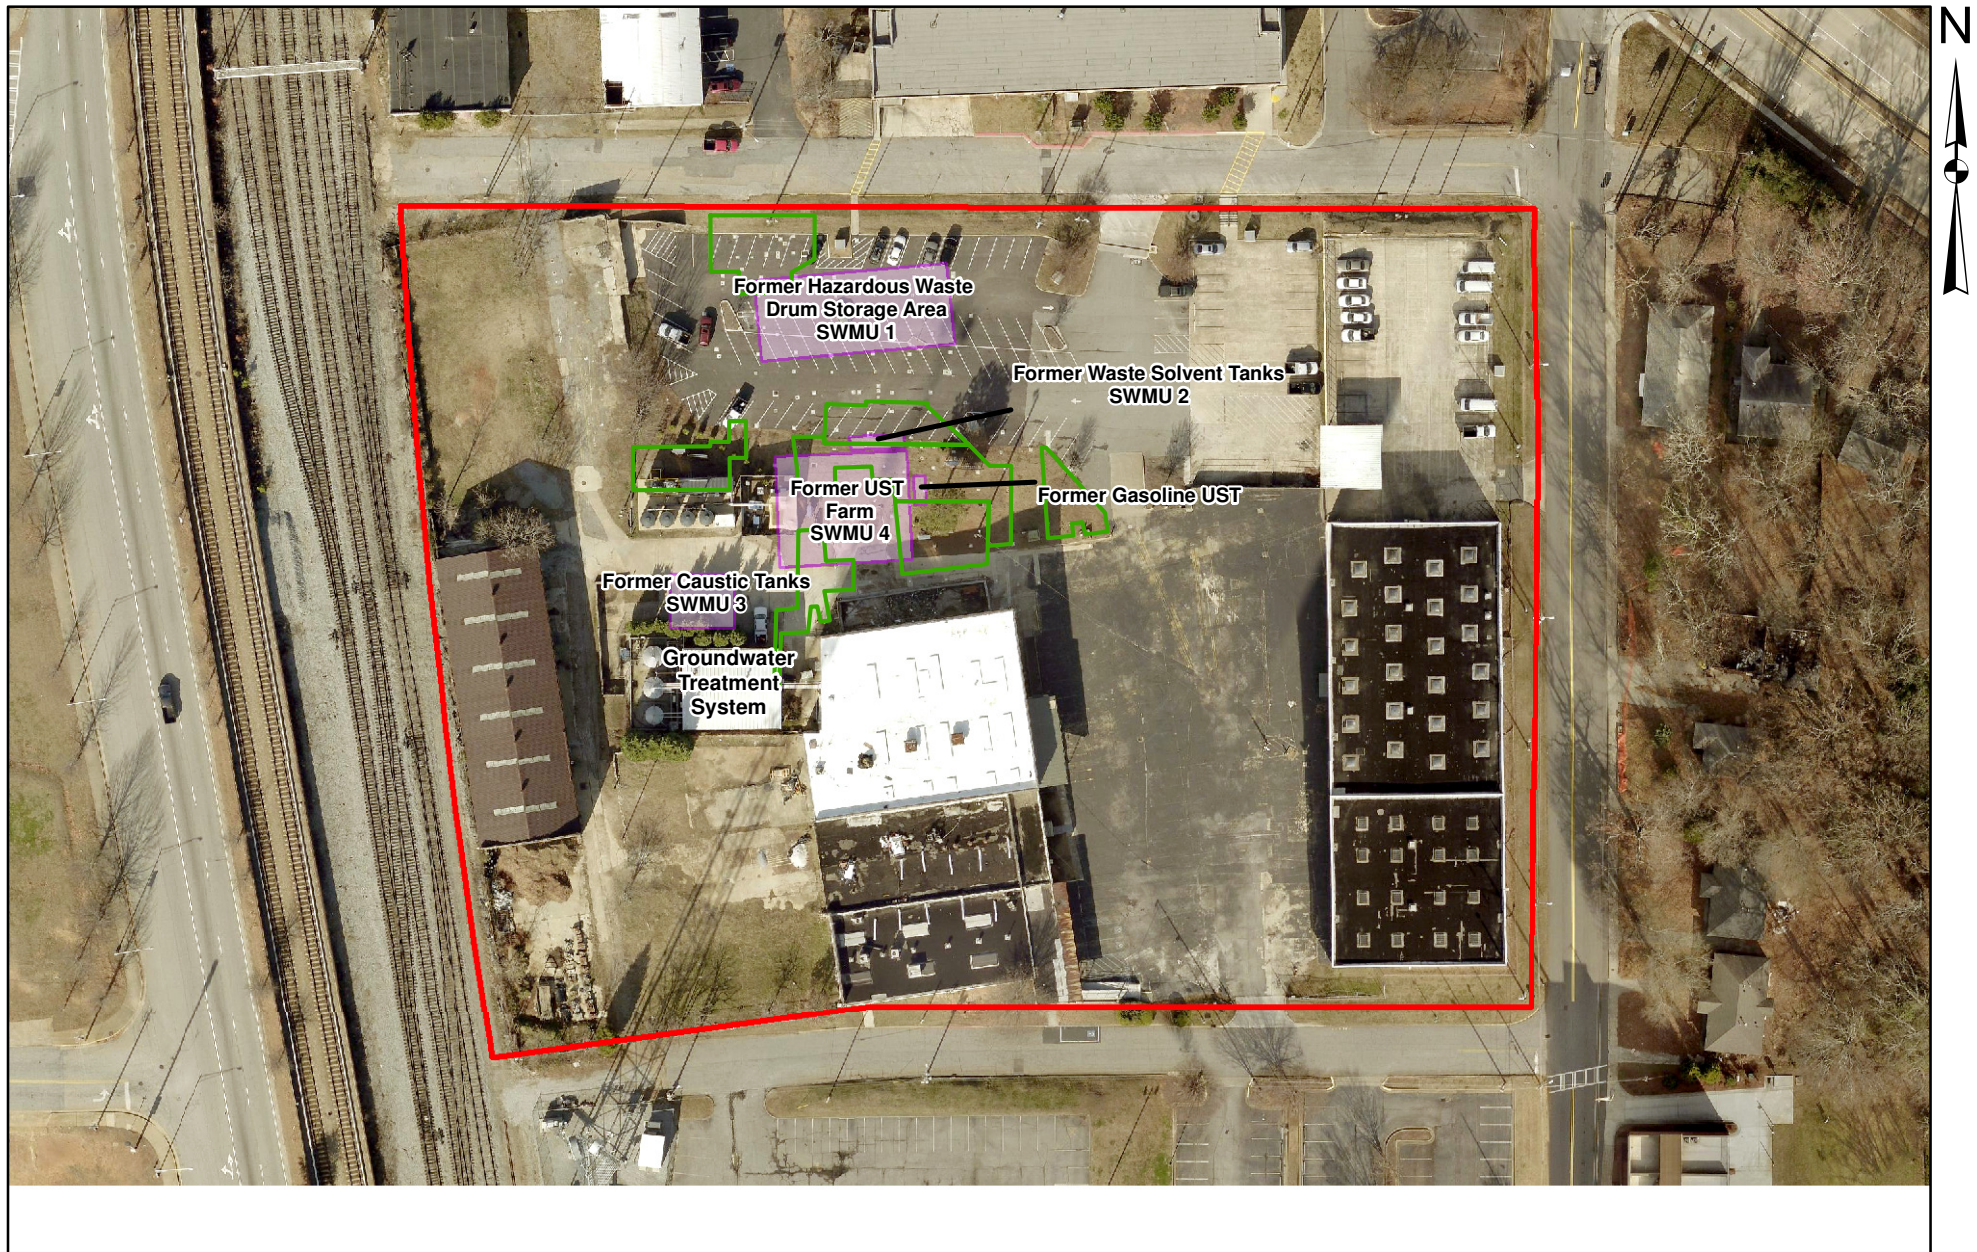
**Figure No.2**

Former SWMUs and Soil Remediation Areas

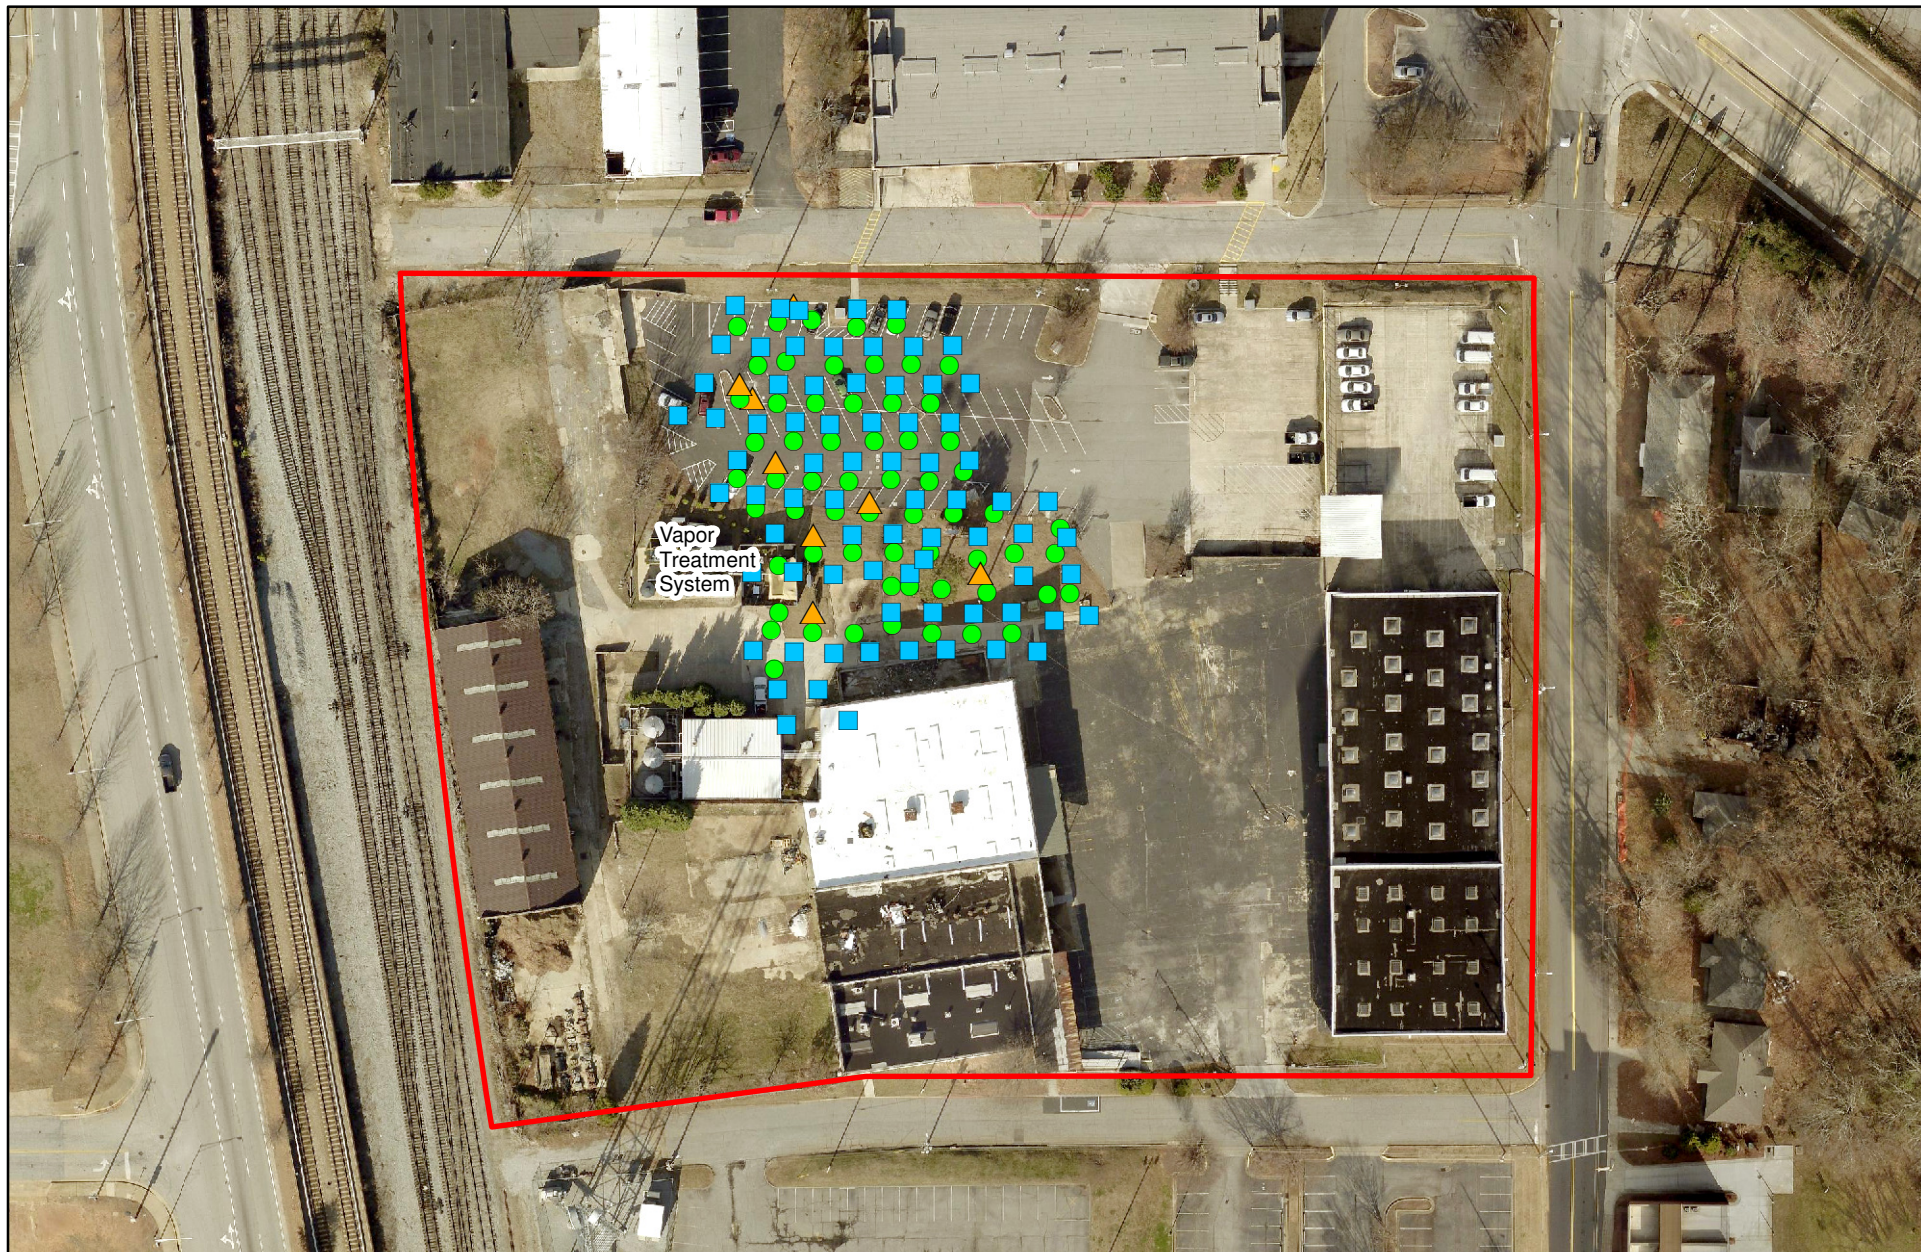
**Figure No.4**

AS/SVE/DPE/ System

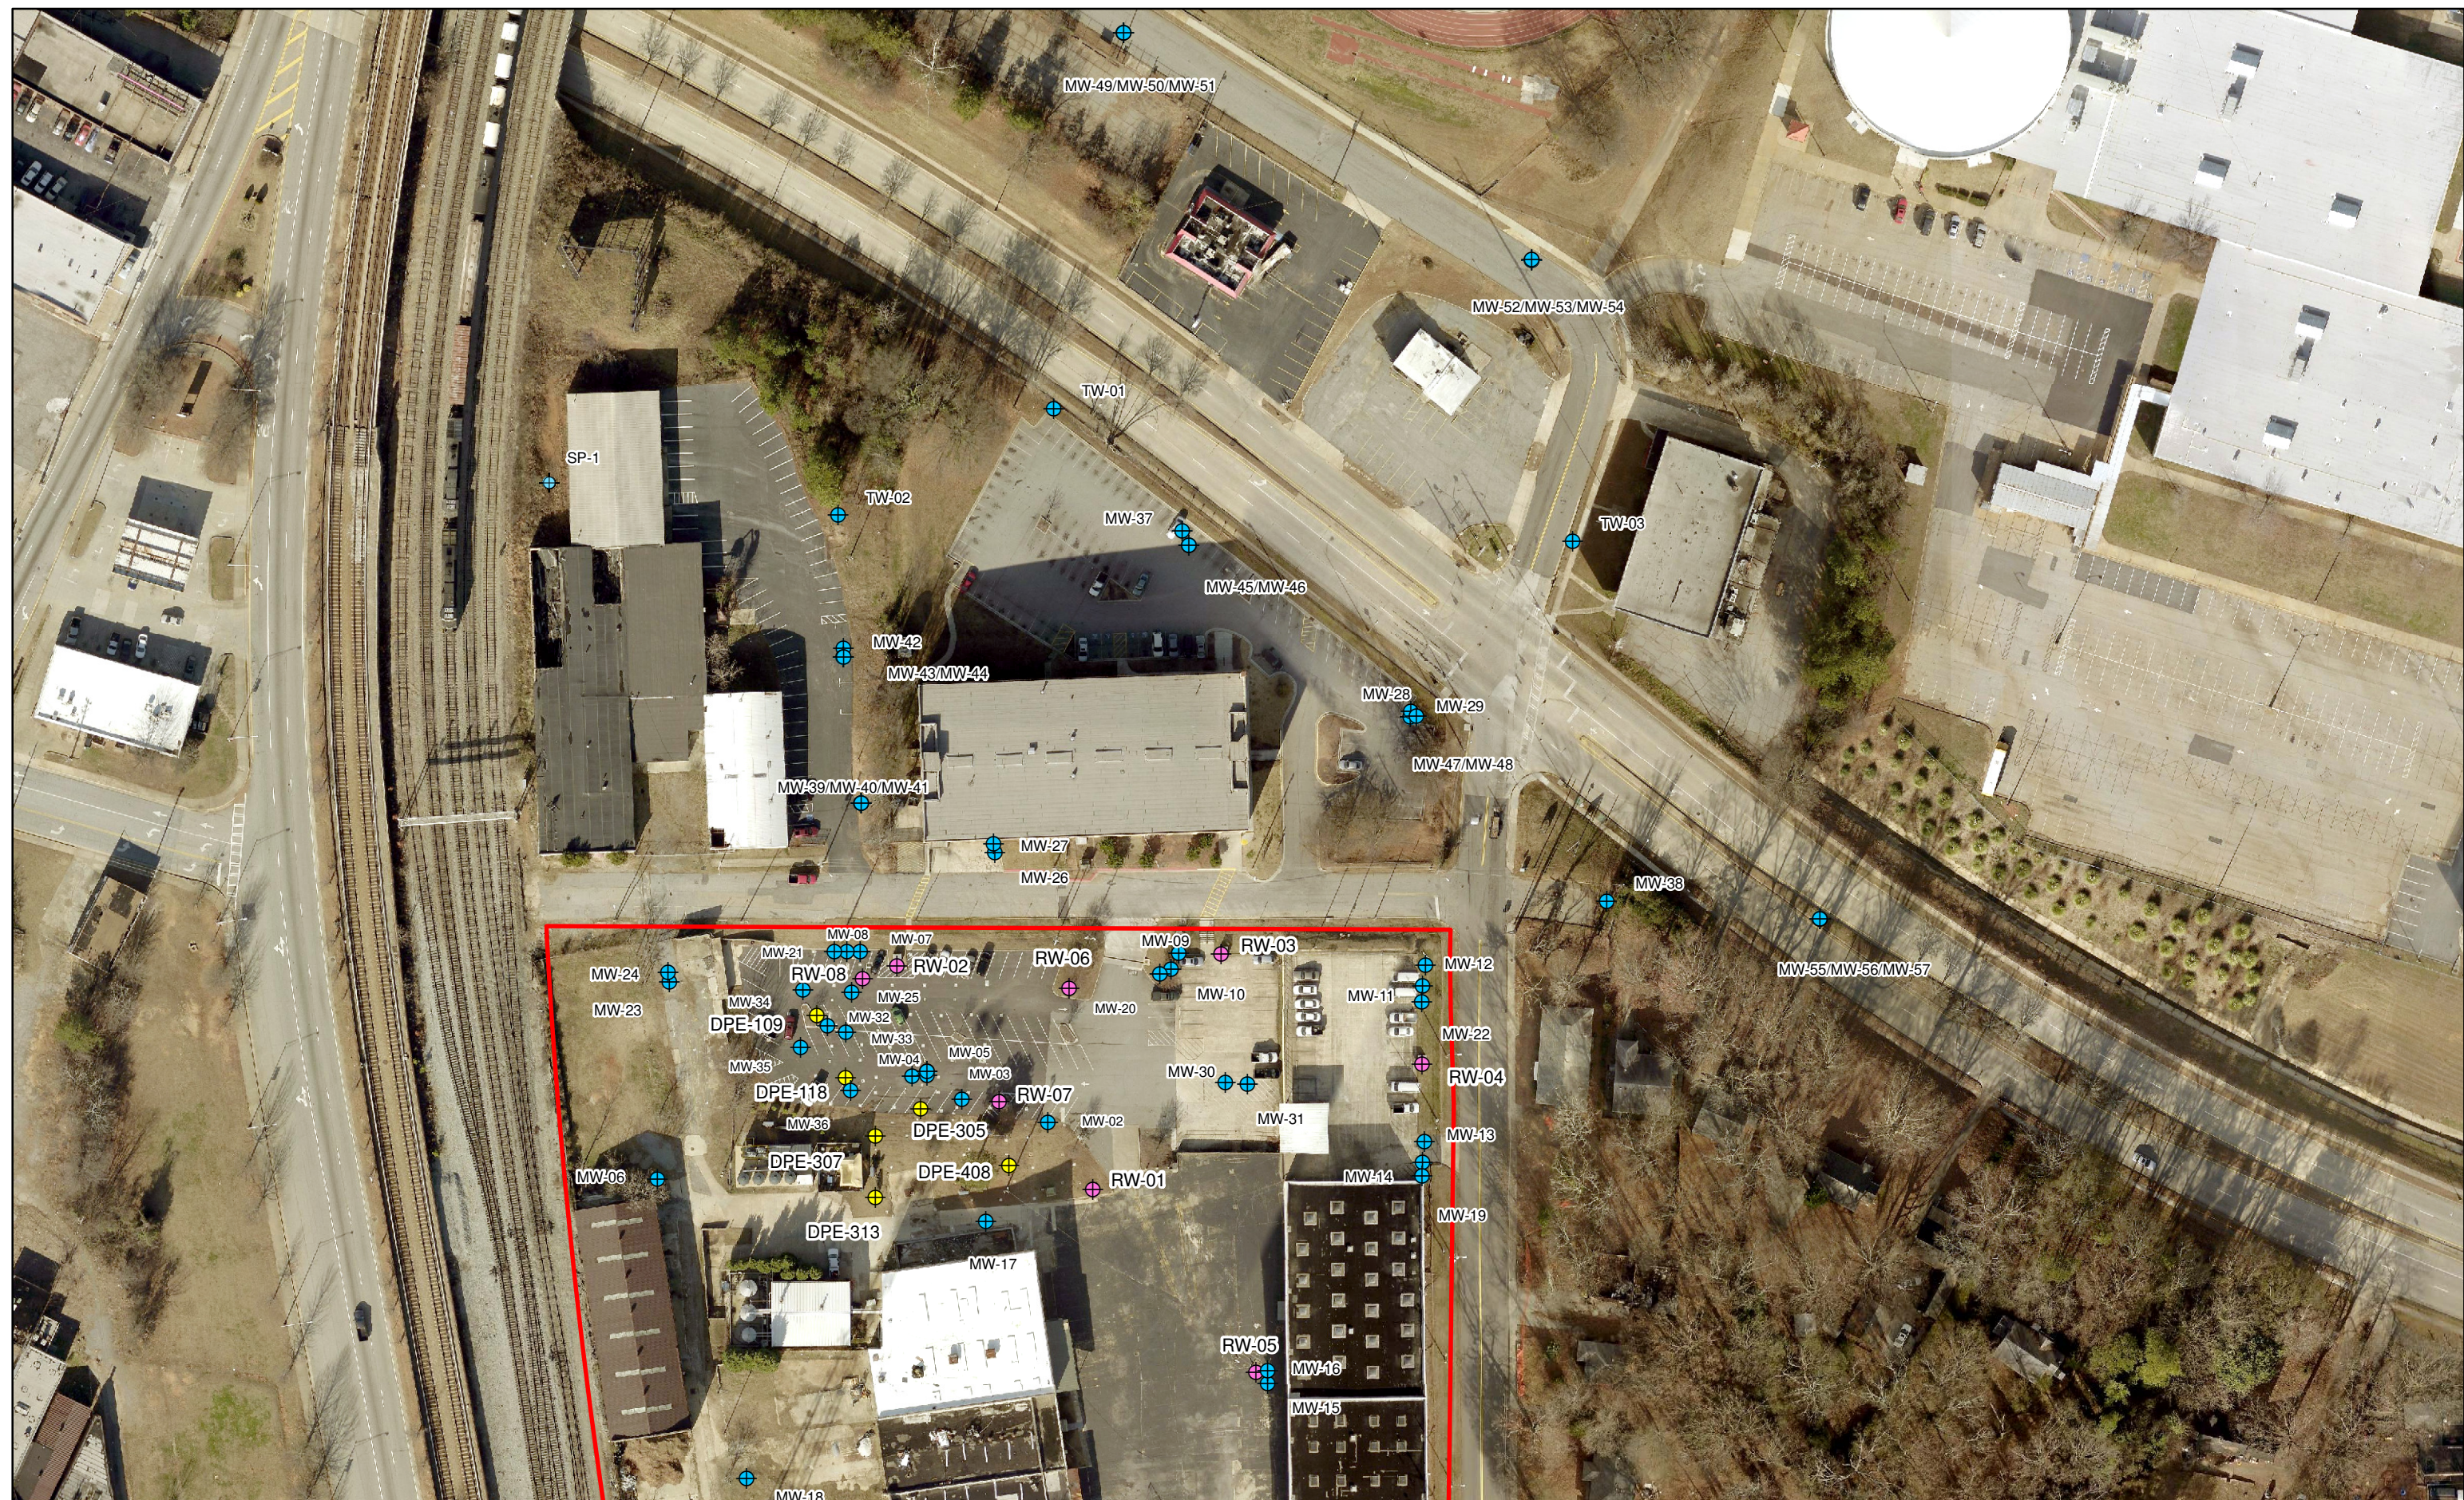
Figure No.5

Well Location Map

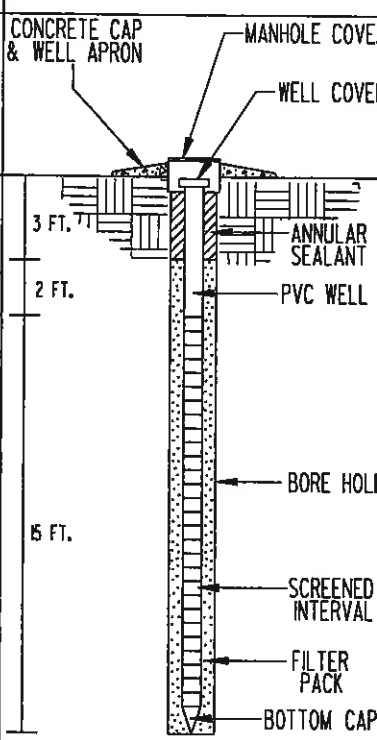
RISER HEIGHT FROM GROUND SURFACE: -0.24 FEET
							SIZE/THICKNESS OF APRON: 2 FEET X 2 FEET
							ANNULAR SEALANT: BENTONITE
							FILTER: OTTAWA SAND
							PVC WELL DIAMETER: 2 INCHES
							BORE HOLE DIAMETER: 6 3/4 INCHES
							TOP OF SCREEN: 5 FEET
							SCREEN LENGTH: 15 FEET
							SCREEN SLOT SIZE: 0.010 INCH
							BOTTOM OF SCREEN: 20 FEET
							BOTTOM OF WELL: 20 FEET
							NOTES
							ND - NON DETECT
							24-HOUR GROUNDWATER LEVEL 5.74'
							GROUNDWATER LEVEL AFTER DEVELOPMENT:
							GROUNDWATER LEVEL AT TIME OF DRILLING: 8'
