# Rooty Creek Watershed Management Plan

September 2014

Prepared by Resource Management Strategies  
under contract with the  
Oconee River Resource, Conservation  
and Development Council, Inc.

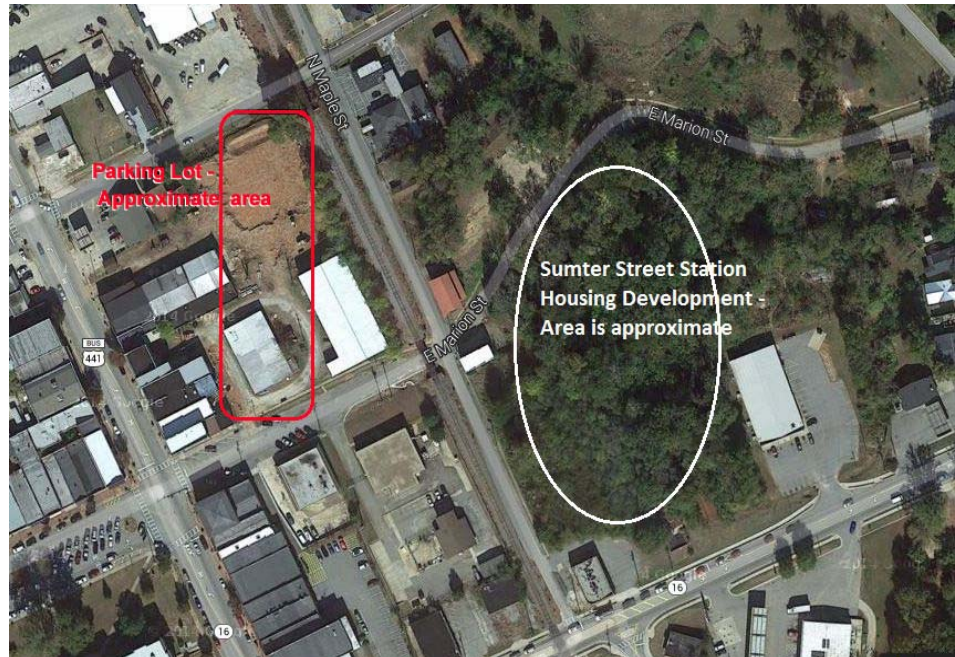
Source: City of Eatonton.

Other planned development that will increase the amount of impervious surface is the proposed Sumter Street housing development. This project is in the conceptual stage but will be constructed in a presently forested area bounded by E. Marion St., N. Maple St., and E. Sumter St.

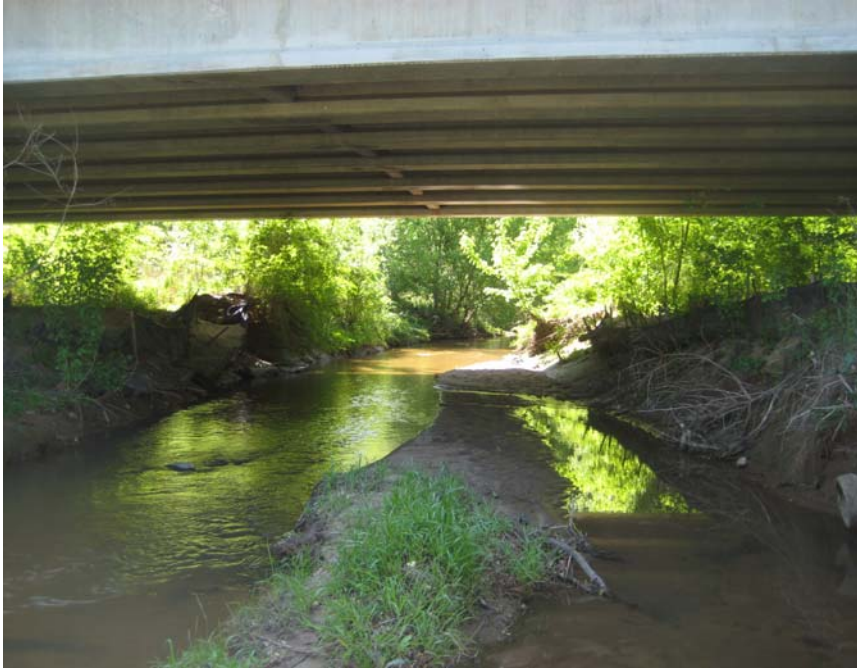
Streambanks at Rooty Creek and E. Sumter Street and Park Road as well as Little Creek and US 441 S need to be stabilized as a result of Georgia Department of Transportation (GDOT) bridge construction. While rip-rap and scrub vegetation were installed at each location, bank erosion has occurred, particularly at the E. Sumter Street bridge, and contributes to sediment deposition to and contamination of Rooty Creek. Without stabilization, bank erosion will continue.

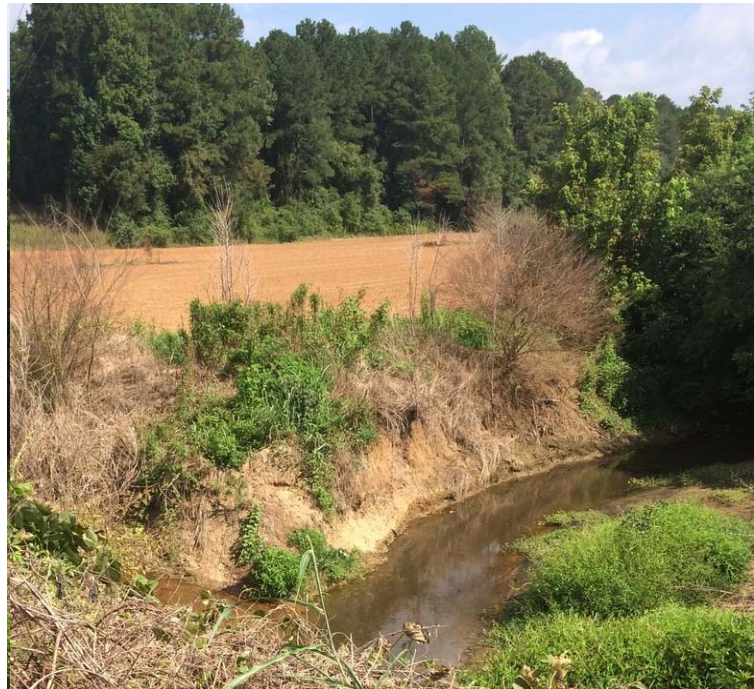
Streambank erosion - Rooty Creek at MLK Jr.

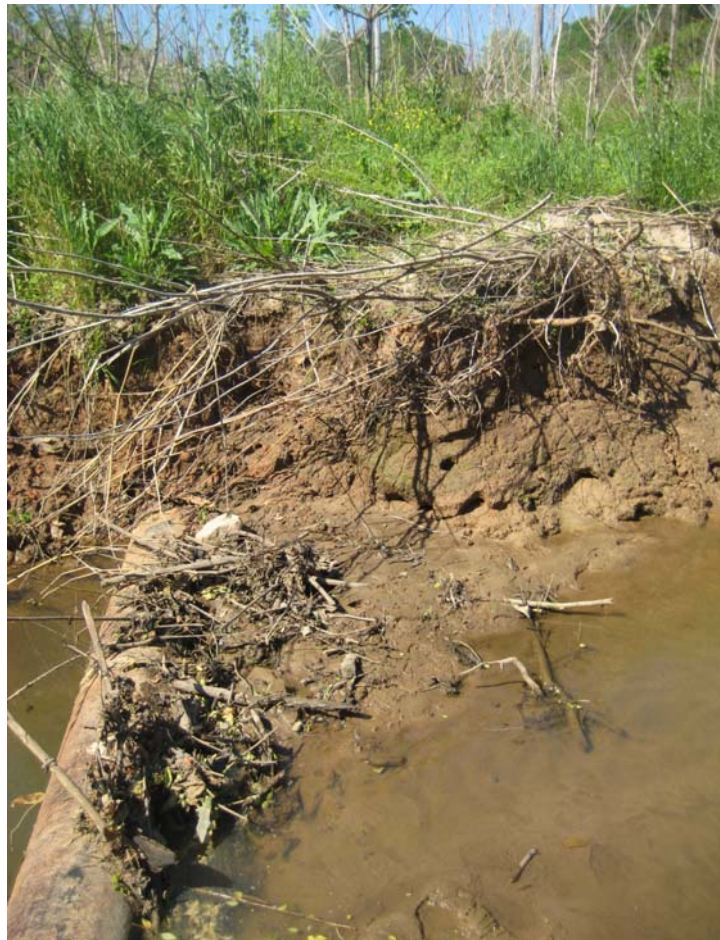
Streambank erosion - Rooty Creek at E. Sumter Street

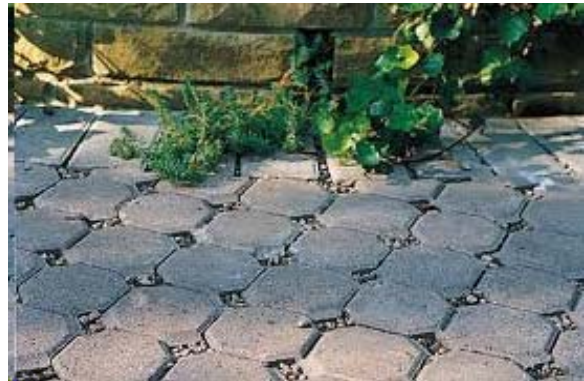
Permeable paving allows rainwater to percolate through the paving and into the ground before it runs off. This approach reduces stormwater runoff volumes and minimizes the pollutants introduced into storm water runoff from impervious surfaces. Permeable paving is appropriate for pedestrian-only areas and for very low-volume, low-speed areas such as overflow parking areas, residential driveways, alleys, and parking stalls. Depending on design, paving material, soil type, and rainfall, permeable paving can infiltrate as much as 70% to 80% of annual rainfall.<sup>22</sup>

Permeable Pavement (sidewalk)

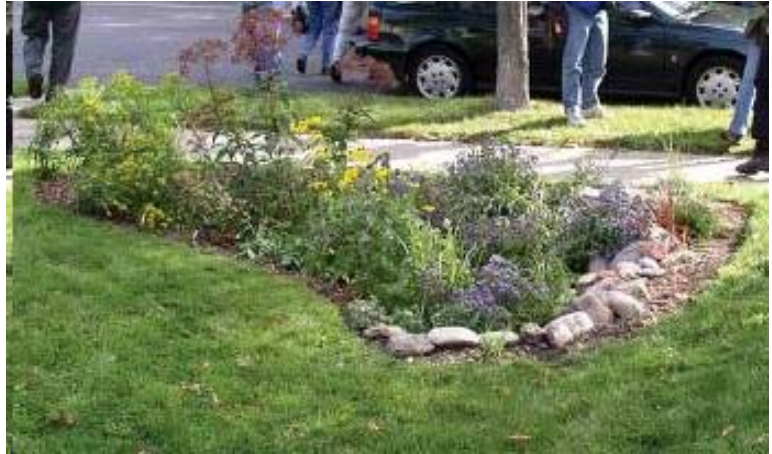
A rain garden is a garden which takes advantage of rainfall and stormwater runoff in its design and plant selection. Usually, it is a small garden which is designed to withstand the extremes of moisture and concentrations of nutrients, particularly Nitrogen and Phosphorus, that are found in stormwater runoff. Rain gardens are ideally sited close to the source of the runoff and serve to slow the stormwater as it travels downhill, giving the stormwater more time to infiltrate and less opportunity to gain momentum and erosive power.

Rain Garden

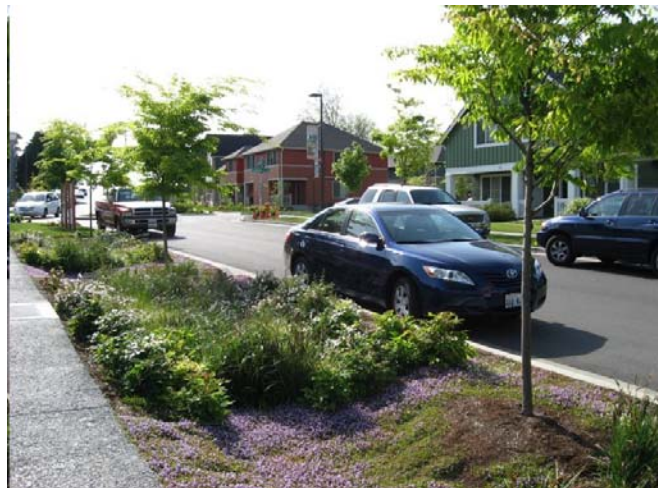
Bioswales are landscape elements designed to remove silt and pollution from surface runoff water. They consist of a swaled drainage course with gently sloped sides (less than six percent) and filled with vegetation, compost and/or riprap. The water's flow path, along with the wide and shallow ditch, is designed to maximize the time water spends in the swale, which aids the trapping of pollutants and silt. Bioswales are commonly used around parking lots. Bioswales can reduce pollutant load by up to 94%.<sup>24</sup>

Bioswale
