Watershed Improvement Plan for Silver Creek

Watershed: Silver Creek

Silver Creek Visual Survey Updated and augmented by McAuliff August 16, 2011.

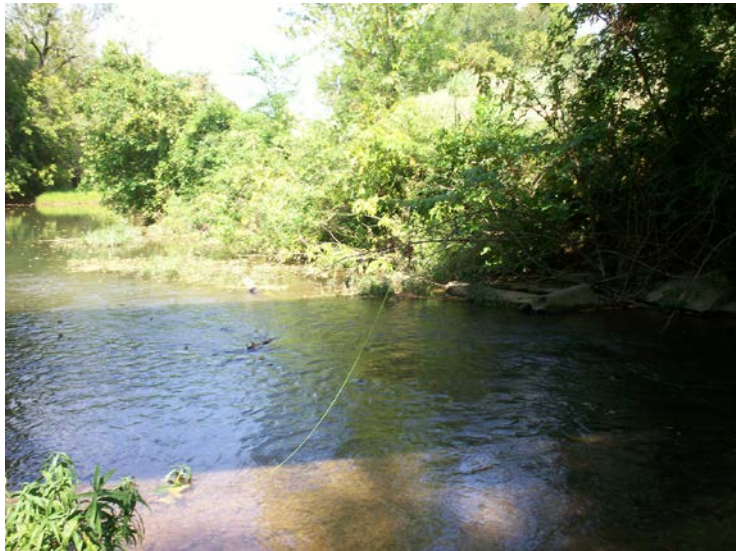
The **Crescent Street** crossing is at the intersection of Highway 53 and Crescent Street, not far south of 53's intersection with 12th Street to the north. The water is shallow and clear, and flows well. Upstream, south of the crossing, a sewer pipe, somewhat suspect as a possible source of fecal coliform in the past, crosses the creek.

View downstream under the bridge.

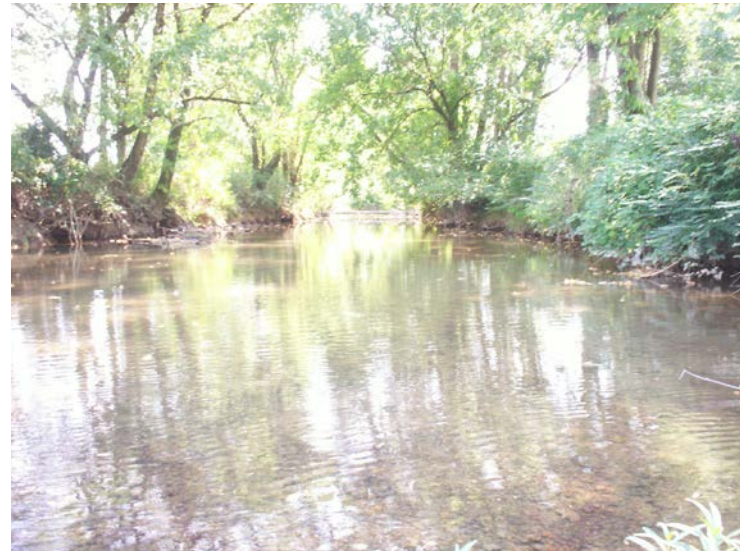
View upstream with a sewer pipe crossing in the distance.

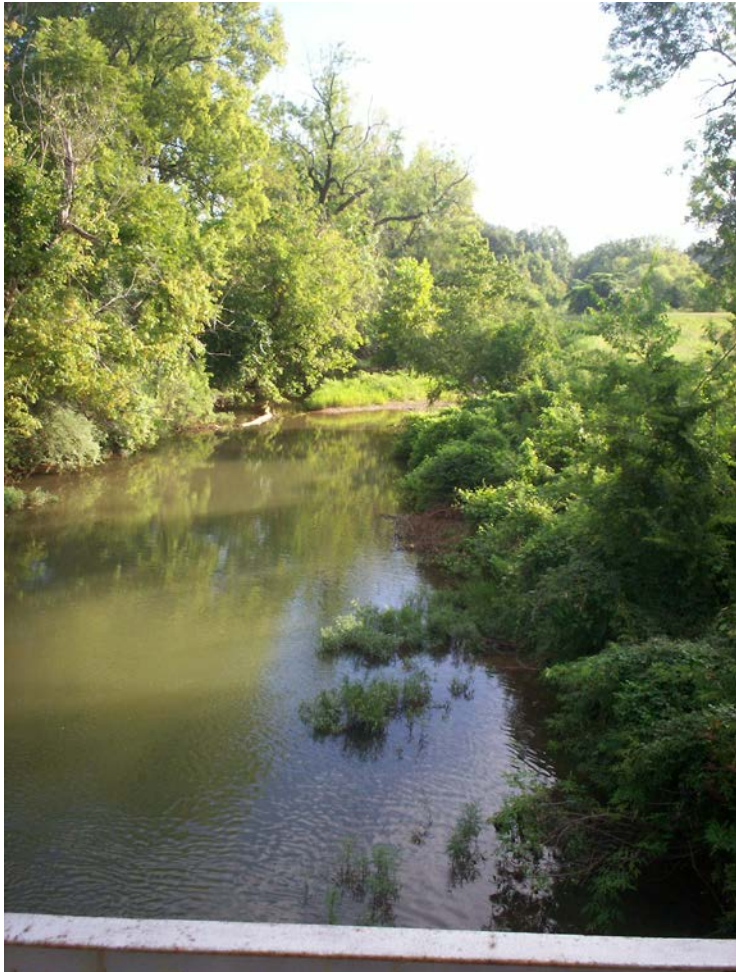
Crescent Street Crossing, August, 2011 Update.

View downstream from bridge.

During the September 2011 site visit, staff noted no significant change from September, 2010.

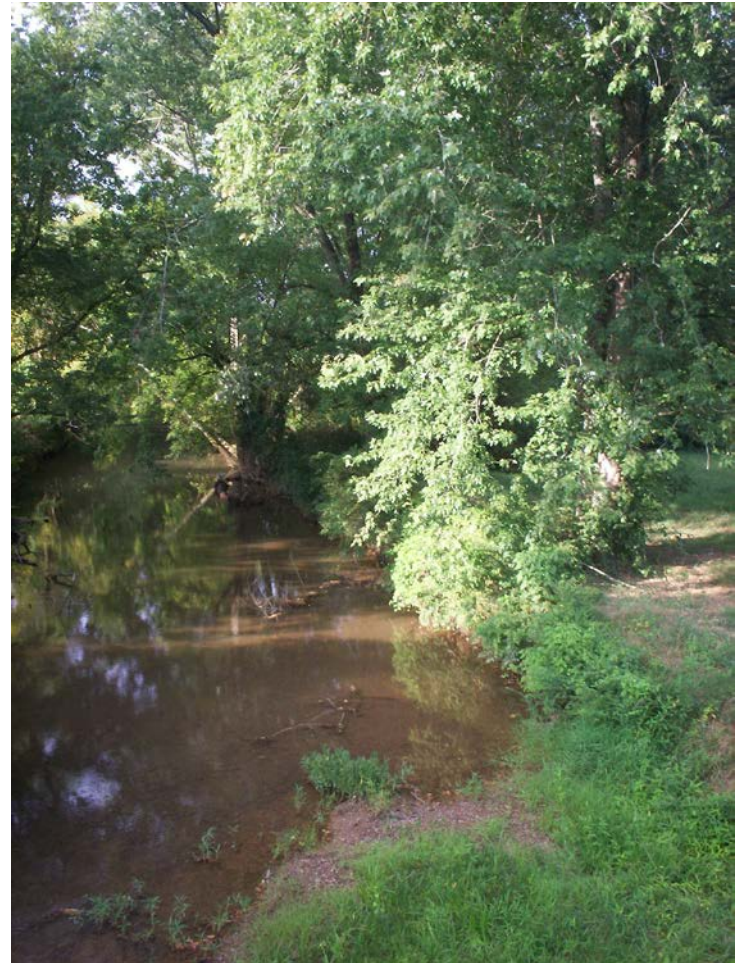
View upstream from bridge.

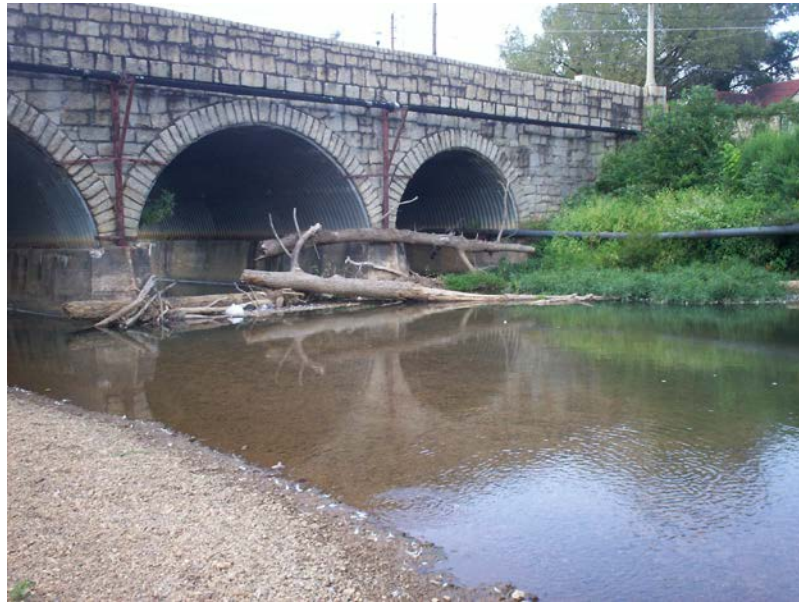
There is also a mixed gaggle of waterfowl that occupy the Park Avenue crossing area, encouraged by handouts from passers-by. Their contribution to the fecal coliform load may be significant, though difficult to gauge.

View downstream. Note feathers all over the bank.

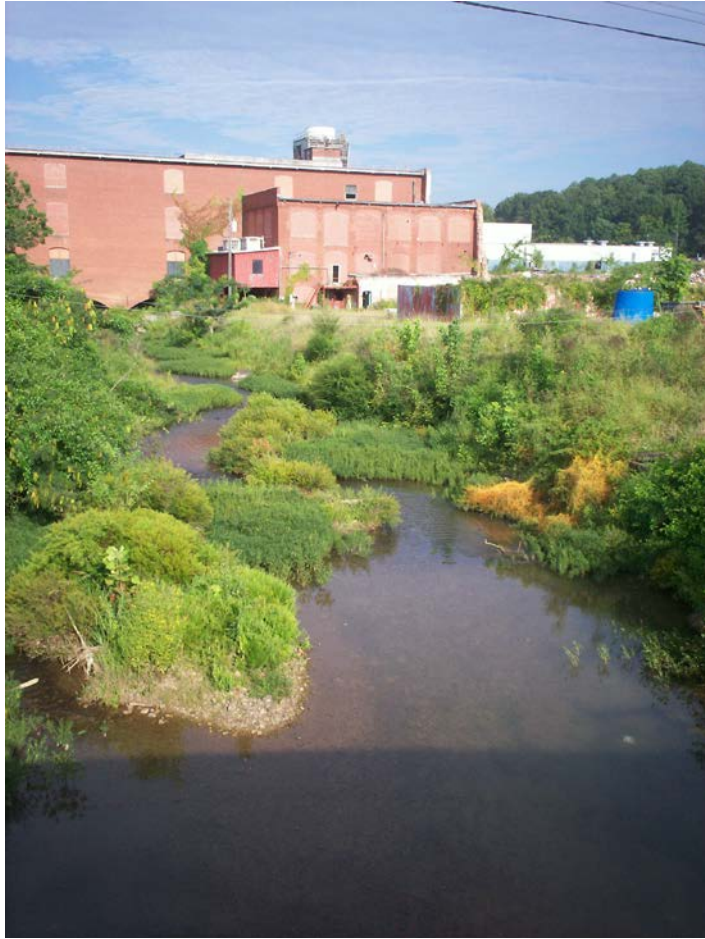
Park Avenue Crossing, August, 2011 update

View downstream from bridge.

Staff noted that the large number of waterfowl seen during the September, 2010 site visit had dwindled to only a few individuals in August of 2011. The observation was confirmed by the lack of feathers, which had formerly covered the stream bank.

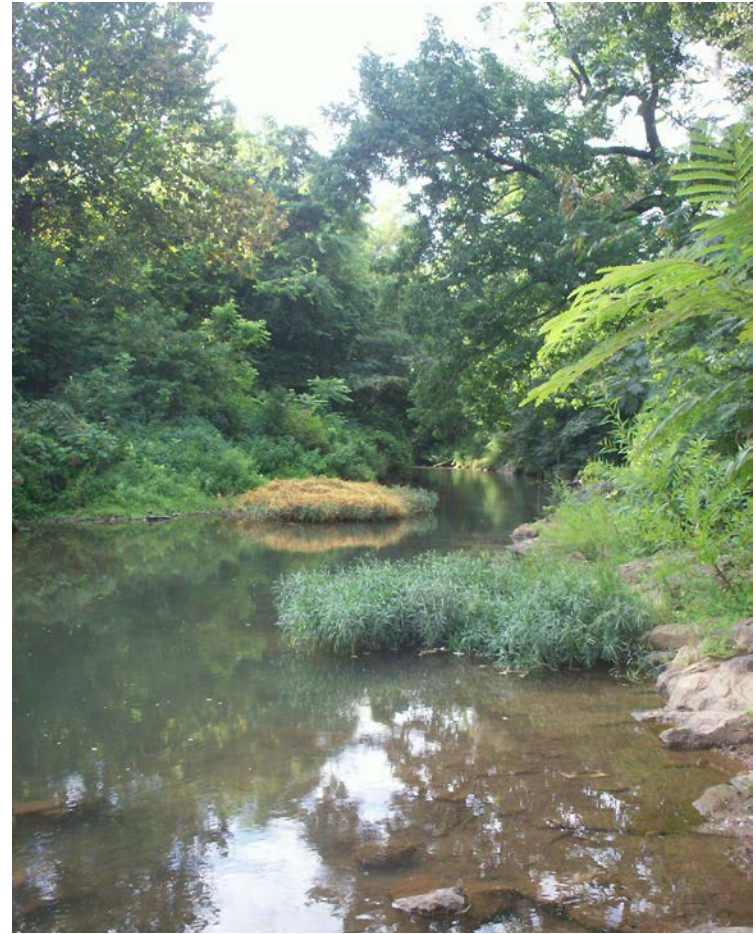
View upstream from bridge.

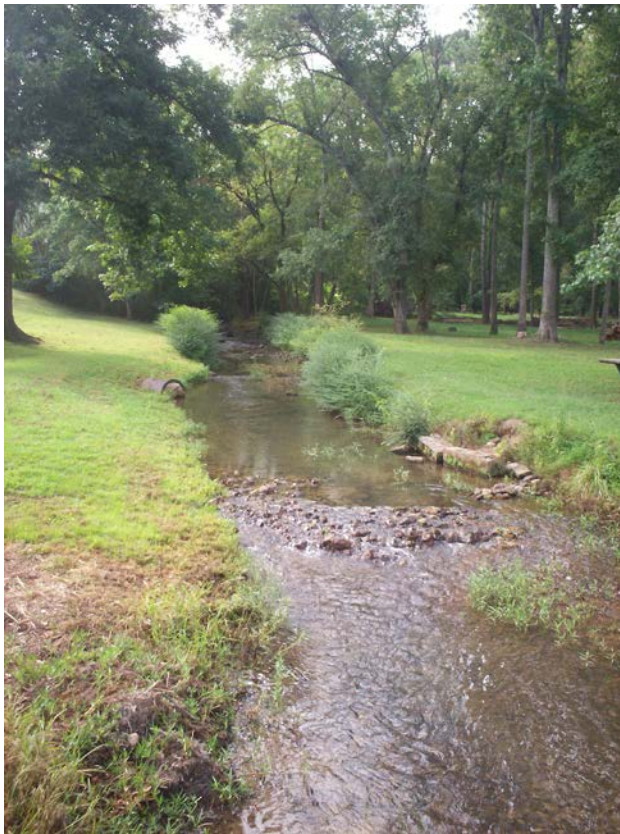
Nixon Park, August, 2011 update

Pictures below are from the August, 2011 update. The earlier survey did not contain Nixon Park pictures. No significant change from September, 2010 was noticed during the update site visit.

View upstream.

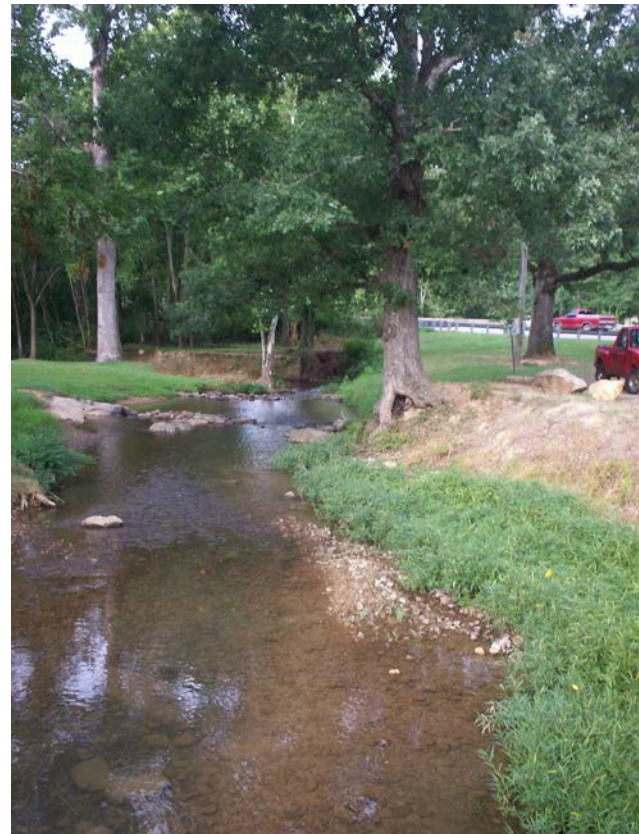
View downstream.

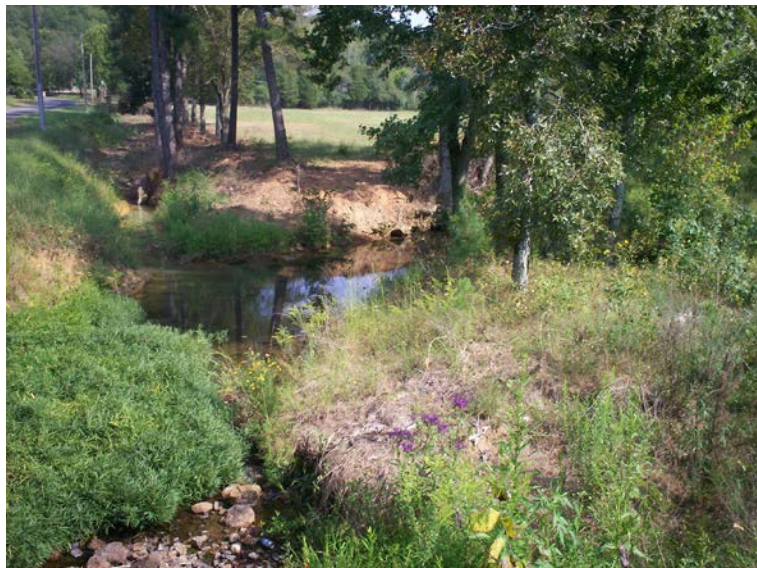
View eastward across creek, showing branch entering.

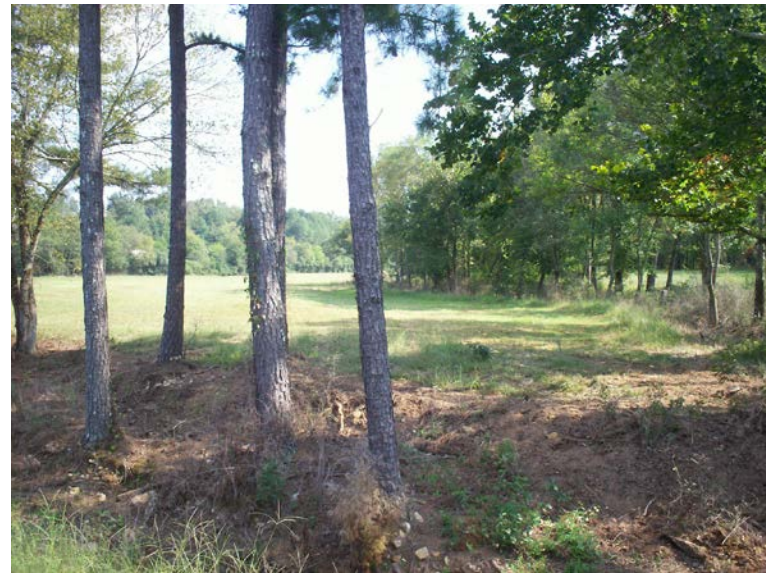
Pastures on both sides of Dunahoo Road appear to be devoid of cattle, and are parched, and there are many houses along Dunahoo Road east of the crossing.

Hayfield adjacent to creek on east.

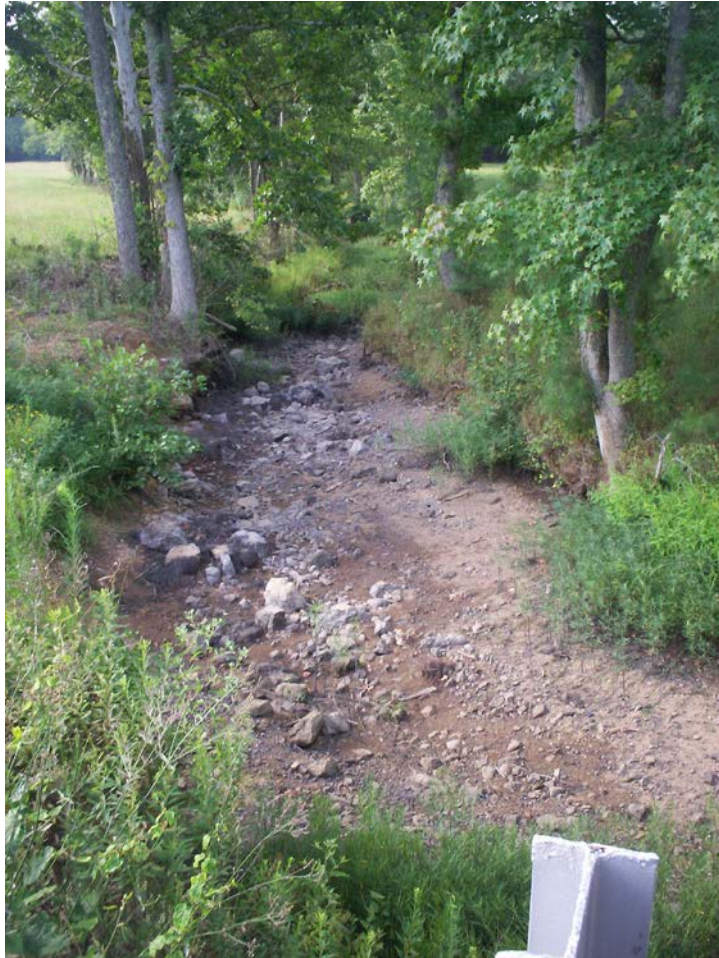
Dunahoo Road Crossing, August, 2011 update

View upstream.

The creek was dry at this crossing. While there were some areas of soil dampness, there was no standing water.

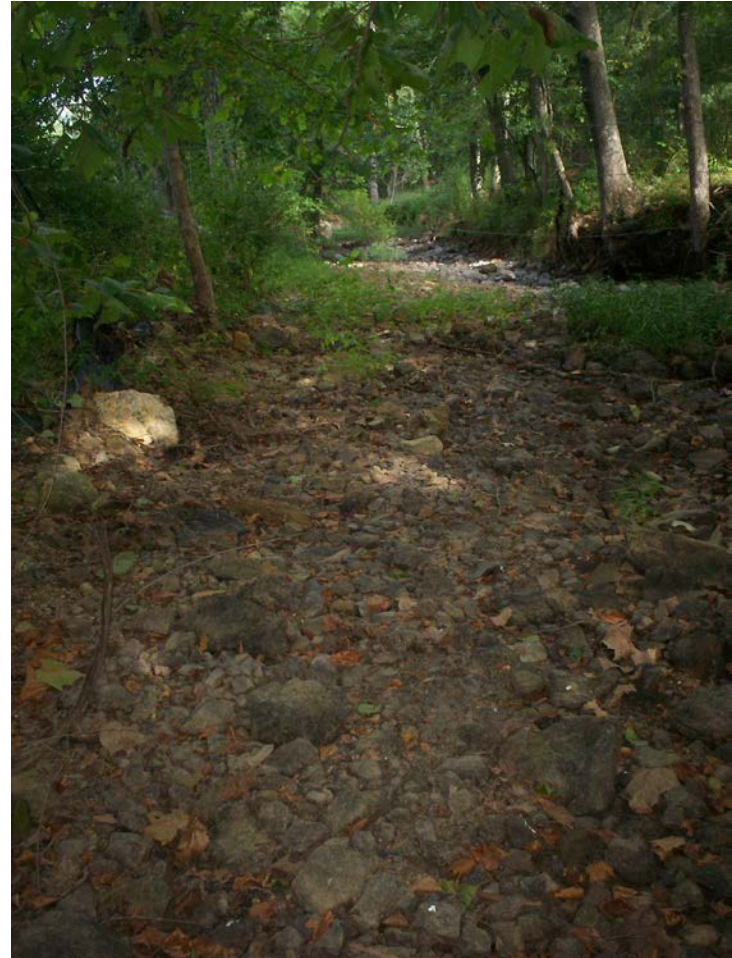
View downstream.

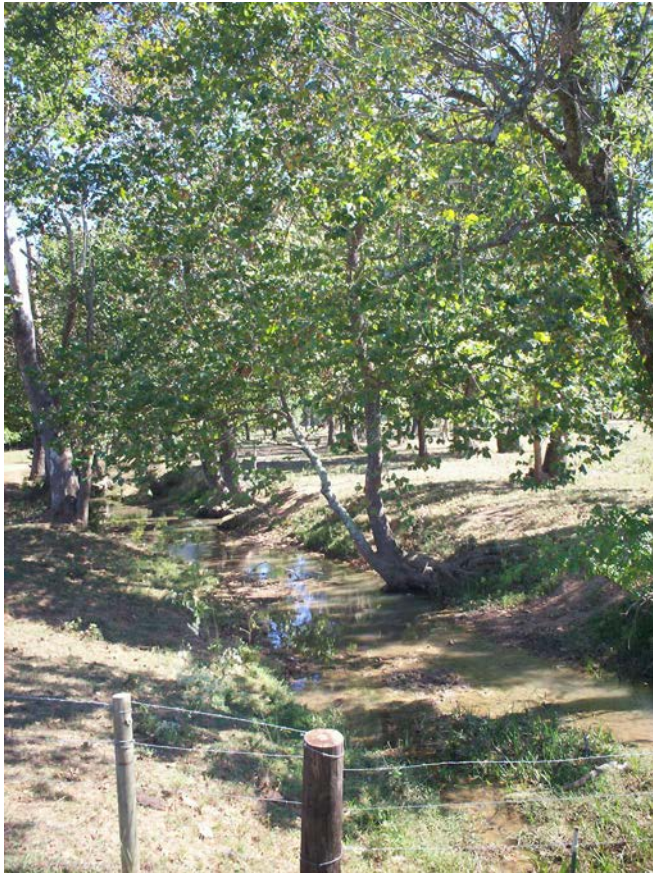
View of creek through Running Wild Ranch.

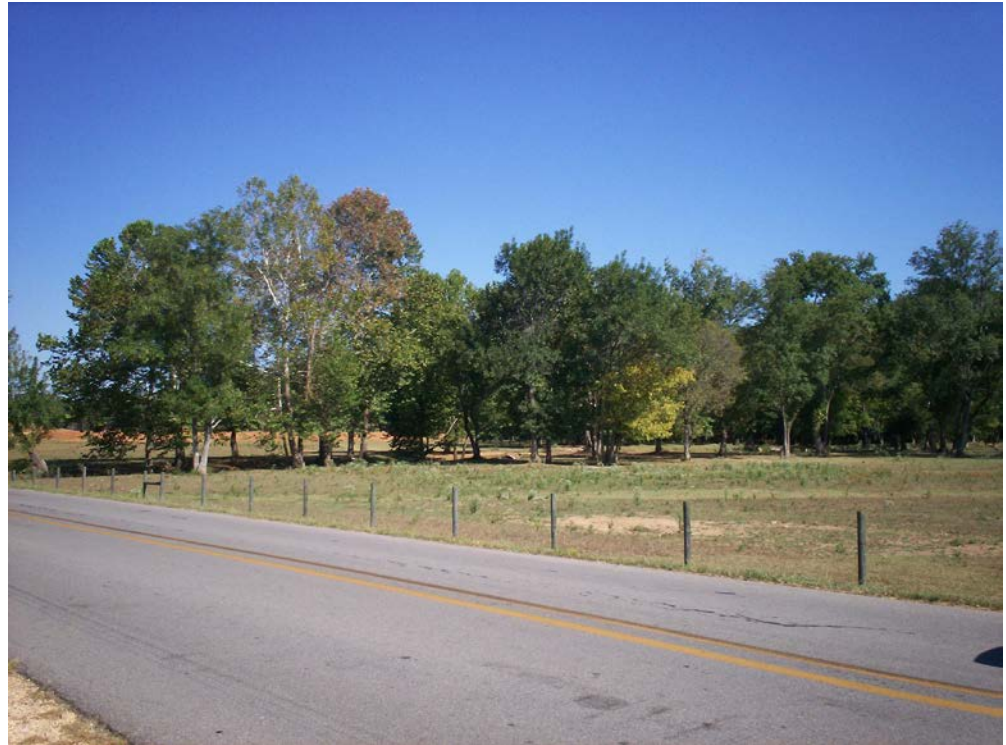
In general, the surrounding area is primarily agriculture and forestry, and driving through the countryside, survey staff noted drought blighted crops and pasture land, the latter mostly devoid of livestock.

General view of Running Wild Ranch with creek in treeline.

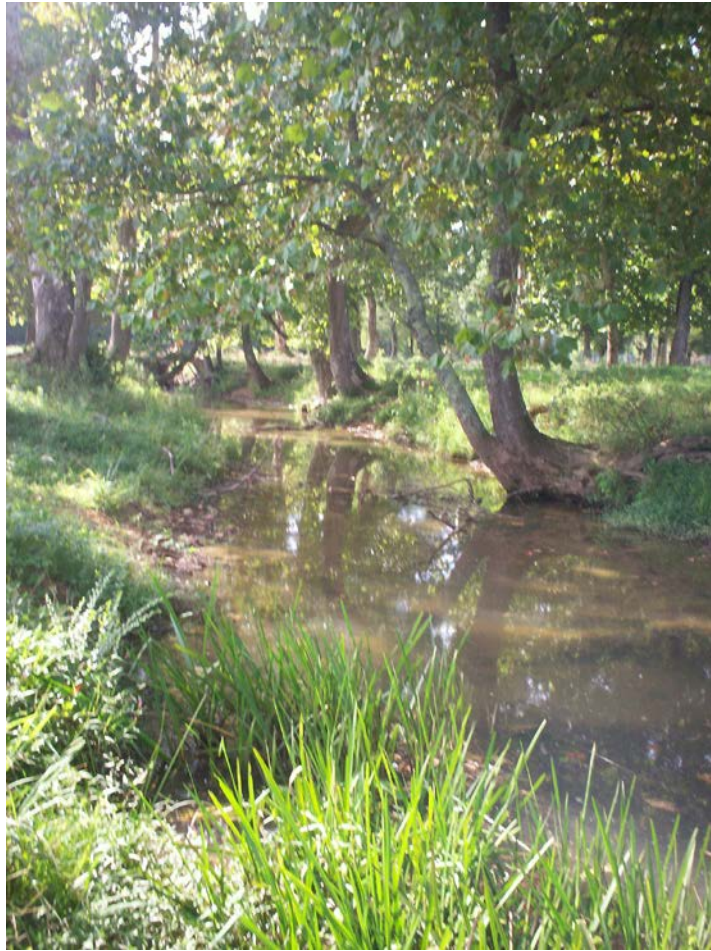
Brice Station Road Crossing, August, 2011 update

View upstream.

Little had changed since the September, 2010 visit. A couple of zebras, some donkeys, and a few exotics were in sight in the distance, and access to the creek still appeared unlimited. The water was cloudy, and appeared almost stagnant. The dryness at the Dunahoo Road crossing downstream suggests that the channel here might be just deep enough to allow a long pool of water to stand in it. That there appears to be no flow also suggests the same possibility.

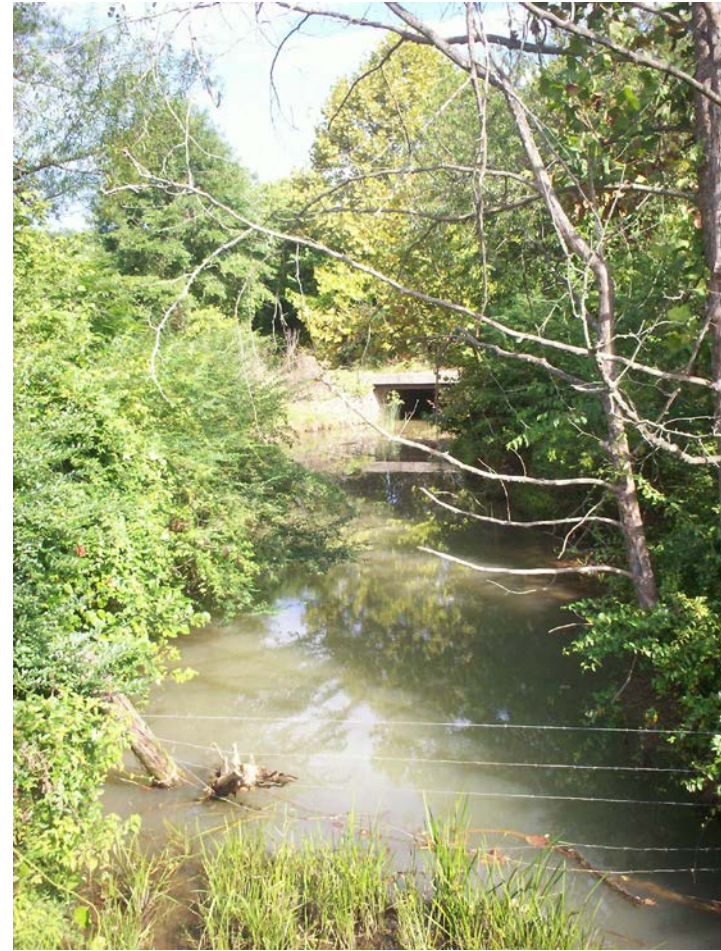
View downstream.

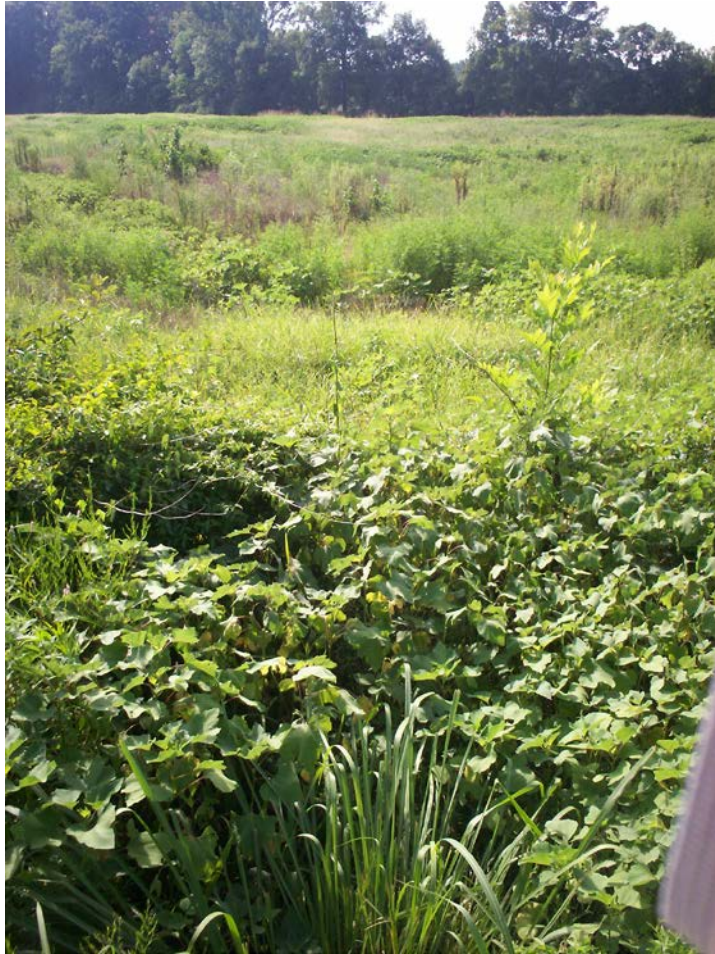
Fish Creek Crossing, August, 2011 update

This upper reach of the creek at **Fish Creek (Polk County) Crossing** was not included in the September, 2010 survey, though it was recorded in the field notes. Conditions appear to be the same. The creek was dry, and only a slight depression marked anything like a channel. The area is agricultural, with a hayfield on the upstream side of the road, and scrub growth with some small crop plantings on the downstream side.

View upstream.

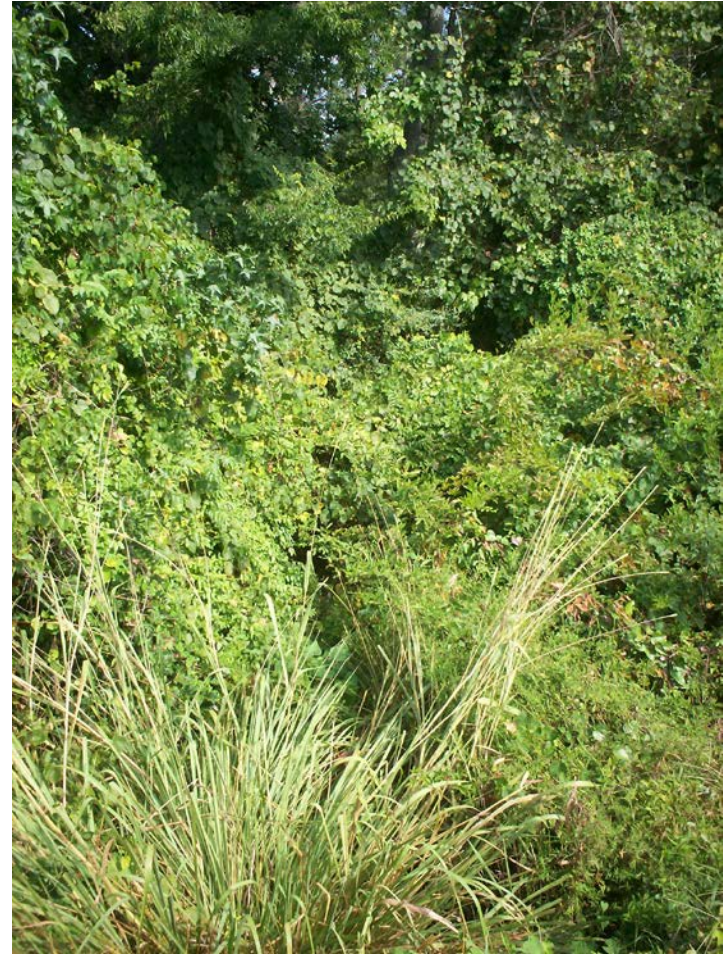
View downstream.
