# Stekoa Creek Watershed Management Plan

Updated HUC 10 - 0306010202

Stekoa Creek - 030601020207 & 030601020208

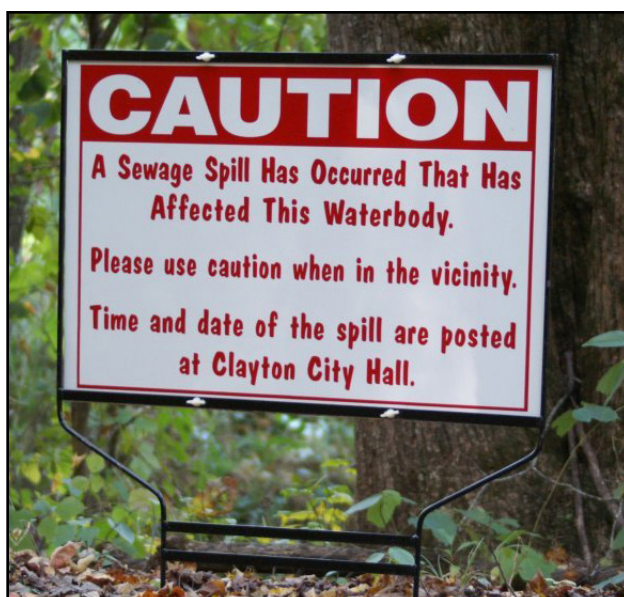
*This sign warns of a public health hazard from a sewage spill in Clayton.*

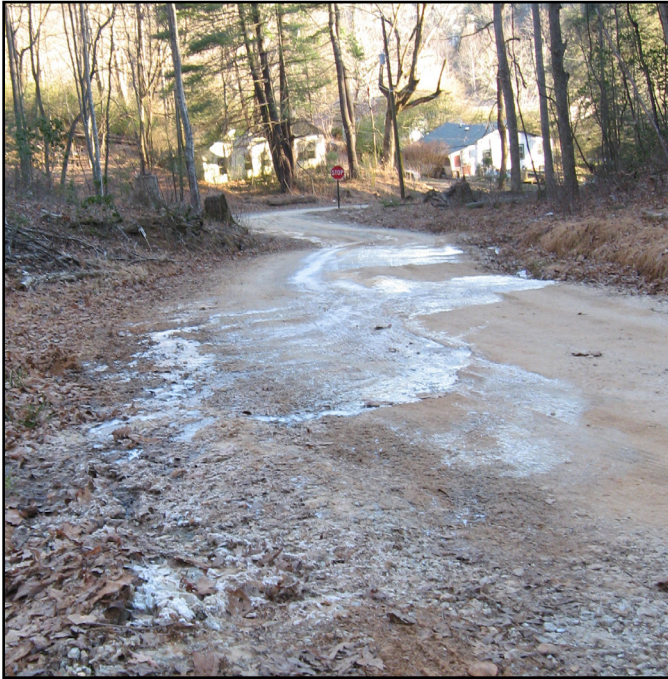
***Sewage from a sewer line leak flowing towards Shadyside Street in Clayton.***

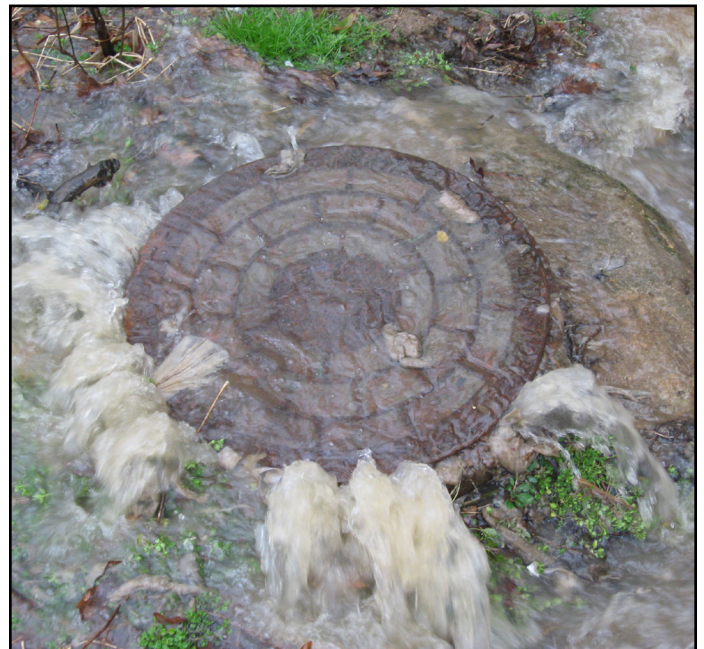
***Stormwater infiltration has caused numerous sewage spills into Scott Creek, a tributary to Stekoa Creek.***

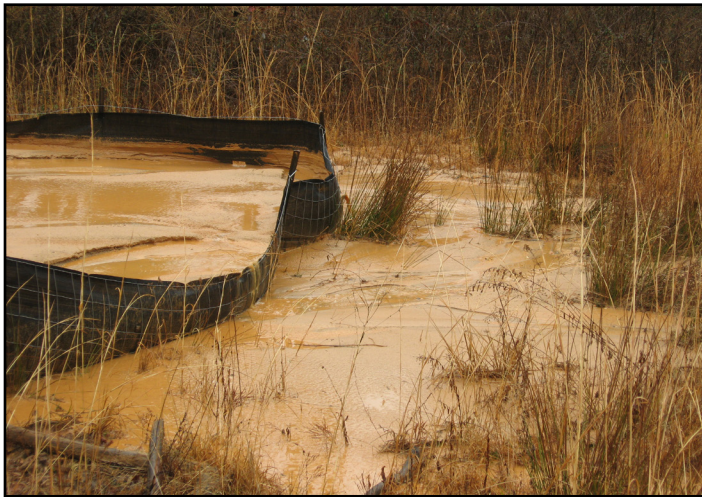
**All past stakeholder meetings about Stekoa Creek have cited concerns about inadequate enforcement of erosion and sedimentation laws.**

◆ **Erosion and Sedimentation Laws** Without exception, all past stakeholder initiatives about Stekoa Creek’s poor water quality have cited concerns about inadequate enforcement of erosion and sedimentation laws. Field surveys during the preparation of this WMP revealed that enforcement of erosion and sedimentation laws remains an active concern.

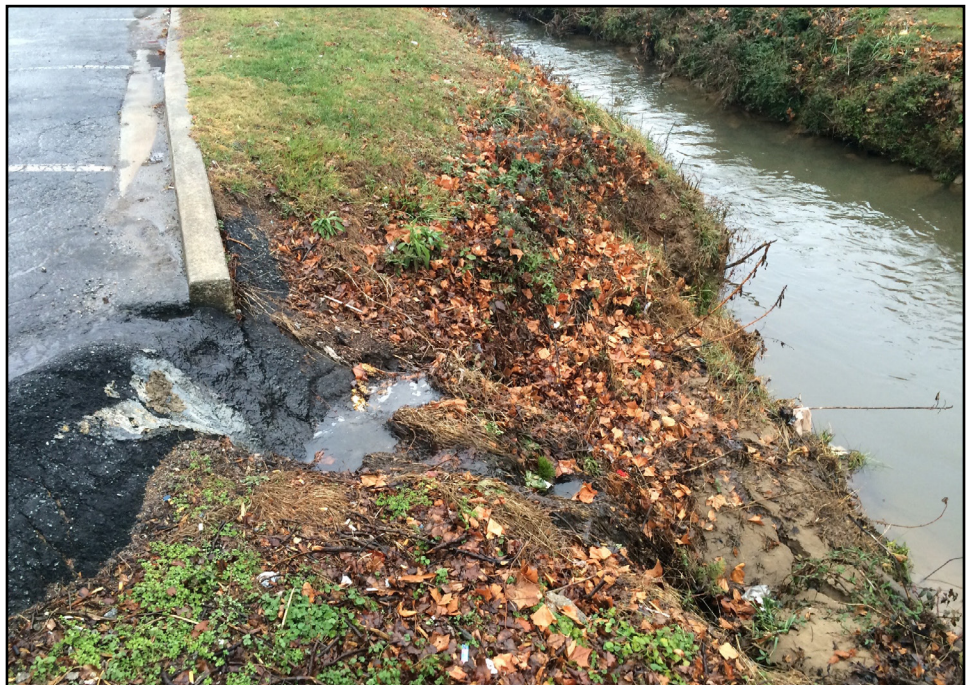
**A large parking lot built in the flood plain next to Stekoa Creek covers the stream's 50-foot buffer zone, and discharges all of its stormwater runoff directly into the creek.**

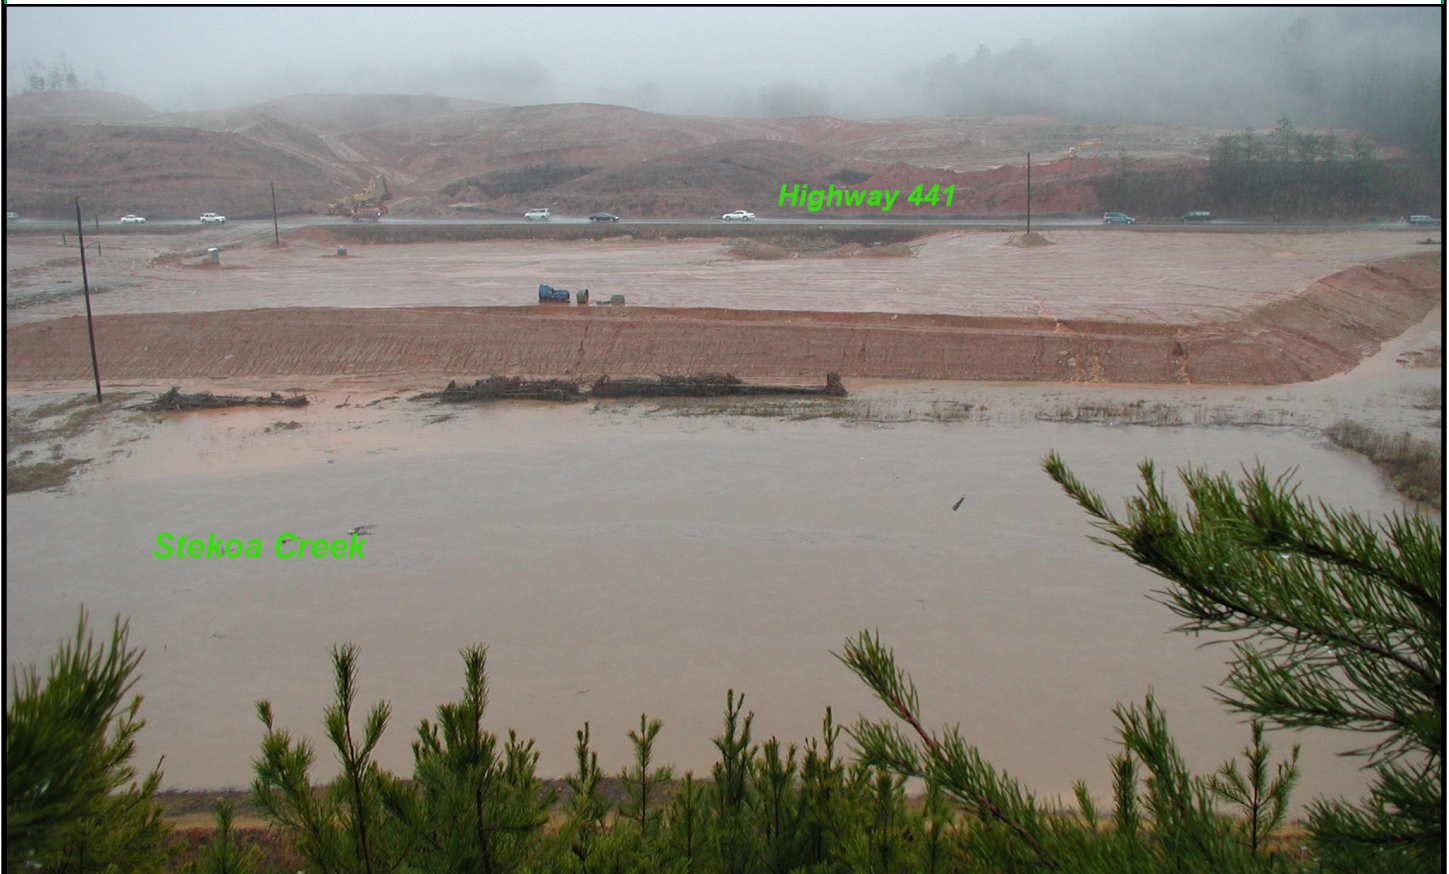
*In 2004, the steep topography on the east side of Highway 441 was leveled to make a flat spot for development, and the dirt was used for filling a portion of Stekoa Creek’s floodplain, putting a massive amount of dirt into the creek.*

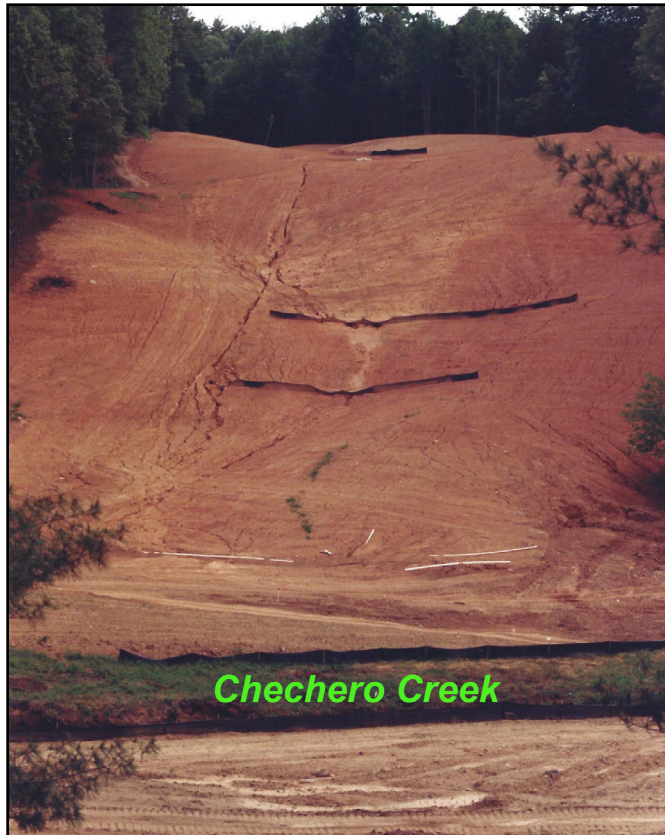
***A massive amount of dirt was deposited in Chechero Creek during the reconstruction of the Kingwood Country Club golf course in 1999.***

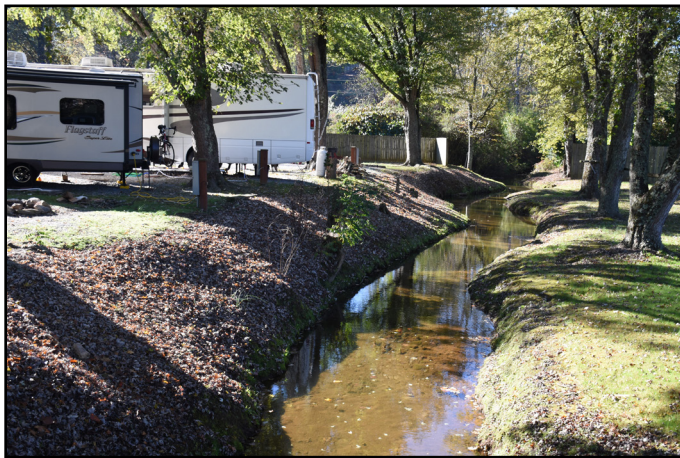
***An unnamed headwaters branch of Stekoa Creek in Mountain City flows through a ditch in a trailer park.***

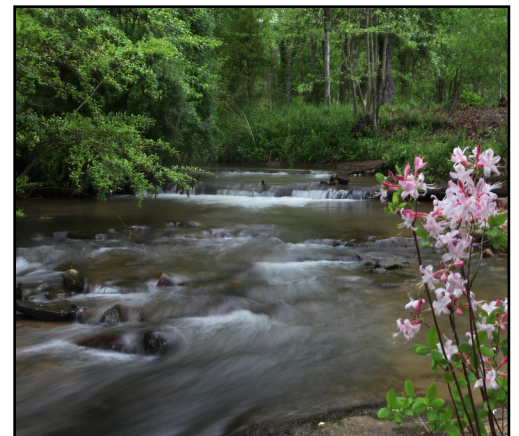
***A 1/4 mile stretch of Stekoa Creek's riparian zone was restored in 2014 during the development of Stekoa Creek Park.***

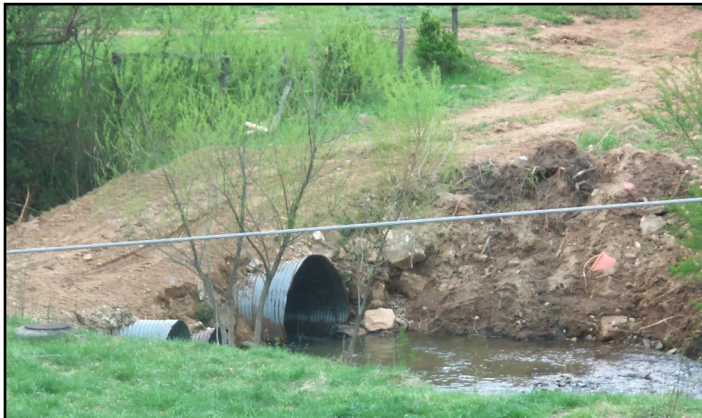
***Undersized culverts in Stekoa Creek, installed by way of an agricultural exemption, have created eroding stream banks.***

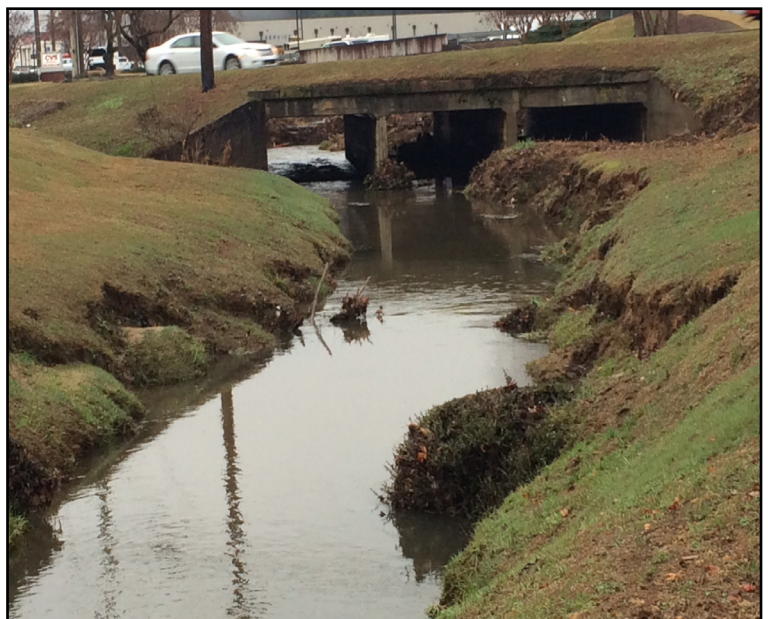
***Stekoa Creek's streambanks exhibit severe erosion damage from the impact of relentless stormwater runoff from Hwy. 441 and parking lots that cover the creek's 50-foot buffer zone.***

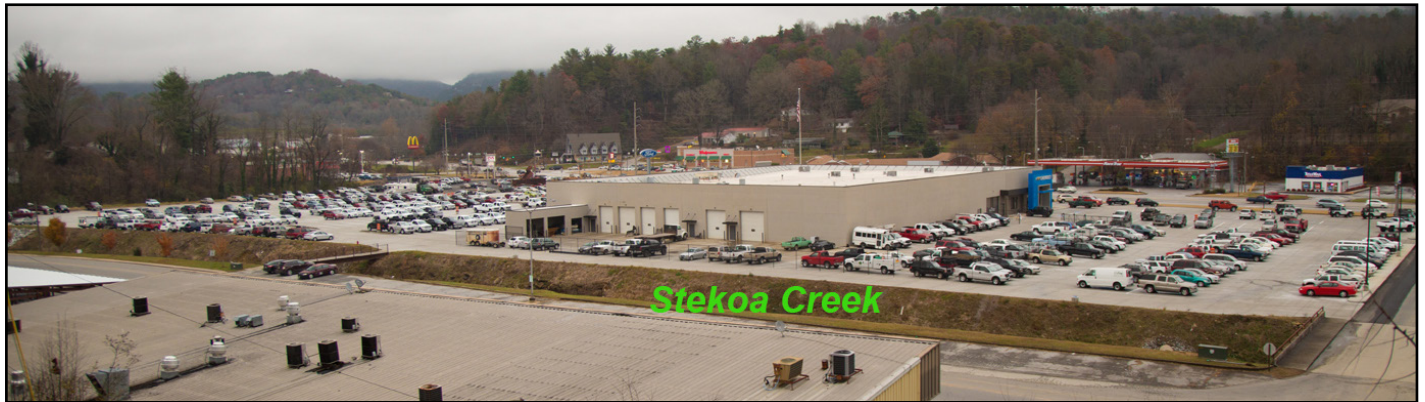
***A large swath of impervious surfaces behind the Duvall car dealership surround Stekoa Creek.***

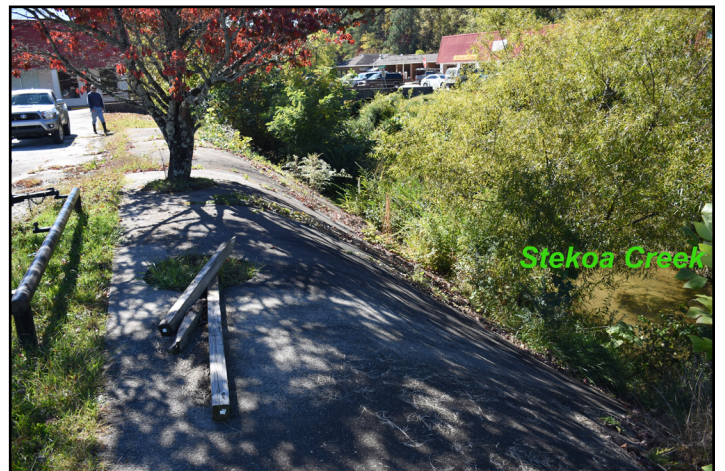
***Concrete embankments channel stormwater discharge into Stekoa Creek at a parking lot site in Clayton.***

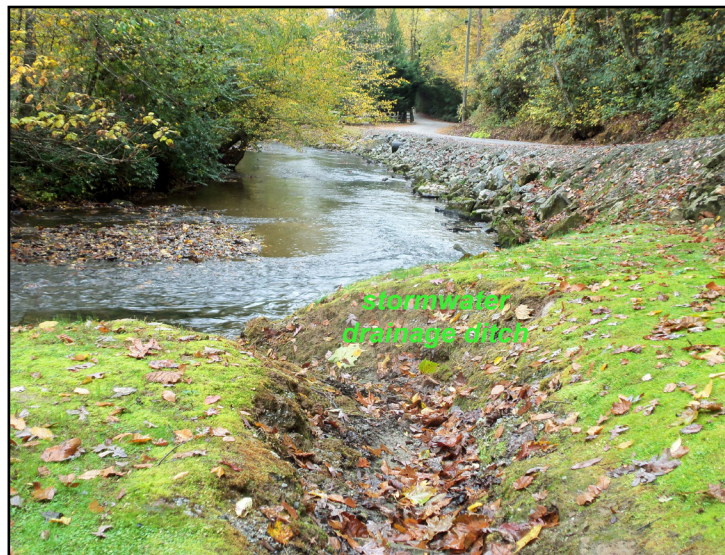
**Stormwater discharge from Rickman Airfield Road is directed into Stekoa Creek through ditches and culverts.**

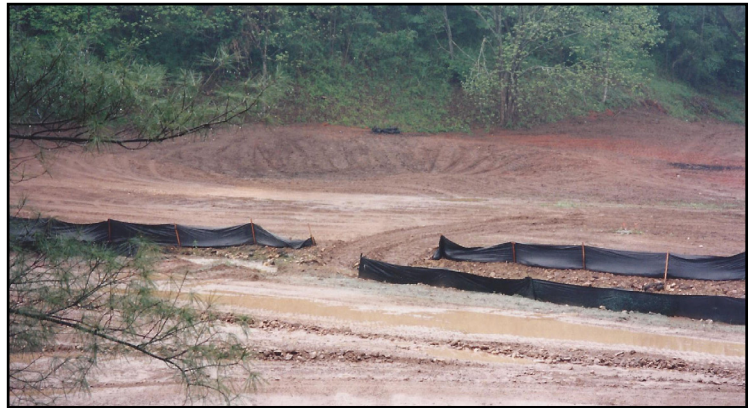
**The absence or improper design of BMPs during reconstruction of the Kingwood golf course caused a massive amount of dirt to wash into Chechero Creek, and evidence of this remains today.**

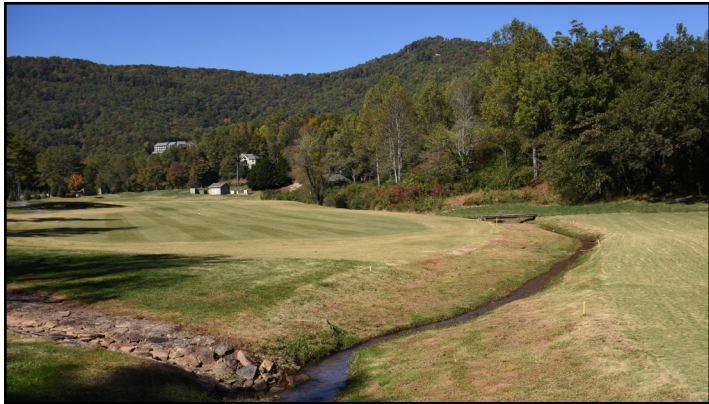
***Chechero Creek is channelized and stripped of native vegetation as it flows through the Kingwood golf course.***

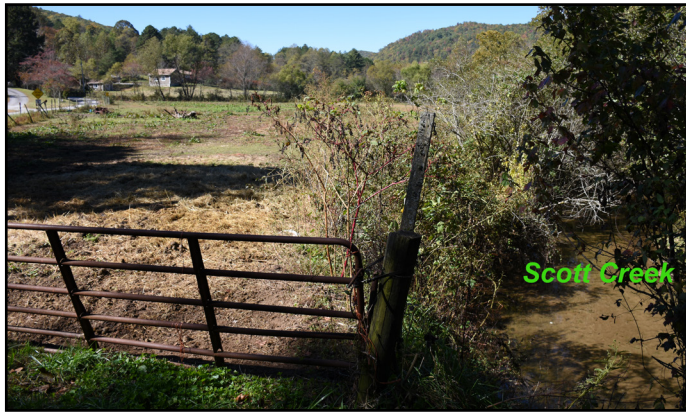
***Scott Creek's pollution sources include sites where livestock have access to the creek and stormwater from pastures flow into the stream.***

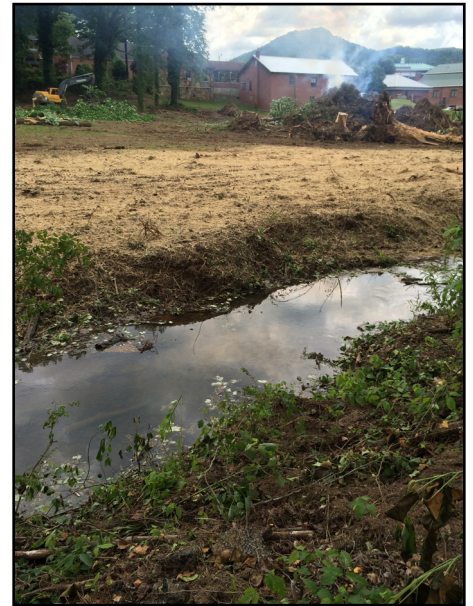
***Ginger Creek, tributary to Scott Creek, shows a lack of BMPs in its stream buffer zone as illustrated by this recent clearing operation.***

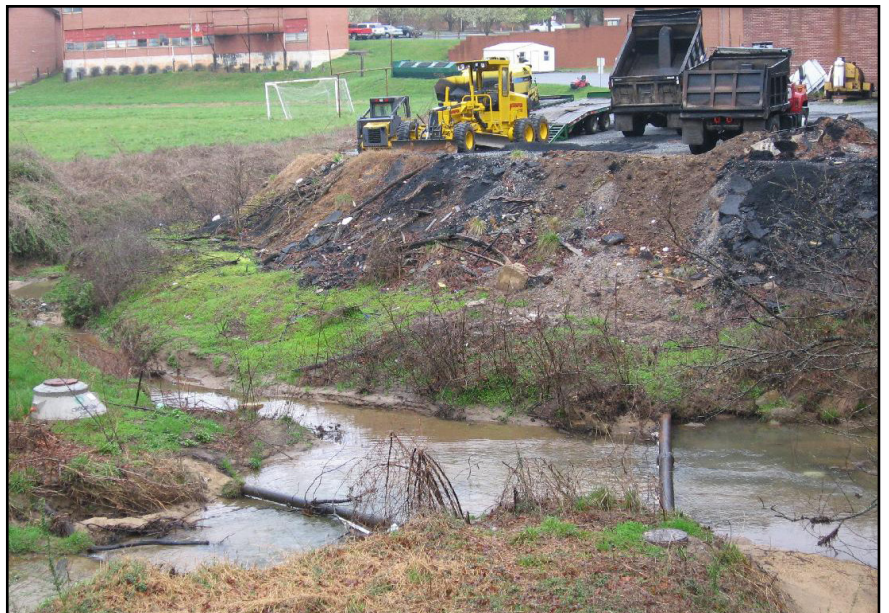
***Scott Creek, behind the Rabun County Civic Center, has been a dump for paving waste and also has a history of combined sewer overflows.***

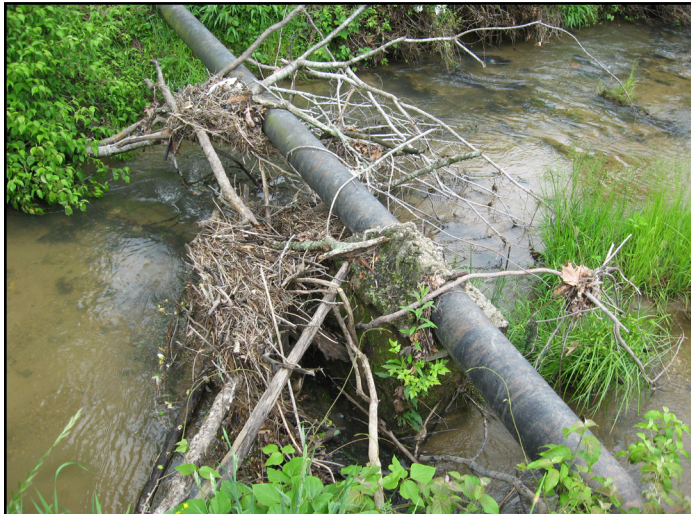
**Problematic sewage lines cross Scott Creek, oftentimes leading to flotsam and debris jams on the infrastructure.**

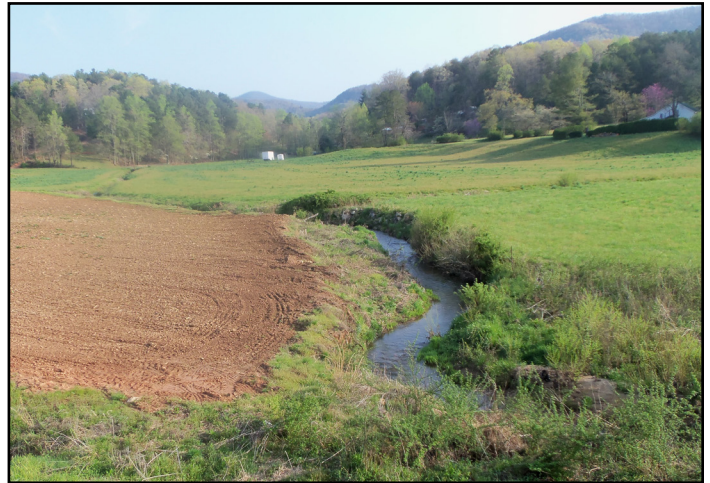
**Before crossing under Highway 76 East, She Creek borders the edge of a field that is plowed up to the edge of the stream, creating a chronic input of sediment into the creek.**

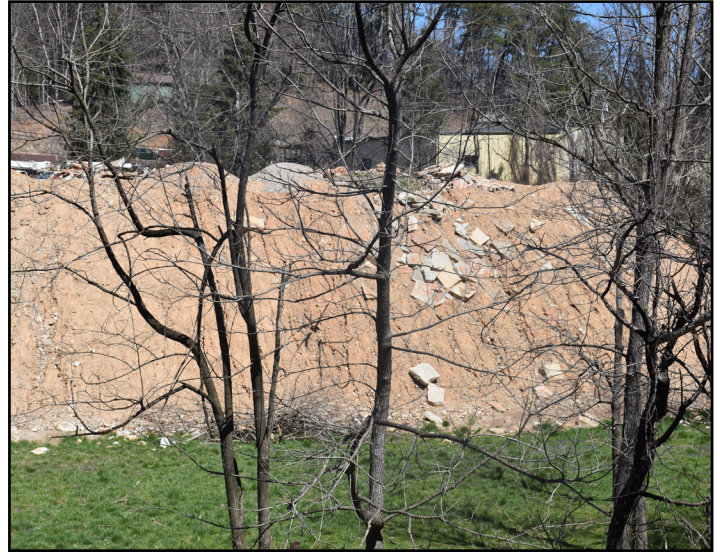
***Filling at this site next to Coffee Branch, a tributary to Stekoa Creek, lacks BMPs for stopping erosion into the stream.***

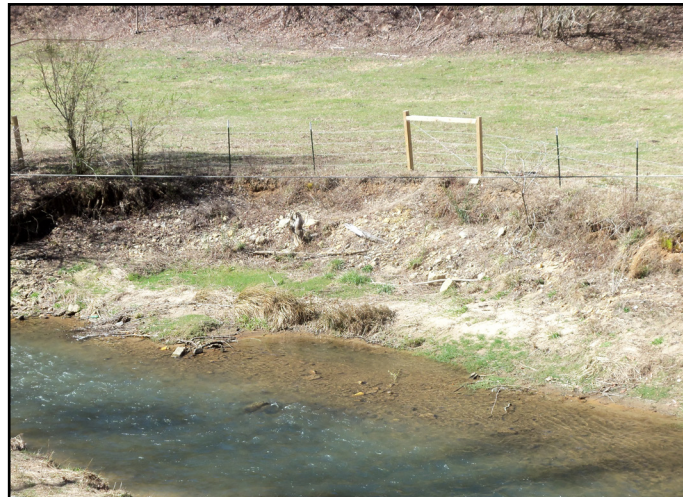
***Recently installed cattle exclusion fencing along a section of Stekoa Creek will help prevent further erosion of this streambank.***

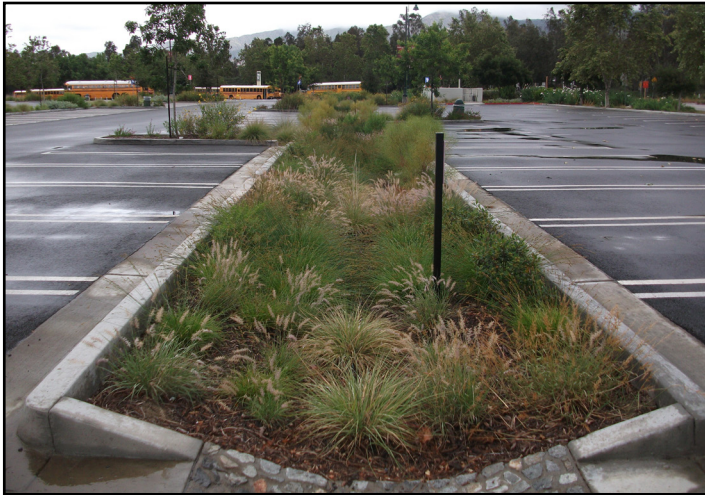
**A parking lot bioswale can control and naturally filter parking lot stormwater runoff.**

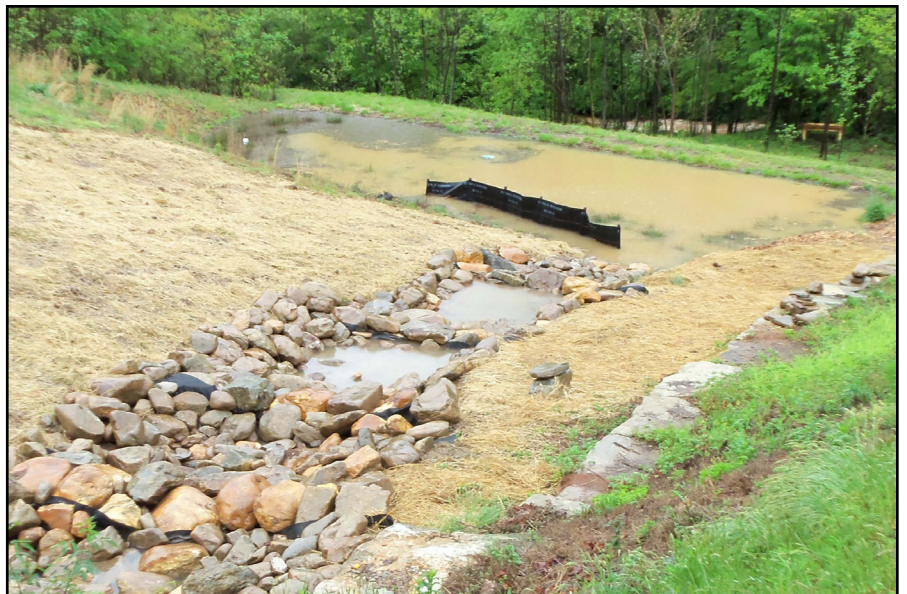
**A rain garden constructed at Stekoa Creek Park in 2014 prevents polluted stormwater from Highway 441 from flowing into Stekoa Creek.**

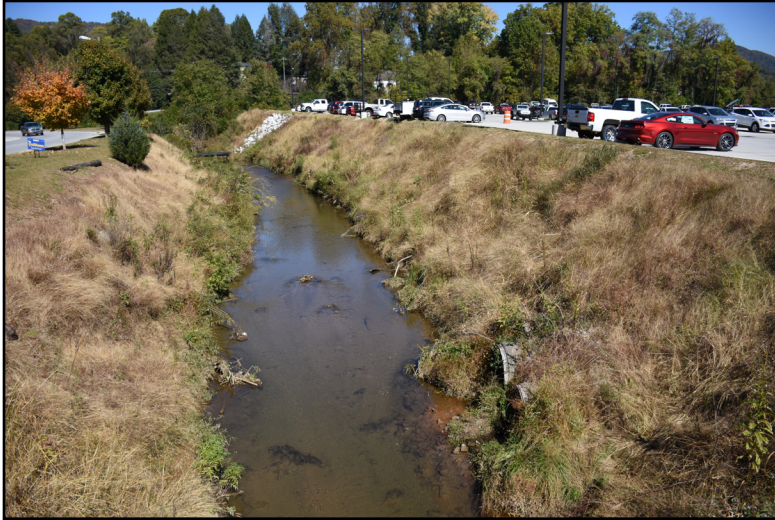
***In Clayton, sections of Stekoa Creek have undergone hydromodification that includes channelizing and confining the stream within rip-rap embankments.***

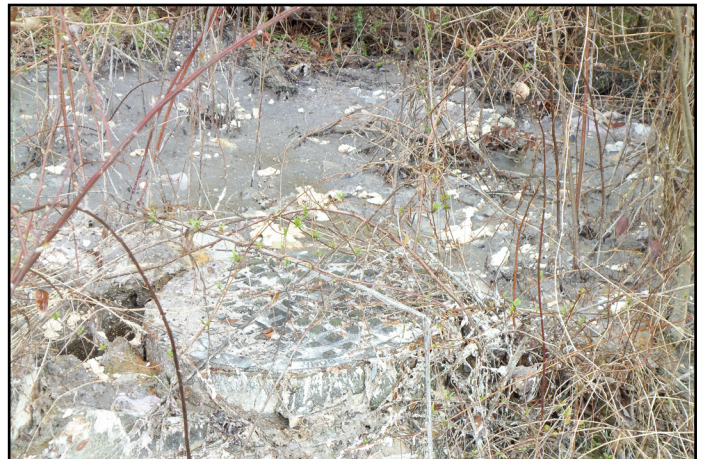
***A sewer manhole overflow into Coffee Branch, a tributary to Stekoa Creek, contributes to the bacteria load in Stekoa Creek.***

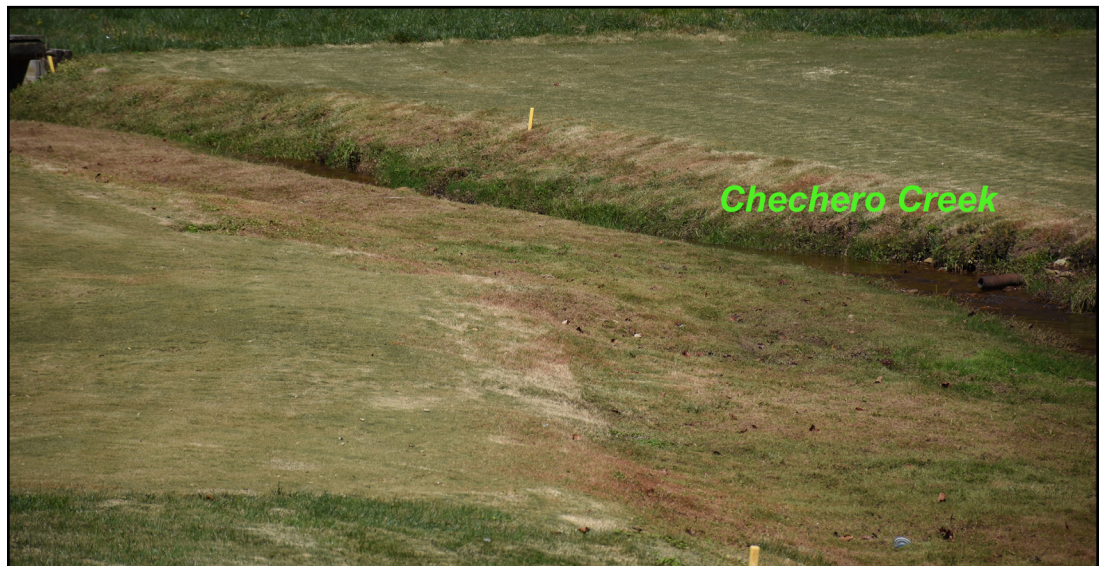
**Chemicals from the Kingwood golf course have the potential to contribute a significant amount of polluted runoff into Chechero Creek.**

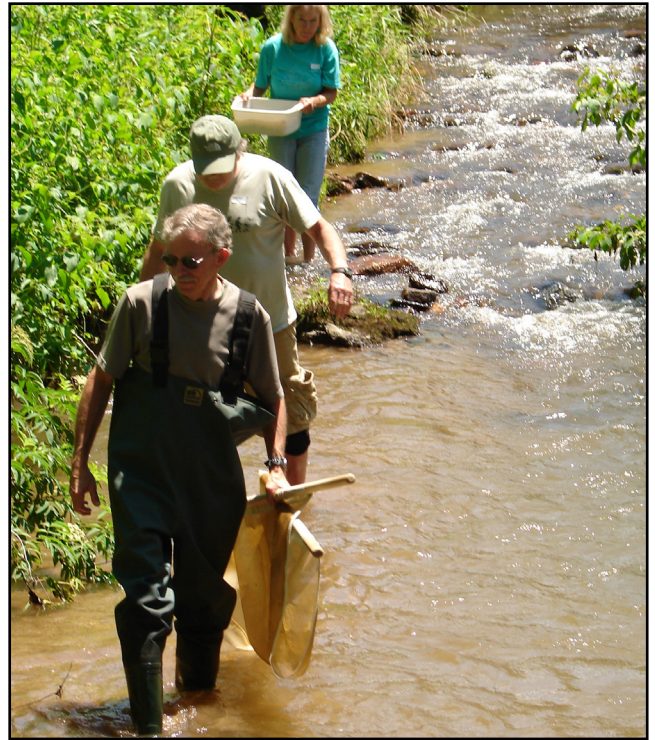
**An Adopt-A-Stream class monitors for benthic macroinvertebrates at Stekoa Creek Park.**

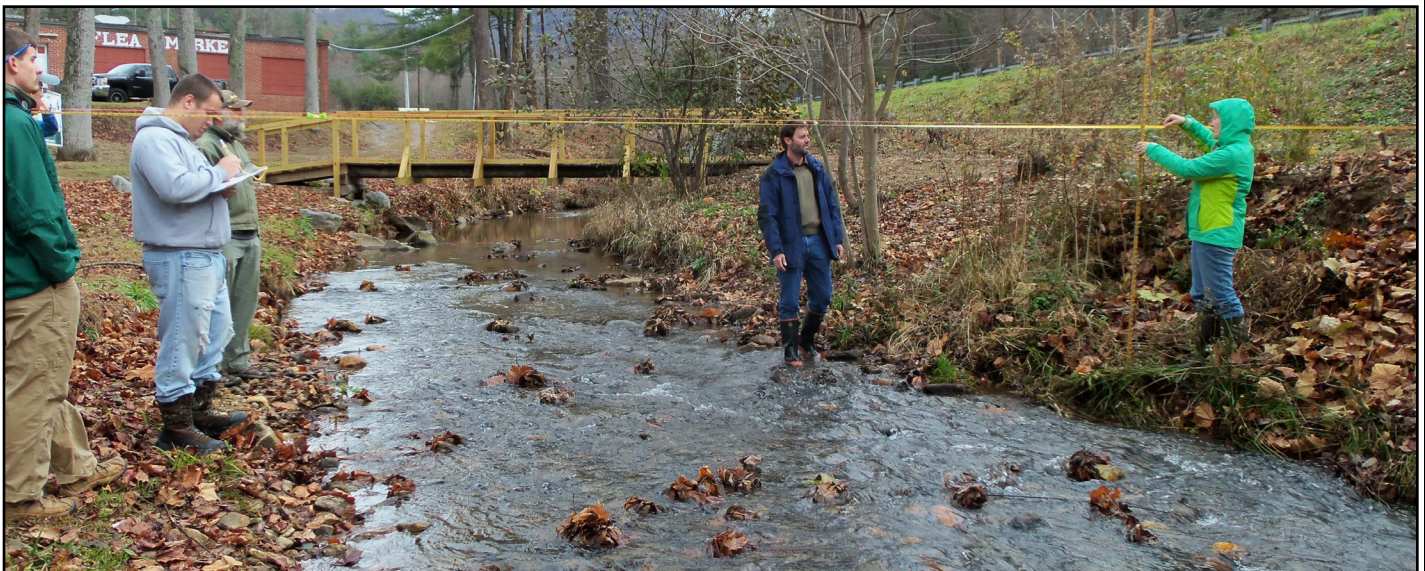
**Monitoring can include visual assessments of the quality of riparian area habitat.**
