# **Watershed Management Plan**

## **Trail Creek – West Fork**

**The Unified Government of Athens-Clarke County**

**December 2010**

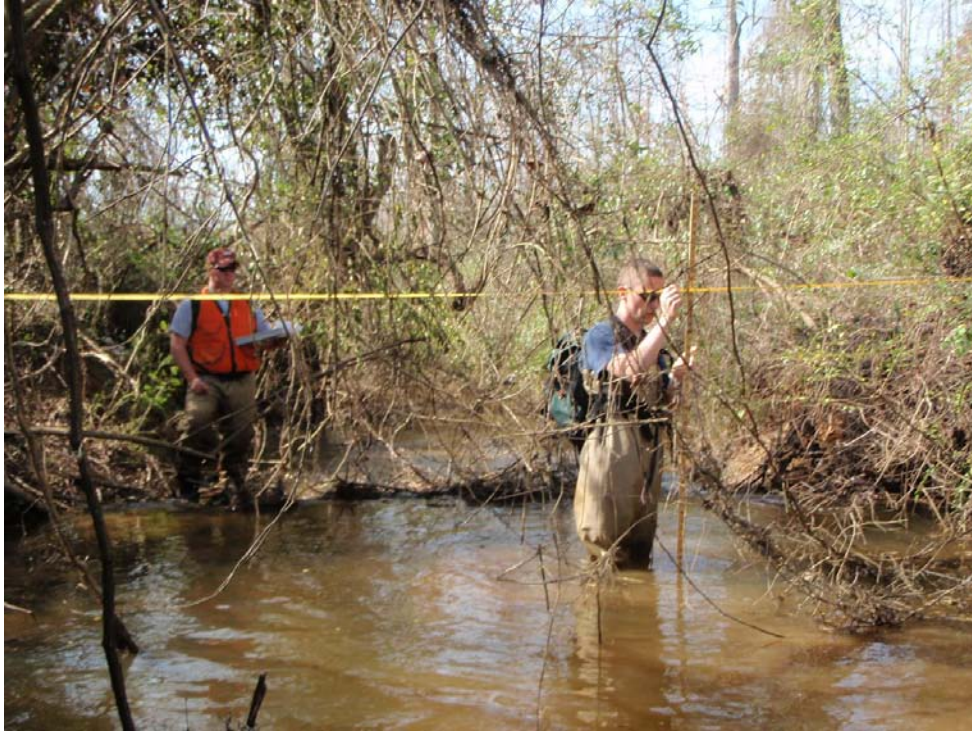
**Photo 3.1.1.1: Stream Assessment of Trail Creek – Taking Bed, Bank, and Buffer Measurements**

each reach and conducted an inventory of stream bed, stream bank, and stream buffer condition. (A stream buffer is the vegetated strip of land along either side of the stream.) Figure 3.1.1.1 shows the reaches surveyed in TCWF and the following photos highlight some of the areas in TCWF (Photos 3.1.1.1-3.1.1.2). Reaches are named alphabetically on the main stem of the West Fork of Trail Creek (e.g. TR-1d)

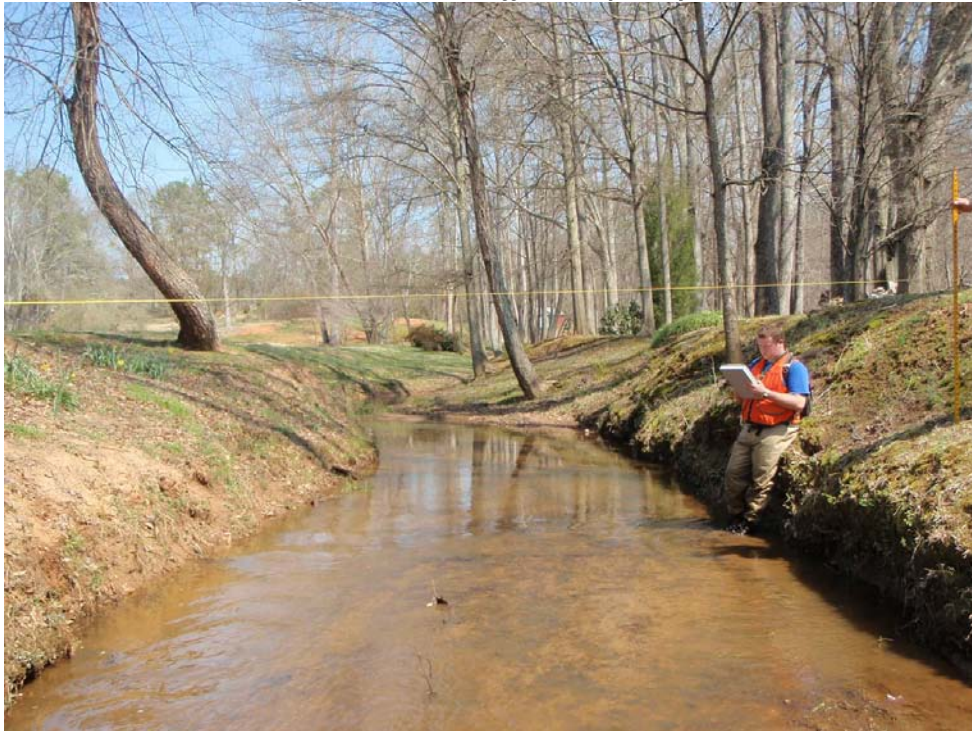
**Photo 3.1.1.2: Stream Assessment of Trail Creek – Buffer Completely Removed**

Trail Creek – West Fork near Hull Road

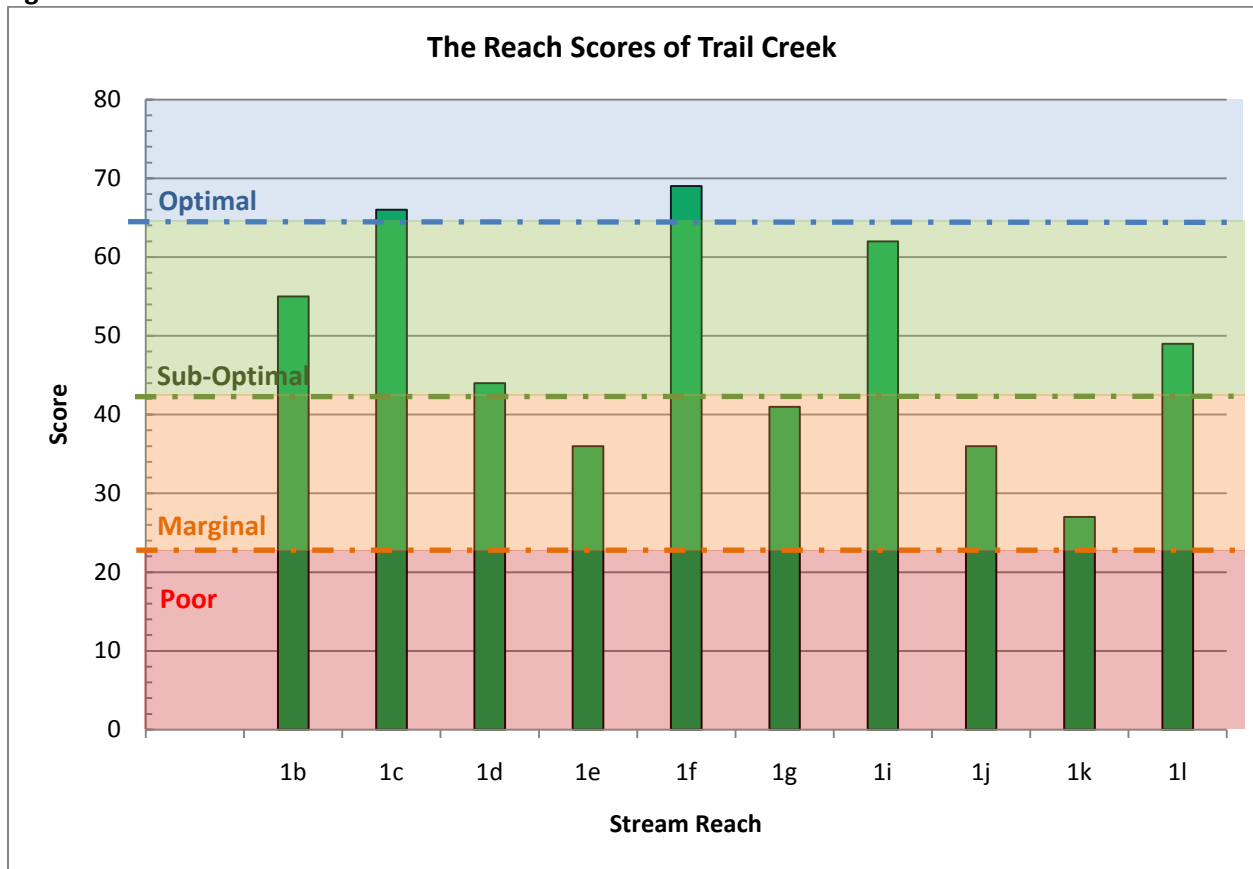
Figure 3.1.1.2: Reach Scores of Trail Creek – West Fork

Reach TR1f rated the highest (69). This reach was characterized by open water wetlands with low banks and very little erosion and intact buffers. Reach 1k rated the lowest (27). This reach was severely eroded with little to no buffer on the left bank and the bed consisting mostly of sand. This reach also contained to oxidation ponds at Country Corners Mobile Home Park.

Table 3.1.1.1 shows the breakdown of the reach assessment scores and the combined scores, as well as the average score of 49.

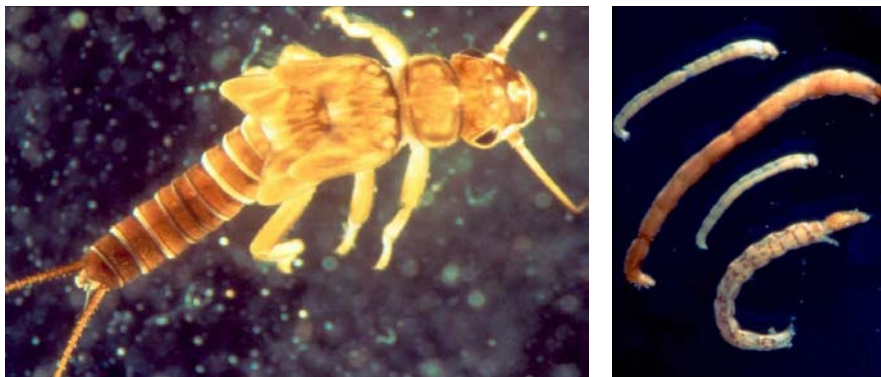
***Photo 3.2.1.1: Macroinvertebrates***

As mentioned earlier, macroinvertebrates are small bugs that can be seen with the human eye that live in the beds of streams. Since different species of macroinvertebrates are more sensitive to pollution and other impairments than others, the number and diversity of macroinvertebrates that are found in a stream can tell us a lot about water quality and stream health.

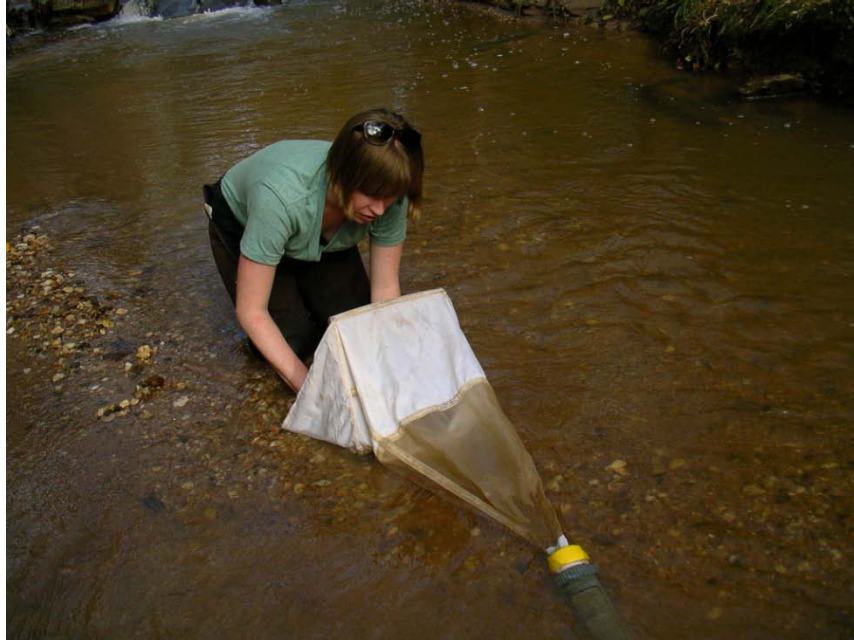
***Photo 3.2.1.2: Macroinvertebrate Sampling***

Macroinvertebrates were collected at three stream sites, shown in Figure 3.2.2.1, in Trail Creek in March of both 2008 and 2009 using a rapid assessment protocol, which is a time saving but scientifically sound way of collecting macroinvertebrate samples (as seen in Photo 3.2.1.2). The results from the sampling sites were scored using the *Save Our Streams Program* of the Izaak Walton League of America, which is based on the presence or absence of “sensitive,” “somewhat sensitive,” and “tolerant” types of macroinvertebrates. Numerical scores were used to indicate water quality (excellent > 22, good = 17-21, fair = 11-16, poor < 11).

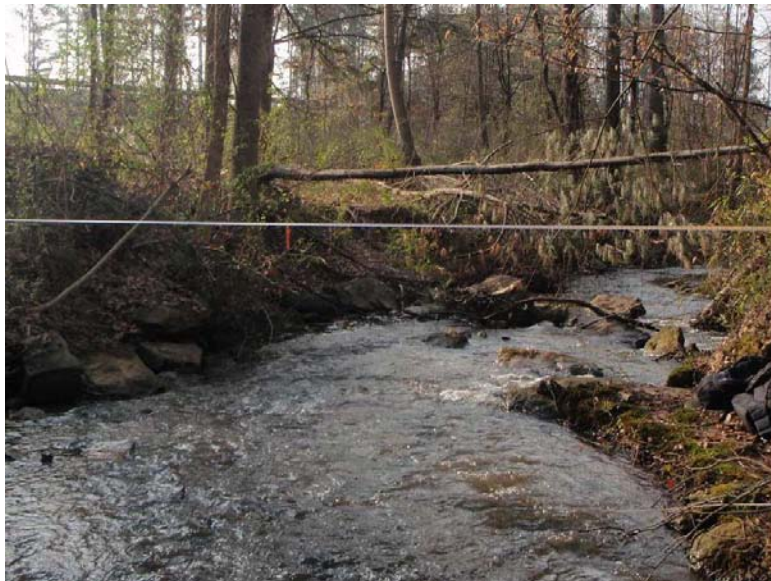
***Photo 3.2.4.1: Good Stream Habitat***

In Photo 3.2.4.1 cobble is present in the bed and undercut banks provide habitat for macroinvertebrates. In Photo 3.2.4.2, the bed is choked by sand and the heavily eroded banks provide no habitat.

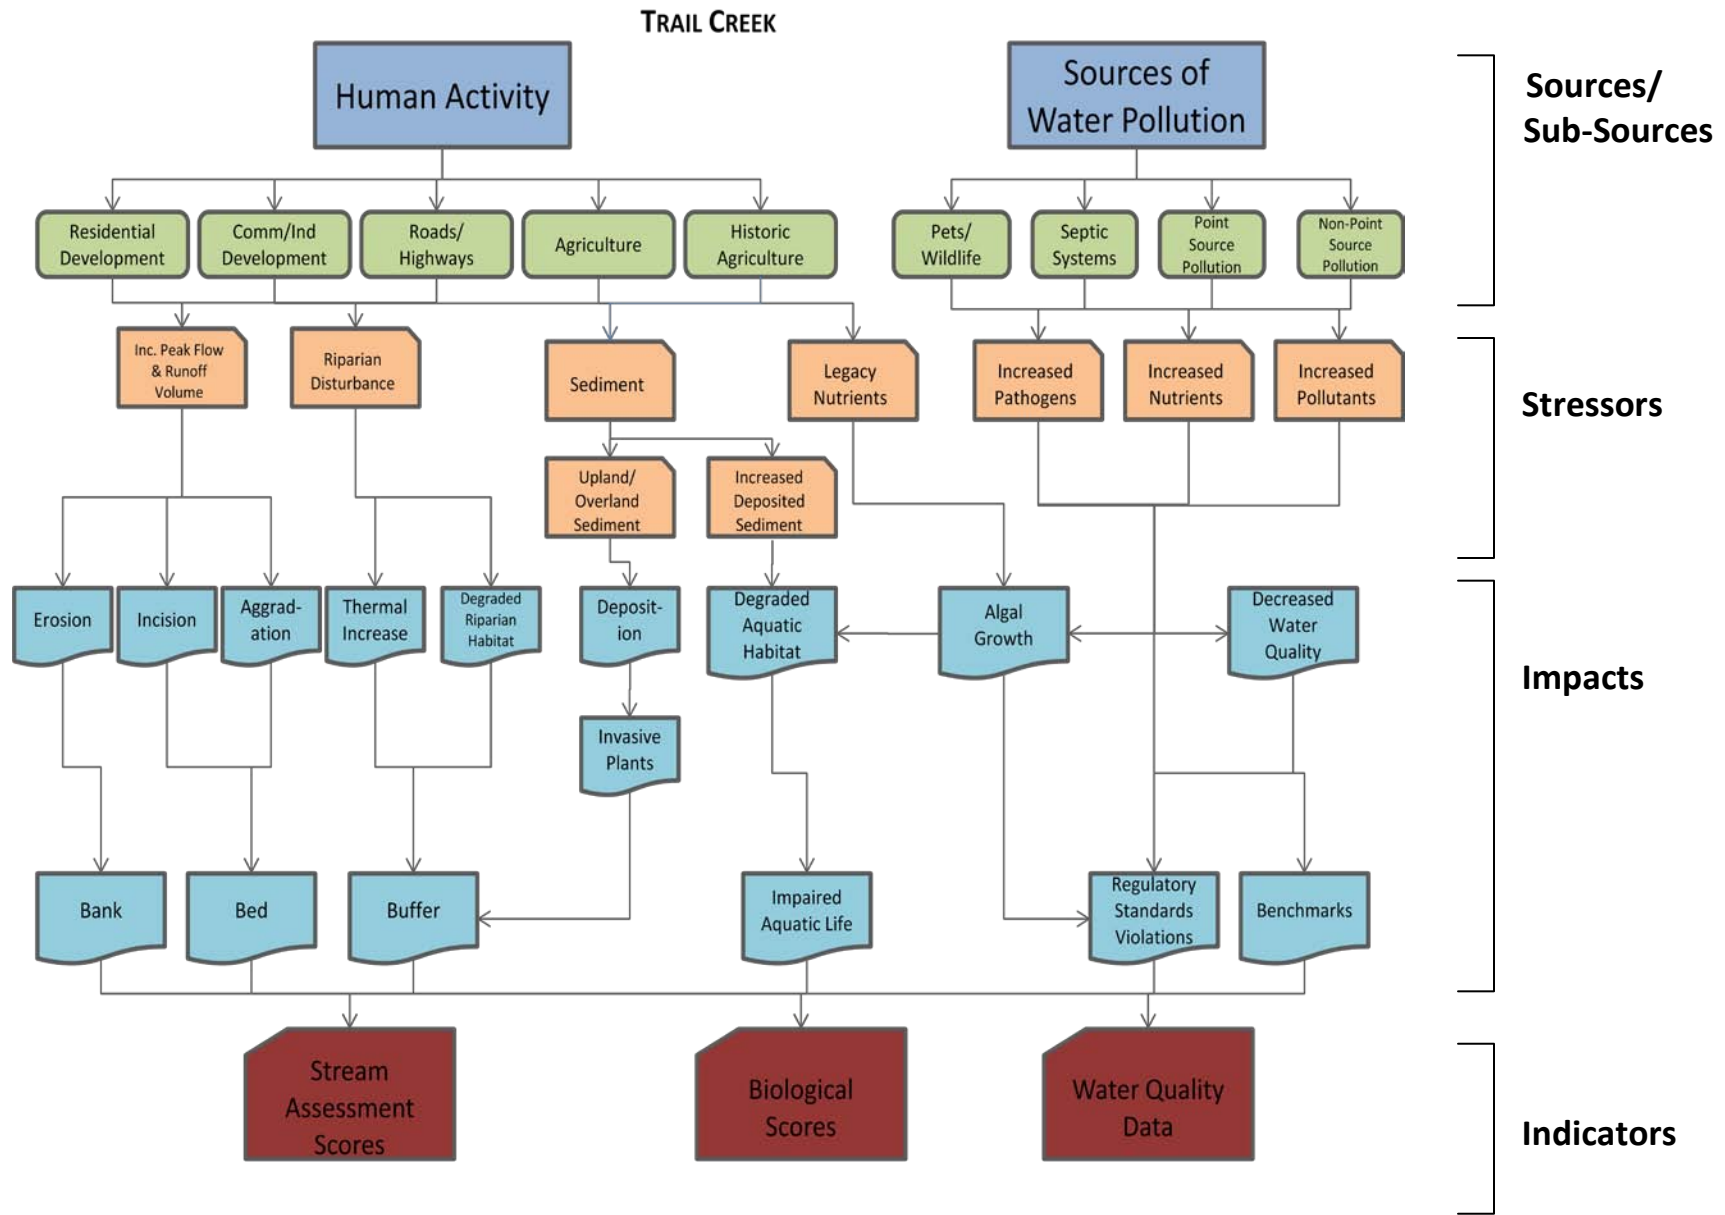
Figure 3.4.1 Conceptual Model of How Pollution Occurs in Streams

Moving up the model, we looked at the local impacts that lead to the indicators mentioned above. These are the “evidence” that a stream is suffering from some type of water pollution. These indicators include specific impacts with a direct correlation to Water Quality Data like regulatory standards violations and missed benchmarks stemming from algal growth and decreased water quality. Degraded aquatic habitat and impaired aquatic life affect biological scores. In the physical assessment of the stream, we focused on the bed, banks, and buffers and noted the particular impact of erosion, incision, aggradation, and degraded riparian habitat in Trail Creek.

Finally, more global sources of stream degradation include Urban Development, Historical Agriculture, and other Sources of Water Pollution. In this study of Trail Creek, it is evident that a majority of the issues in this watershed stem from human sources, particularly Historical Agriculture and Urban Development. Sources of Water Pollution also contribute to poor water quality, but the data does not suggest that the impacts are as great as Historical Agriculture and Urban Development.

Overall, as mentioned, the driving factor on the condition of TCWF is human activity. We can point to three key stressors as having impacts on aquatic life, hydrologic function, and water quality. These

stressors are sedimentation and hydromodification due to development, fecal coliform contamination, and excessive nutrients. Land disturbance in the form of historical agriculture as well as more recent development has contributed to stream sedimentation. This sediment is not readily moving through the system due to the stream's inability to generate enough energy and flow as a result of low grade and the presence of beaver dams, wetlands, and NRCS lakes. Fecal coliform contamination has already resulted in the stream being listed on the state's 303(d) list; however, the sources of this contamination are uncertain at this time and the data shows no signs of a continuous source. Further source identification is needed. The lack of stormwater BMPs and noted urban and suburban development are likely the dominant factor in nutrient loading from nonpoint sources in TCWF. However, there are methods for controlling some nutrient inputs, such as fertilizers, including education and outreach.
