Two Mile Branch Watershed Management Plan

City of Valdosta, Georgia

November 2007

Stantec

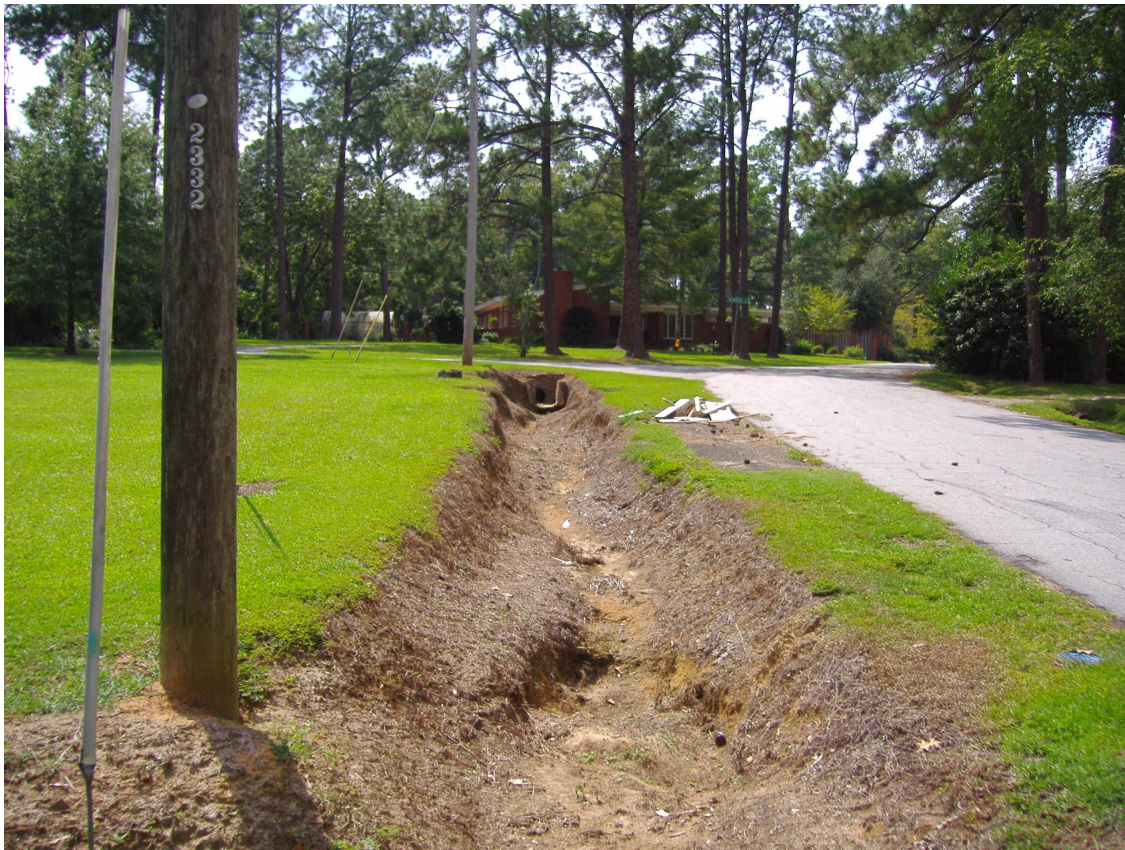
Figure 12. Eroding roadside ditch

Another sediment source found in portions of the watershed was eroding ditches (See Figure 12). Some ditches had steep, vertical banks and it was evident that sediment was carried downstream during storm events. It also appeared some of the ditches were sprayed in order to kill vegetation or they were mowed. Vegetation helps stabilize ditches and should not be removed. Those ditches that appeared to be in the worst shape were identified and recorded (See Figure 10).

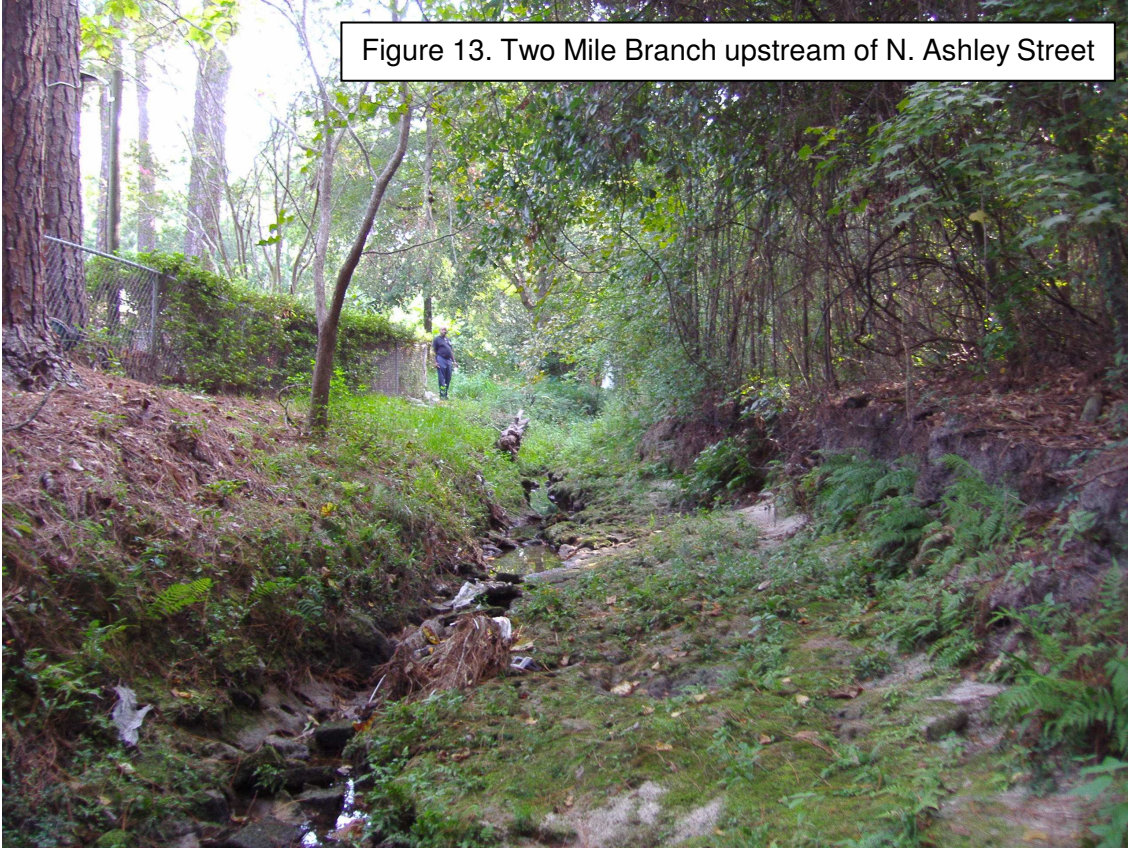
Figure 13. Two Mile Branch upstream of N. Ashley Street

With regard to instream sediment and erosion problems, the main stem of Two Mile Branch was incised and actively eroding along the majority of its length. In the portion upstream of N. Ashley Street, the channel was eroded down to the hardpan and a new channel had begun to form within it (See Figure 13). From N. Ashley Street downstream, the streambanks were steep and eroding (See Figure 14). Given these observations of geomorphic conditions in Two Mile Branch, the channel itself is likely to be the single largest source of sediment transported downstream to Joree Millpond and will continue to be so into the future without active measures to stabilize the stream and implement additional stormwater control.

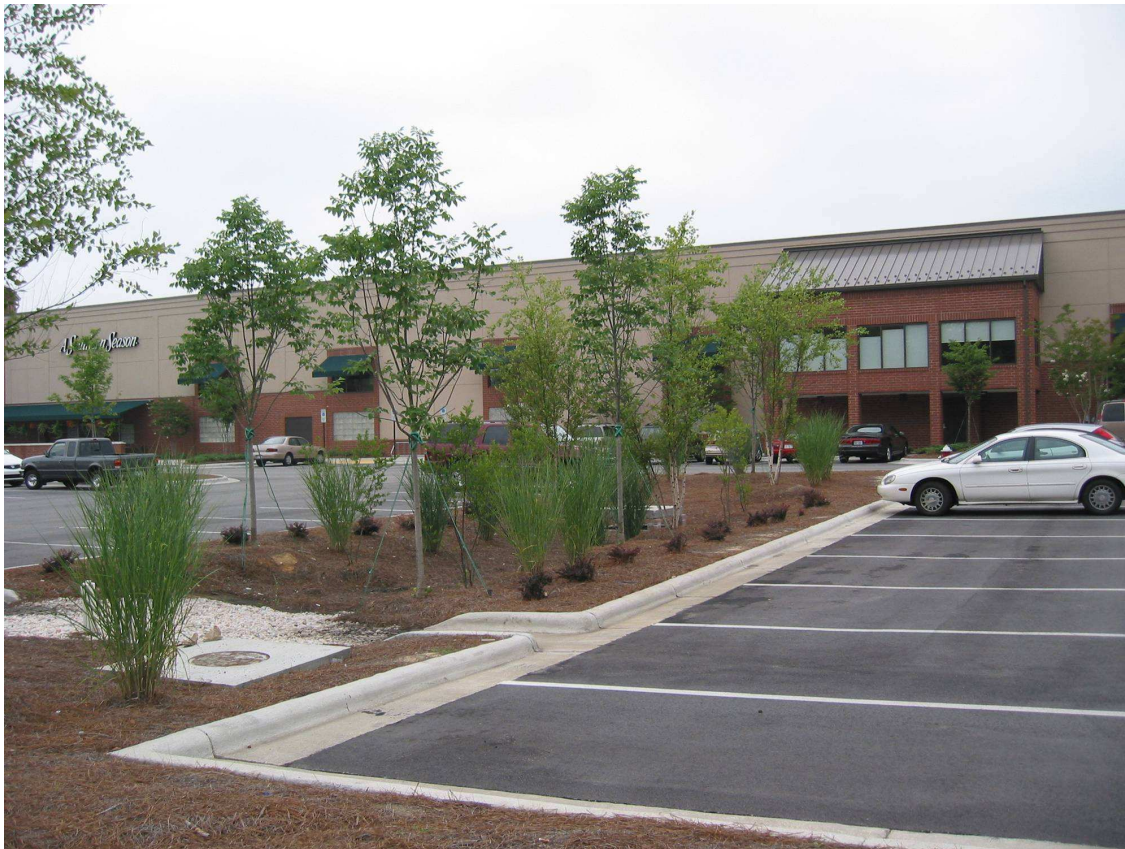
Figure 16. Bioretention cell located in a shopping center

Bioretention cells remove pollutants using physical, chemical, and biological processes including absorption, microbial action, plant uptake, sedimentation, and filtration. Bioretention areas differ from detention ponds and stormwater wetlands because they only hold water for short periods of time. They usually drain down within 24 hours after a rain event (Hunt 1999). A typical bioretention area includes a set of underdrains overlain by a specialized sandy fill media that ranges from 2 to 4 feet deep. The underdrain allows treated stormwater to enter the stormdrain system or be discharged into a grass channel. Since water drains down quickly, bioretention areas can be landscaped with typical landscaping plants surrounded by a mulch layer. It is important to spread out the vegetation to allow sufficient sunlight to reach the mulch layer. A layer of mulch covers the surface. Bioretention cells should be located in areas where the water table is at least 2 feet below the surface.

Most of the proposed projects in Two Mile Branch are bioretention cells. These cells are a good fit for small drainage areas (less than 10 acres) with high levels of impervious surfaces as they can be used as a landscape feature for a commercial or institutional property. Bioretention cells are particularly suitable for urban landscapes because they require small areas for implementation and can often be constructed in existing green spaces such as traffic islands.

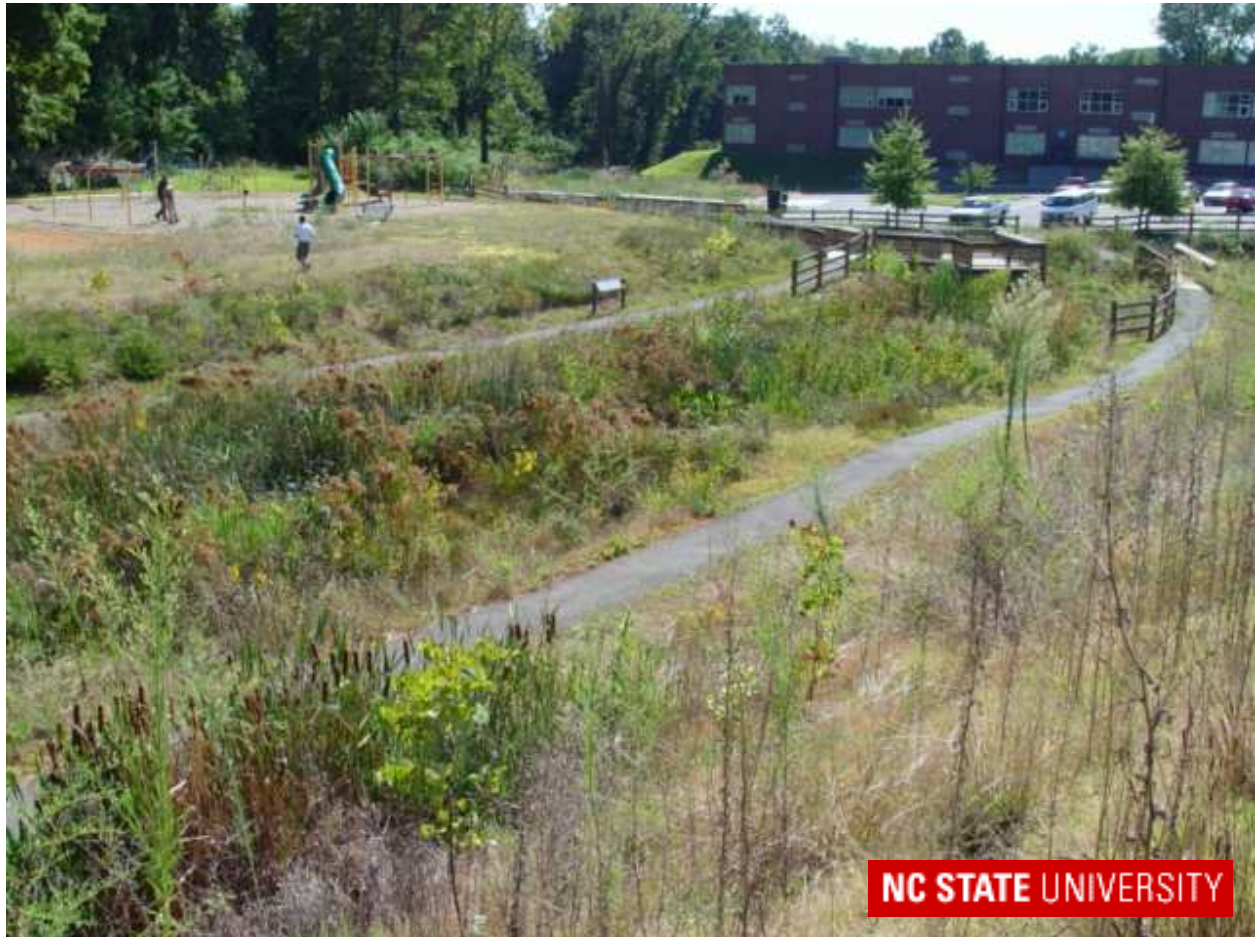
Figure 17. Stormwater wetland at an elementary school

submerged areas, or shallow land, is only wet during storm events and provides a place for vegetation that likes to be wet only some of the time. This area accounts for 30-40% of the wetland. Finally upland areas can be included in the wetland design to allow for observation points. The diverse vegetation found in a stormwater wetland helps prevent mosquitoes by attracting other insect and bird species. The vegetation also provides aesthetic value for the community (See Figure 17).

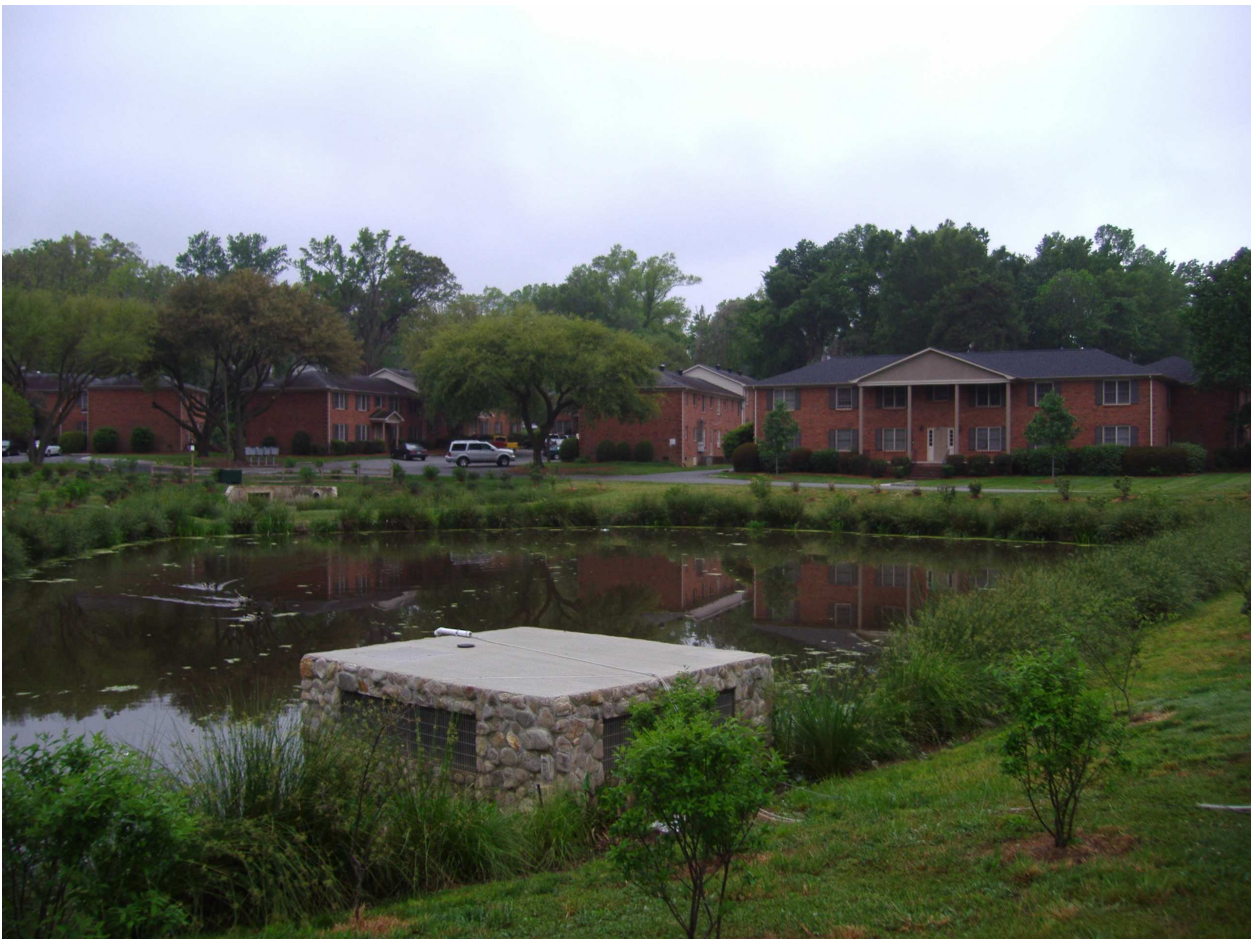
Figure 18. Detention pond retrofit with new forebay and vegetated shelf

Although Joree Millpond was not designed as a BMP, it does help improve water quality. The millpond essentially acts as a large regional detention pond, holding water and allowing sediment to settle out. Creating a littoral shelf around the north and south edges of the pond will improve these water quality functions. The vegetation planted on the shelf will help prevent erosion along the pond edge and will slow water entering from the outfalls located along the north side. Figure 18 is an example of a detention pond with mentioned retrofits.

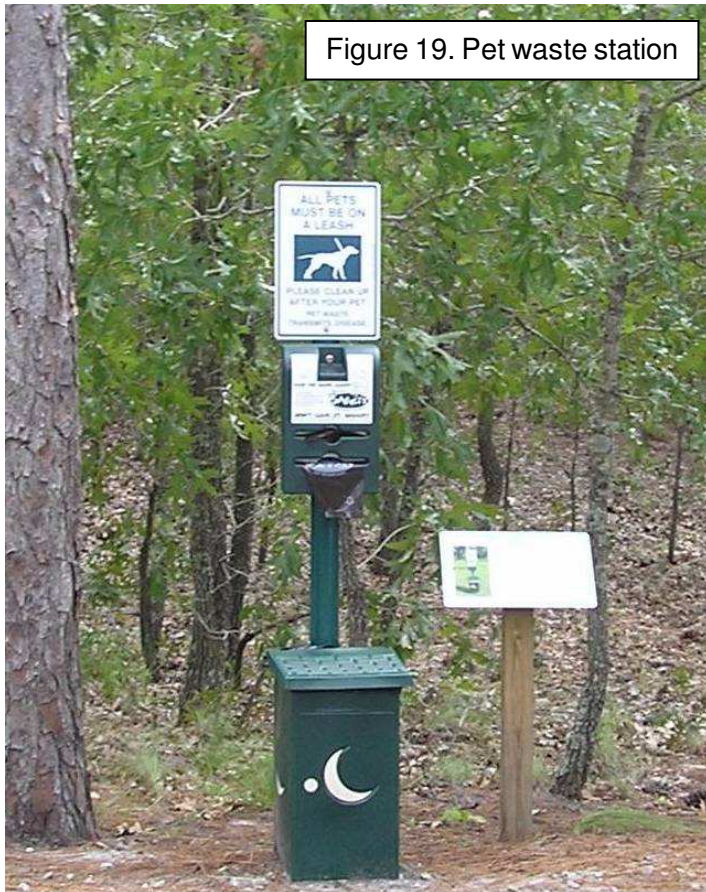
Pet waste collection stations are comprised of an educational message, instructions for proper use, plastic bags for collecting waste, and a garbage can for disposal (See Figure 19). It is recommended that these stations be located where pet owners need them most, including parks and rest areas. The stations can be built by local organizations, allowing them to be specifically designed to fit budgetary constraints. The NC DOT implemented such a program by installing stations at rest areas along major highways in North Carolina. A survey conducted on the success of the stations showed that approximately 70% of the people used the pet waste bags provided (Holman, 2007a). It should be noted that an increase in fecal coliform levels occurred after a station was installed near an urban stream in Charlotte, NC. Investigation showed that the station only provided bags and did

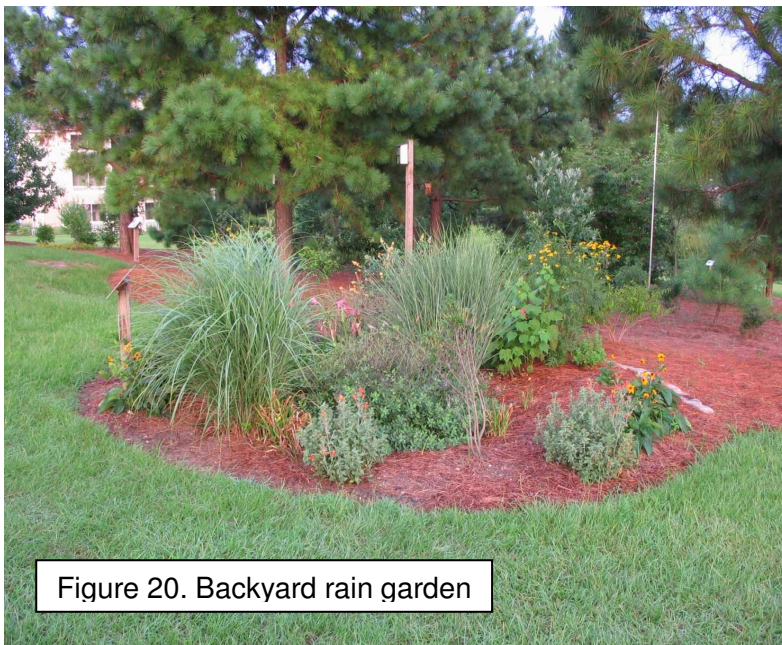
A rain garden is a planted depression designed to absorb rainwater runoff from impervious surfaces such as driveways, roofs, sidewalks, and compacted lawns, trapping water before it reaches storm drains and streets. Runoff is decreased in two ways: the trapping of the rainwater increases infiltration to groundwater, and the plantings absorb excess water and transfer it to the atmosphere via transpiration. Rain gardens also have the added benefit of providing habitat beneficial to wildlife. When properly landscaped, standing water is only present in the garden for a day or two as it slowly filters into the ground, and does not become a breeding ground for mosquitoes.
